**REPORT OF COMPLIANCE SAMPLING INSPECTION (CSI) &  
INDUSTRIAL STORMWATER  
COMPLIANCE EVALUATION INSPECTION (CEI)**

**Lehigh Cement Company, LLC  
700 25<sup>th</sup> Street NW  
Mason City, IA 50401**

NPDES NO: IA0001945  
STATE PERMIT NO: 1700100  
&  
NPDES NO: IA0072907  
STATE PERMIT NO: 1700113

**U. S. ENVIRONMENTAL PROTECTION AGENCY  
Region 7  
Enforcement and Compliance Assurance Division (ECAD)**

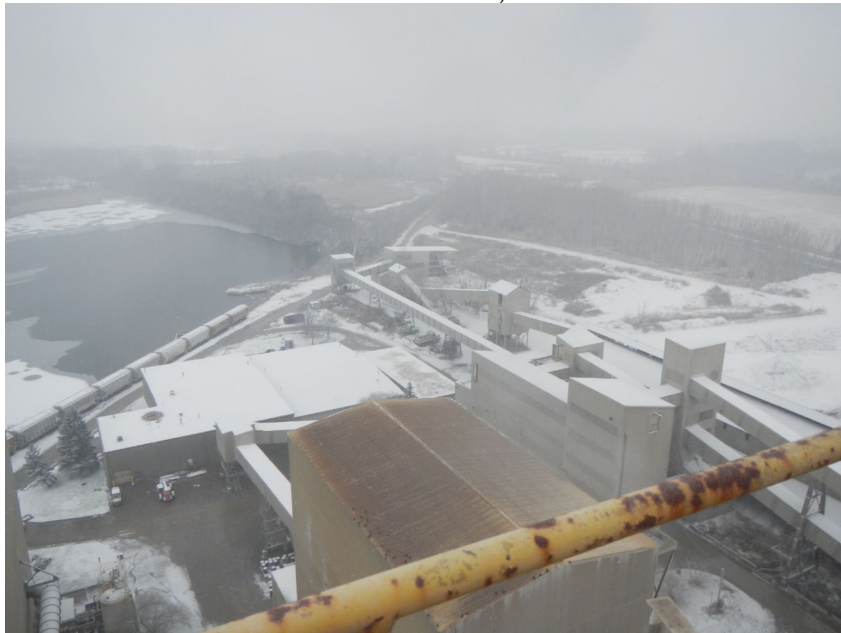
| Compliance<br>Evaluation<br>Inspection<br><br>Direction: NW | DESCRIPTION | Overview shot of the facility, facing west, from the top of the mill. | 7 |

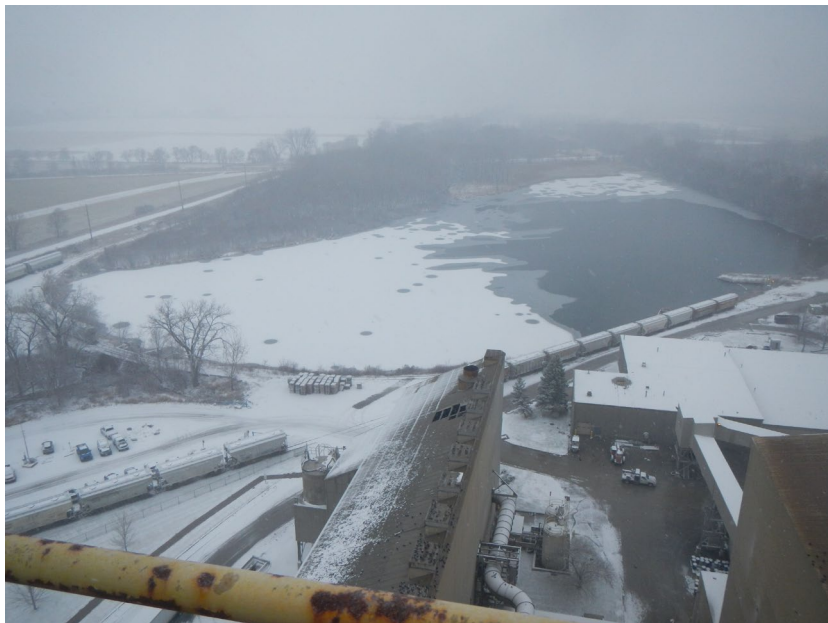
| Compliance<br>Evaluation<br>Inspection<br><br>Direction: SW | DESCRIPTION | Overview shot of the facility, facing west, from the top of the mill. | 8 |

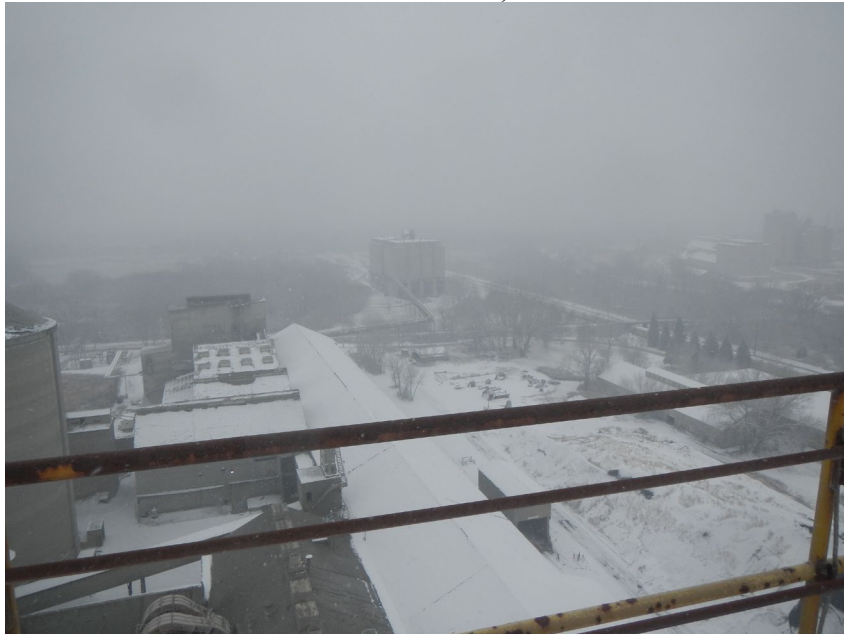
| Compliance<br>Evaluation<br>Inspection<br><br>Direction: SE | DESCRIPTION | Overview shot of the facility, facing east, from the top of the mill. | 9 |

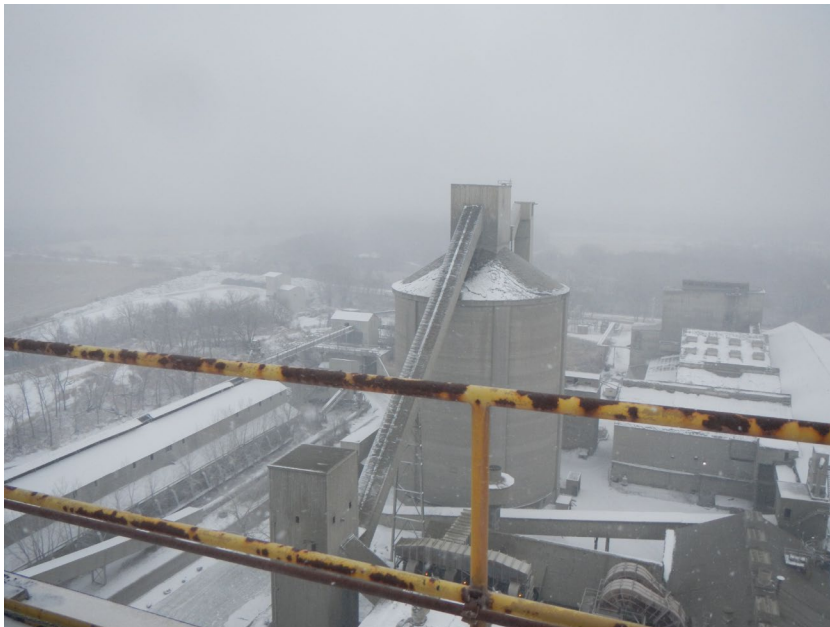
| Compliance<br>Evaluation<br>Inspection<br><br>Direction: NE | DESCRIPTION | Overview shot of the facility, facing east, from the top of the mill. | 10 |

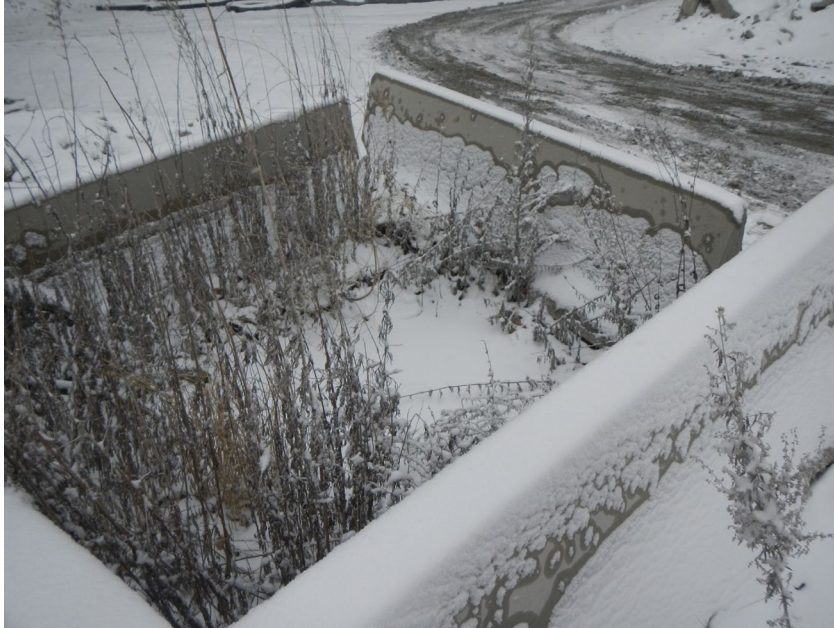
| Compliance<br>Evaluation<br>Inspection | DESCRIPTION | Stormwater collection basin | 13 |

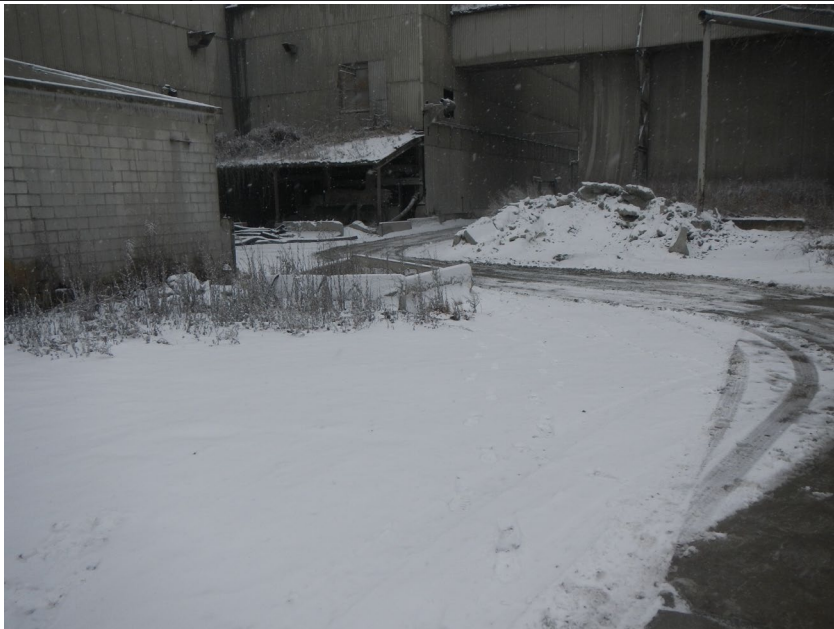
| Compliance<br>Evaluation<br>Inspection | DESCRIPTION | Overview of stormwater flow to the stormwater collection area in photo 13. | 14 |

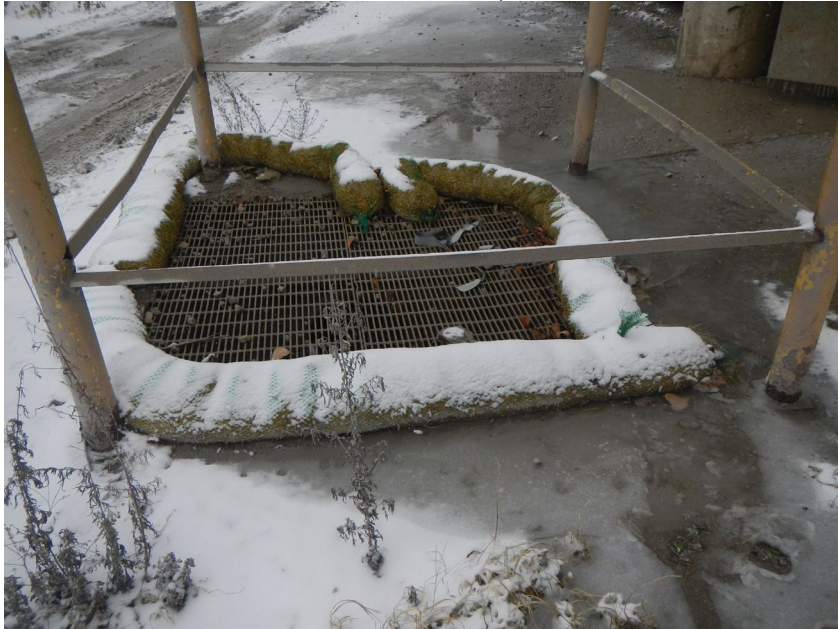
| Compliance<br>Evaluation<br>Inspection | DESCRIPTION | Stormwater collection pit | 15 |

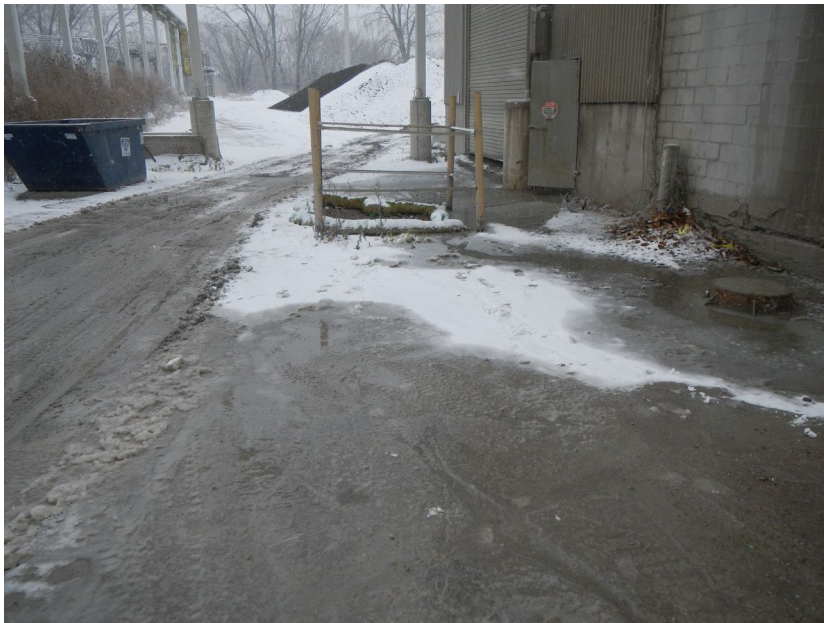
| Compliance<br>Evaluation<br>Inspection | DESCRIPTION | Stormwater collection pit from photo 15 | 16 |

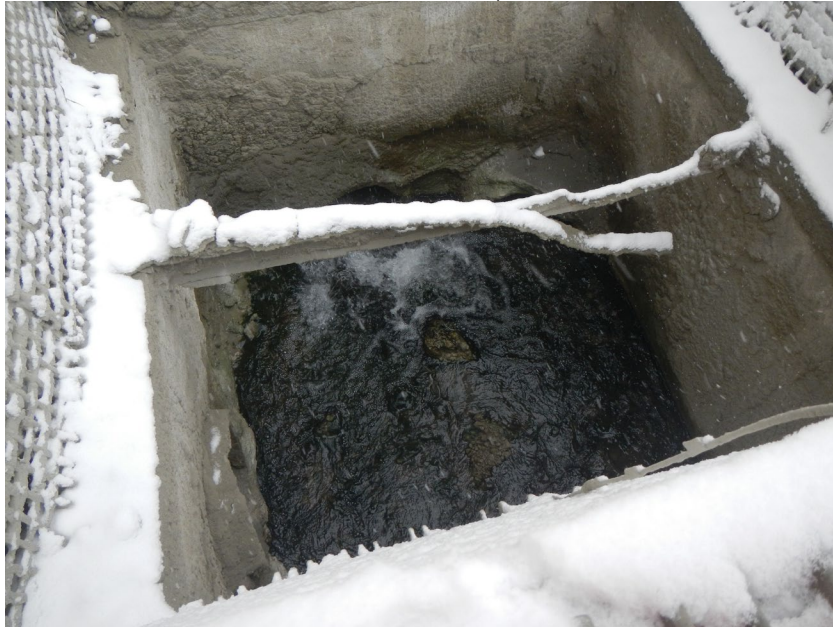
| Compliance<br>Evaluation<br>Inspection | DESCRIPTION | Outfall 002 sampling point and stormwater collection pit | 17 |

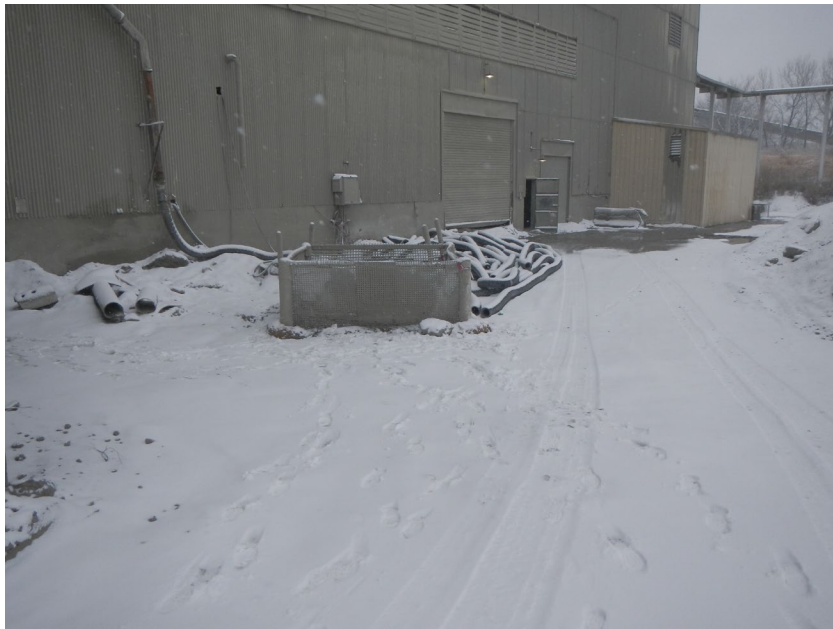
| Compliance<br>Evaluation<br>Inspection | DESCRIPTION | Overview of outfall 002 sampling point | 18 |

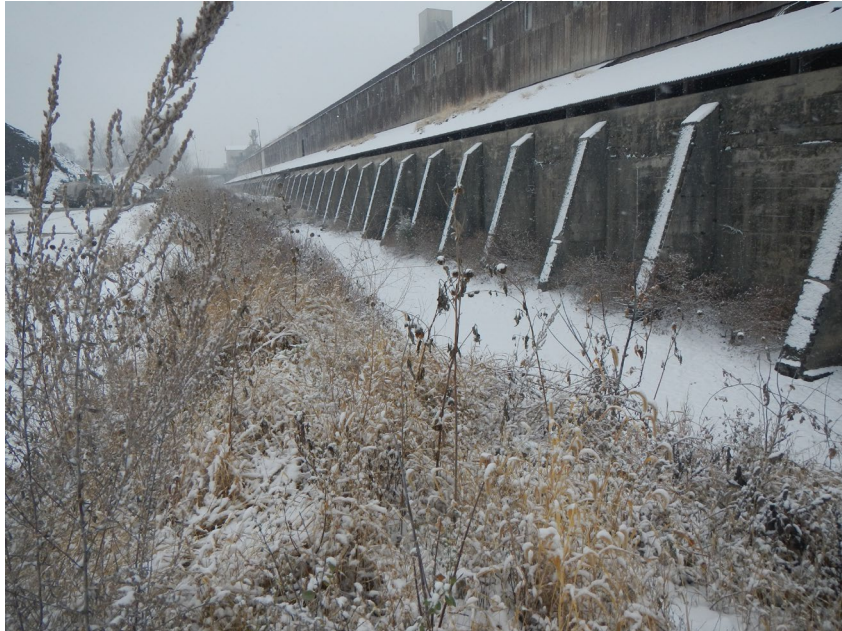
| Compliance<br>Evaluation<br>Inspection<br><br>Direction: SE | DESCRIPTION | Stormwater collection ditch along north side of facility | 19 |

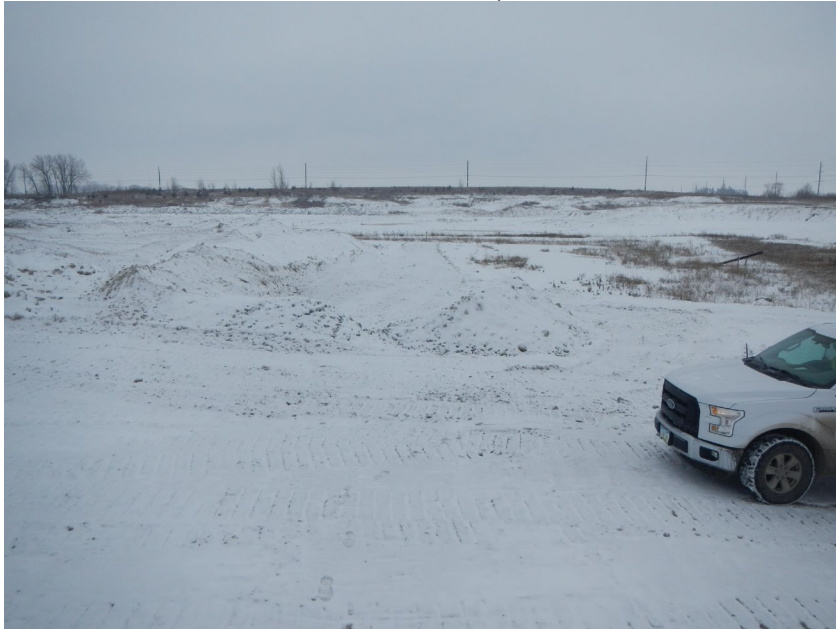
| Compliance<br>Evaluation<br>Inspection | DESCRIPTION | Area around the landfill | 23 |

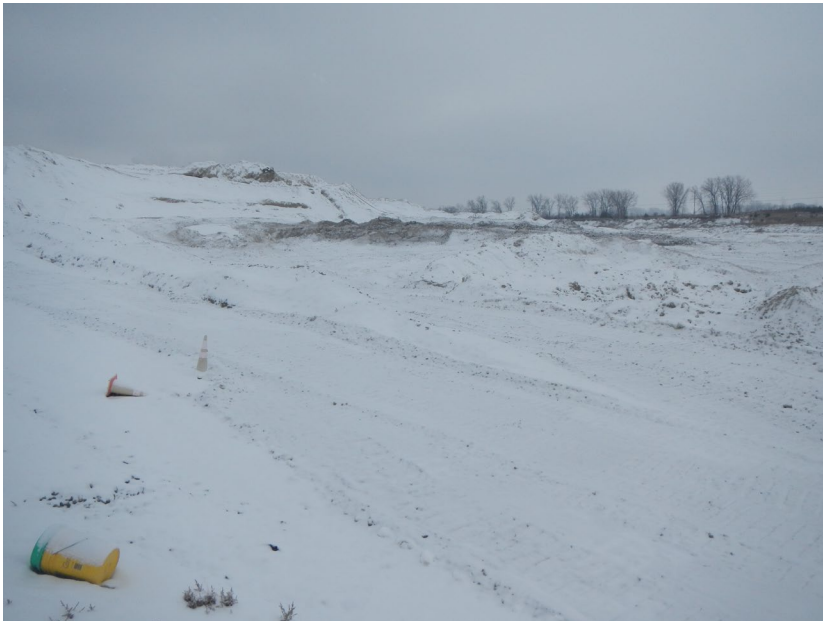
| Compliance<br>Evaluation<br>Inspection | DESCRIPTION | Haul road going into the landfill. CKD landfill in the background. | 24 |

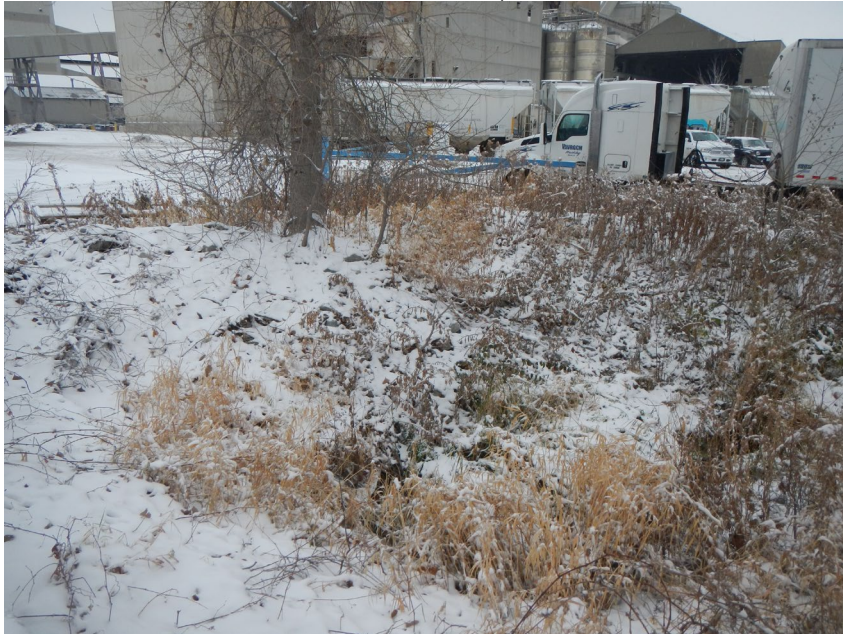
| Compliance<br>Evaluation<br>Inspection<br><br>Direction: NE | DESCRIPTION | Outfall 001 and 012 | 27 |

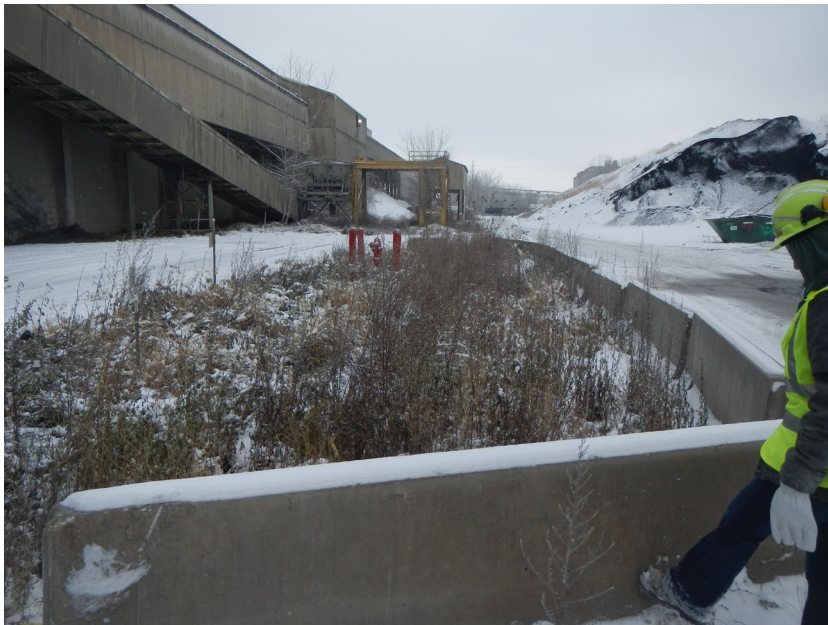
| Compliance<br>Evaluation<br>Inspection<br><br>Direction: E | DESCRIPTION | Drainage collection ditch along south side of craneway storage building. | 28 |

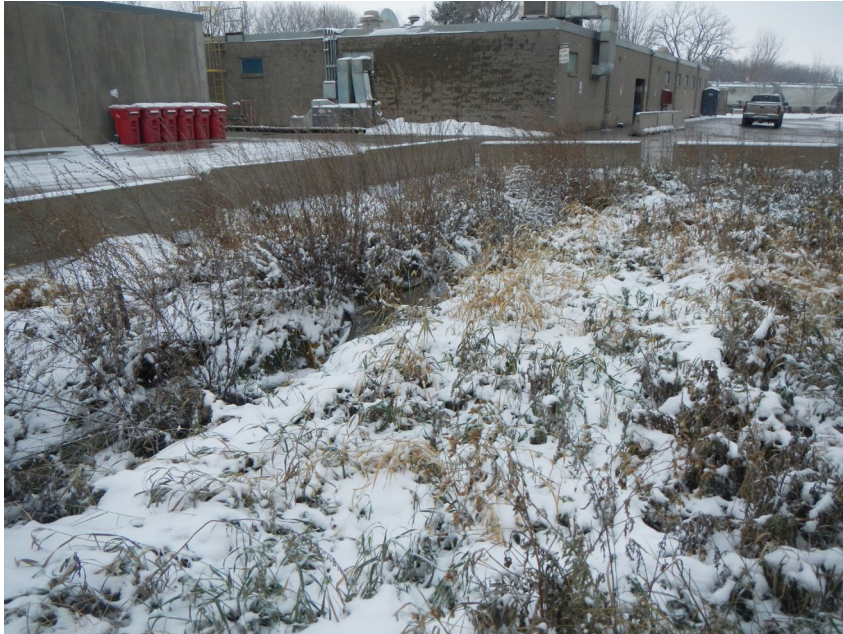
| Compliance<br>Evaluation<br>Inspection | DESCRIPTION | Drainage collection ditch along south side of craneway storage building.<br>Opposite direction of photo 28. | 29 |

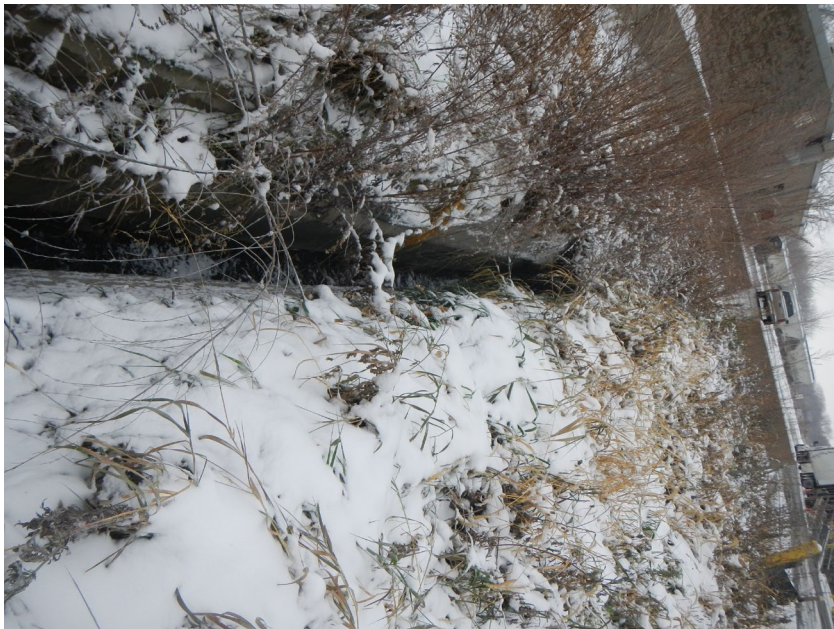
| Compliance<br>Evaluation<br>Inspection | DESCRIPTION | Same collection ditch as photos 28/29. | 30 |

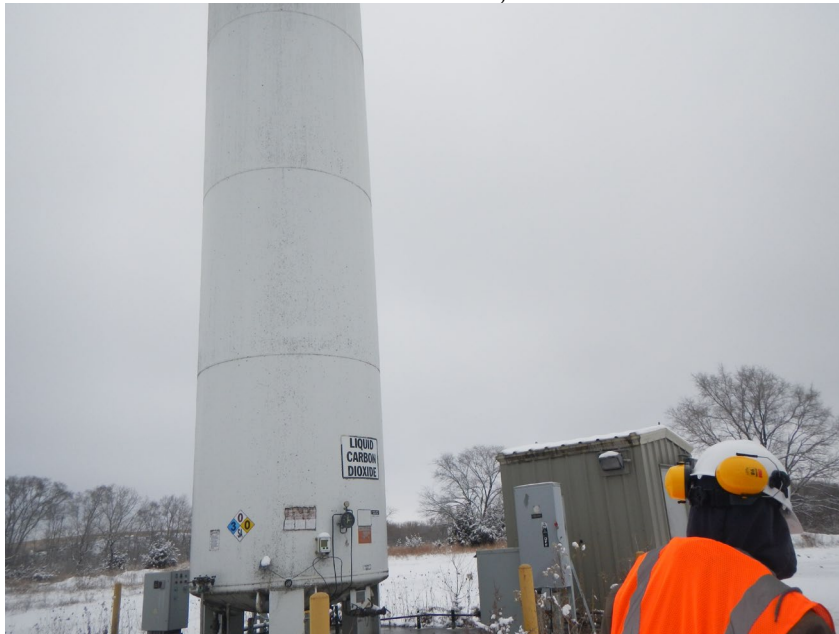
| Compliance<br>Evaluation<br>Inspection | DESCRIPTION | Liquid carbon dioxide tank at treatment facility for permit #IA0072907. | 31 |
