## Region 6 Compliance Assurance and Enforcement Division

### INSPECTION REPORT

| Company Name: | <b>Southwestern Electric Power Company</b> | | |
| Facility Name: | <b>Arsenal Hill Power Plant</b> | | |

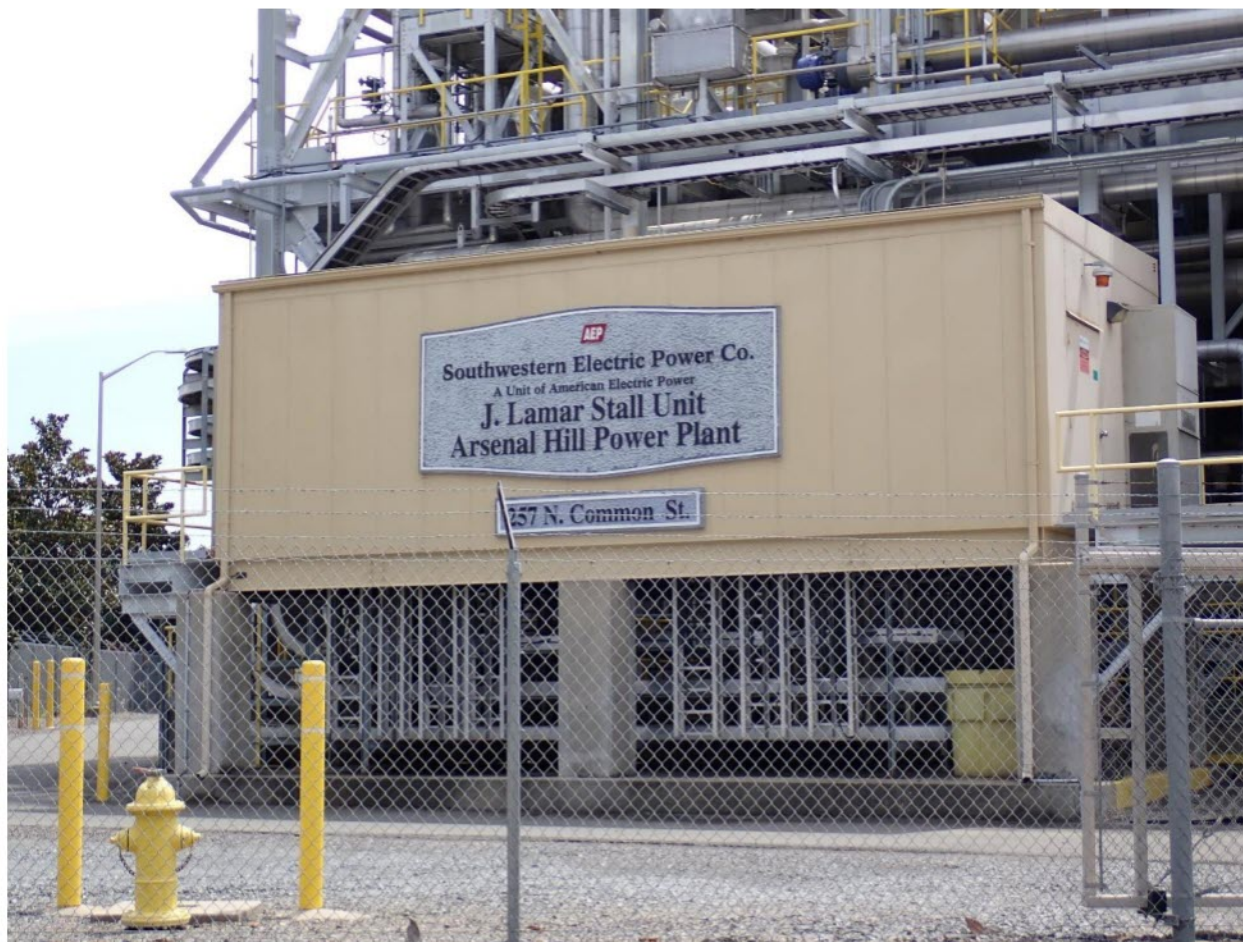
Photo No. 1

Photograph File Name: P8190001.JPG  
Date of Photograph: 08/19/2024  
Latitude and Longitude: 32.520089 -93.760323  
Orientation: W  
Map Datum: WGS-84  
Time of Photo: 1:13 PM  
Photographer: Jack Arias  
Description: This image shows the name and entrance of the facility.

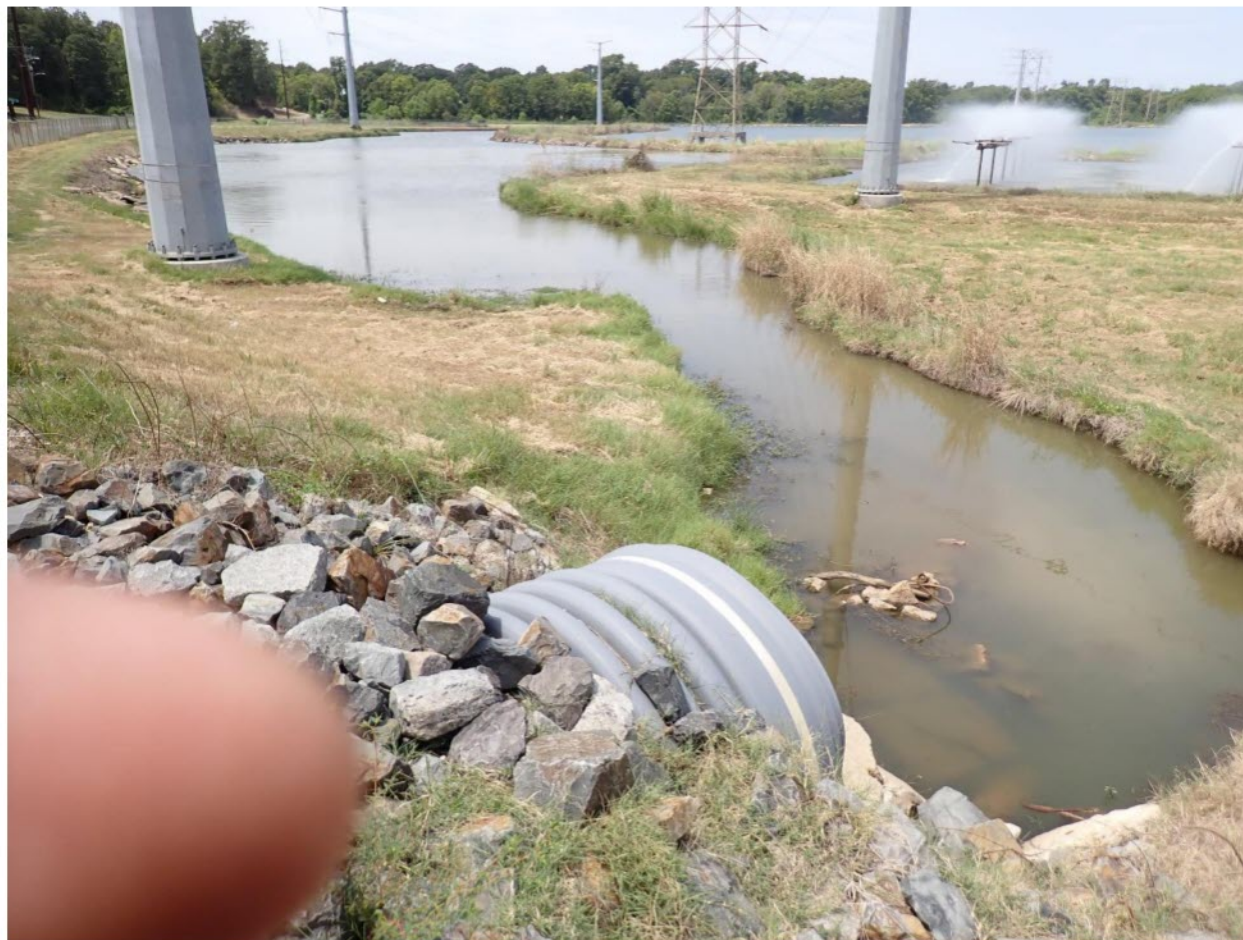
Photograph File Name: P8200041.JPG  
Date of Photograph: 08/20/2024  
Latitude and Longitud: 32.515956 -93.763297  
Orientation: SW  
Map Datum: WGS-84  
Time of Photo: 12:16 PM  
Photographer: Jack Arias  
Description: This image shows the cooling pond connected to the stormwater discharge system.
