INSPECTION REPORT

| <b>Type of Inspection</b> | Compliance Evaluation Inspection (CEI) | | |
| <b>Permittee Name</b> | Village Of Maxwell | | |
| <b>Permit Number(s) (If Applicable)</b> | NM0029149 | | |

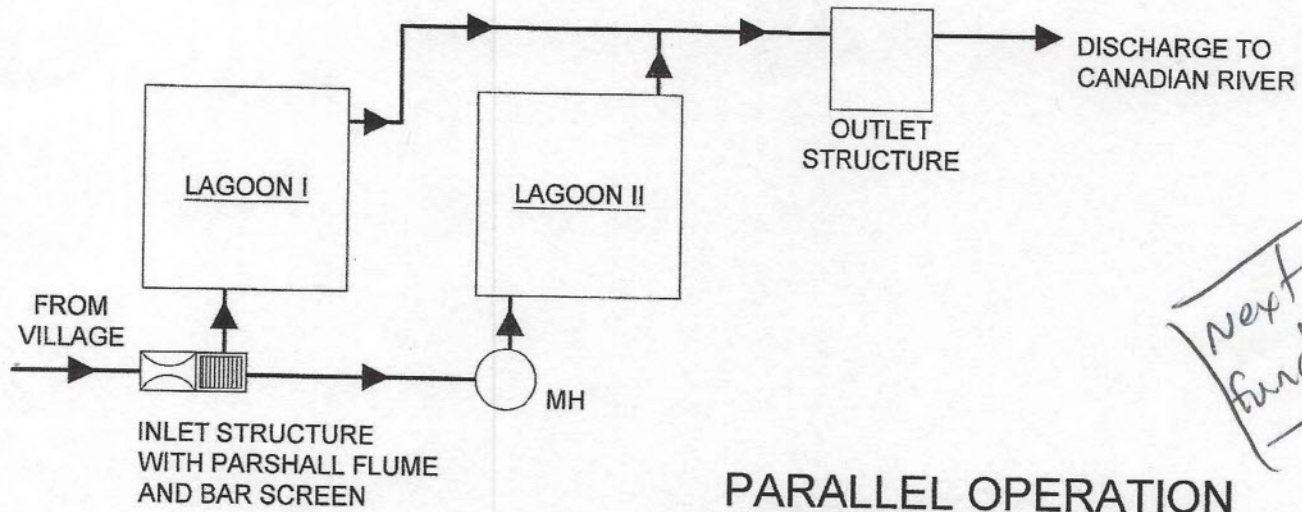
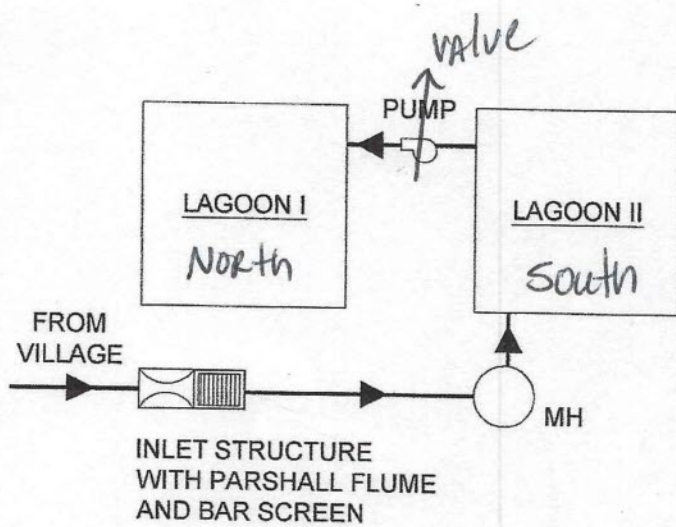
There are two lagoons at the Maxwell treatment facility. Neither of these lagoons are aerated, and they serve as facultative ponds for treatment, storage and/or evaporation of the wastewater. The lagoons were designed with identical dimensions and elevations - a 200-foot square bottom, a total depth of 12-feet, and a bank slope of 2 horizontal to 1 vertical. The design operating depth of the lagoon is 5-feet, leaving 7-feet of freeboard. The 7-feet of free board is due to the elimination of a lift station to the lagoons so gravity flow from the Village can be utilized. the sides of the lagoons are lined with a 36-mil Hypalon liner and the bottoms are compacted natural clay.

Operations at the time of the inspection was gravity flow from the Village to the South Lagoon. The South Lagoon is then manually pumped to the North Lagoon. No reported discharges at the time of this inspection.
