Happy Import Auto Salvage  
Industrial User Inspection Report  
May 19, 2021

## U.S. Environmental Protection Agency Region 5

**Purpose:** Industrial Stormwater Inspection

**Facility:** Happy Import Auto Salvage, INRM00795  
305 South Tibbs Avenue  
Indianapolis, Indiana 46261 (317) 484-9780

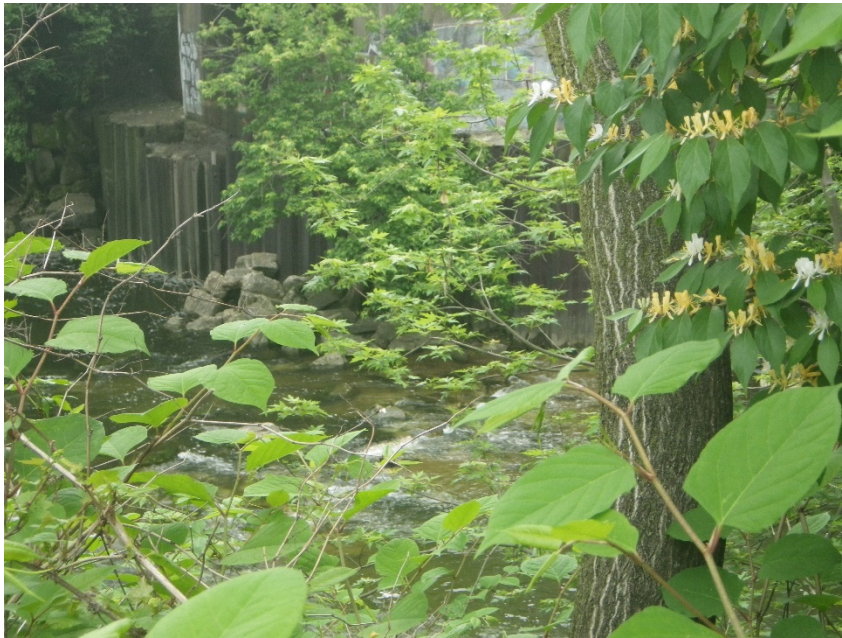
IMGP0013

A primary focus of the inspection team was to locate Outfall 001 as described in the NOI and SWPPP BMP layout. The inspection team investigated the heavily vegetated and very steep embankment for a discrete pipe thought to be Outfall 001. Several low areas on the East embankment of Eagle Creek appeared to contain broken pipes. Upon investigation, some of these locations were comprised of old vehicle wheel cowlings and automotive parts integrated into the embankment soil matrix. Mr. Browder did not think that a unique discharge pipe designated as Outfall 001 existed to Eagle Creek (Photo #13) as there are no storm sewers or storm inlets within the salvage area.

Description: Eagle Creek looking down heavily vegetated steep embankment.

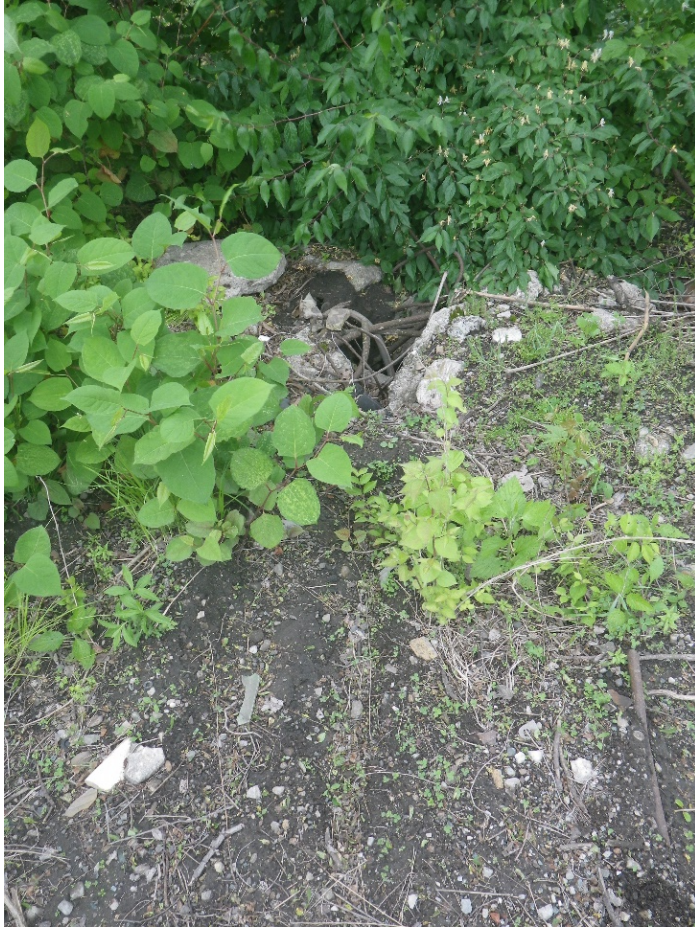
IMGP0016

Creek. Holes observed in the embankment indicated that the embankment may not be sufficiently stabilized to prevent point source discharges.

Description: This area was lower, wet, and had a hole as pictured.

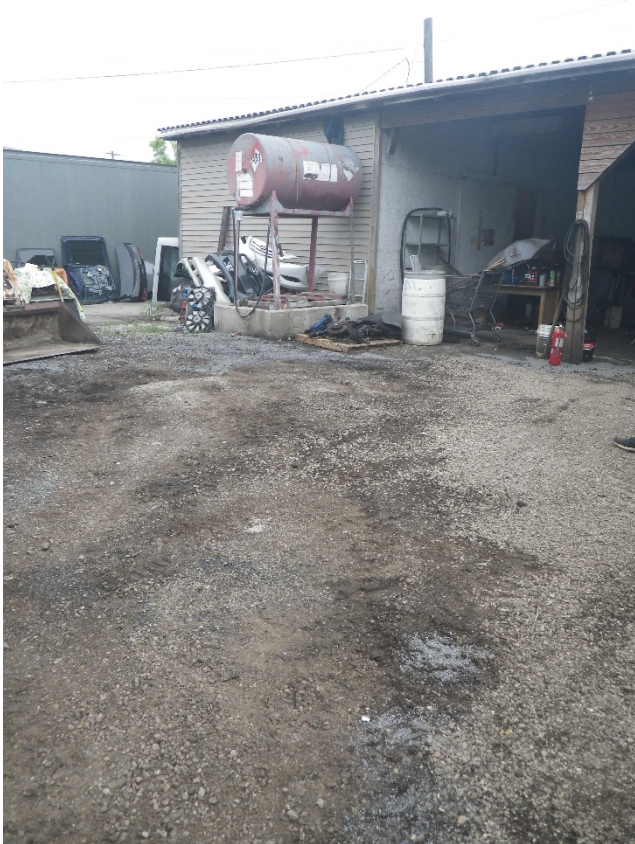
IMGP0024

- The drain plug on the secondary containment structure for the 300-gallon diesel tank was not secure. The secondary containment structure appeared to not provide adequate volume to contain 300-gallons from the diesel fuel tank.
- The 300-gallon used engine oil storage tank showed signs of overflow or leakage to the secondary containment vessel which also exhibited oil overflow or spillage.

Description: Diesel fuel storage tank and antifreeze storage tank in white secondary drum.

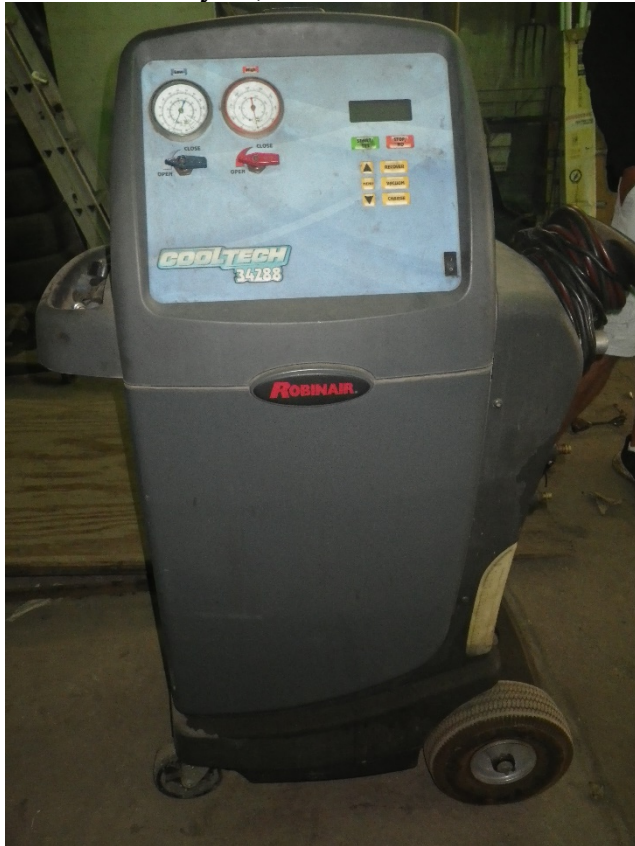
IMGP0028

As we walked through the shop area to the office, we noticed the freon recovery unit (Photo #28) used to remove freon from the air conditioners of the vehicles as needed.

Description: Freon recovery unit.
