PURPOSE OF INSPECTION

The purpose of the inspection by the U.S. Environmental Protection Agency (USEPA) at the Tilden Mining Company L.C. mine (Tilden) of the Cleveland-Cliffs Inc. facility (Cliffs or Facility) in Ishpeming, Michigan was to describe, evaluate, and document compliance with the Clean Water Act (CWA) and their National Pollutant Discharge Elimination System (NPDES) permit.

**Cleveland Cliffs Inc. – Tilden and Empire Mine
EPA Inspection 9/13/2022 – 9/15/2022
Photomap Overview**

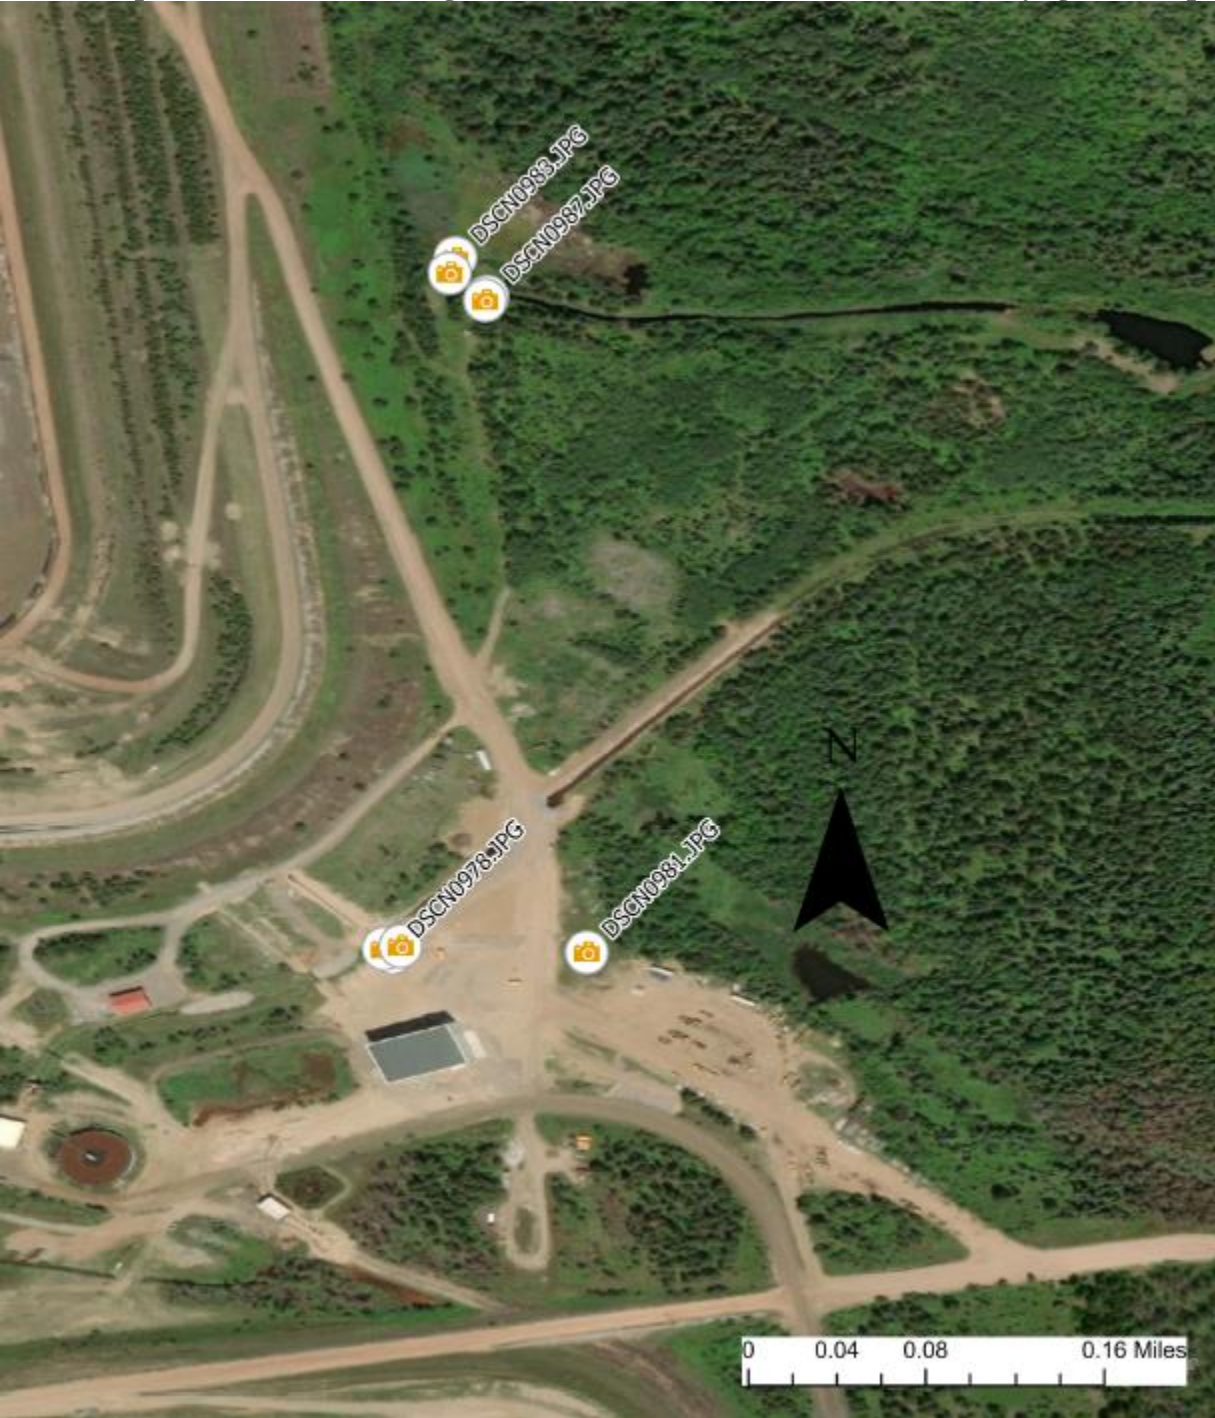
Photomap East of Tilden Tailings Basin, Treatment Plant and Possible Daylighted Seep

- USEPA observed and conducted field monitoring on flowing water originating from a location near the toe of the outslope of the east side of the Tilden tailings basin, at a location north of the Gribben Clarification Facility. The waterway is shown in photos 19 through 24, including a video of the flowing water. This location is a possible daylighted seep, which is not monitored as an NPDES outfall, stormwater monitoring location, nor an SSMP location. USEPA field monitoring at this location showed a conductivity of greater than 1,000 $\mu\text{S}/\text{cm}$, which is above the background values.

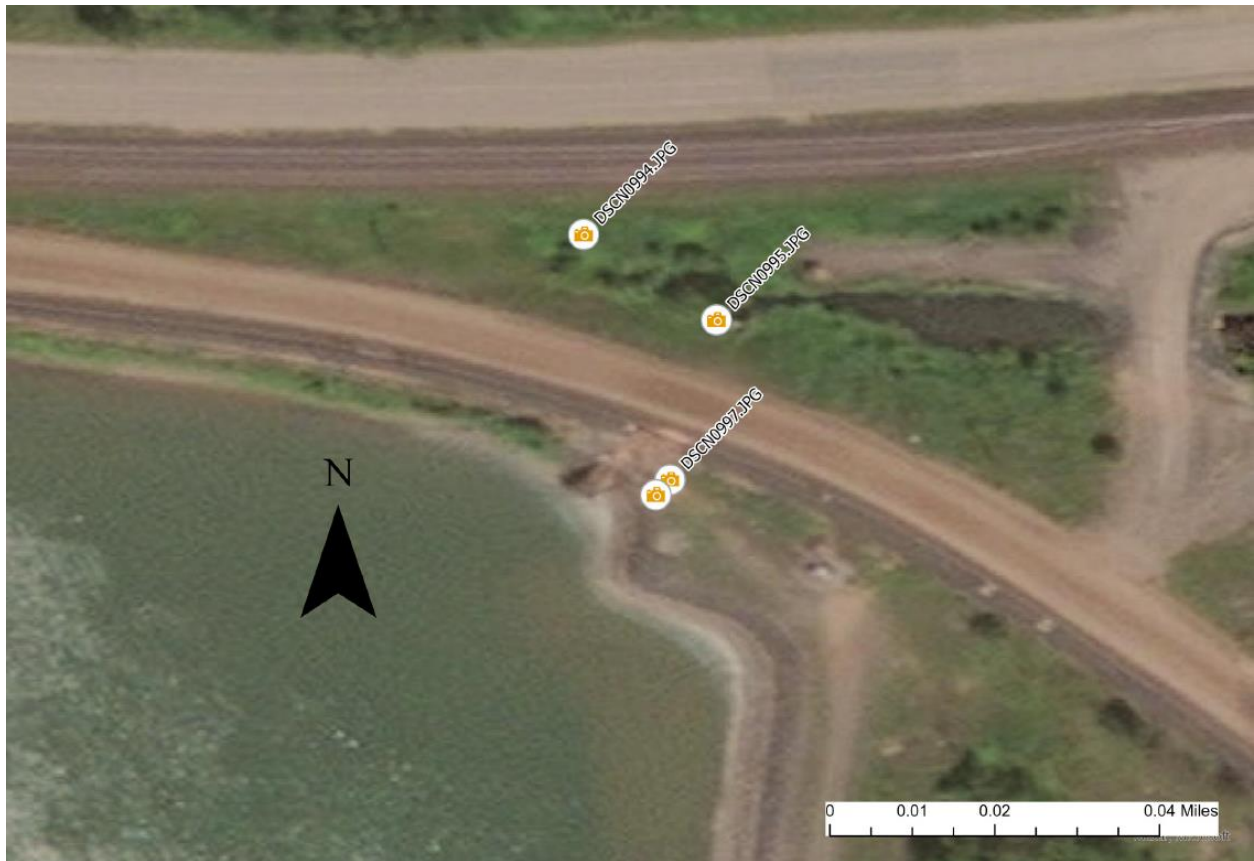
**Cleveland Cliffs Inc. – Tilden and Empire Mine
EPA Inspection 9/13/2022 – 9/15/2022
Photomap Hoover Pond and Inactive Outfall Tilden 001**

- USEPA observed and conducted field monitoring of flowing water originating near Hoover Pond impoundment of process water. Water flowing from inside culvert connected to impoundment was originating from an unspecified source. Northeast of the culvert is a possible daylighted seep and EPA field monitoring at this location showed a conductivity of greater than 900 $\mu\text{S}/\text{cm}$, which is above the background values. The waterway, culvert, and possible daylight seep are depicted in photos 29 through 32.

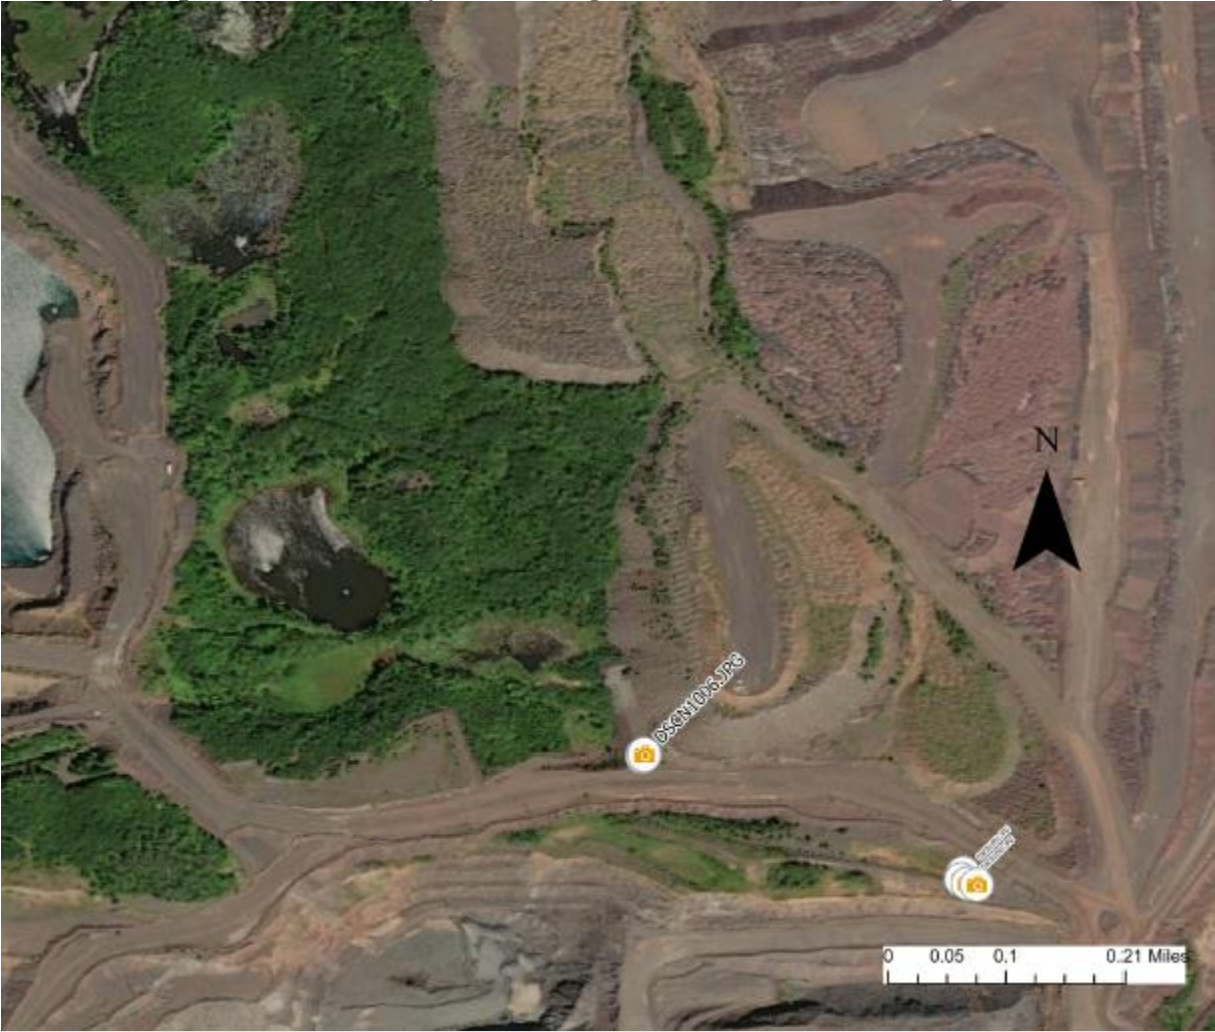
Photomap Partial Tributary to Partridge Creek and Historic Empire Outfall 003

- During the inspection, USEPA observed waste material from mining operations adjacent to a waterway known as Partridge Creek. Runoff from the slopes of the waste material would drain into a waterway flowing through a historic outfall 003. This is shown in Photos 37 through 42. The Facility representatives stated that NPDES compliance monitoring was no longer being conducted at this location because the discharge was not considered a wastewater. A copy of a cover letter from Michigan Department of Environmental Quality (now EGLE) on June 29, 2017, transmitting the compliance evaluation inspection notes from an April 27, 2017, visit at the Empire Mine (MI0000094) was given to EPA. The June 29, 2017, cover letter was provided as the record of the approval from EGLE. The June 29, 2017, letter references a low selenium concentration and no active mine pit dewatering as justification for changing the NPDES permit, which had expired in 2016.

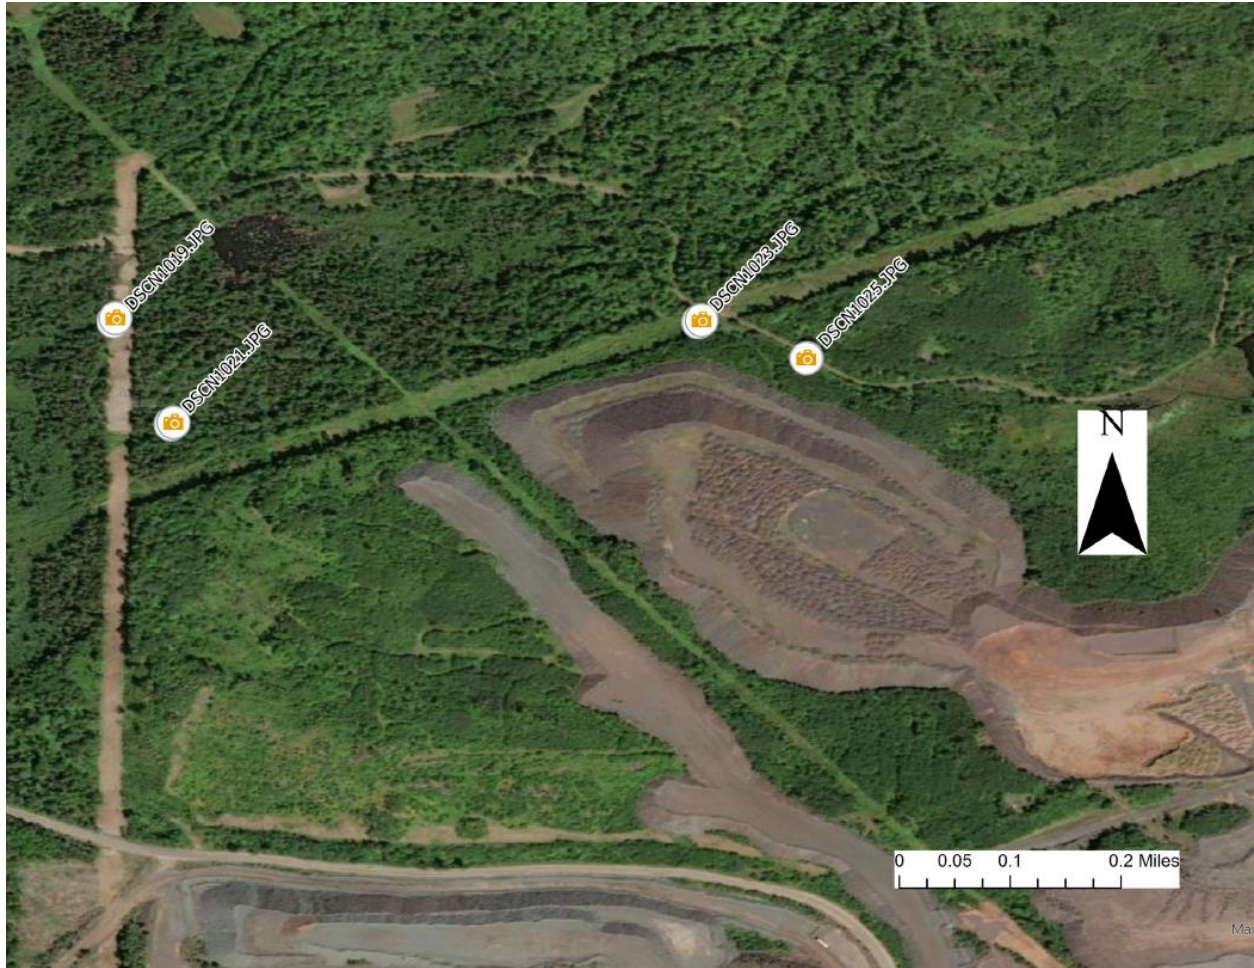
**Cleveland Cliffs Inc. – Tilden and Empire Mine
EPA Inspection 9/13/2022 – 9/15/2022
Photomap Location ‘M’ or CC-93, CC-290 and CC-291**

- Stormwater monitoring location 'M' or CC-93: the SWPPP shows that the rock stockpiles are a source of exposure in the tributary to this location. Field monitoring conducted by USEPA showed a conductivity of 585 $\mu\text{S}/\text{cm}$, which is above the background values. At the time of the inspection, this stormwater monitoring location was flowing despite dry weather conditions.

- Locations CC-291 and CC-292 were not in the current version of the SWPPP available during the inspection, and are not associated with an NPDES outfall. USEPA field monitoring during the inspection showed a specific conductivity of 623 $\mu\text{S}/\text{cm}$ and 439 $\mu\text{S}/\text{cm}$ respectively. At the time of the inspection, these monitoring locations were flowing despite dry weather conditions.
- During the inspection, USEPA observed unvegetated rock piles in the tributary for the water flowing to the control structure for the historic Empire outfall E003.
- Several on-site water bodies present with dark orange coloring, suggesting high levels of iron and conductivity within the water.
 - Stormwater monitoring location '13' or CC-179, was visited during the inspection. The water at this location had an unnatural red color and is shown in photo 63.

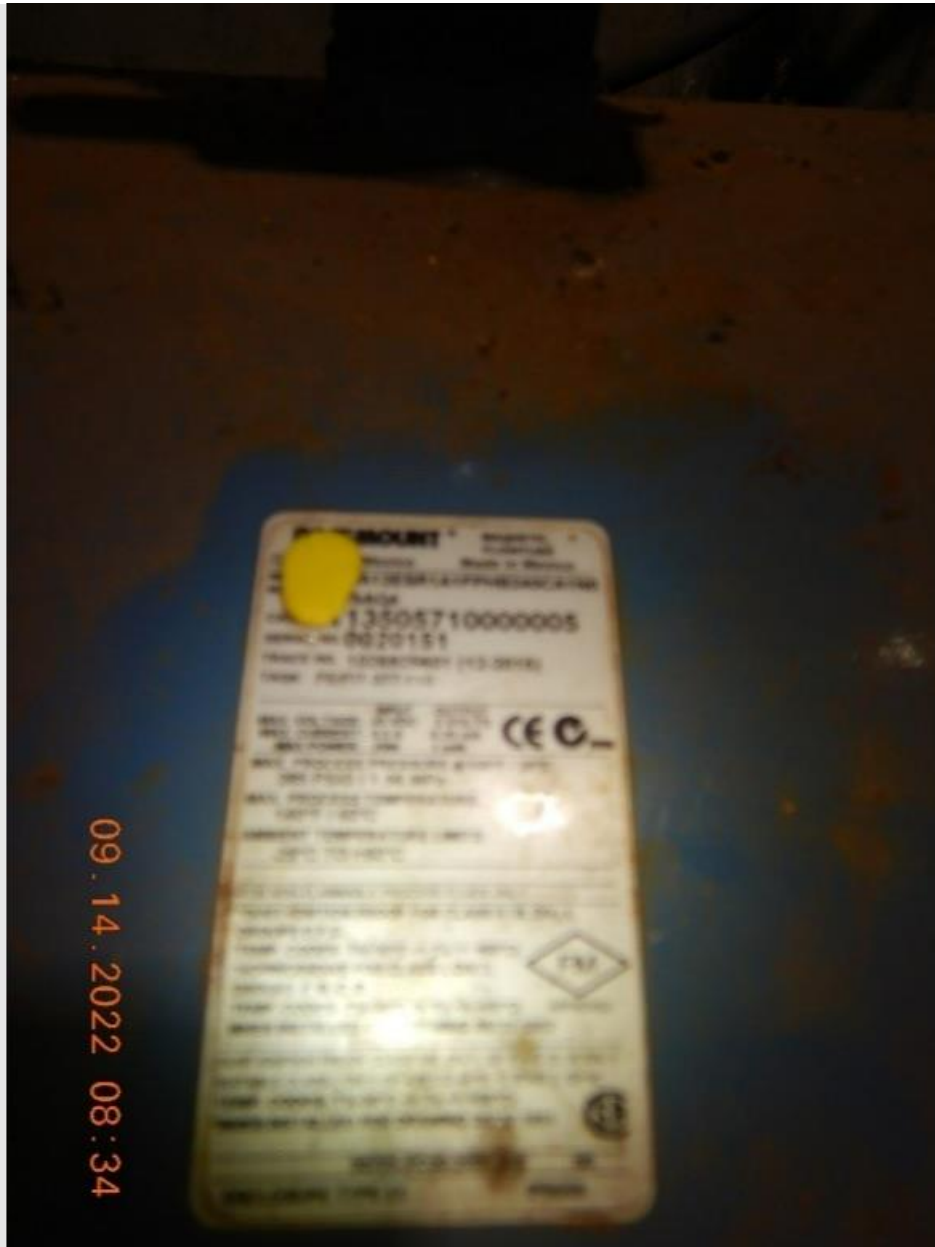
12: DSCN0971.JPG

Description: pH, Temperature and Turbidity measurements on train #1 at the treatment facility for the Tilden tailings basin discharge. Per Michael Korvela, these continuous measurements are for operational purposes only. At the time of the inspection, pH, temperature, and turbidity all had active alarms.

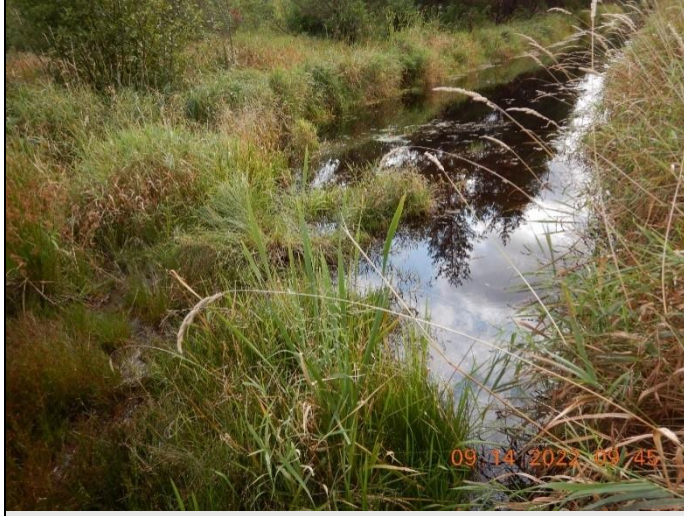
20: DSCN0984.JPG

Description: Location of possible daylighted seep at the east side of the tailings basin. Flow was visible The water had an iridescent sheen.

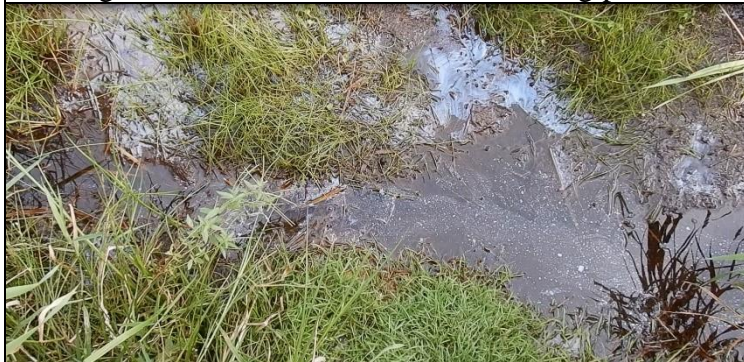
21: DSCN0985.JPG

Description: Location of possible daylighted seep at the east side of the tailings basin. Camera is facing downstream. Location of monitoring point 04.

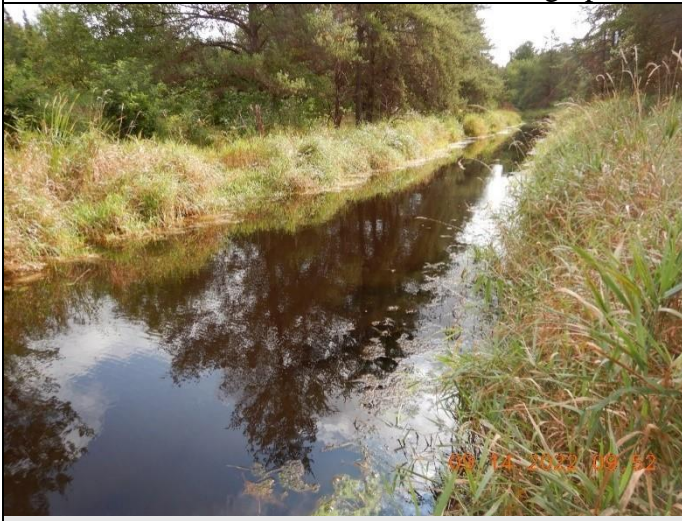
23: DSCN0987.JPG

Description: Location of possible daylighted seep at the east side of the tailings basin. The water had an iridescent sheen. Camera is looking upstream at the outslope of the tailings basin.

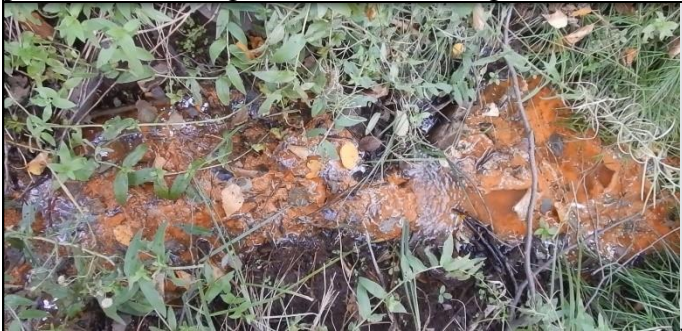
31: DSCN0995.JPG

Description: Northeast of the location of the downstream end of the culvert shown in photo 29. Possible location of a daylighted seep. At the time of the inspection the water shown in this photo was flowing and had a red/orange discoloration.

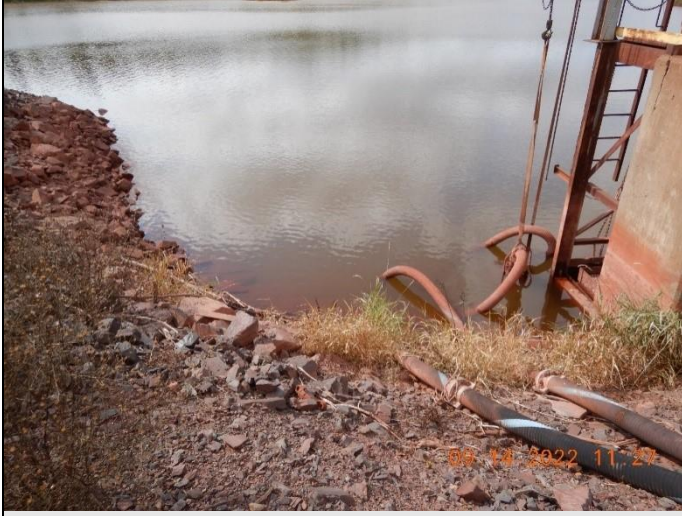
32: DSCN0996.MP4

Description: Northeast of the location of the downstream end of the culvert shown in photo 29. Possible location of a daylighted seep. At the time of the inspection the water shown in this video was flowing and had a red/orange discoloration.

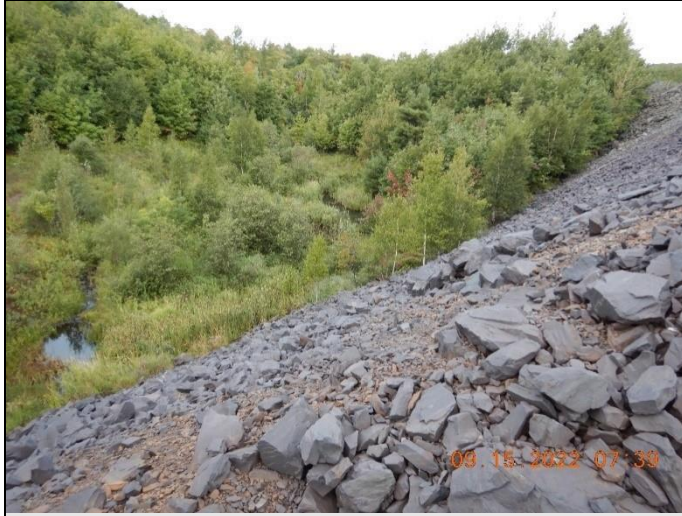
42: DSCN1006.JPG

Description: Area tributary to Partridge Creek. Runoff from this area is tributary to the control structure shown in photos 37 through 41.

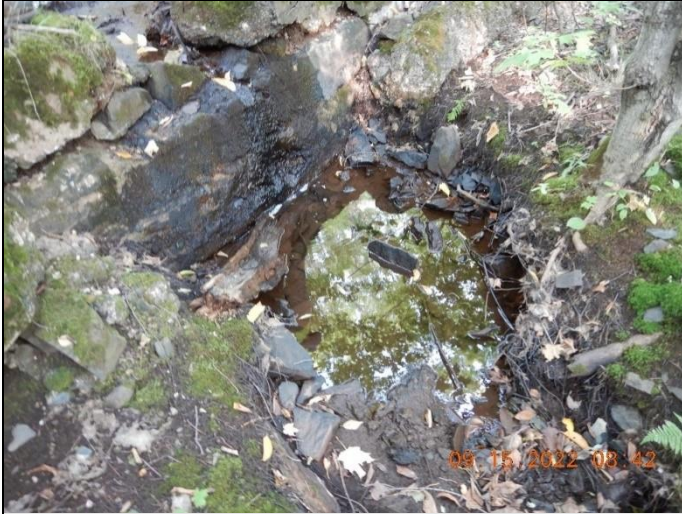
50: DSCN1014.JPG

Description: At stormwater monitoring location '12' or CC-175. Stormwater is monitored at the location shown in this photo, as the water flows over the end of a small stone bridge. EPA monitoring location 13.

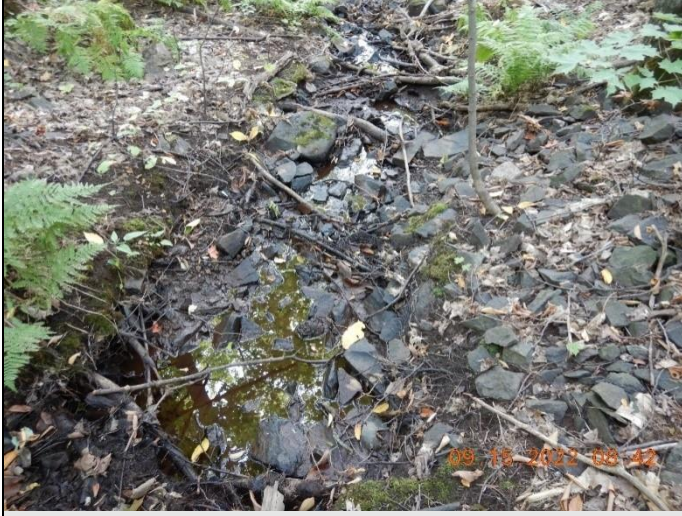
51: DSCN1015.JPG

Description: At stormwater monitoring location '12' or CC-175. Looking downstream from where stormwater monitoring occurs.

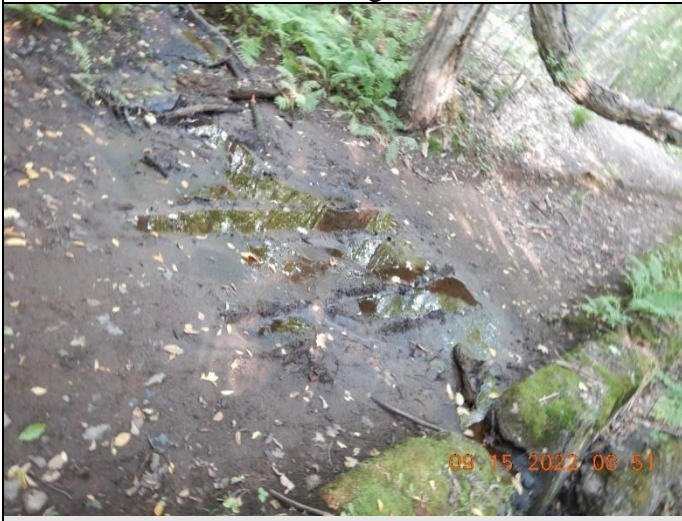
52: DSCN1016.JPG

Description: At stormwater monitoring location '12' or CC-175. Location where stormwater flows across the top of a bridge for a rough pathway upstream of where stormwater monitoring occurs.

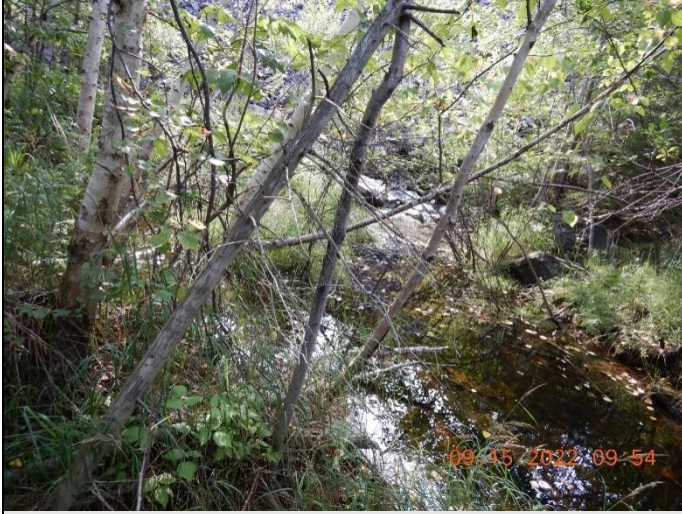
53: DSCN1017.JPG

Description: At stormwater monitoring location '12' or CC-175. Looking upstream of where stormwater monitoring occurs.

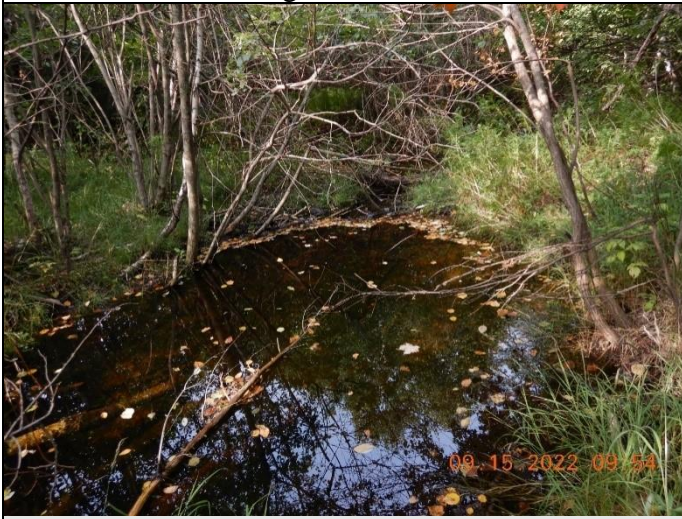
54: DSCN1018.JPG

Description: At stormwater monitoring location '12' or CC-175. Looking upstream of where stormwater monitoring occurs.

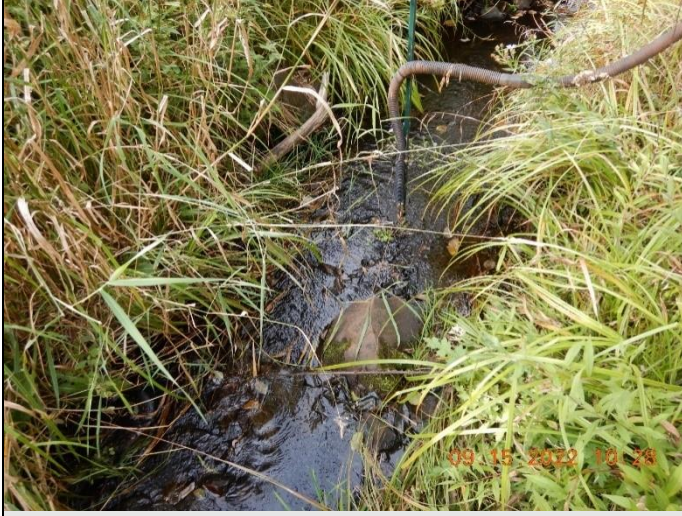
56: DSCN1020.JPG

Description: At the location of stormwater monitoring location CC-292. At the time of the inspection, the depth of the water at this location was several inches. EPA monitoring location 15.

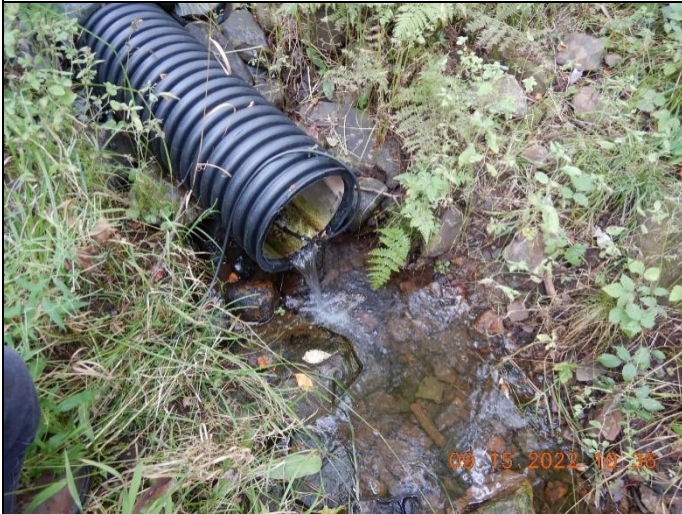
57: DSCN1021.JPG

Description: At the location of the selenium monitoring location CC-291. EPA monitoring location 16.

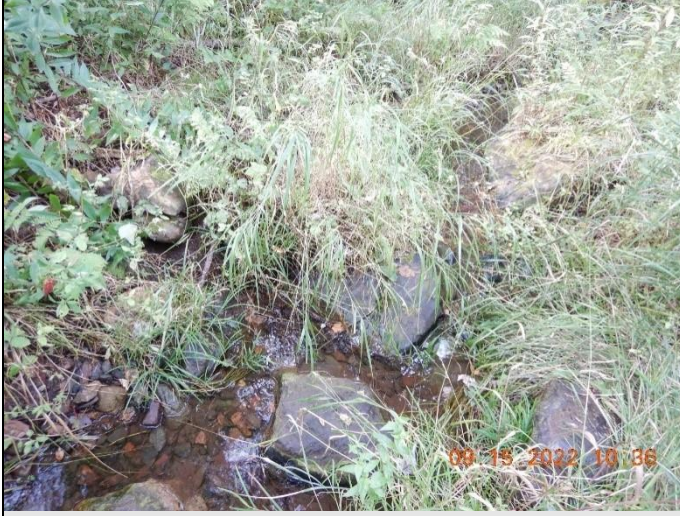
58: DSCN1022.JPG

Description: Downstream of the location of the selenium monitoring location CC-291.

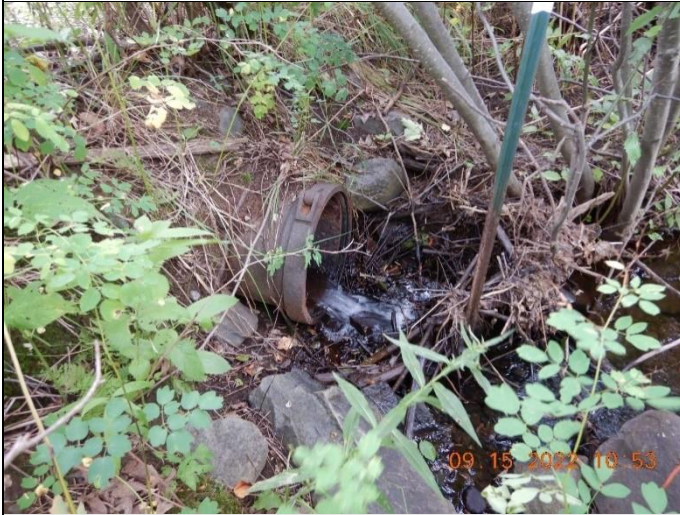
59: DSCN1023.JPG

Description: At the location of the stormwater monitoring location 'M' or CC-93.

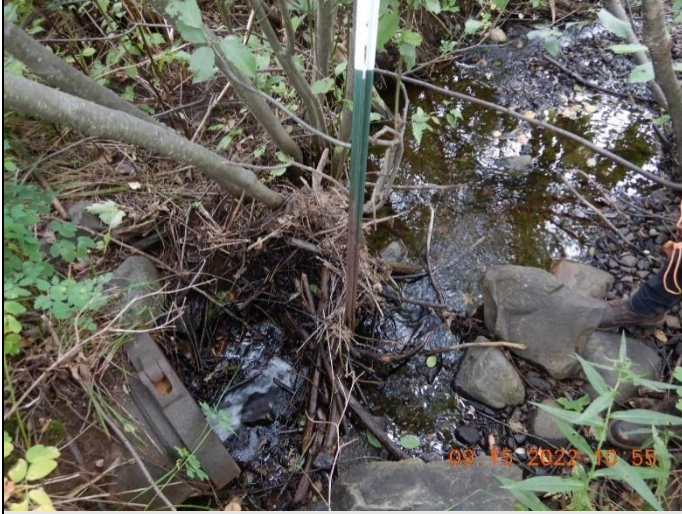
60: DSCN1024.JPG

Description: At the location of the stormwater monitoring location 'M' or CC-93.

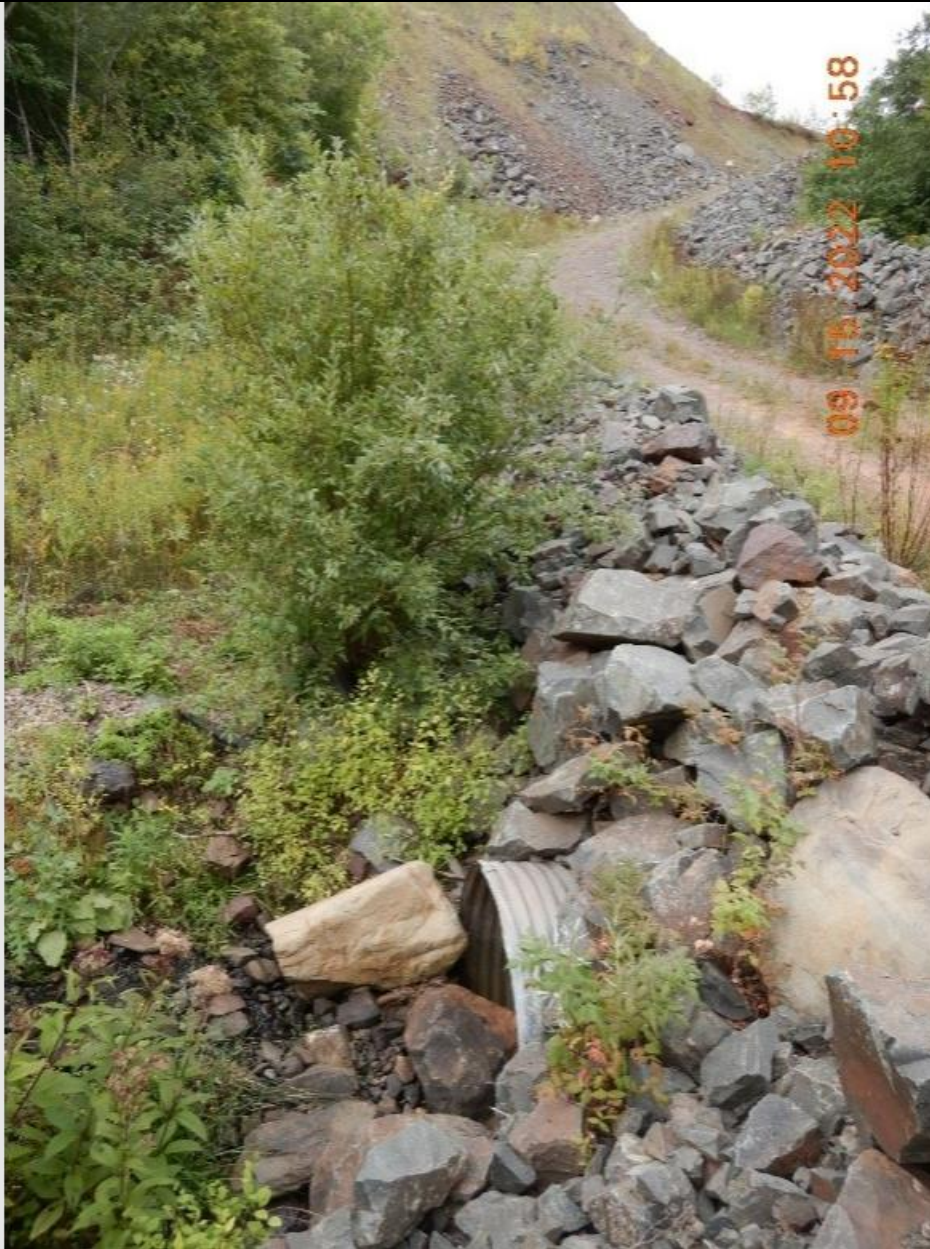
61: DSCN1025.JPG

Description: Upstream of the stormwater monitoring location 'M' or CC-93.

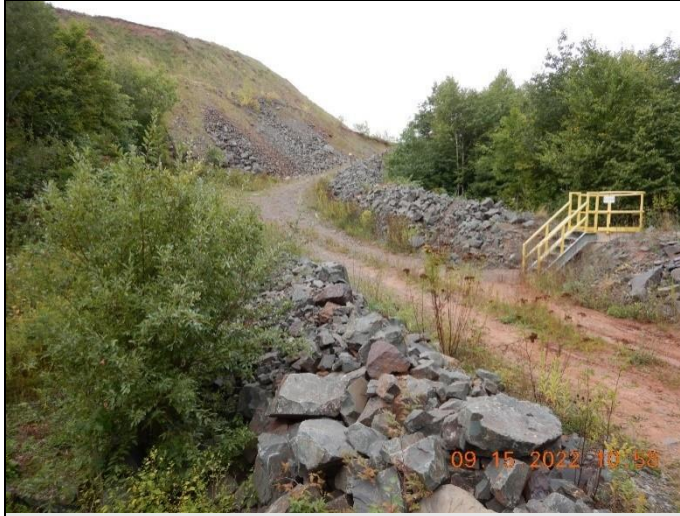
62: DSCN1026.JPG

Description: Upstream of the stormwater monitoring location 'M' or CC-93.
