## Clean Water Act Section 404: Site Visit/Case Development

| Site Name | Mastro Ready Mix, Inc | | | | |

EPA CWA 404 Inspection Photolog  
Mastro Ready Mix, Inc.

July 18, 2023

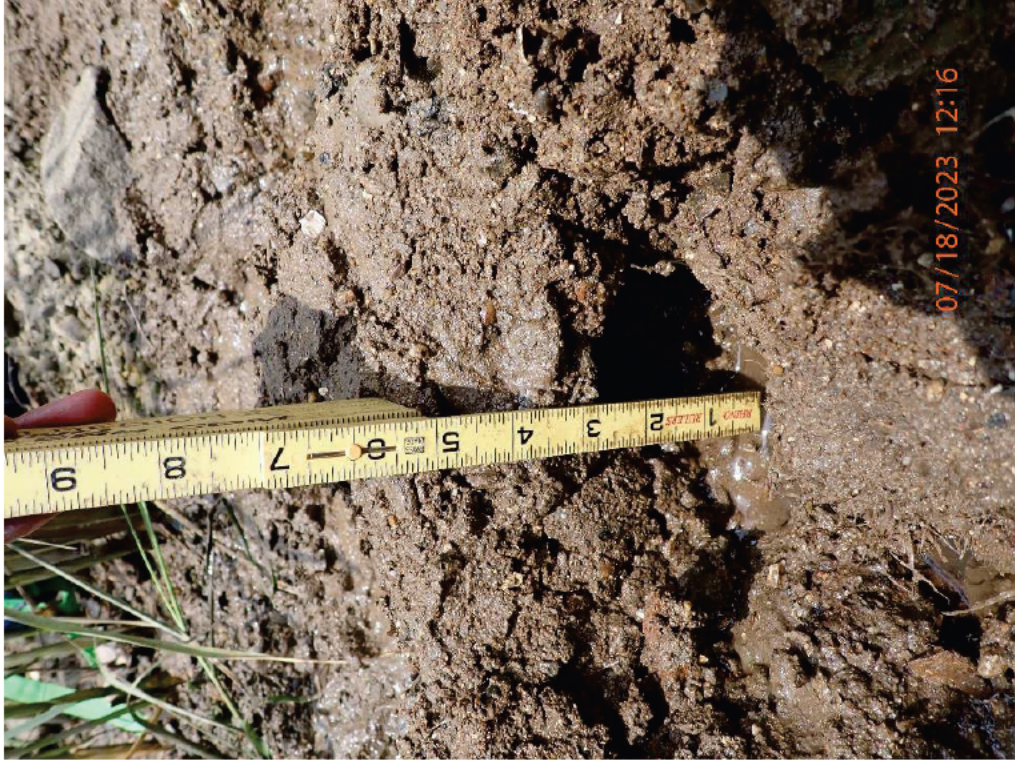
**Date:** 7/18/2023  
**Time:** 12:14 PM  
**Photographer:** S. Andreescu  
**Photo ID:** 9 – P7180115  
**Description:**  
Soil profile
