**NPDES Stormwater Reconnaissance Inspection  
Industrial Facility**

**VEGA BAJA SOLID WASTE MUNICIPAL LANDFILL**  
Road PR-668 Int., Cibuco Ward, Vega Baja, PR 00694  
Coordinates: 18.478408°N, 66.359097°W (Decimal)

**NPDES MSGP ID: PRR053137**

**Inspection Date: April 7, 2022**

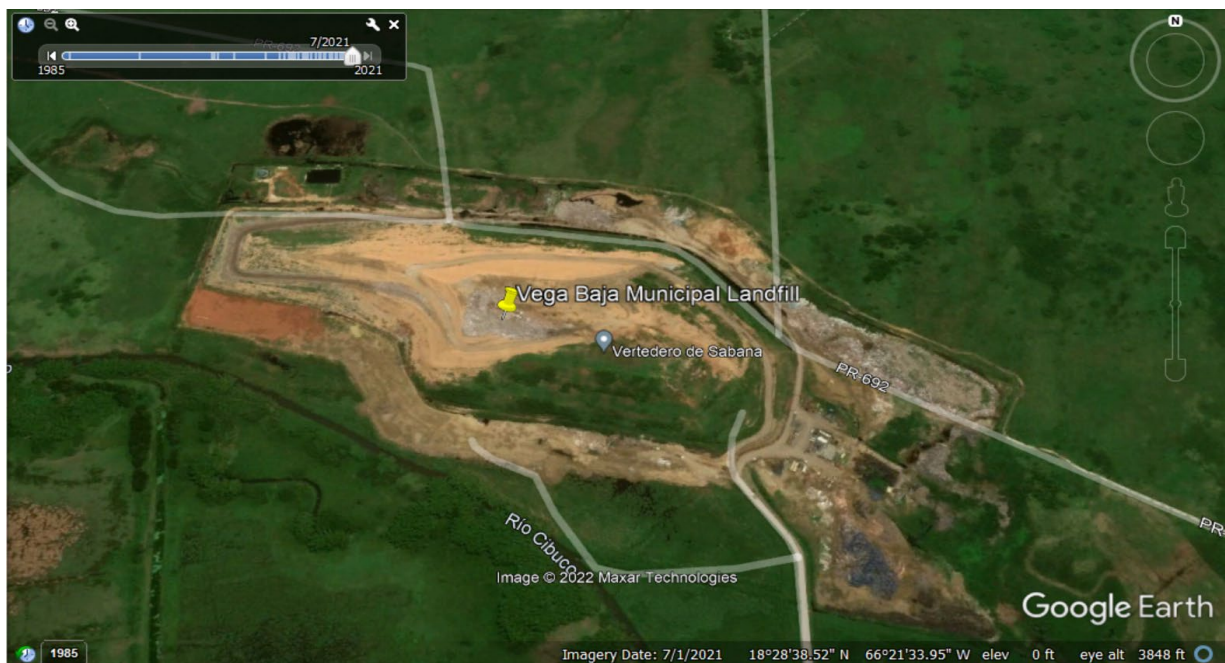
**Image 1<sup>1</sup>**

**Image 1** depicts an aerial photograph of the Facility and its surroundings.

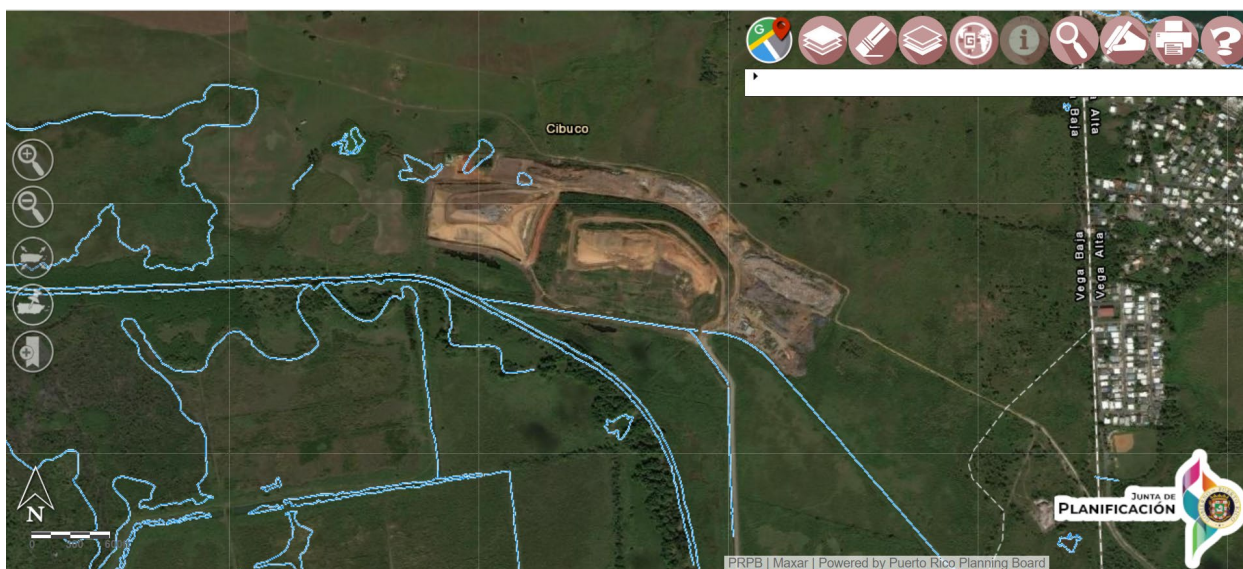
Image 2

The storm water runoff from the drainage areas associated with Outfall 004 flow from the west and the northwest sides of the Landfill into a drainage channel located northwest of the Landfill, which in turn flows and discharges into the Cibuco River. Silt fences and synthetic hay bales were installed. **Figure 1** (next page) depicts a site map of the area where the Landfill is located and flow schematic of the Facility. **Image 2** (page 7) depicts the hydrographic area near the Facility and the location of Cibuco River.
