## Clean Water Act Section 404: Site Visit/Case Development

| Site Name | Kelly Branch | | | | | | |

| Inspection Purpose | Initial site visit | | |

Inspection Photographic Log  
Evarts, Kentucky  
May 7, 2024

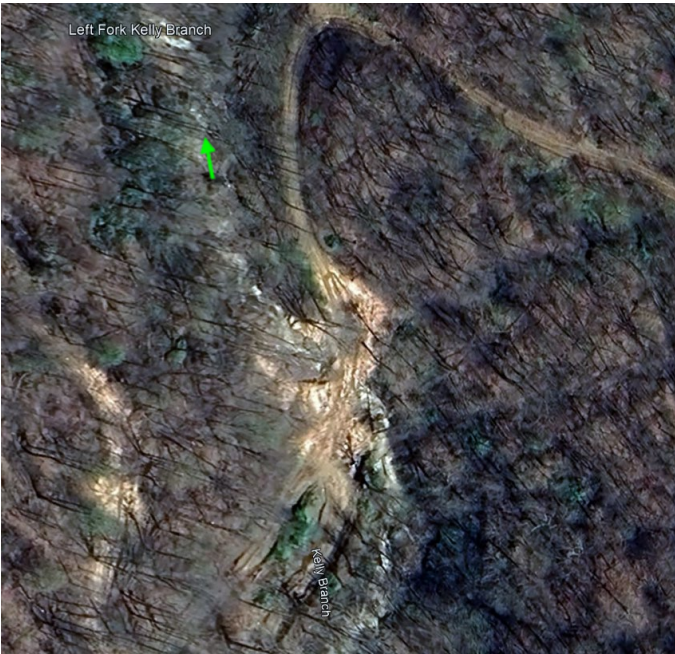
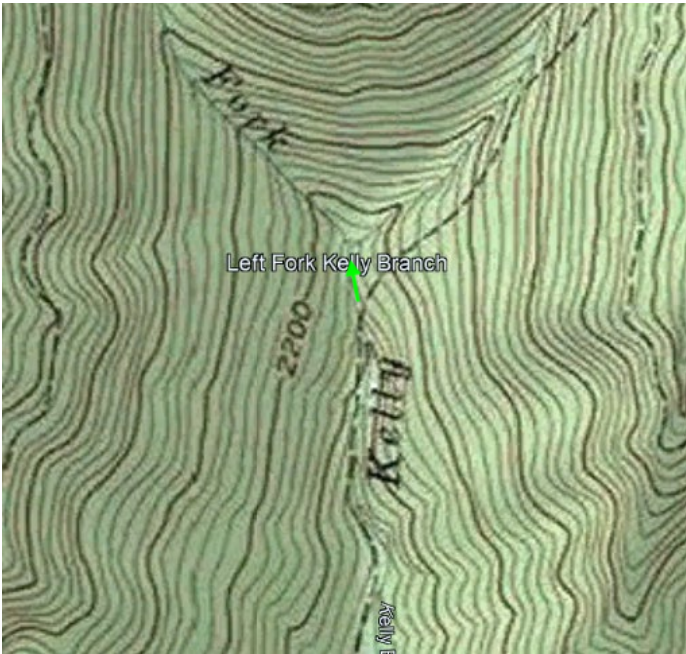
| Title | Photo 7 |

| Description | Kelly Branch facing upstream. Left Fork straight ahead and mainstem of Kelly Branch coming in from the right. |

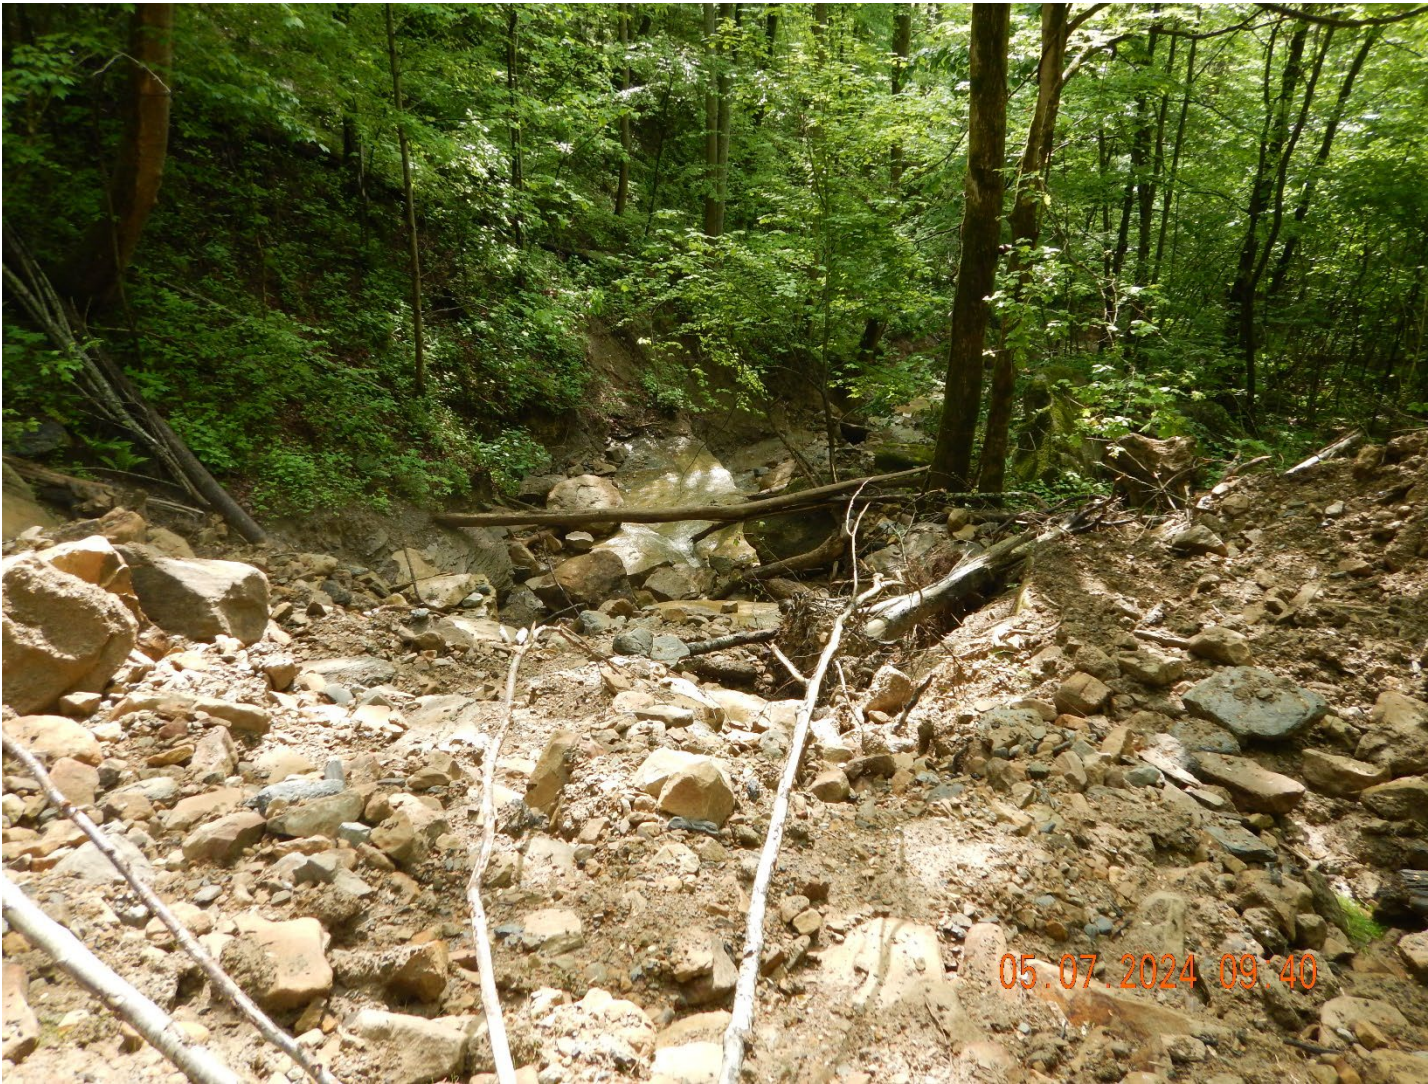
| Title | Photo 9 |

| Description | Duplicate of previous photo. |
