**CWA COMPLIANCE EVALUATION INSPECTION REPORT
U.S. ENVIRONMENTAL PROTECTION AGENCY, REGION 5**

Purpose: Compliance Evaluation Inspection

Simler's Winding Acres Farm
3017 South Van Brocklin Road
Freeport, Illinois
Stephenson County
42.256066, -89.702072

Date of Inspection: September 24, 2020

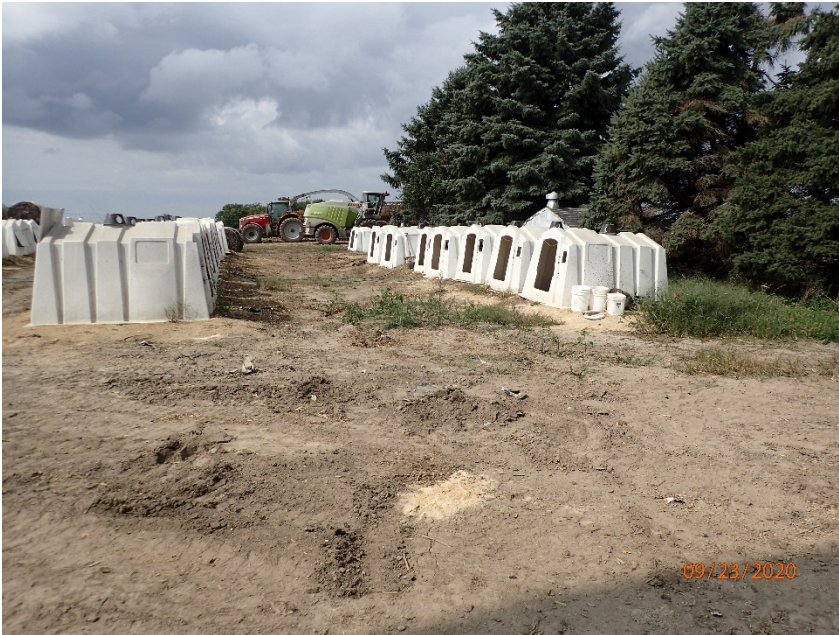
4: P9230004

Description: Outdoor calf hutch area.

Location: West side of Facility.

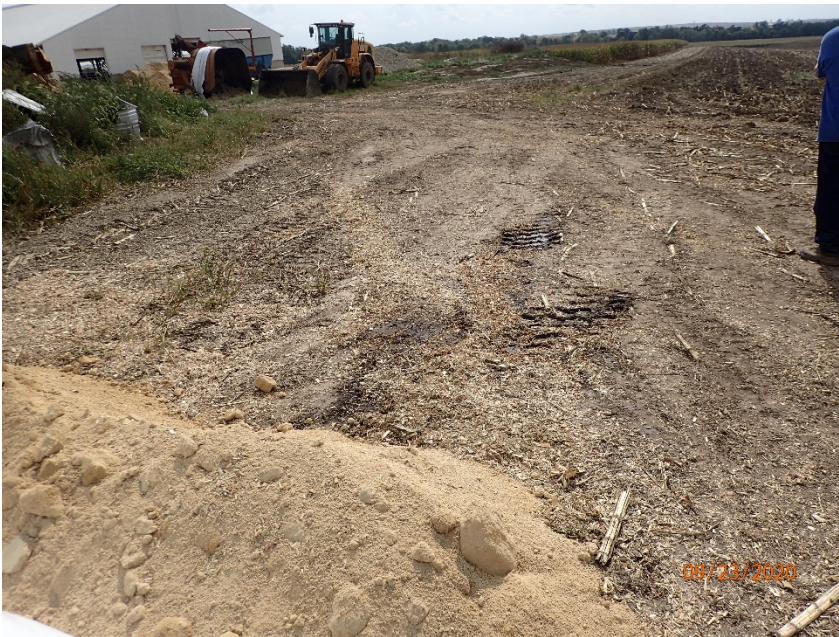
5: P9230005

The Inspectors then walked south around the west silage bag area (photos 5 and 6). The Inspectors continued south past the west side of the Big Barn (photo 7) and then east along the south side of the Big Barn to the manure push out area on the east side of the Big Barn (8). The Inspectors observed the mortality composting area in the northwest corner of the manure push out area and that the north and south edges of the manure pushout area were raised to prevent manure or runoff from flowing anywhere other than to the Big Pit (photos 8-10). The Inspectors observed an area of freshly disturbed soil at the south end of the Big Pit. The Inspectors observed some partially decomposed animal remains in the disturbed area (photos 11 and 12). The Operator stated that he was working on building a new loadout area for the Big Pit and that they had used some of their mortality compost as fill. The Inspectors suggested that the animal remains that were not completely composted should be removed and returned to the new compost pile to ensure that no mortality leachate left the site.

Description: Sand sealing South end of silage bags on west side of Facility.

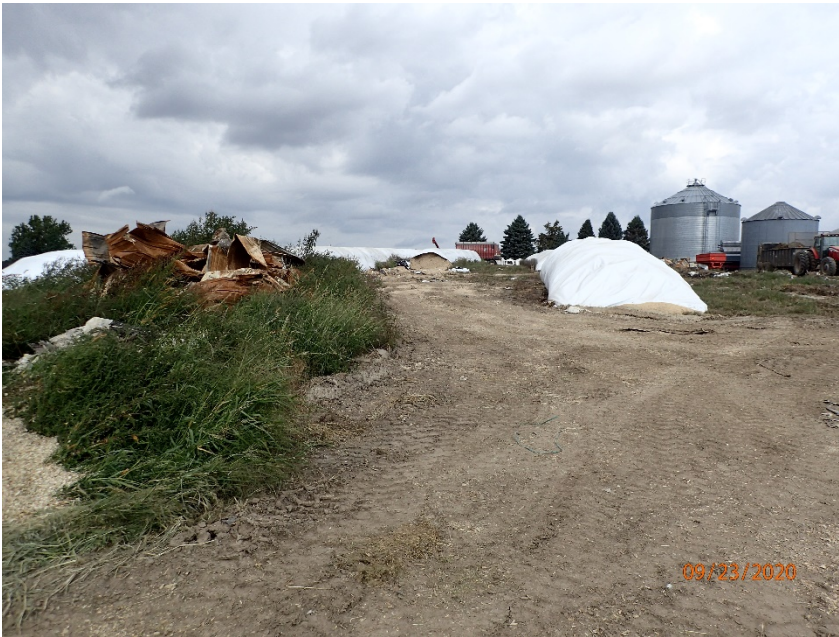
6: P9230006

Description: Looking northeast along silage bags on the west side of the Facility.

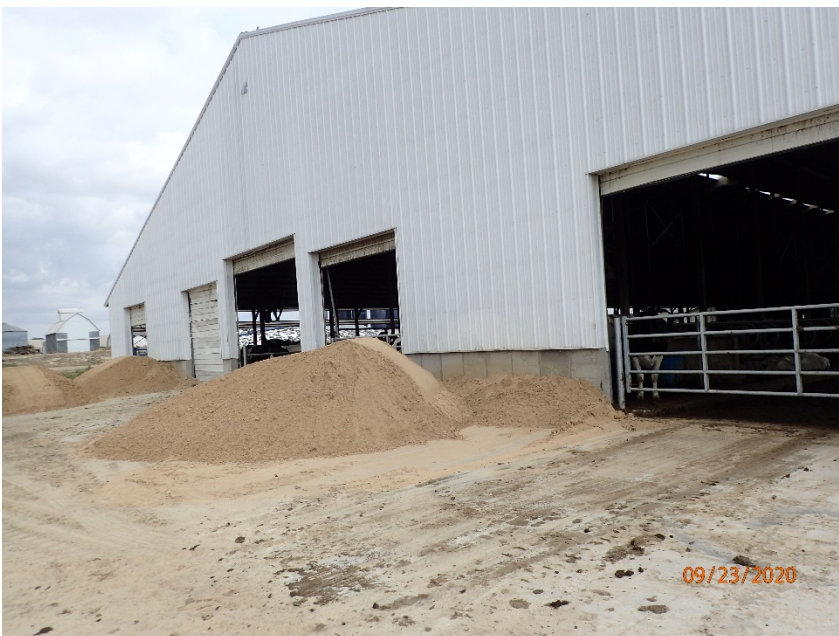
7: P9230007

Description: New sand bedding stacked on the west side of the Big Barn.

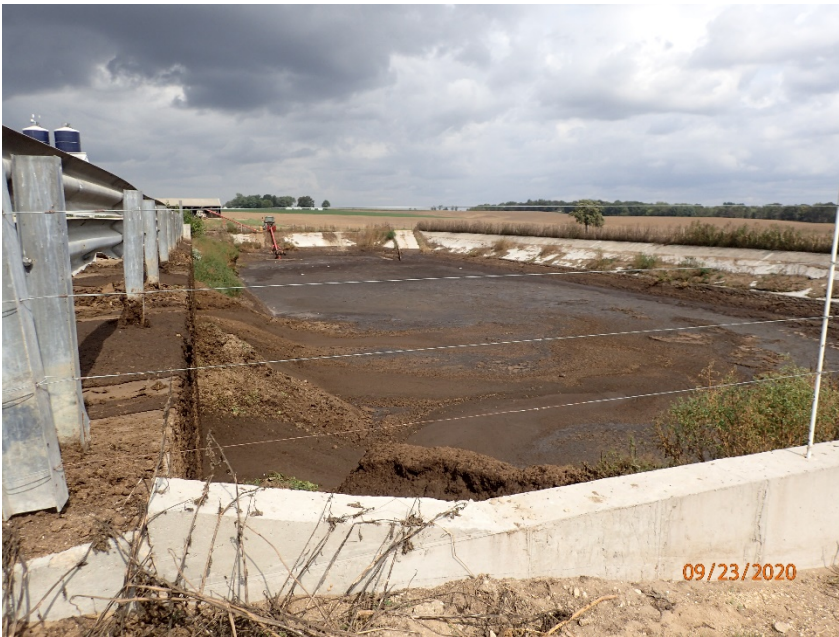
9: P9230009

Description: Looking north from the southwest corner of the Big Pit. Big Barn manure push off to the left.

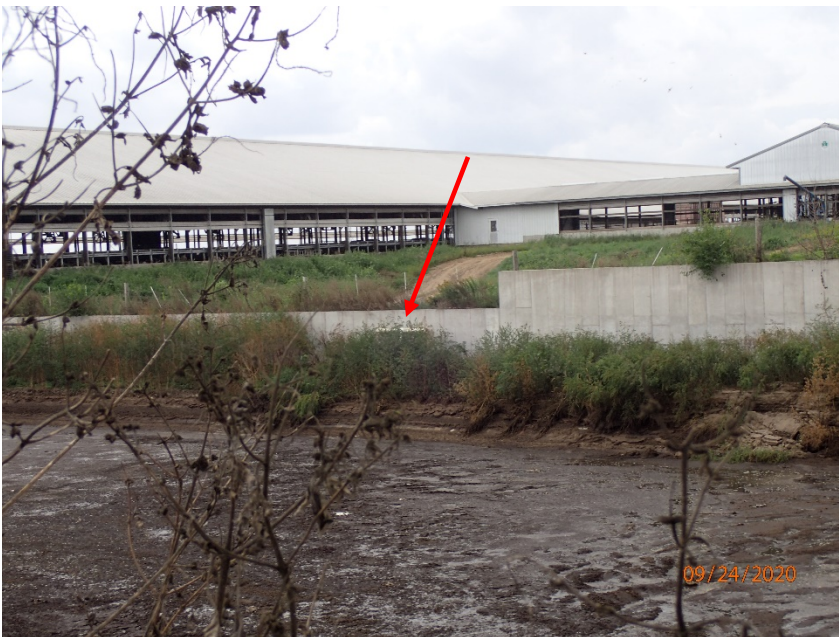
13: P9240013

The Inspectors then walked east around the south end of the Big Pit and north along the east side of the Big Pit. The Inspectors observed the depth marker in the Big Pit and the manure push out area from the Middle Barn (photos 13 and 14). The Inspectors then walked west around the north end of the Big Pit and observed a flow path coming from the northeast corner of the Little Pit which appeared to flow east to a berm which directed it to the Big Pit (photos 15-17). The Operator stated that he had observed the leak in the Little Pit and was in the process of cleaning it out enough to repair it. The Inspectors walked around the Little Pit (photos 18-20).

Description: Big Pit as seen from the east side. Note depth gauge (red arrow).

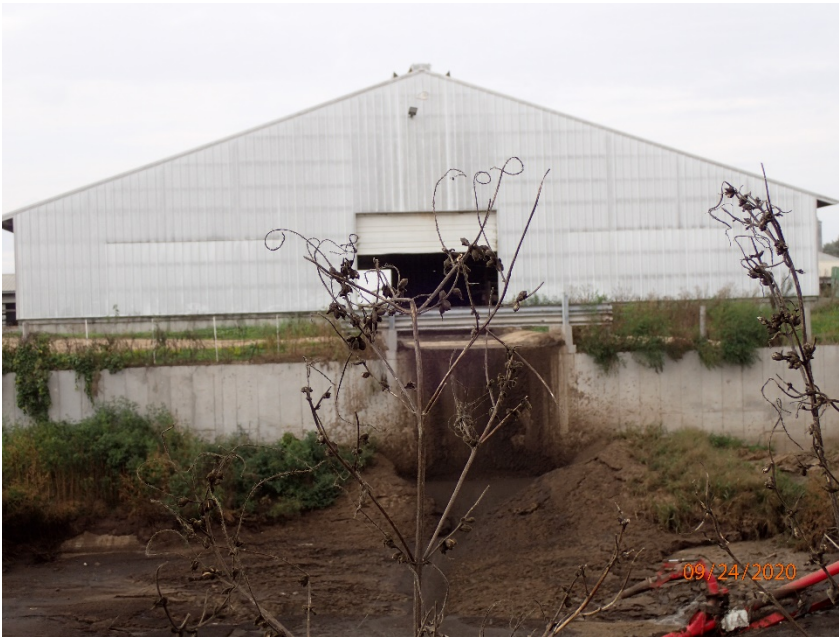
14: P9240014

Description: Manure push off area of the Middle Barn.

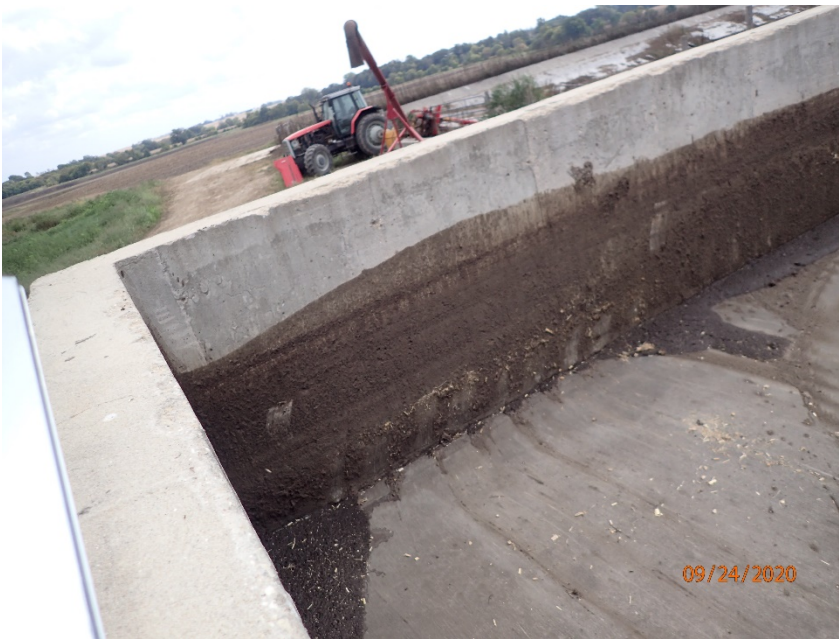
18: P9240018

1. Leachate from the North Silage Pad was observed leaving the pad.
2. Partially decomposed mortalities were observed in the filled area south of the Big Pit.
3. The Little Pit had a leak in the northeast corner.

Description: View of the interior of the northeast corner of the Little Pit.

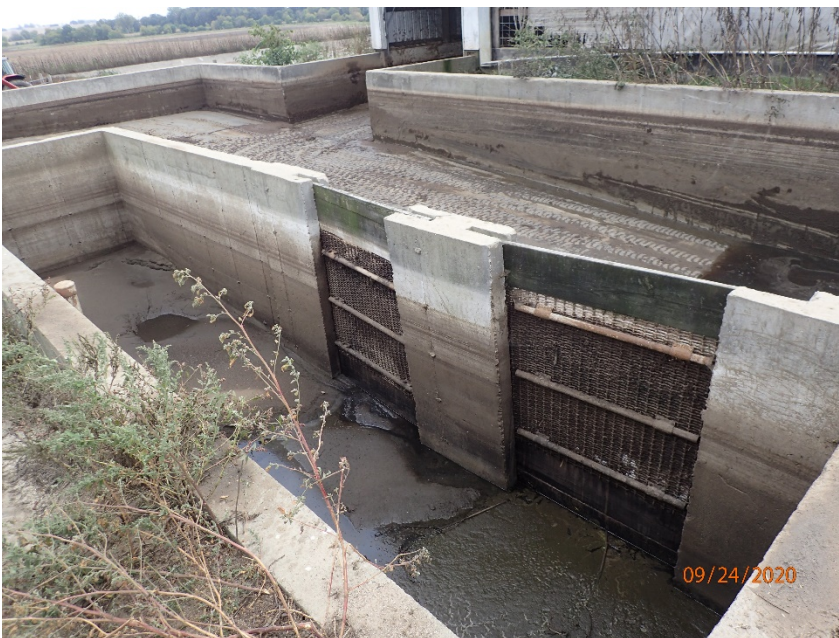
19: P9240019

Description: Little Pit as seen from the northwest corner. Liquids enter this center section through the slatted weep wall.

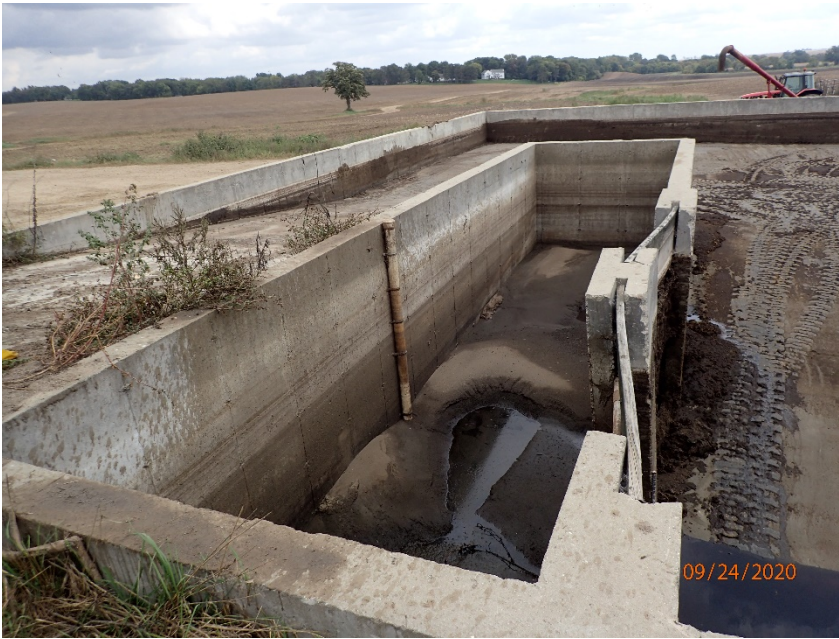
20: P9240020

Description: Little Pit as seen from the west side. Center portion collects liquids from the slatted weep wall.

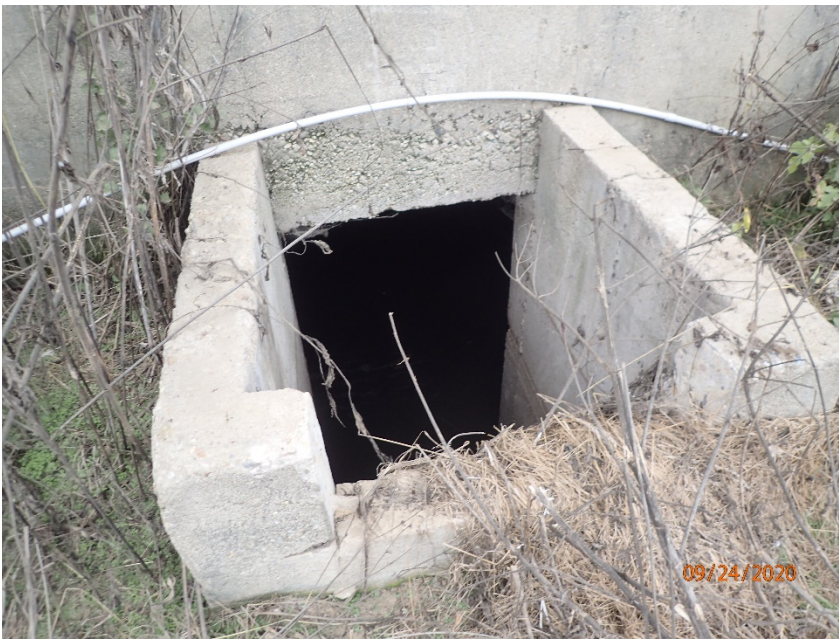
21: P9240021

Description: Pump out location of pit under the Old Dairy Barn.

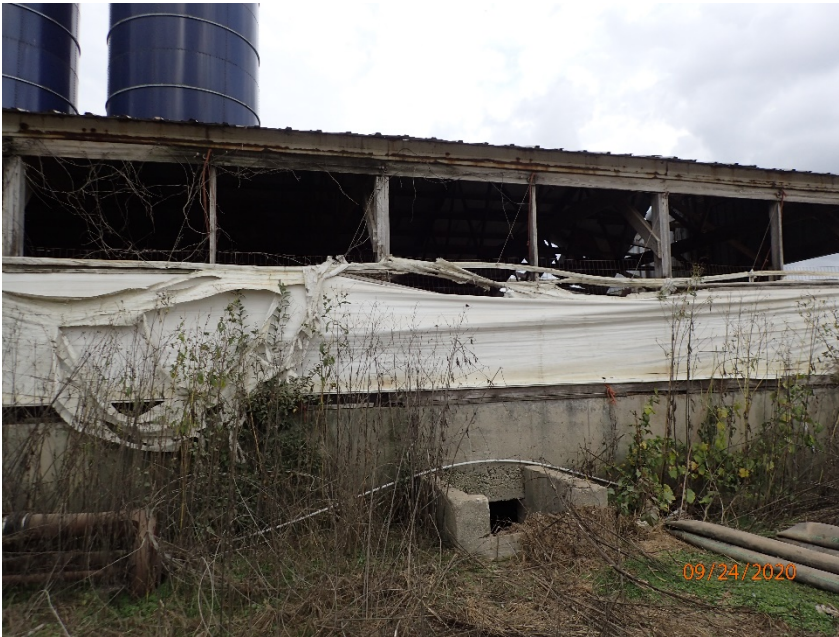
22: P9240022

Description: Pump out location of pit under the Old Dairy Barn.

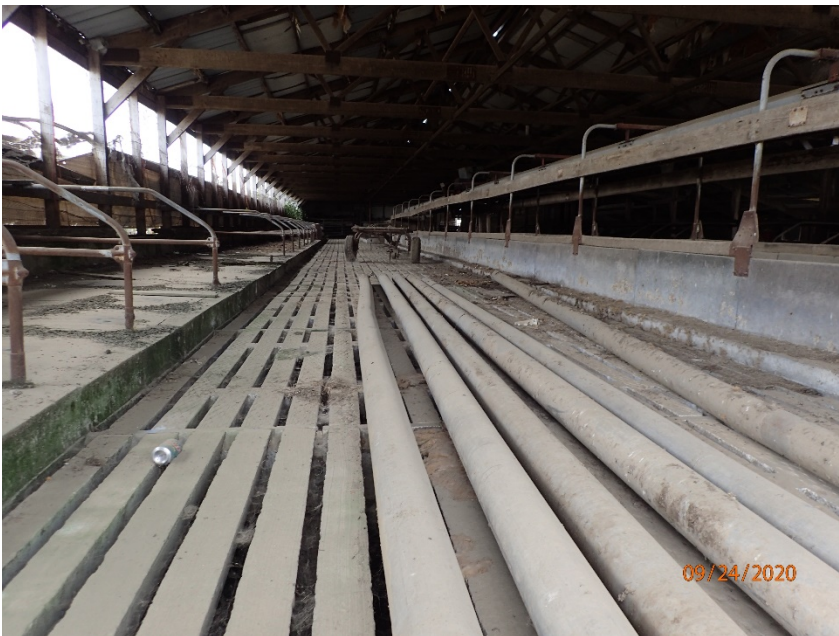
23: P9240023

Description: Interior of the Old Dairy Barn as seen from the east end. Note slatted floor above under barn pit.

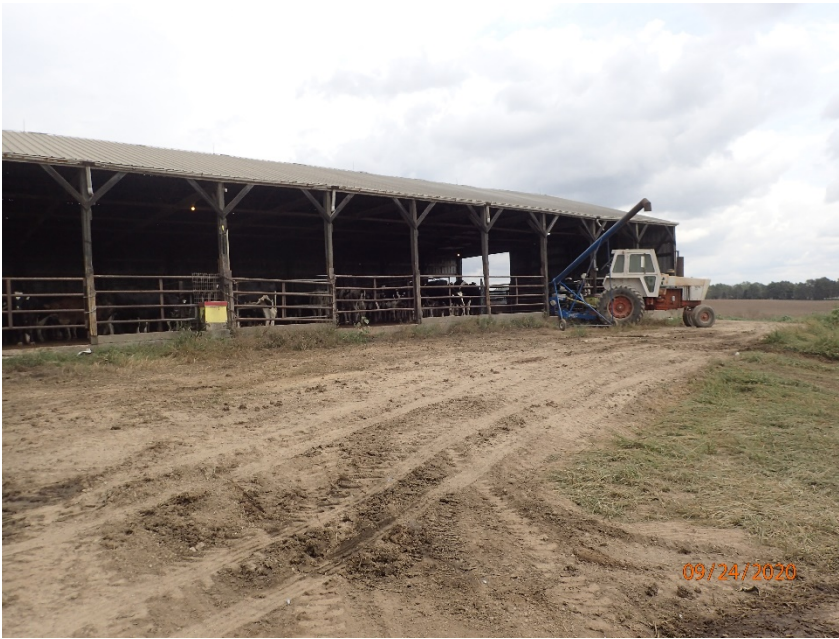
24: P9240024

The Inspectors continued North and observed the Beef Barn (photo 24) and then observed, between the Beef Barn and the Steer Lot, silage leachate that appeared to have leaked from the North Silage Pad (photo 25). It appeared that the Operator had formed berms to collect the leachate. The Operator stated that due to unusually wet silage he had been collecting and scraping the leachate daily. He stated that this was the first year they had encountered that problem and intended to return to putting up their silage drier the following year.

Description: Looking northeast along south side of the Beef Barn.

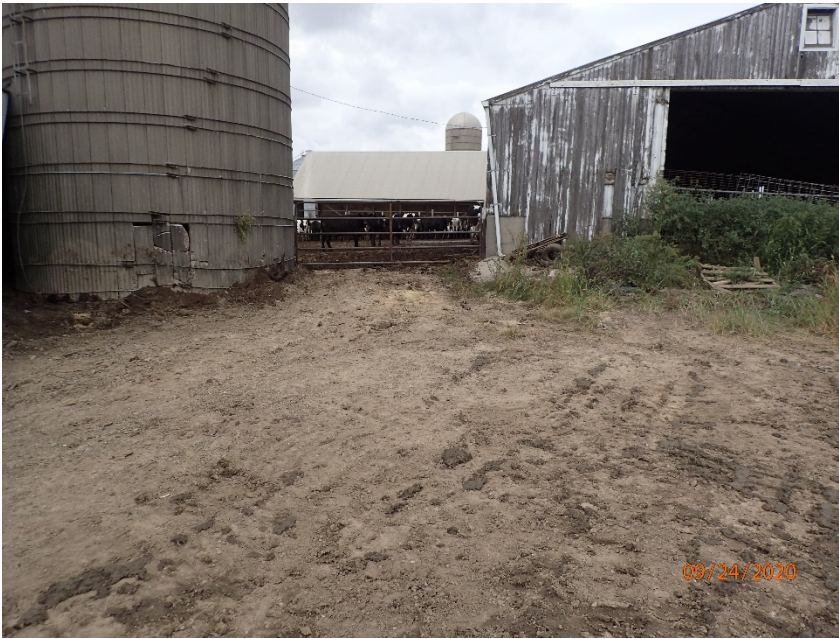
26: P9240026

Description: Looking west toward the Steer Lot.

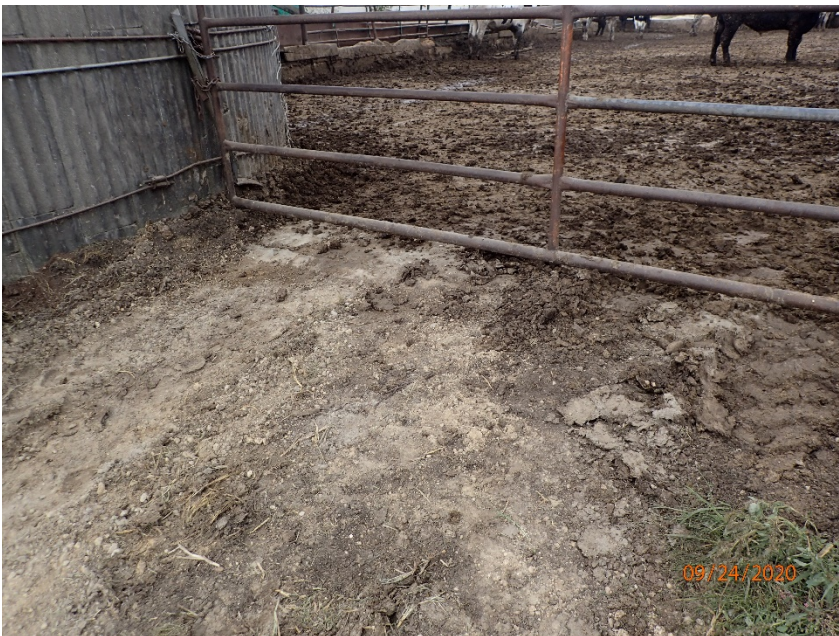
27: P9240027

The Inspectors walked west and observed the east side of the Steer Lot. The Inspectors observed gutters on the Steer Lot to direct roof runoff away from the lot (photos 26-28). The Inspectors walked south and then west around the Steer Lot and observed the cattle walkway with mountable curbs which directed manure and runoff from the Steer Lot to the underbuilding pit below the Old Dairy Barn (photos 29 – 30). The Inspectors then Observed two surface inlets (photos 31-32). The Operator stated that these inlets conveyed stormwater away from the barns to the grassed waterway to the east.

Description: Closer look at the gate on the east side of the Steer Lot. The Operator stated the lot was sloped so that all manure and process wastewater runoff from the lot would be collected into the pit under the Old Dairy Barn. Raised concrete below the gate prevented manure and process wastewater from flowing to the east.

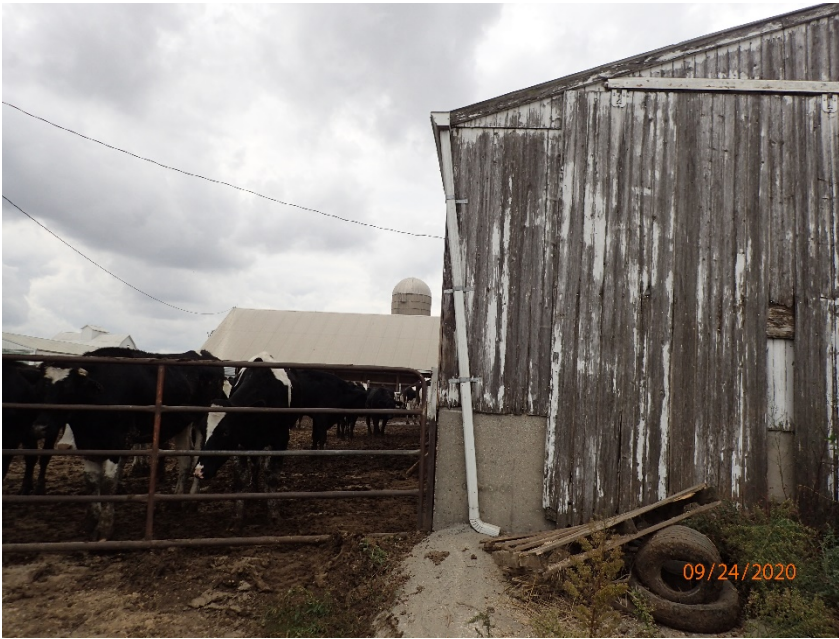
28: P9240028

Description: East side of the Steer Lot. Note gutter and downspout directing roof water away from the Steer Lot.

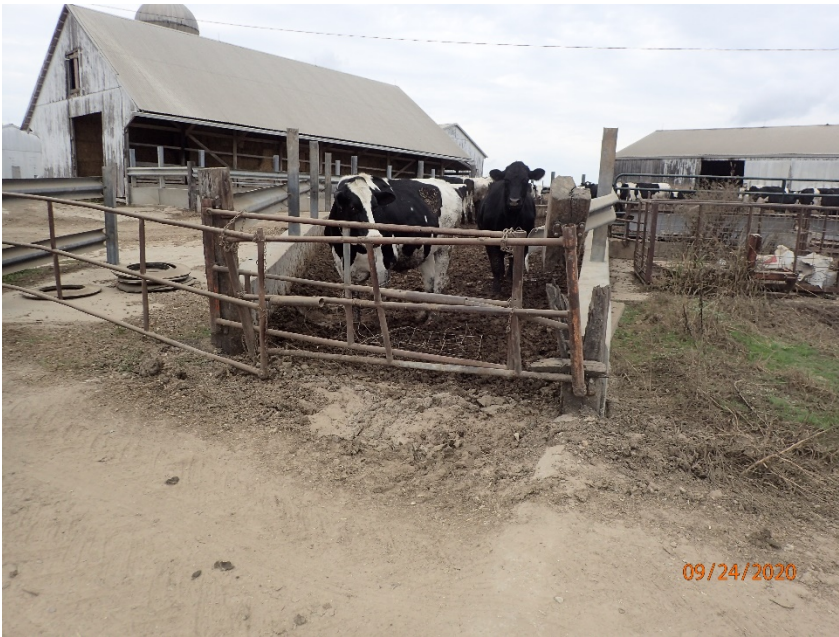
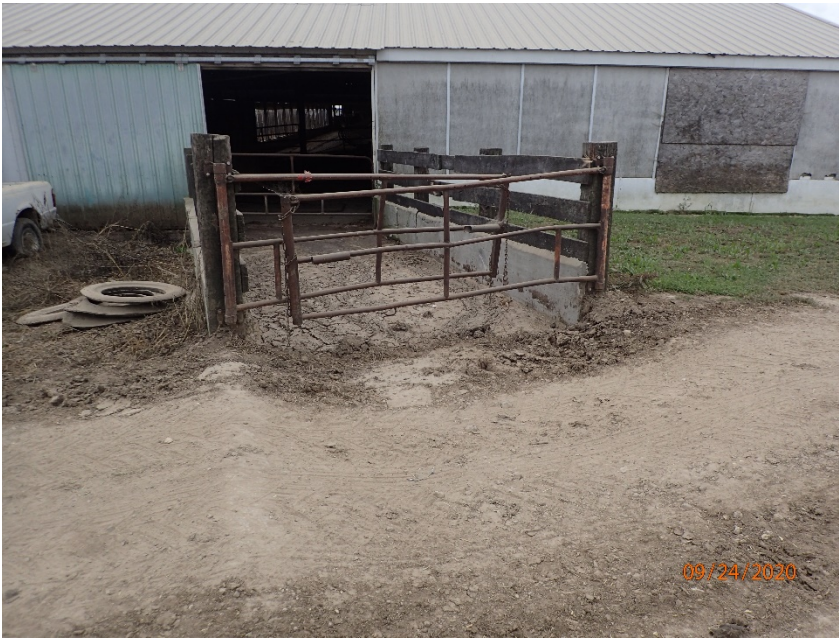
Description: Curbed walkway between the Steer Lot and the Old Dairy Barn that conveys manure and process wastewater runoff to the pit under the Old Dairy Barn.

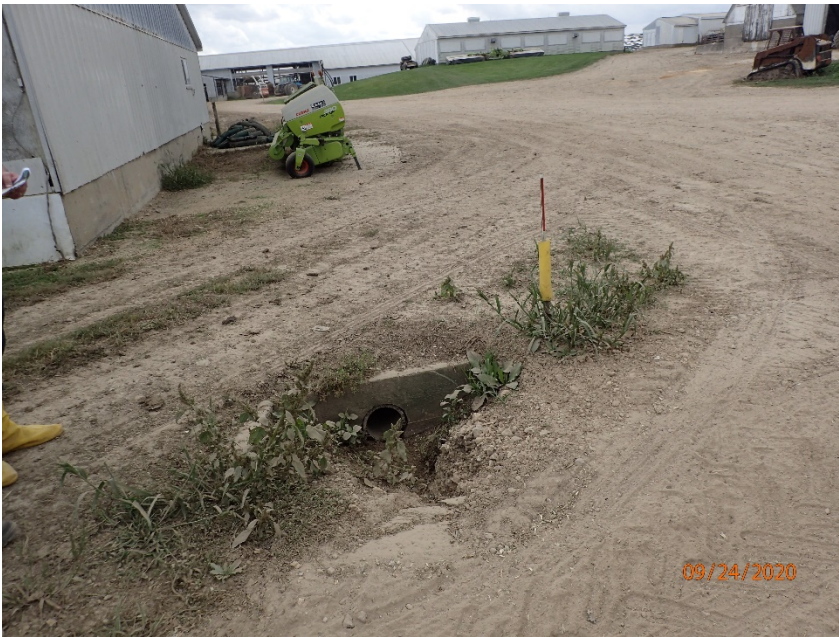
31: P9240031

Description: Stormwater inlet collects runoff from the roads and conveys it to the east side of the Facility.

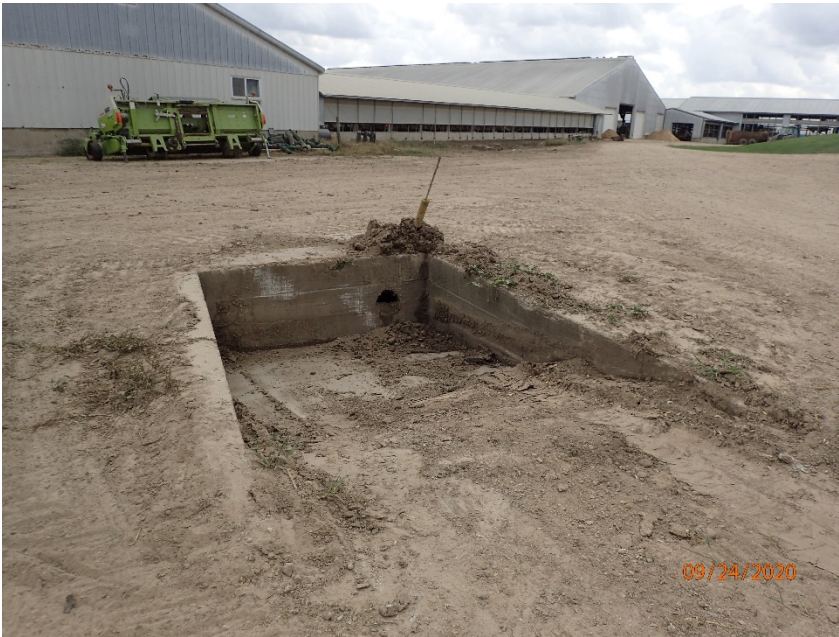
32: P9240032

Description: Stormwater inlet collects runoff from the roads and conveys it to the east side of the Facility. Note that this is a separate storm water drain than the one seen in Photo 31.

Location: West of stormwater drain seen in Photo 31.

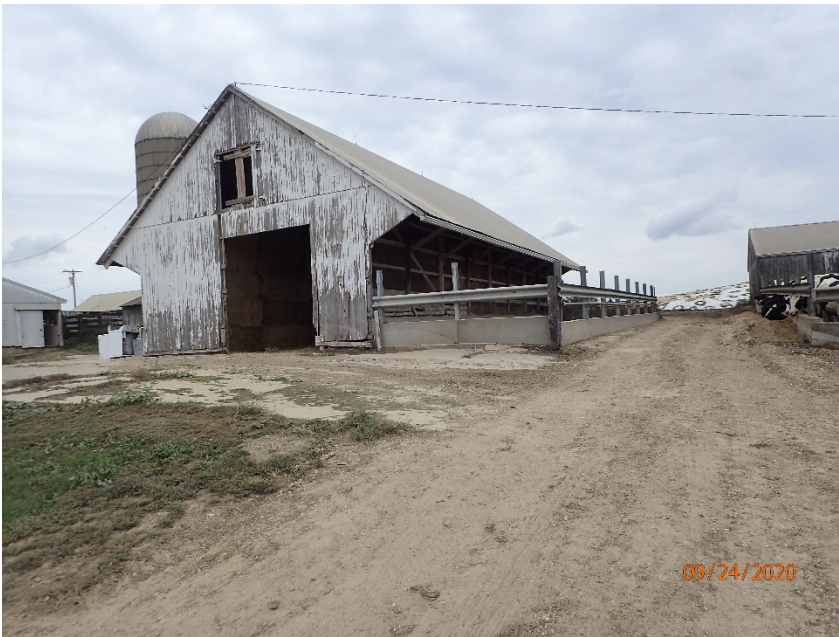
33: P9240033

Description: Looking North between the Hay Shed (left) and the Steer Lot (right). The west end of the North Silage Pad is seen in the distance.

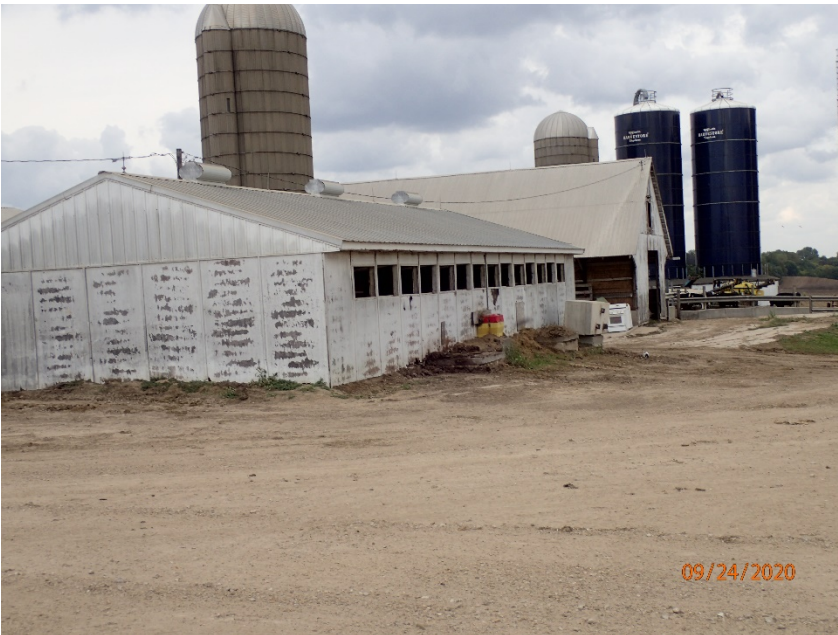
37: P9240037

Description: Looking east along the south side of Calf Barn 3.

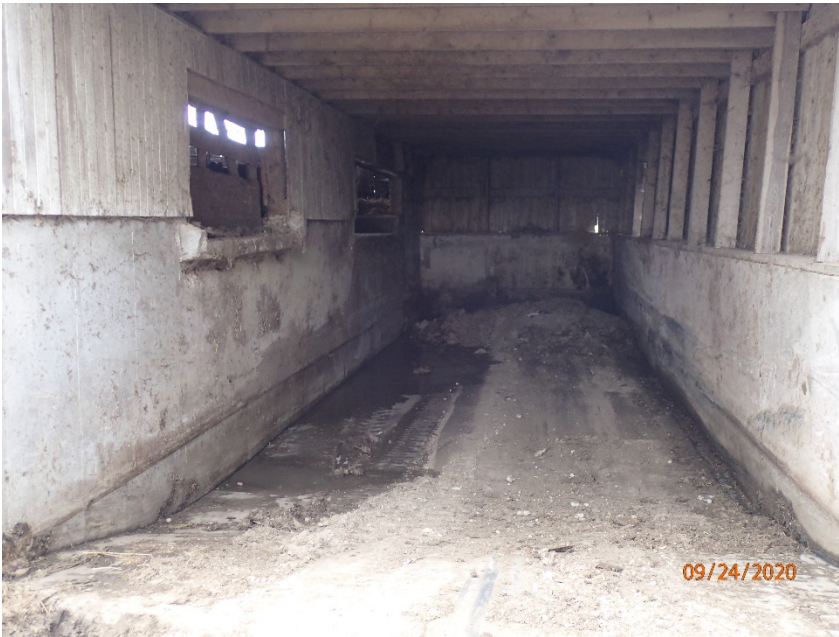
38: P9240038

The Inspectors then walked west around the North Silage Pad and silage and haylage bags then south around the west side of the Calf Barn 1, 2, and 3 and observed the manure loading area at the southeast corner of Calf Barn 1 (photos 37 and 38). The Inspectors then walked south past the Comodity Building (photo 39) and observed an additional storm water inlet on the west side of the covered walkway between the Old Dairy Barn and the Middle Barn (photo 40).

Description: Manure loading area on the east side of Calf Barn 1. Manure and used bedding from the calf barn is stored here until it can be land applied.

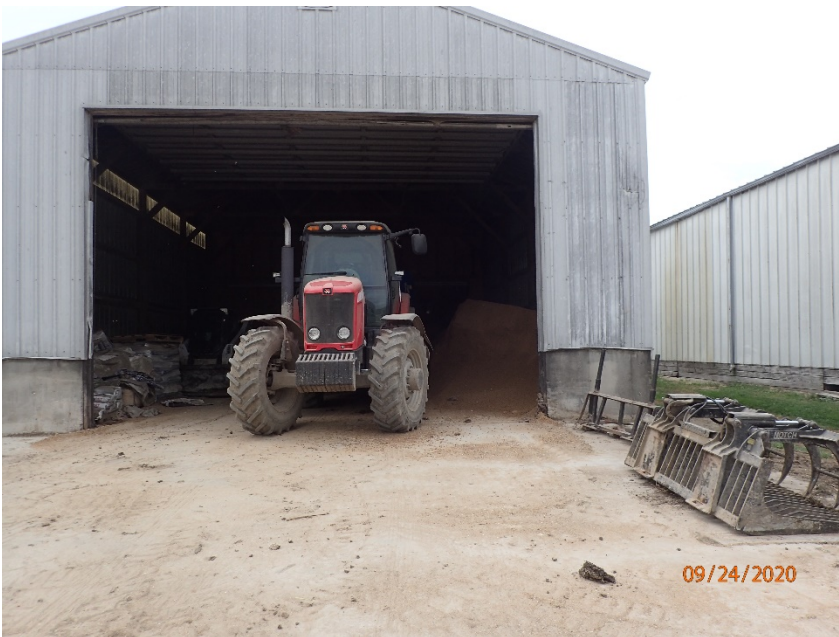
39: P9240039

Description: Looking west into the Commodities Building. Dry gluten and additional dry commodities were stored in here.

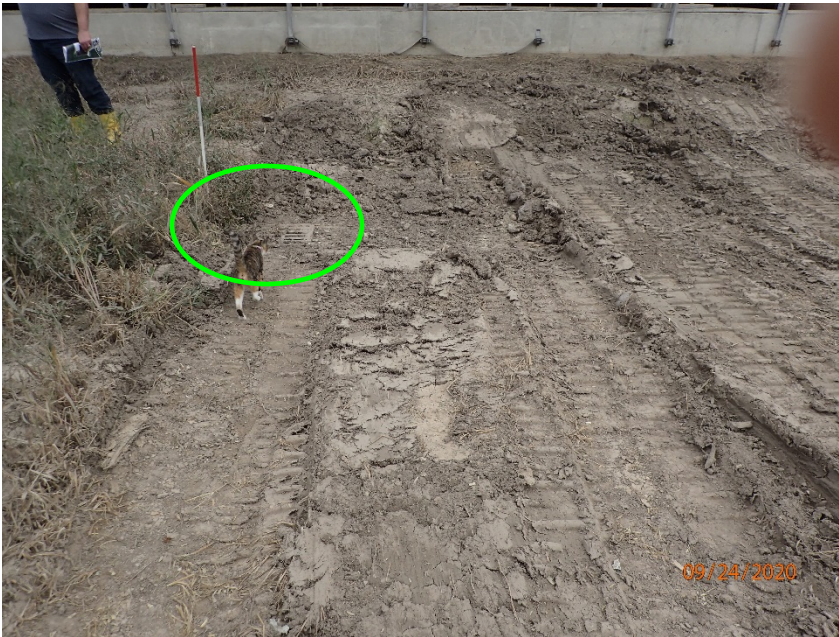
40: P9240040

Description: Surface inlet (denoted by the circle) west of the covered cattle walkway between the Old Dairy Barn and the Middle Barn. This inlet conveys flow to the east side of the Facility.

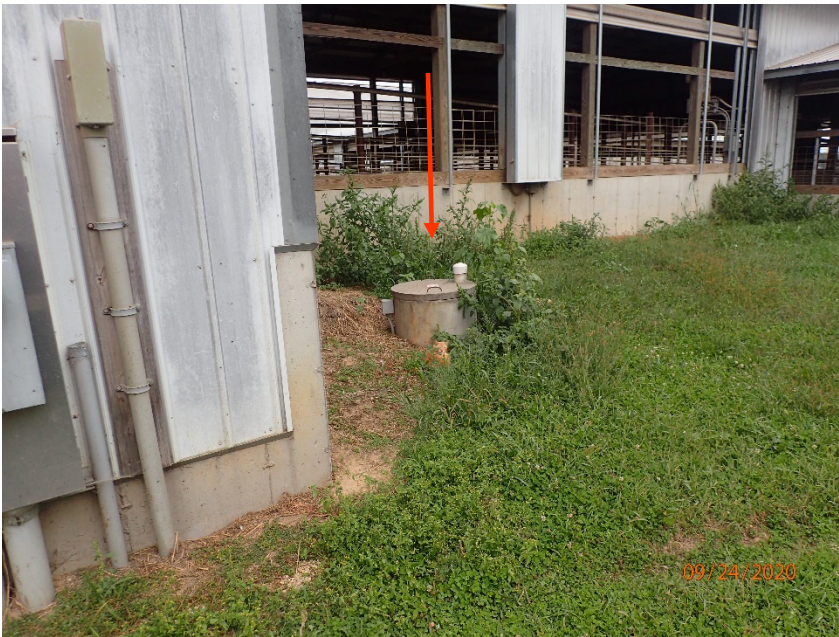
41: P9240041

The Inspectors walked south and observed the access riser for the plate cooler water tank (photo 41) on the south side of the Milking Parlor. The Inspectors also observed two surface drain inlets on the north side of the Big Barn (photos 42-45). The Operator stated that these drains conveyed stormwater runoff under the Big Barn to the southeast.

Description: Area between the milking parlor the Big Barn. Note the access riser for the plate cooler water (arrow).

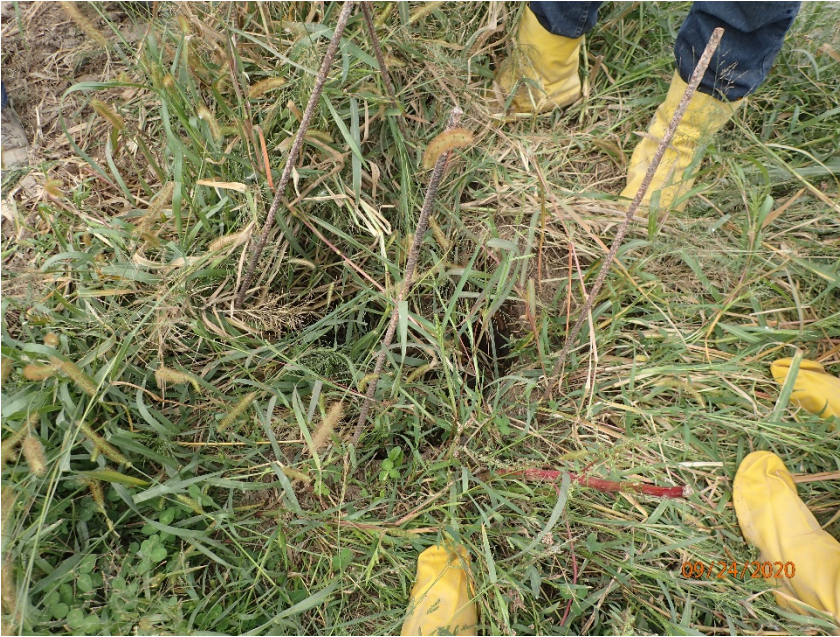
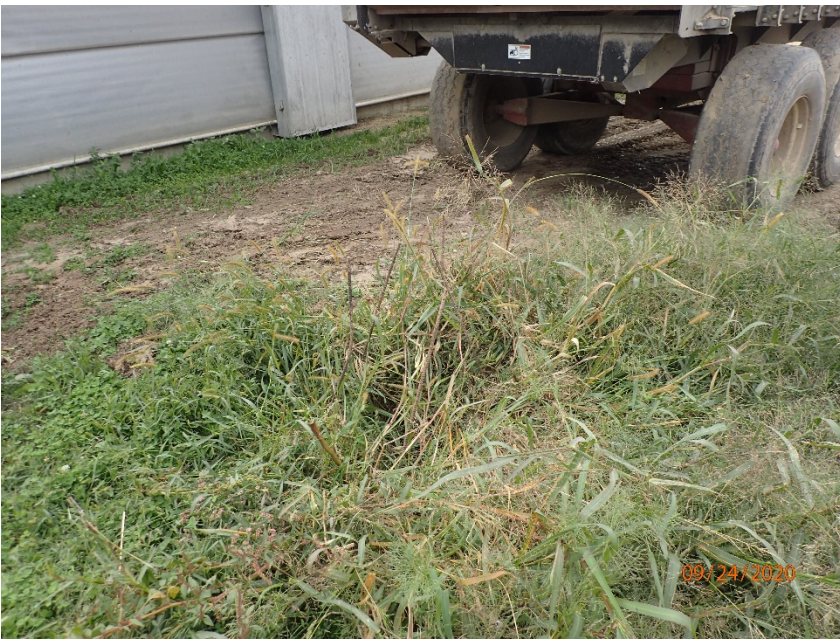
Description: Surface inlet for drain tile that outlets storm water flow to the southeast of the facility.

Description: Surface inlet for drain tile that outlets storm water flow to the southeast of the facility. Same inlet as seen in Photo 42.

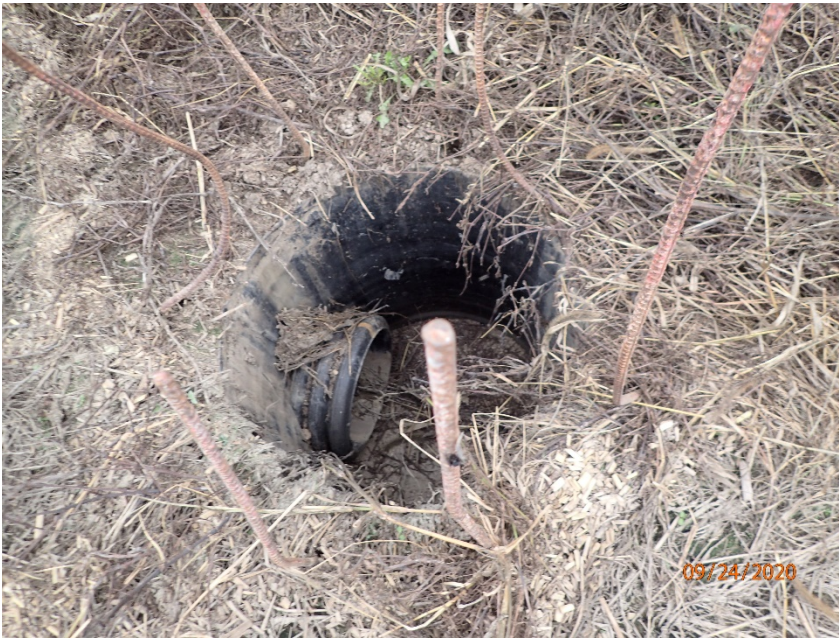
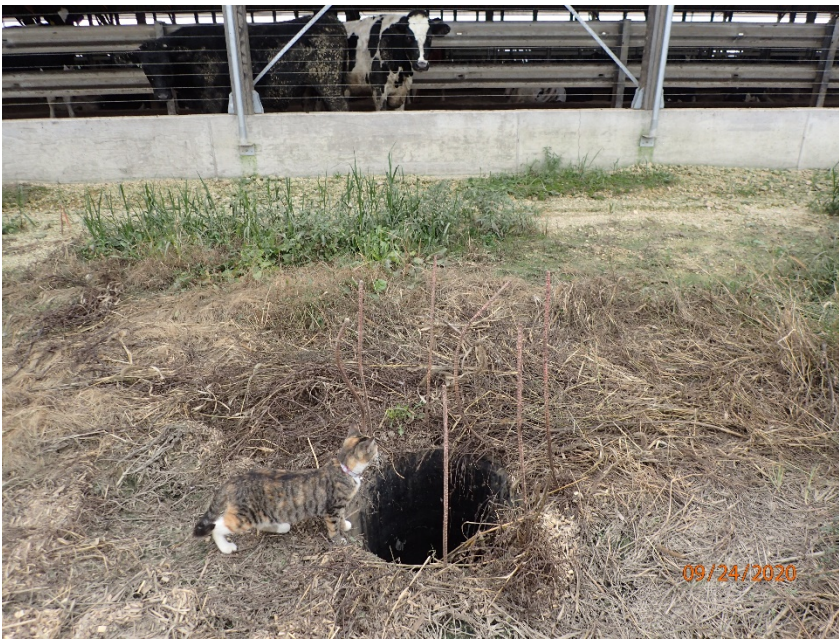
Description: Additional surface inlet to drain tile on the north side of the Big Barn.

Description: Additional surface inlet to drain tile on the north side of the Big Barn. Same inlet as seen in Photo 44.

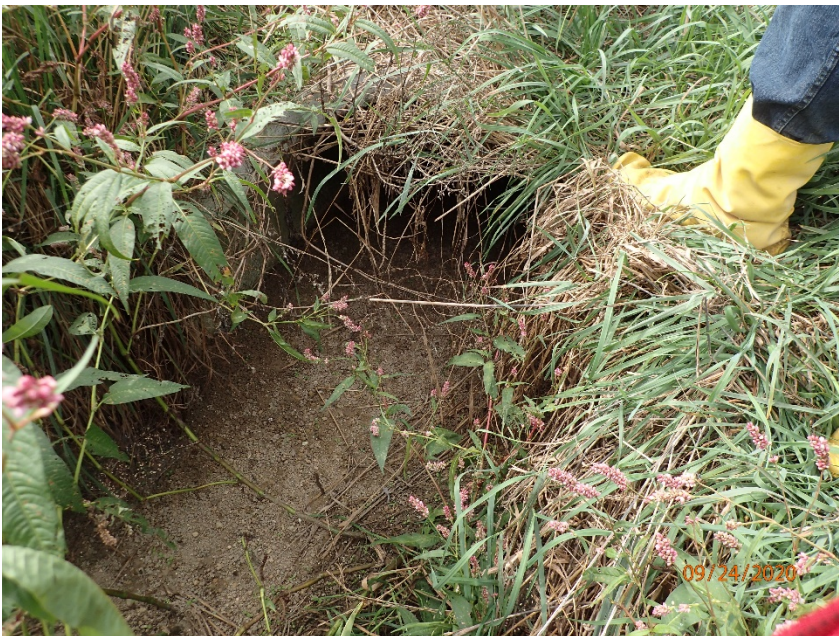
47: P9240047

Description: Outlet of surface drain north of the Milking Parlor to the grassed area east of the Milking Parlor.

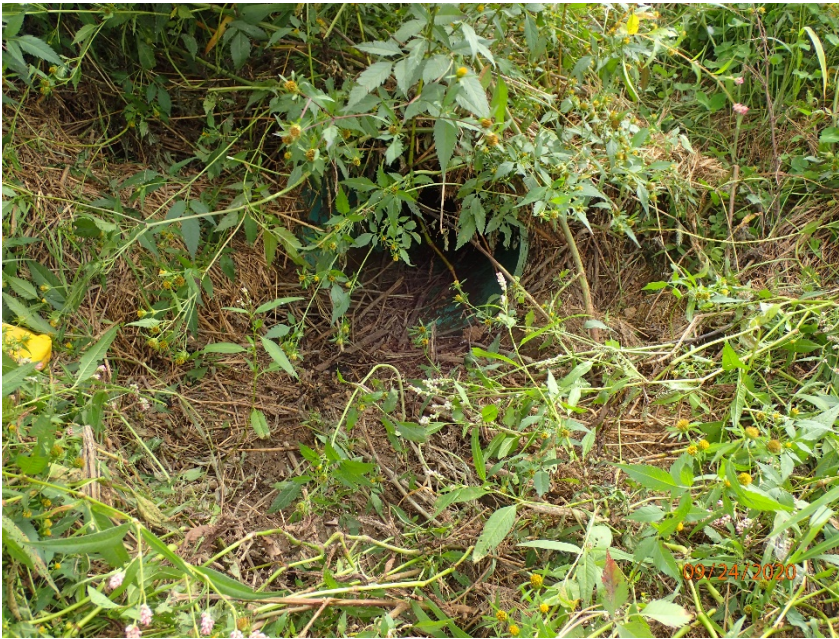
48: P9240048

The Inspectors walked back around the south side of the Big Barn and observed an outlet pipe on the hillslope southeast of the Big Barn (photo 46). The Operator stated that this pipe was the outlet for the inlets seen on the northside of the Big Barn as well as an inlet in the grassed area east of the Milking Parlor. The Inspectors walked to the grassed area east of the Milking Parlor and observed an outlet in the northwest corner of the grassed area (photo 47) which the Operator stated was from a drain on the northside of the Milking Parlor and an inlet in the southeast corner (photo 48) which the operator stated conveyed flow to the outlet seen southeast of the Big Barn (photo 46).

Description: Inlet of surface drain in the southeast corner of the grassed area east of the Milking Parlor. The Operator stated that this inlet was connected to the outlet seen in Photo 46.
