## Region 6 Compliance Assurance and Enforcement Division

### INSPECTION REPORT

| Company Name: | <b>Graphic Packaging International, LLC</b> | | |
| Facility Name: | <b>West Monroe Paper Mill</b> | | |

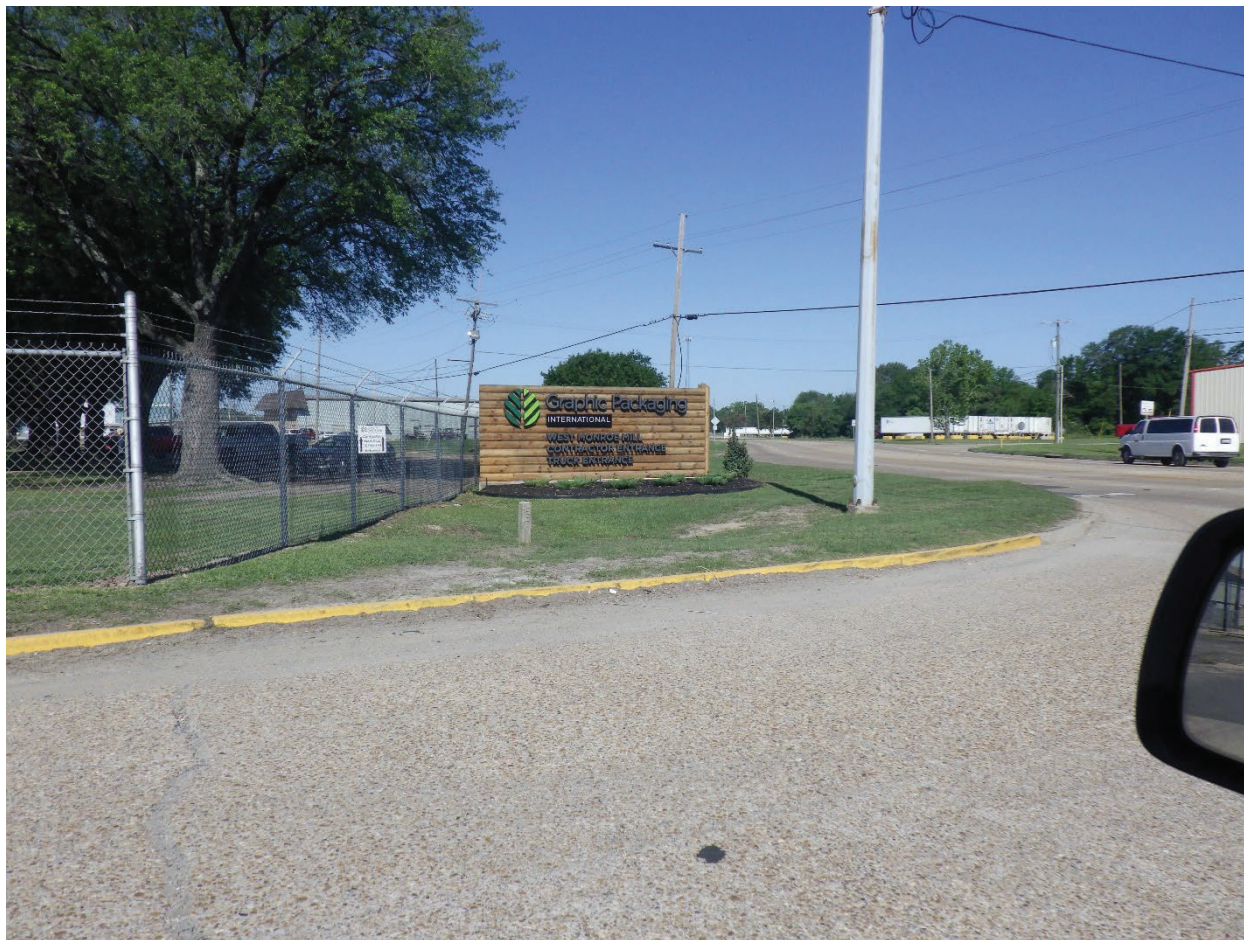
Photo No. 1

Photograph File Name: R0010826.JPG  
Date of Photograph: 04/23/2024  
Latitude and Longitude: 32.485205, -92.149951  
Orientation: E  
Map Datum: WGS-84  
Time of Photo: 09:35 AM  
Photographer: Jack Arias  
Description: This image shows the name and entrance of the facility.

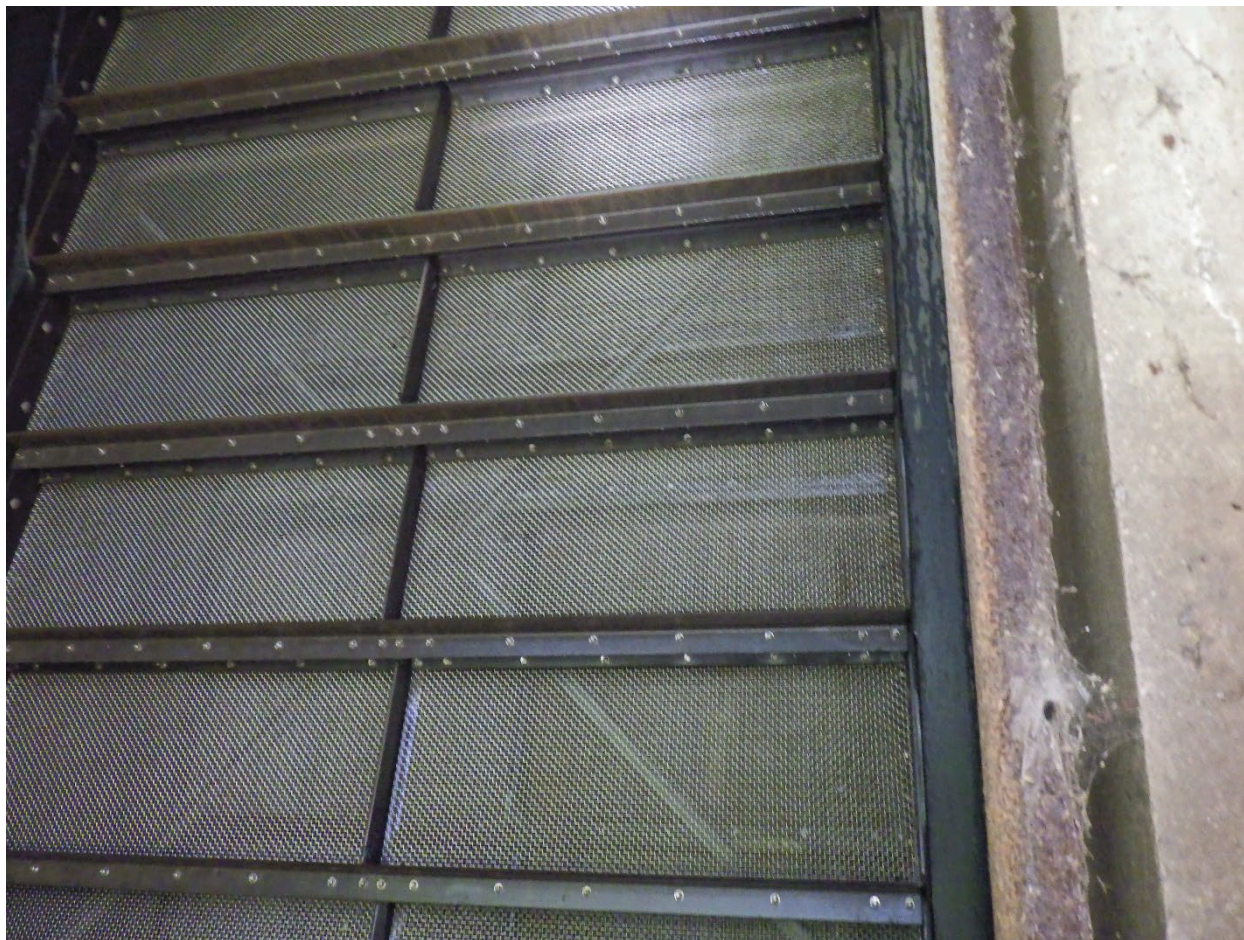
Photo No. 4

Photograph File Name: R0010833.JPG  
Date of Photograph: 04/23/2024  
Latitude and Longitud: 32.488572      -92.125388  
Orientation: E  
Map Datum: WGS-84  
Time of Photo: 11:41 AM  
Photographer: Jack Arias  
Description: This image shows screens (approximately 3/8-inch square steel mesh each) being pumped by circulating water pumps at the Water Intake Structure.

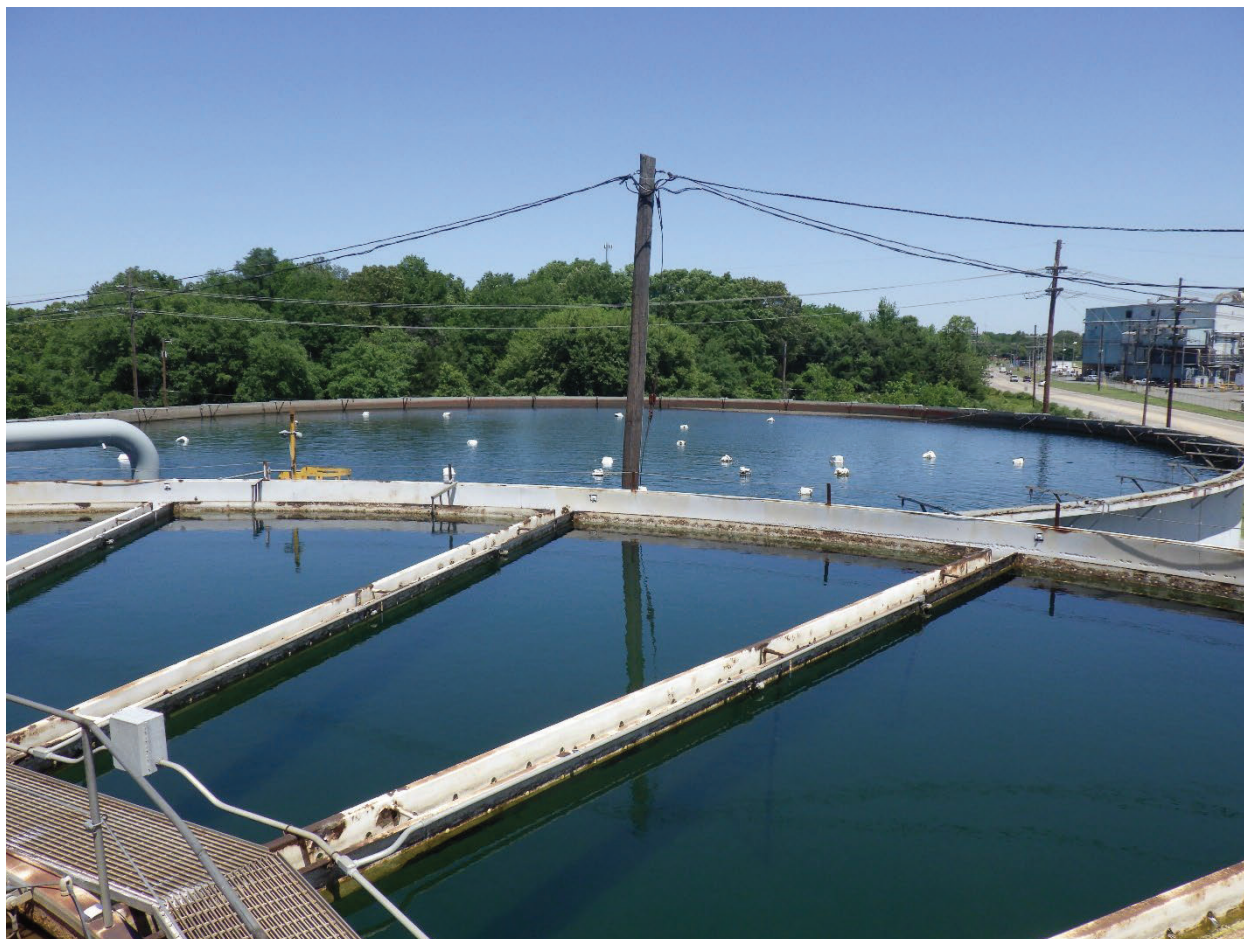
Photo No. 6

The purpose of the river water clarifiers is to remove solids/sludge from the river water (water intake procedure from Quachita River) through clarification procedures. These procedures consist of two treatments (primary and secondary clarification treatments) through tank systems. These treatments improve the removal of solids/sludge from the river water. At the time of the inspection, I did not observe any deficiencies on the water intake, clarification, containment, and transfer of the tank system (See Photo Nos. 5 – 6 in Appendix 1).

Photograph File Name: R0010846.JPG  
Date of Photograph: 04/23/2024  
Latitude and Longitude: 32.481707 -92.155541  
Orientation: W  
Map Datum: WGS-84  
Time of Photo: 12:24 PM  
Photographer: Jack Arias  
Description: This image shows inside the Mill River Water Clarifier tank system (primary clarification treatment).

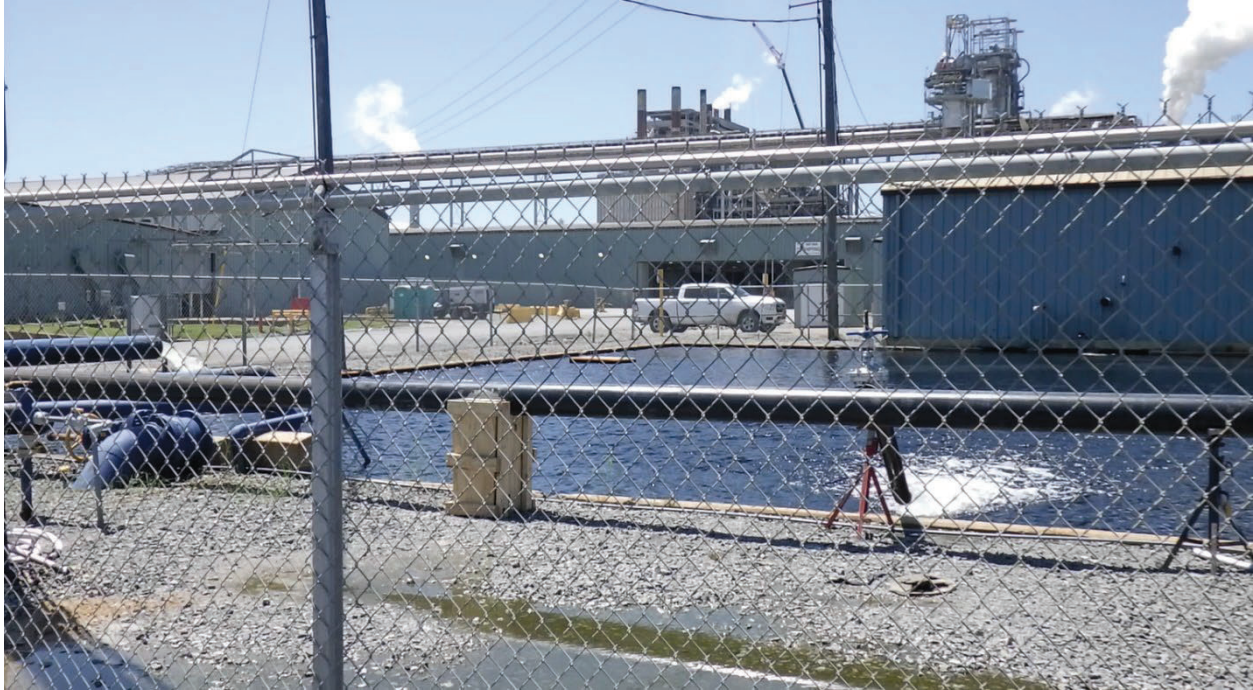
Photograph File Name: SwimmingPoolSystem.JPG  
Date of Photograph: 04/23/2024  
Latitude and Longitud: 32.483807 -92.150182  
Orientation: SE  
Map Datum: WGS-84  
Time of Photo: 1:20 PM  
Photographer: Jack Arias  
Description: This image shows a concrete holding pond referred to as the "swimming pool" is filled with chlorinated well water that feeds various mill process operations.

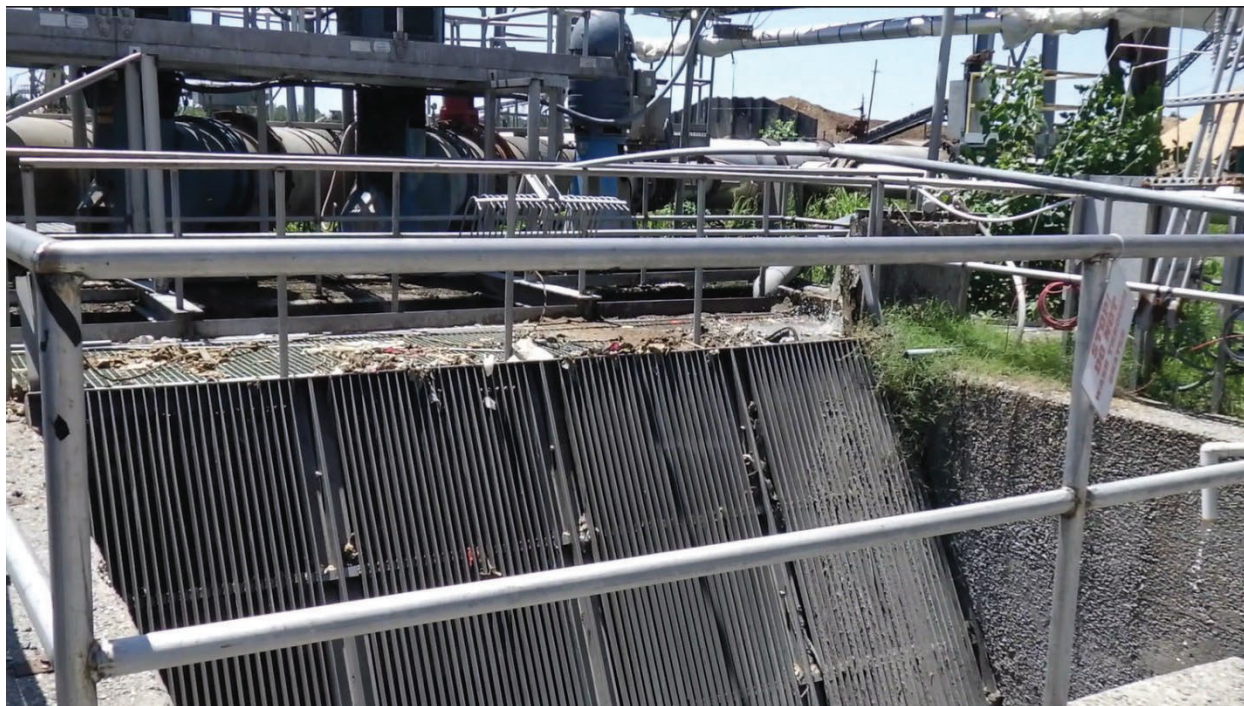
Photo No. 11

This image shows the mill pit which is a wastewater treatment system that collects all process wastewater through a system that drain to the mill effluent pit where the wastewater is then pumped through a pipe to the primary clarifier (basin processing area).

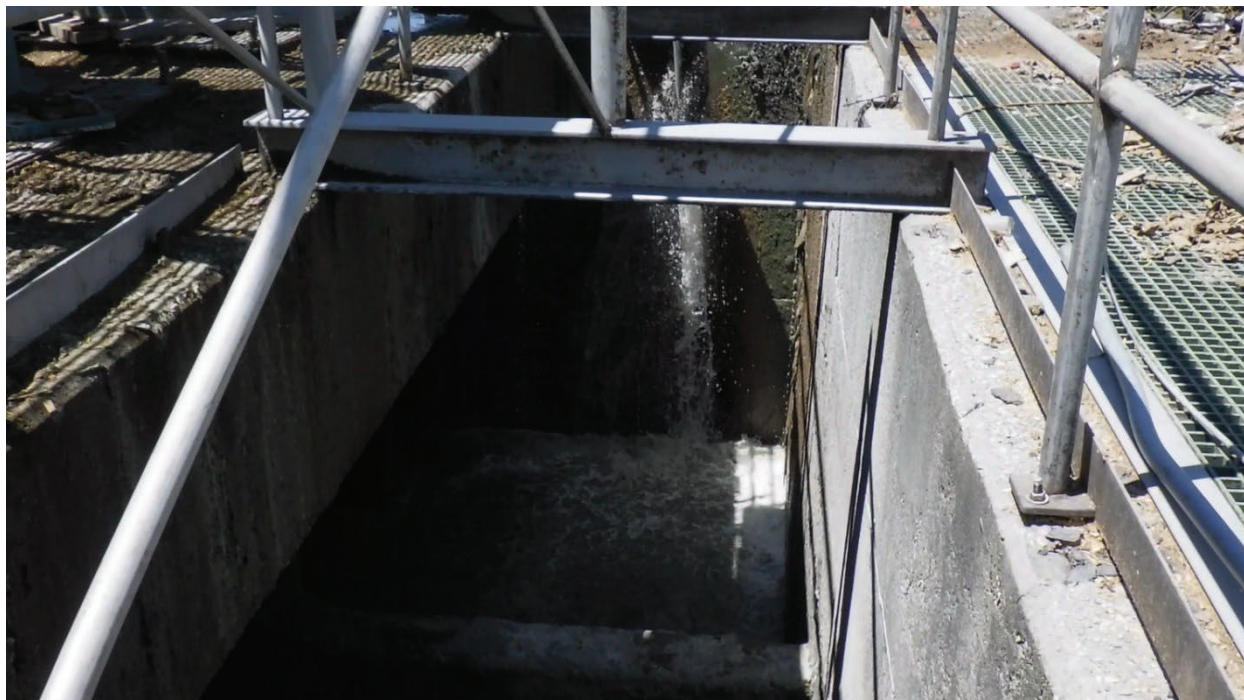
Photo No. 12

This image shows the mill pit collecting process wastewater and transferring wastewater through a pipe to the primary clarifier (basin processing area).

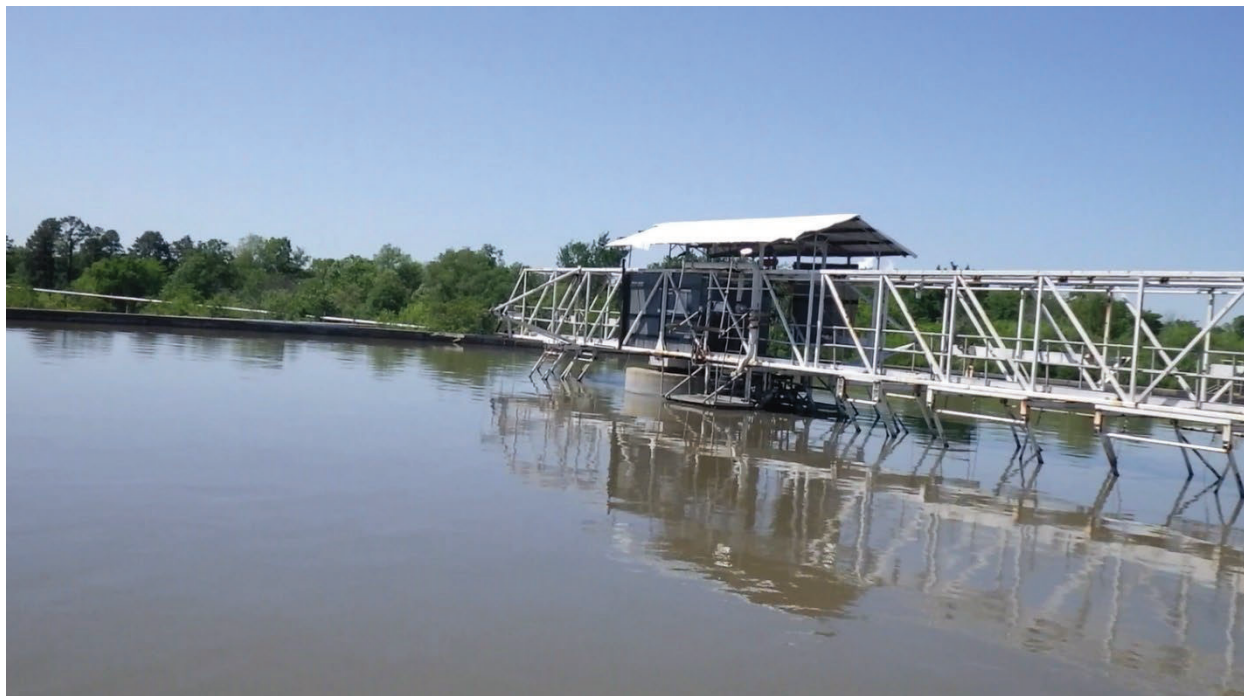
Photograph File Name: PClarifier.JPG  
Date of Photograph: 04/23/2024  
Latitude and Longitude: 32.473638 -92.146516  
Orientation: S  
Map Datum: WGS-84  
Time of Photo: 2:00 PM  
Photographer: Jack Arias  
Description: This image shows the primary clarifier. It removes heavy solids such as ash, grit, fiber, and lime and skim any oils from the surface.

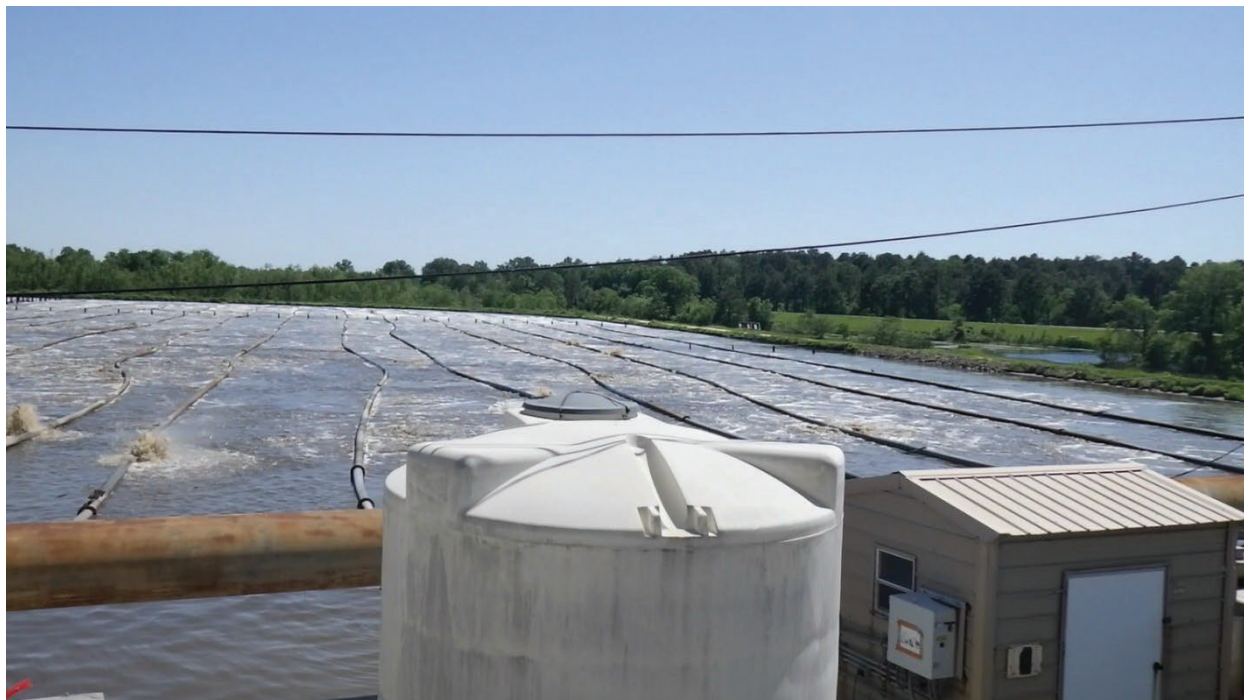
This image shows the aerated stabilization basin (ASB). The ASB is used for the biological treatment of soluble organics in the water from sources such as black liquor, starch, turpentine, methanol, and foul condensate.

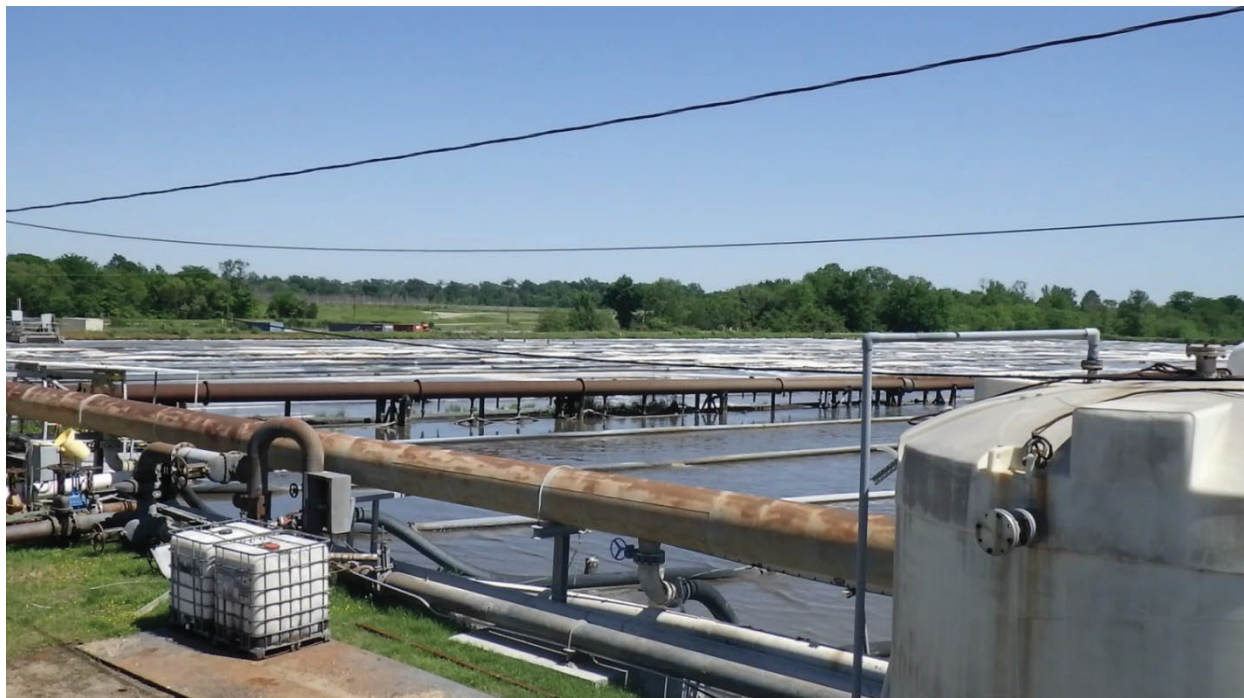
Photograph File Name: Basin2.JPG  
Date of Photograph: 04/23/2024  
Latitude and Longitude: 32.472344 -92.145314  
Orientation: S  
Map Datum: WGS-84  
Time of Photo: 2:15 PM  
Photographer: Jack Arias  
Description: This image shows the east part of aerated stabilization basin (ASB).

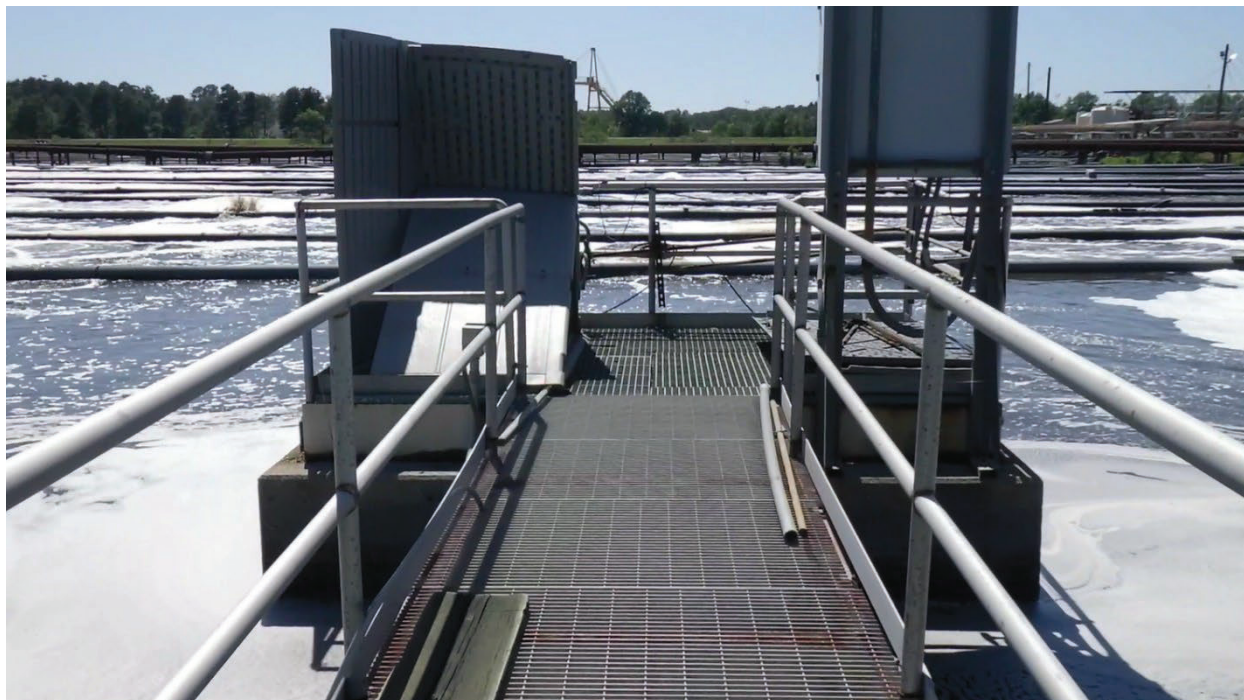
Photograph File Name: Sampling.JPG  
Date of Photograph: 04/23/2024  
Latitude and Longitud: 32.473438      -92.144849  
Orientation: S  
Map Datum: WGS-84  
Time of Photo: 2:20 PM  
Photographer: Jack Arias  
Description: This image shows the sampling point at the aerated stabilization basin (ASB).

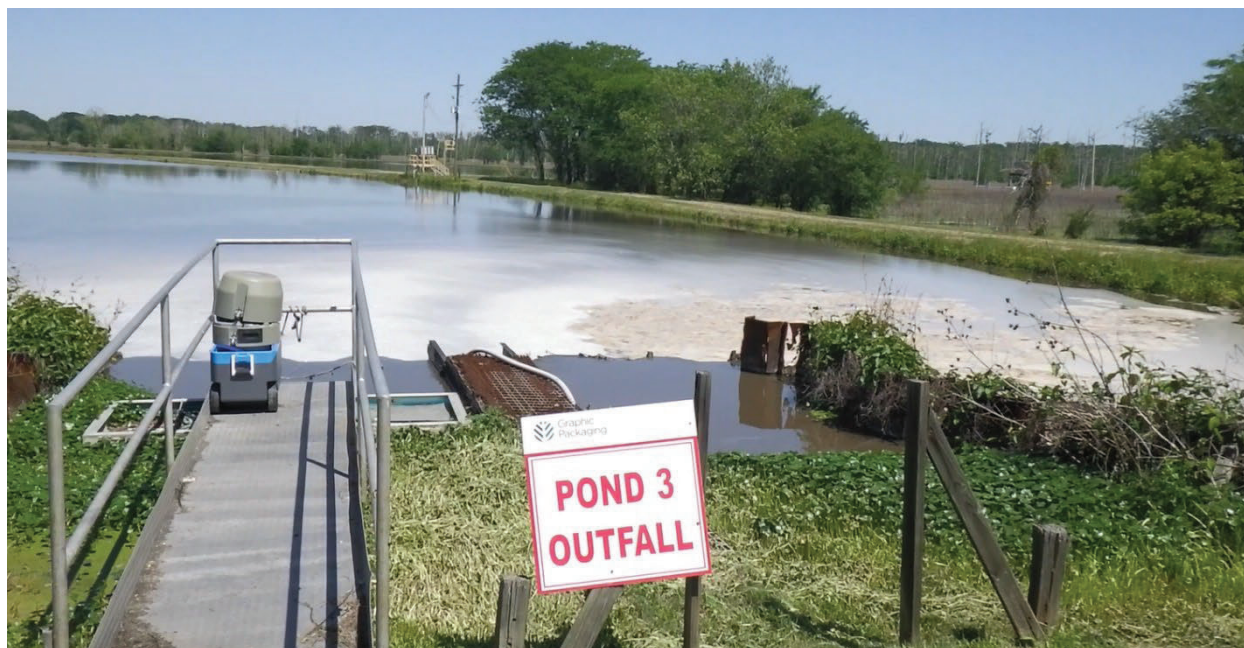
This image shows a settling pond. Solids are removed from the effluent through a series of three settling ponds before the effluent is discharged into the Ouachita River. Effluent is monitored to ensure compliance with LPDES Permit limits for pH, total suspended solids, and biochemical oxygen demand.

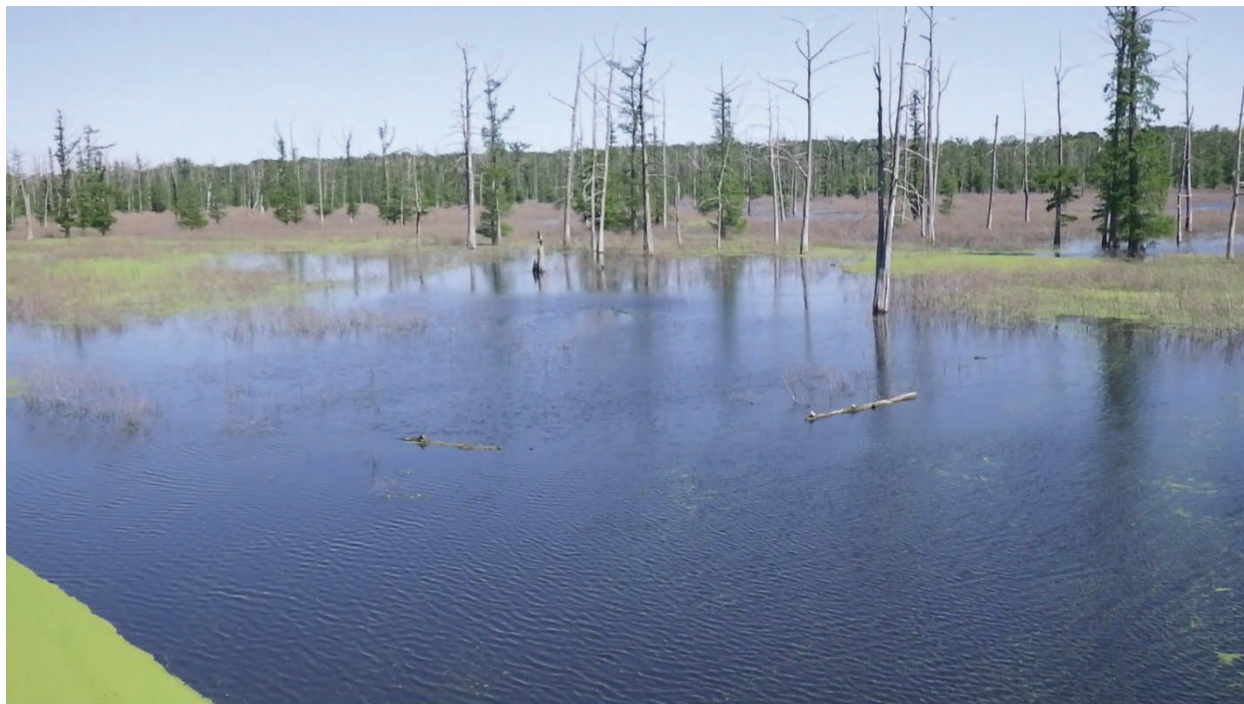
Photograph File Name: UnnamedTribuary.JPG  
Date of Photograph: 04/23/2024  
Latitude and Longitud: 32.448908 -92.130109  
Orientation: SE  
Map Datum: WGS-84  
Time of Photo: 3:20 PM  
Photographer: Jack Arias  
Description: This image shows the Outfall 401 discharging into an unnamed tributary, thence to Outfall 001, thence to the Quachita River.
