**REGION 1**

Re: *Bemmer Petroleum Corporation*: Notice of Potential Violations Pursuant to Section 112(r) of the Clean Air Act, Inspection Close-Out List in Attachment 2, and Notice of Upcoming Compliance Order

## ATTACHMENT 1

### Sample Photographs from EPA's Inspection

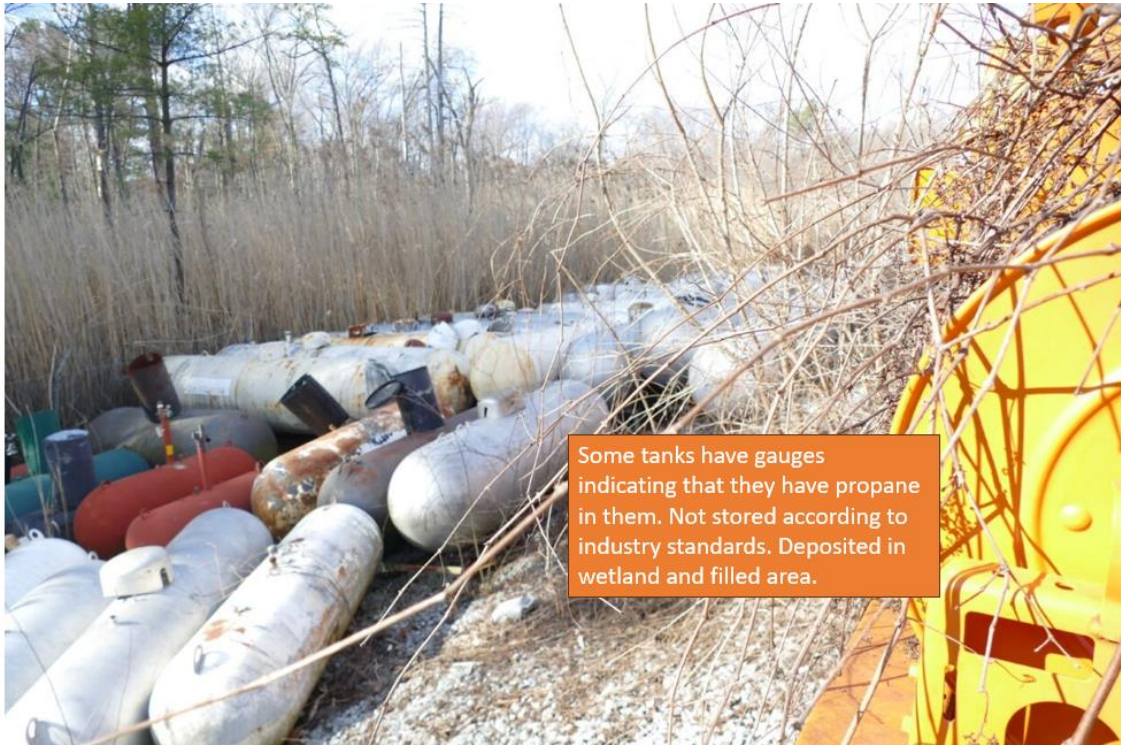
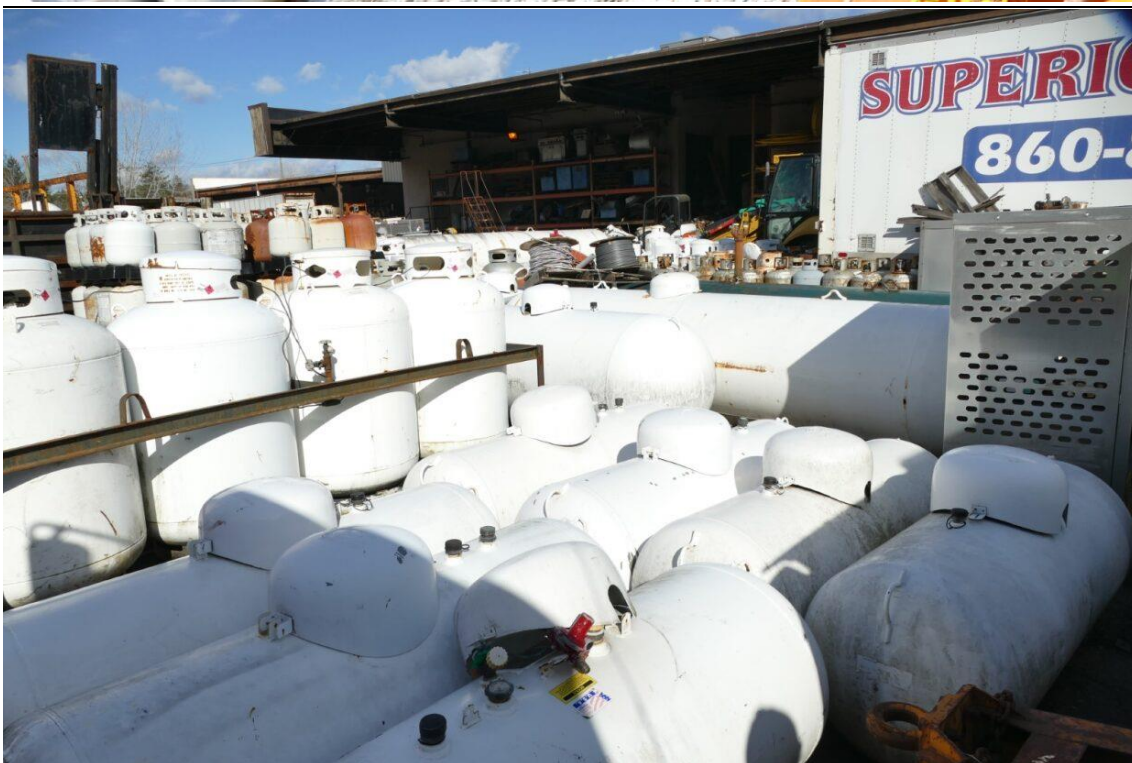
30,000-gallon and 60,000-gallon tanks of propane, filled by trucks. Not in compliance with industry standards of care (NFPA 58).

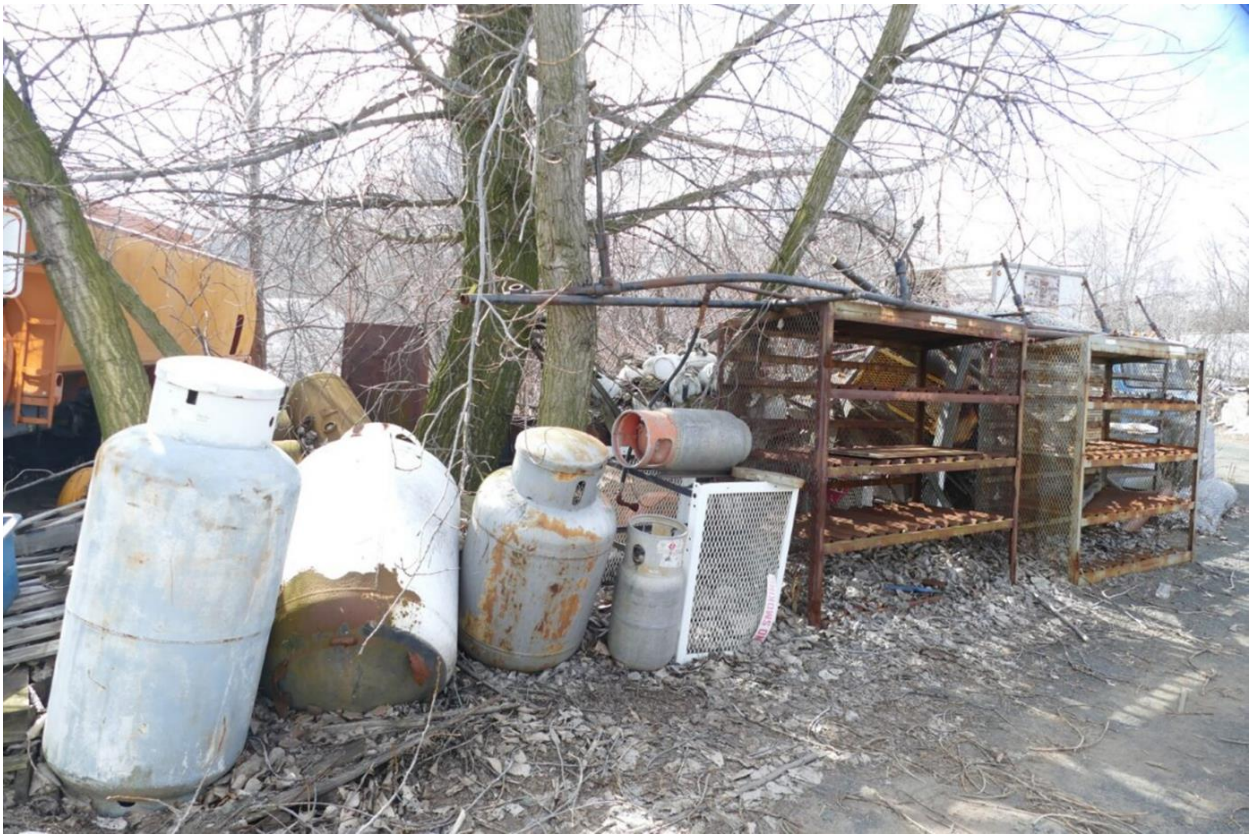
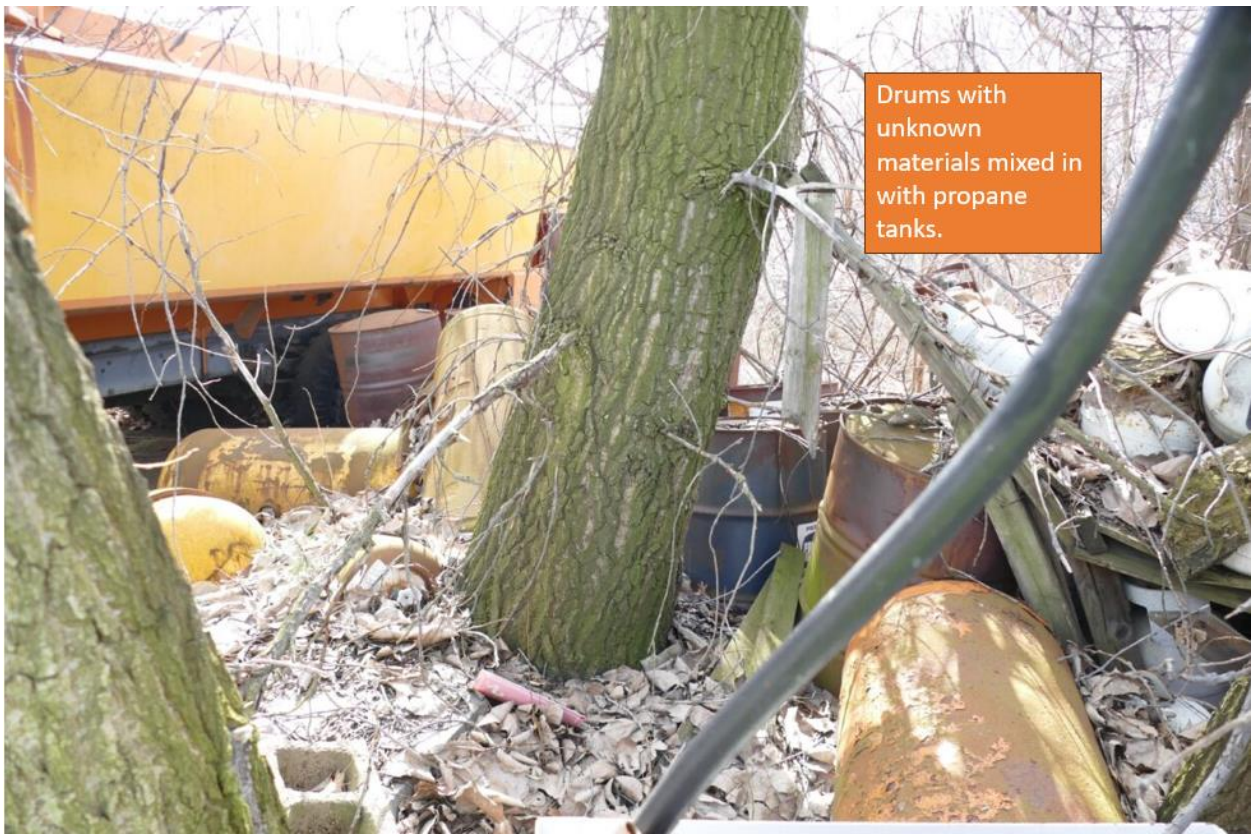
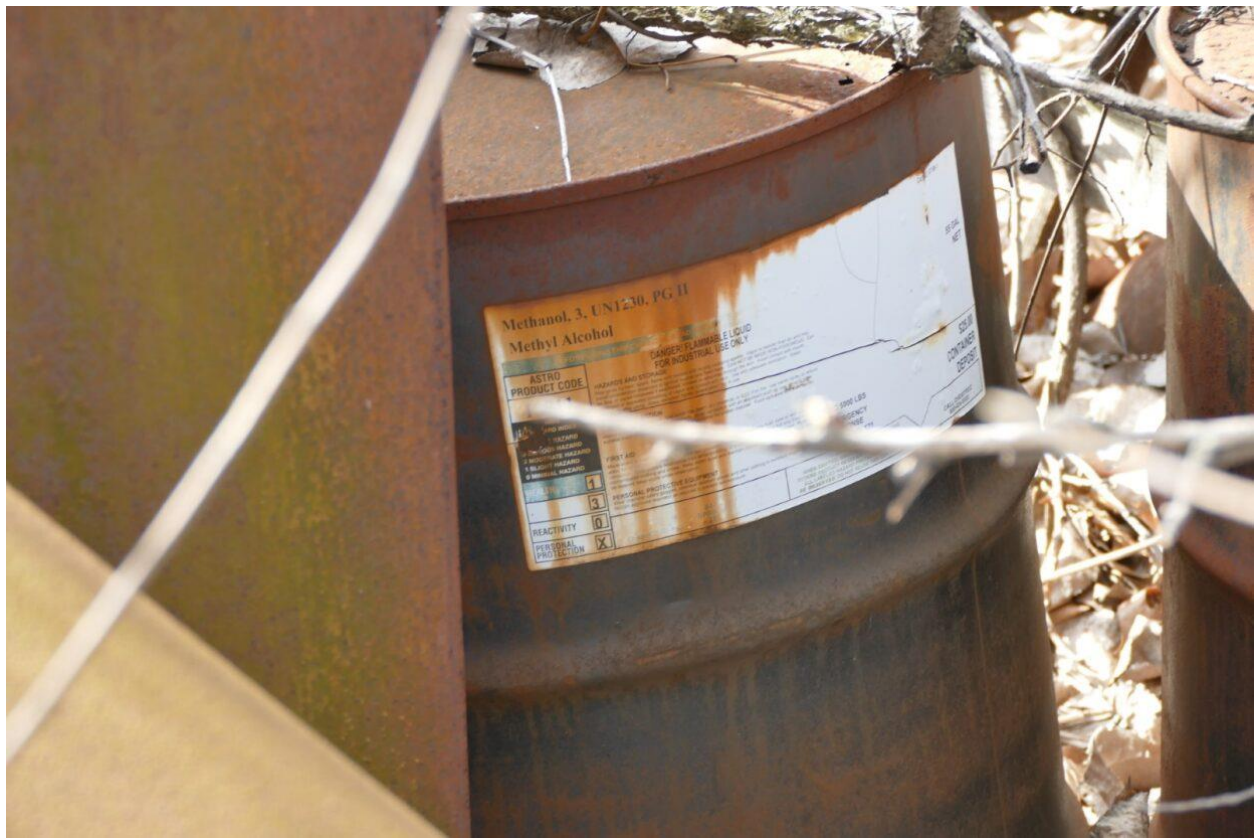
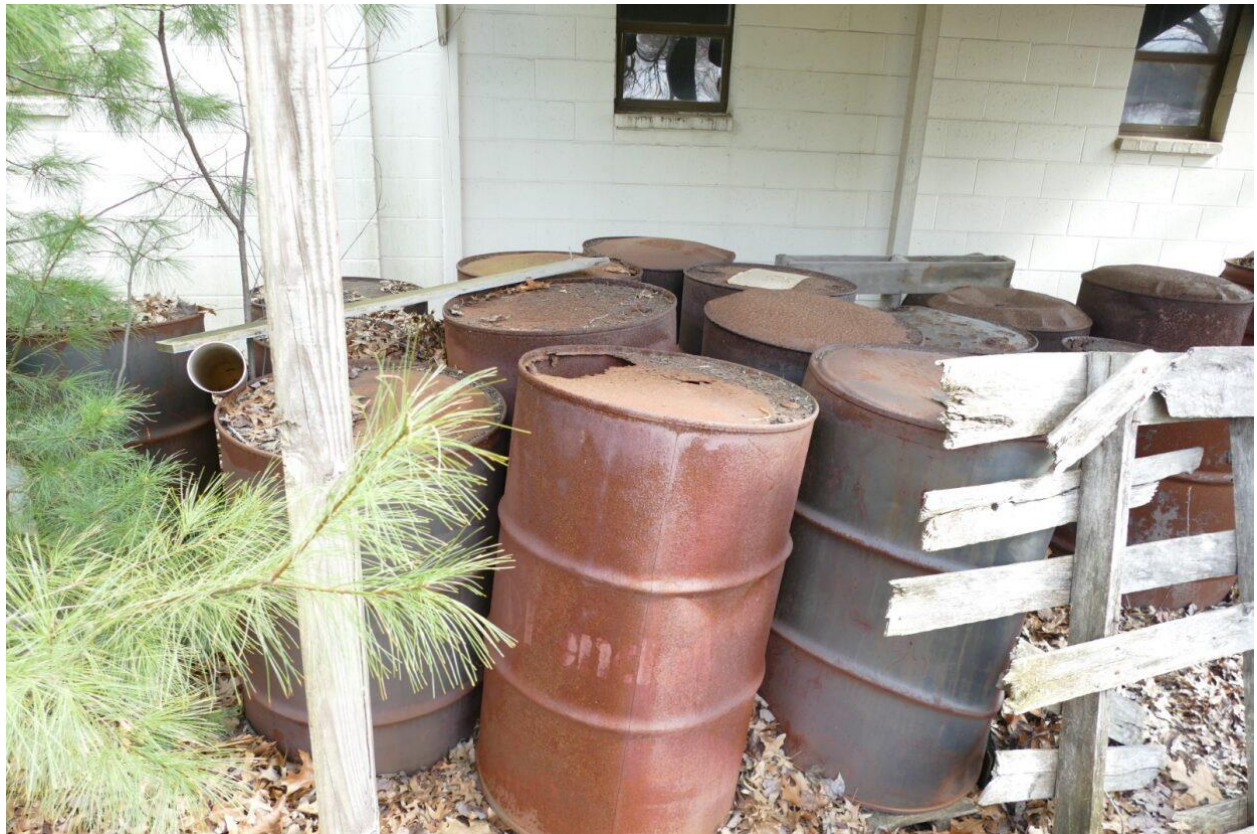
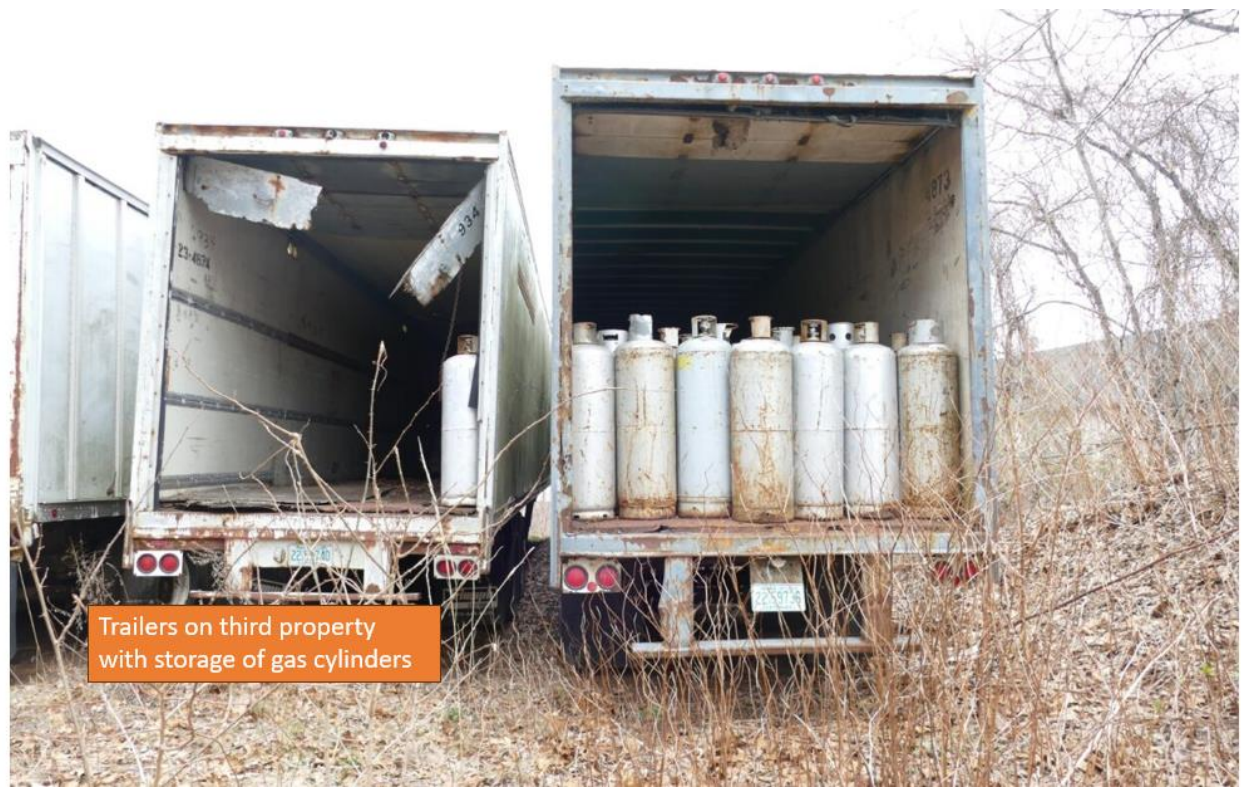
Tank support system in poor repair.
