**UNITED STATES ENVIRONMENTAL PROTECTION AGENCY  
REGION 8  
RESOURCE CONSERVATION AND RECOVERY ACT**

Industrial Container Services Co, LLC  
(a.k.a., Mauser Packaging Systems)

**Date of Inspection:** August 10, 2023

**Type and Purpose of Inspection:** Compliance Evaluation Inspection  
Compliance with RCRA Subtitle C

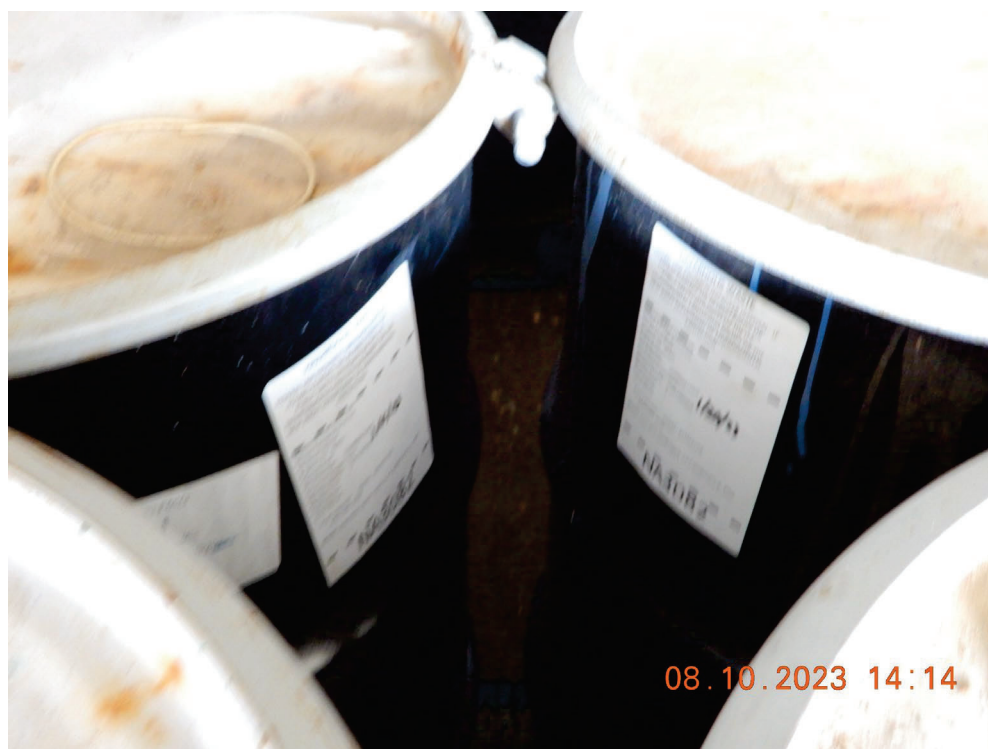
Photo 16.  
(blurry photo)  
(DSCN0738.JPG)

Photo 18.  
Clear photo for  
photos 16 & 17.  
Drums in  
hazardous waste  
accumulation  
area labeled  
D006 hazardous  
waste and dated  
1/6/23 and  
1/20/23.  
(DSCN0740.JPG)
