UNITED STATES ENVIRONMENTAL PROTECTION AGENCY  
REGION III

**Report Title:** Clean Water Act, Section 404 Inspection Report for the Route 19 Morris Development  
**Inspection Date(s):** 05/09/2022  
**Start Time:** 9:00am **End Time:** 1:30pm  
**Regulatory Program(s):** Inspections authorized pursuant to Clean Water Act, Sections 308 and 404 (33 U.S.C. §§ 1318 and 1344)  
**Site Name:** Route 19 Morris Development  
**Site Location:** Approximately 1.25 miles east on Route 19 from the intersection of Route 19 and I-79  
Sutton, West Virginia 26601  
**Latitude:** 38.6087 N **Longitude:** -80.7368 W  
**County/Parish:** Braxton County  
**Company:** Waco Oil & Gas Company, Inc.  
**Mailing Address:** P.O. Box 397  
Glennville, West Virginia 26351

**Unique Project #:** 3E22WW046A

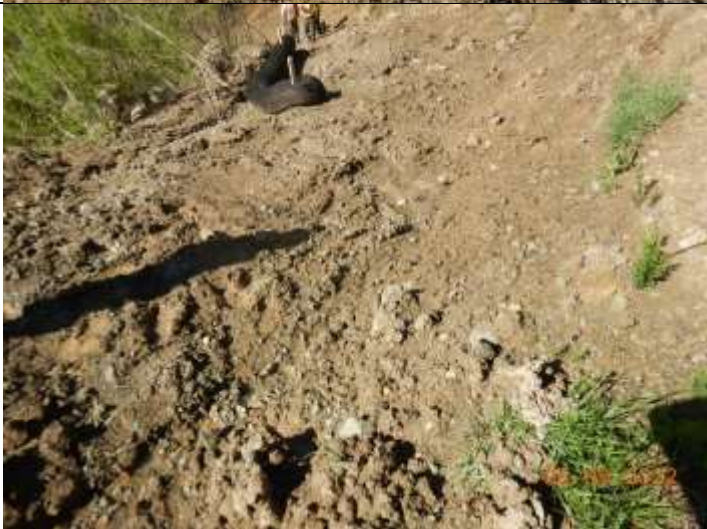
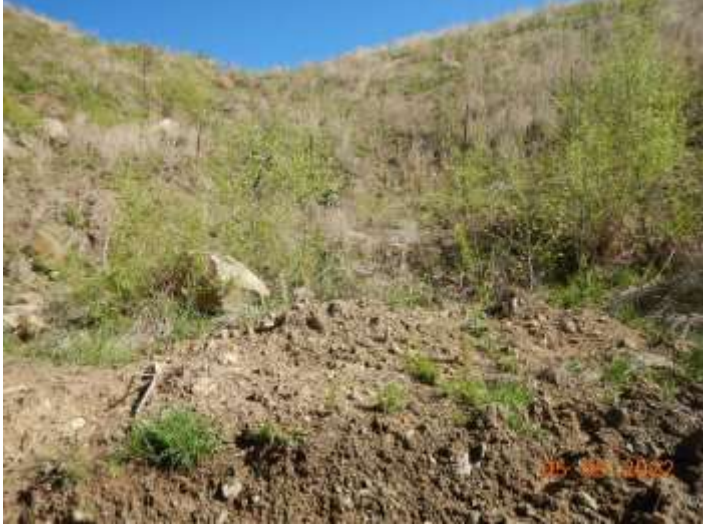
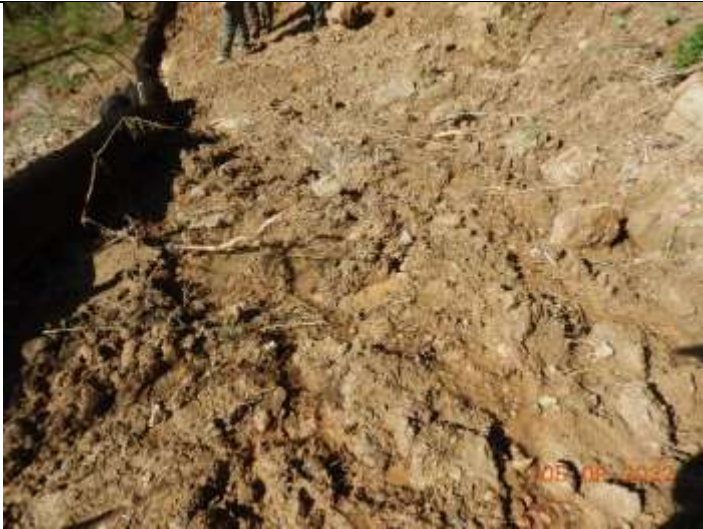
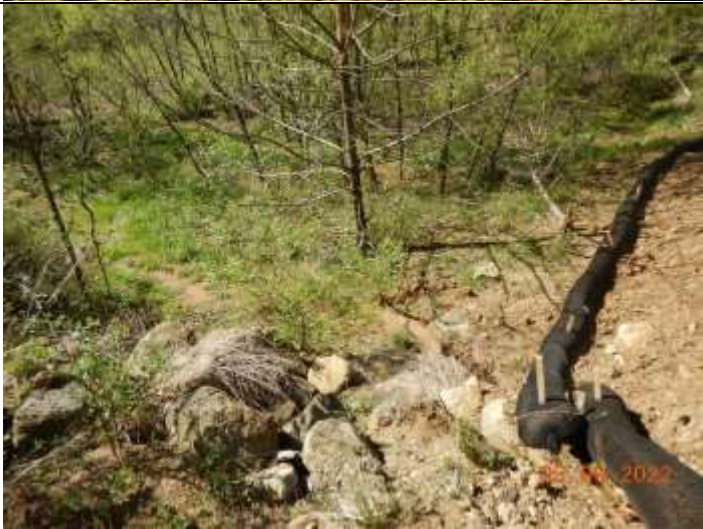
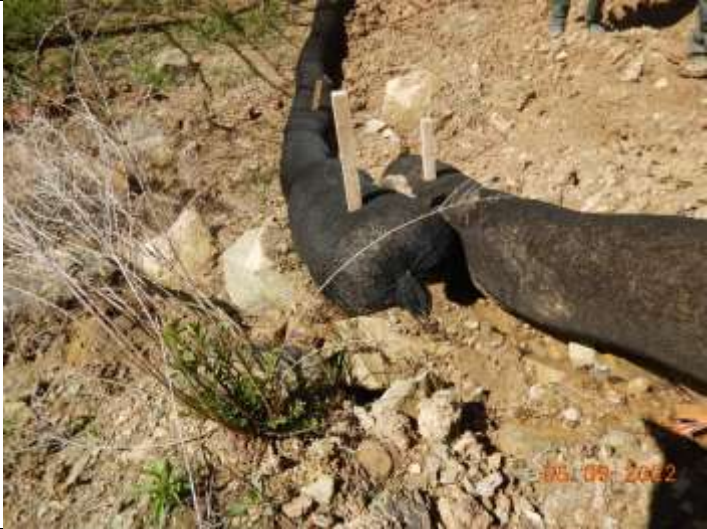
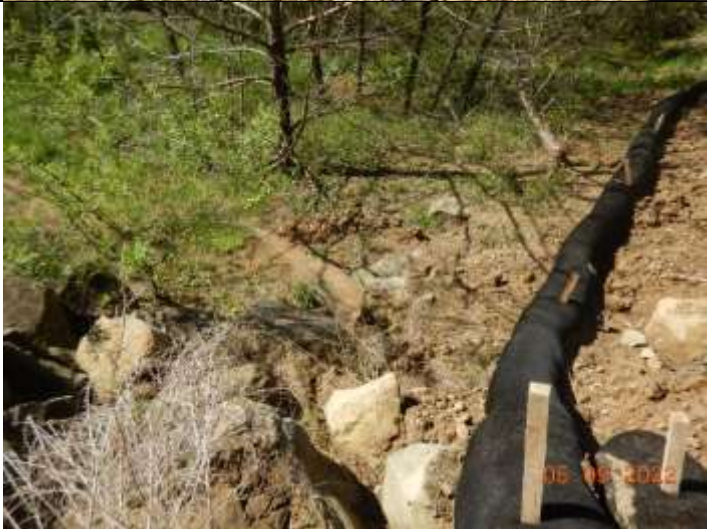
| | <p>Photo ID: DSCN3751.JPG<br/>Date: May 9, 2022</p> <p>Notes: slip area on Pad 1</p> |

| | <p>Photo ID: DSCN3752.JPG<br/>Date: May 9, 2022</p> <p>Notes: slip area on Pad 1</p> |
| | <p>Photo ID: DSCN3753.JPG<br/>Date: May 9, 2022</p> <p>Notes: slip area on Pad 1</p> |
| | <p>Photo ID: DSCN3754.JPG<br/>Date: May 9, 2022</p> <p>Notes: slip area on Pad 1</p> |

| | <p>Photo ID: DSCN3756.JPG<br/>Date: May 9, 2022</p> <p>Notes: slip area on Pad 1</p> |
| | <p>Photo ID: DSCN3757.JPG<br/>Date: May 9, 2022</p> <p>Notes: slip area on Pad 1</p> |

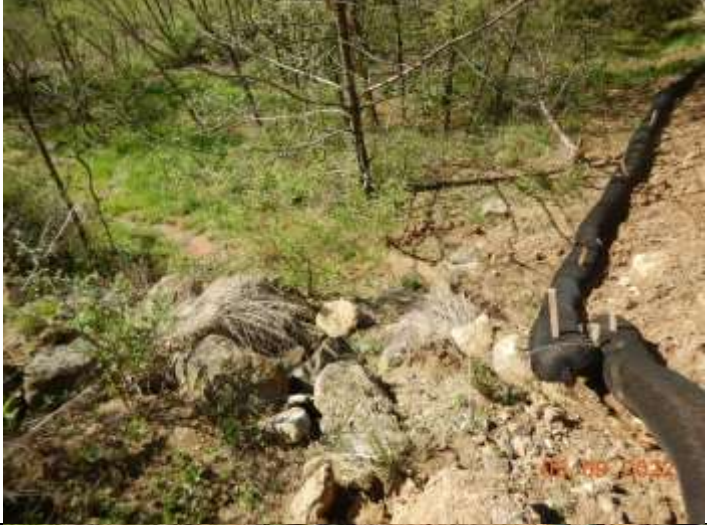
| | <p>Photo ID: DSCN3755.JPG<br/>Date: May 9, 2022</p> <p>Notes: slip area on Pad; looking southeast</p> |

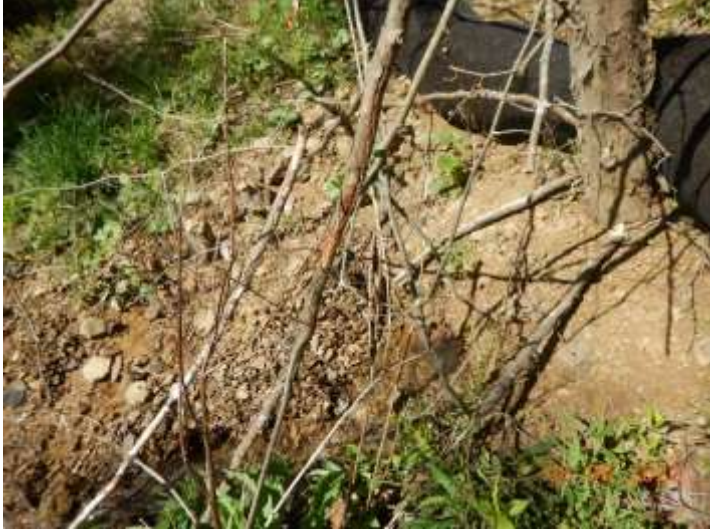
| | <p>Photo ID: DSCN3761.JPG<br/>Date: May 9, 2022</p> <p>Notes: near toe of Pad 1 at the slip area</p> |

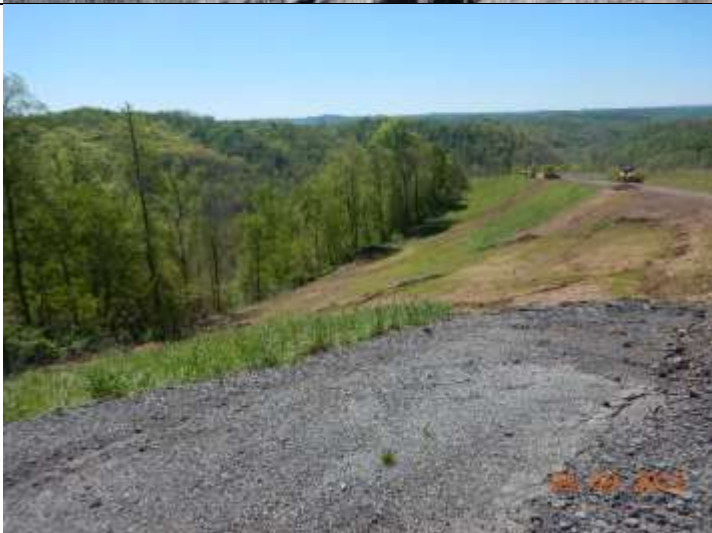
| | <p>Photo ID: DSCN3775.JPG<br/>Date: May 9, 2022</p> <p>Notes: access road slip between Pad 1 and Pad 2; looking south</p> |

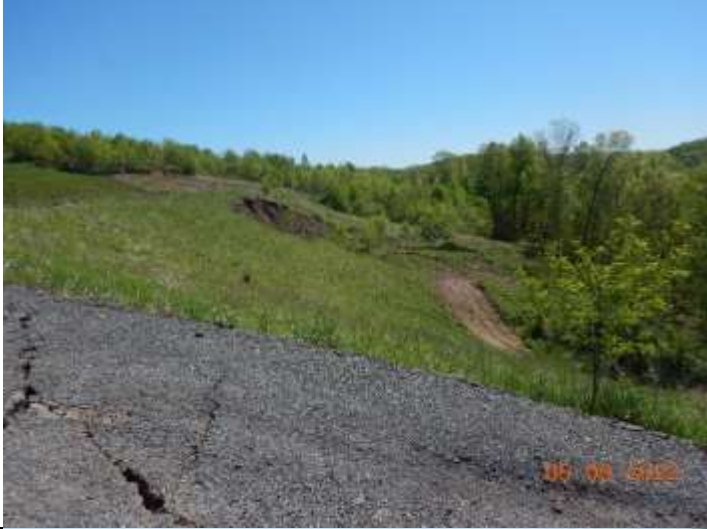
| | <p>Photo ID: DSCN3776.JPG<br/>Date: May 9, 2022</p> <p>Notes: access road slip between Pad 1 and Pad 2; looking north</p> |

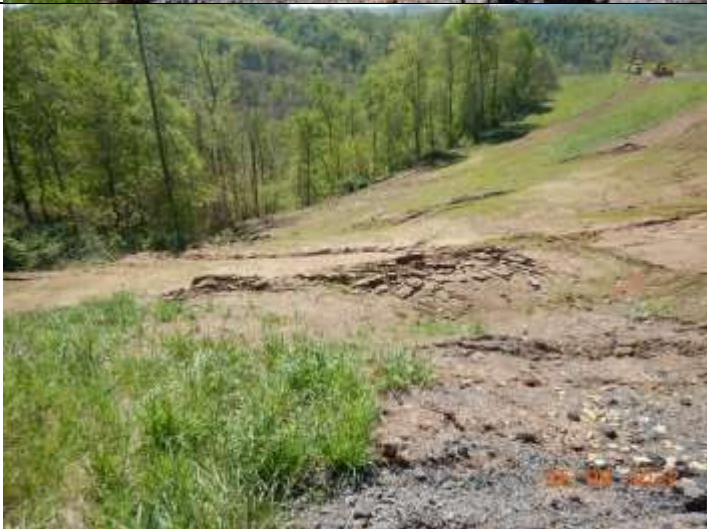
| | <p>Photo ID: DSCN3778.JPG<br/>Date: May 9, 2022</p> <p>Notes: access road slip between Pad 1 and Pad 2; looking southeast</p> |

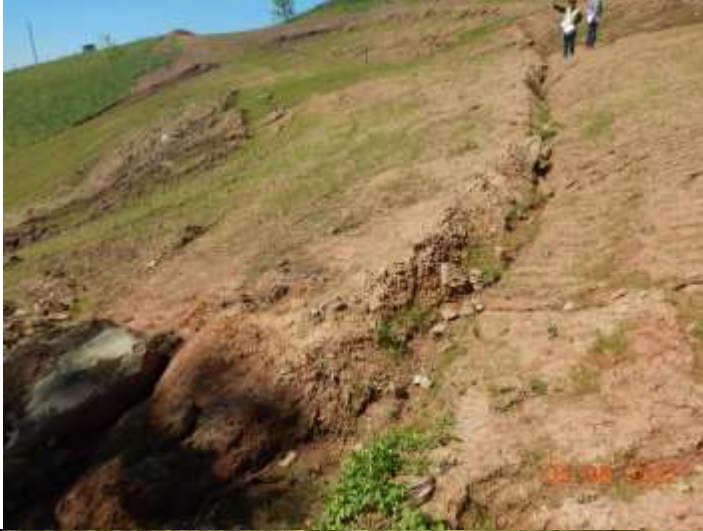
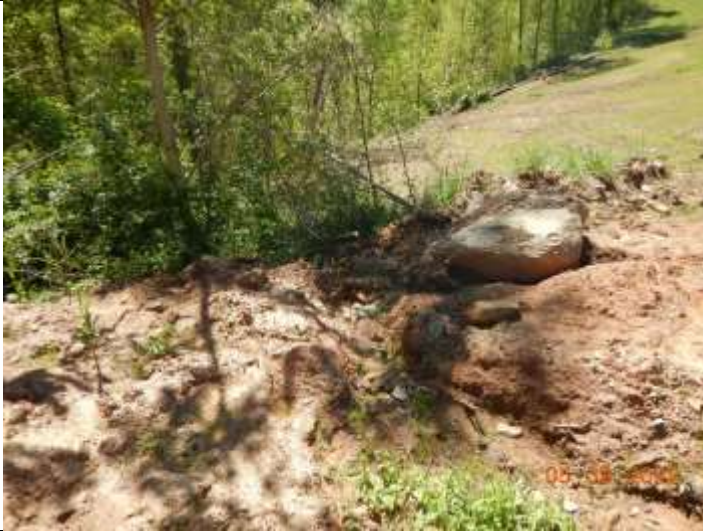
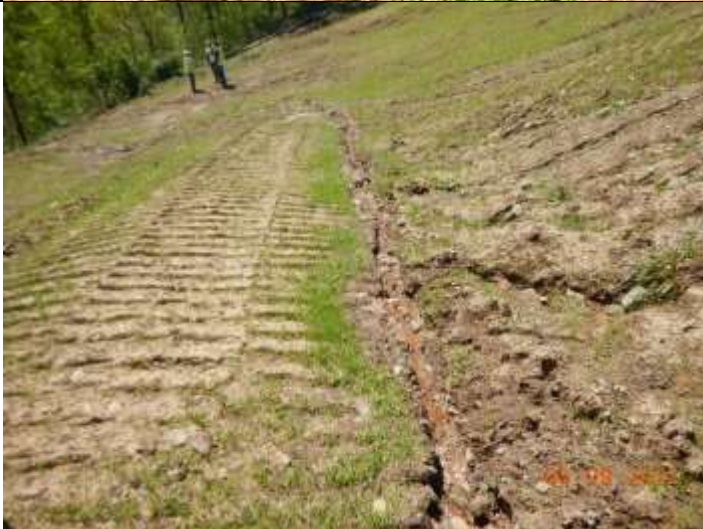
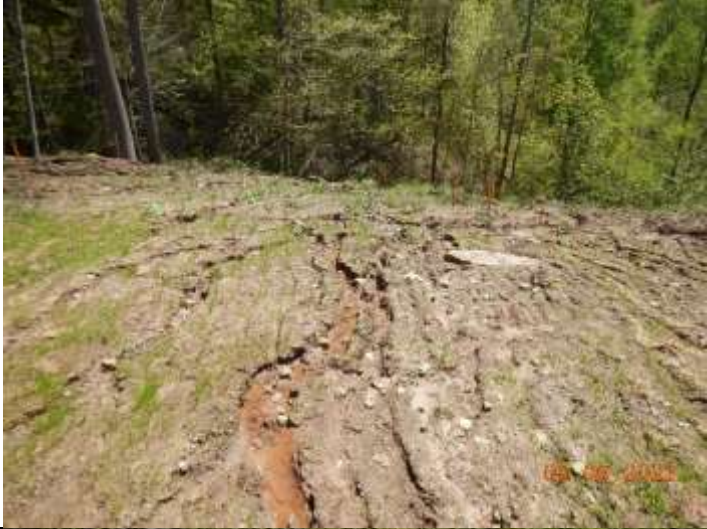
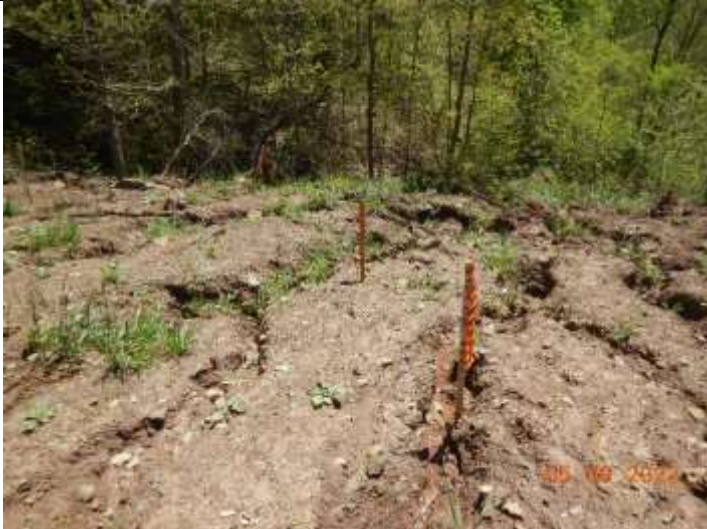
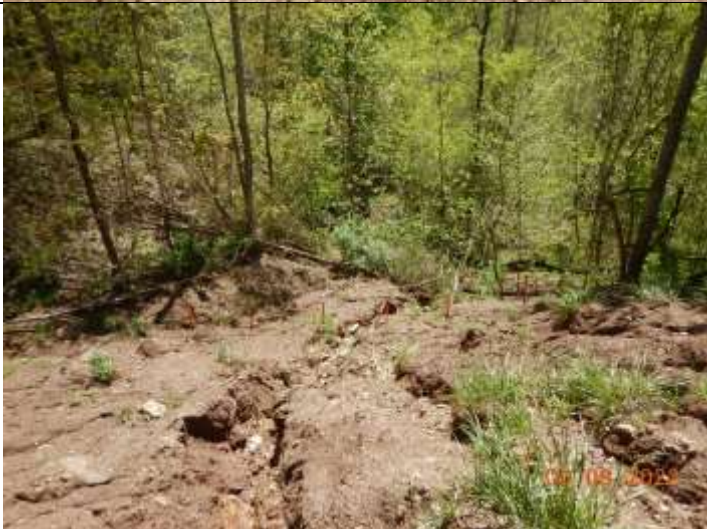
| | <p>Photo ID: DSCN3779.JPG<br/>Date: May 9, 2022</p> <p>Notes: slip area; looking south</p> |
| | <p>Photo ID: DSCN3780.JPG<br/>Date: May 9, 2022</p> <p>Notes: slip area; looking southeast</p> |
| | <p>Photo ID: DSCN3781.JPG<br/>Date: May 9, 2022</p> <p>Notes: slip area; looking southeast</p> |

| | <p>Photo ID: DSCN3782.JPG<br/>Date: May 9, 2022</p> <p>Notes: slip area; looking east</p> |
| | <p>Photo ID: DSCN3783.JPG<br/>Date: May 9, 2022</p> <p>Notes: slip area; looking east</p> |
| | <p>Photo ID: DSCN3784.JPG<br/>Date: May 9, 2022</p> <p>Notes: slip area; looking east</p> |

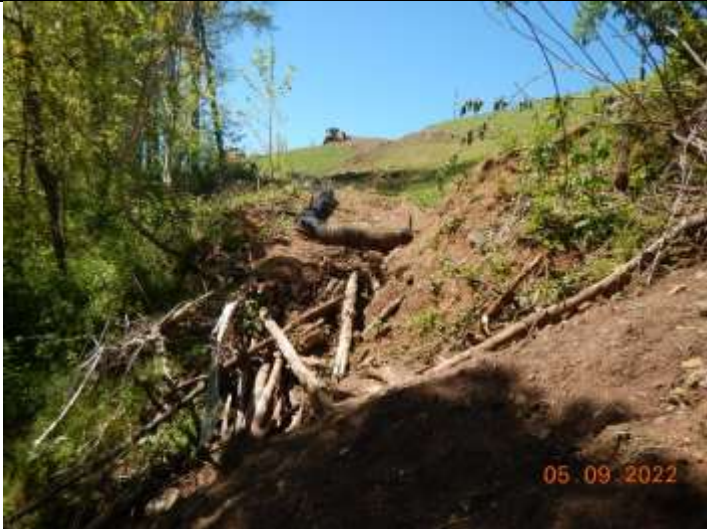
| | <p>Photo ID: DSCN3785.JPG<br/>Date: May 9, 2022</p> <p>Notes: slip area; looking west</p> |

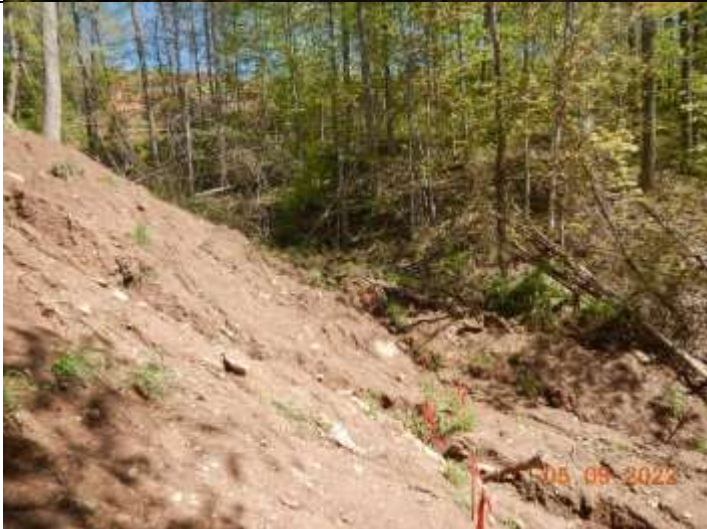
| | <p>Photo ID: DSCN3786.JPG<br/>Date: May 9, 2022</p> <p>Notes: slip area; looking north</p> |

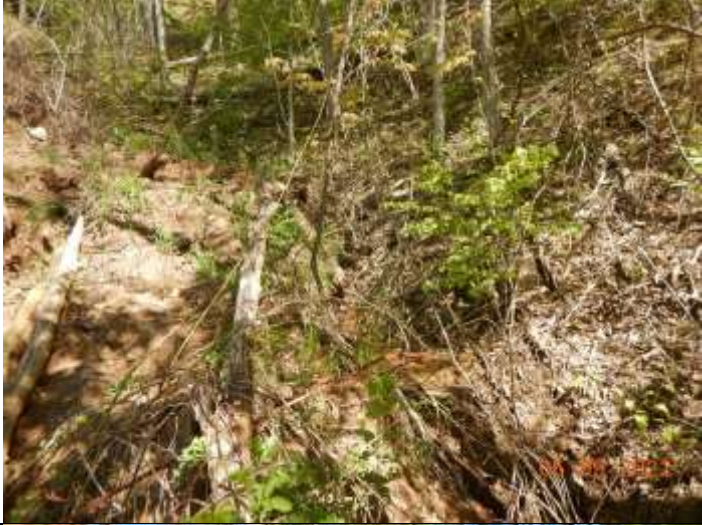
| | <p>Photo ID: DSCN3788.JPG<br/>Date: May 9, 2022</p> <p>Notes: slip area downstream into Unnamed Tributary C mainstem; looking northwest</p> |

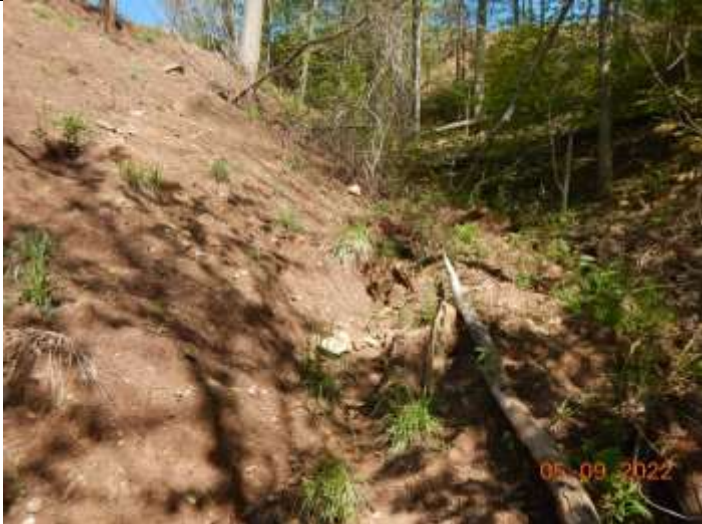
| | <p>Photo ID: DSCN3789.JPG<br/>Date: May 9, 2022</p> <p>Notes: slip area downstream into Unnamed Tributary C mainstem; looking northwest</p> |

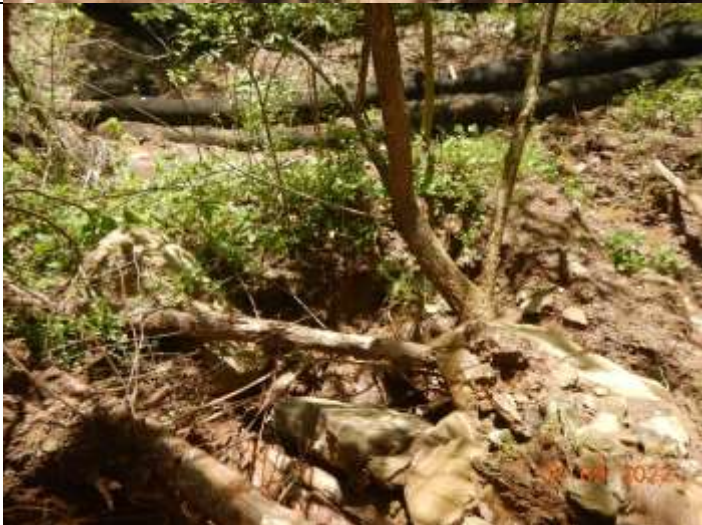
| | <p>Photo ID: DSCN3790.JPG<br/>Date: May 9, 2022</p> <p>Notes: slip material in Unnamed Tributary C mainstem; looking east</p> |

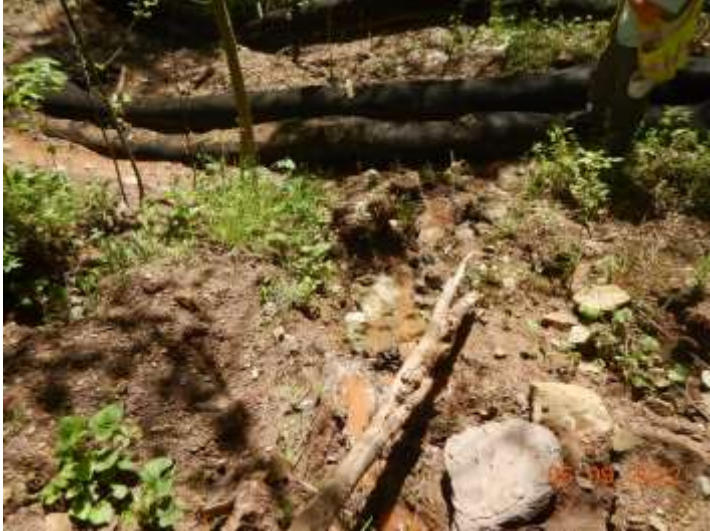
| | <p>Photo ID: DSCN3791.JPG<br/>Date: May 9, 2022</p> <p>Notes: slick material in Unnamed Tributary C mainstem</p> |

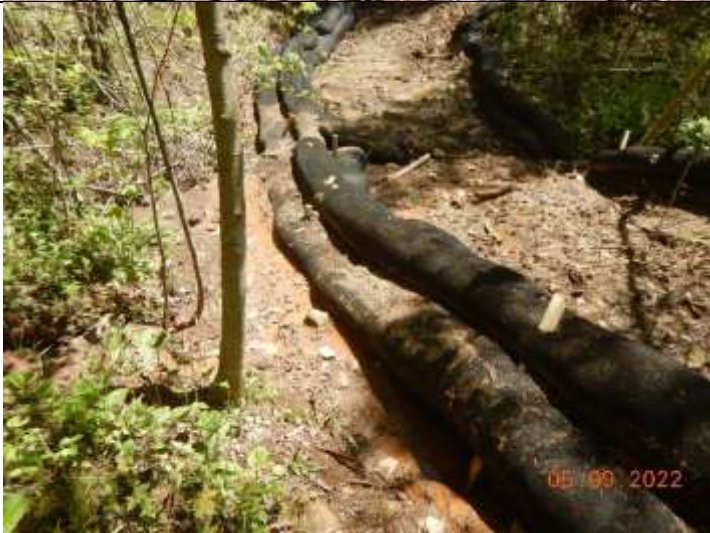
| | <p>Photo ID: DSCN3792.JPG<br/>Date: May 9, 2022</p> <p>Notes: slick material in Unnamed Tributary C mainstem</p> |

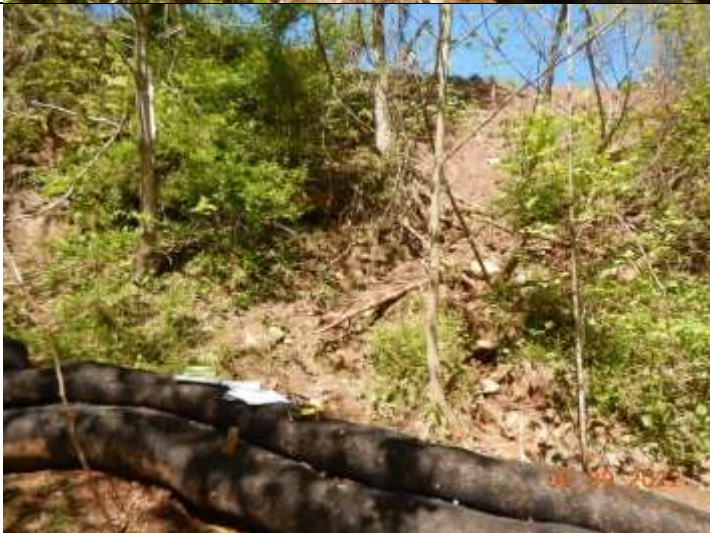
| | <p>Photo ID: DSCN3793.JPG<br/>Date: May 9, 2022</p> <p>Notes: slick material; looking west</p> |

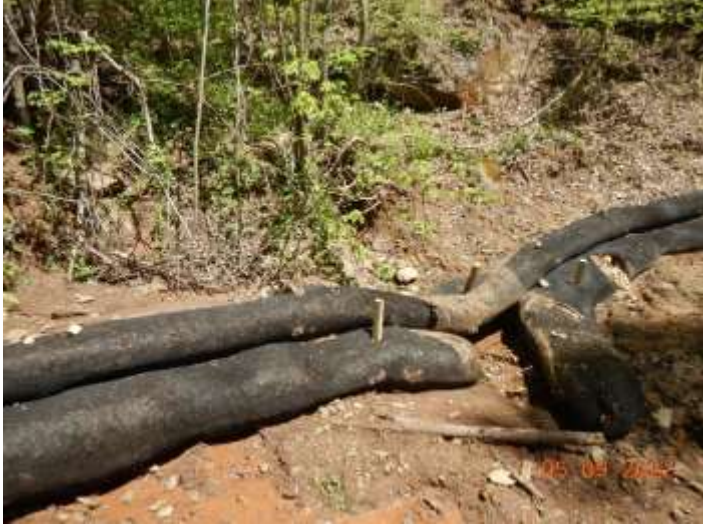
| | <p>Photo ID: DSCN3794.JPG<br/>Date: May 9, 2022</p> <p>Notes: slip material in Unnamed Tributary C mainstem</p> |

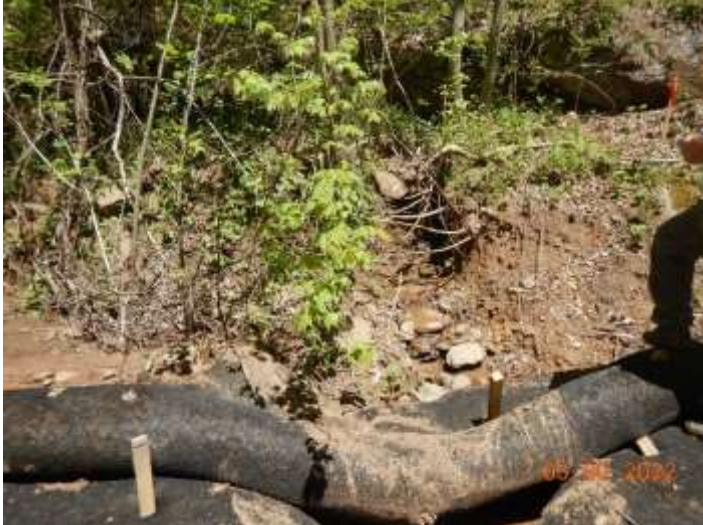
| | <p>Photo ID: DSCN3795.JPG<br/>Date: May 9, 2022</p> <p>Notes: slip material in Unnamed Tributary C mainstem</p> |

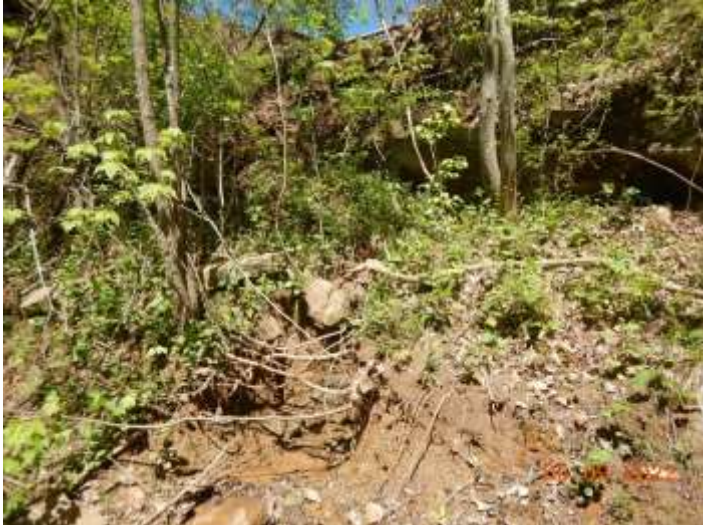
| | <p>Photo ID: DSCN3796.JPG<br/>Date: May 9, 2022</p> <p>Notes: slip area; looking northwest</p> |

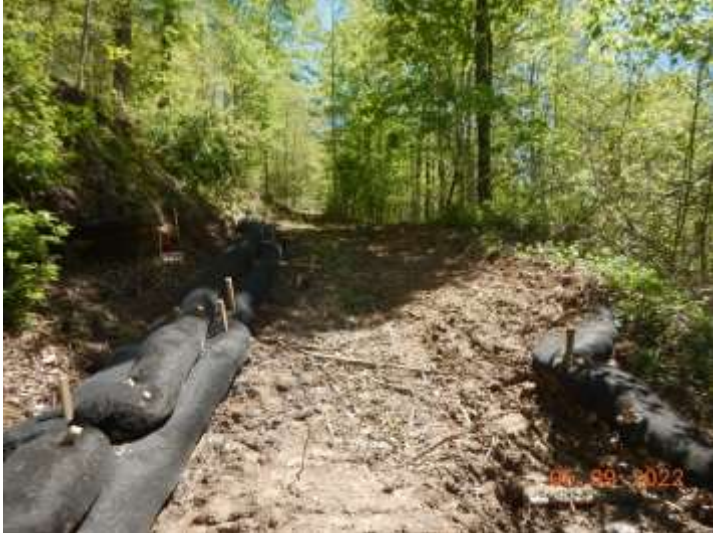
| | <p>Photo ID: DSCN3797.JPG<br/>Date: May 9, 2022</p> <p>Notes: slip area; looking north</p> |

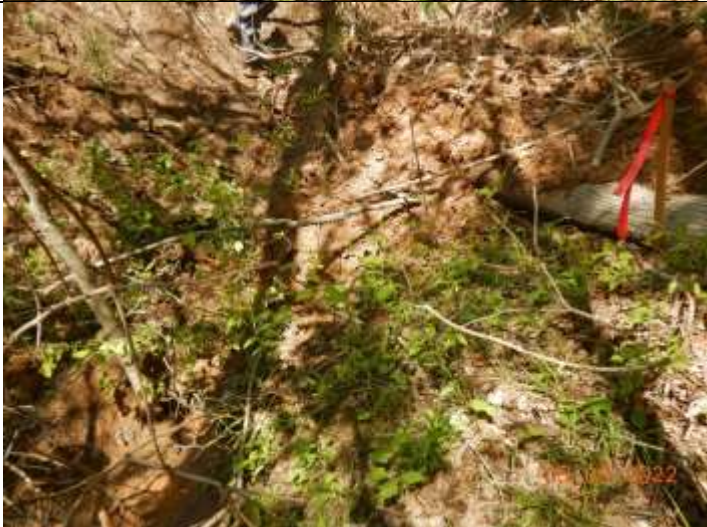
| | <p>Photo ID: DSCN3802.JPG<br/>Date: May 9, 2022</p> <p>Notes: slip material; looking<br/>northwest</p> |

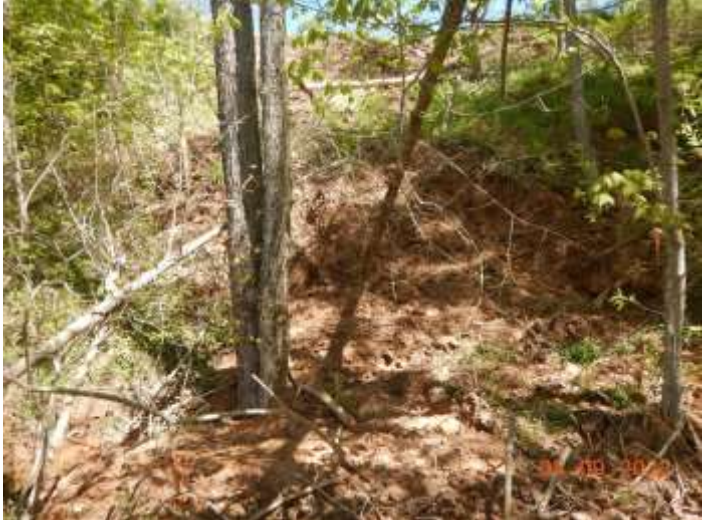
| | <p>Photo ID: DSCN3803.JPG<br/>Date: May 9, 2022</p> <p>Notes: slip material; looking north</p> |

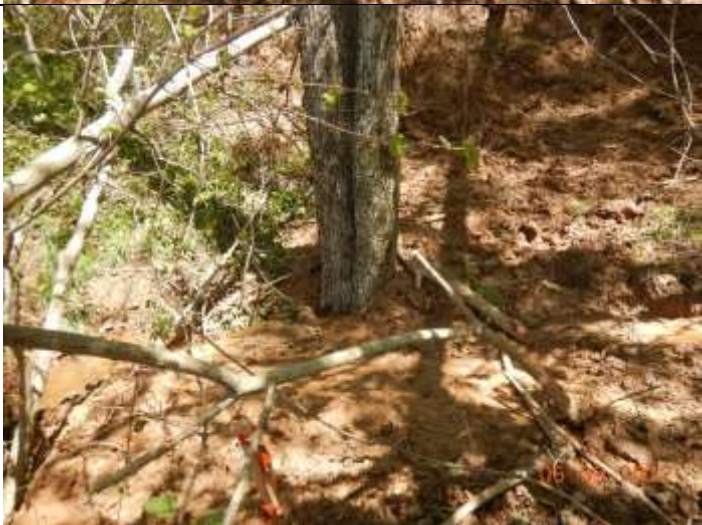
| | <p>Photo ID: DSCN3804.JPG<br/>Date: May 9, 2022</p> <p>Notes: slip material; looking north</p> |

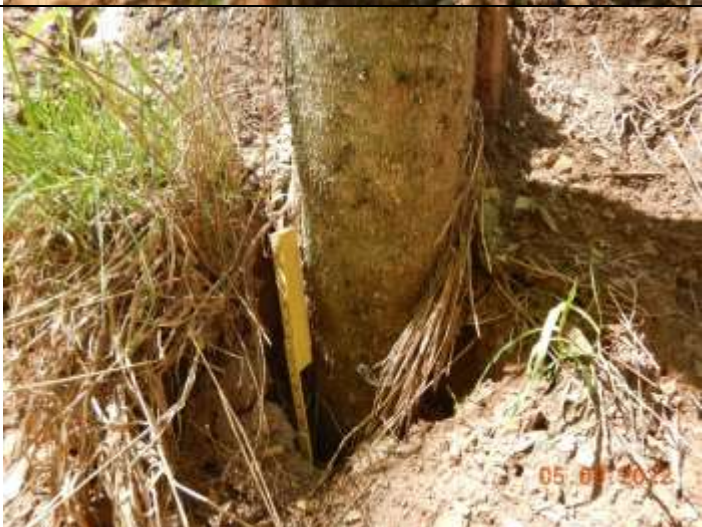
| | <p>Photo ID: DSCN3805.JPG<br/>Date: May 9, 2022</p> <p>Notes: slip material</p> |

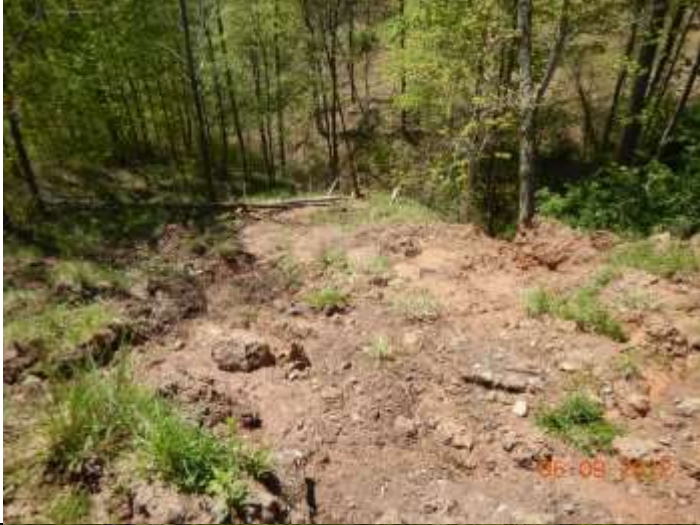
| | <p>Photo ID: DSCN3806.JPG<br/>Date: May 9, 2022</p> <p>Notes: slip area near Unnamed Tributary C3; looking south</p> |

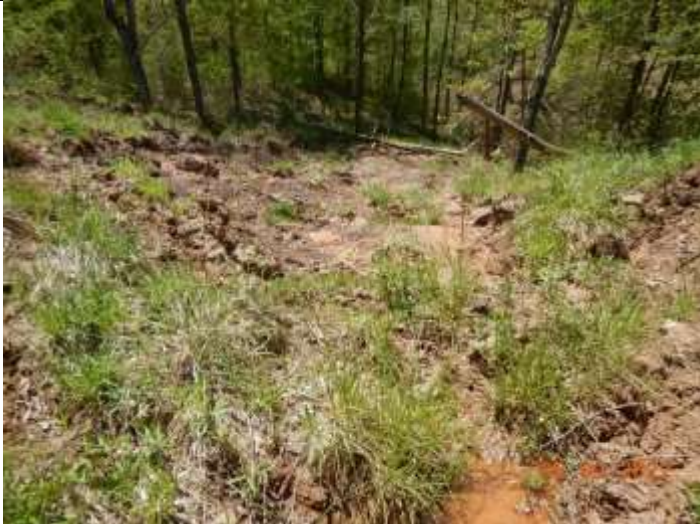
| | <p>Photo ID: DSCN3807.JPG<br/>Date: May 9, 2022</p> <p>Notes: slip area near Unnamed Tributary C3; looking south</p> |

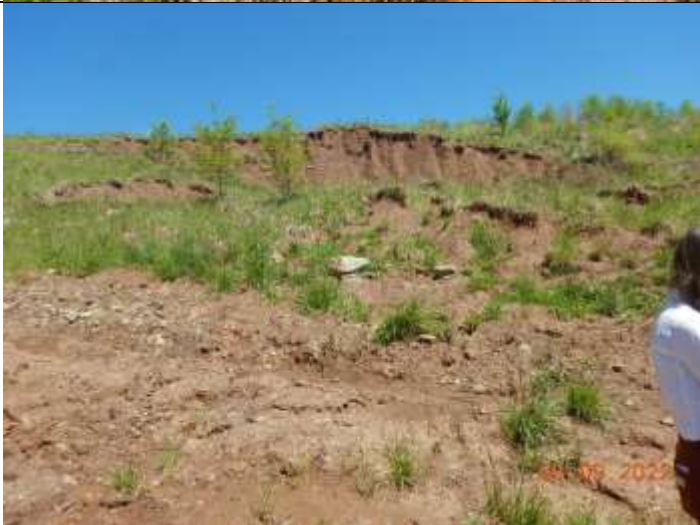
The inspection walkthrough continued to the area along Pad 2 that was north of Unnamed Tributary C3. The top area of a slip was observed, and part of the hillside was exposed (DSCN3808). The area was mostly unvegetated. Closer to the upstream end of Unnamed Tributary C3 some vegetation was observed as well as pooling water and seeps (DSCN3806 and DSCN3807). A wetland area, dominated by soft rush (*Juncus effusus*), was also observed in this area along the eastern edge of Pad 2 near the headwaters of Unnamed Tributary C3 (DSCN3809 to DSCN3810). CEC stated that, considering its location, the wetland likely formed as a result of the grading/earth-moving activities for Pad 2 and the having the hydrology sit there would not be beneficial for long term stability. CEC discussed stockpiling the soil from the wetland areas developing on Pad 2 for use in the proposed wetland areas for the restoration work at Pad 1, which would provide a "jump start" and seed bank for those proposed wetland areas. The inspector agreed that it would be a beneficial effort during the future restoration activities.

| | <p>Photo ID: DSCN3808.JPG<br/>Date: May 9, 2022</p> <p>Notes: top of slip area above Unnamed Tributary C3 area; looking north</p> |

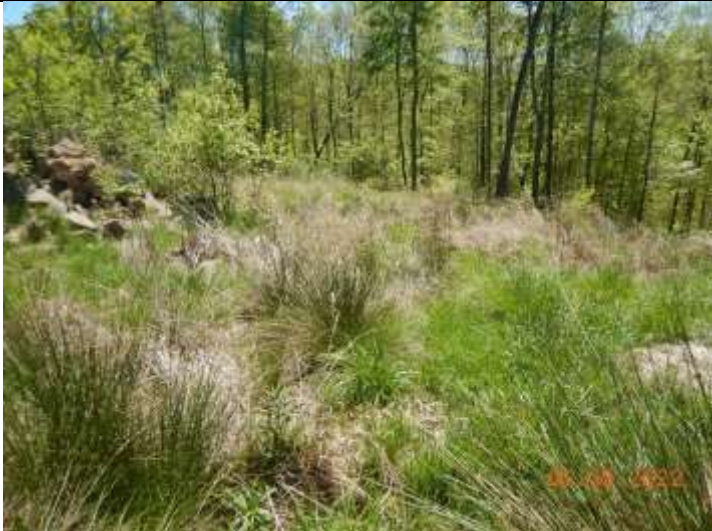
| | <p>Photo ID: DSCN3810.JPG<br/>Date: May 9, 2022</p> <p>Notes: wetland area formed near slip area near Unnamed Tributary C3; looking south</p> |

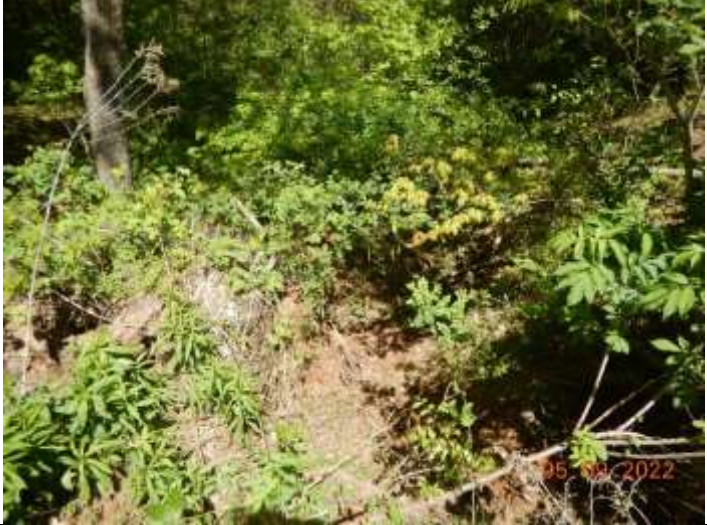
The inspection walkthrough continued to the northwest side of Pad 2 to observe Unnamed Tributary G (DSCN3816 and DSCN3817). Unnamed Tributary G was observed around the limits of disturbance from the impacted reach to the unimpacted stream reach. The western slope of Pad 2 was well-vegetated in this area with 100% coverage of herbaceous vegetation. Immediately downstream of the limits of disturbance the undisturbed channel for Unnamed Tributary G was observed. The stream had a narrow but continuous channel with an Ordinary High Water Mark. The channel was moist but was not flowing at the time of the inspection. CEC discussed the potential geotechnical and grading work that is under consideration for Pad 2 that could be implemented to allow for positive drainage across the Pad 2 area. CEC pointed out a slip with groundwater seeps along the eastern side of Pad 2 and wetland areas forming on Pad 2 (upslope of Unnamed Tributary G) (DSCN3815). They stated that they were evaluating potential design options that could pipe the hydrology under Pad 2 to Unnamed Tributary G. CEC also discussed repairing the slip. Waco did express a concern that regrading Pad 2 would require additional revegetation efforts and that good vegetation coverage had finally been achieved there.

| | <p>Photo ID: DSCN3816.JPG<br/>Date: May 9, 2022</p> <p>Notes: Unnamed Tributary G;<br/>looking west</p> |

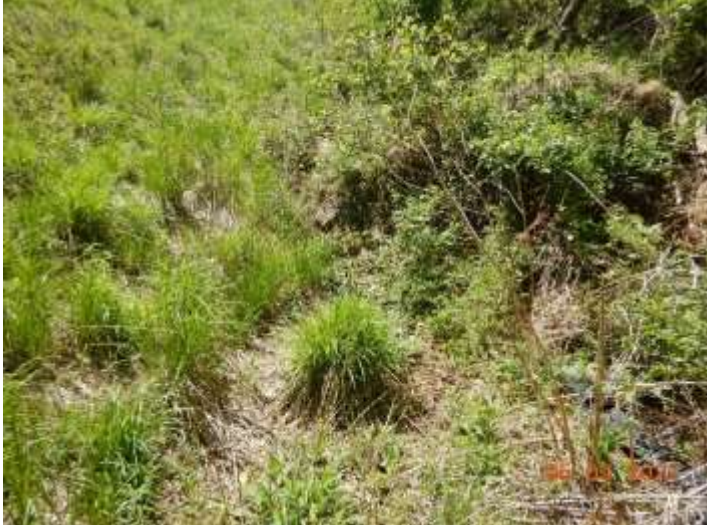
| | <p>Photo ID: DSCN3817.JPG<br/>Date: May 9, 2022</p> <p>Notes: Unnamed Tributary G near<br/>limits of disturbance</p> |

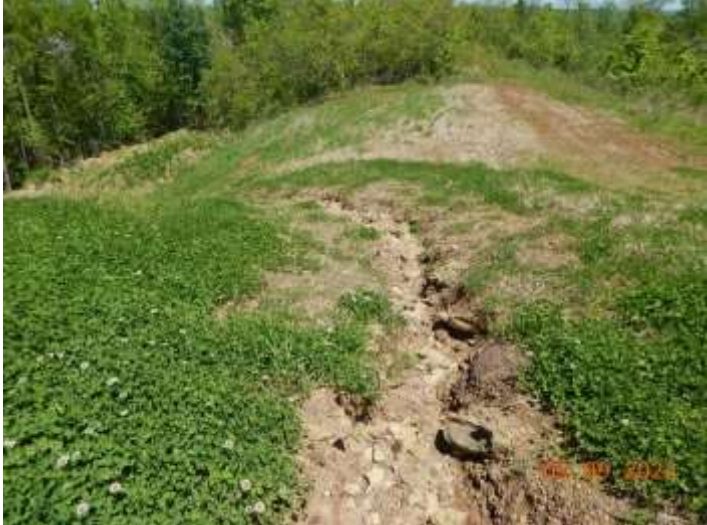
| | <p>Photo ID: DSCN3821.JPG<br/>Date: May 9, 2022</p> <p>Notes: rill into sediment pond;<br/>looking northwest</p> |

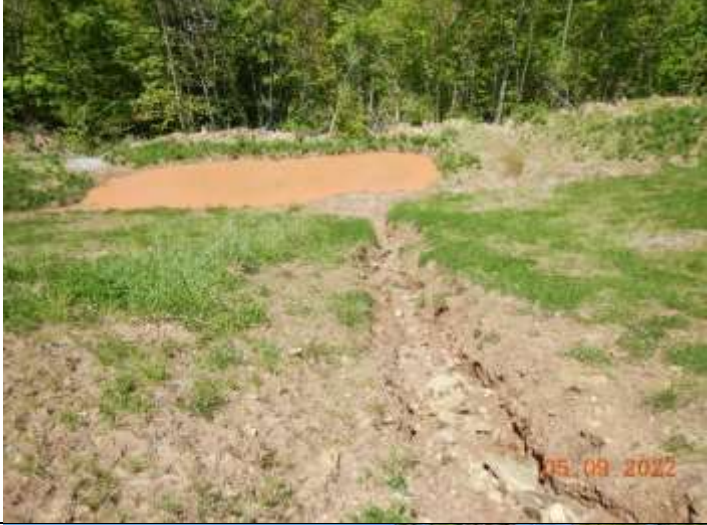
The inspection walkthrough continued to Unnamed Tributary H at the northwest edge of Pad 2. The sediment pond was observed at the base of the slope for Pad 2 (DSCN3819). Based on a visual observation, the sediment pond appeared to be full capacity. On the north side an erosional rill was observed from Pad 2 that discharged into the sediment pond (DSCN2821 and DSCN3822). Upstream, at the south end of sediment pond a rill/channel was also observed (DSCN3823). The feature formed within the side slope of Pad 2 and drained into the sediment pond. CEC discussed how, based on their desktop review, this feature followed the pre-disturbance topographic indications of a stream channel was likely the pre-disturbance flow pathway for Unnamed Tributary H. CEC stated that as part of the geotechnical and restoration work the sediment pond would be reclaimed. The feature was next to the rock-lined outlet of the sediment pond (DSCN3823 and DSCN3824). The outlet terminates near the limits of disturbance at the Site. The inspector then observed the area downstream of the sediment pond. At the limits of disturbance, piled woody and earthen debris were observed (DSCN3825). Downstream of this disturbance, the channel of Unnamed Tributary H was observed (DSCN3826). The stream had a continuous channel with an Ordinary High Water Mark. Flow was not observed in the channel at the time of the inspection. The inspector and CEC discussed that it was likely that the ephemeral- intermittent point for Unnamed Tributary H typically occurred near what is now the downstream end of the sediment pond. CEC stated that they were still evaluating the options for stream restoration in this area which currently focus on the space trade-offs between space for Pad 2 and lower gradient for stream restoration.

| | <p>Photo ID: DSCN3822.JPG<br/>Date: May 9, 2022</p> <p>Notes: sediment pond in Unnamed<br/>Tributary H; looking west</p> |

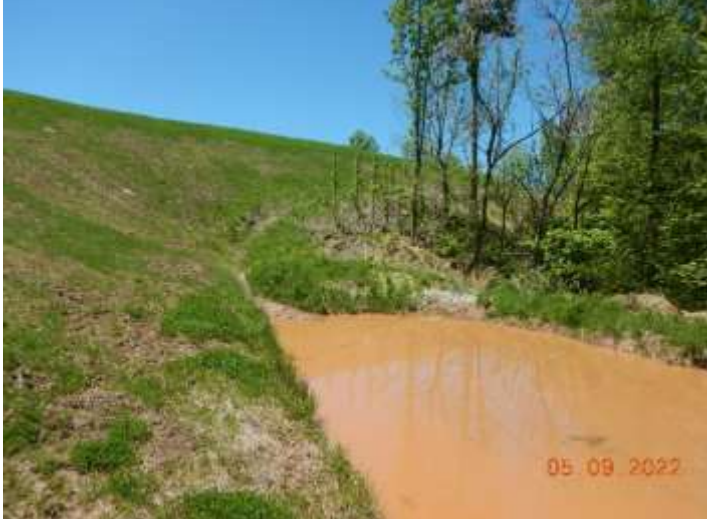
| | <p>Photo ID: DSCN3823.JPG<br/>Date: May 9, 2022</p> <p>Notes: sediment pond in Unnamed<br/>Tributary H; looking south</p> |
