INSPECTION REPORT

| <b>Type of inspection:</b> | CEI - Compliance Evaluation Inspection | | | | |
| <b>Facility or Site Name:</b> | CITY OF KENDALLVILLE WASTEWATER TREATMENT PLANT | | | | |
| <b>Permit Number:</b> | IN0020656 | | | | |

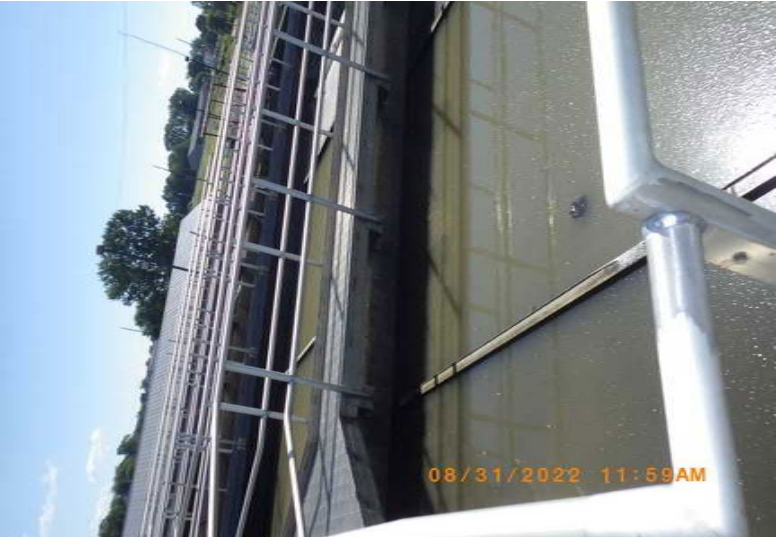
| KEND0128.JPG | |

| I observed the floating palm oil blobs collected along the back of primary clarifier #2 |

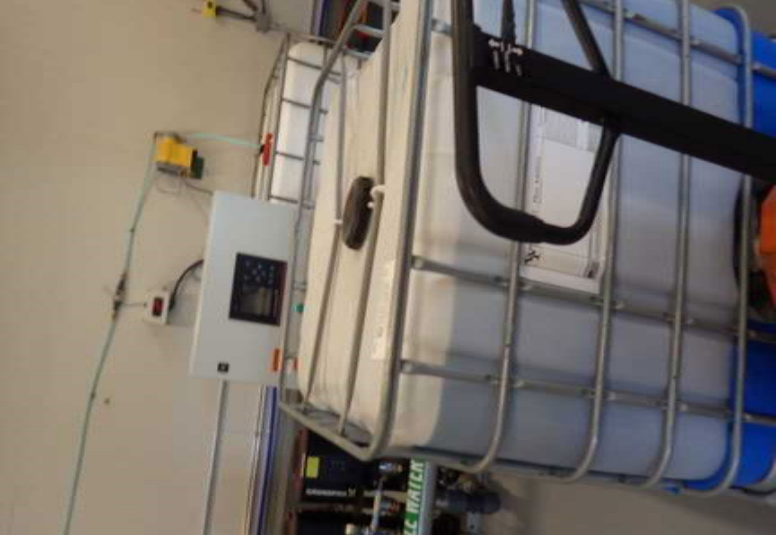
| KEND0137.JPG | |

| <p>After disinfection we walked to the RAS Building and observed the phosphorus feed into the RAS line (see Photo Log image KEND0137), and the two BOD feed tanks (see Photo Log image KEND0138). The Superintendent said the molasses-based BOD feed "is used when Kraft is down." Before departing the building, we observed the phosphorus removal chemical tank (see Photo Log image KEND0139). The aluminum-bearing chemical product is also used to help with copper levels.</p> | |

| Phosphorus feed into the RAS line | |

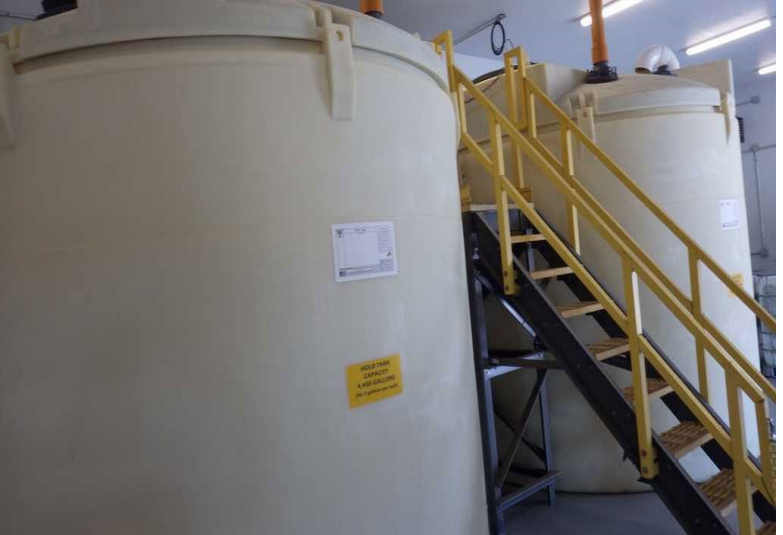
| KEND0138.JPG | |

| BOD feed tanks (2) | |
| Tanks contain molasses-based BOD feed. | |

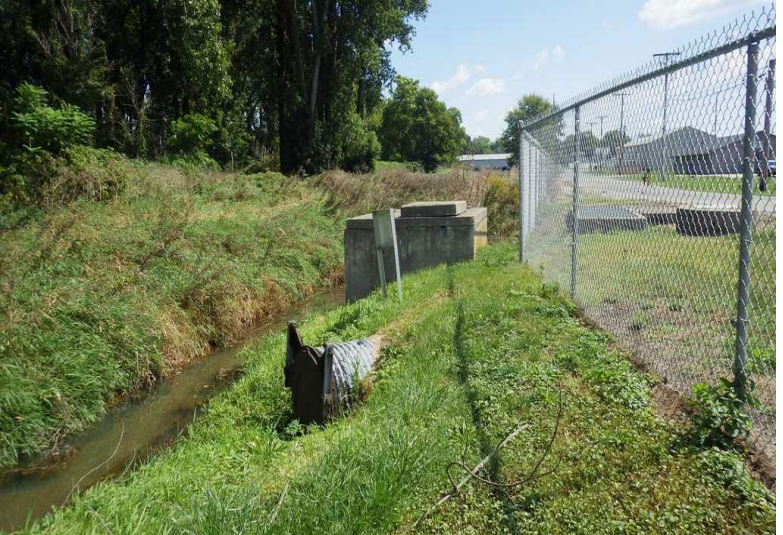
We returned to the final outfall area at the end of the physical facility tour. I observed a clear discharge from Final Outfall #003 and noted some vegetation growth along the bed of the receiving water (see Photo Log image KEND0140). Outfall #003 discharges to an unnamed tributary just upstream of Henderson Lake.

| Outfall #003 discharges to an unnamed tributary just upstream of Henderson Lake. Discharge appeared clear. | |

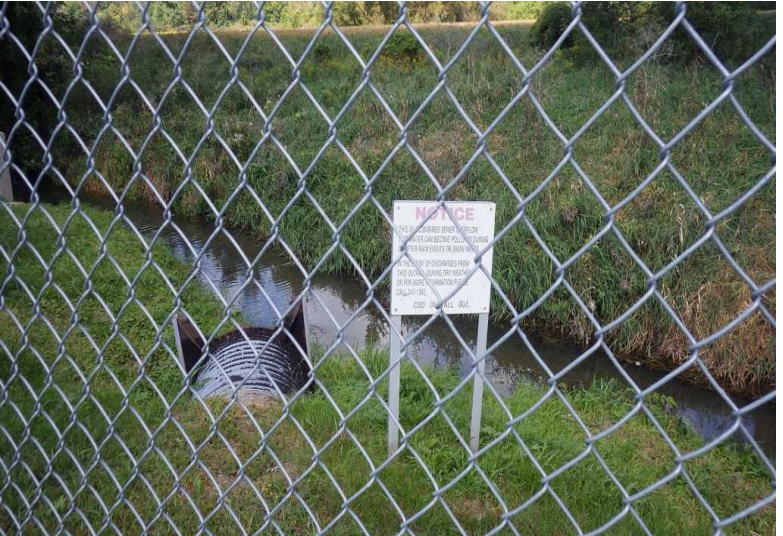
| <p>I observed CSO Outfall #002 (see Photo Log images KEND0141 and KEND0142). CSO Outfall #002 is located just upstream from Outfall 003, on the unnamed tributary that flows to Henderson Lake.</p> | |

| CSO Outfall #002 | |
