## REGION 10 Enforcement Division

### INSPECTION REPORT

| <b>Facility or Site Name:</b> | Schlumberger Technology Corporation East Facility | | | |

Type of inspection: CEI - Compliance Evaluation Inspection

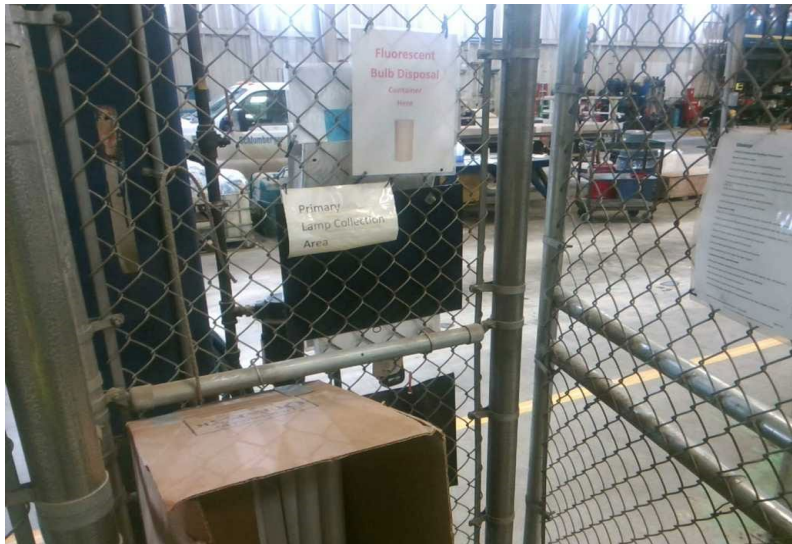
| Front shop/Parts cage | |

At the time of the inspection, I saw an open cardboard box that according to Mr. Muir, contained waste fluorescent lamps. The container held eight loose lamps and a box that contained additional lamps. The box held 22 lamps. The container was labeled with the words "Universal Waste -lamps", but it was not closed.

| View of signage on the cage, as well as the open box of waste lamps. | |

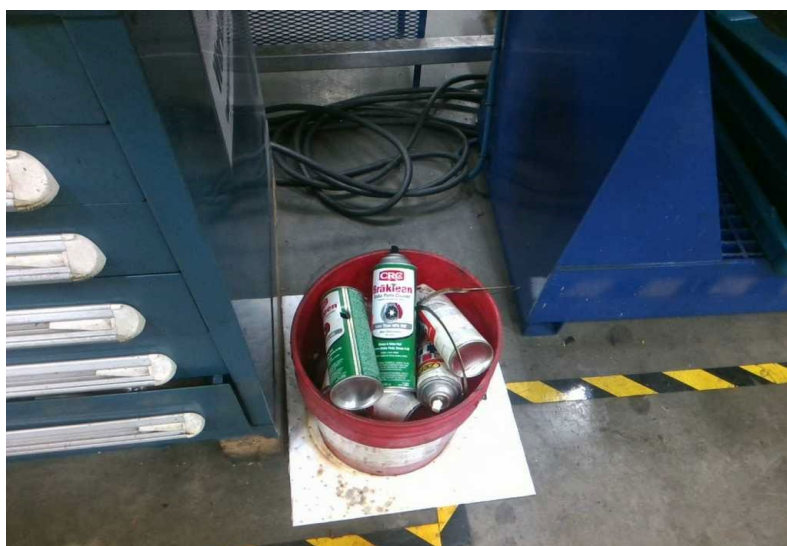
Another view of 5-gallon bucket that held six punctured aerosol cans.

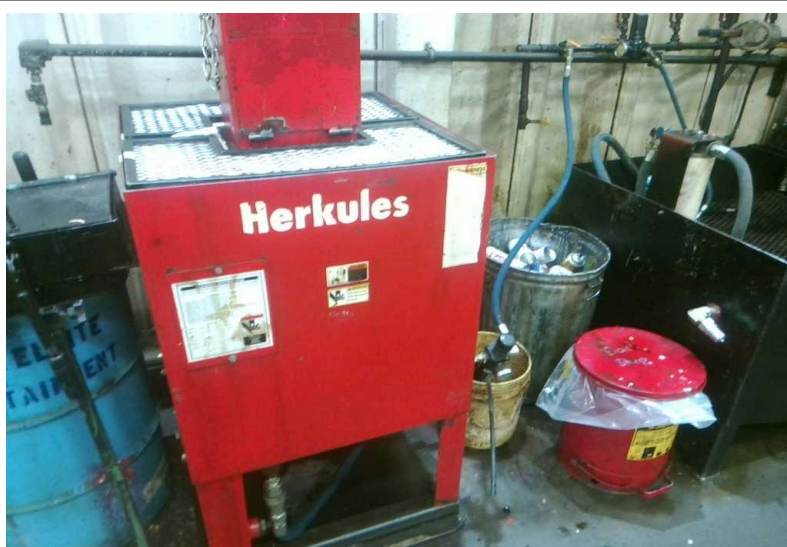
| View of 5-gallon bucket that was being used to accumulate the used oil from the filter crusher. The 5-gallon bucket was not labeled with the words "Used Oil." The container was approximately 1/3 full of used oil. |
