# **REPORT OF COMPLIANCE EVALUATION INSPECTION**

AT  
City of Salina Public Water Supply  
300 West Ash Street  
Salina, Kansas 67402

October 7-9, 2025

BY  
U.S. ENVIRONMENTAL PROTECTION AGENCY  
Region 7  
Enforcement and Compliance Assurance Division (ECAD)

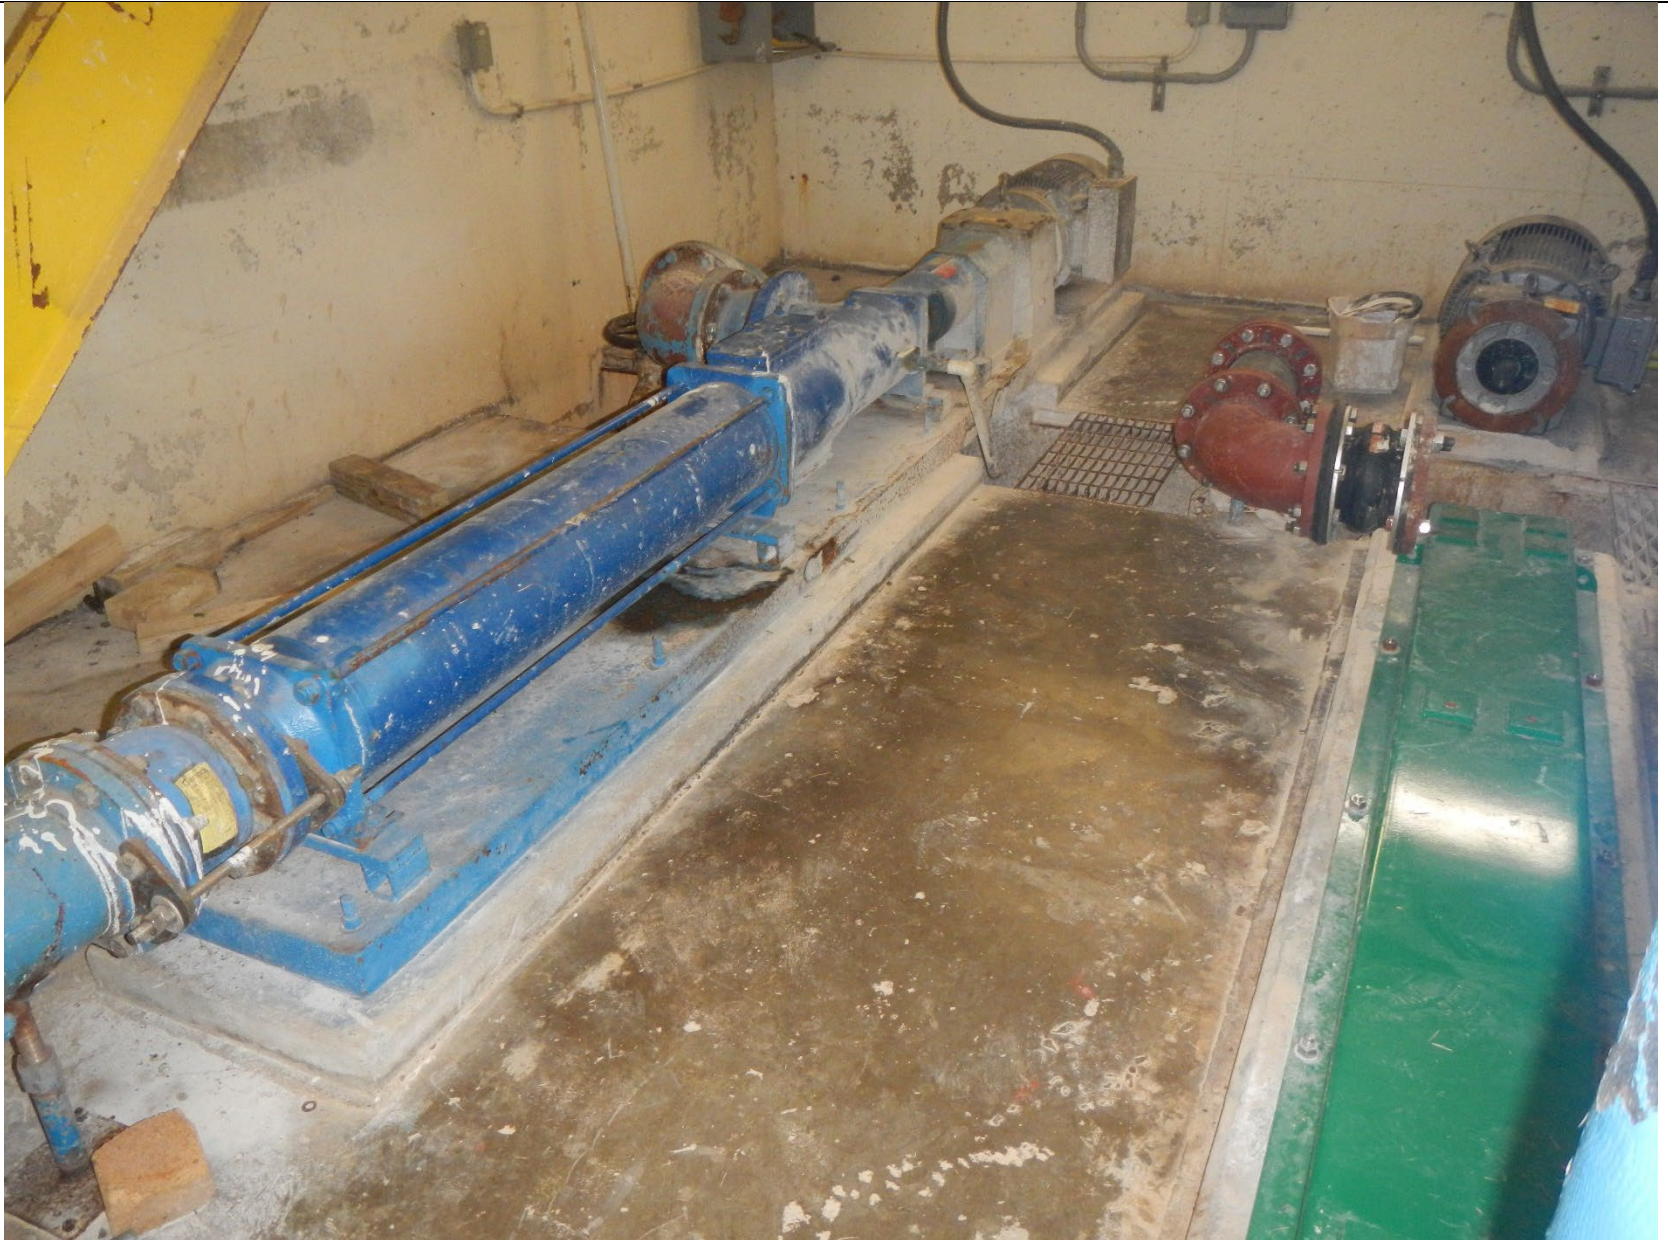
| Digital Image Number | File Name | Description | Date and Time Digital Image Taken |
|---|---|---|---|
| 6 | DSCN5113.JPG | Sludge pumps – one missing for maintenance | 2025:10:07 12:10:31 |

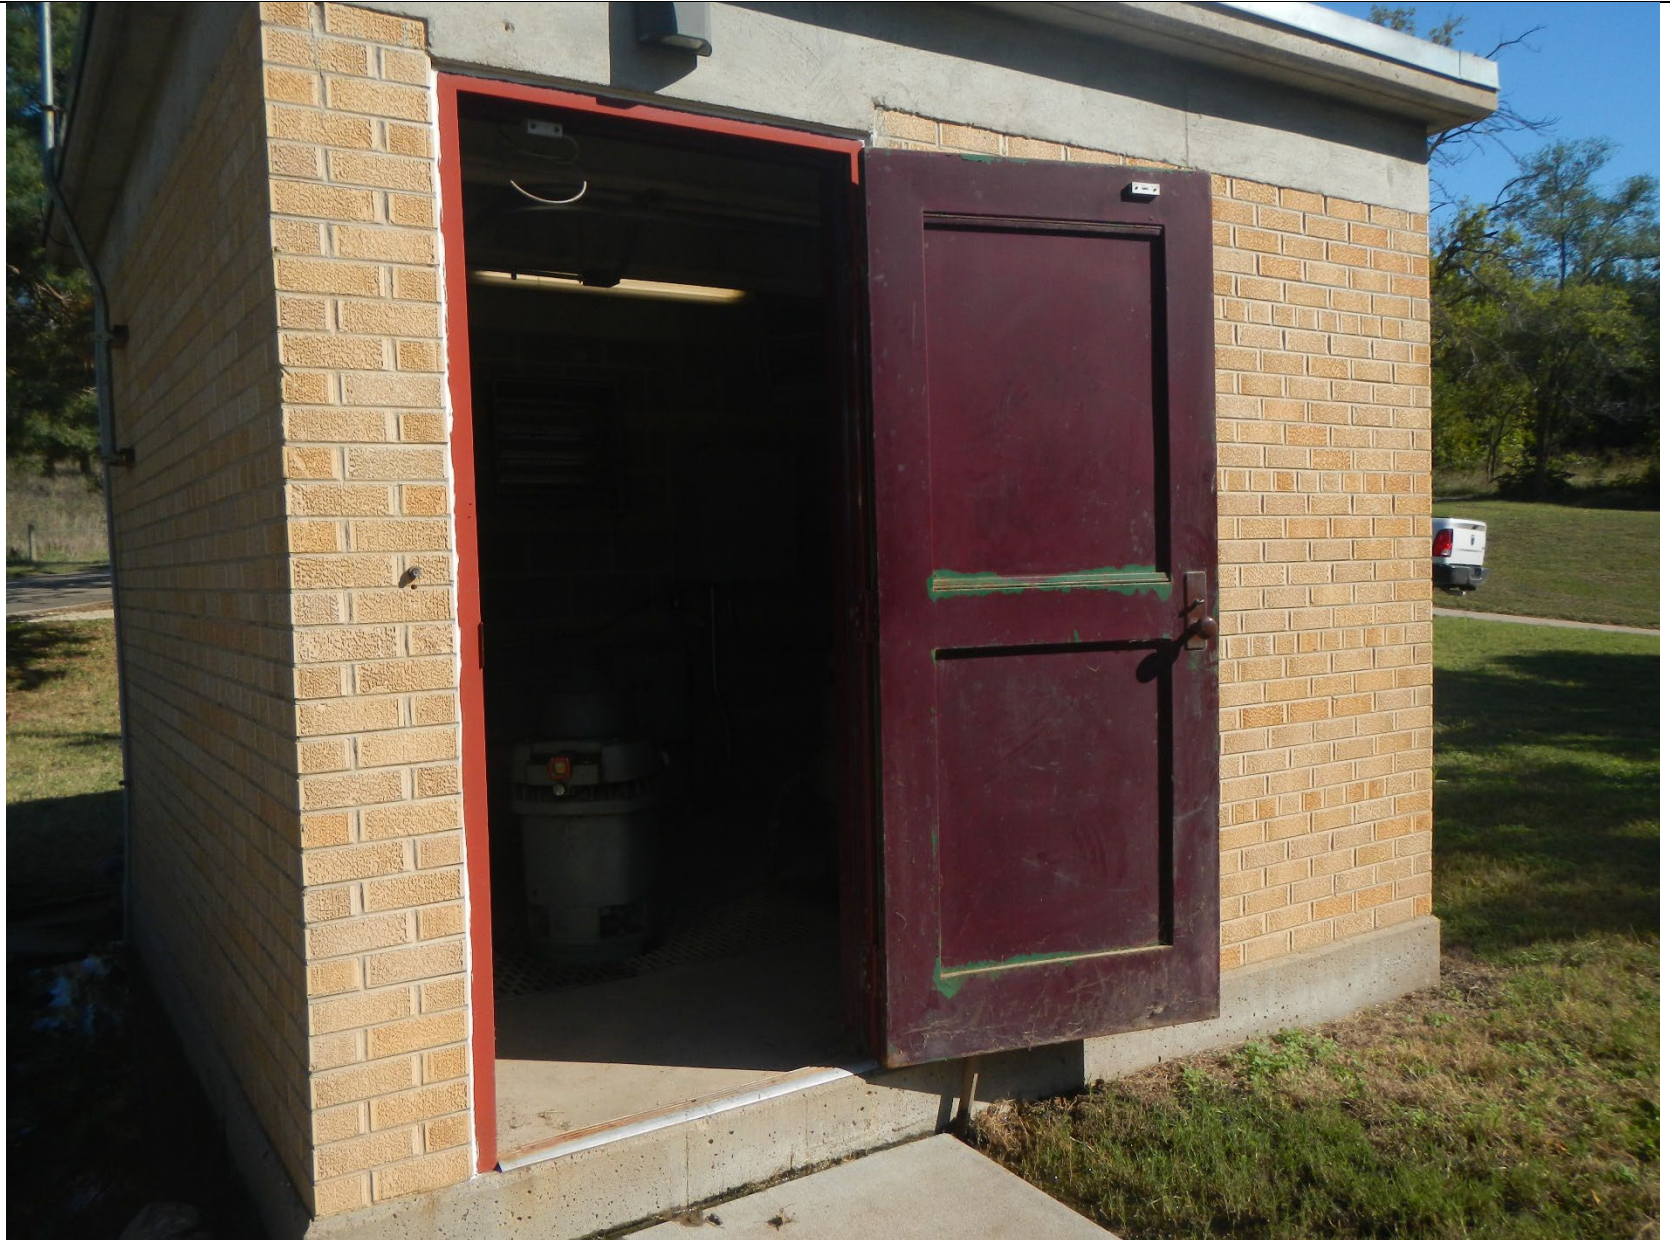
15

The distribution system also includes five booster stations. I observed all five booster stations (photos 15, 34, and 37) during my inspection. All of the booster stations appeared to be in good condition and no issues were observed. The booster stations are inspected weekly by system personnel and preventative maintenance is completed monthly to ensure proper operation.
