**Region 6 - Enforcement & Compliance Assurance Division**  
**INSPECTION REPORT**

| Inspection Date(s): | 5/22/2024 | |
| Company Name: | <b>MidAmerica Environmental Holdings, LLC</b> | |
| Facility Name: | <b>USA Disposal – El Dorado</b> | |

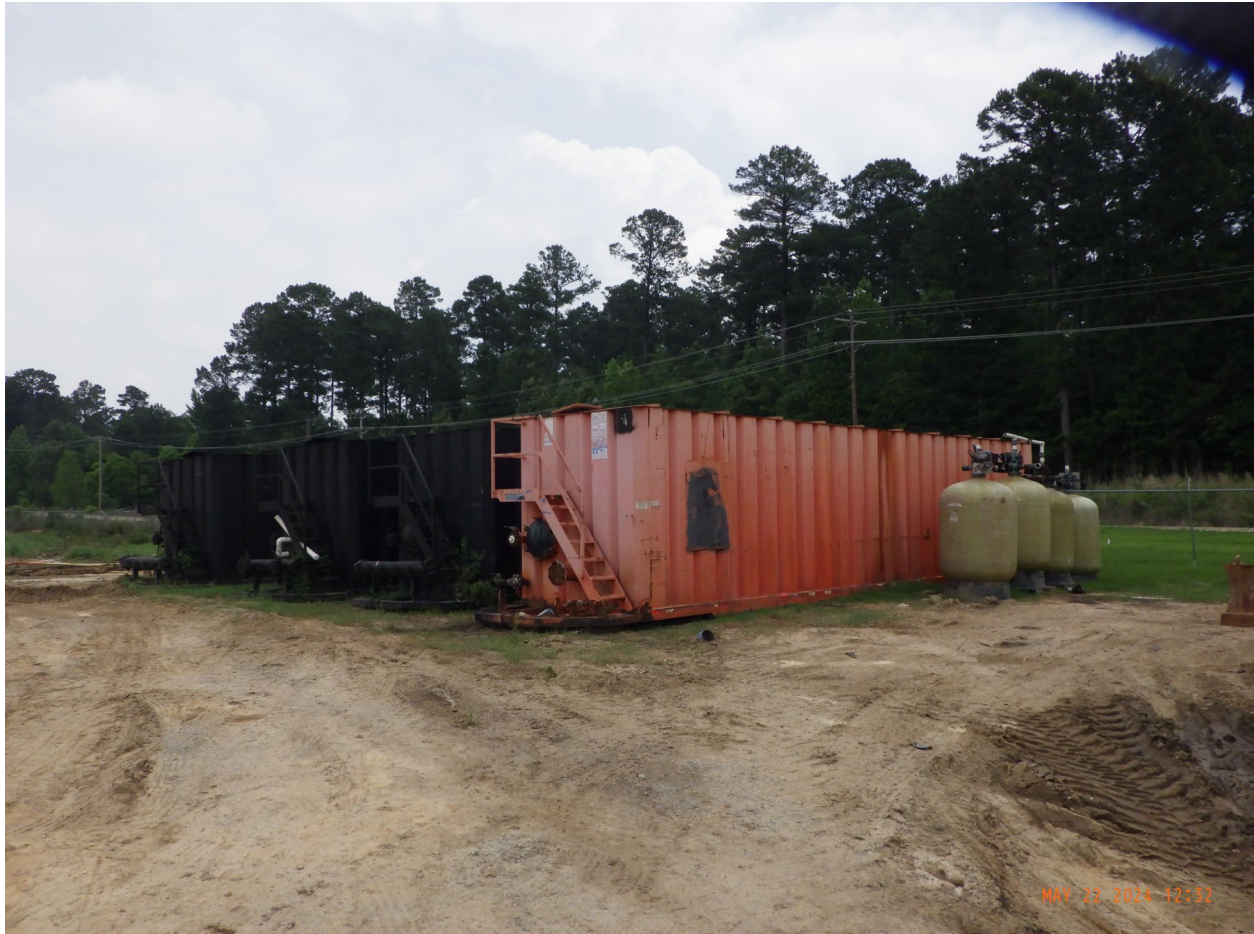
**Photo File Name:** R0010153

**Description:** Looking SE, this photo showed the opposite view from Photo No. 3. A spill was observed in front of the red frac tank.

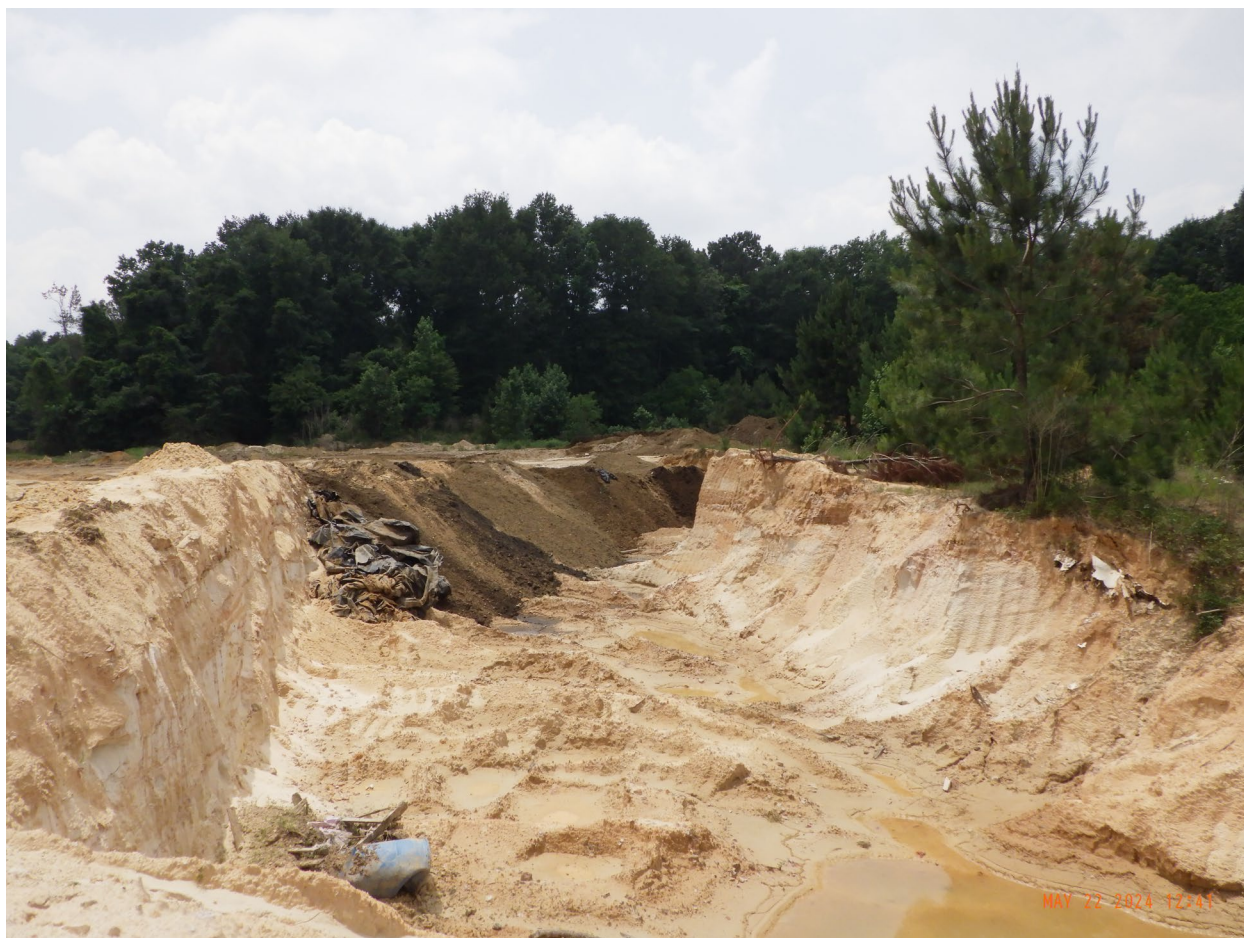
**Photo File Name:** R0010164

**Description:** Looking S-SE, this photo showed bulked waste material (liquid waste blended with sawdust) with runoff adjacent to the stockpile. Synthetic liner pieces were observed in the bulked material, and algal growth was noted in the adjacent runoff.

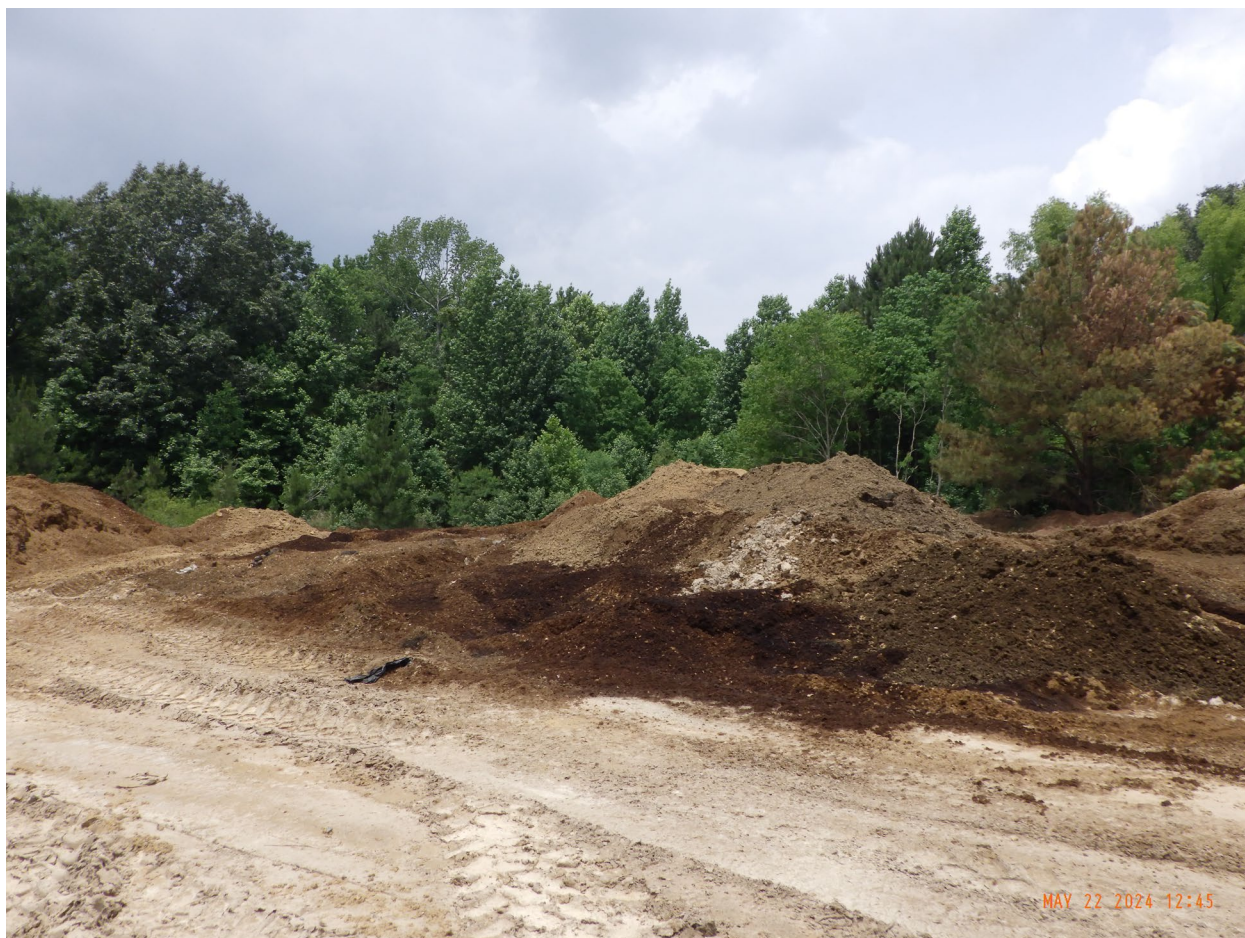
**Photo File Name:** R0010171

**Description:** Looking SW, this photo showed bulked material and leachate discharged into the wetland at the facility. Algal growth was noted in the surface water.

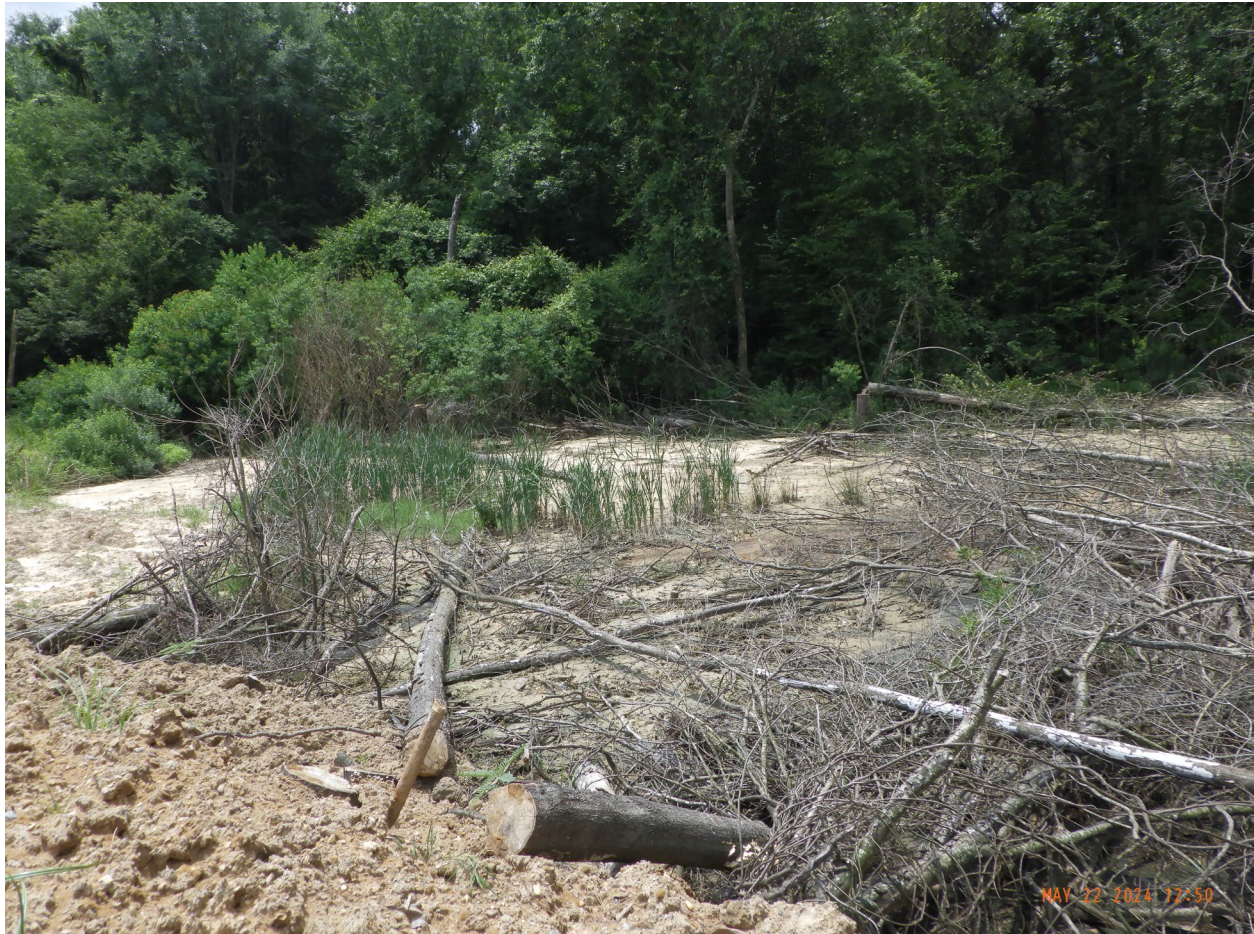
**Photo File Name:** R0010176

**Description:** Looking SW, this photo showed bulked material adjacent to another wetland located at the facility. Dead vegetation was noted in the wetland.

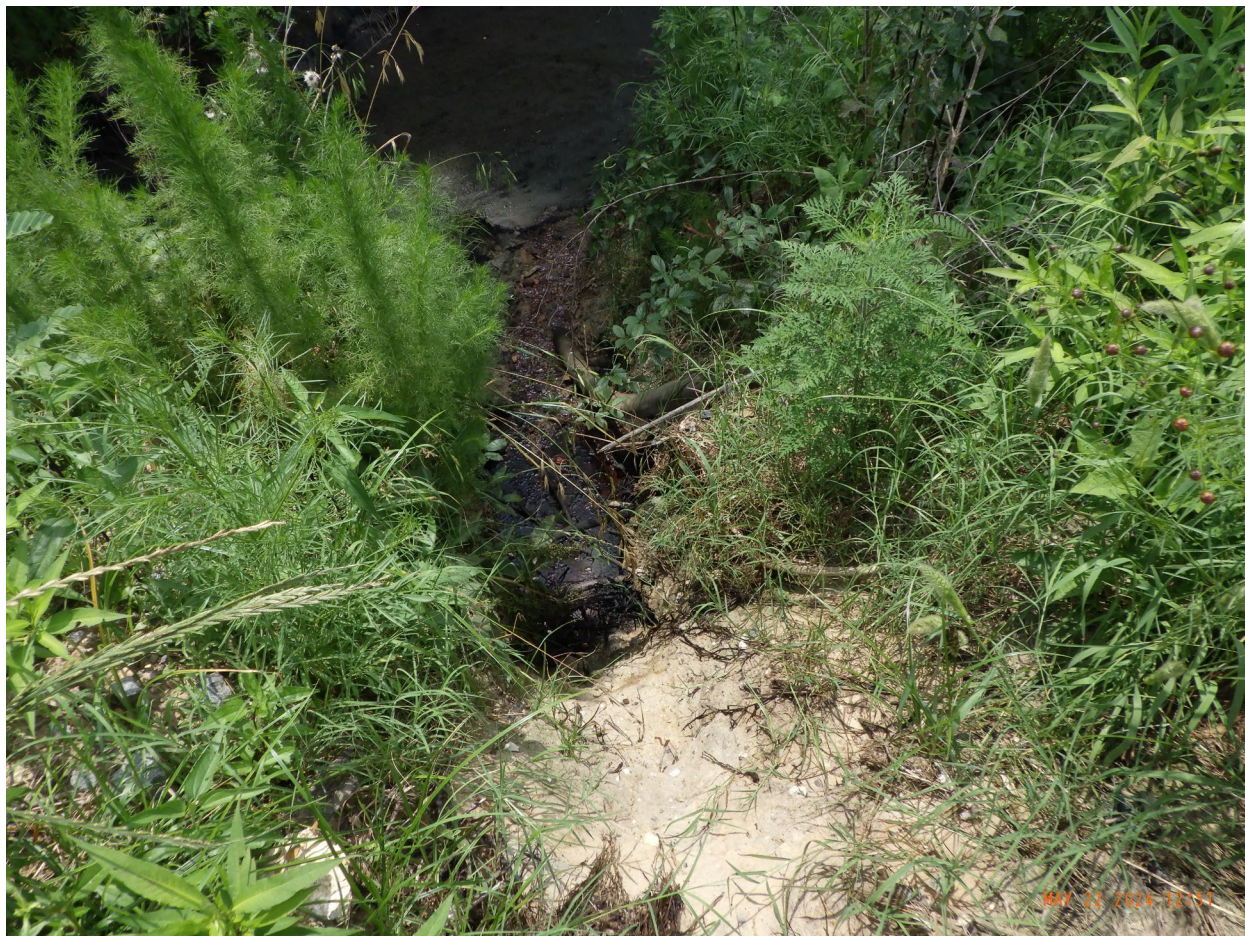
**Photo File Name:** R0010180

**Description:** Looking SW, this photo showed an erosion gully formed in the stormwater pond levee directed to the receiving stream (unnamed tributary (UT) of Boggy Creek). Black staining was noted within the gully.

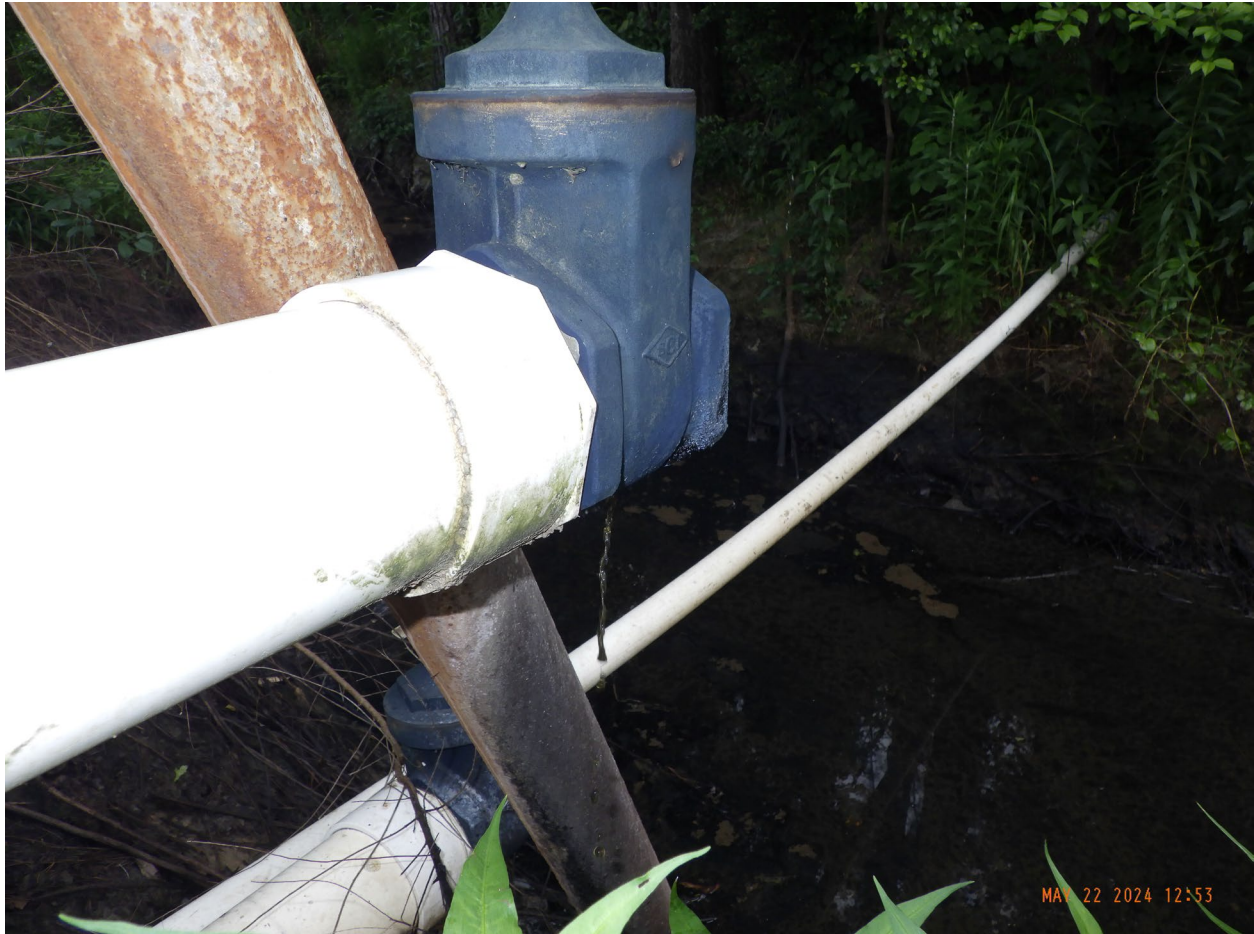
**Photo File Name:** R0010185

**Description:** Looking S, this photo showed two drainpipes for the stormwater pond. Both with shutoff valves and screw caps (caps not in use and uppermost valve actively leaking). The two additional pipes, one in the vertical position and one crossing the receiving stream, are not connected or being used.

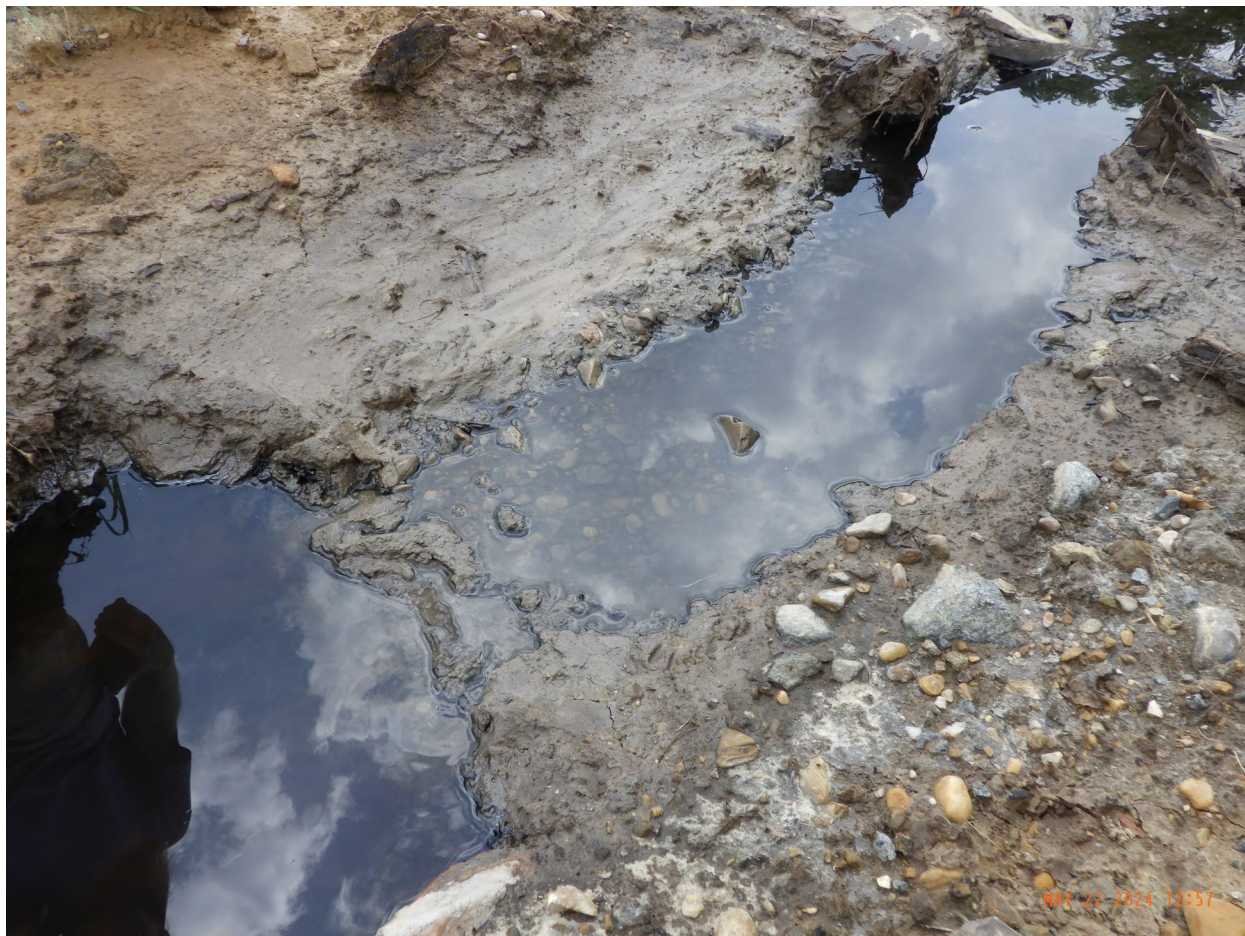
**Photo File Name:** R0010194

**Description:** Looking N-NW, this photo showed an additional view of the stormwater pond utilized by the facility. Gas bubbles from unknown wastes in the stormwater pond were observed.

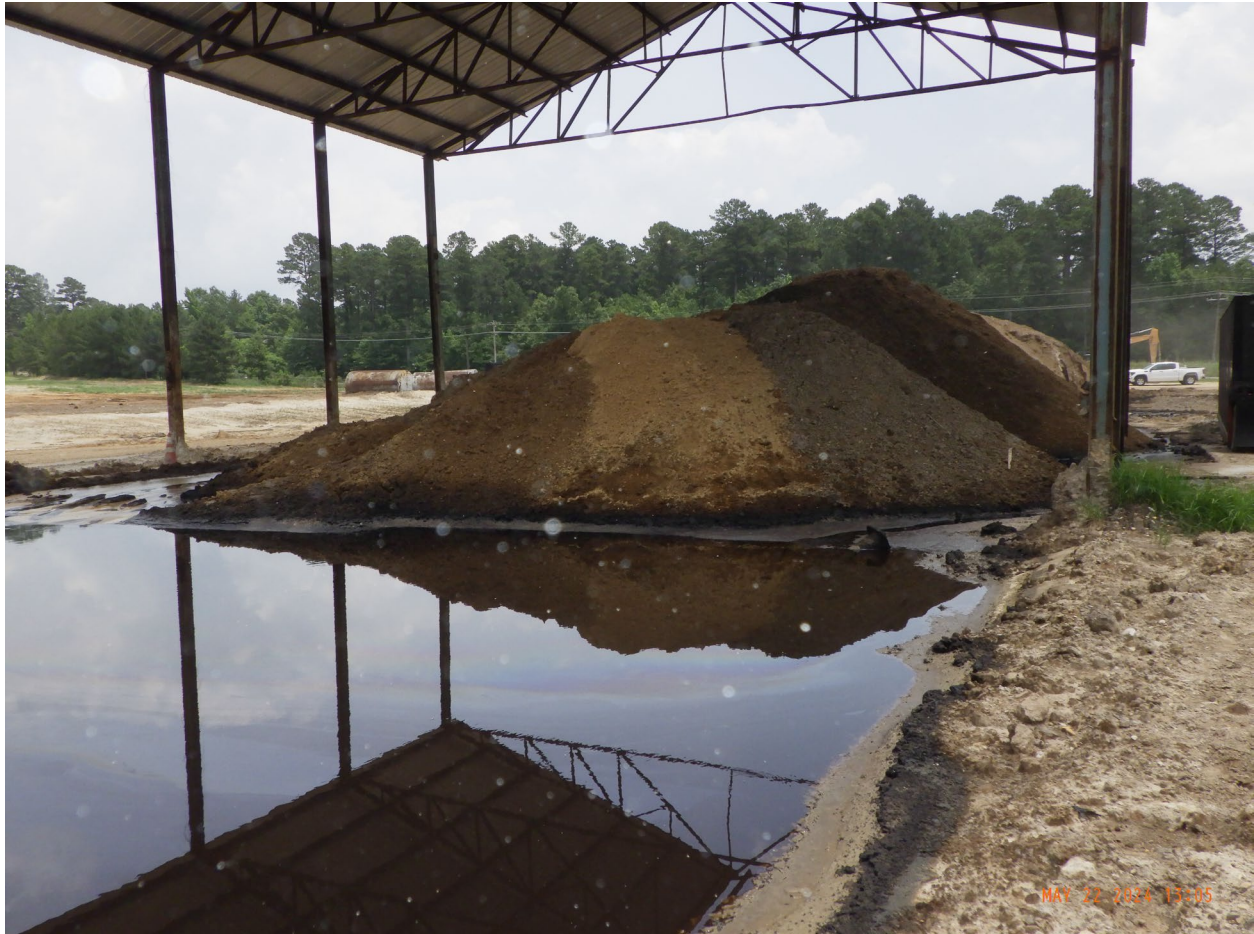
**Photo File Name:** R0010211

**Description:** Looking N-NE, this photo showed another large, concrete pit used to catch leachate from the bulked material. Soil used to make an earthen berm. An erosion gully was noted in the earthen berm with overflows directed toward the concrete pit in Photo No. 37.

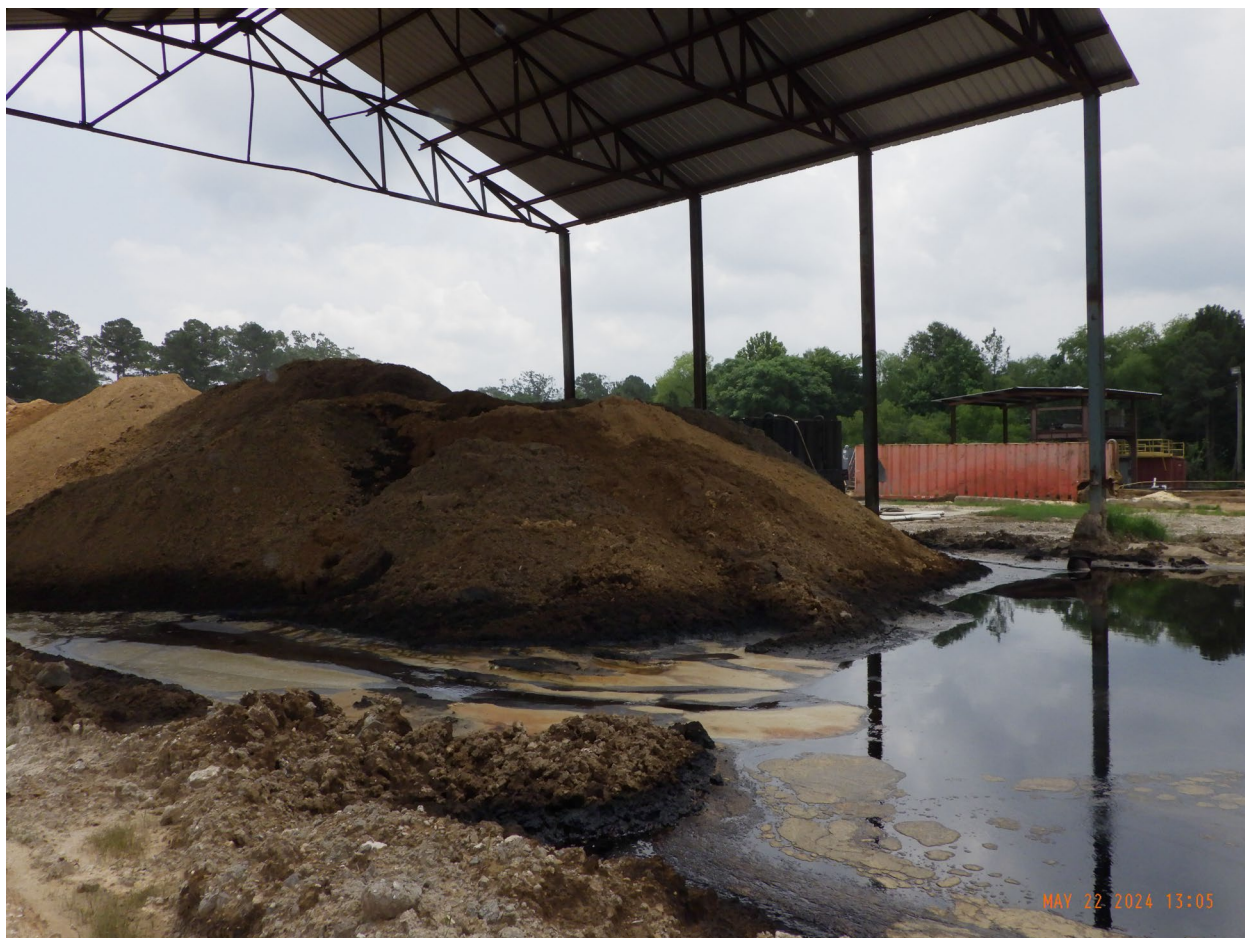
**Photo File Name:** R0010213

**Description:** Looking SW, this photo showed an additional view of the large, concrete pit in Photo No. 37. Black staining was noted outside the concrete pit.
