## **RCRA Inspection Report**

TAV Holdings, Inc.  
3311 Empire Boulevard  
Atlanta, Fulton County, Georgia 30354

January 19, 2023

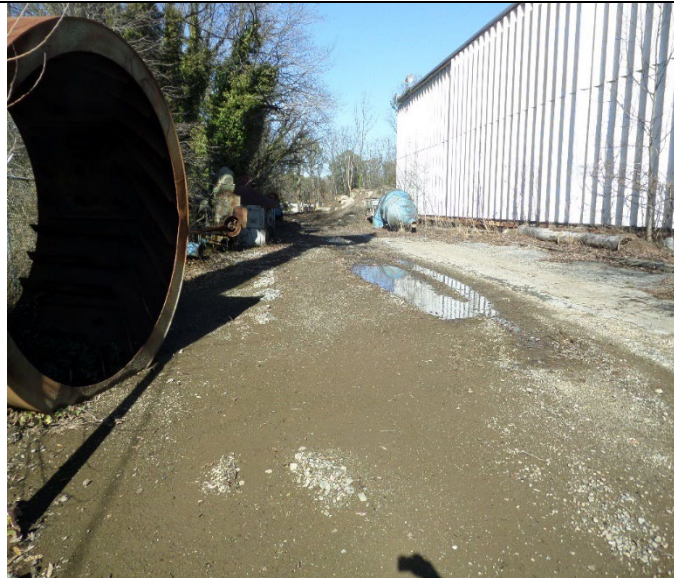
Keebler West Pile Area. The inspectors observed ASR material accumulating on the ground in piles. Photograph 32 taken at 1:47 p.m.
