**UNITED STATES ENVIRONMENTAL PROTECTION AGENCY  
REGION III**

**Report Title:** Clean Water Act, Section 404 Inspection Report for the Sun  
Outdoors Chesapeake Bay Site  
**Inspection Date(s):** 04/05/2023  
**Start Time:** 8:55 **End Time:** 11:30

**Regulatory Program(s):** Inspections authorized pursuant to Clean Water Act, Sections 308  
and 404 (33 U.S.C. §§ 1318 and 1344)  
**Site Name:** Sun Outdoors Chesapeake Bay

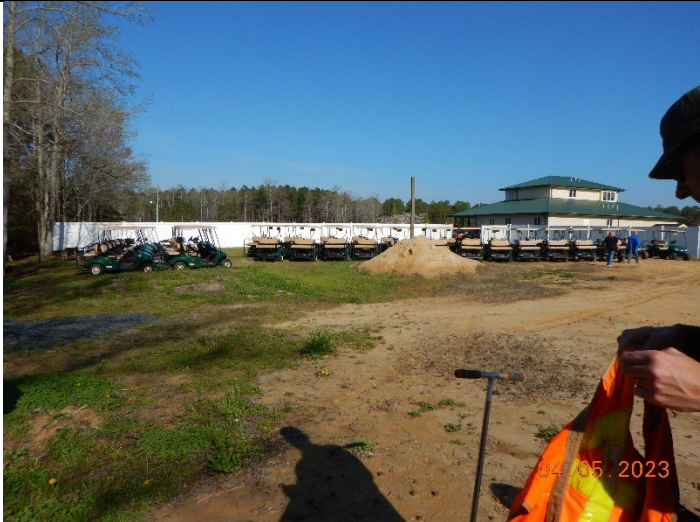
Following the Opening Conference, the inspectors traveled to the southeast of the Welcome Center where Mr. Iocona had stated that approximately 40 truckloads of fill were recently placed. The inspectors observed a rectangular area where brown sandy fill had been discharged (Attachment 2, DSCN4601-DSCN4604). Henceforth, this area will be referred to as Area of Concern (“AOC”) 1.

| A wide-angle photograph of a golf course area. In the background, there is a large, two-story clubhouse with a green roof. To the left, several golf carts are parked. The foreground is a mix of grass and dirt. A person's arm and a yellow safety vest are visible in the lower right corner. A date stamp '04.05.2023' is in the bottom right. | <p>Sun Outdoors Chesapeake Bay<br/>Date: April 5, 2023<br/>Photo ID: DSCN4604<br/>Photo taken by: Katelyn Almeter</p> <p>Notes: View of AOC-1.</p> |

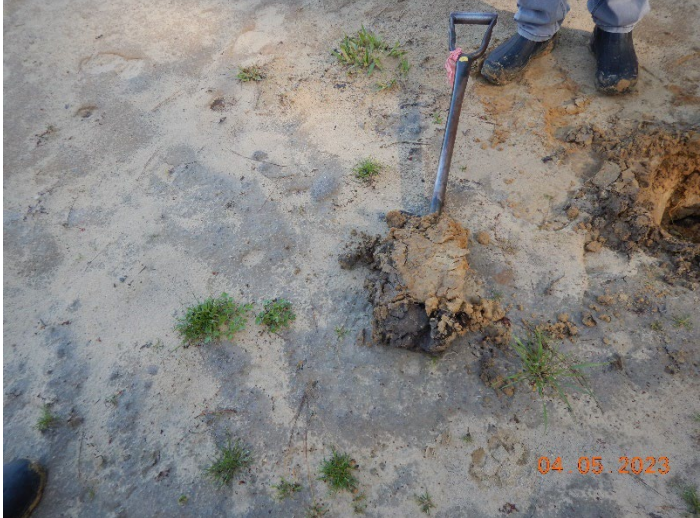
| | <p>Sun Outdoors Chesapeake Bay<br/>Date: April 5, 2023<br/>Photo ID: DSCN4610<br/>Photo taken by: Katelyn Almeter</p> <p>Notes: Bor-2 extracted from AOC-1.</p> |

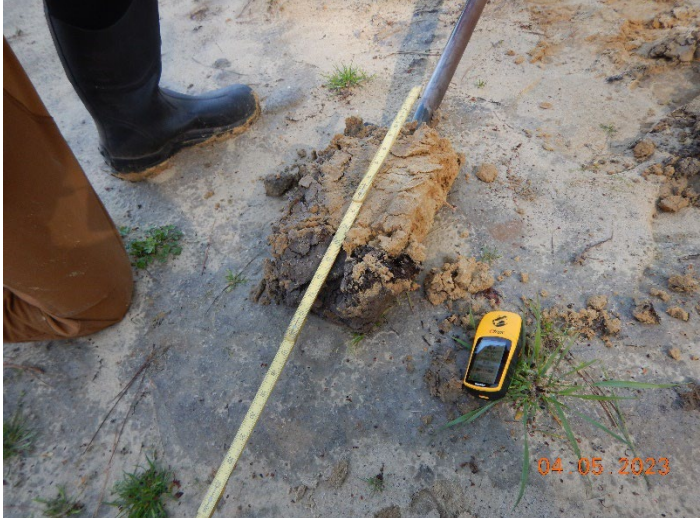
| | <p>Sun Outdoors Chesapeake Bay<br/>Date: April 5, 2023<br/>Photo ID: DSCN4611<br/>Photo taken by: Katelyn Almeter</p> <p>Notes: Soil profile of Bor-2.</p> |

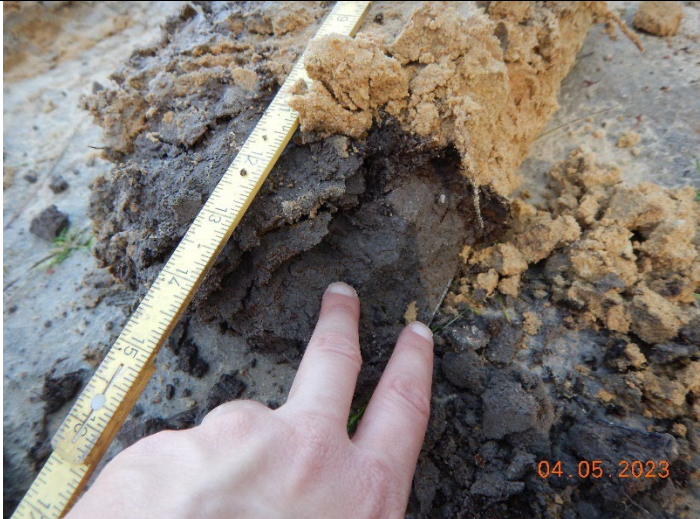
| | <p>Sun Outdoors Chesapeake Bay<br/>Date: April 5, 2023<br/>Photo ID: DSCN4612<br/>Photo taken by: Katelyn Almeter</p> <p>Notes: Soil profile of Bor-2. Note interface between sandy fill and native soil, which exhibited reduced chroma (i.e. &lt;2) and redoximorphic features.</p> |

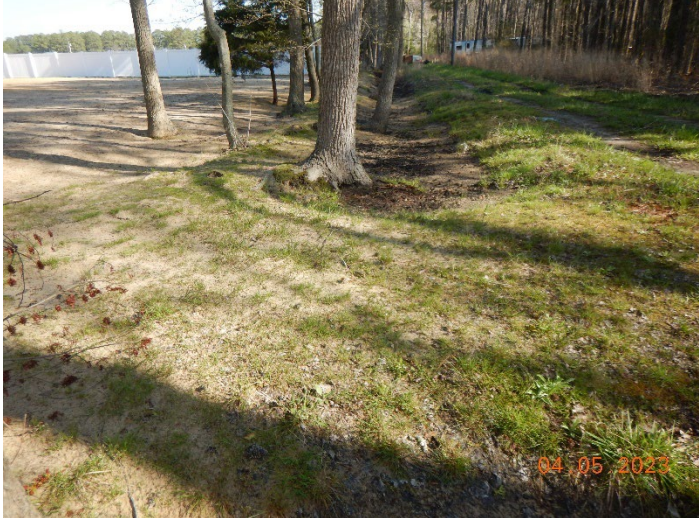
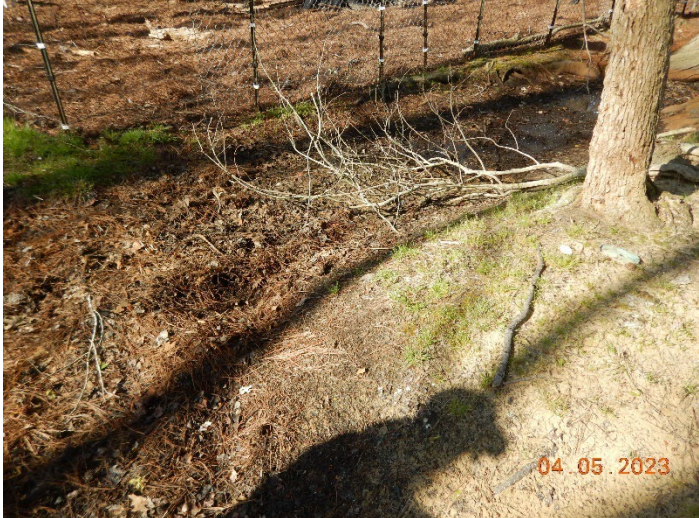
The inspectors walked east and encountered a linear ditch bordering the property, oriented from north to south. The ditch possessed an ordinary high-water mark, flow, and the bed was indicative of regular flow. At the time of inspection, the ditch was full of water with discernable flow toward the Pocomoke Sound. Sandy fill was observed within this ditch (DSCN4608 and DSCN4609). Soil boring Bor-2 was documented immediately to the west of the ditch at the northeastern corner of AOC-1 at 37.929619, -75.652603 (DSCN4610- DSCN4612): [0-10 inches] mixed matrix 80% 7.5YR 5/2 sandy fill and 20% 7.5YR 5/8 sandy fill; [10-11 inches] root mat and native soil surface encountered, 10YR 2/1 organic peat; [11-14+ inches] 10YR 3/1 sandy loam with 5% 2.5YR 3/6 oxidized rhizospheres. The observed native soil profile met the technical definition of a hydric soil (Indicator S5). Vegetation was not observed within AOC-1 as all three parameters (i.e., vegetation, soil, and hydrology) were significantly disturbed by the discharge of fill. AOC-1 was further documented, and fill was observed butting up against multiple tree trunks (DSCN4613- DSCN4615).

| | <p>Sun Outdoors Chesapeake Bay<br/>Date: April 5, 2023<br/>Photo ID: DSCN4613<br/>Photo taken by: Katelyn Almeter</p> <p>Notes: AOC-1.</p> |
| | <p>Sun Outdoors Chesapeake Bay<br/>Date: April 5, 2023<br/>Photo ID: DSCN4614<br/>Photo taken by: Katelyn Almeter</p> <p>Notes: AOC-1.</p> |

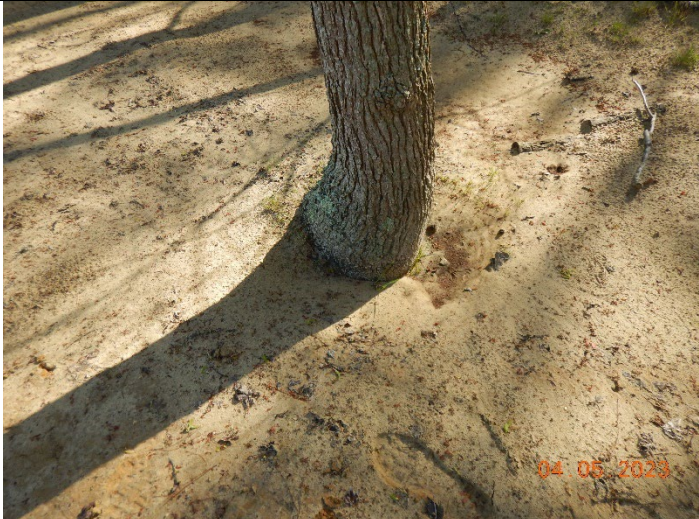
| | <p>Sun Outdoors Chesapeake Bay<br/>Date: April 5, 2023<br/>Photo ID: DSCN4615<br/>Photo taken by: Katelyn Almeter</p> <p>Notes: Note depth of fill around a tree located within AOC-1.</p> |

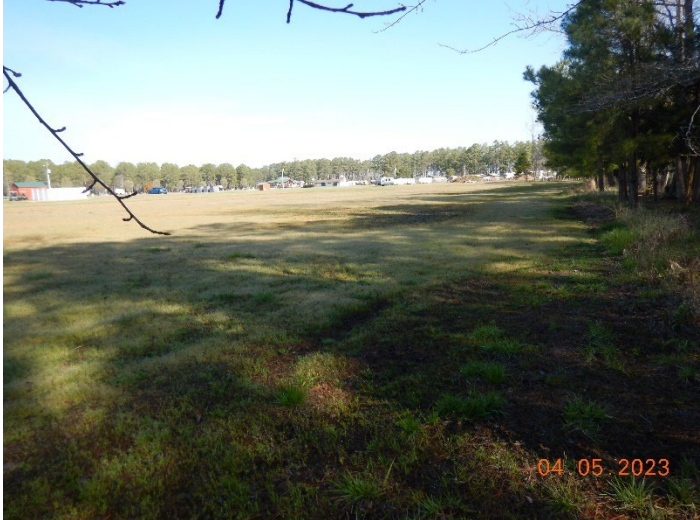
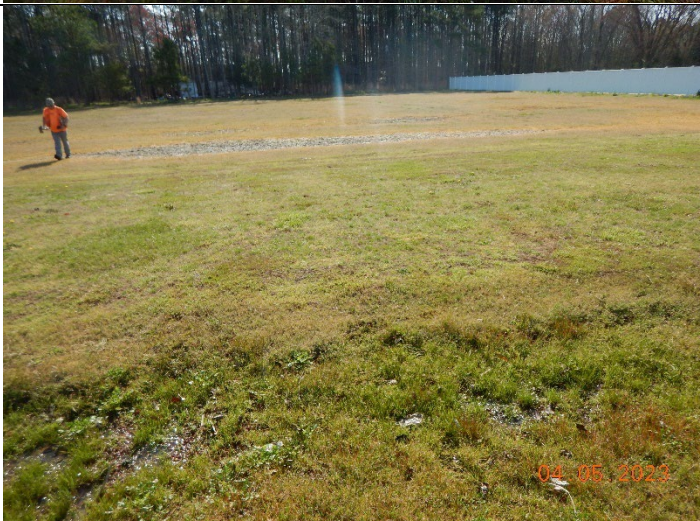
| | <p>Sun Outdoors Chesapeake Bay<br/>Date: April 5, 2023<br/>Photo ID: DSCN4616<br/>Photo taken by: Katelyn Almeter</p> <p>Notes: Field located to the north of AOC-1.</p> |
| | <p>Sun Outdoors Chesapeake Bay<br/>Date: April 5, 2023<br/>Photo ID: DSCN4617<br/>Photo taken by: Katelyn Almeter</p> <p>Notes: Field located to the north of AOC-1.</p> |

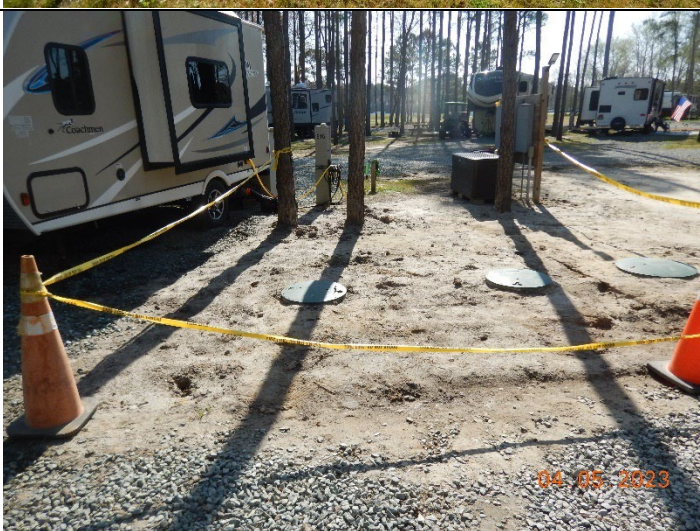
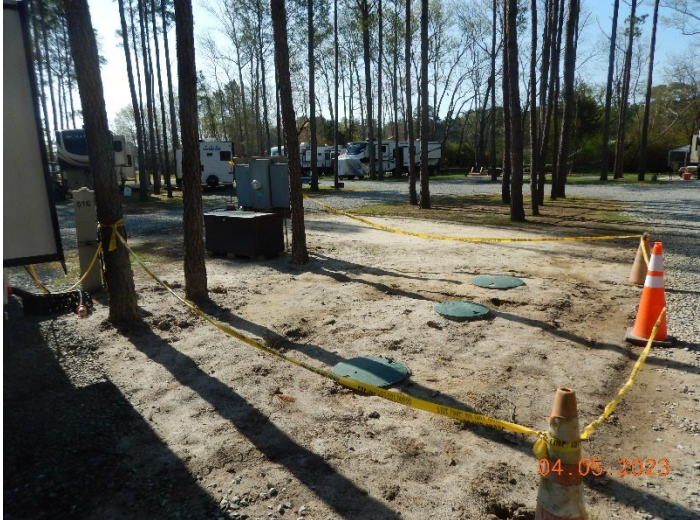
The inspection team walked to the north a field (DSCN4616 and DSCN4617), then traveled west to where a septic tank was recently installed (DSCN4618- DSCN4619). The inspection team then traveled to the southeast, where publicly available 2021 aerial imagery indicated earthmoving or filling activity may have occurred. The inspectors observed two oblong areas where fill had been placed (DSCN4620-DSCN4626). Henceforth, this area will be referred to as AOC-2.

| | <p>Sun Outdoors Chesapeake Bay<br/>Date: April 5, 2023<br/>Photo ID: DSCN4618<br/>Photo taken by: Katelyn Almeter</p> <p>Notes: Site of recently installed septic tanks.</p> |

| | <p>Sun Outdoors Chesapeake Bay<br/>Date: April 5, 2023<br/>Photo ID: DSCN4619<br/>Photo taken by: Katelyn Almeter</p> <p>Notes: Site of recently installed septic tanks.</p> |

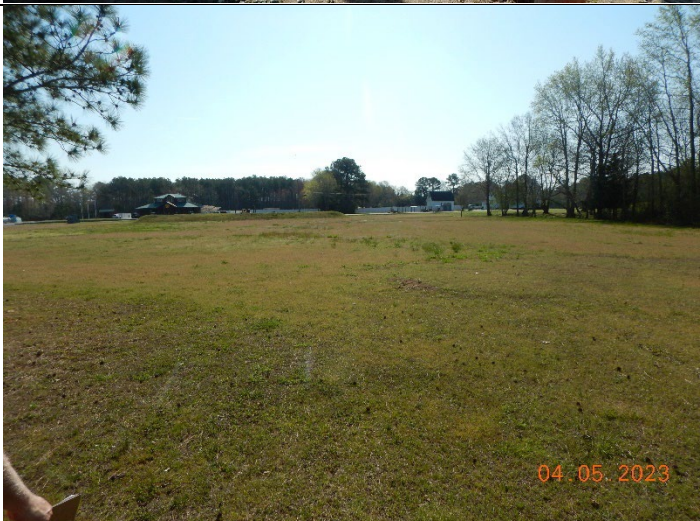
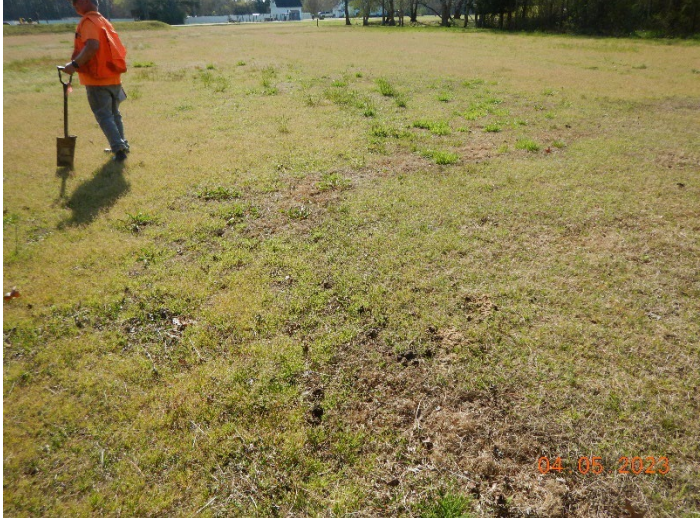
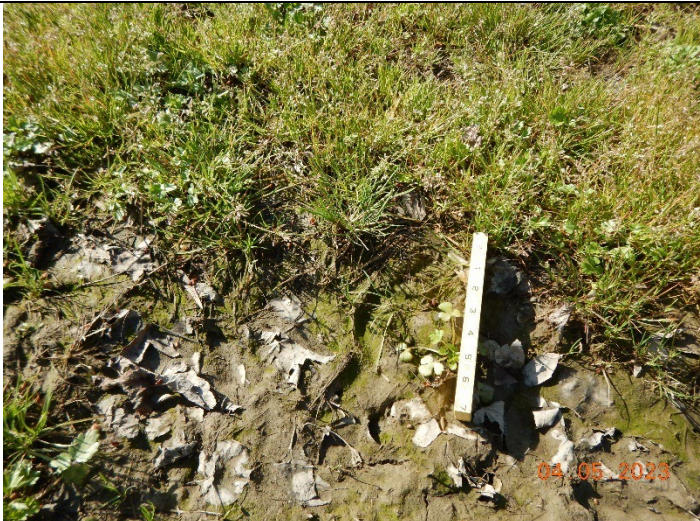
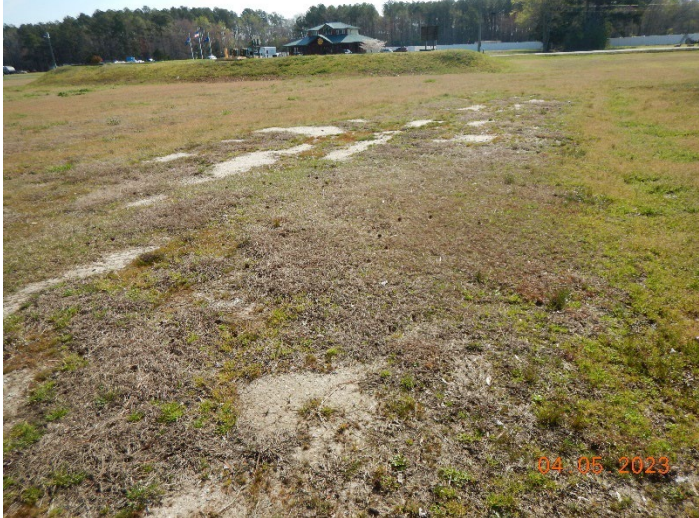
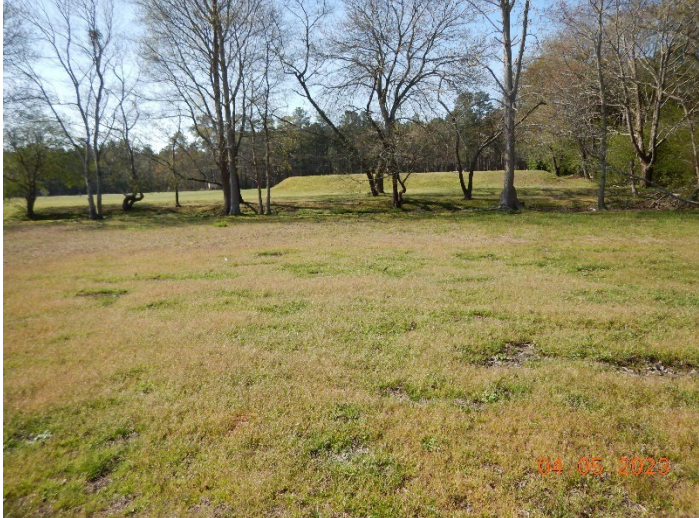
| | <p>Sun Outdoors Chesapeake Bay<br/>Date: April 5, 2023<br/>Photo ID: DSCN4620<br/>Photo taken by: Katelyn Almeter</p> <p>Notes: View of AOC-2.</p> |

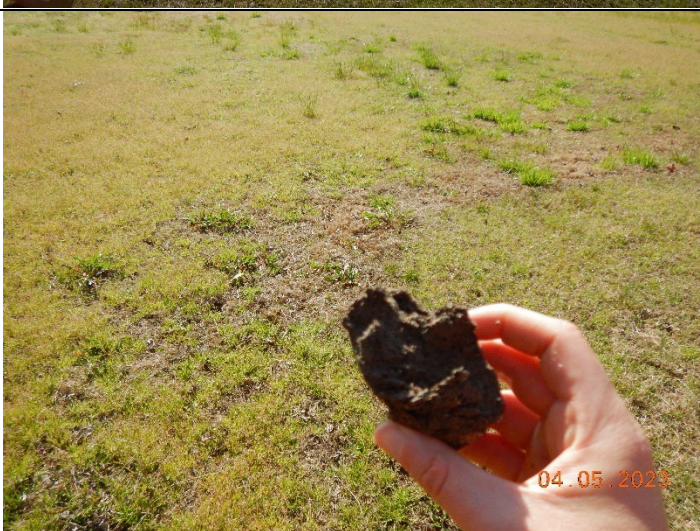
| | <p>Sun Outdoors Chesapeake Bay<br/>Date: April 5, 2023<br/>Photo ID: DSCN4621<br/>Photo taken by: Katelyn Almeter</p> <p>Notes: Soil extracted from AOC-2.</p> |

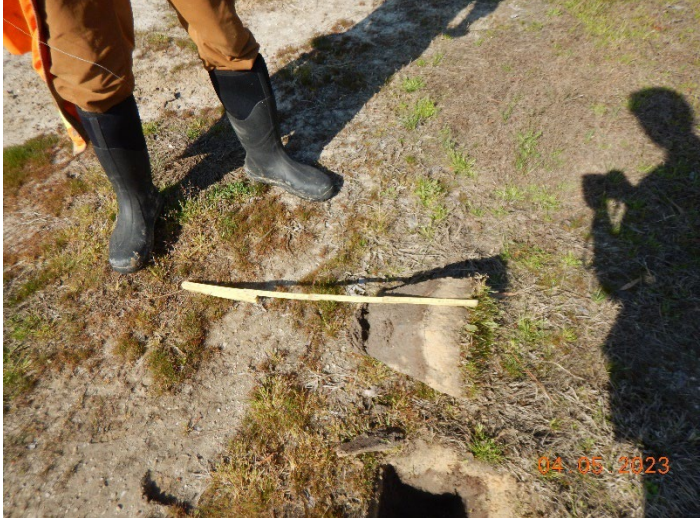
Soil boring Bor-3 was extracted from AOC-2 at 37.929972, -75.655328 (DSCN4627-DSCN4630): [0-3.5 inches] mixed matrix 80% 7.5YR 6/3 sandy fill and 20% 10YR 4/1 sandy loam; [3.5-13 inches] native soil surface encountered, 10YR 4/1 sandy loam with 15% 2.5YR 3/6 oxidized rhizospheres. The observed native soil profile met the technical definition of a hydric soil (Indicator S5). Bor-3 was collected from mowed field which was dominated by turfgrass: Bermudagrass (*Cynodon dactylon*) and annual bluegrass (*Poa annua*). Vegetation in this area was altered by regular maintenance and the soil was impacted by the discharge of fill. While AOC-2 was further documented, including a ditch to the south (DSCN4631-DSCN4637), Ms. Scott stated that in December 2022 a storm inundated the eastern portion of the Site and Mr. Iocona followed up that material was placed in that area in January 2023 because maintenance trucks had difficulty with access.

| | <p>Sun Outdoors Chesapeake Bay<br/>Date: April 5, 2023<br/>Photo ID: DSCN4628<br/>Photo taken by: Katelyn Almeter</p> <p>Notes: Bor-3 extracted from AOC-2.<br/>Note clear demarcation of fill layer and native soil.</p> |

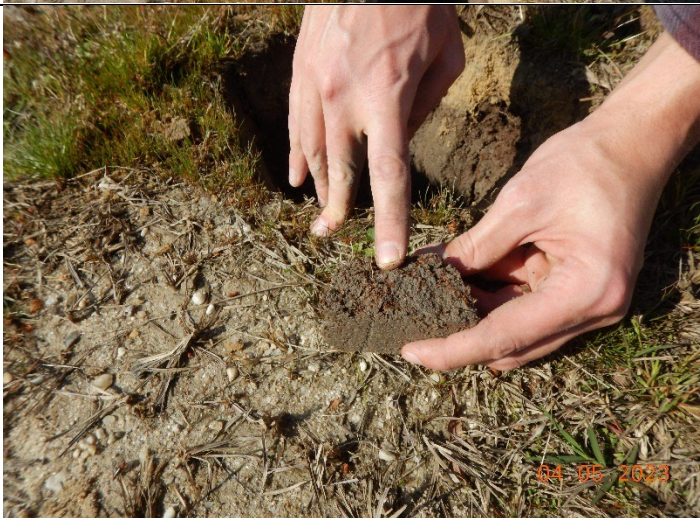
| | <p>Sun Outdoors Chesapeake Bay<br/>Date: April 5, 2023<br/>Photo ID: DSCN4629<br/>Photo taken by: Katelyn Almeter</p> <p>Notes: Oxidized rhizospheres occurring within native soil.</p> |

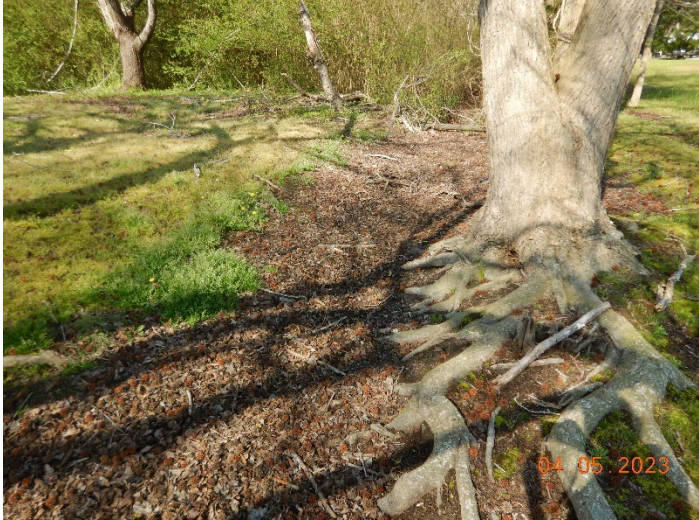
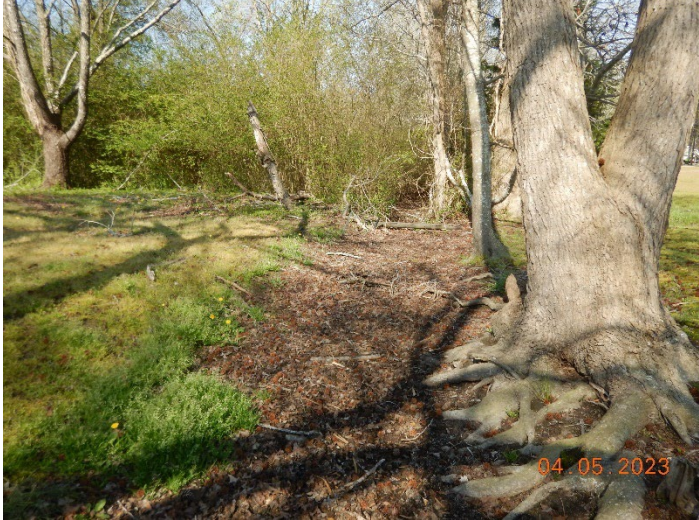
| | <p>Sun Outdoors Chesapeake Bay<br/>Date: April 5, 2023<br/>Photo ID: DSCN4631<br/>Photo taken by: Katelyn Almeter</p> <p>Notes: Area south of AOC-2.</p> |
| | <p>Sun Outdoors Chesapeake Bay<br/>Date: April 5, 2023<br/>Photo ID: DSCN4632<br/>Photo taken by: Katelyn Almeter</p> <p>Notes: Area south of AOC-2.</p> |

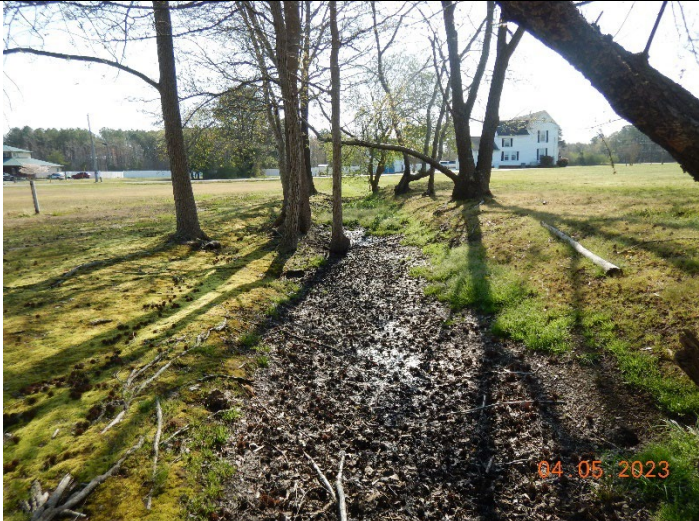
| | <p>Sun Outdoors Chesapeake Bay<br/>Date: April 5, 2023<br/>Photo ID: DSCN4633<br/>Photo taken by: Katelyn Almeter</p> <p>Notes: Ditch observed to the south of AOC-2.</p> |

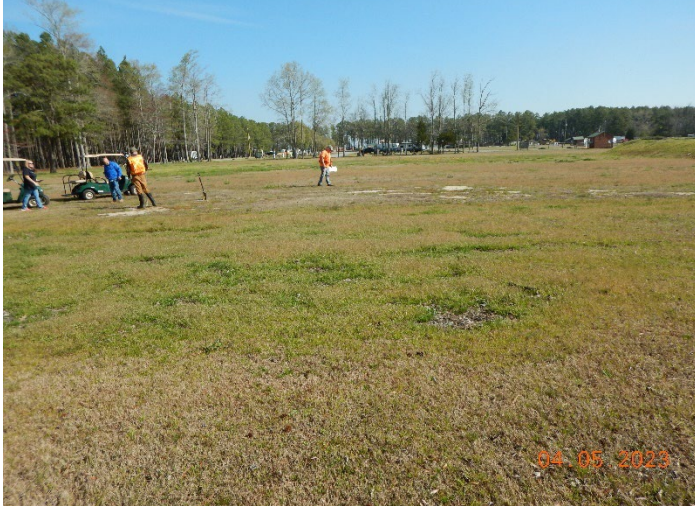
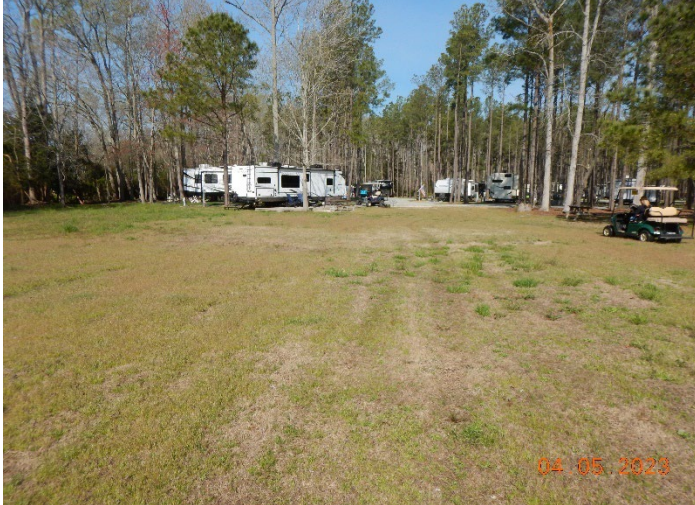
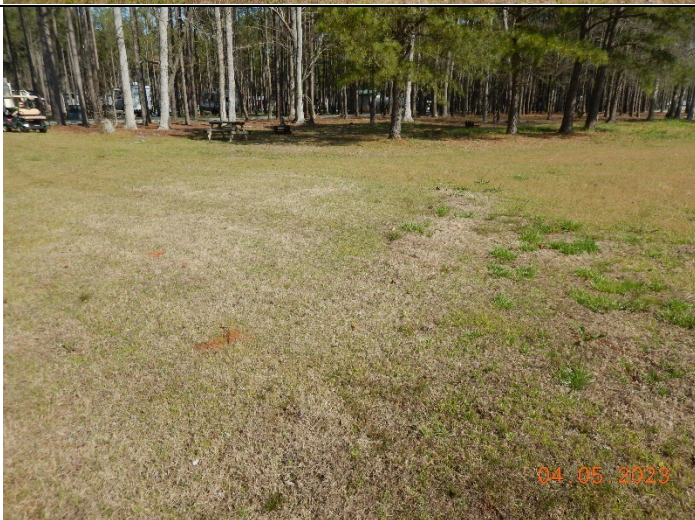
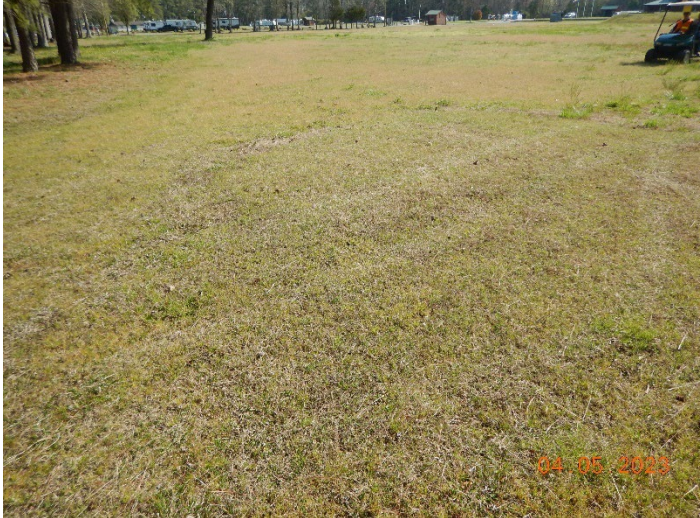
| A wide-angle photograph of a grassy field with a line of trees in the background. Several people and golf carts are visible on the left side. The date stamp "04.05.2023" is in the bottom right corner. | <p>Sun Outdoors Chesapeake Bay<br/>Date: April 5, 2023<br/>Photo ID: DSCN4634<br/>Photo taken by: Katelyn Almeter</p> <p>Notes: Northward view of AOC-2.</p> |
| A photograph of a grassy field with a line of trees in the background. Several white trailers and golf carts are visible. The date stamp "04.05.2023" is in the bottom right corner. | <p>Sun Outdoors Chesapeake Bay<br/>Date: April 5, 2023<br/>Photo ID: DSCN4635<br/>Photo taken by: Katelyn Almeter</p> <p>Notes: Westward view of AOC-2.</p> |
| A photograph of a grassy field with a line of trees in the background. Several golf carts are visible. The date stamp "04.05.2023" is in the bottom right corner. | <p>Sun Outdoors Chesapeake Bay<br/>Date: April 5, 2023<br/>Photo ID: DSCN4636<br/>Photo taken by: Katelyn Almeter</p> <p>Notes: View of AOC-2.</p> |

| | <p>Sun Outdoors Chesapeake Bay<br/>Date: April 5, 2023<br/>Photo ID: DSCN4637<br/>Photo taken by: Katelyn Almeter</p> <p>Notes: View of AOC-2.</p> |

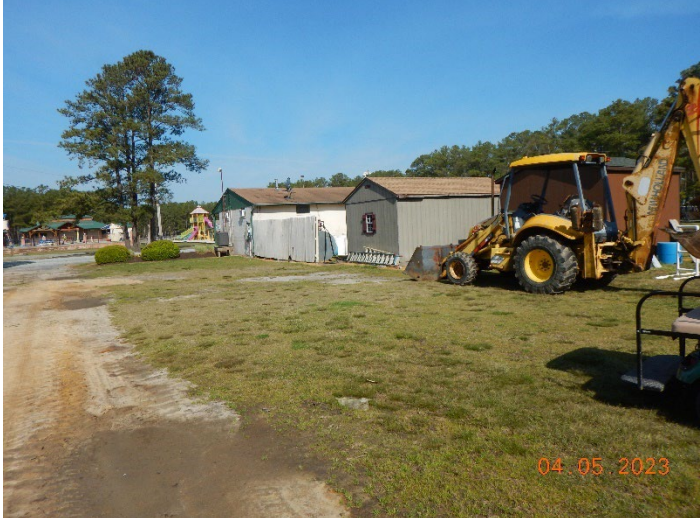
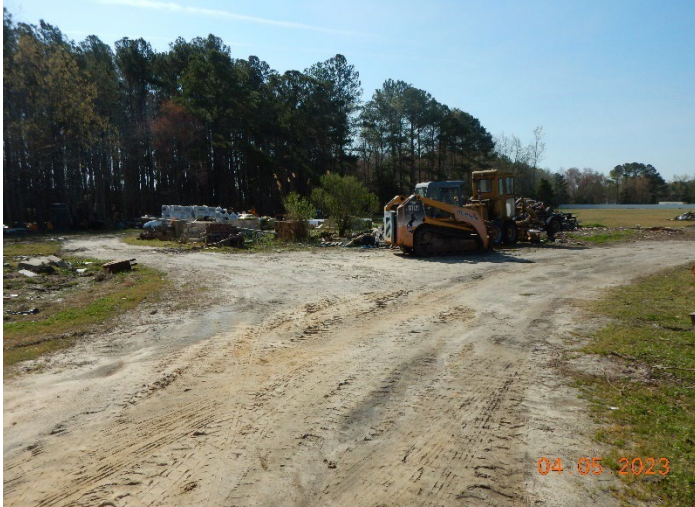
| | <p>Sun Outdoors Chesapeake Bay<br/>Date: April 5, 2023<br/>Photo ID: DSCN4638<br/>Photo taken by: Katelyn Almeter</p> <p>Notes: Road observed within AOC-3.</p> |

| | <p>Sun Outdoors Chesapeake Bay<br/>Date: April 5, 2023<br/>Photo ID: DSCN4641<br/>Photo taken by: Katelyn Almeter</p> <p>Notes: View of road constructed within AOC-3.</p> |

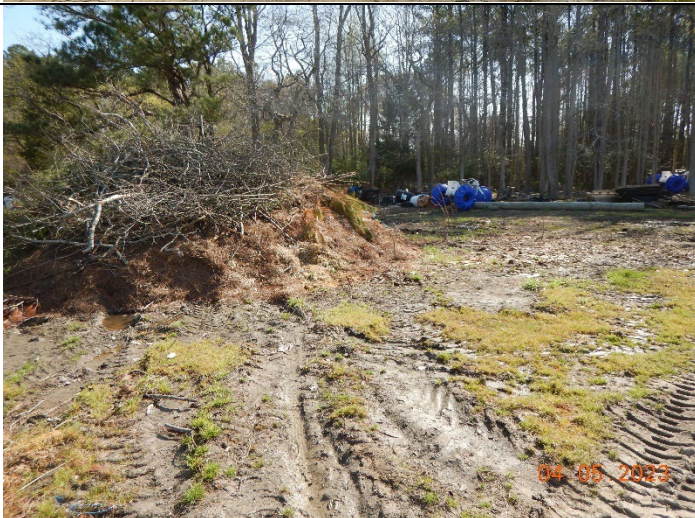
| | <p>Sun Outdoors Chesapeake Bay<br/>Date: April 5, 2023<br/>Photo ID: DSCN4642<br/>Photo taken by: Katelyn Almeter</p> <p>Notes: AOC-3: pile of woody debris in foreground and recreational equipment located in background.</p> |

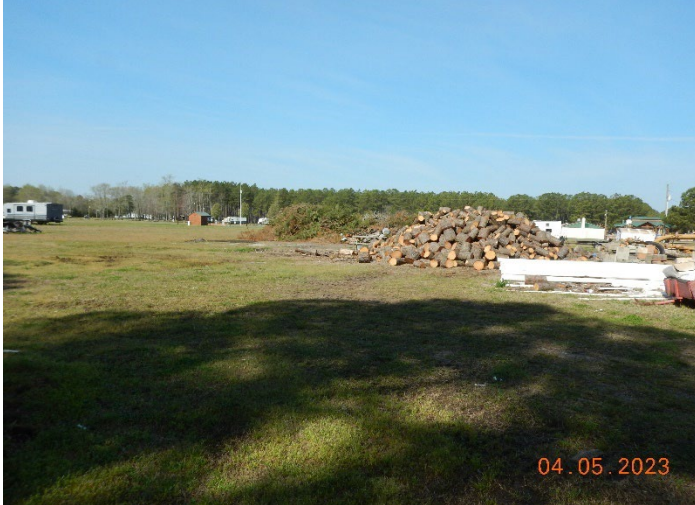
| | <p>Sun Outdoors Chesapeake Bay<br/>Date: April 5, 2023<br/>Photo ID: DSCN4644<br/>Photo taken by: Katelyn Almeter</p> <p>Notes: Log pile observed within AOC-3.</p> |

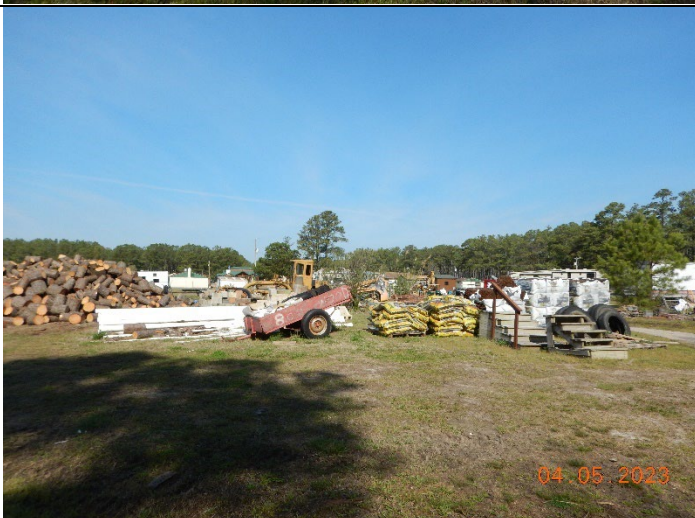
| | <p>Sun Outdoors Chesapeake Bay<br/>Date: April 5, 2023<br/>Photo ID: DSCN4645<br/>Photo taken by: Katelyn Almeter</p> <p>Notes: View of landscaping equipment stored at AOC-3.</p> |

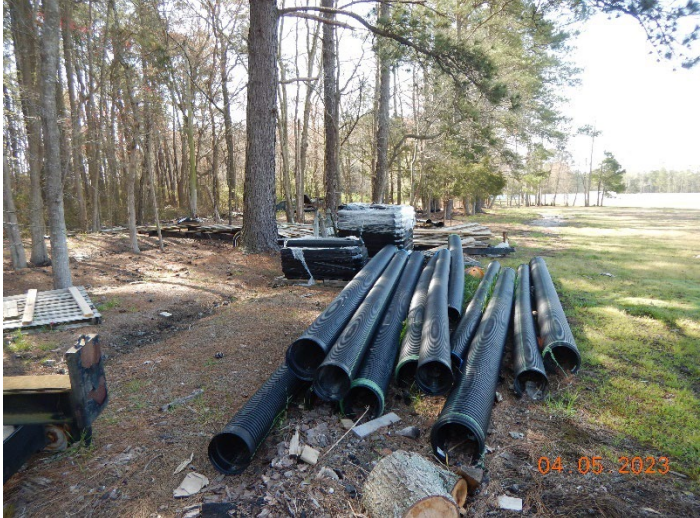
| A photograph showing several large, black, corrugated drainage pipes lying on the ground in a wooded area. The pipes are stacked and some are cut. The ground is covered with dry leaves and pine needles. A date stamp "04.05.2023" is visible in the bottom right corner of the photo. | <p>Sun Outdoors Chesapeake Bay<br/>Date: April 5, 2023<br/>Photo ID: DSCN4646<br/>Photo taken by: Katelyn Almeter</p> <p>Notes: Corrugated drainage pipe stored within AOC-3.</p> |

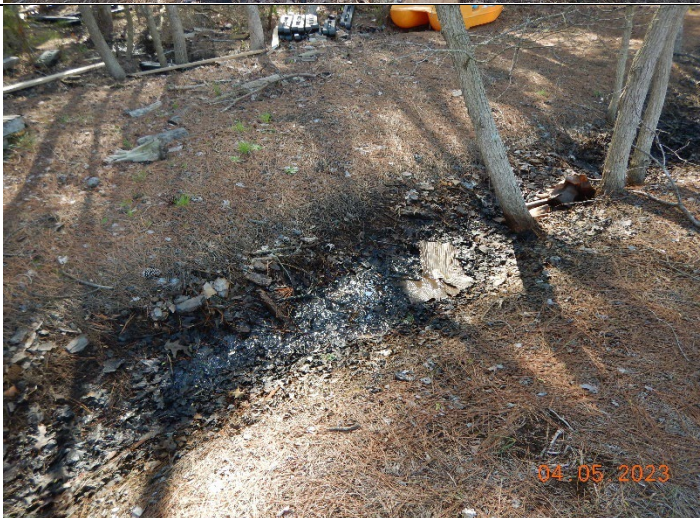
| A photograph showing a narrow, shallow ditch or gully in a wooded area. The ditch is filled with dry leaves and pine needles. The ground on either side is covered with a thick layer of dry leaves and pine needles. A date stamp "04.05.2023" is visible in the bottom right corner of the photo. | <p>Sun Outdoors Chesapeake Bay<br/>Date: April 5, 2023<br/>Photo ID: DSCN4647<br/>Photo taken by: Katelyn Almeter</p> <p>Notes: Ditch observed along the eastern boundary of the Site.</p> |

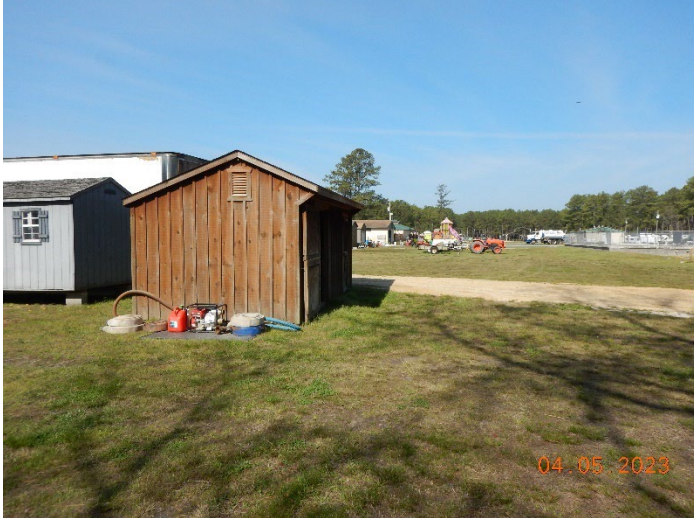
| A photograph showing a wooden shed with a gabled roof and a small window. To the left is a white building. The ground is grassy with some patches of dirt. In the background, there are trees and a clear blue sky. A date stamp "04.05.2023" is visible in the bottom right corner. | <p>Sun Outdoors Chesapeake Bay<br/>Date: April 5, 2023<br/>Photo ID: DSCN4649<br/>Photo taken by: Katelyn Almeter</p> <p>Notes: Westward view of Site.</p> |

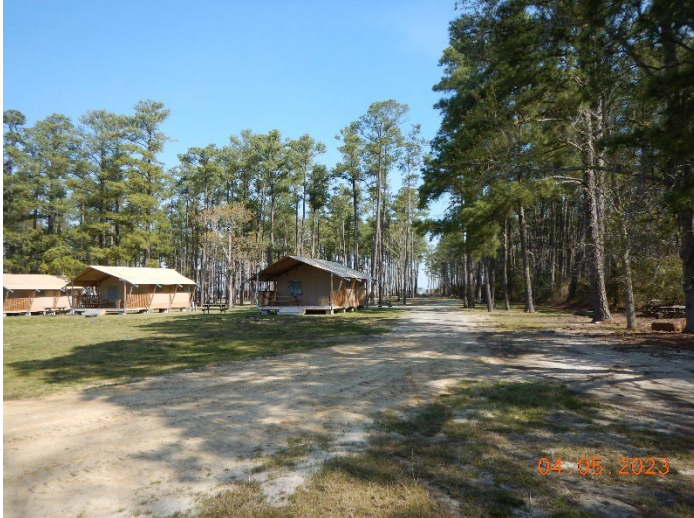
| A photograph of a sandy road or path lined with tall, thin trees. In the distance, there are some small buildings. The sky is clear and blue. A date stamp "04.05.2023" is visible in the bottom right corner. | <p>Sun Outdoors Chesapeake Bay<br/>Date: April 5, 2023<br/>Photo ID: DSCN4650<br/>Photo taken by: Katelyn Almeter</p> <p>Notes: Northward view of sandy road located on the eastern portion of the Site.</p> |

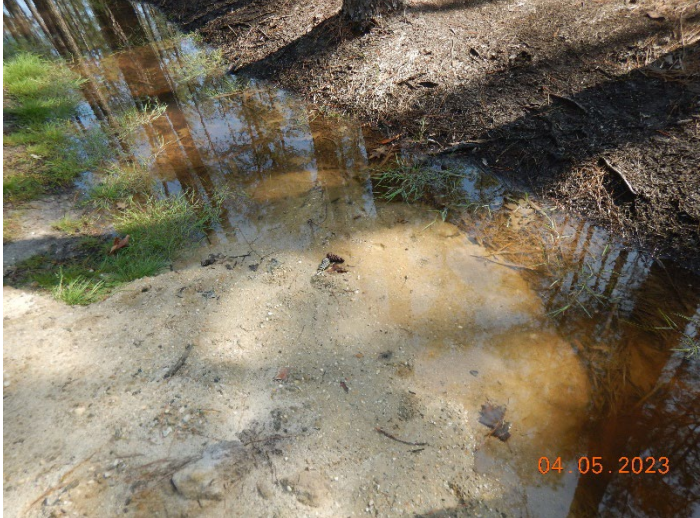
| A photograph showing a shallow ditch with muddy water. A large area of light-colored sand is visible in the foreground, partially submerged in the water. The background shows trees and foliage. A date stamp '04.05.2023' is visible in the bottom right corner of the photo. | <p>Sun Outdoors Chesapeake Bay<br/>Date: April 5, 2023<br/>Photo ID: DSCN4658<br/>Photo taken by: Katelyn Almeter</p> <p>Notes: View of ditch to the east of the road where sand was discharged.<br/>AOC-4</p> |

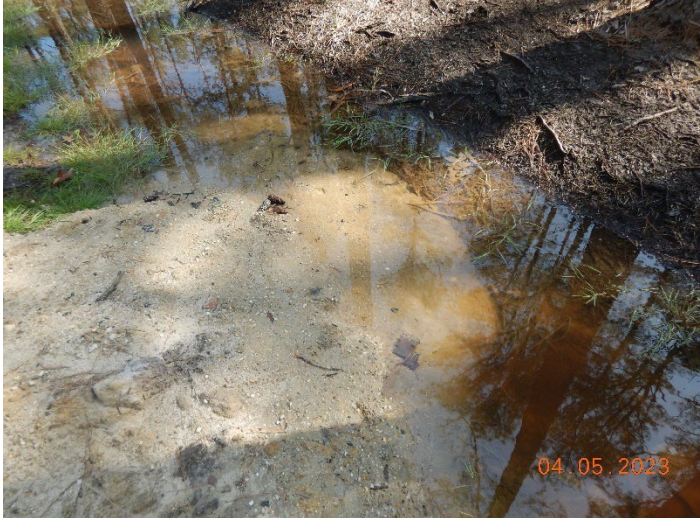
The road continued northward, and large fill piles were observed on the road (DSCN4652-DSCN4655). Ms. Scott stated that the piles were comprised of spoils excavated from the where the new septic system was recently installed (See above at Section III, Paragraph 4 [pg. 5] and photos DSCN4618-DSCN4619). The inspection team continued northward on the road, and it appeared that some of the sand used to construct the road had spilled into a ditch, which ran parallel east of the road (DSCN4656- DSCN4661). This was a downstream section of the ditch abutting AOC-1.

| A photograph showing a shallow ditch with muddy water. A large area of light-colored sand is visible in the foreground, partially submerged in the water. The background shows trees and foliage. A date stamp '04.05.2023' is visible in the bottom right corner of the photo. | <p>Sun Outdoors Chesapeake Bay<br/>Date: April 5, 2023<br/>Photo ID: DSCN4659<br/>Photo taken by: Katelyn Almeter</p> <p>Notes: View of ditch to the east of the road where sand was discharged.<br/>AOC-4</p> |

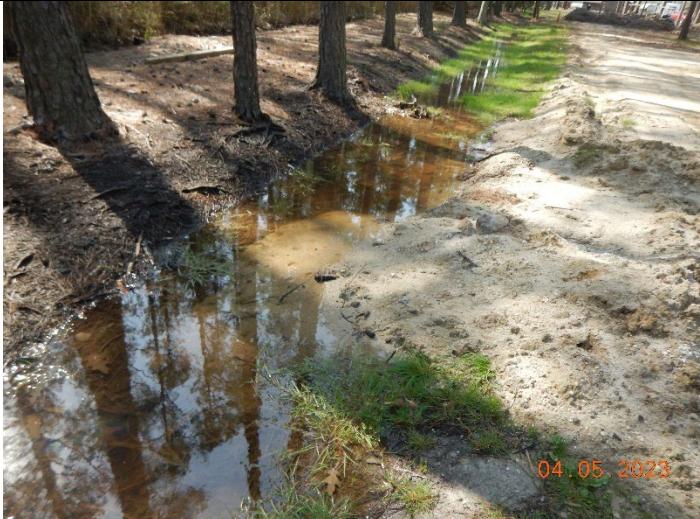
| A photograph showing a shallow ditch with muddy water. A large area of light-colored sand is visible in the foreground, partially submerged in the water. The background shows trees and foliage. A date stamp '04.05.2023' is visible in the bottom right corner of the photo. | <p>Sun Outdoors Chesapeake Bay<br/>Date: April 5, 2023<br/>Photo ID: DSCN4660<br/>Photo taken by: Katelyn Almeter</p> <p>Notes: Southward view of ditch to the east of the road where sand was discharged. AOC-4</p> |

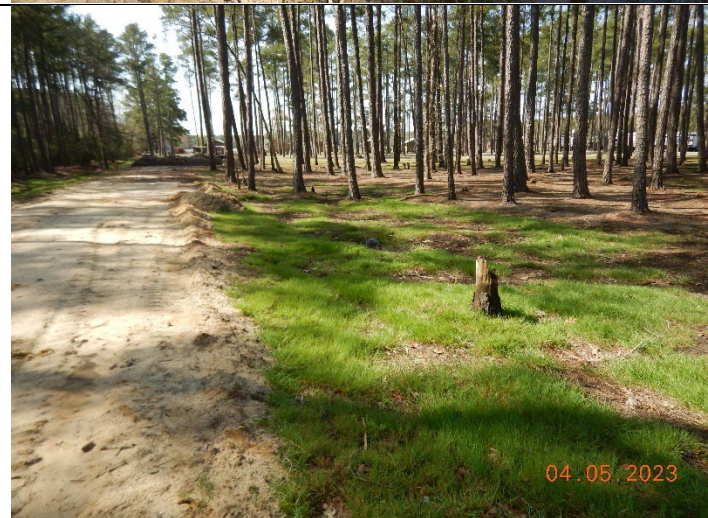
- AOC-4, road constructed above-grade with sand. Two fill piles were observed at the southern and northern terminuses. Ms. Scott stated that the fill pile located on the southern extent was comprised of excavated spoils from the recently constructed septic system; and

| | <p>Sun Outdoors Chesapeake Bay<br/>Date: April 5, 2023<br/>Photo ID: DSCN4662<br/>Photo taken by: Katelyn Almeter</p> <p>Notes: View of the road constructed of sand located on the northern portion of the Site. AOC-4</p> |

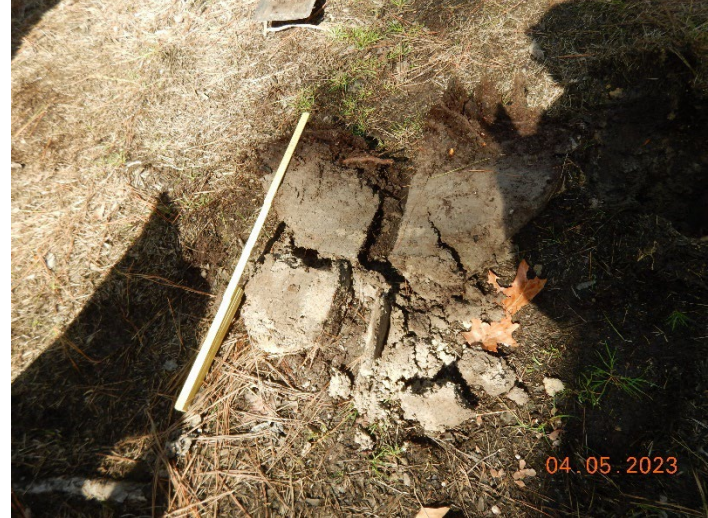
The inspection team then walked west to a reference area that was forested and collected Bor-6 at 37.933881, -75.652378 (DSCN4664-DSCN4666): [0-4 inches] 10YR 2/1 black organic peat and root mat; [4-12 inches] 10YR 3/1 sandy clay; [12-18+ inches] 10YR 4/1 sandy clay with 5% 2.5YR 4/6 redoximorphic features. The observed soil profile met the technical definition of a hydric soil (Indicator S1). Primary indicators of hydrology were observed. For example, the soil was saturated, and the water table was seeping into the boring at a depth of 15 inches. The vegetation community was dominated by mature loblolly pine (*Pinus taeda*) in the tree stratum. The community did not contain a sapling or shrub strata. The herbaceous stratum contained a few individual whorled pennywort (*Hydrocotyle verticillata*). This area met the technical definition of a wetland as hydric soils, wetland hydrology, and a hydrophytic vegetation were observed. The inspection team then walked to the northwest and encountered a linear ditch filled with water. A culvert conveyed water under the road crossing (DSCN4667-DSCN4669). The inspection team then continued north on the road located at AOC-4 (DSCN4670-DSCN4673) until they reached the northeastern extent of the Site, which was set on the waterfront of the Pocomoke Sound.

| | <p>Sun Outdoors Chesapeake Bay<br/>Date: April 5, 2023<br/>Photo ID: DSCN4664<br/>Photo taken by: Katelyn Almeter</p> <p>Notes: Soil sample extracted from Bor-6.</p> |

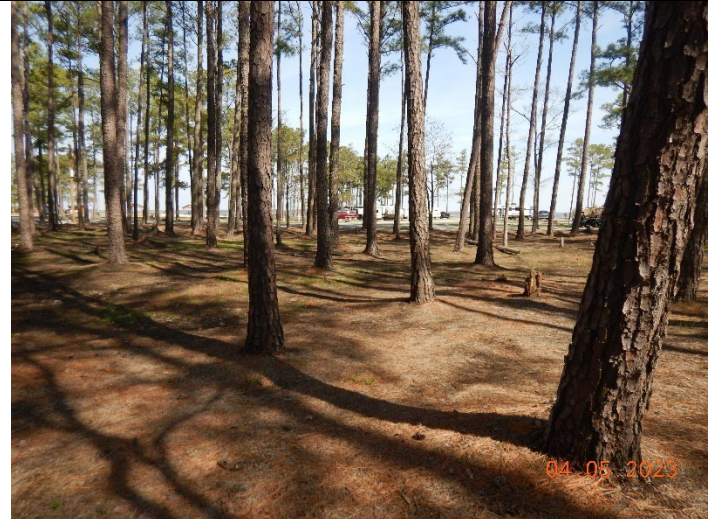
| | <p>Sun Outdoors Chesapeake Bay<br/>Date: April 5, 2023<br/>Photo ID: DSCN4666<br/>Photo taken by: Katelyn Almeter</p> <p>Notes: View of mature loblolly pine (<i>Pinus taeda</i>) located proximate to Bor-6.</p> |

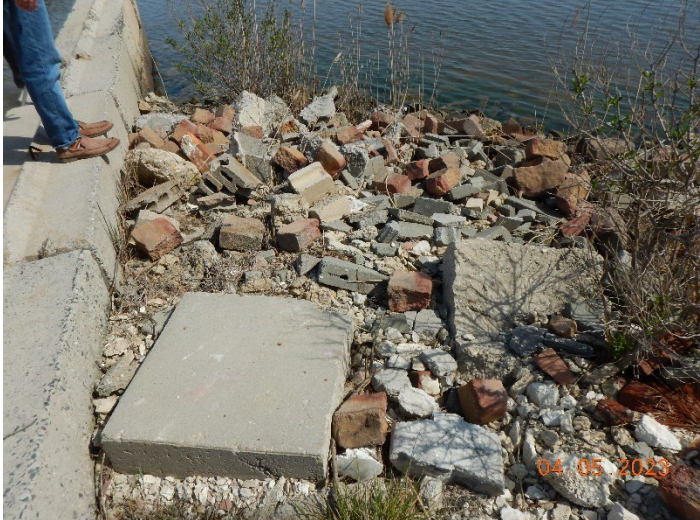
The inspectors walked the waterfront from east to west and observed a concrete bulkhead situated along the waterfront of Pocomoke Sound. Bricks, concrete, and cinderblocks were observed waterward of the bulkhead (DSCN4675- DSCN4678, DSCN4681- DSCN4684). Campsites, complete with septic hookups were located to the south of the bulkhead (DSCN4680). A wooden pier was observed extending northward into the sound (DSCN4679, DSCN4682, DSCN4684, and DSCN4685). Continuing westward, the inspection team encountered an inlet (DSCN4686 and DSCN4687). To the south of the inlet, a large, inundated area was encountered. On the western bank of the open water area was sparsely vegetated sand, which appeared to have been recently placed (DSCN4688) and included a picnic area, extending to the western boundary and waterfront (DSCN4690- DSCN4694). The inspection team and attendees then traveled back to the Welcome Center conference room, where the Closing Conference was then conducted.

| A photograph showing a concrete bulkhead on the left. A person's legs in blue jeans and brown shoes are visible on the bulkhead. To the right of the bulkhead is a large pile of debris in the water, including red bricks, grey concrete slabs, and light-colored cinder blocks. The water is calm and blue. A date stamp '04.05.2023' is visible in the bottom right corner of the photo. | <p>Sun Outdoors Chesapeake Bay<br/>Date: April 5, 2023<br/>Photo ID: DSCN4676<br/>Photo taken by: Katelyn Almeter</p> <p>Notes: Bricks, concrete, and cinder blocks located waterward of the concrete bulkhead.</p> |

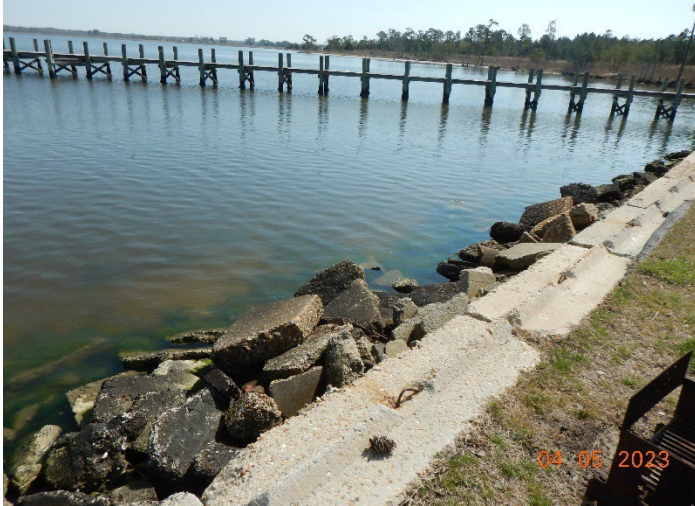
| <p>04/05/2023</p> | <p>Sun Outdoors Chesapeake Bay<br/>Date: April 5, 2023<br/>Photo ID: DSCN4682<br/>Photo taken by: Katelyn Almeter</p> <p>Notes: Bricks, concrete, and cinder blocks located waterward of the concrete bulkhead.</p> |

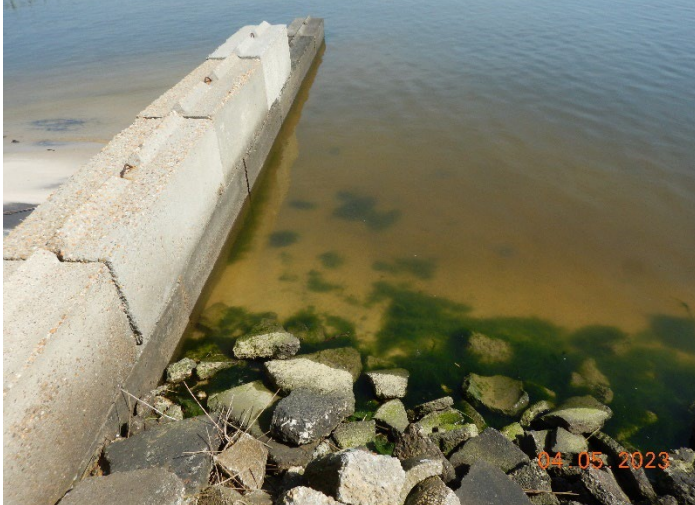
| <p>04/05/2023</p> | <p>Sun Outdoors Chesapeake Bay<br/>Date: April 5, 2023<br/>Photo ID: DSCN4683<br/>Photo taken by: Katelyn Almeter</p> <p>Notes: Bricks, concrete, and cinder blocks located waterward of the concrete bulkhead.</p> |

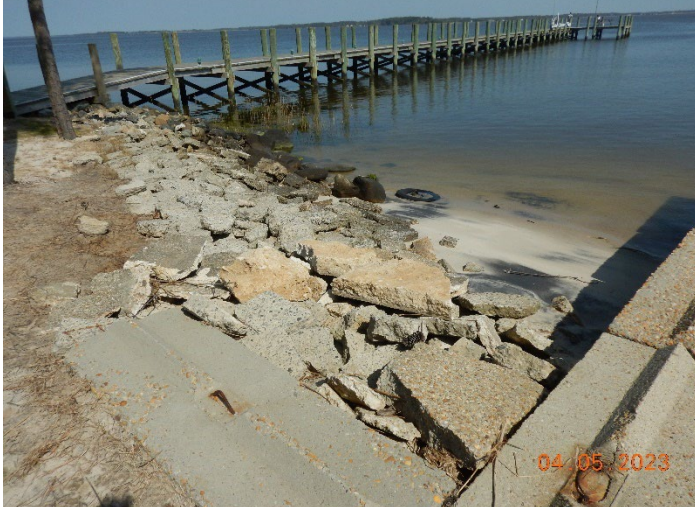
| <p>04/05/2023</p> | <p>Sun Outdoors Chesapeake Bay<br/>Date: April 5, 2023<br/>Photo ID: DSCN4684<br/>Photo taken by: Katelyn Almeter</p> <p>Notes: Concrete located waterward of the concrete bulkhead. Pier located in background.</p> |

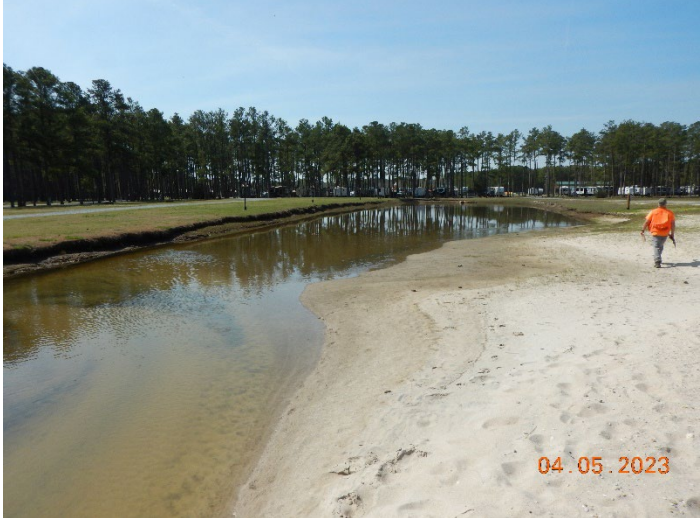
- Waterfront area, it appeared that there was new construction associated with the waterfront campsites located on the northeastern portion of the property. To the west, sparsely vegetated sand was observed on the northwestern portion of the Site.

| | <p>Sun Outdoors Chesapeake Bay<br/>Date: April 5, 2023<br/>Photo ID: DSCN4688<br/>Photo taken by: Katelyn Almeter</p> <p>Notes: View of northwestern portion of the Site. Note sparsely vegetated sand, which appears to have been recently placed.</p> |

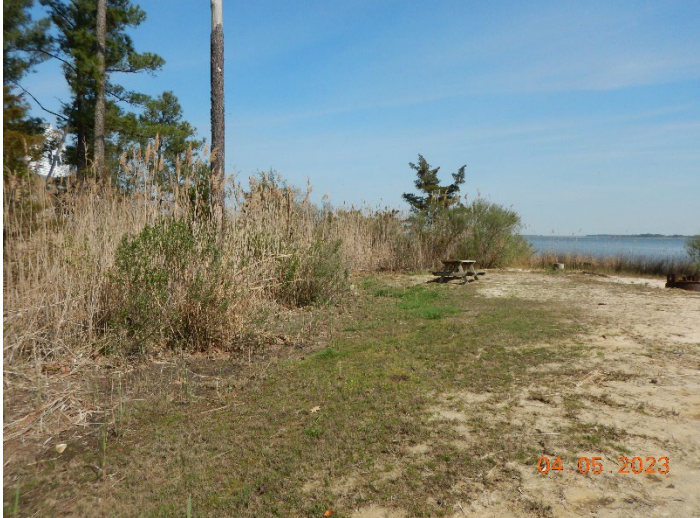
| A photograph showing a grassy area with tall reeds in the foreground and a body of water in the background. The date stamp '04.05.2023' is visible in the bottom right corner. | <p>Sun Outdoors Chesapeake Bay<br/>Date: April 5, 2023<br/>Photo ID: DSCN4691<br/>Photo taken by: Katelyn Almeter</p> <p>Notes: Northwestern boundary of the Site dominated by common reed (<i>Phragmites australis</i>).</p> |
