# NPDES Compliance Inspection Report

## Hill AeroSystems

**NPDES Permit Tracking Number  
# WAR126743**

**Inspection Date: 05/12/2023**

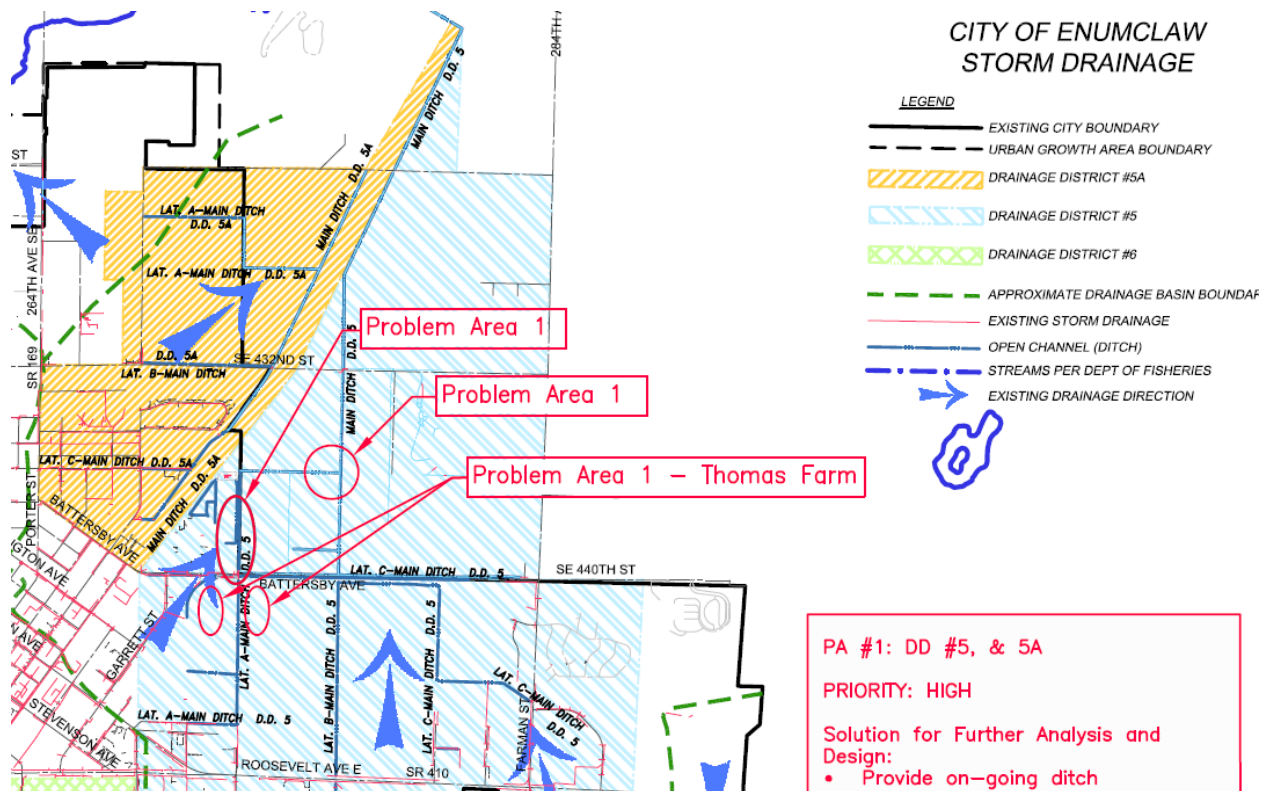
Figure 3: Image from pdf pg. 164 of city's Comprehensive Stormwater Plan. Stormwater from the Facility flows east and north, then north through Drainage District 5 to the Newaukum Creek.

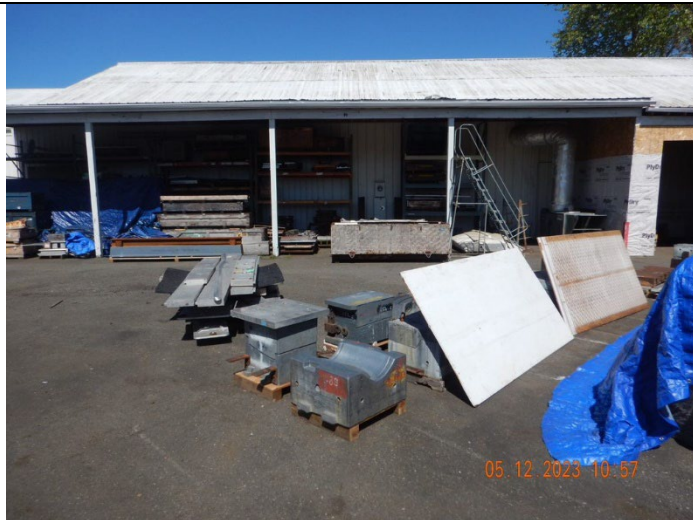
Photo: #17 (DSC0599.JPG)

We moved south, between the two buildings and saw what appeared to be the box trailer portion of a box-type truck on the ground. We looked inside and saw three 55-gallon drums, an approximately 200-gallon tank, seven 5-gallon pails, and many smaller containers holding a variety of oils (**Photo 16**). We noted one of the larger containers sat on a spill pallet with plywood covering the grating of the pallet and possibly rendering it an insufficient containment device. We also observed a spill kit in the rear of the trailer, and a large pile of used absorbent pads on the floor next to the trailer. Outside the trailer we saw more large tooling pieces stored outside without cover (**Photo 17**). Mr. Thornton indicated the Facility also sought to dispose of this equipment.

Description: Facing northwest, additional outside machining supply storage.

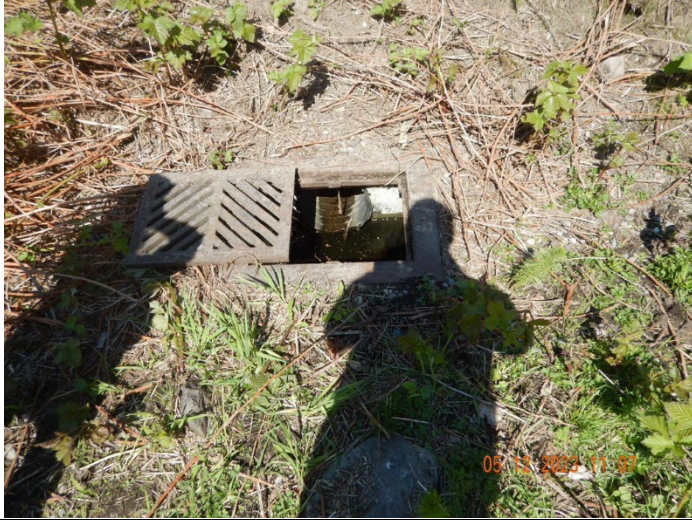
Photo: #19 (DSC0601.JPG)

Description: Additional catch basin to the northeast of the main outfall, just northwest of the second building.
