## Region 6 Compliance Assurance and Enforcement Division

### INSPECTION REPORT

| Company Name: | <b>ANGUS Chemical Company</b> | | |
| Facility Name: | <b>Sterlington Plant</b> | | |

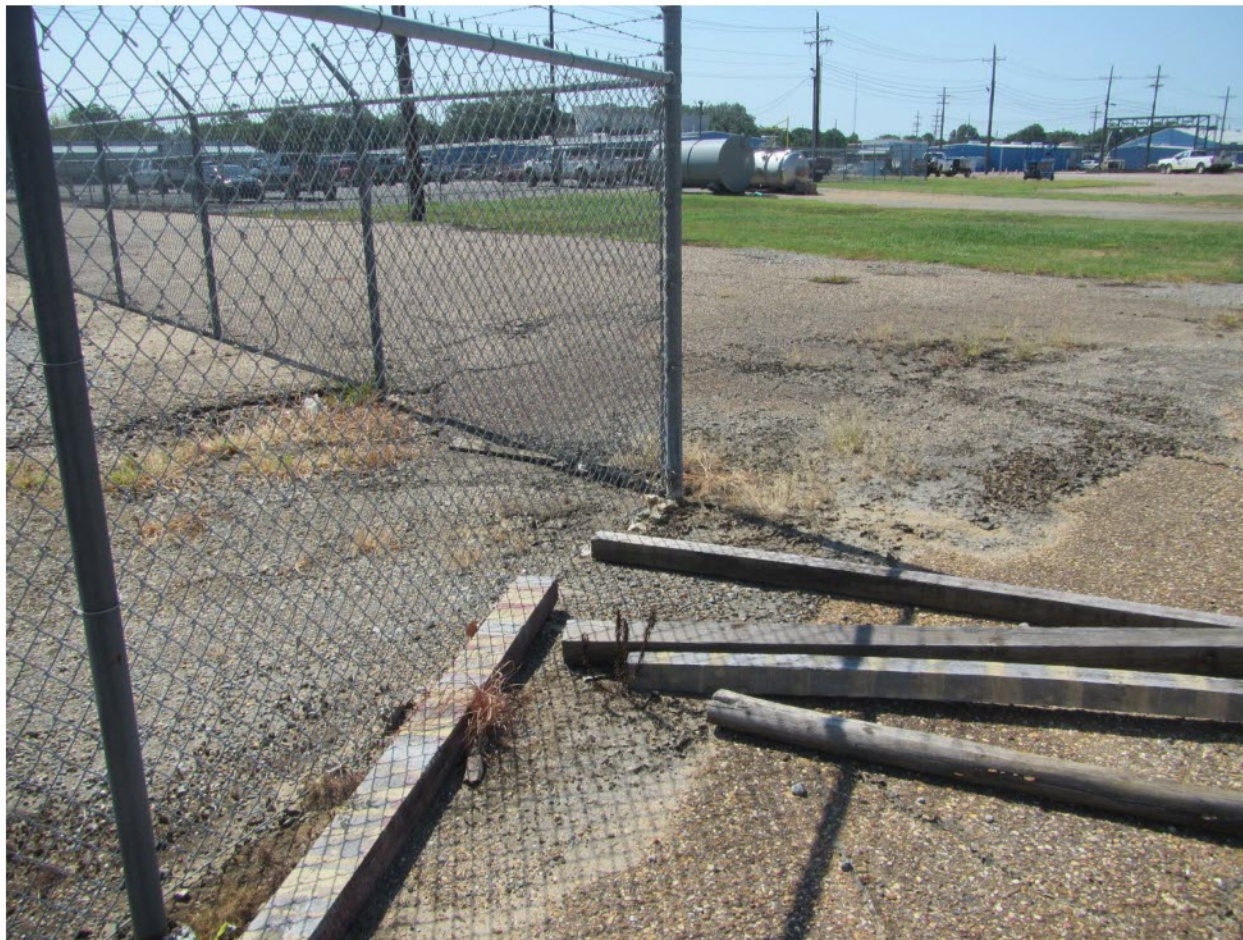
Photograph File Name: IMG\_4983.JPG  
Date of Photograph: 08/03/2023  
Latitude and Longitude: -92.080203°, 32.694191°  
Orientation: N  
Map Datum: WGS-84  
Time of Photo: 10:00 AM  
Photographer: Jack Arias  
Description: This image shows boilers 6 and 7.
