## Region 6 Compliance Assurance and Enforcement Division

### INSPECTION REPORT

| Company Name: | Jamie Oil Inc. | | |
| Facility Name: | Ezzell B-2 | | |

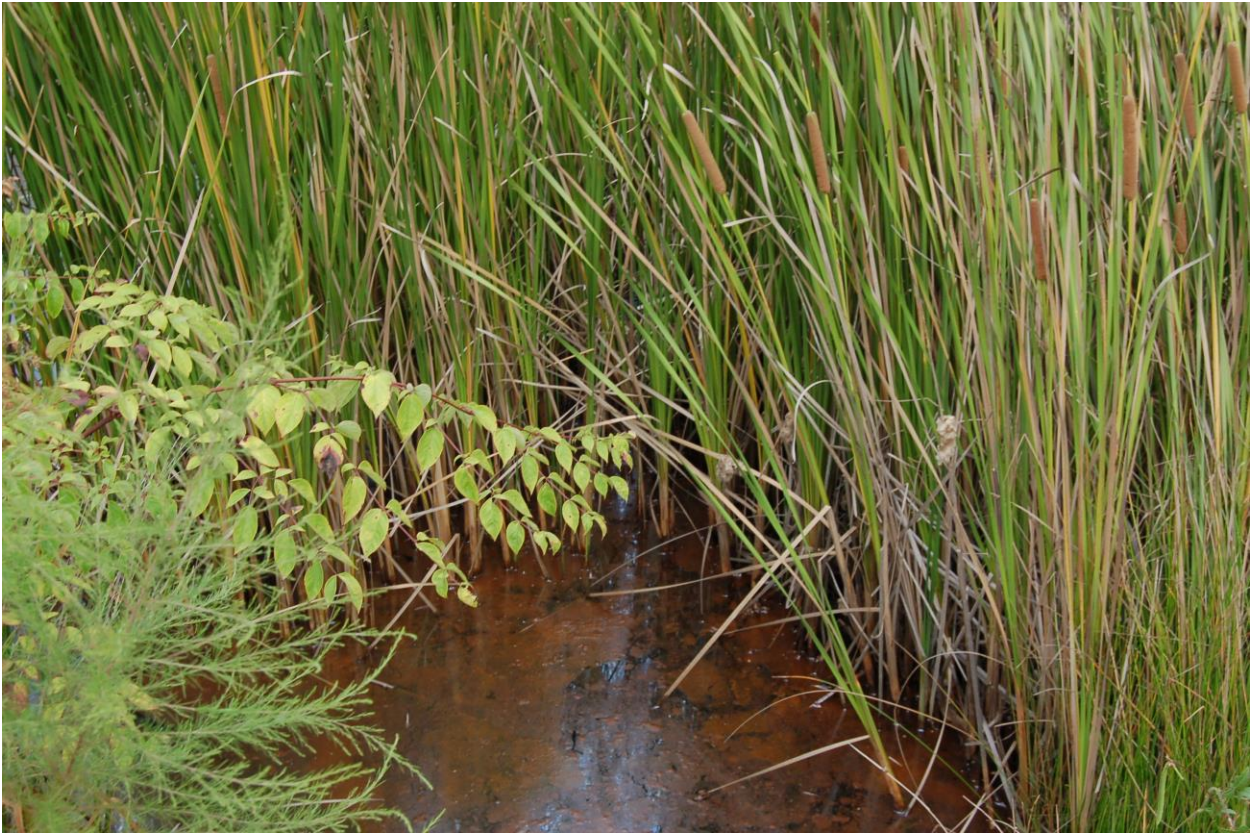
Photo File Name: Photo 16 taken north

I arrived at the facility on September 15, 2015, and noticed that brine and oil had been discharged from the secondary containment area. The facility is located at the Ezzell B-2 battery site located near El Dorado, Arkansas. Photo 1 shows the sign identifying the lease. Photo 2 is a general overview of the main battery associated with the discharge. Photos 3 and 4 show the brine facility near the main battery where the discharge occurred. Photos 5 and 6 show the drain pipe and valve used to discharge brine and oil into the nearby creek. Photo 7 shows a YSI meter reading of >80,000 parts per million Total Soluble Salts (TSS) at the discharge point. Photo 8 shows the discharge path which eventually runs into a small oil stained ditch shown in both Photos 9 and 10. Photo 11 shows the point of entry of the ditch into the creek and marsh. Photos 12, 13, and 14 show more oil and brine in the creek and marsh. Photo 15 shows a YSI meter reading of 9600 ppm TSS in the creek even after several rainfall events. Photo 16 shows the unaffected upstream portion of the creek which has a TSS of 700 ppm (Photo 17).
