Re: EPA Inspection Report – Michigan Sugar Company Piling Grounds

**CLEAN WATER ACT COMPLIANCE EVALUATION INSPECTION REPORT
U.S. ENVIRONMENTAL PROTECTION AGENCY, REGION 5**

Facilities: Michigan Sugar Company – Piling Grounds of Albee, Blumfield, Breckenridge, Au Gres and Hope/Midland

Date of Inspection: March 23, 2022

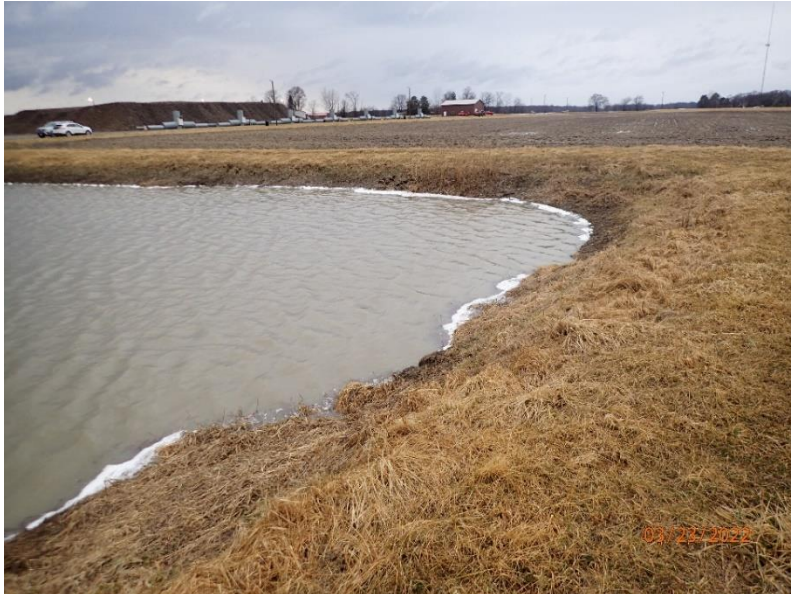
1: P3230078

Description: The pond at the Albee Piling Ground. The pipe from the piling ground is under water.

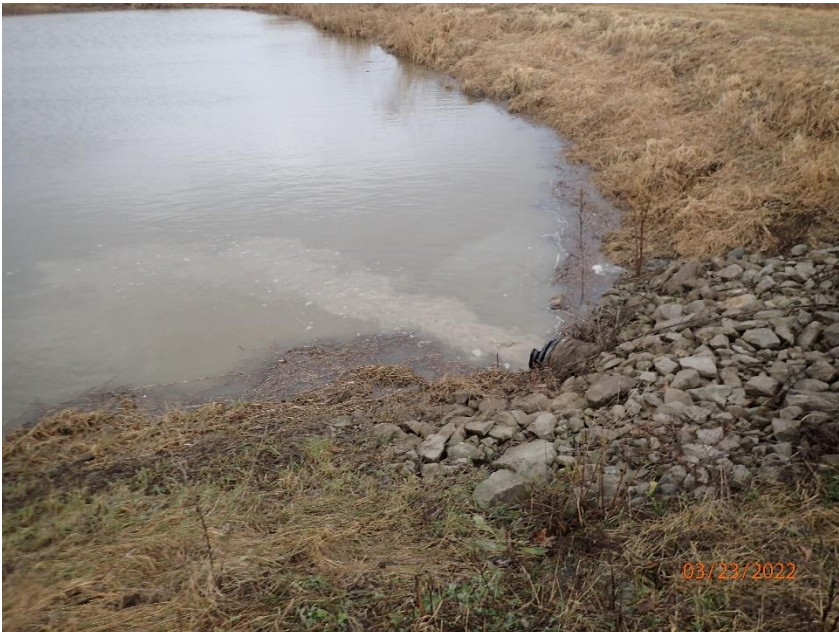
8: P3230085

Description: Note the plume into the pond from the pipe from the piling ground.

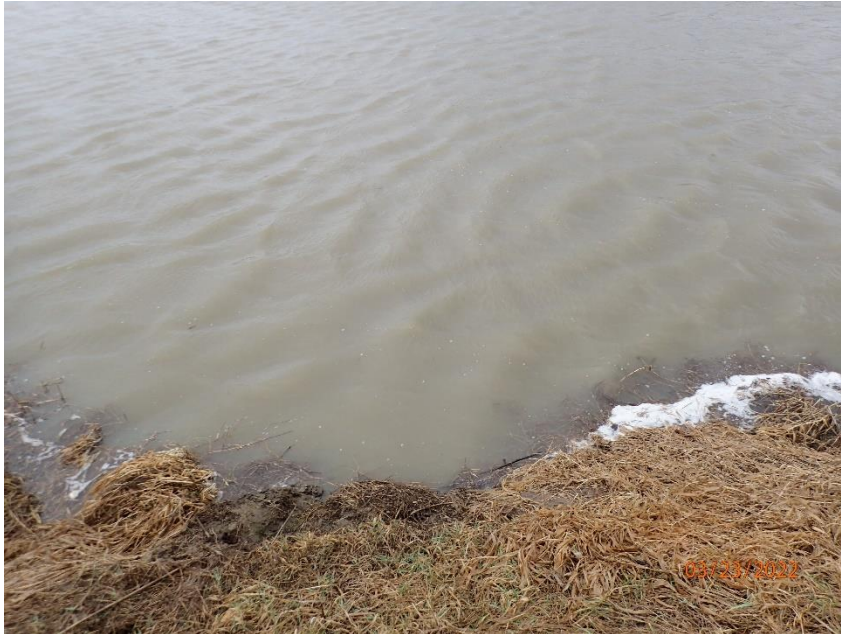
8: P3230092

Description: A sample was taken from this location in the Albee pond. Sample was named "Albee Pond" and was taken at 8:42 A.M.

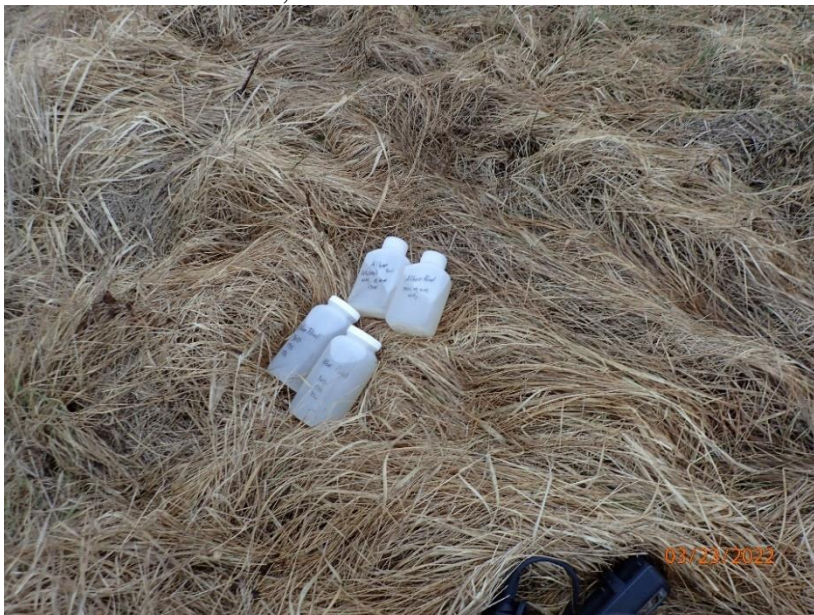
9: P3230093

Description: Sample named “Albee Pond” was taken from the pond at the Albee Piling Ground at 8:42 A.M. The dissolved oxygen (DO) at the pipe to the pond was 38.6% and the DO in the pond was 14.8%

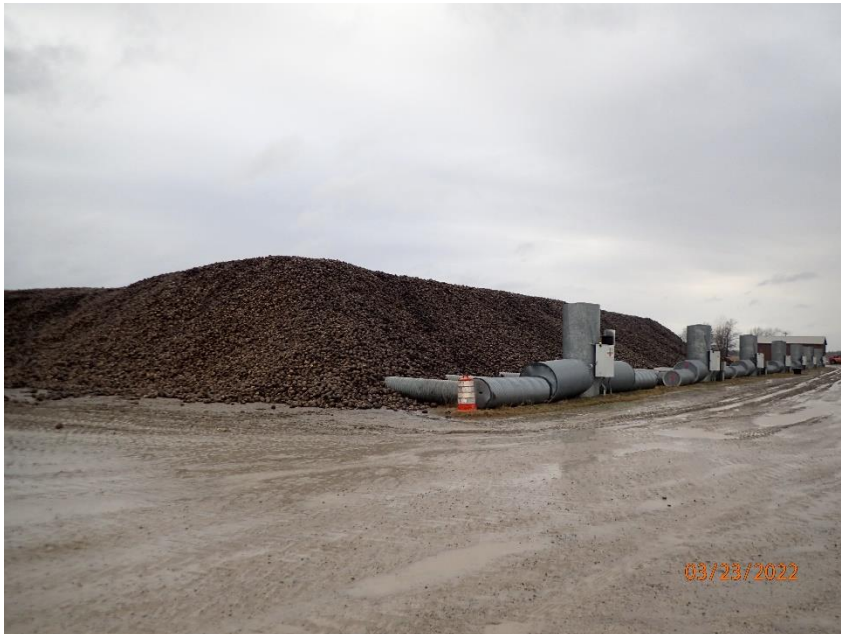
18: P3230095

Description: Sugar beets were still present at the Albee Piling Ground on the day of the inspection.

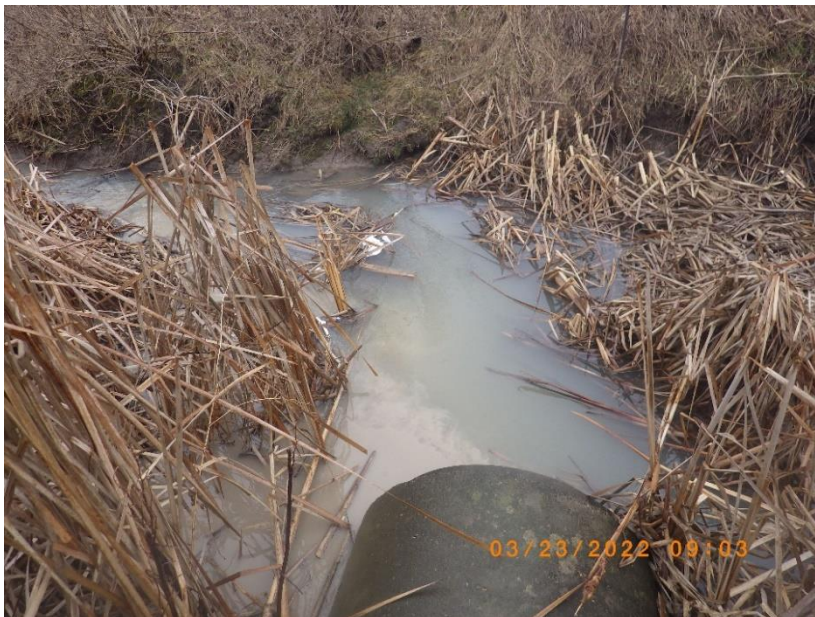
25: RIMG2487

Description: Pipe discharging runoff from the Blumfield East piling ground into an unnamed tributary north of the piling ground.

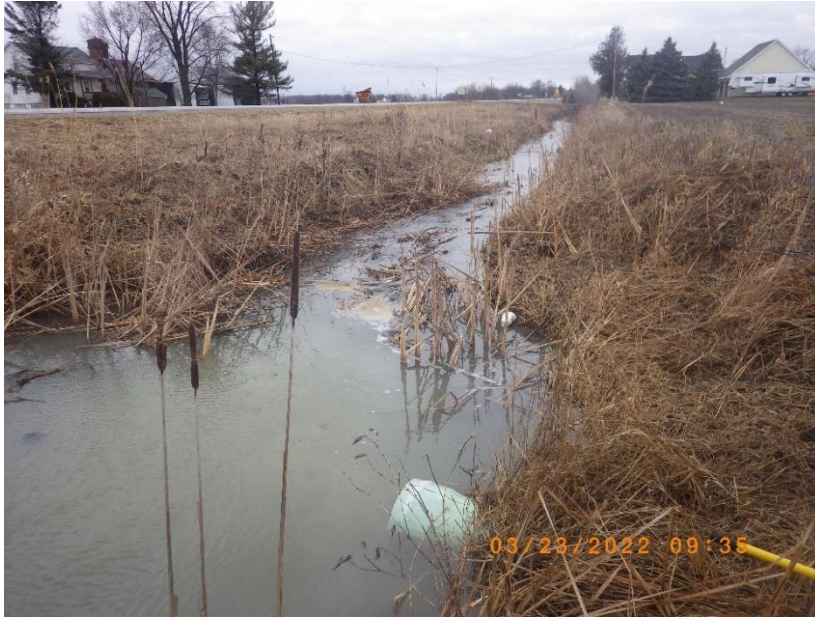
26: RIMG2488

Description: Pipe discharging into the North Gera Road ditch from the pond at Blumfield East. Pipe was partially under water at the time of inspection.

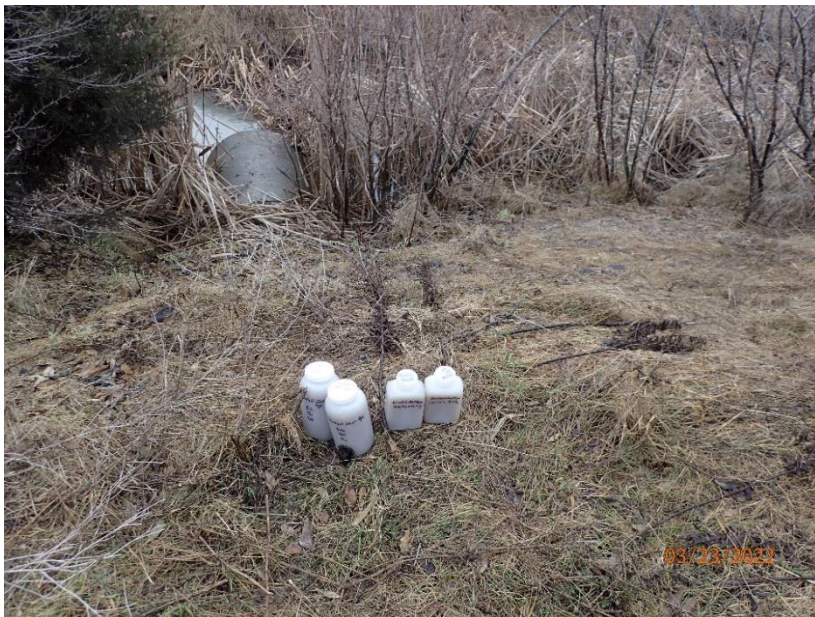
16: P3230102

Description: EPA took sample named "Blumfield East Pipe" from the pipe to the ditch on the north side of the site at 10:21 A.M. The DO level was 89.1%

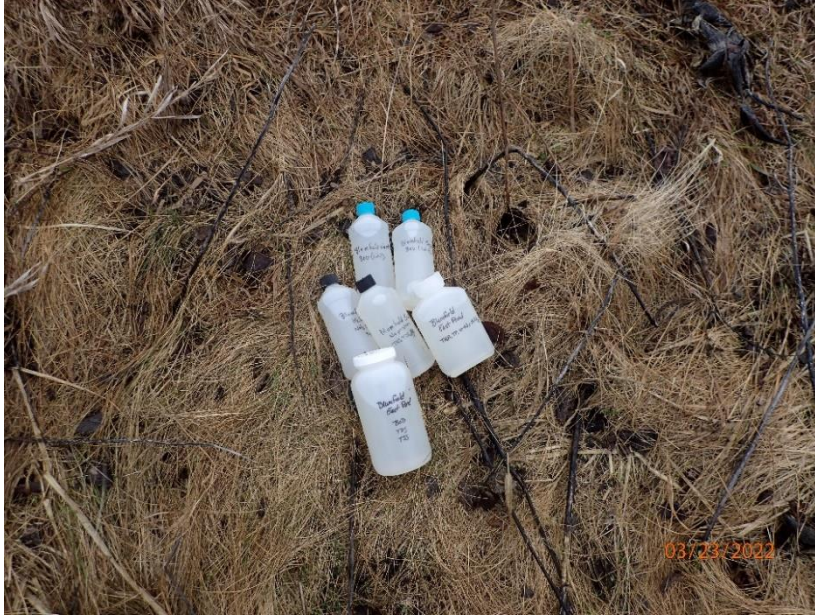
19: P3230109

Description: At 10:38 A.M., EPA took sample named “Blumfield East Pond” from the pond at the Blumfield East Piling Ground near the pond’s discharge pipe on the west side. The DO level was 65%

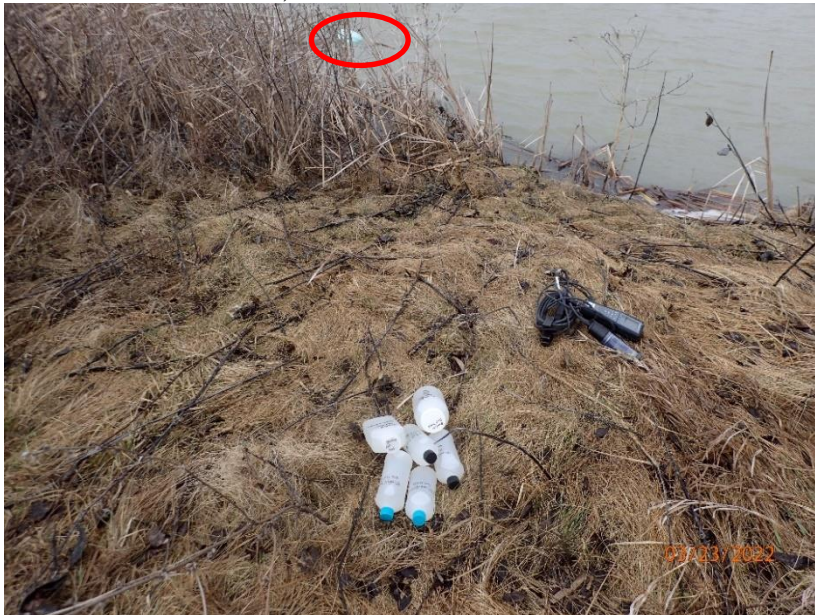
20: P3230110

Description: “Blumfield East Pond” samples. Red circle shows the location of the pipe in the pond that takes water from pond to the roadside ditch.

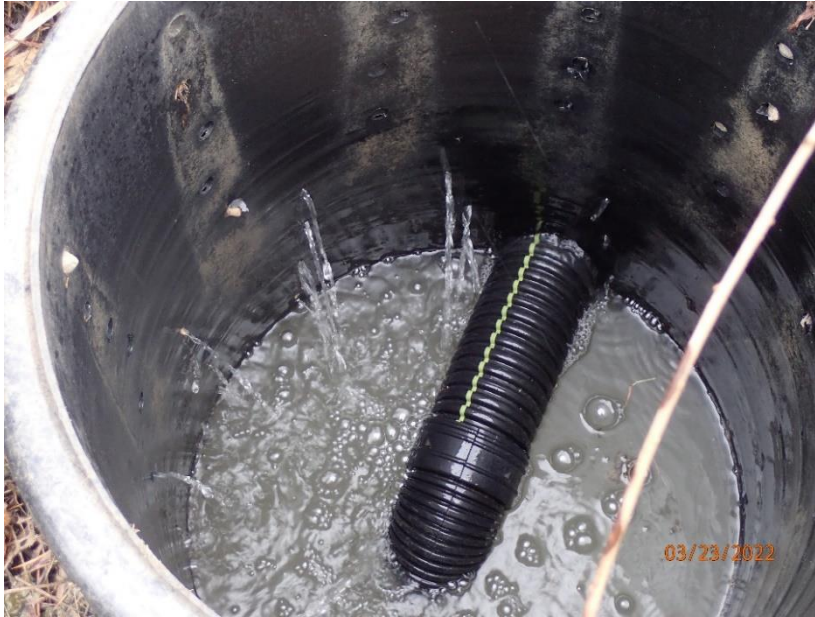
40: P3230113

Description: Water flowing into the catch basin on the west end of the Blumfield West Piling Ground.

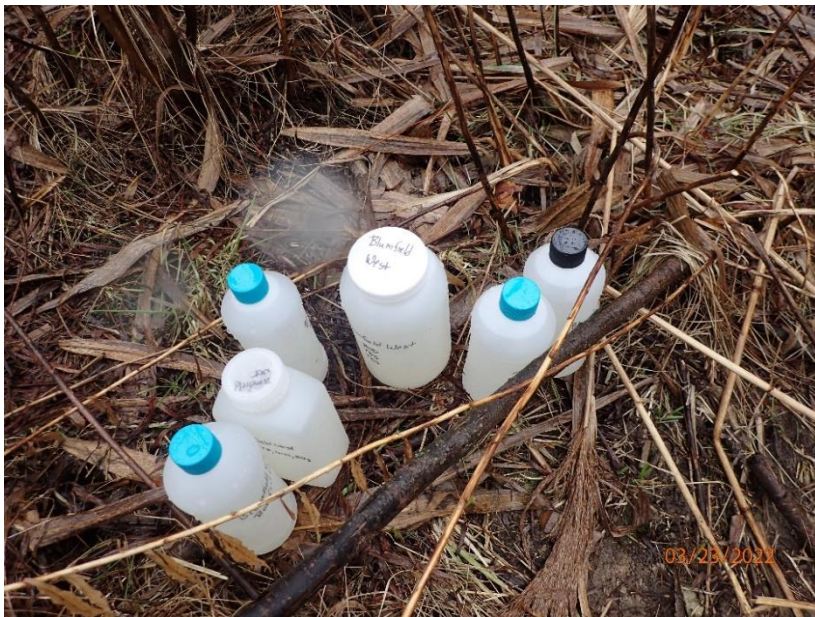
41: P3230114

Description: EPA took sample named "Blumfield West" from the discharge from a pipe on the west side of the berm on the west side of the Blumfield West Piling Ground.

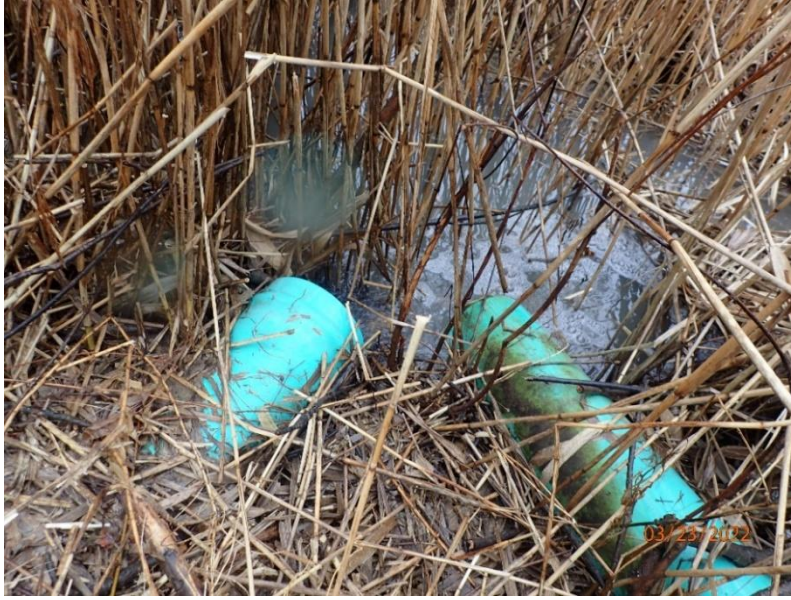
42: P3230115

Description: The pipe from the Blumfield West Piling Ground goes through a berm to the west and discharges to a ditch.

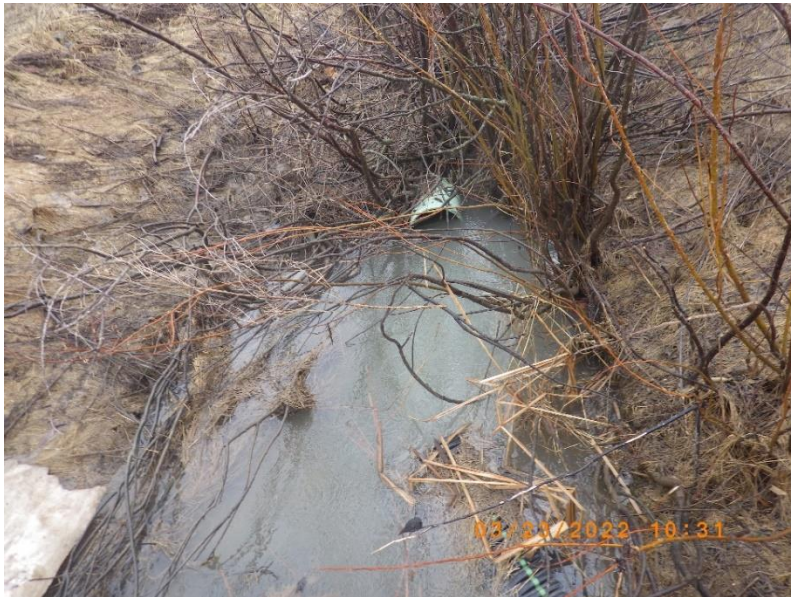
43: RIMG2495

EPA walked north along the ditch, from the discharge pipe at Blumfield West to where the ditch entered a pipe underground, approximately 1000 feet from the discharge point, as shown in photo 43. EPA walked further north to the start of another field ditch, approximately 1,700 feet from the discharge point, that flowed west. EPA did not observe any pipes flowing into this ditch from the direction of the piling ground.

Description: The unnamed tributary of Blumfield West, flows north and approximately 1000 feet, into a green PVC pipe.

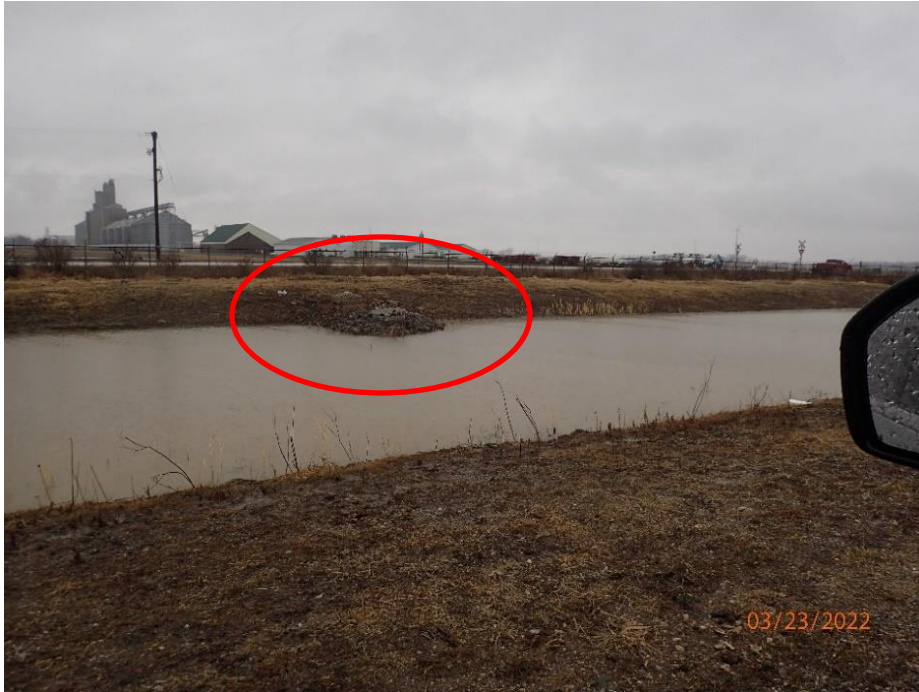
47: P3230116

Description: The outlet from the pond is beneath the first inlet pipe in the rock structure (circled with a red circle).

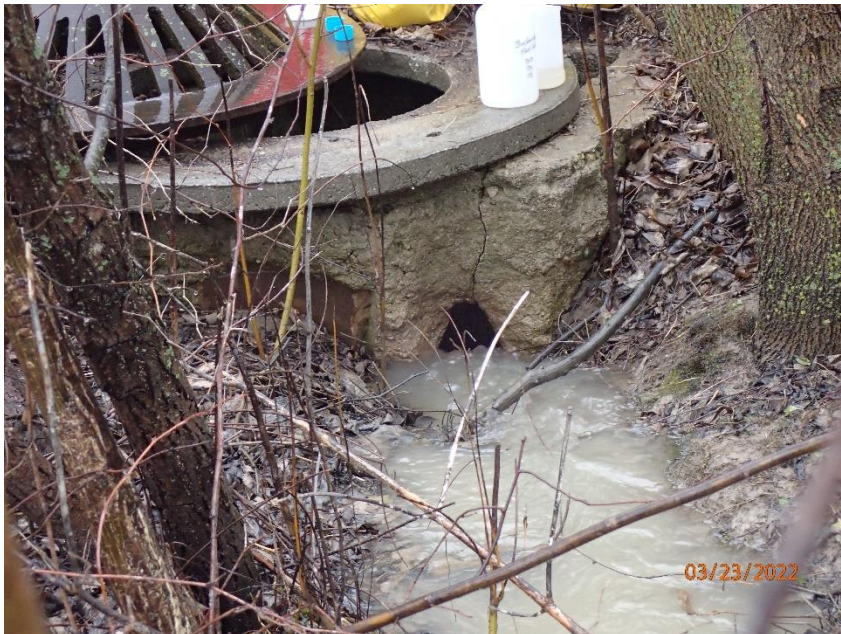
60: P3230128

Description: The flow goes into the side of the storm water structure.

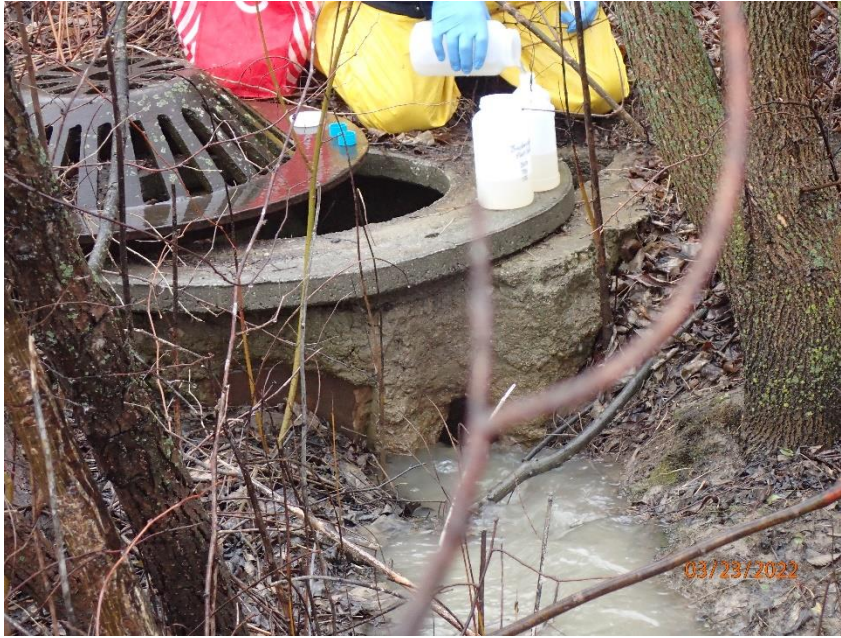
61: P3230129

Description: EPA took sample named “Breckenridge East/Monroe” from the flow into the storm water structure on the north side of the piling ground at 1:37 P.M..

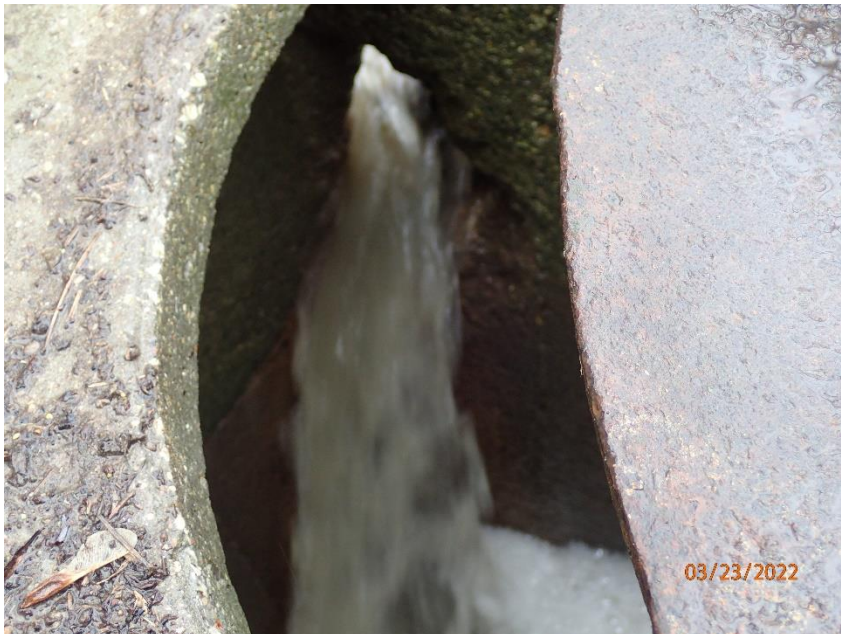
62: P3230130

Description: The flow into the storm water structure. The DO was 69%

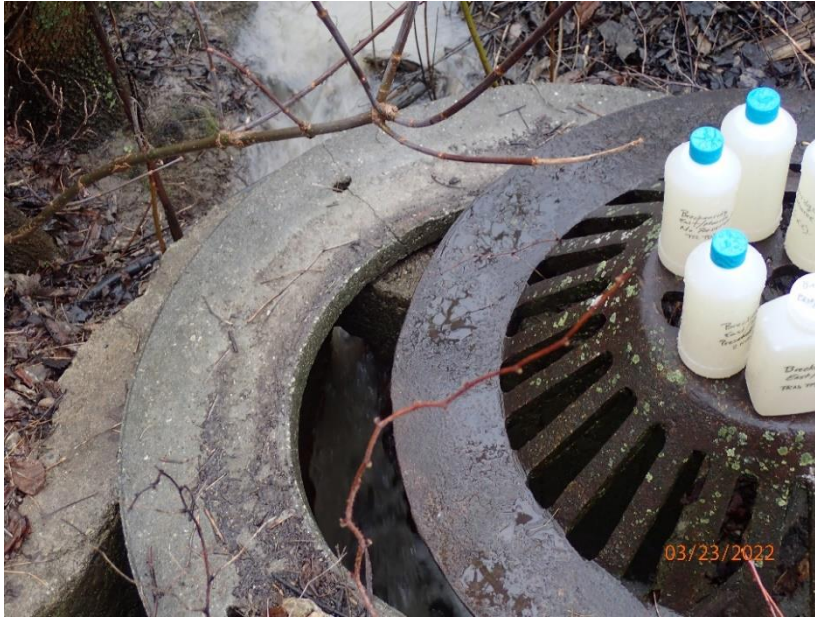
63: P3230131

Description: EPA took sample named “Breckenridge East/Monroe” from the flow into the storm water structure on the north side of the piling ground at 1:37 P.M.

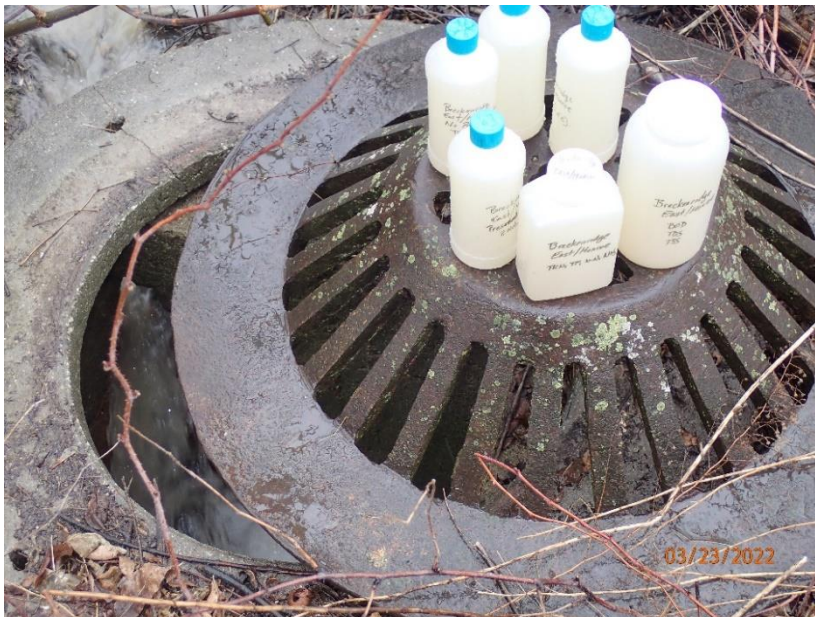
64: P3230132

Description: EPA took sample named “Breckenridge East/Monroe” from the flow into the storm water structure on the north side of the piling ground at 1:37 P.M.

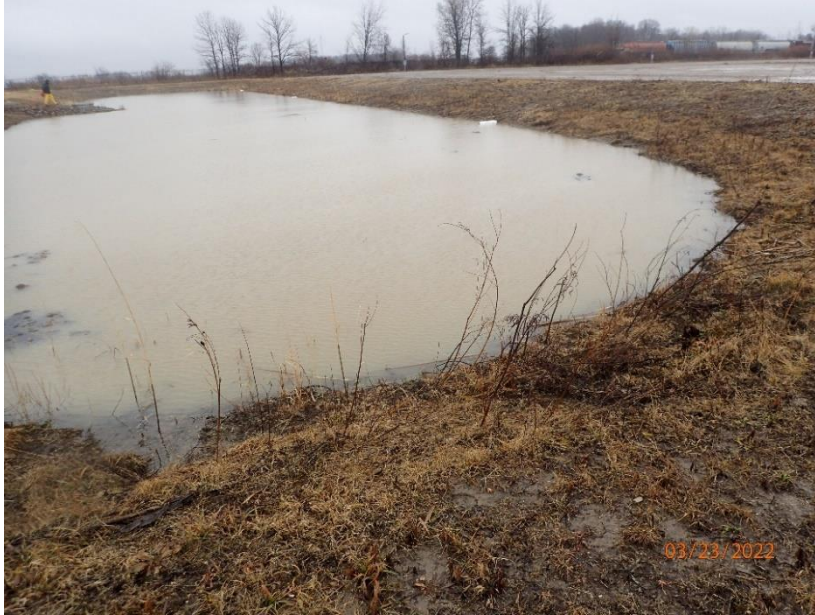
65: P3230133

Description: The stone outlet structure from the Breckenridge Piling Ground pond is on the left hand side of the photo.

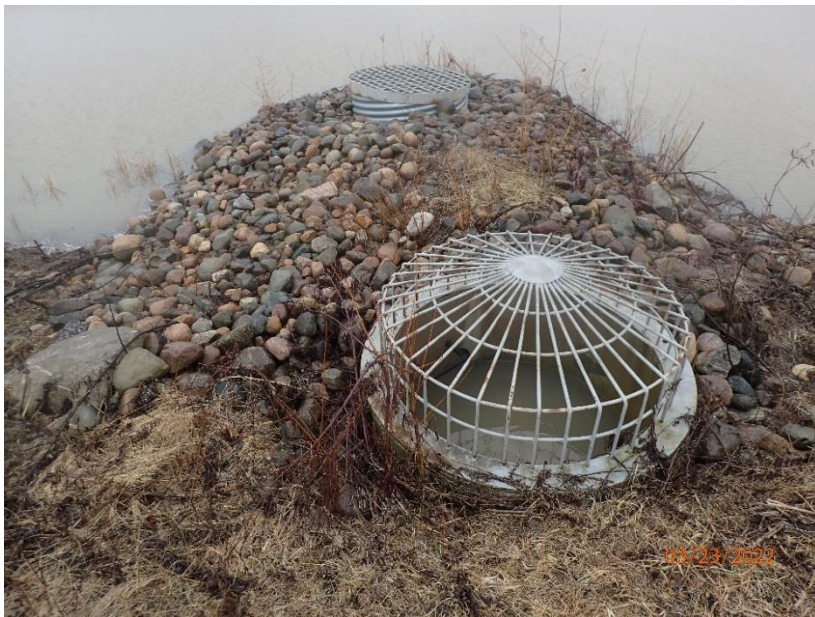
66: P3230134

Description: The stone outlet structure from the Breckenridge Piling Ground pond to the ditch along Ransom Road. The inlet pipe is in the inlet structure furthest from the camera.

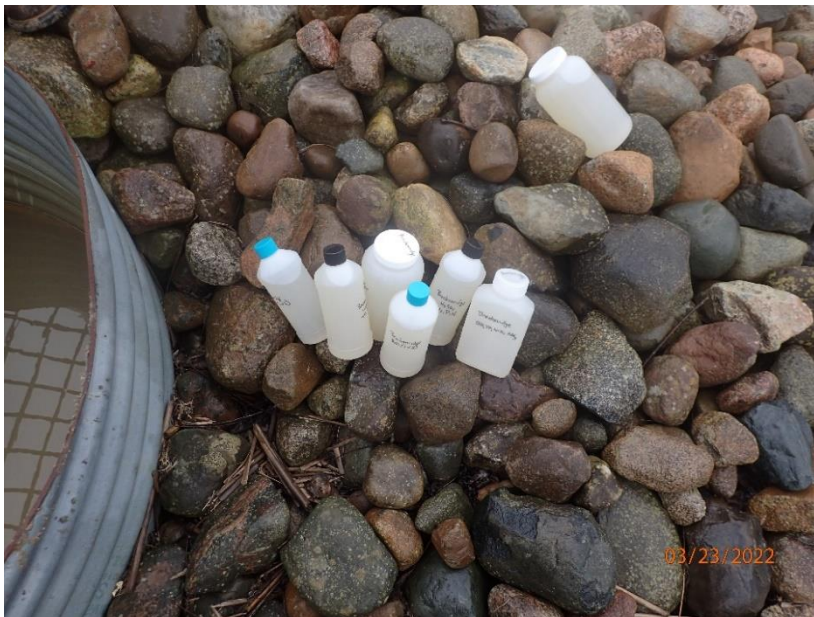
68: P3230136

Description: EPA took sample named "Breckenridge" from the inlet structure at 2:07 P.M.

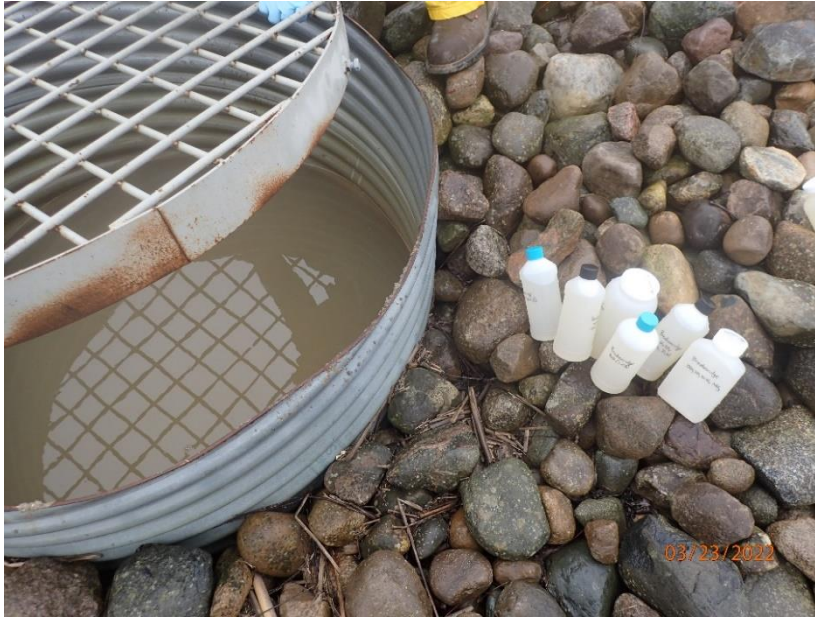
69: P3230137

Description: EPA took sample named "Breckenridge" from the inlet structure at 2:07 P.M.

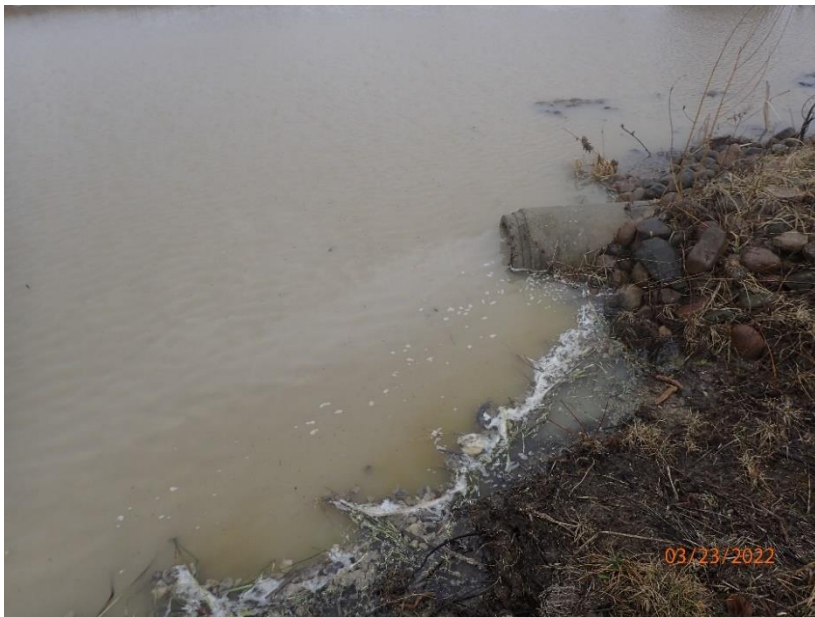
70: P3230138

Description: The inlet pipe to the Breckenridge Piling Ground pond from the piling ground. Note the plume from the pipe.

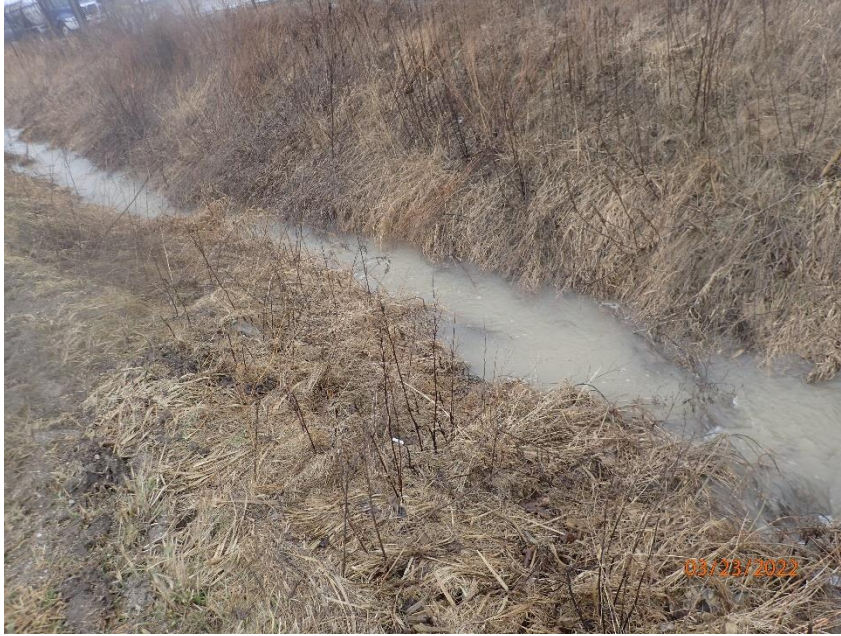
71: P3230139

Description: The flow pathway in the ditch on the east side of Ransom Road. Flow goes south.

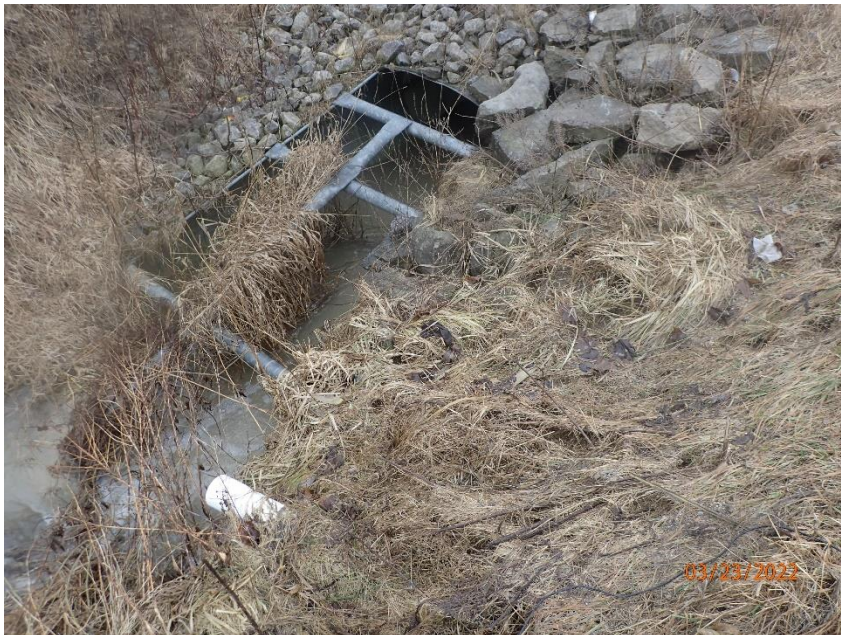
72: P3230140

Description: Flow along the east side of Ransom Road goes to a culvert under Monroe Road.

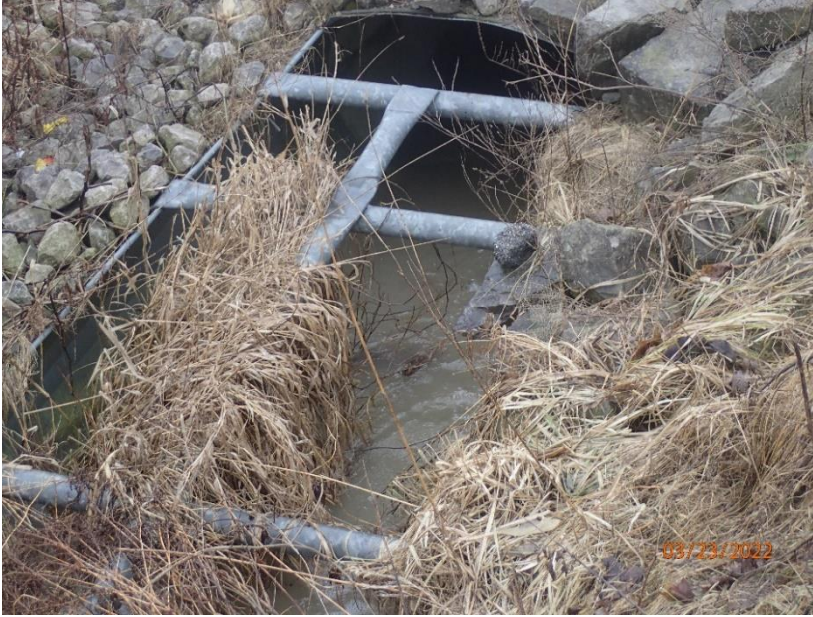
73: P3230141

Description: The flow in the ditch on the east side of Ransom road flows into a culvert under Monroe Road.

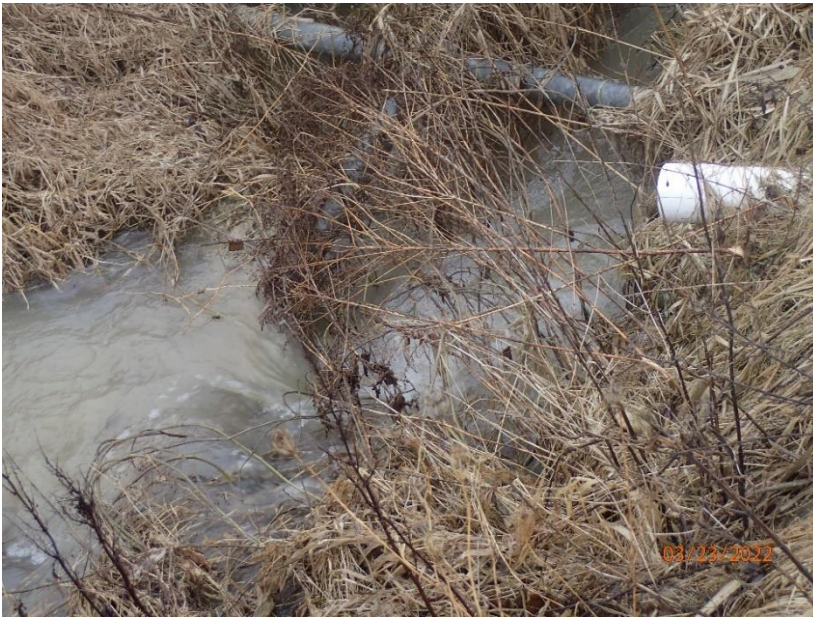
74: P3230142

Description: The flow in the ditch on the east side of Ransom road flows into a culvert under Monroe Road.

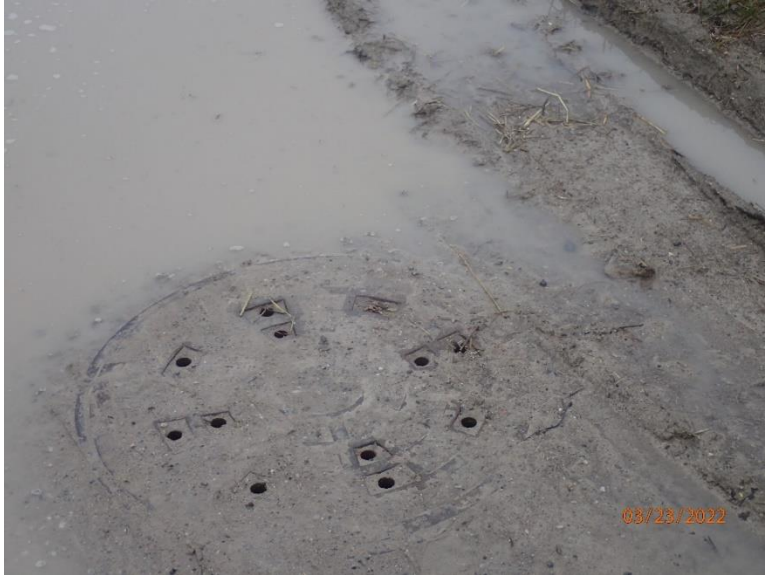
75: P3230143

Description: Manhole in the road is location of pipe under East Monroe Road.

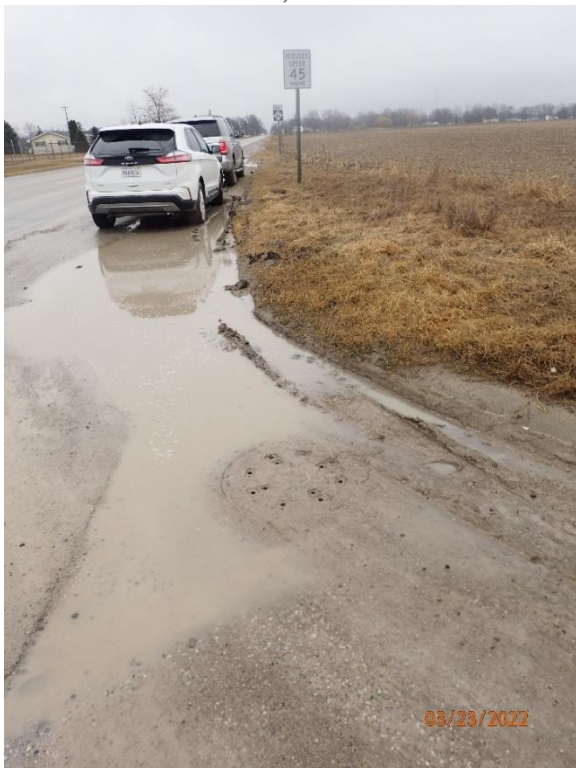
76: P3230144

Description: Manhole in the road is location of pipe under East Monroe Road.

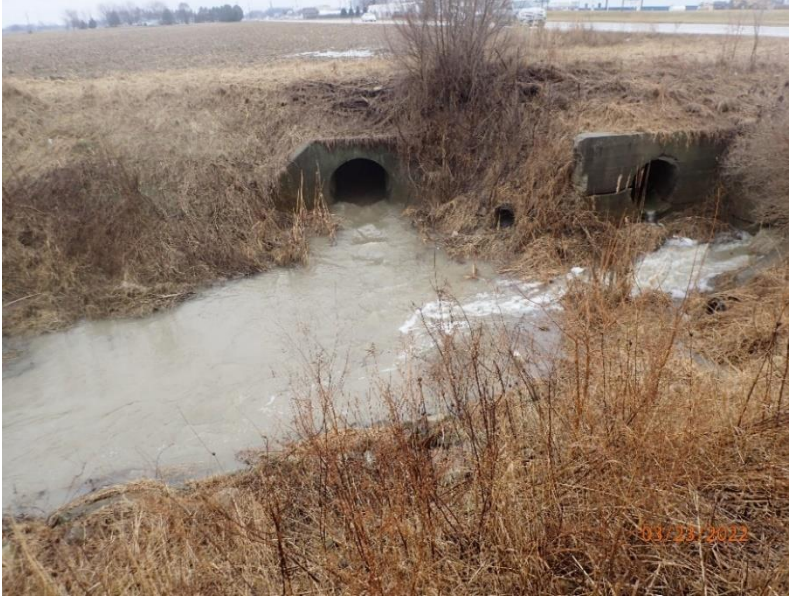
77: P3230145

Description: Flow enters a ditch on the south side of Monroe Road from three pipes. EPA believes that the one on the right is from the flow from the culvert at the corner of Ransom Road and Monroe Road.

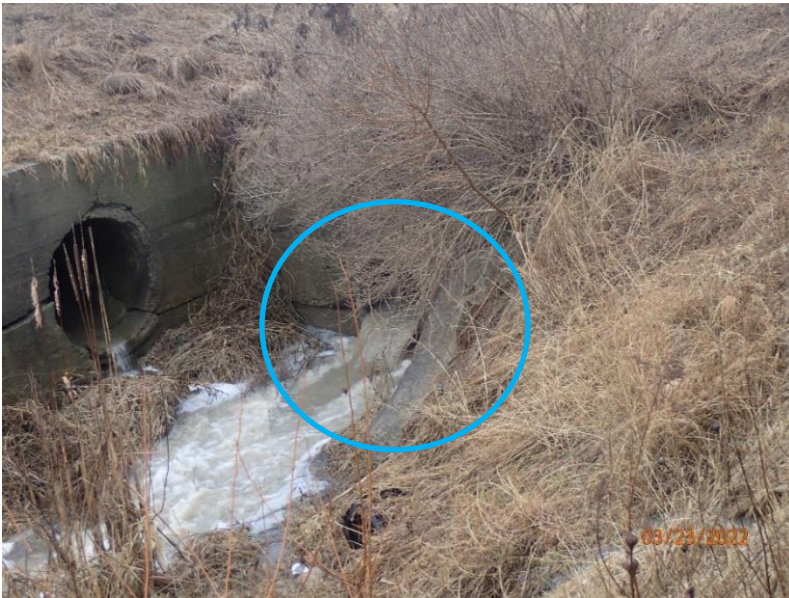
78: P3230146

Description: A third pipe (denoted with blue circle) is from the storm structure on the north side of the Breckenridge Piling Ground.

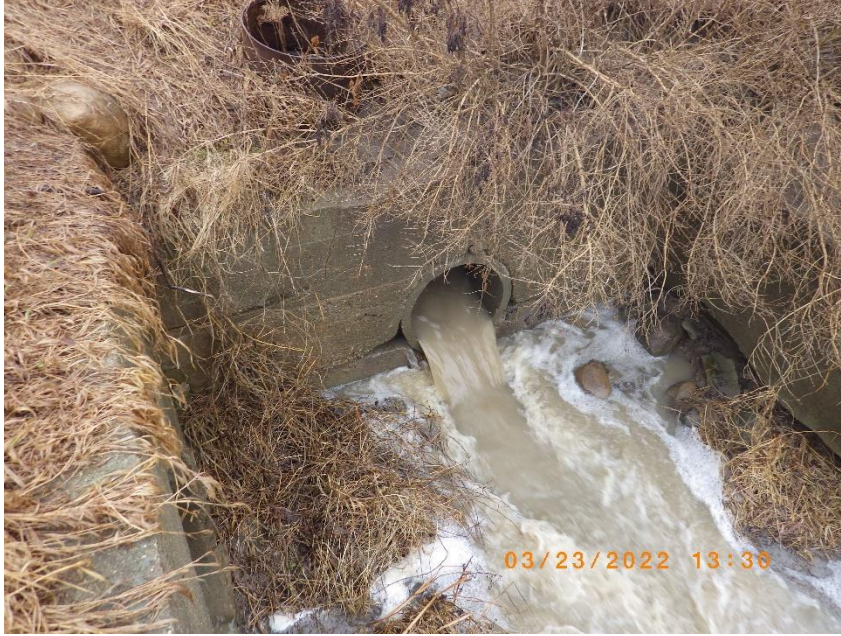
79: RIMG2506

Description: Discharge from the underground county drain that runs from north to south through the Breckenridge piling ground. It discharges into the unnamed tributary south of East Monroe road.

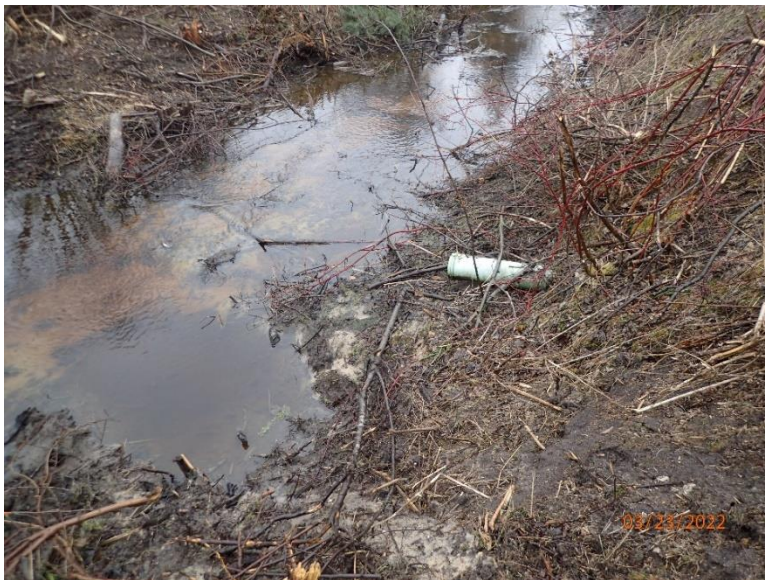
80: P3230147

EPA observed no flow from the pipe on the north side of the piling ground to the unnamed tributary of the Au Gres River.

Description: Pipe from the piling ground to a ditch on the north side of the Au Gres Piling Ground.

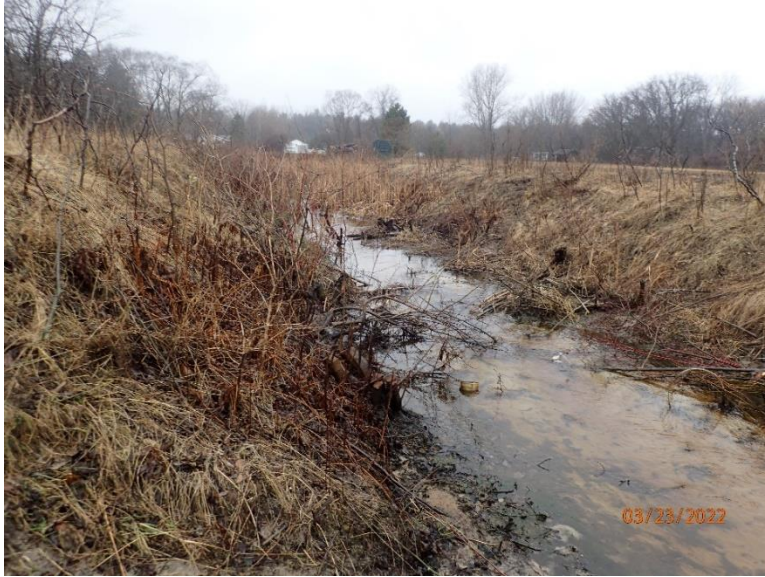
81: P3230148

Description: The ditch on the north side of the Au Gres Piling Ground.

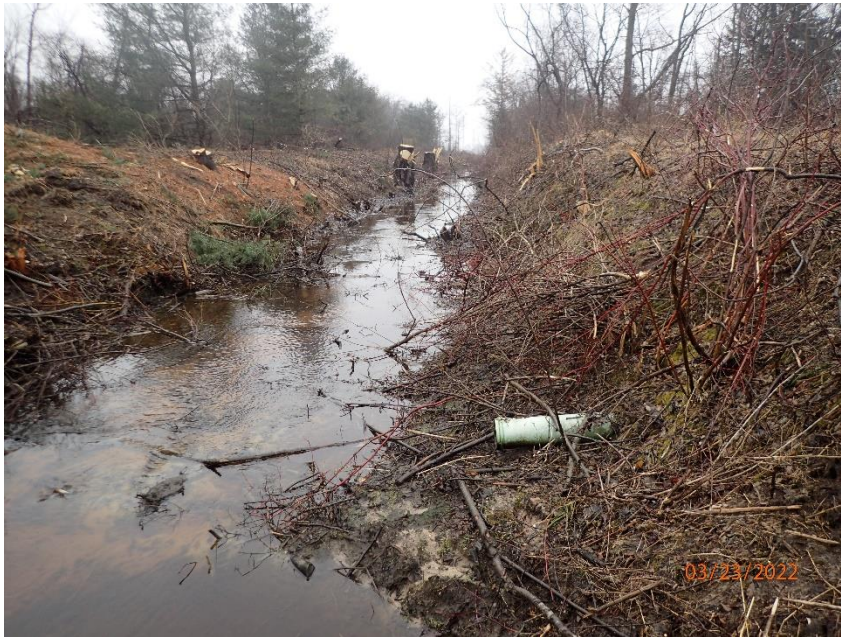
82: P3230149

Description: The ditch on the north side of the Au Gres Piling Ground.

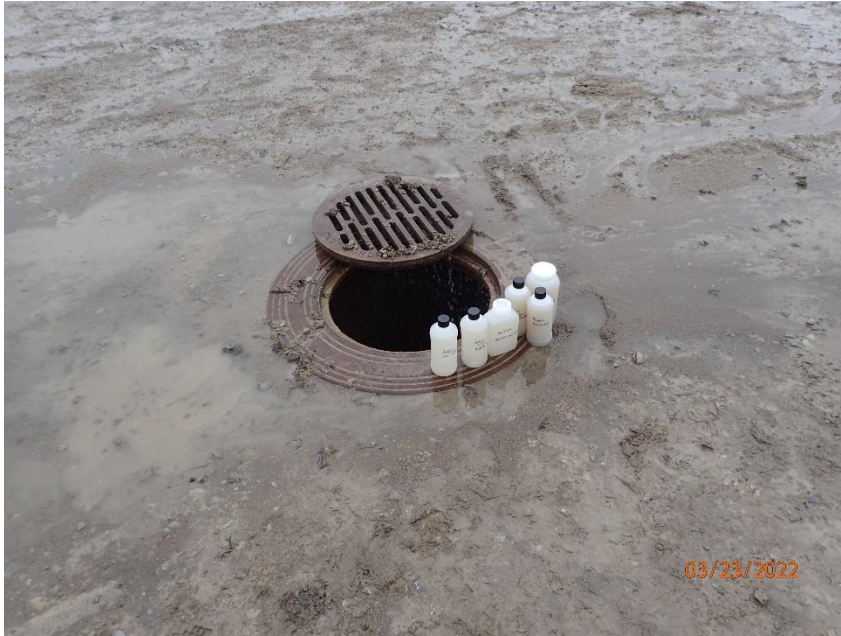
83: P3230150

Description: EPA took the sample named "Au Gres" from the southernmost manhole on the Au Gres Piling Ground at 4:29 P.M.

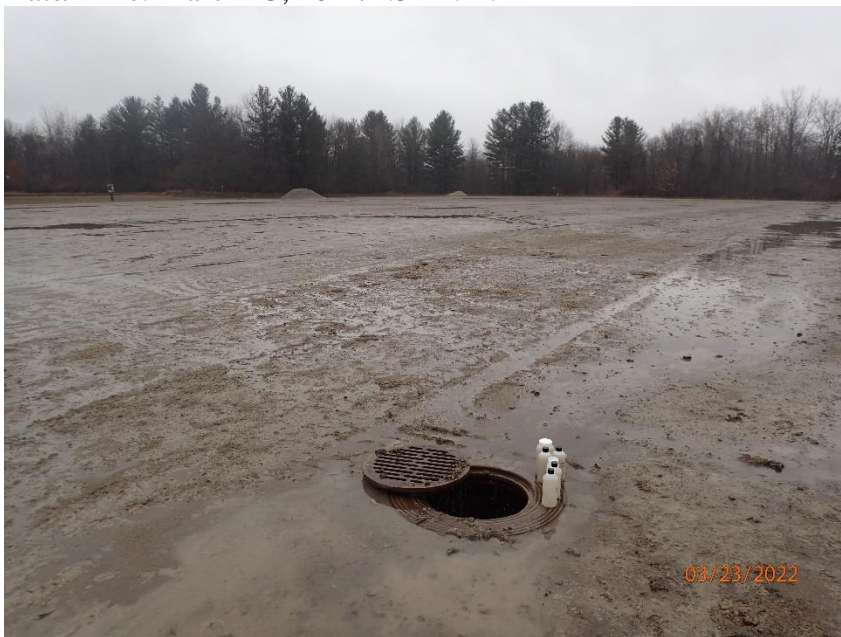
84: P3230151

Description: EPA took the sample named "Au Gres" from the southernmost manhole on the Au Gres Piling Ground at 4:29 P.M.

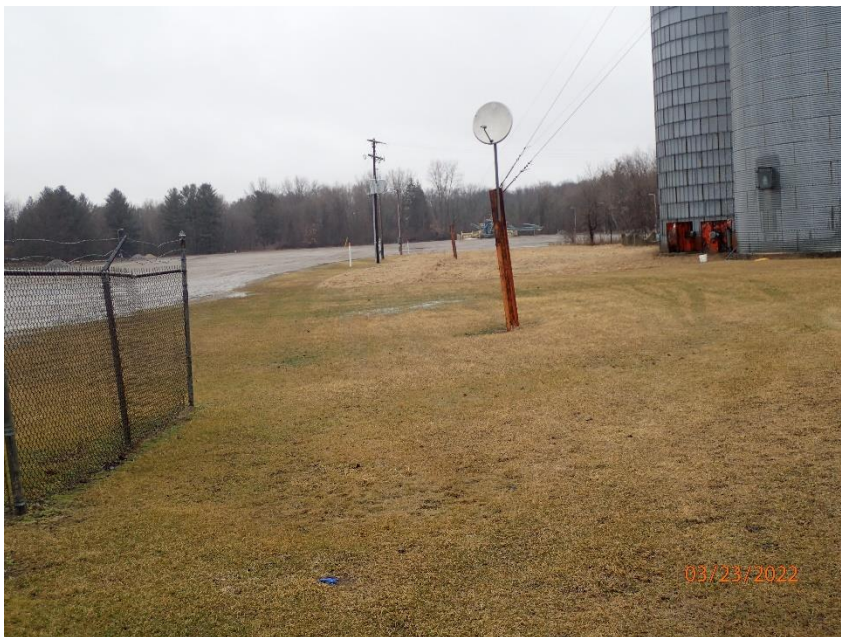
86: P3230153

Description: The direction of flow in the manholes is to the south and to storm sewers off site.

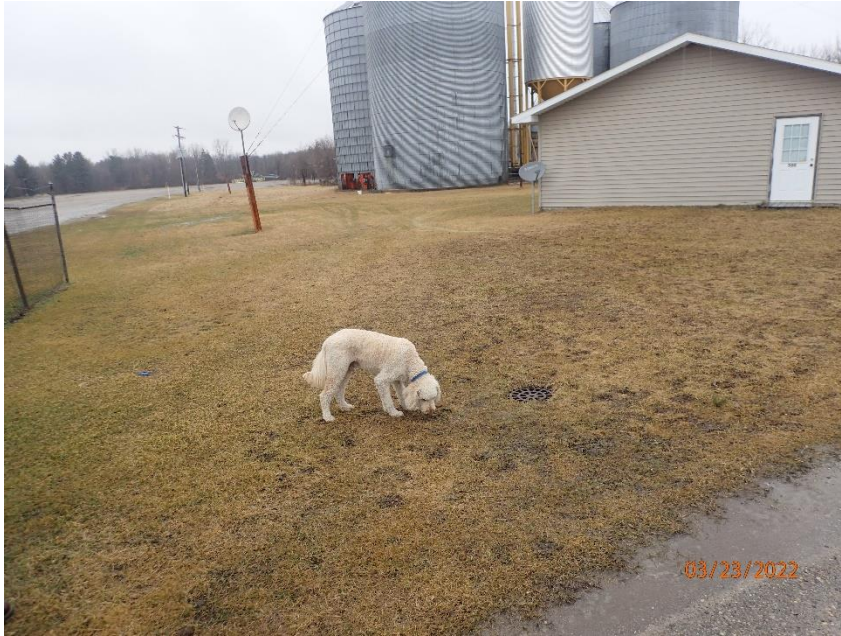
87: P3230154

Description: Storm sewer just to the southeast of the Au Gres Piling Ground.

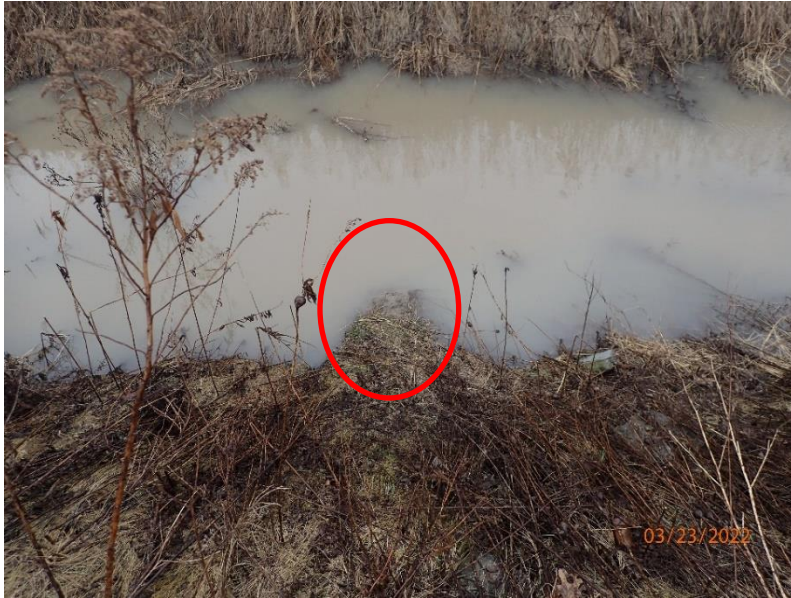
89: P3230156

The outlet pipe that conveyed water from the catch basins on site to Harris Drain where EPA took a sample from in April 2019, was under water at the time of this inspection (photos 89 and 90). EPA observed runoff flowing into a catch basin, approximately 200 feet west of the discharge pipe. EPA took sample “Hope/Midland” from inside the catch basin at 6:17 P.M. The sample was immediately preserved. The water in the catch basin flowed east towards Harris Drain.

Description: The receiving waterway for the flow from the Hope/Midland Piling Ground. Red circle indicates the location of the discharge pipe under water.
