Re: EPA Inspection Report – Michigan Sugar Company Piling Grounds

**CLEAN WATER ACT COMPLIANCE EVALUATION INSPECTION REPORT
U.S. ENVIRONMENTAL PROTECTION AGENCY, REGION 5**

Facilities: Michigan Sugar Company – Piling Grounds of Albee, Blumfield, Breckenridge, Au Gres and Hope/Midland

Date of Inspection: March 23, 2022

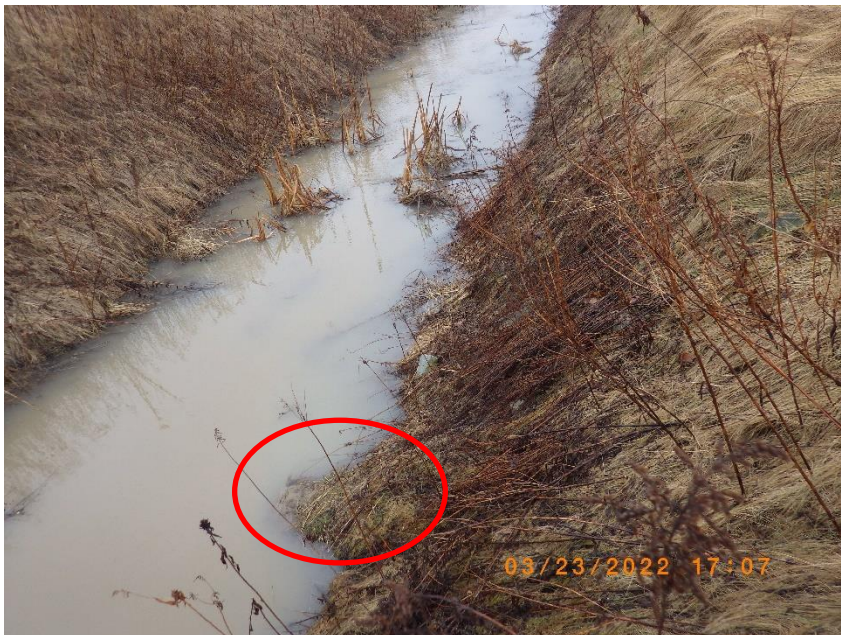
90: RIMG2513

The outlet pipe that conveyed water from the catch basins on site to Harris Drain where EPA took a sample from in April 2019, was under water at the time of this inspection (photos 89 and 90). EPA observed runoff flowing into a catch basin, approximately 200 feet west of the discharge pipe. EPA took sample “Hope/Midland” from inside the catch basin at 6:17 P.M. The sample was immediately preserved. The water in the catch basin flowed east towards Harris Drain.

Description: Discharge pipe at the Hope/Midland piling ground was under water. Red circle indicates the location of the pipe.

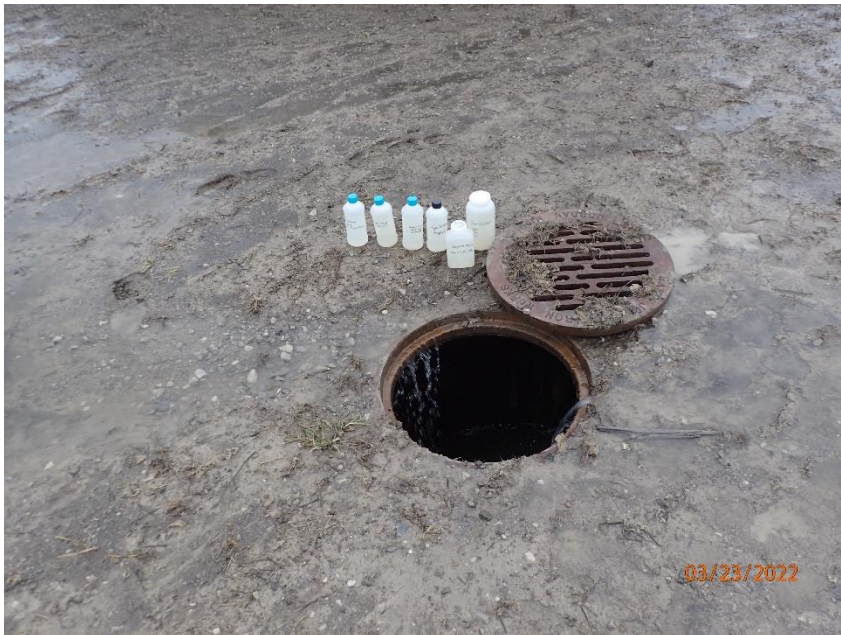
92: P3230158

Description: EPA took sample named "Hope/Midland" from the flow into a manhole on the south side of the site at 6:17 P.M. The DO level was 124%

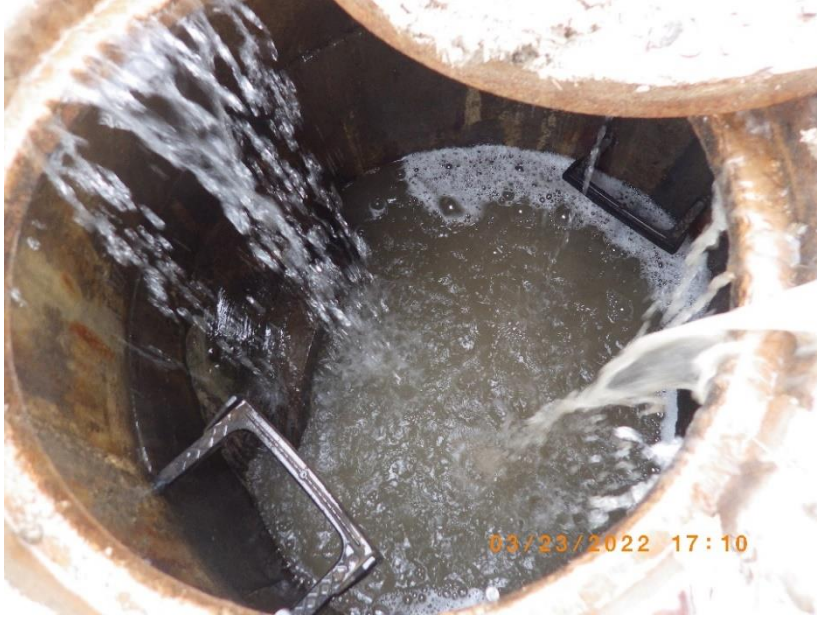
95: RIMG2515

Description: Catch basin at Hope/Midland piling ground that was receiving runoff and conveying it into the Harris Drain, east of the piling ground.
