**Region 6 - Enforcement & Compliance Assurance Division**  
**INSPECTION REPORT**

| Inspection Date(s): | 06/05/2023 | |
| Facility Name: | <b>Tri-County Regional Water Distribution District Public Water System</b> | |

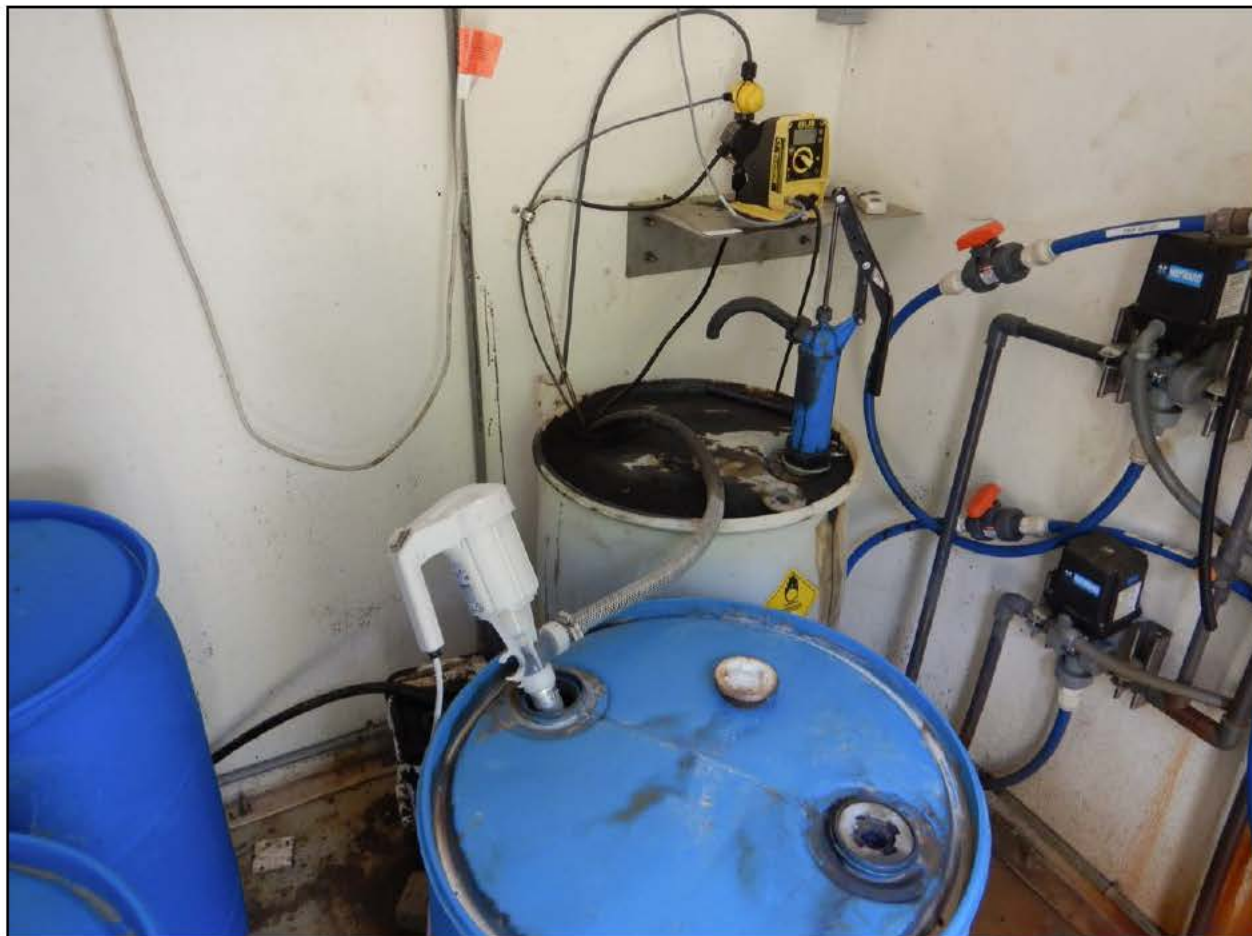
Photo No. 12

Photograph 12. Raw Water Chemical Feed Building, Hector WTP View of the inside of the raw water chemical feed building [REDACTED]

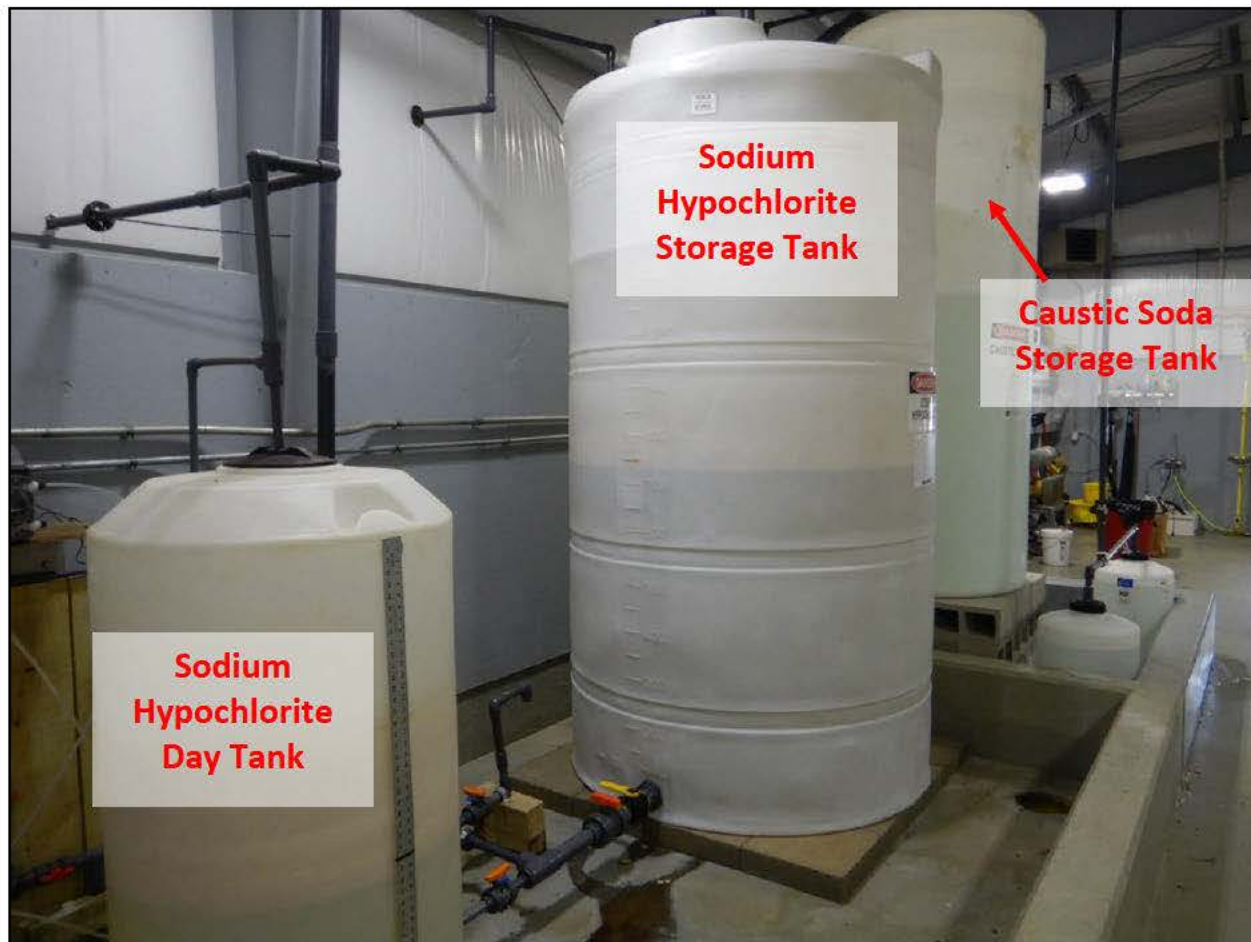
Photo No. 14

**Observation 16.** When the EPA Inspection Team arrived at the Hector WTP, there was no label on the coagulant tank (refer to [Appendix 2, Photograph 13](#)). WTP representatives stated that the tank was new, and the label had not been added yet. When WTP representatives became aware of this, a label was added. Additionally, the caustic soda tank was on cinderblocks, and therefore was elevated above the secondary containment wall that it was surrounded by (refer to [Appendix 2, Photograph 14](#)).

Photograph 14. Sodium Hypochlorite and Caustic Soda Storage Tanks, [REDACTED] View of the sodium hypochlorite and caustic soda storage tanks and the sodium hypochlorite day tank [REDACTED]

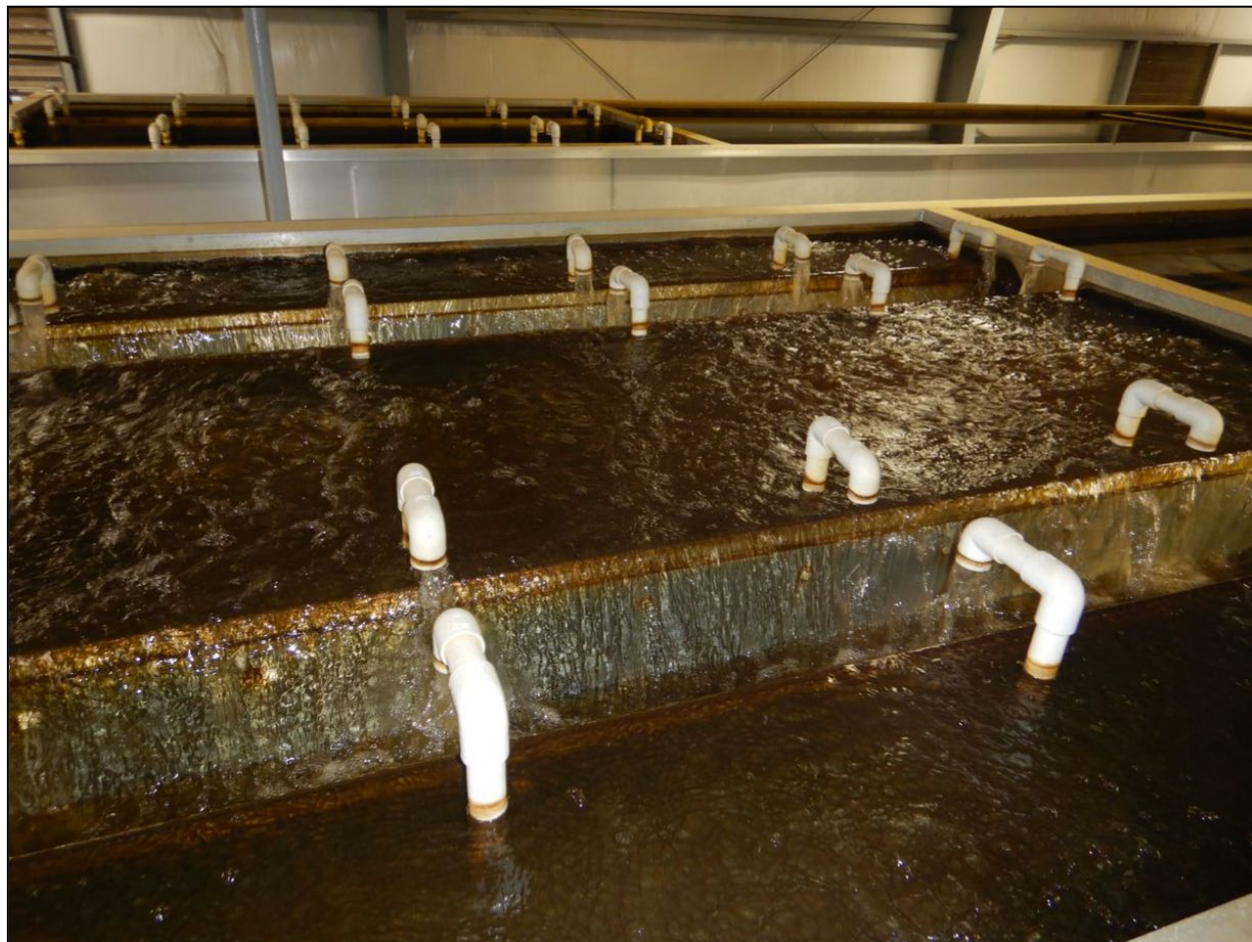
Photo No. 17

**Photograph 17. Filter Backwash, Hector WTP** View of the air scour that took place during the filter backwash in treatment Train #2.

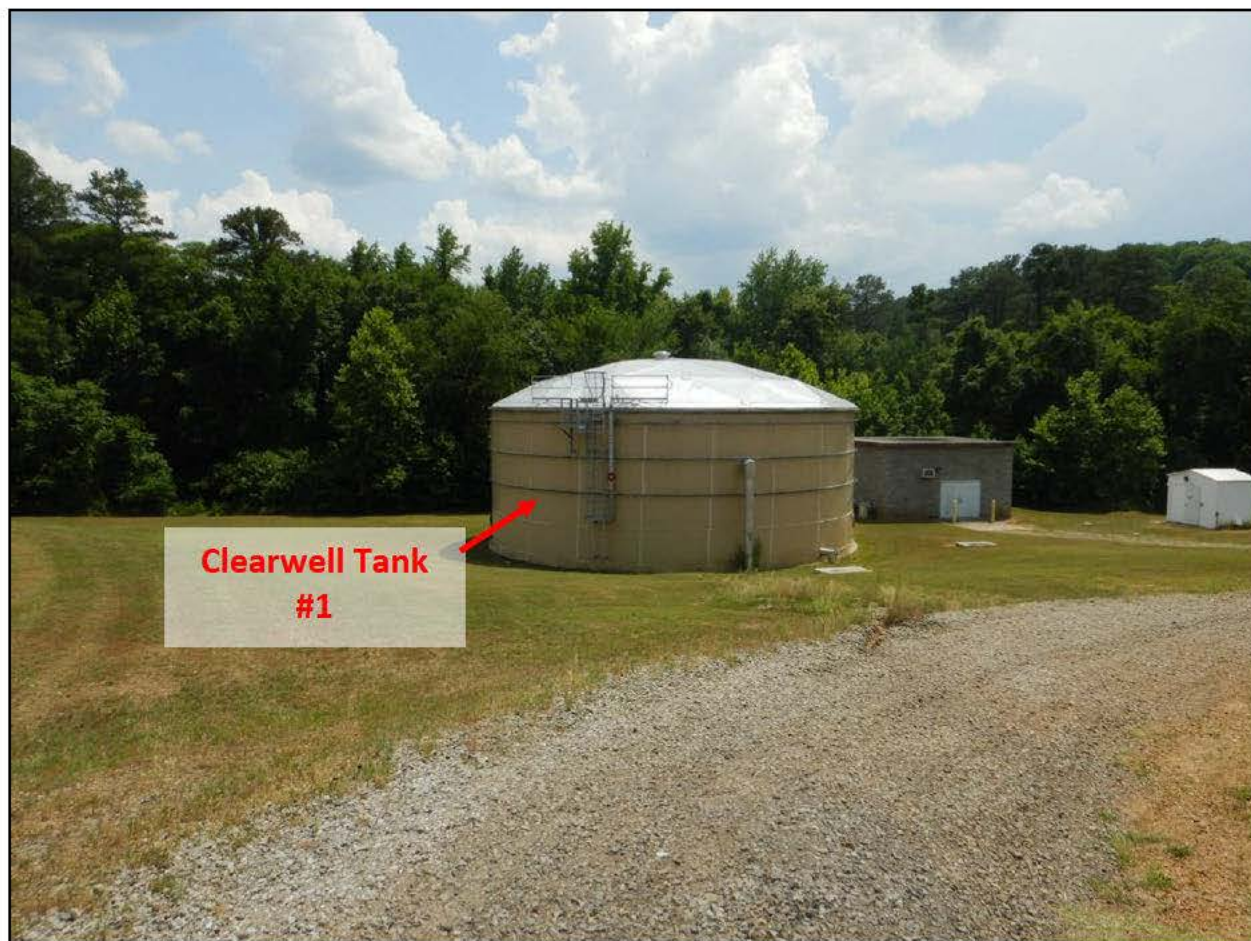
Photo No. 18

**Photograph 18. Clearwell Tank #1, Hector WTP** View of Clearwell Tank #1 at the Hector WTP, where finished water is stored prior to distribution.

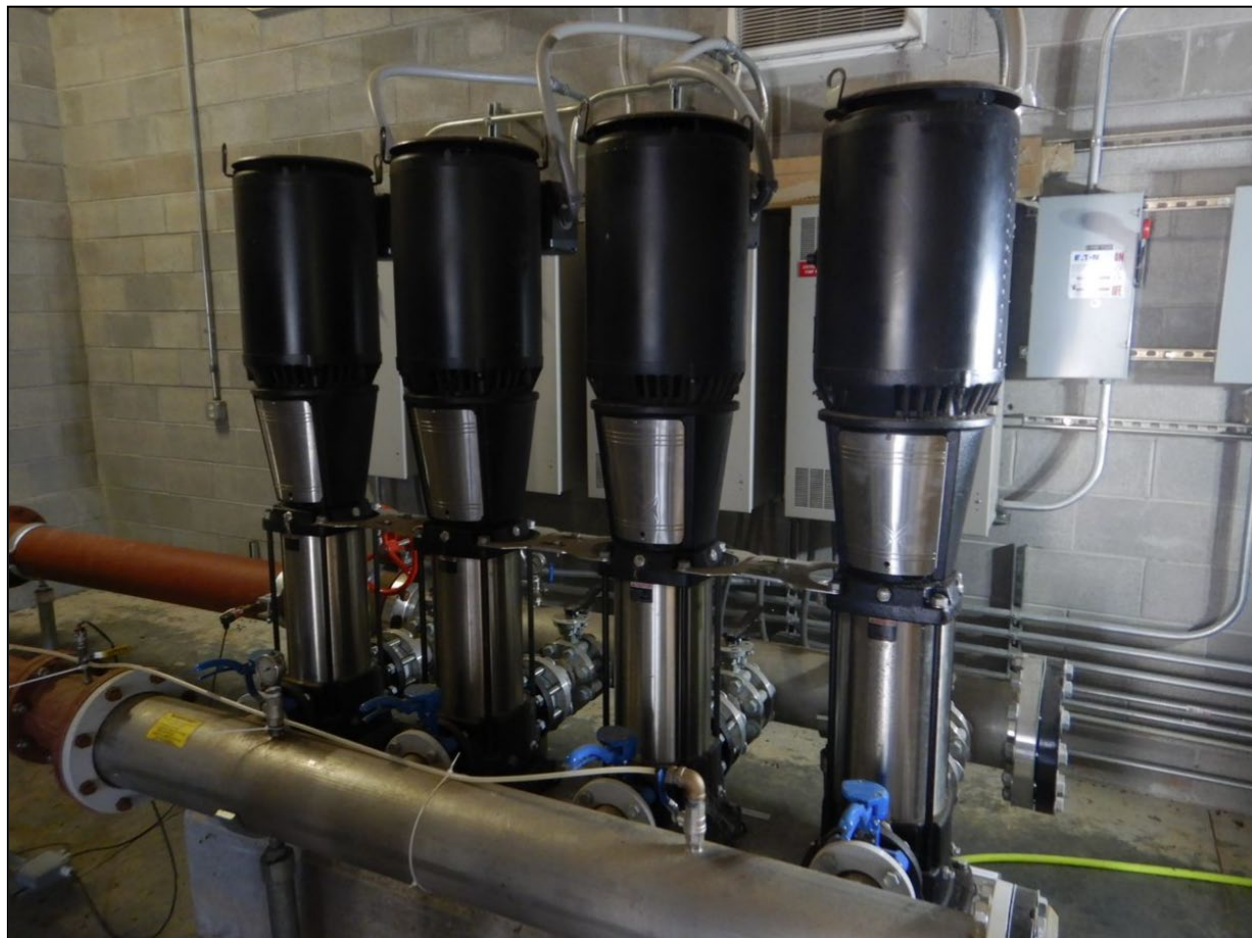
Photo No. 20

**Photograph 20. High Service Pump Station, Hector WTP** View of the four VFD pumps at the HS Pump Station. This pump station delivers finished water to the distribution system following treatment at the Hector WTP.
