INSPECTION REPORT

| Type of Inspection | Compliance Evaluation Inspection (CEI) | | |
| Company Name | Phillips 66 Company | | |
| Facility or Site Name | Phillips 66 Co Ferndale | | |

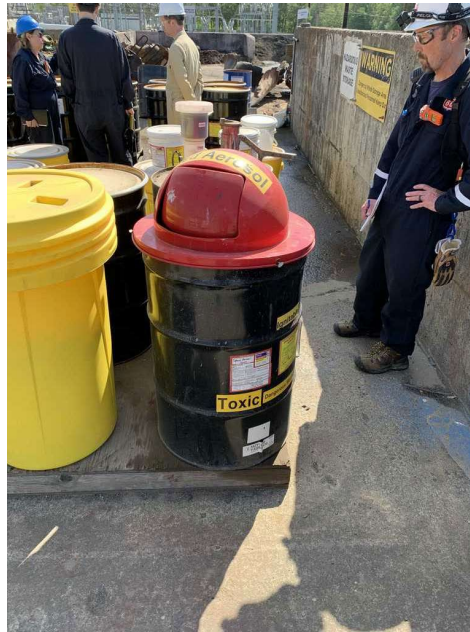
| [Title] | | | IMG_1004.jpg |

| View of waste aerosol storage container that is not closed. | | | |

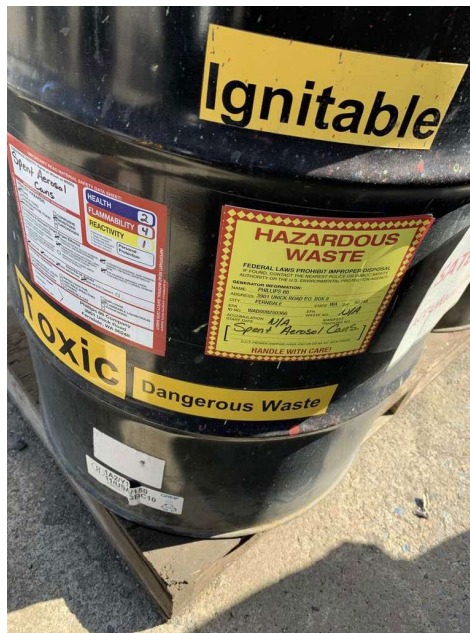
| [Title] | | | IMG_1005.jpg |

| View of the labeling on the waste aerosol storage container. | | | |

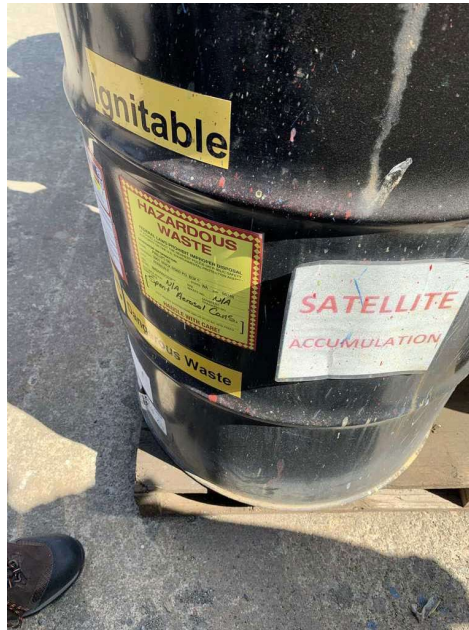
| [Title] | | | IMG_1006.jpg |

| View of the labeling on the waste aerosol storage container. | | | |

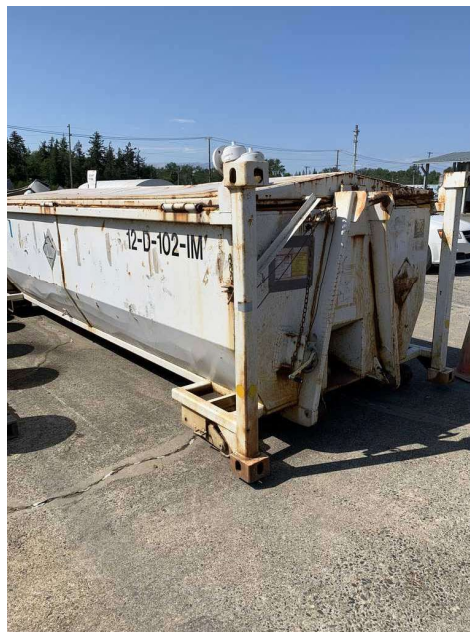
| [Title] | | | IMG_1011.jpg |

| <p>There was a 20 cubic yard roll-off container of waste, marked "Pending Analysis," was not marked with an ASD and not closed.</p> <p>A second 20 cubic yard roll-off container, labeled as containing hazardous waste PPE with waste codes F037 and D008, was not closed.</p> | <b>Regulation:</b> | <b>Sections:</b> |

| View of 20 cubic yard roll-off that is not closed. | | | |

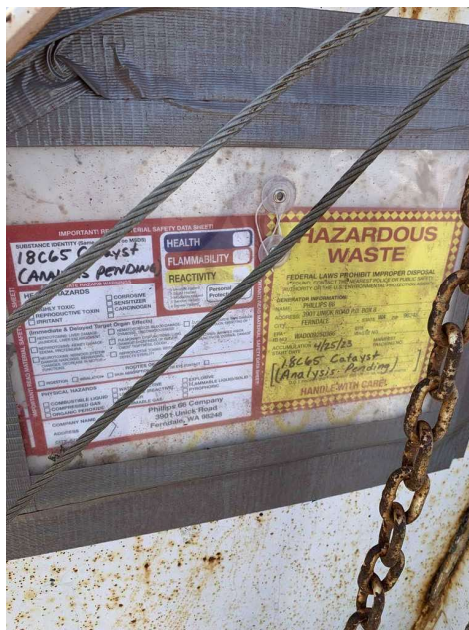
| [Title] | | | IMG_1012.jpg |

| Close-up view of the labeling on the 20 cubic yard roll-off that was not closed. | | | |

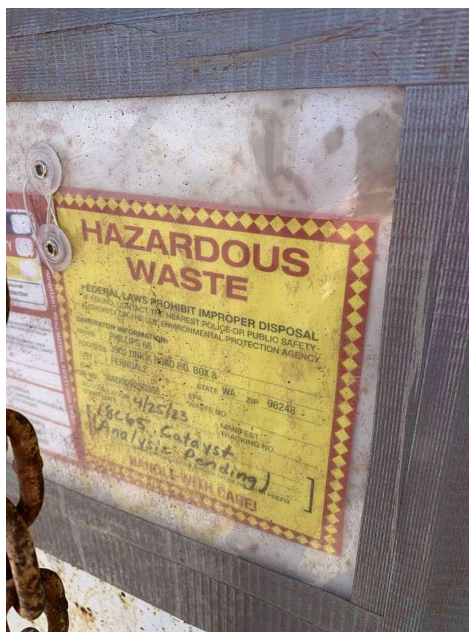
| [Title] | | | IMG_1013.jpg |

| Another close-up view of the labeling on the 20 cubic yard roll-off. | | | |

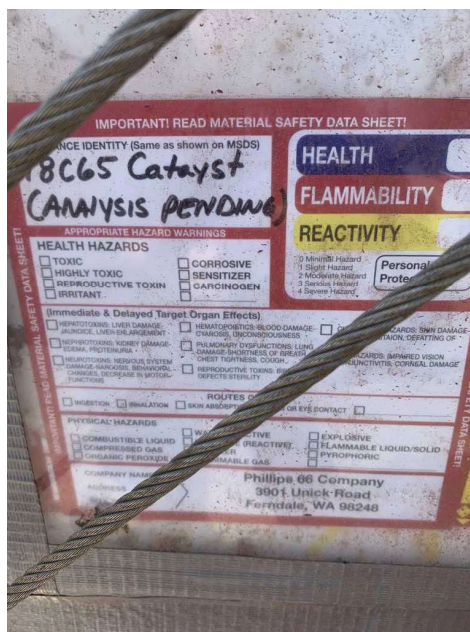
| [Title] | | | IMG_1014.jpg |

| Another close-up view of the labeling on the 20 cubic yard roll-off. | | | |

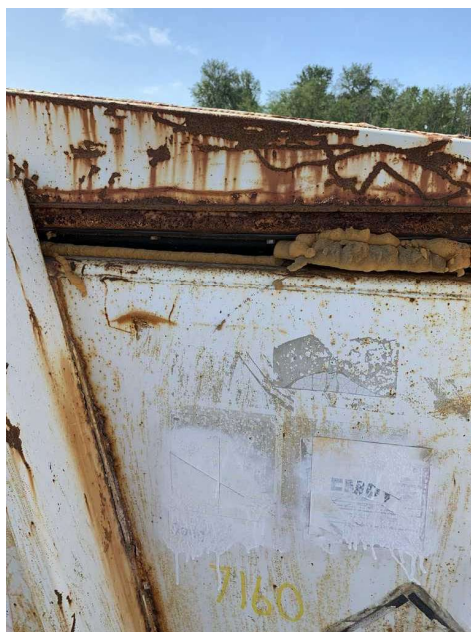
| [Title] | | | IMG_1015.jpg |

| Another close-up view of the gap between the lid and the top of the 20 cubic yard roll-off, showing that the roll-off container is not closed. | | | |

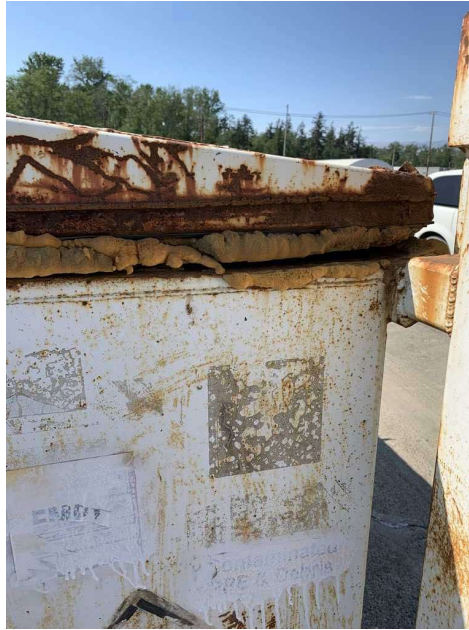
| [Title] | | | IMG_1016.jpg |

| Another close-up view of the gap between the lid and the top of the 20 cubic yard roll-off, showing that the roll-off container is not closed. | | | |

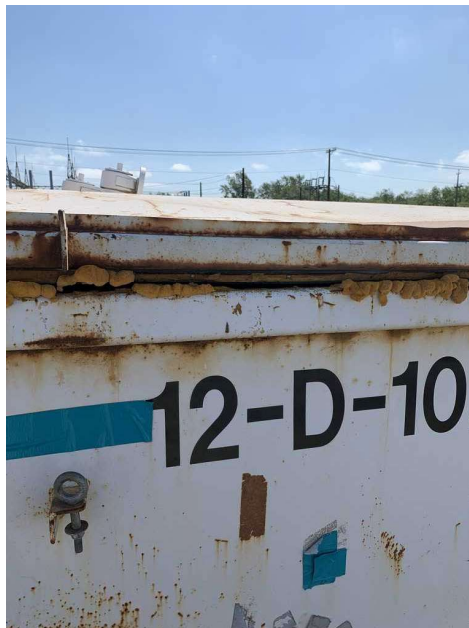
| [Title] | | | IMG_1017.jpg |

| Another close-up view of the gap between the lid and the top of the 20 cubic yard roll-off, showing that the roll-off container is not closed. | | | |

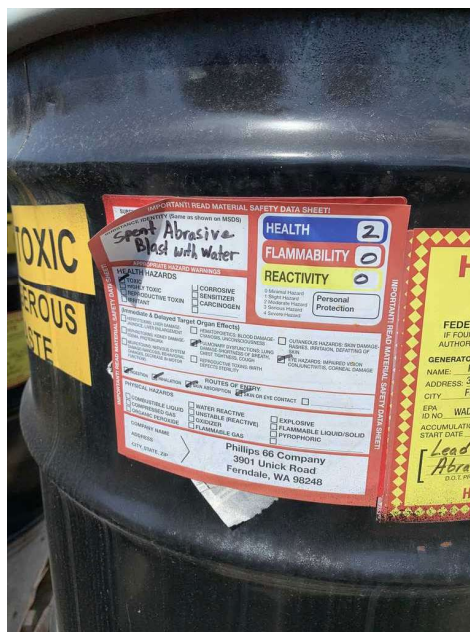
| [Title] | | | IMG_1027.jpg |

| Another close-up view of the container labeling on the waste that had been stored for greater than a year. | | | |

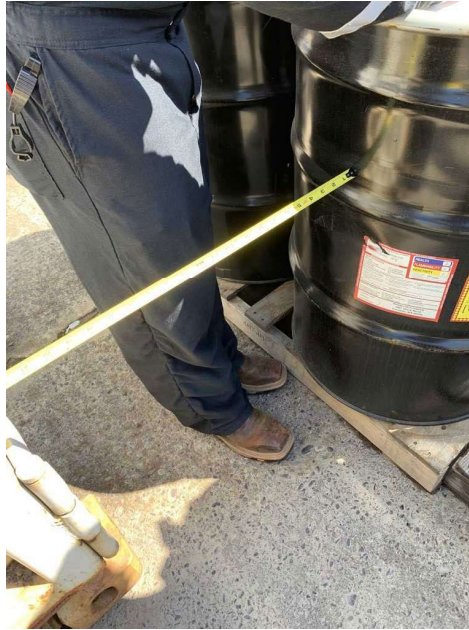
| [Title] | | | IMG_1036.jpg |

| View of 55-gallon container of Hex Chrome waste that doesn't have 30 inches of aisle space between it and a 20 cubic yard roll-off container of waste. | | | |

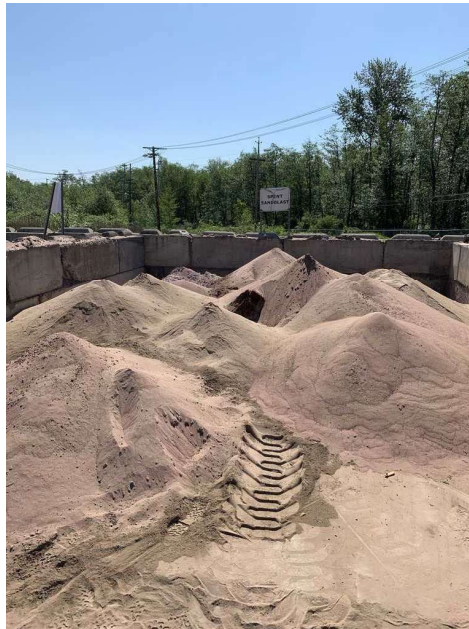
| [Title] | | | IMG_1039.jpg |

| Failure to make a waste determination at the point of generation for a pile of spent sandblast media. | <b>Regulation:</b> | <b>Sections:</b> |

| Close-up view of the piles of spent sandblast media. | | | |

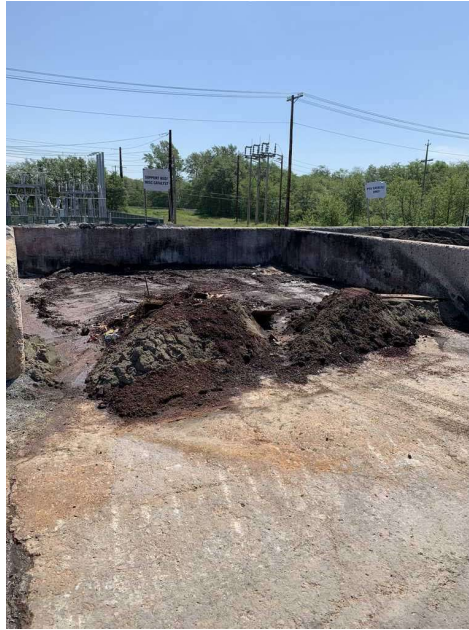
| [Title] | | | IMG_1040.jpg |

| Another view of the PTU catalyst bunker with accumulated spent catalyst. | | | |

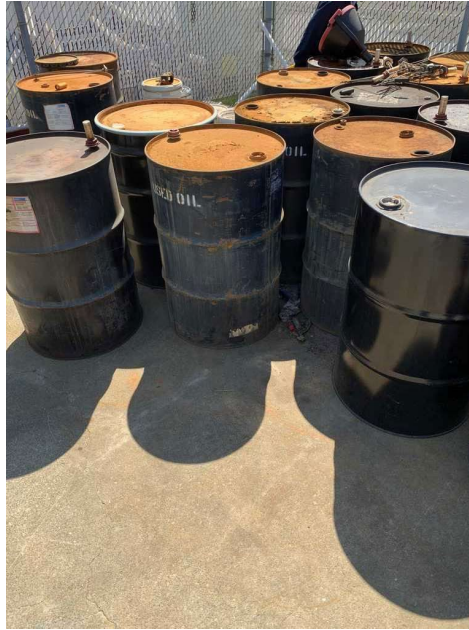
| [Title] | | | IMG_1042.jpg |

| View of 55-gallon used oil containers that are not closed. | | | |

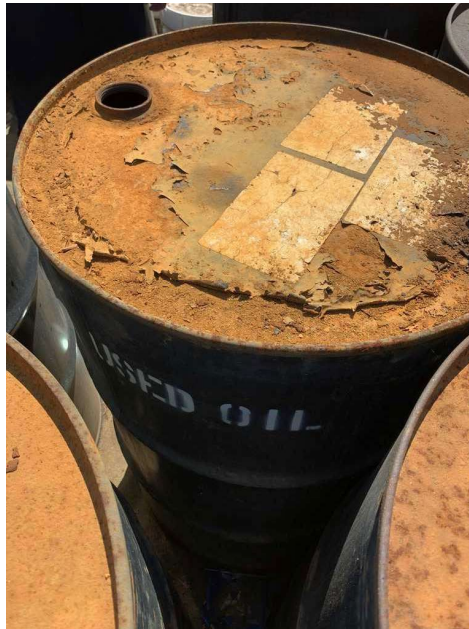
| [Title] | | | IMG_1043.jpg |

| Close-up view of a 55-gallon used oil container that is not closed. | | | |

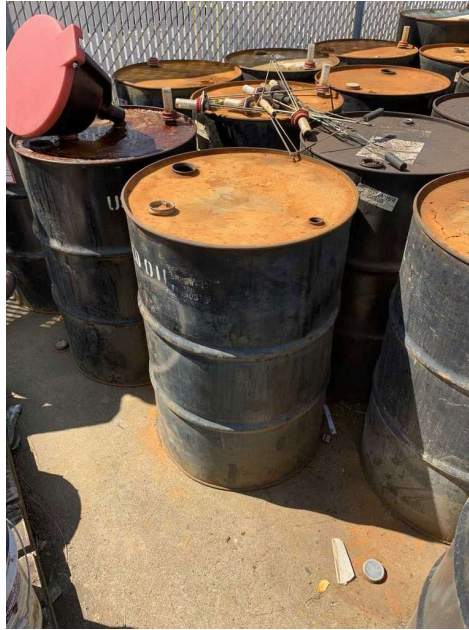
| [Title] | | | IMG_1044.jpg |

| Another close-up view of a 55-gallon used oil container that is not closed. | | | |

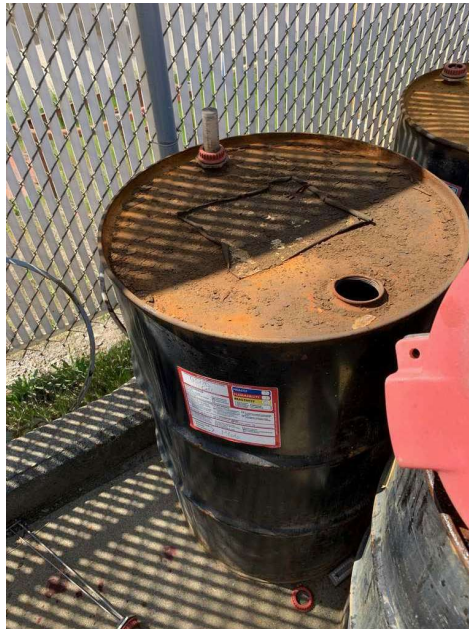
| [Title] | | | IMG_1045.jpg |

| Another close-up view of a 55-gallon used oil container that is not closed. | | | |

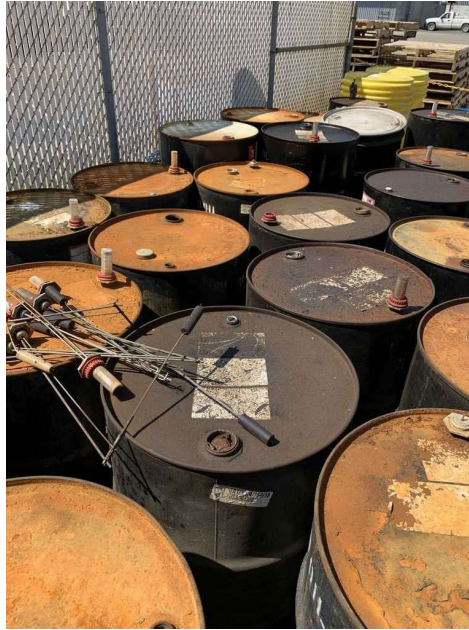
| [Title] | | | IMG_1046.jpg |

| Another view of 55-gallon used oil containers that are not closed. | | | |

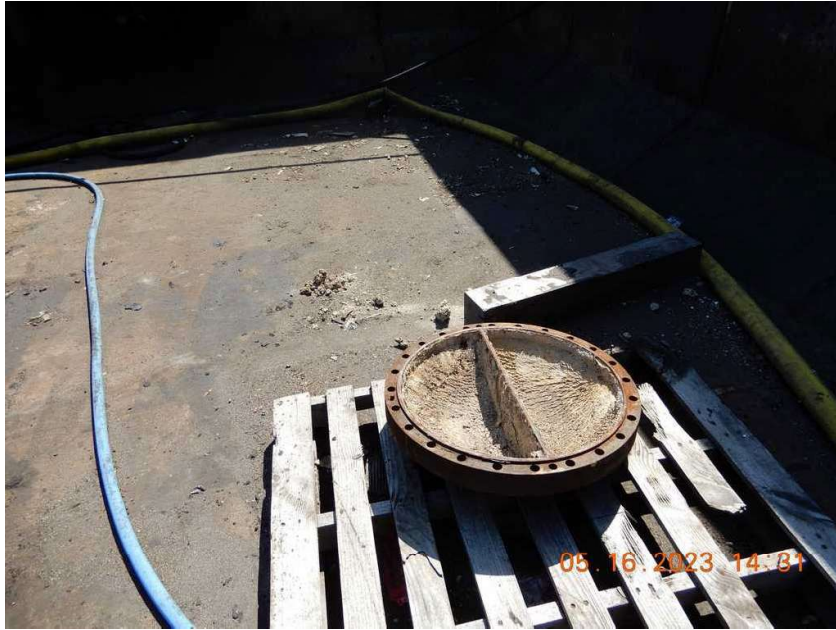
| [Title] | | | DSCN0685.JPG |

| <p>There was debris on the pad that looked like dried waste solids (K050) from the bundle cleaning process.</p> <p>There was a round pan, that looked like an oil drain pan, that contained a nasty looking unknown waste that was both black and brown in color. At the time of the inspection, site personnel did not know what the contents of the pan were and failed to make a waste determination.</p> <p>There was a box, on the bundle cleaning pad, containing a couple of spent waste aerosol cans. At the time of the inspection, these two waste aerosol cans were not labeled with the words "Hazardous Waste" or a hazard/risk indicator.</p> <p>There was a single waste aerosol can on the bundle cleaning pad that was not labeled with the words "Hazardous Waste" and was not marked with a hazard/risk indicator.</p> | <b>Regulation:</b> | <b>Sections:</b> |

| View of end of bundle still containing residues and solid residues on the ground on the bundle cleaning pad. | | | |

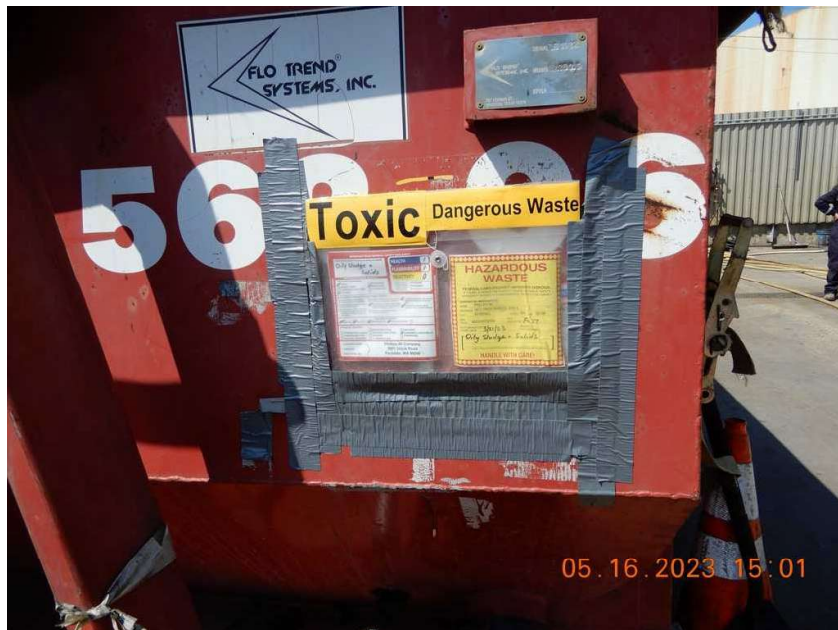
| [Title] | | | DSCN0690.JPG |

| <p>There was a 20 cubic yard hazardous waste roll-off dewatering box that held F037 waste, and dated 3/21/23, that was not closed.</p> <p>In the CAA, there was a 55-gallon container and a five-gallon bucket. The 55-gallon container was marked with the word "Empty" and was full of something, but site personnel did not know what the container held. The five-gallon bucket was approximately 3/4 full of another</p> | <b>Regulation:</b> | <b>Sections:</b> |

| Close-up view of the label on the dewatering box on 900 pad. | | | |

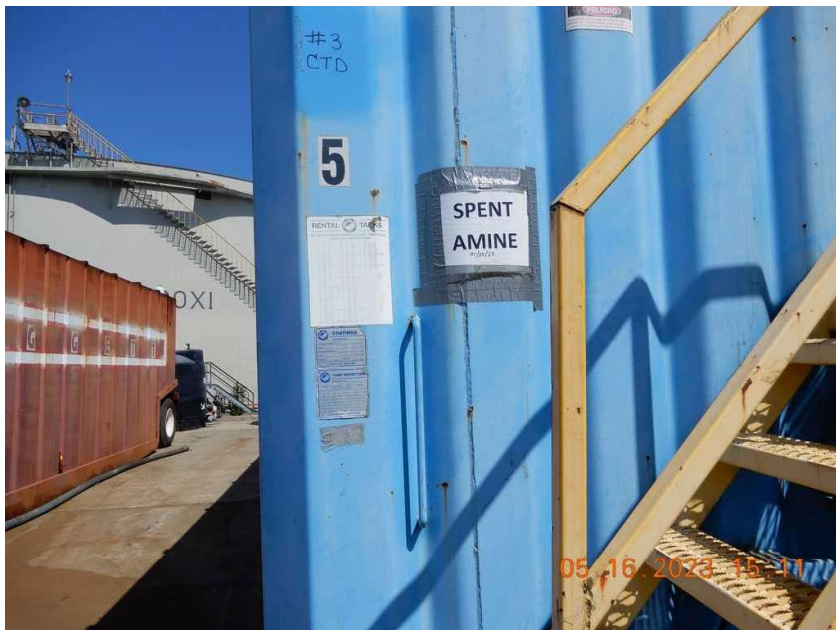
| [Title] | | | DSCN0696.JPG |

| Close-up view of the label on the spent amine frac tank on the 900 pad. | | | |

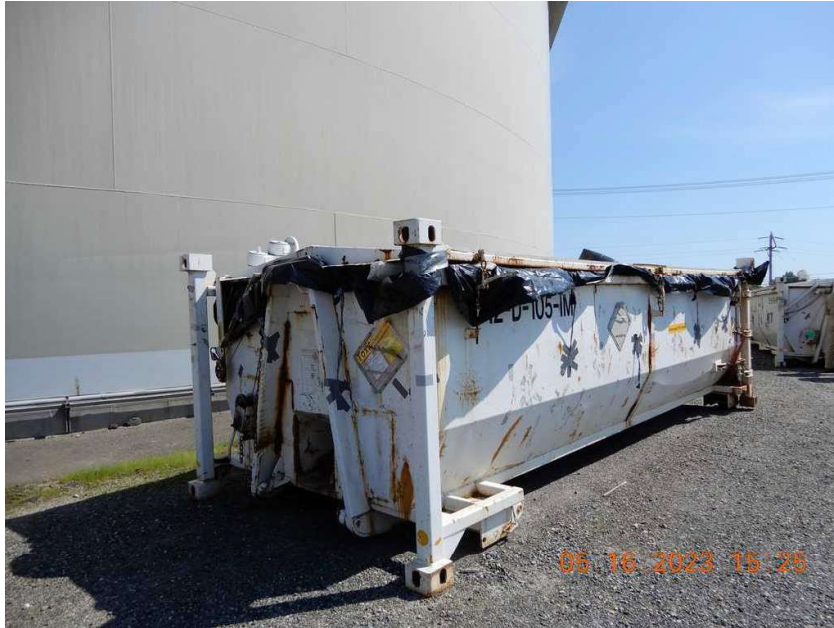
| [Title] | | | DSCN0699.JPG |

| View of roll-off containing contaminated PPE and debris at 900 Pad area. | | | |

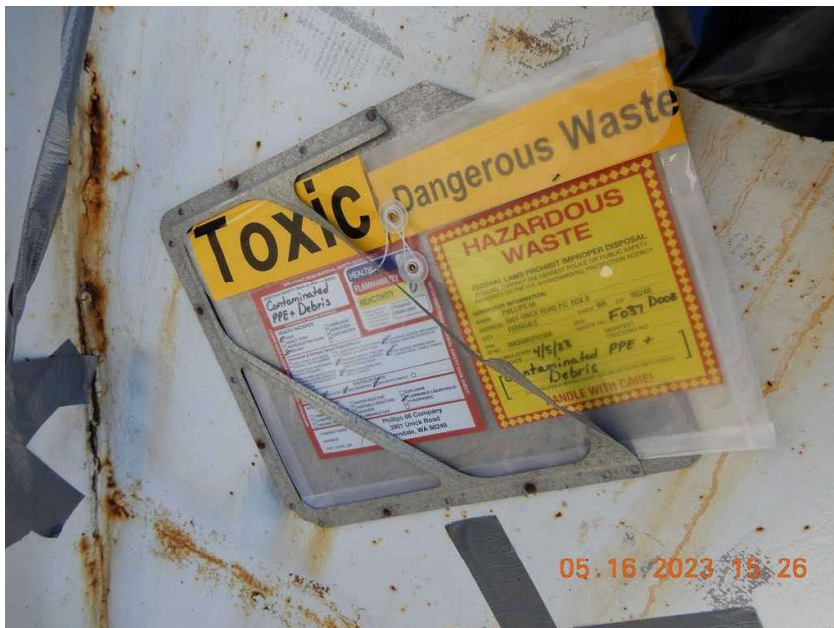
| [Title] | | | DSCN0700.JPG |

| View of the label on the roll-off of contaminated PPE and debris at the 900 Pad area. | | | |

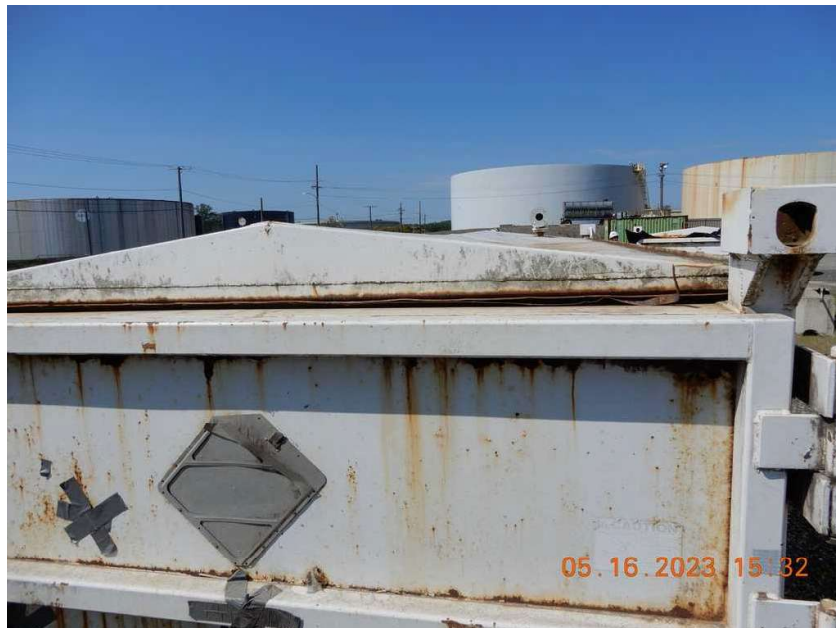
| [Title] | | | DSCN0704.JPG |

| Another view of open space between container and lid on roll-off of catalyst that was pending analysis at the 900 Pad area with no ASD. | | | |

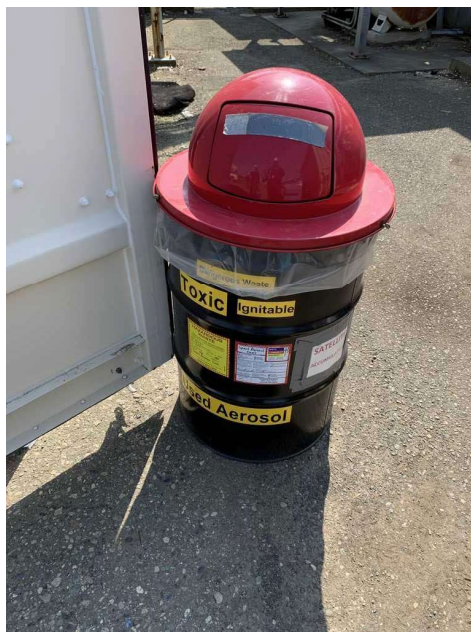
| [Title] | | | IMG_1049.jpg |

| View of the 55-gallon SAA container of waste aerosol cans, showing the lid with swinging door that does not make a complete seal. | | | |

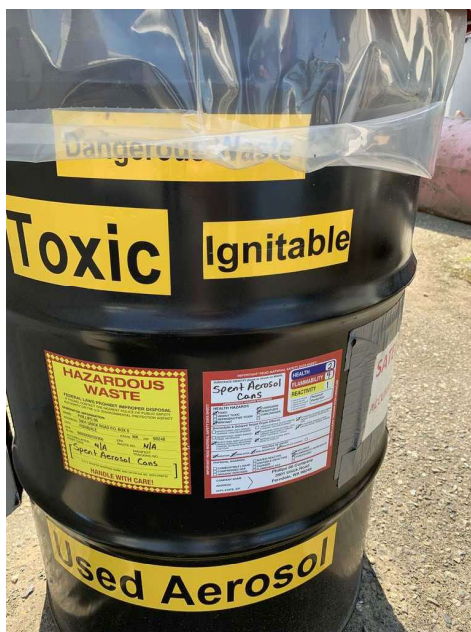
| [Title] | | | IMG_1050.jpg |

| Close-up view of the labeling on the 55-gallon SAA container of waste aerosol cans, with the lid with swinging door that does not make a complete seal. | | | |

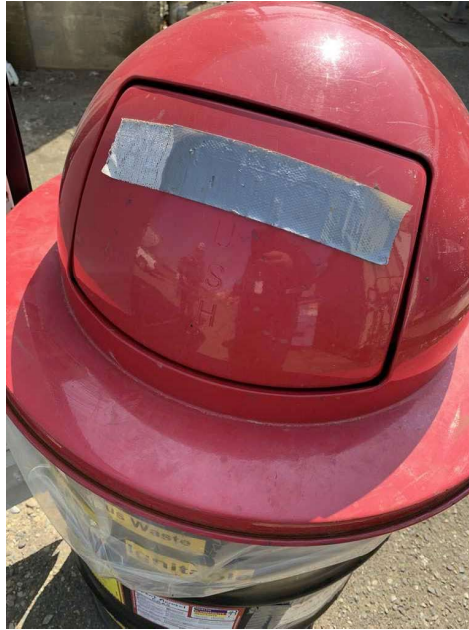
| [Title] | | | IMG_1051.jpg |

| Close-up view , showing the lid with swinging door that does not make a complete seal. | | | |

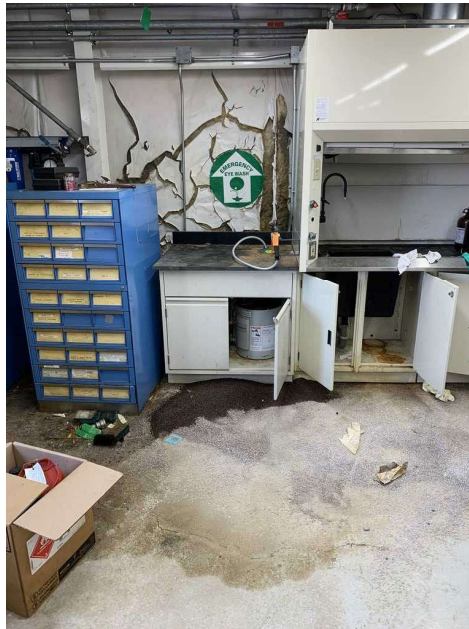
| [Title] | | | IMG_1056.jpg |

| <p>At the time of the inspection, the gasoline-soaked waste absorbent had been on the floor of the lab for a week (Since last Tuesday, 5/9/2023), and was still on the floor and had not been cleaned up and containerized, allowing it to evaporate. According to Mr. Sumera, the gasoline-soaked waste absorbent would be managed as a hazardous waste.</p> <p>There were also saw two, one-gallon glass bottles that had at one time contained Pentane. At the time of the inspection, these two, one-gallon containers were not closed and were inside of an open, actively running fume hood.</p> | <b>Regulation:</b> | <b>Sections:</b> |

| Another view of the lab, showing the gasoline spill absorbent on the floor. | | | |

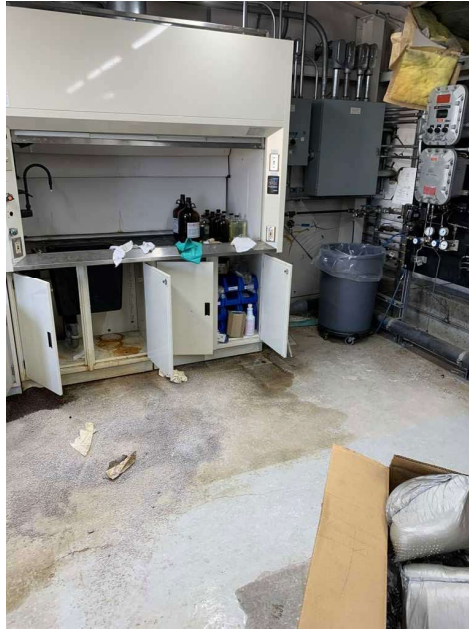
| [Title] | | | IMG_1057.jpg |

| Another view inside the lab, showing the gasoline spill and absorbent on the floor. | | | |

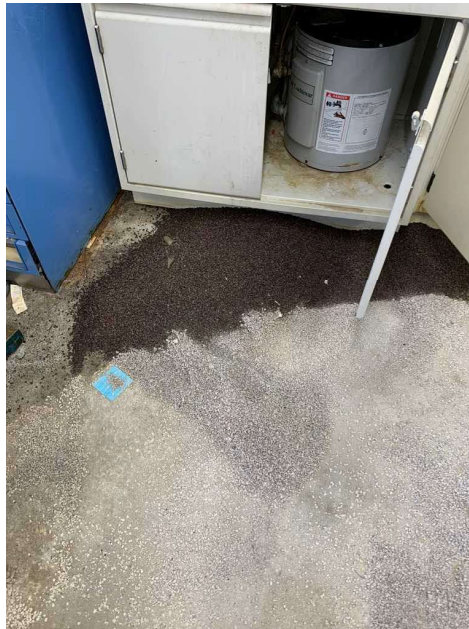
| [Title] | | | IMG_1058.jpg |

| Close-up view of absorbent material on the floor of the lab, saturated from a gasoline spill. | | | |

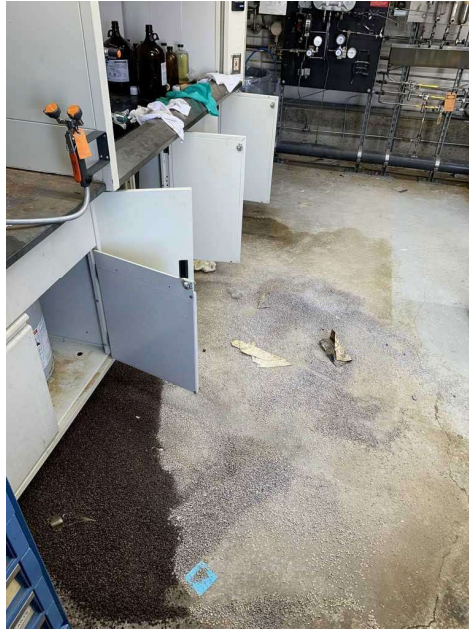
| [Title] | | | IMG_1059.jpg |

| Another view of the absorbent material on the floor of the lab, saturated with spilled gasoline. | | | |

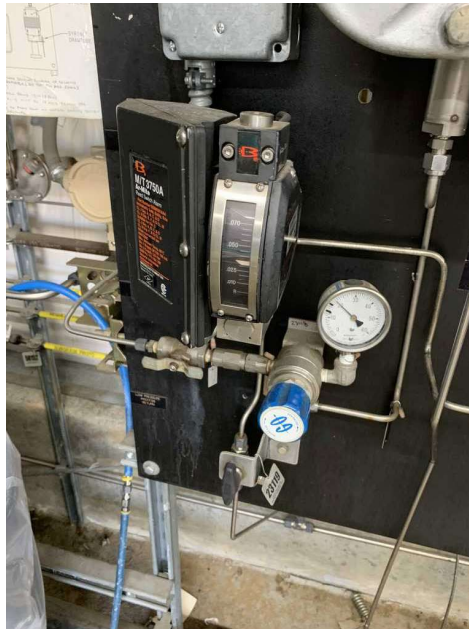
| [Title] | | | IMG_1060.jpg |

| View of the Flow Meter with site glass that was installed after the previous one broke, causing the gasoline spill in the decommissioned lab. | | | |

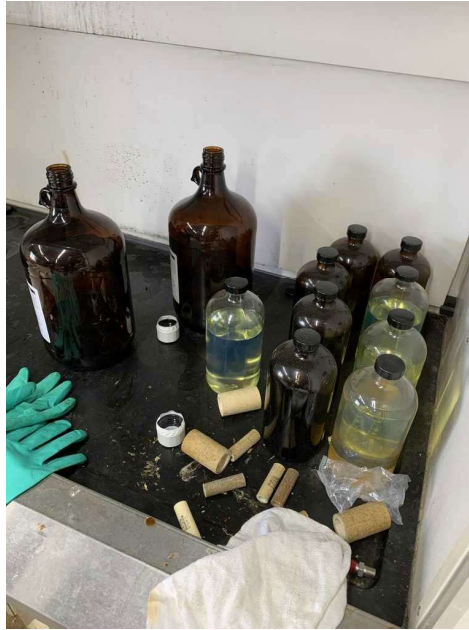
| [Title] | | | IMG_1061.jpg |

| View of sample bottles, containing gasoline, and two, one-gallon containers that last contained Pentane, inside an actively running fume hood in the decommissioned lab. | | | |

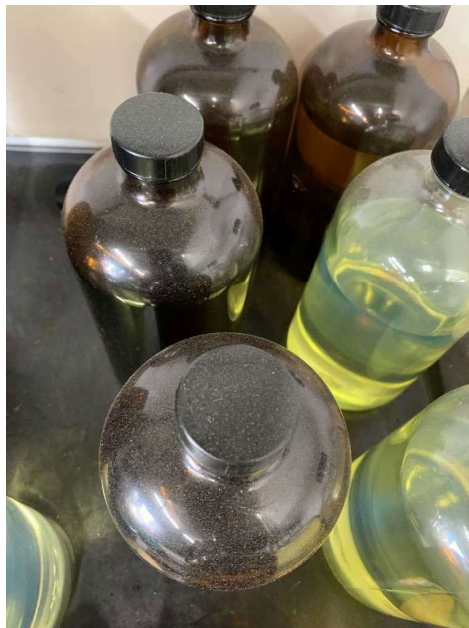
| [Title] | | | IMG_1062.jpg |

| Close-up view of the sample bottles inside the fume hood of the decommissioned lab. | | | |

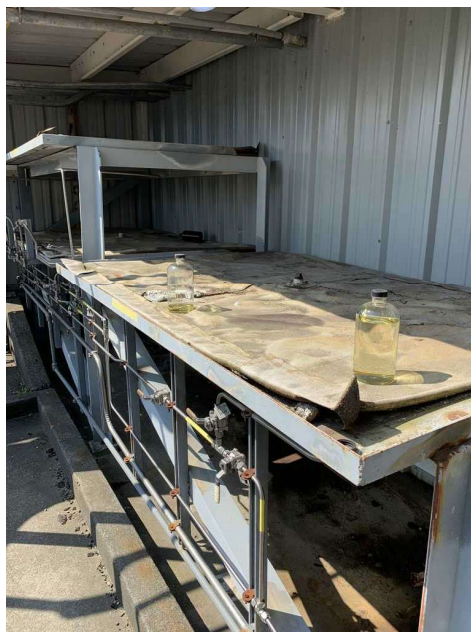
| [Title] | | | IMG_1063.jpg |

| View of the area, outside and behind the decommissioned Engine Knock Lab, showing sample bottles containing gasoline that are presumed to be left when the lab was shut down ten years earlier. | | | |

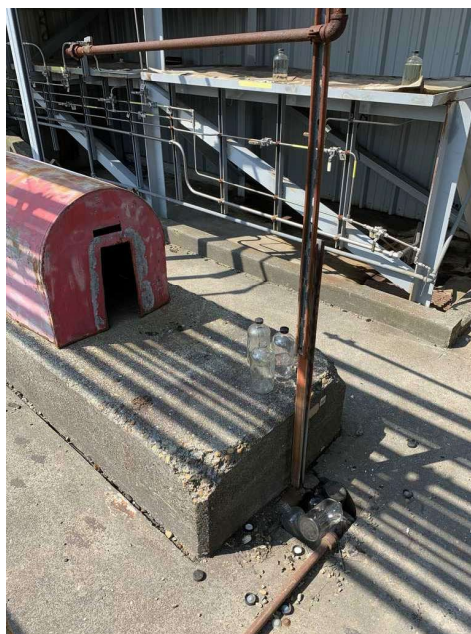
| [Title] | | | IMG_1064.jpg |

| Another view of the area behind the decommissioned lab, showing the discarded gasoline samples left behind following the lab shutdown. | | | |

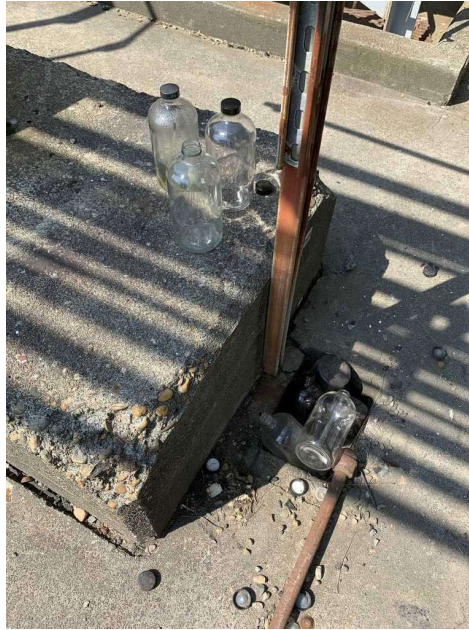
| [Title] | | | IMG_1065.jpg |

| Close-up view of the discarded sample bottles found behind the decommissioned lab. | | | |

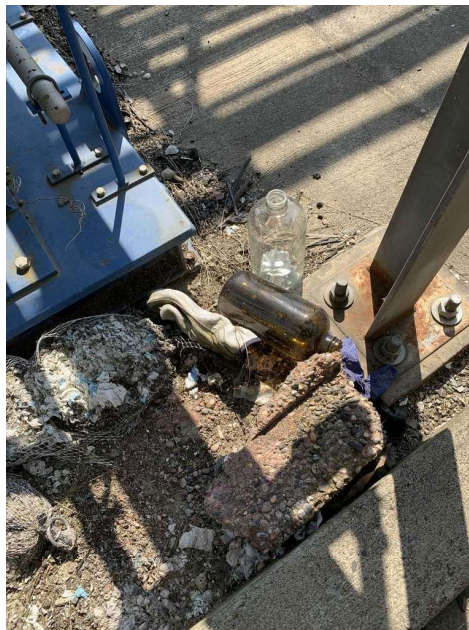
| [Title] | | | IMG_1066.jpg |

| We also saw a discarded leather glove. I explained to Mr. Sumera that waste leather gloves fail Toxicity Characteristic Leaching Process analysis (TCLP) for Chrome (D007) and told him that a waste determination would be required for the waste glove as well as any other waste leather gloves generated at the site. | | |

| Another close-up view of the discarded sample bottles found behind the decommissioned lab, along with a waste leather glove. | | | |

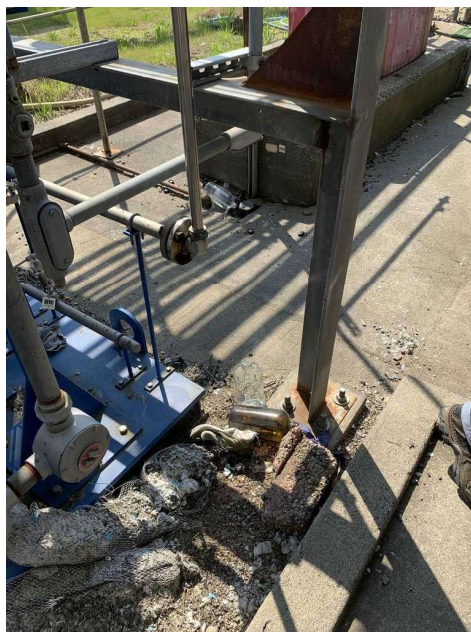
| [Title] | | | IMG_1067.jpg |

| Another view of the discarded sample bottles and waste leather glove found behind the decommissioned lab. | | | |

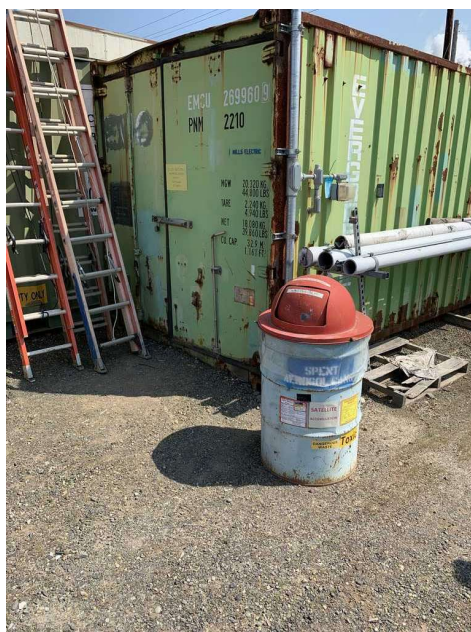
| [Title] | | | IMG_1068.jpg |

| View of 55-gallon waste aerosol SAA that is not closed. SAA container is seen here with a swinging door type lid that doesn't contact the container when in the closed position. | | | |

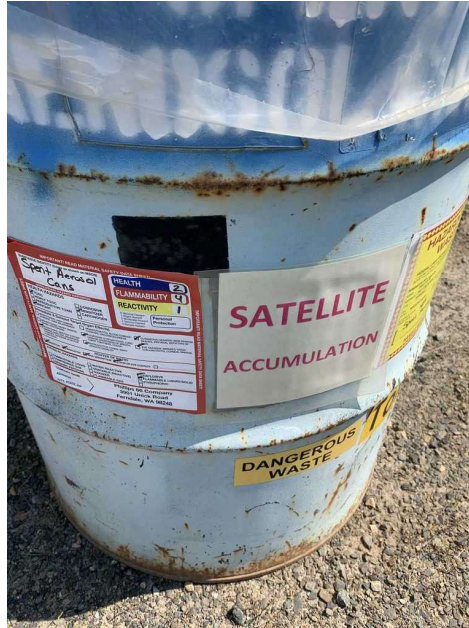
| [Title] | | | IMG_1069.jpg |

| Close-up view of the labeling on the 55-gallon waste aerosol SAA seen in photo IMG_1068.jpg. | | | |

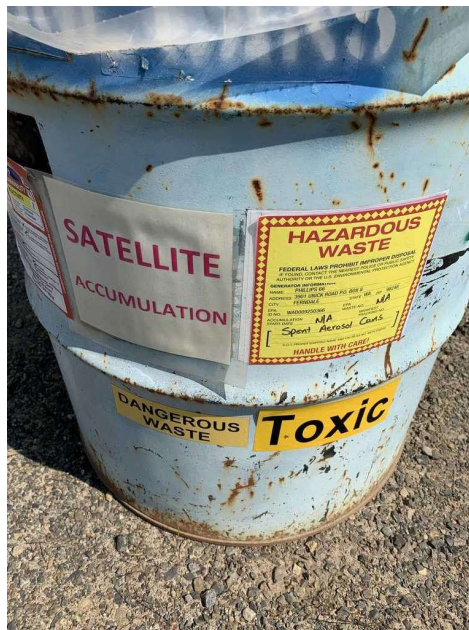
| [Title] | | | IMG_1070.jpg |

| Another close-up view of the labeling on the 55-gallon waste aerosol SAA seen in photo IMG_1068.jpg. | | | |

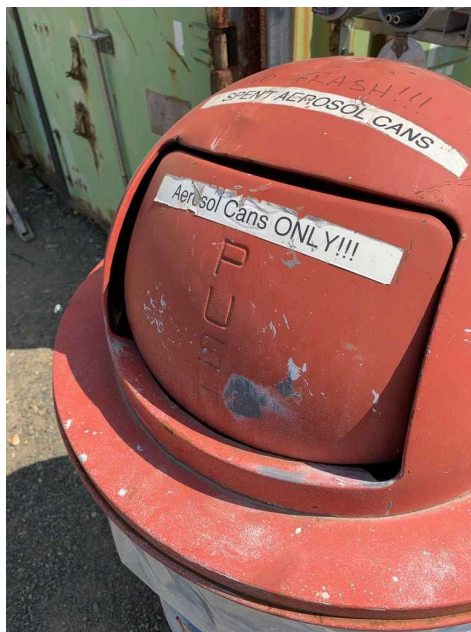
| [Title] | | | IMG_1071.jpg |

| Close-up view of the swinging door type lid on the 55-gallon waste aerosol SAA, seen in photo IMG_1068.jpg, showing how the swinging door not only won't close, but doesn't make a complete seal even if it was able to close. | | | |

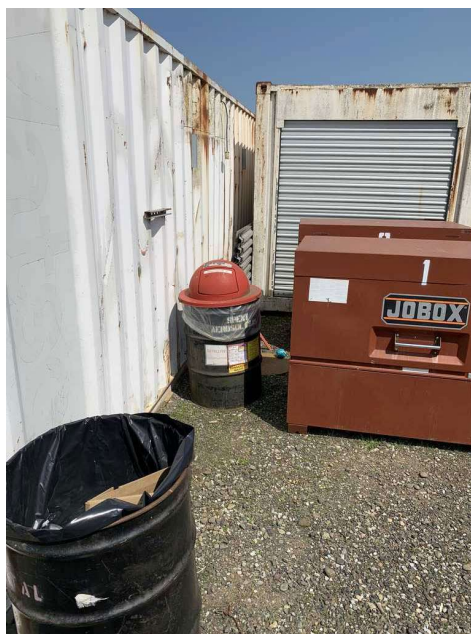
| [Title] | | | IMG_1072.jpg |

| View of another 55-gallon waste aerosol can SAA that is not closed, due to the design of the swinging door type lid. | | | |

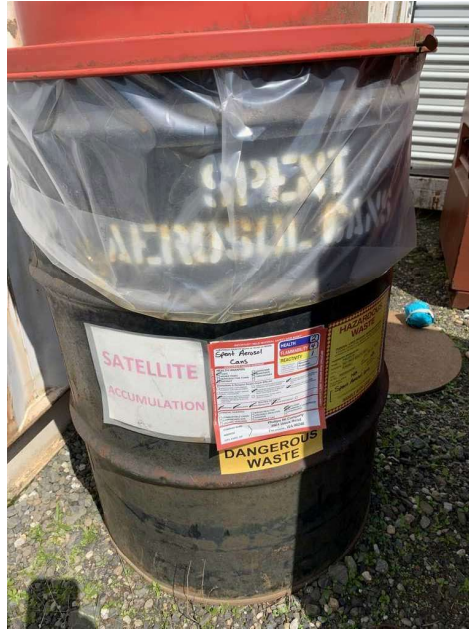
| [Title] | | | IMG_1073.jpg |

| Close-up view of the labeling on the same waste aerosol can SAA seen in photo IMG_1072.jpg. | | | |

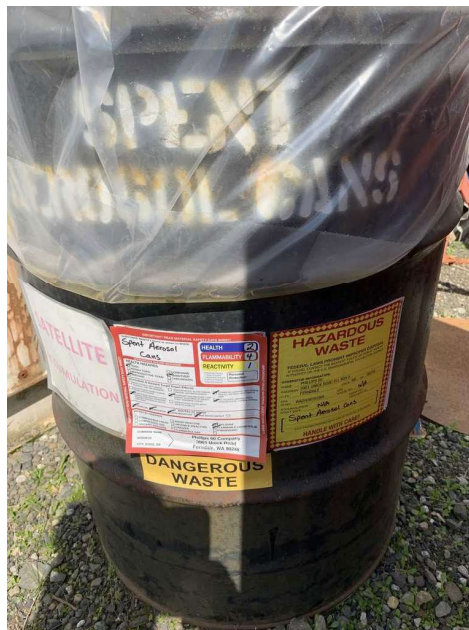
| [Title] | | | IMG_1074.jpg |

| Another close-up view of the labeling on the same waste aerosol can SAA seen in photo IMG_1072.jpg. | | | |

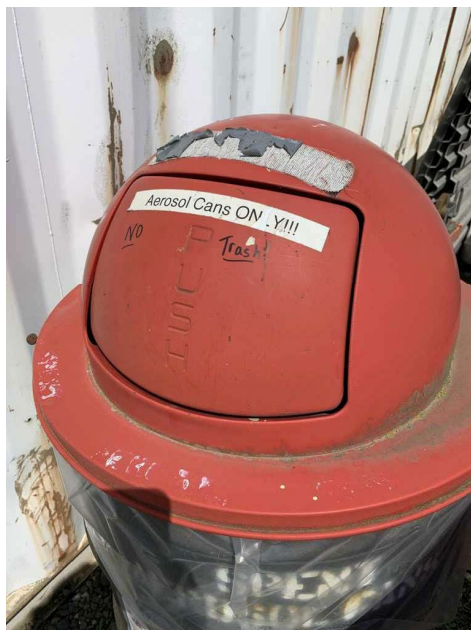
| [Title] | | | IMG_1075.jpg |

| Close-up view of the swinging door type lid on the 55-gallon waste aerosol SAA, seen in photo IMG_1072.jpg, showing how the swinging door doesn't make a complete seal even when in the closed position. | | | |

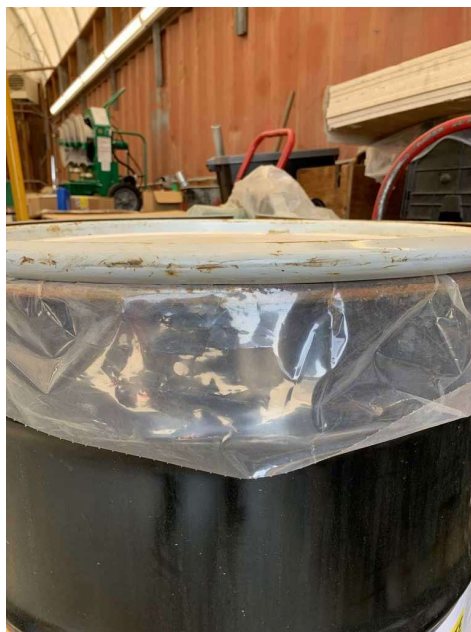
| Close-up view of the lid on the 55-gallon waste oily metal shavings SAA container (F037), showing that the container is not closed. Shown here, the drum ring is attached to the lid and both drum ring and lid are just resting on top of the container and not making a complete seal with the container. | | | |

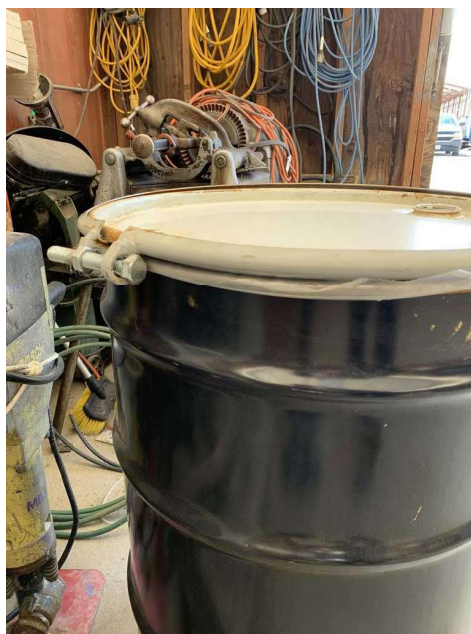
| [Title] | | | IMG_1080.jpg |

| View of the same container, seen in photo IMG_1079, showing the gap between the lid and container. | | | |

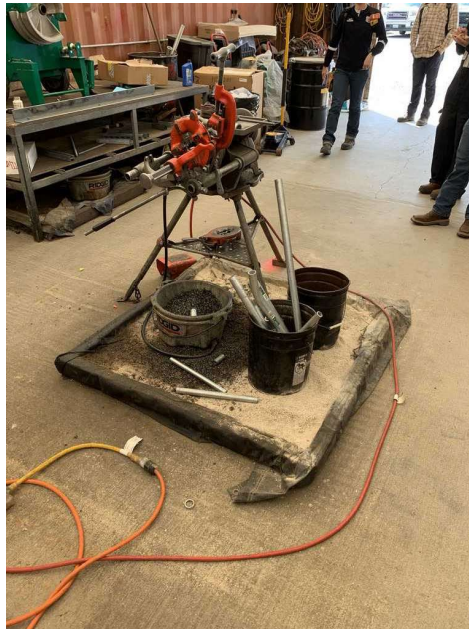
| [Title] | | | IMG_1082.jpg |

| There was a small, "Ridgid" brand, ~2.5-gallon bucket, beneath a pipe threader, that also contained the same waste metal shavings and was not labeled with the words "Hazardous Waste," marked with a hazard indicator or closed. The ~2.5-gallon bucket was being used as a SAA container and, according to Mr. Reed Stanley, Supervisor with | | |

| <p>Mills Electric, was being emptied into the 55-gallon hazardous waste SAA container either weekly or bi-weekly.</p> <p>The same waste metal shavings were also piling up, beneath the pipe threader, around the bucket.</p> <p>There was a five-gallon container beneath the pipe threader, adjacent to the ~2.5-gallon bucket, approximately 1/8 full of the same waste metal shavings and not labeled with the words "Hazardous Waste," marked with a hazard indicator or closed.</p> <p>There was an additional ~2.5-gallon "Ridgid" brand bucket on the floor beneath a work bench with a half-gallon or less of the same waste metal shavings that was not labeled with the words "Hazardous Waste," marked with a hazard indicator or closed.</p> | | |

| View of a ~2.5-gallon container, seen here beneath a pipe cutter/threader, that contains the same waste oily metal shavings (F037) and is not closed or labeled. | | | |

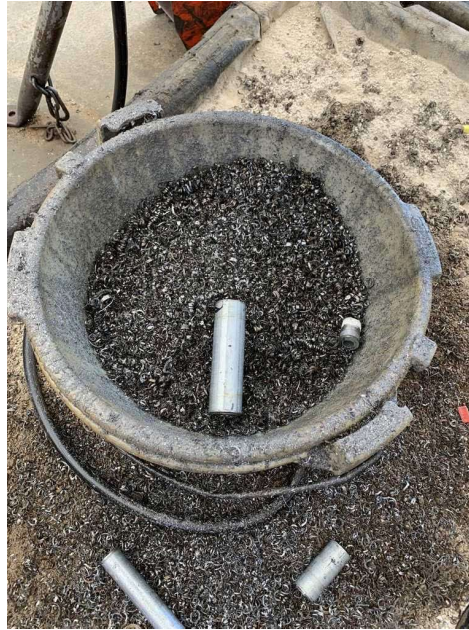
| [Title] | | | IMG_1083.jpg |

| Close-up view of the ~2.5-gallon container, seen in photo IMG_1082.jpg, that contains the same waste oily metal shavings (F037) and is not closed or labeled. | | | |

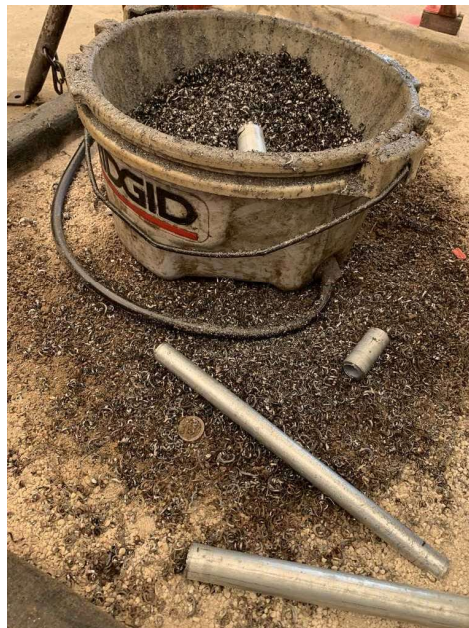
| [Title] | | | IMG_1084.jpg |

| Another close-up view of the ~2.5-gallon container, seen in photo IMG_1082.jpg, that contains the same waste oily metal shavings (F037) and is not closed or labeled. | | | |

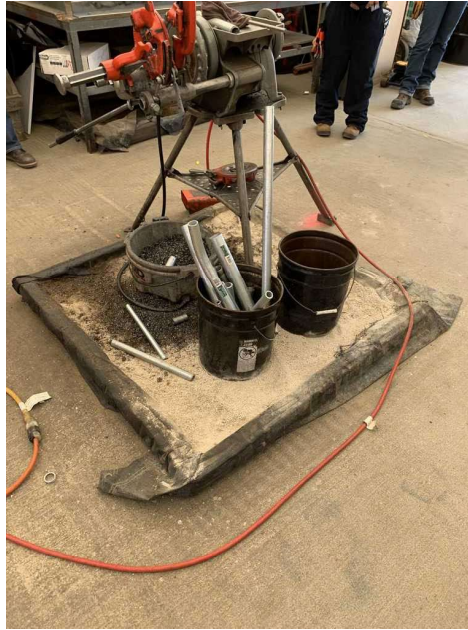
| [Title] | | | IMG_1085.jpg |

| Another view of the ~2.5-gallon container, seen in photo IMG_1082.jpg, that contains the same waste oily metal shavings (F037) and is not closed or labeled. | | | |

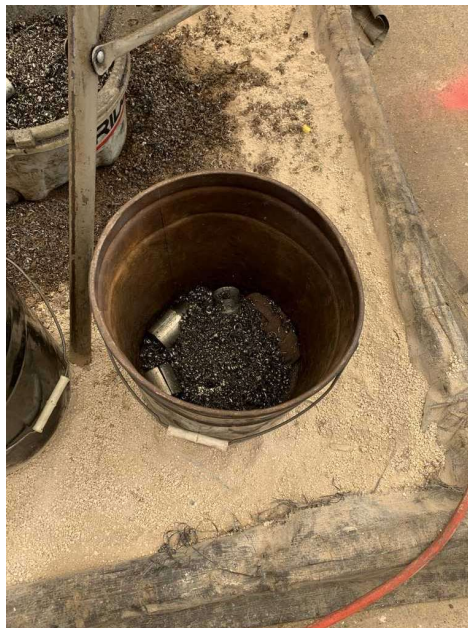
| [Title] | | | IMG_1086.jpg |

| A close-up view of a 5-gallon container, seen in photo IMG_1082.jpg, that contains the same waste oily metal shavings (F037) and is not closed or labeled. | | | |

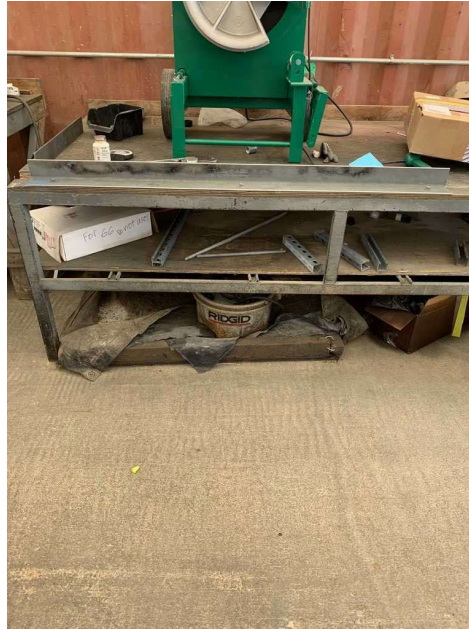
| [Title] | | | IMG_1087.jpg |

| View of another ~2.5-gallon container, seen under some shelving, that contains the same waste oily metal shavings (F037) and is not closed or labeled. | | | |

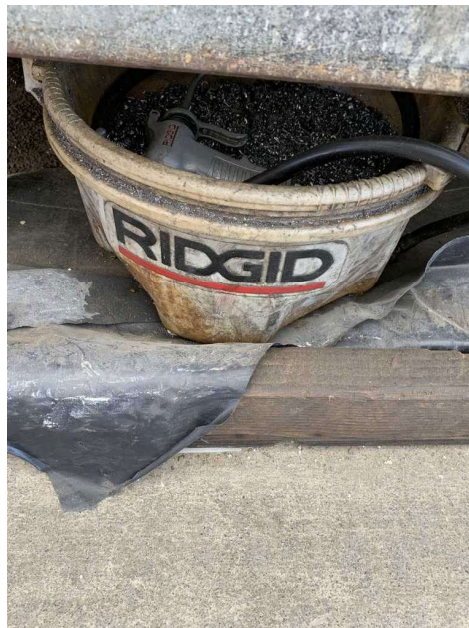
| [Title] | | | IMG_1088.jpg |

| Close-up view of the ~2.5-gallon container, seen in photo IMG_1087.jpg, that contains the same waste oily metal shavings (F037) and is not closed or labeled. | | | |

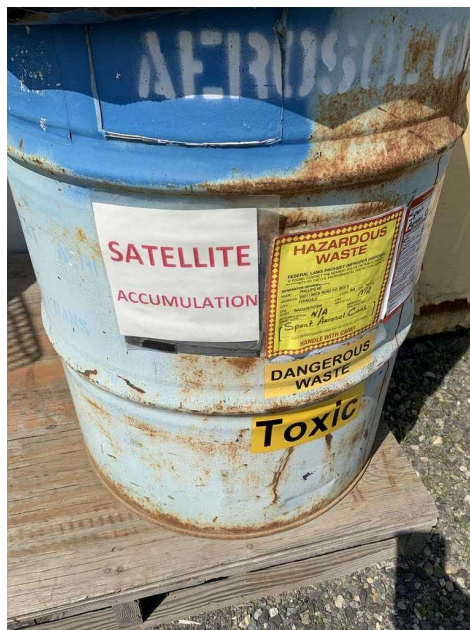
| [Title] | | | IMG_1090.jpg |

| Close-up view of the labeling on the same waste aerosol can SAA seen in photo IMG_1089.jpg. | | | |

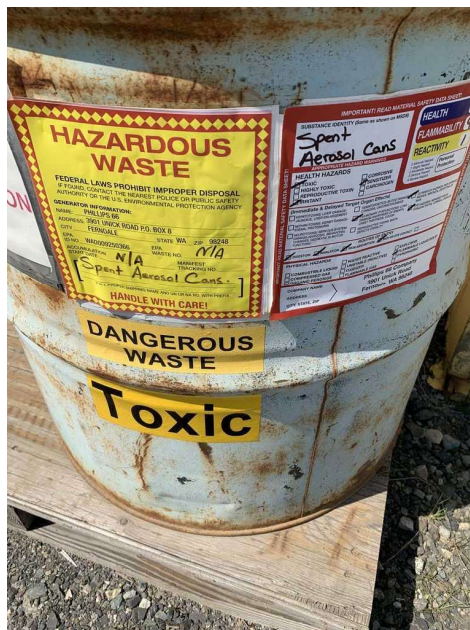
| [Title] | | | IMG_1091.jpg |

| Another close-up view of the labeling on the same waste aerosol can SAA seen in photo IMG_1089.jpg. | | | |

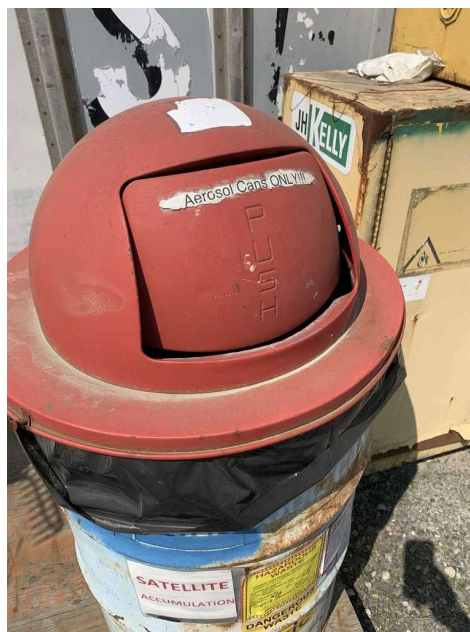
| [Title] | | | IMG_1092.jpg |

| Close-up view of the swinging door type lid on the 55-gallon waste aerosol SAA, seen in photo IMG_1089.jpg, showing how the swinging door not only won't close, but doesn't make a complete seal even if it was able to close. | | | |
