INSPECTION REPORT

| Type of Inspection | Compliance Evaluation Inspection (CEI) | | |
| Company Name | Phillips 66 Company | | |
| Facility or Site Name | Phillips 66 Co Ferndale | | |

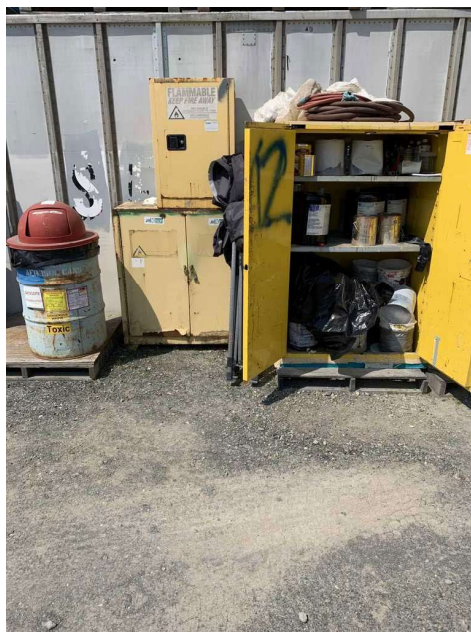
| [Title] | | | IMG_1093.jpg |

| View of the yellow flammable storage cabinet, adjacent to the waste aerosol SAA container, that contains waste paint related material that's been allowed to dry out/solidify. | | | |

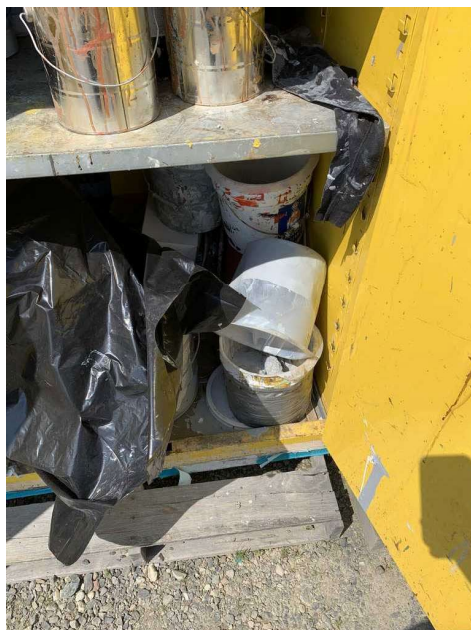
| [Title] | | | IMG_1094.jpg |

| View of the waste paint related material in the process of drying out/solidifying in the bottom of the flammable storage cabinet. | | | |

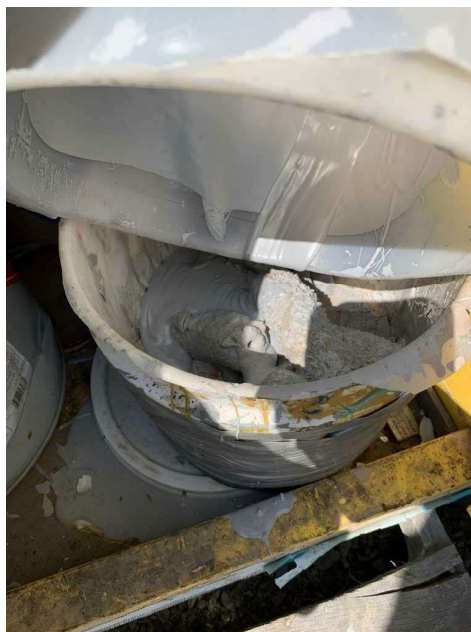
| [Title] | | | IMG_1095.jpg |

| Close-up view of the waste paint related material in the process of drying out/solidifying in the bottom of the flammable storage cabinet. | | | |

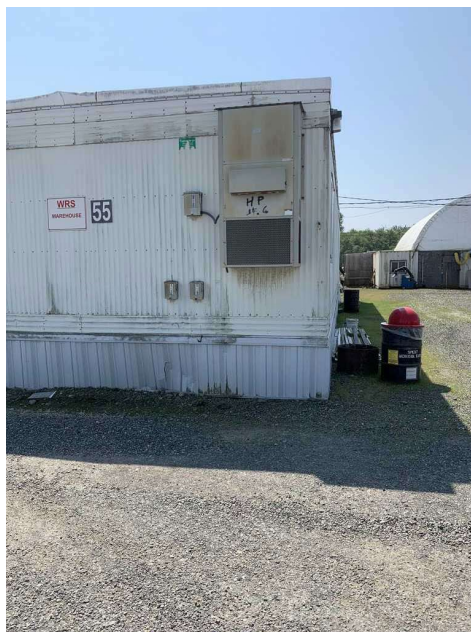
| [Title] | | | IMG_1099.jpg |

| View of another 55-gallon waste aerosol can SAA that is not closed, due to the design of the swinging door type lid. | | | |

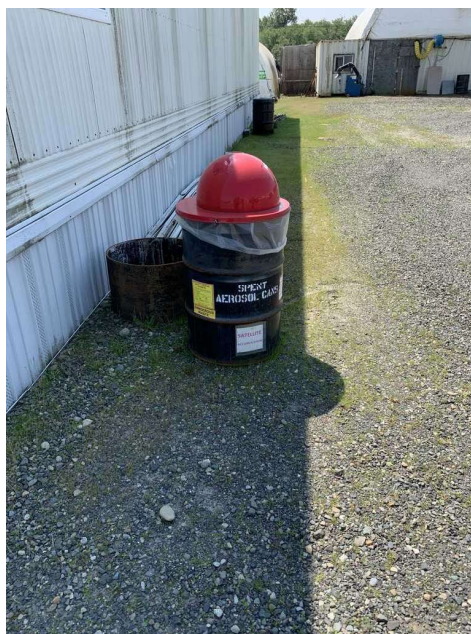
| [Title] | | | IMG_1100.jpg |

| Close-up view of the 55-gallon waste aerosol can SAA, seen in photo IMG_1099, that is not closed, due to the design of the swinging door type lid. | | | |

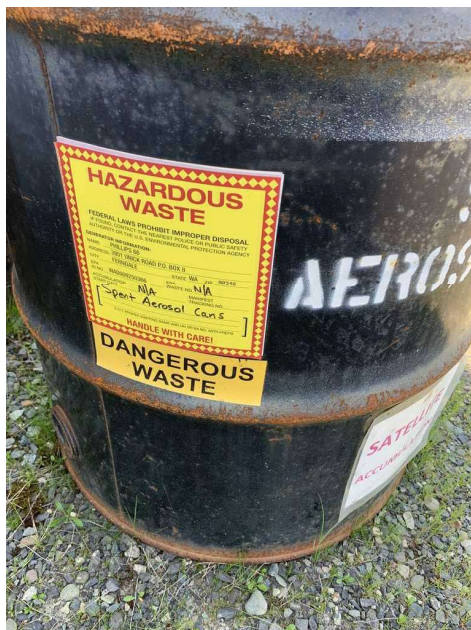
| [Title] | | | IMG_1101.jpg |

| Close-up view of the labeling on the 55-gallon waste aerosol can SAA, seen in photo IMG_1099. | | | |

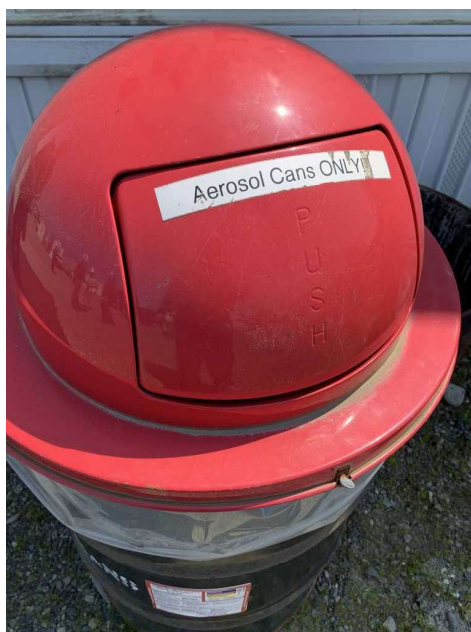
| [Title] | | | IMG_1104.jpg |

| Close-up view of the swinging door type lid on the 55-gallon waste aerosol SAA, seen in photo IMG_1099.jpg, showing how the swinging door doesn't make a complete seal even when in the closed position. | | | |

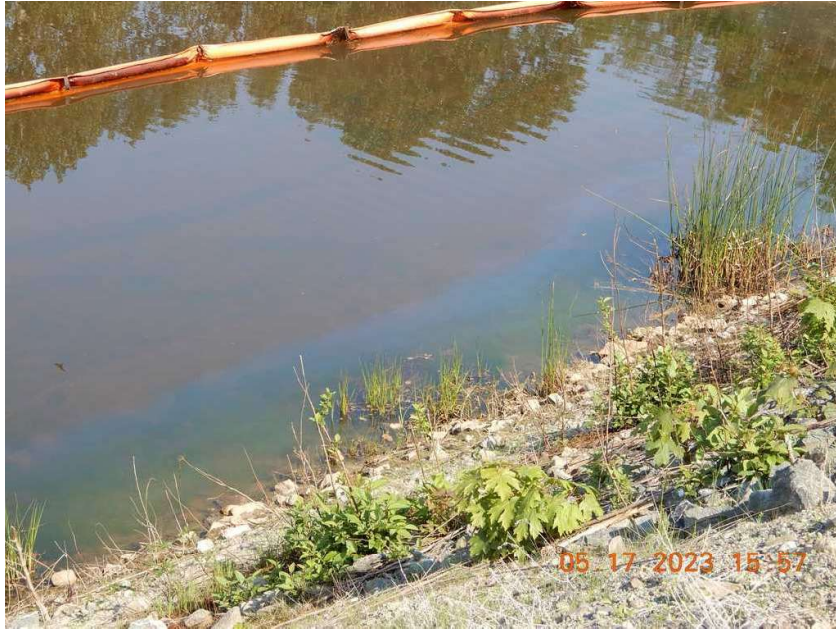
| [Title] | | | DSCN0708.JPG |

| vegetation inside the spill basin, near the water, with some very dark brown staining as well as an oily discharge we observed flowing from a black pipe into the spill basin. If this discharge is from either of the process sewers, then process wastewaters are entering the spill basin during a period that would not be from wet weather flow. This would result in the spill basin receiving wastewaters that generate F037 primary separation sludge. | | |

| View of discharge out of pipe to Spill Basin from oily water sewer lift station. | | | |

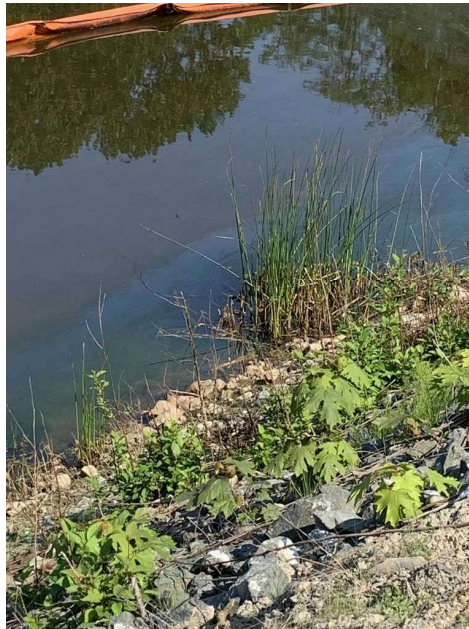
| [Title] | | | IMG_1122.jpg |

| Another view of discharge out of pipe to Spill Basin from oily water sewer lift station. | | | |

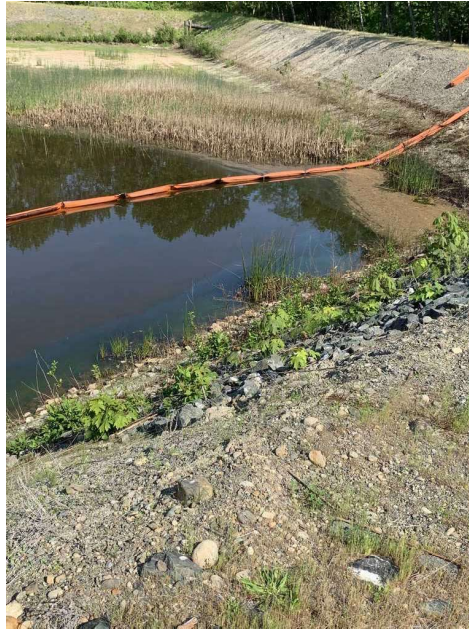
| [Title] | | | IMG_1123.jpg |

| View of the discharge sheen coming from the lift station discharge pipe. | | | |

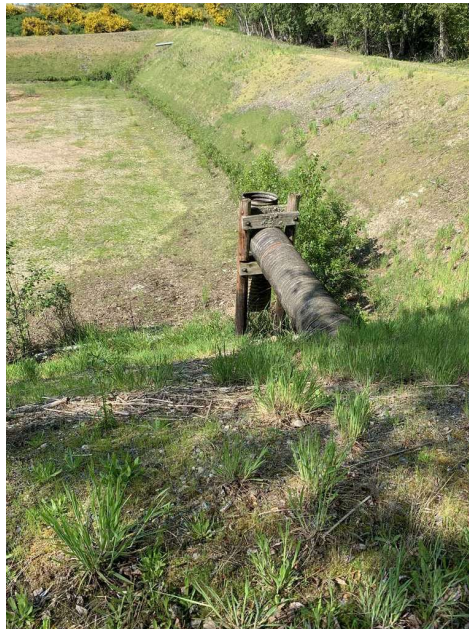
| [Title] | | | IMG_1129.jpg |

| Another view of the overflow pipe. | | | |

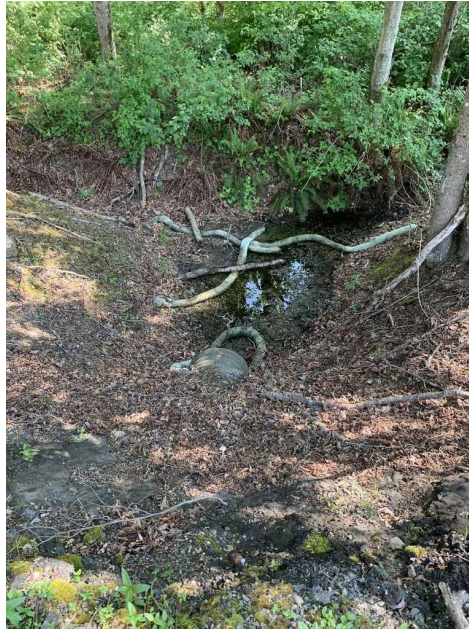
| [Title] | | | IMG_1130.jpg |

| View of outlet of overflow pipe from Spill Basin to wooded area. | | | |

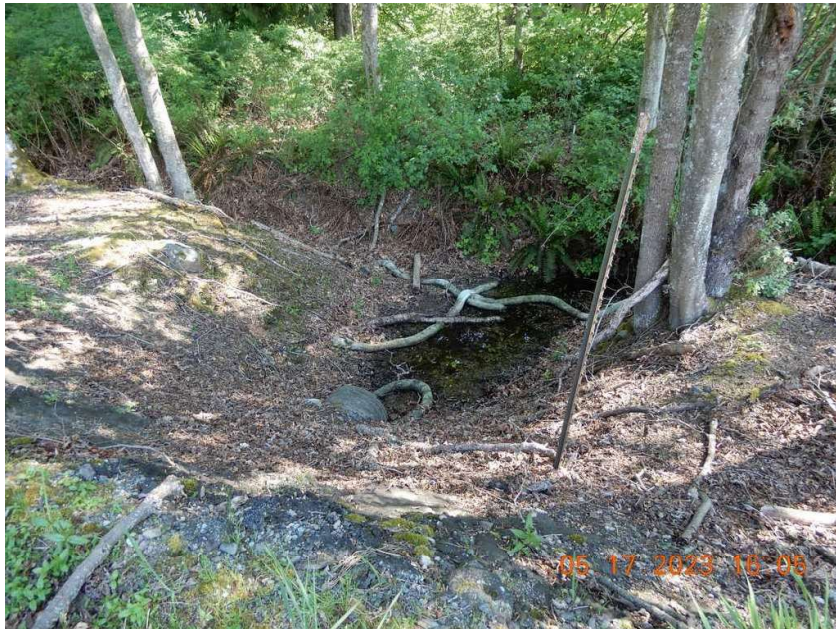
| [Title] | | | DSCN0713.JPG |

| View of outlet of overflow pipe from Spill Basin to wooded area. | | | |

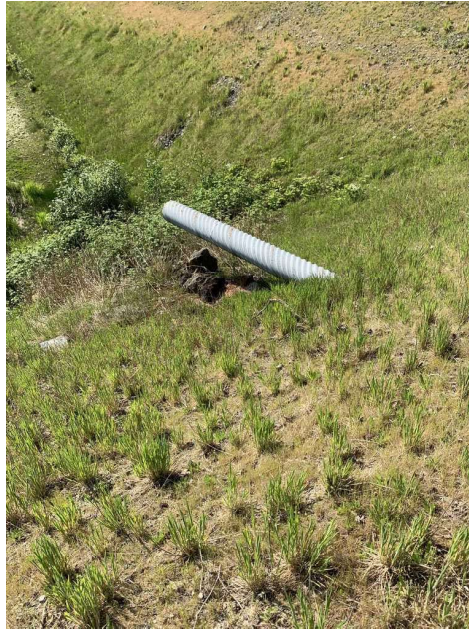
| [Title] | | | IMG_1131.jpg |

| Closer view of unidentified inlet pipe to Spill Basin, first seen in photo DSCN0712.JPG at the top of page 115 of 175. | | | |

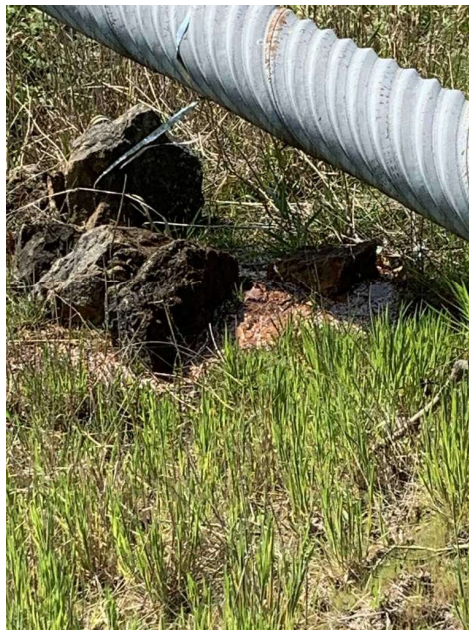
| [Title] | | | IMG_1132.jpg |

| Closer view of unidentified inlet pipe to Spill Basin, seen in photo IMG_1131.jpg above. | | | |

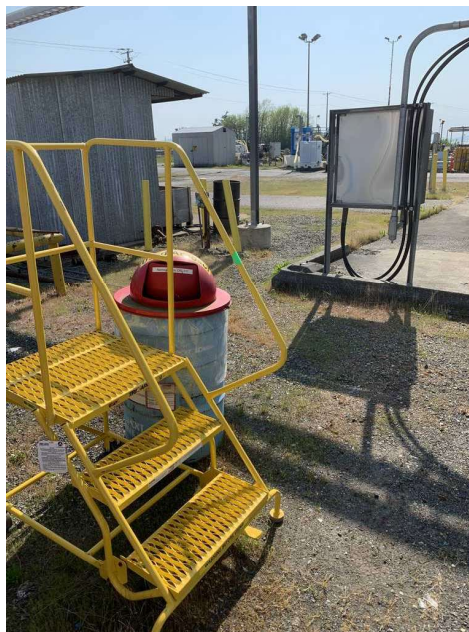
| [Title] | | | IMG_1136.jpg |

| View of the waste aerosol SAA container outside of the WWTP Shop, seen here with the same style of lid that does not make a complete seal with the container when closed. | | | |

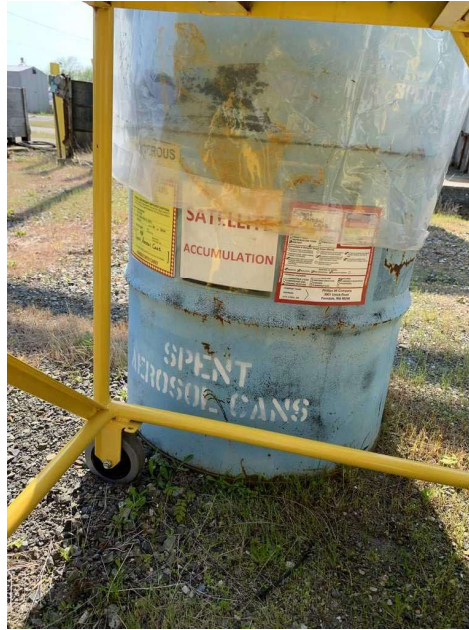
| [Title] | | | IMG_1137.jpg |

| View of the labeling on the waste aerosol SAA container. | | | |

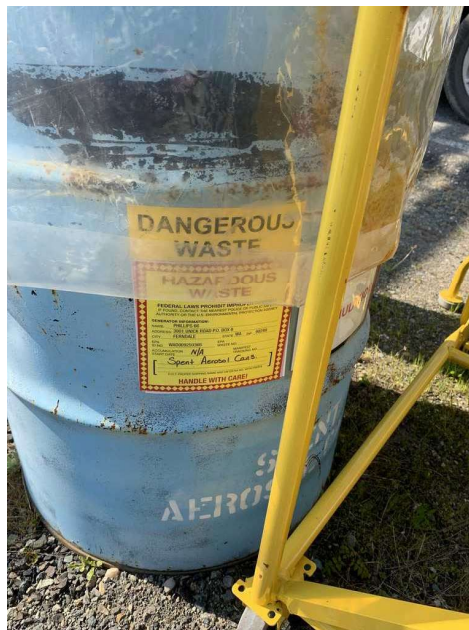
| [Title] | | | IMG_1138.jpg |

| Another view of the labeling on the waste aerosol SAA container. | | | |

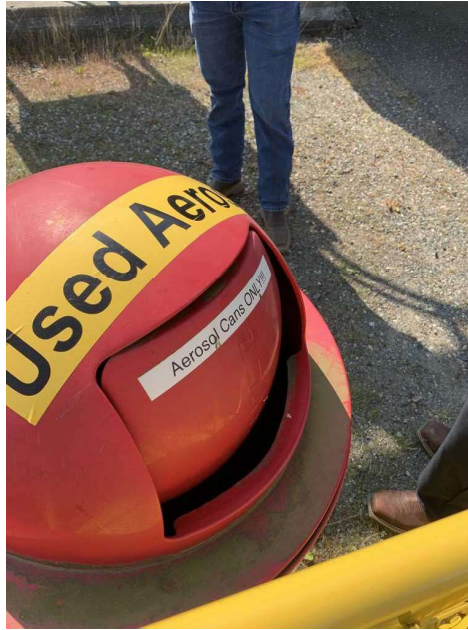
| [Title] | | | IMG_1139.jpg |

| A close-up view of the waste aerosol SAA container outside of the WWTP Shop, seen here with the same style of lid that does not make a complete seal with the container when closed. | | | |

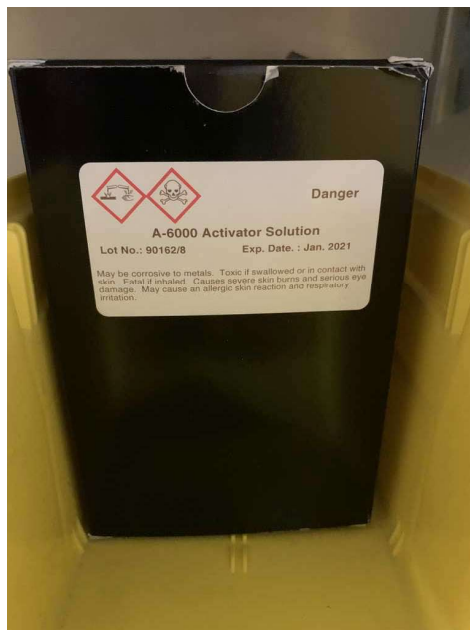
| Lab/North Connex | | | 48.83161111, -122.69049722 |

| View of a container of expired sodium hydroxide, seen here with an expiration date of November 2021. | | | |

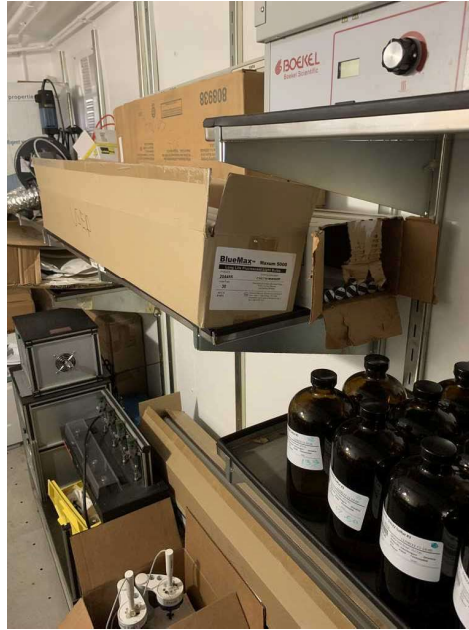
| Lab/South Connex | | | 48.83161111, -122.69036111 |

| View of waste fluorescent lamps in a container, seen here on the floor, that is not closed and not labeled universal waste lamps. The open box of waste lamps had also been in storage for greater than 2 years. | | | |

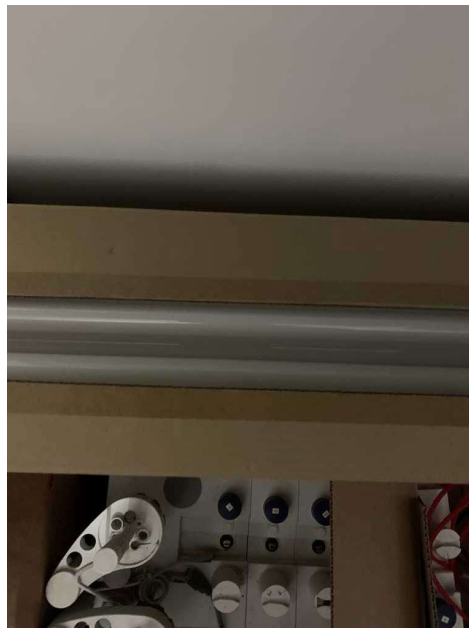
| Lab/South Connex | | | 48.83157777, -122.69031388 |

| View of waste fluorescent lamps in a container, seen here on the top shelf, that is not closed and not labeled universal waste lamps. The open box of waste lamps had also been in storage for greater than 2 years. | | | |

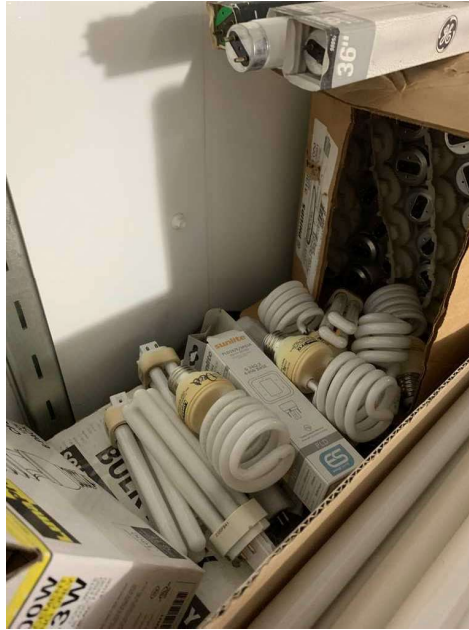
| Lab/South Connex | | | 48.83115277, -122.69178055 |

| Close-up view of the waste lamps in the container that's not closed and the waste CFLs that are not packaged. Both seen here not labeled as universal waste lamps and in storage greater than 2 years. | | | |

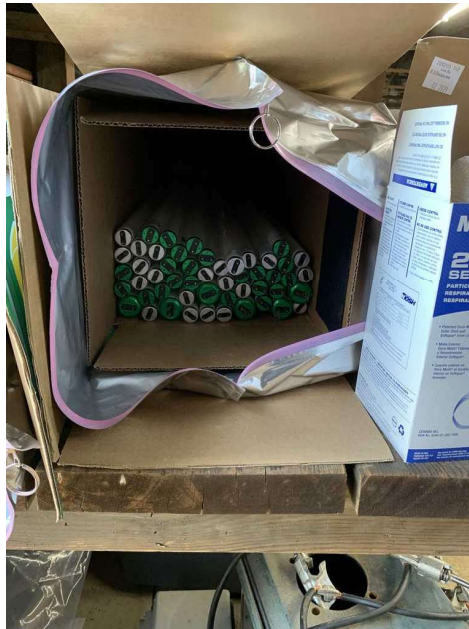
| Spent fluorescent lamp storage | | | 48.82668333, -122.69506944 |

| View of a container of universal waste lamps that is seen here not closed. | | | |

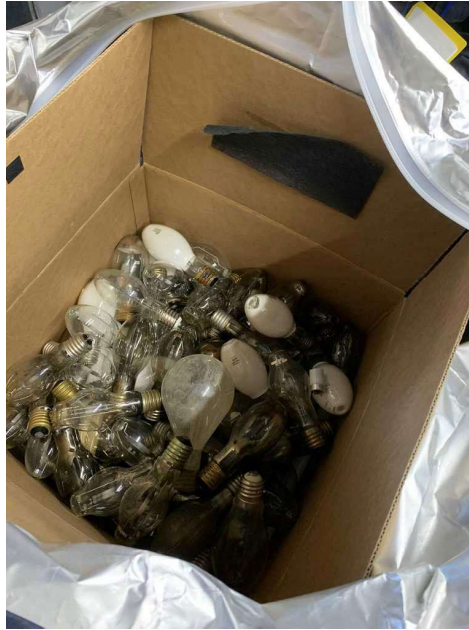
| Spent fluorescent lamp storage | | | 48.826225, -122.69421388 |

| View of a container of universal waste lamps that is seen here not closed. | | | |

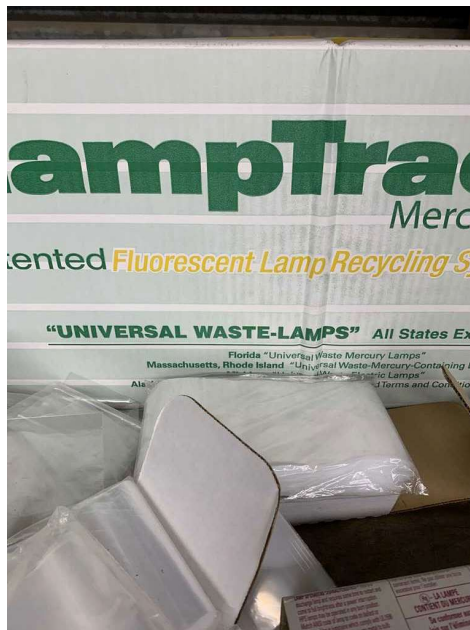
| Spent fluorescent lamp storage | | | 48.82603333, -122.69357222 |

| View of a container of universal waste High-pressure sodium lamps that is seen here not closed. | | | |

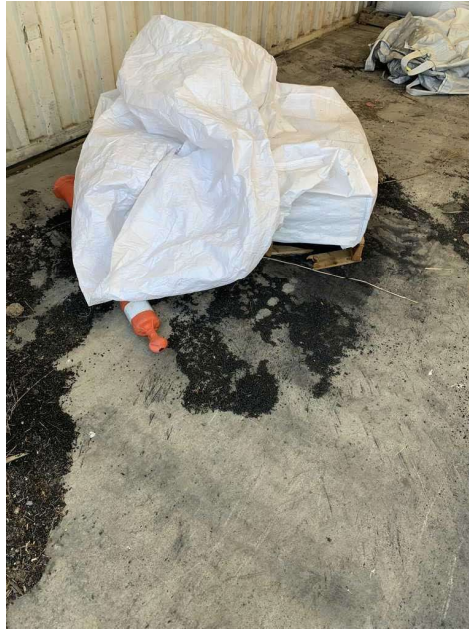
| Spent carbon storage area | | | 48.82910277, -122.70494166 |

| View of spent carbon seen here on the ground, at the entrance of the storage area. | | | |

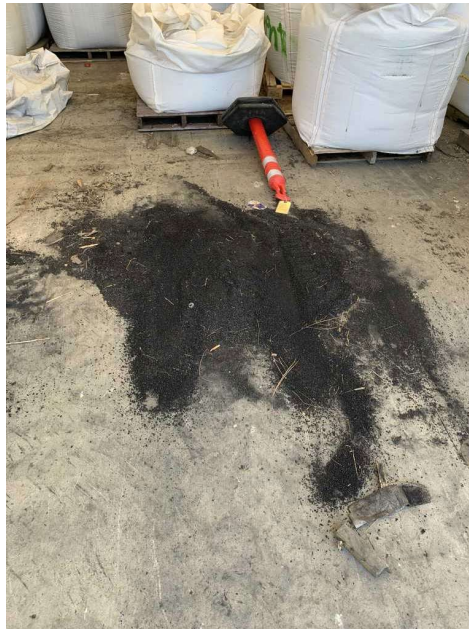
| Spent carbon storage area | | | 48.82910833, -122.70493333 |

| Another view of spent carbon seen here on the ground, at the entrance of the storage area. | | | |

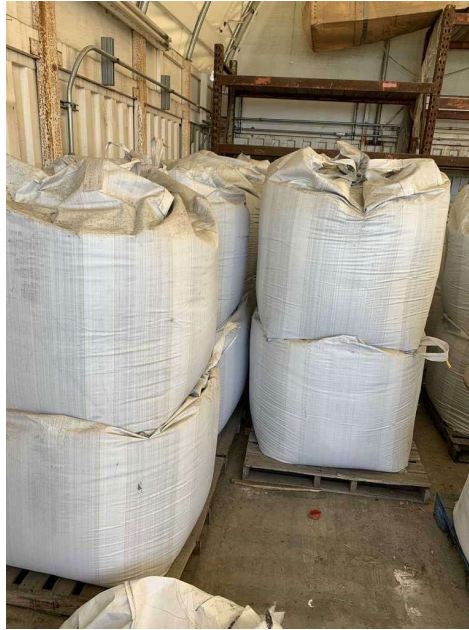
| Spent carbon storage area | | | 48.82911388, -122.70491666 |

| Another view of spent carbon seen here on the ground, at the entrance of the storage area. | | | |

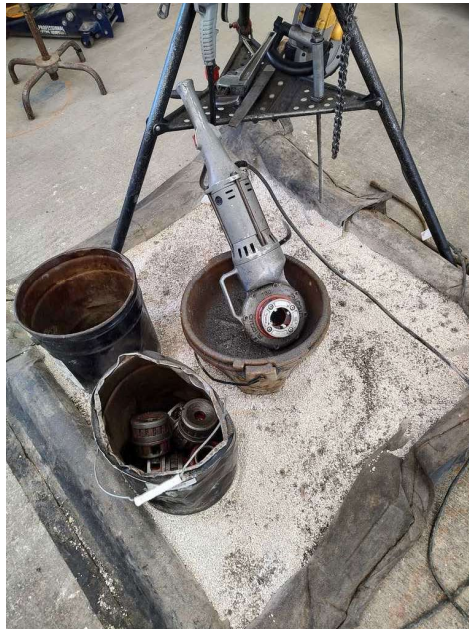
| View of the area after the waste metal shavings had been put into the SAA container. | | | |

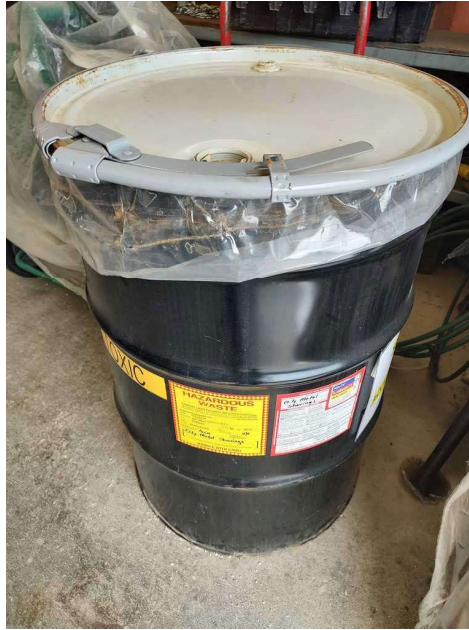
| View of the area after the waste metal shavings had been put into the SAA container. | | | |

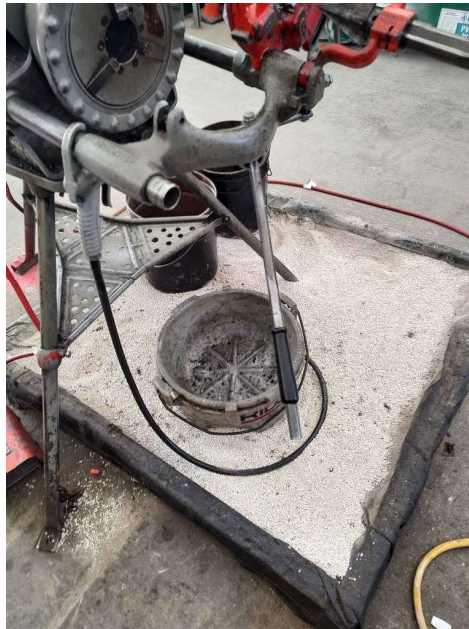
| View of SAA container after being closed. | | | |

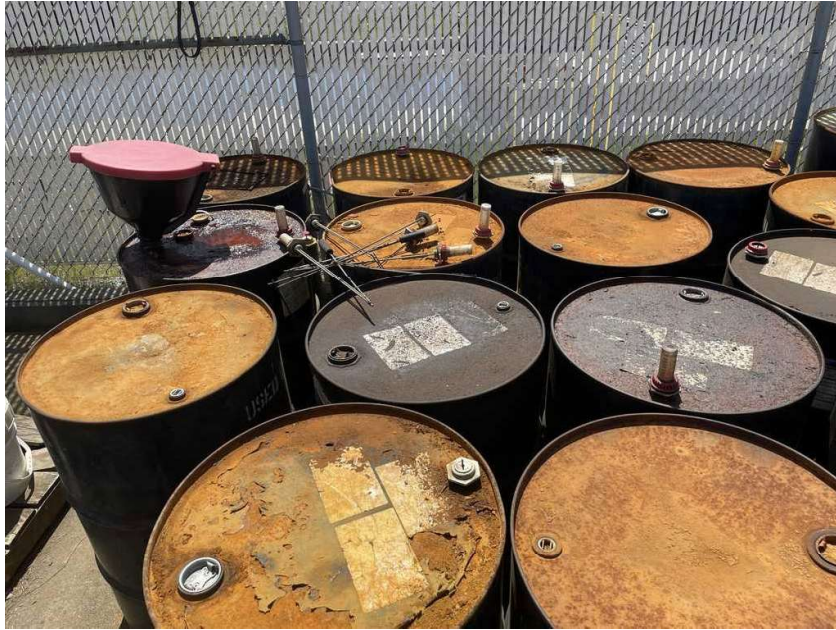
| View of container after the hazard indicator was added. | | | |

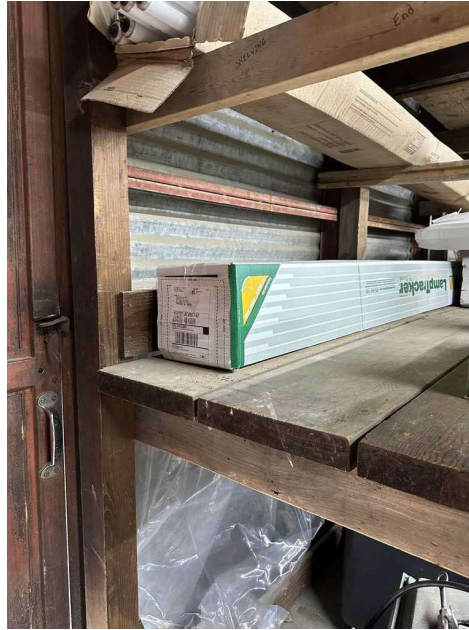
| View of corrective action taken by the facility to close containers of universal waste lamps. | | | |

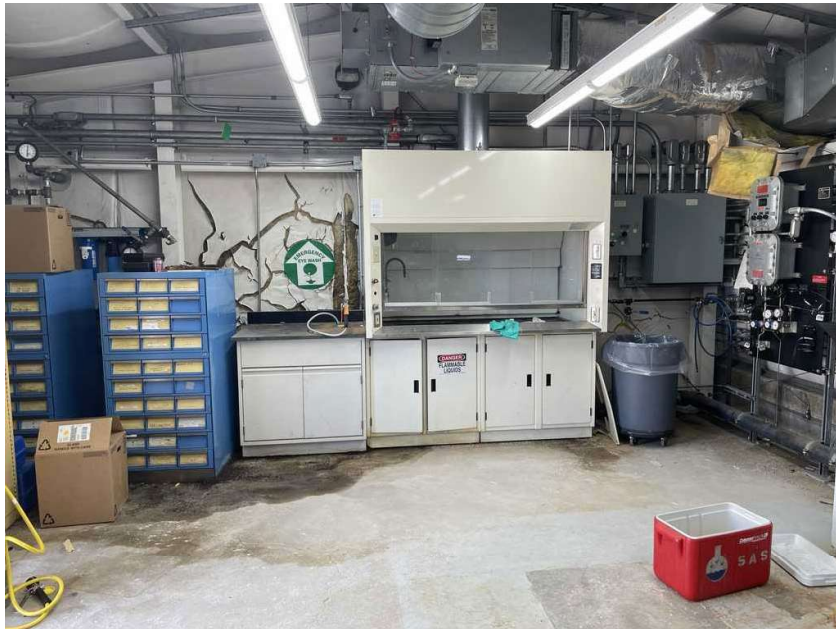
| Photo documents the removal of the waste gas samples. | | | |

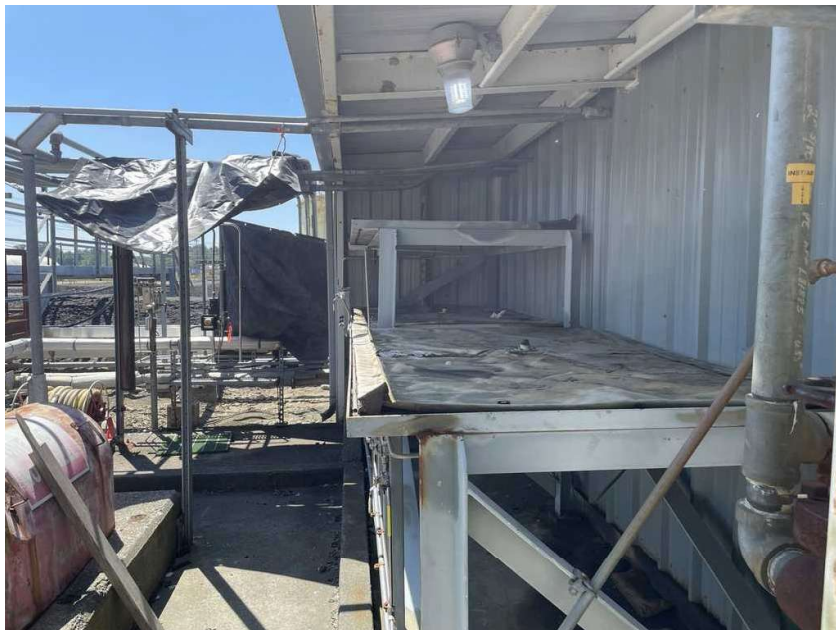
| Photo documents that the area was cleaned up. | | | |
