## Clean Water Act Section 404: Site Visit/Case Development

| Site Name | Care365 Realty, LLC Property | | | | |
| Site Address* | 272 NY State Route 59 (Tax ID: 55.12-1-5) | | | | |

| Inspection Purpose | Initial site visit | | |

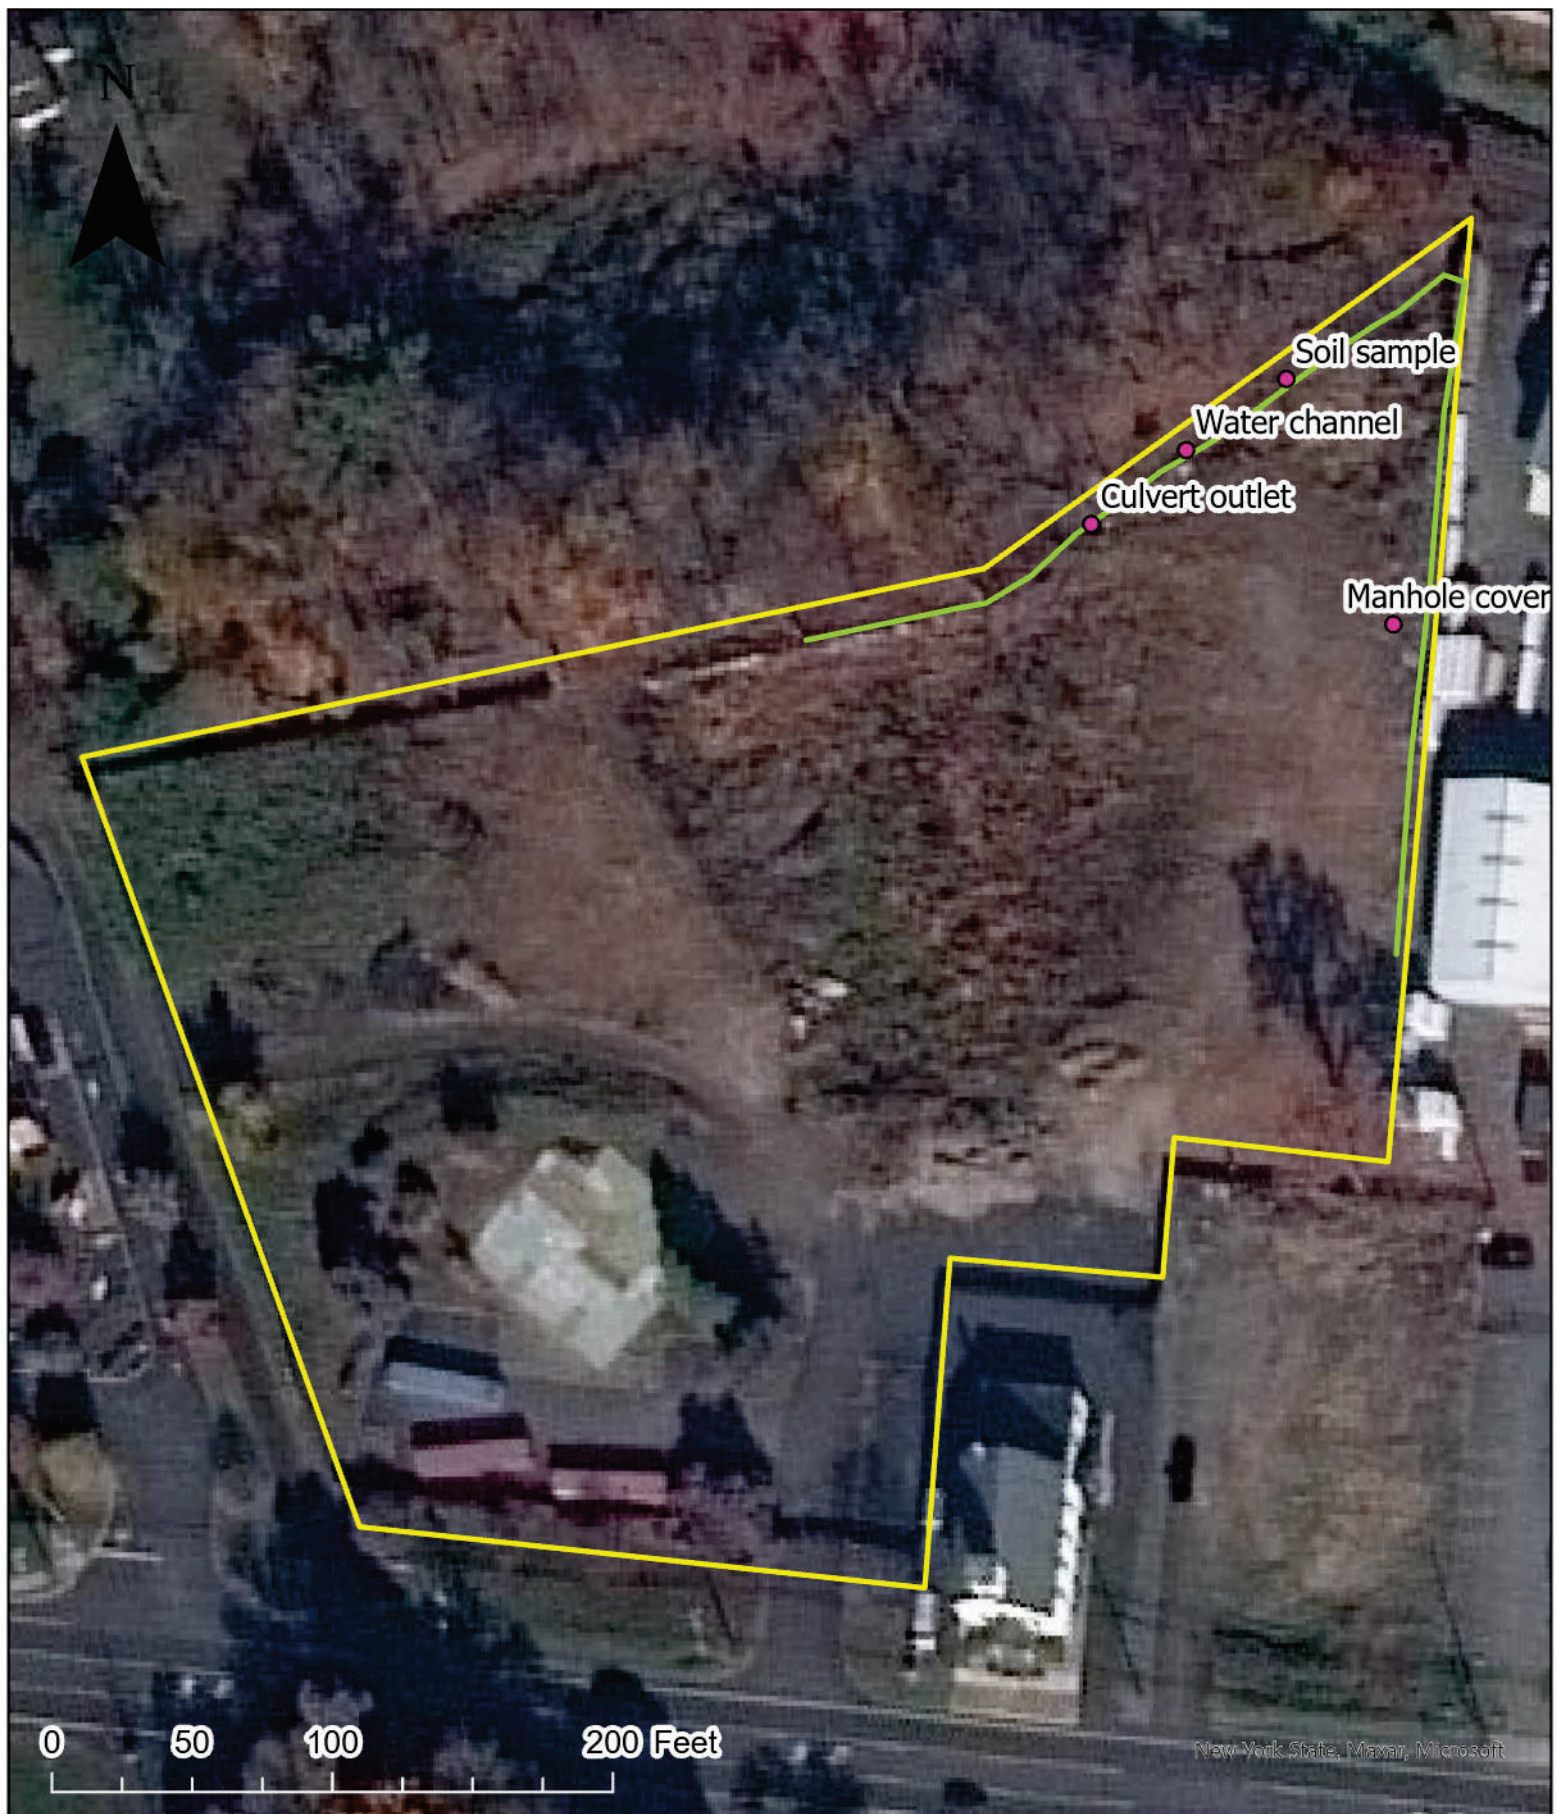
6/24/2024 EPA CWA 404 INSPECTION  
MAP OF RECORDED GPS DATA  
Care365 Realty, LLC Property  
Tallman, Rockland County, NY  
Tax ID: 55.12-1-5  
41.11250, -74.10256

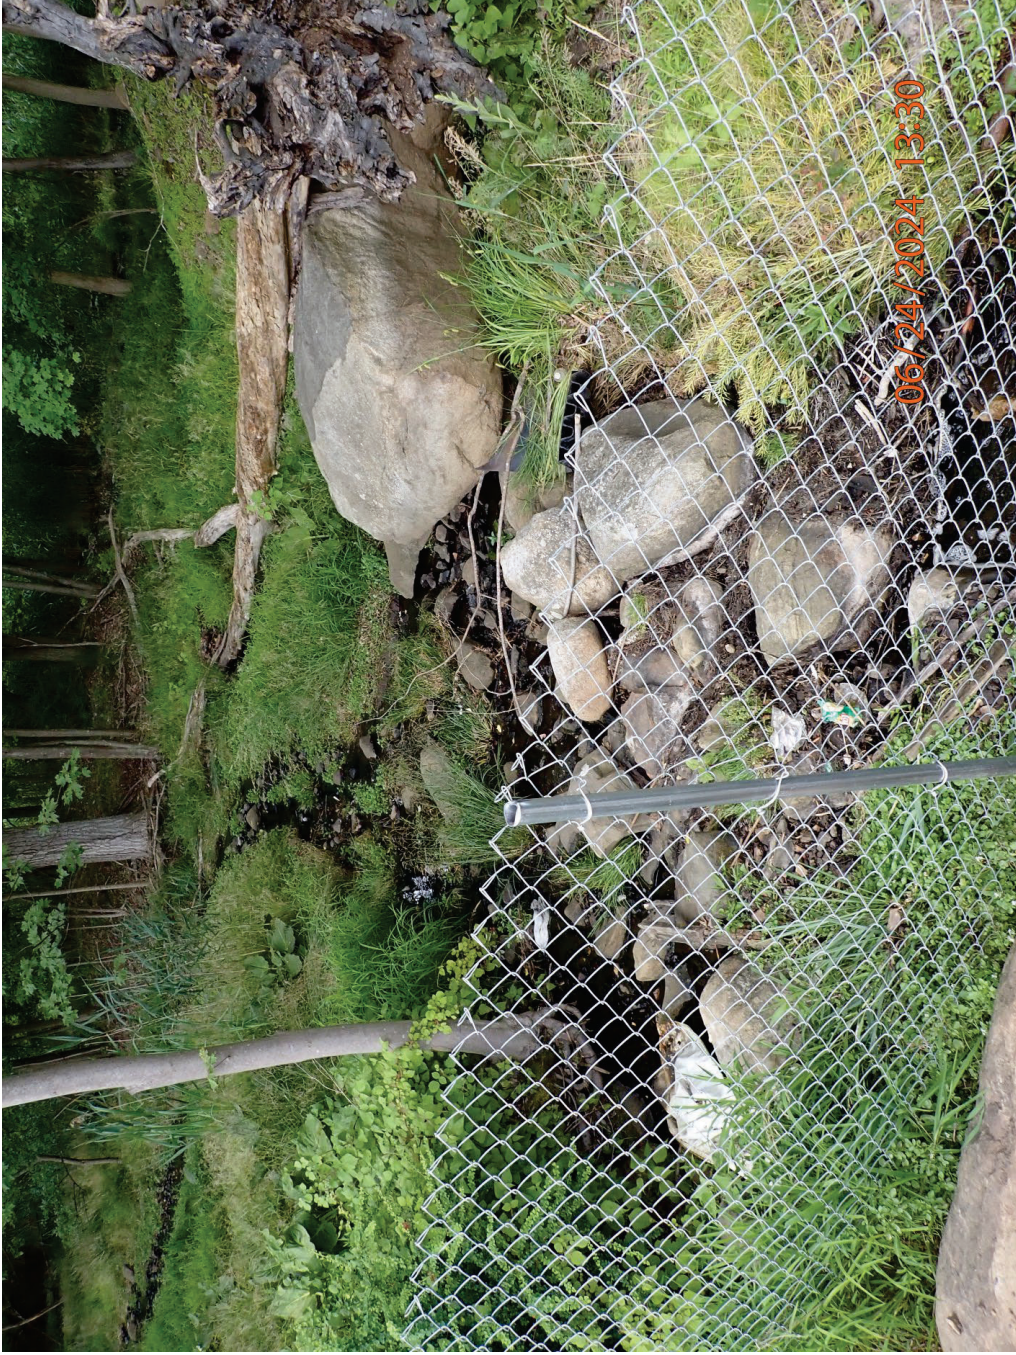
**Date:** 6/24/2024  
**Time:** 1:30 PM  
**Photographer:** S. Andreescu  
**Photo ID:** 1 – P6240560

**Description:**  
(1/8) Panorama of site

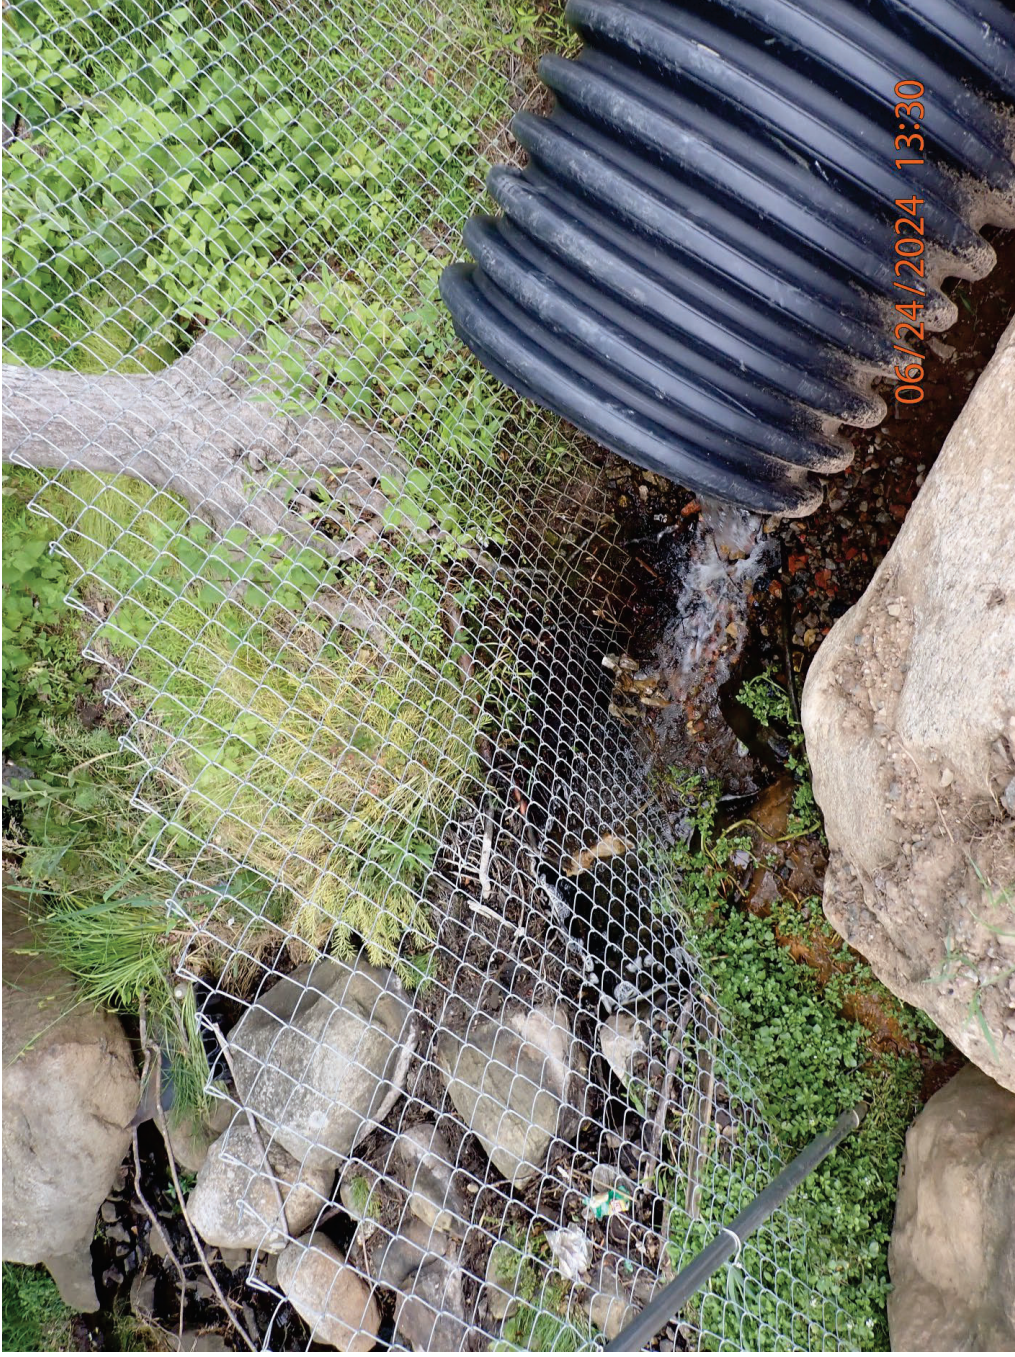
**Date:** 6/24/2024  
**Time:** 1:30 PM  
**Photographer:** S. Andreescu  
**Photo ID:** 2 – P6240561  
**Description:**  
(2/8) Panorama of site

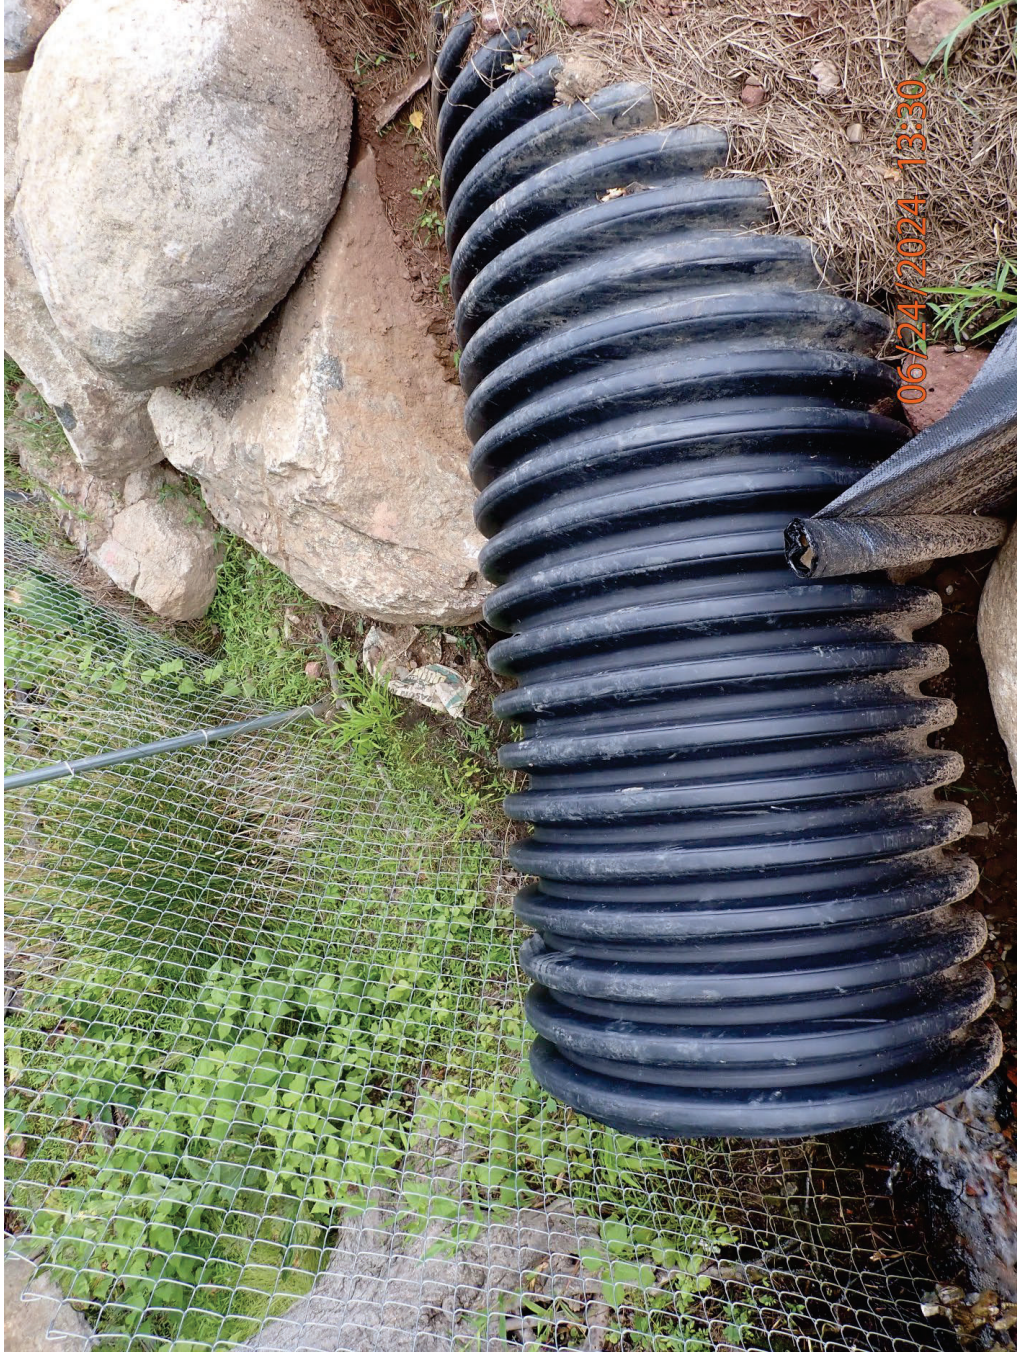
**Date:** 6/24/2024  
**Time:** 1:30 PM  
**Photographer:** S. Andreescu  
**Photo ID:** 3 – P6240562

**Description:**  
(3/8) Panorama of site

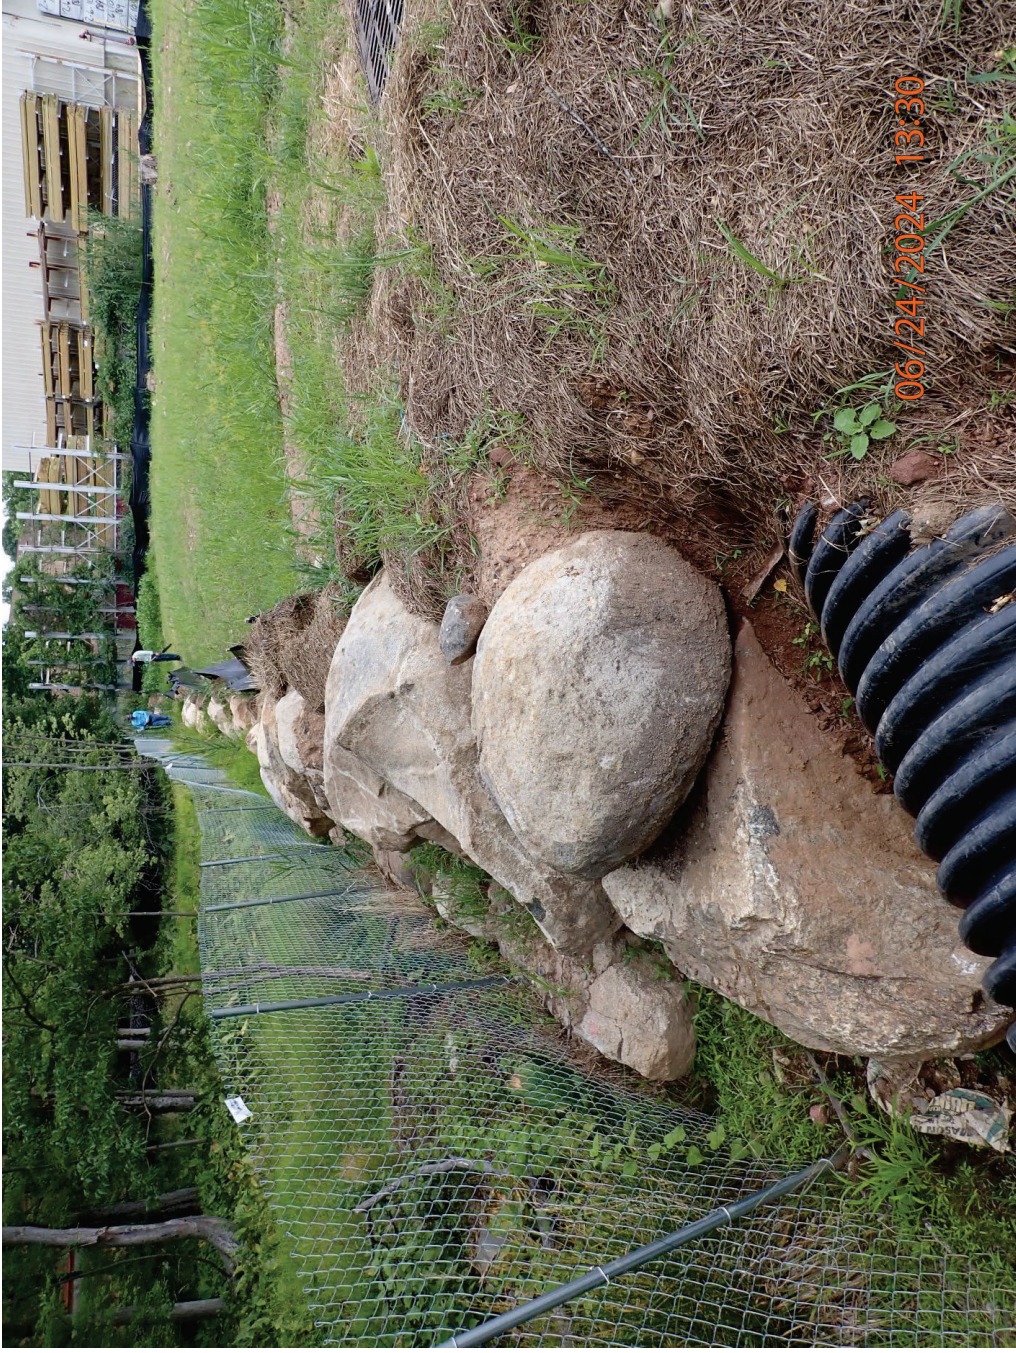
**Date:** 6/24/2024  
**Time:** 1:30 PM  
**Photographer:** S. Andreescu  
**Photo ID:** 4 – P6240563  
**Description:**  
(4/8) Panorama of site

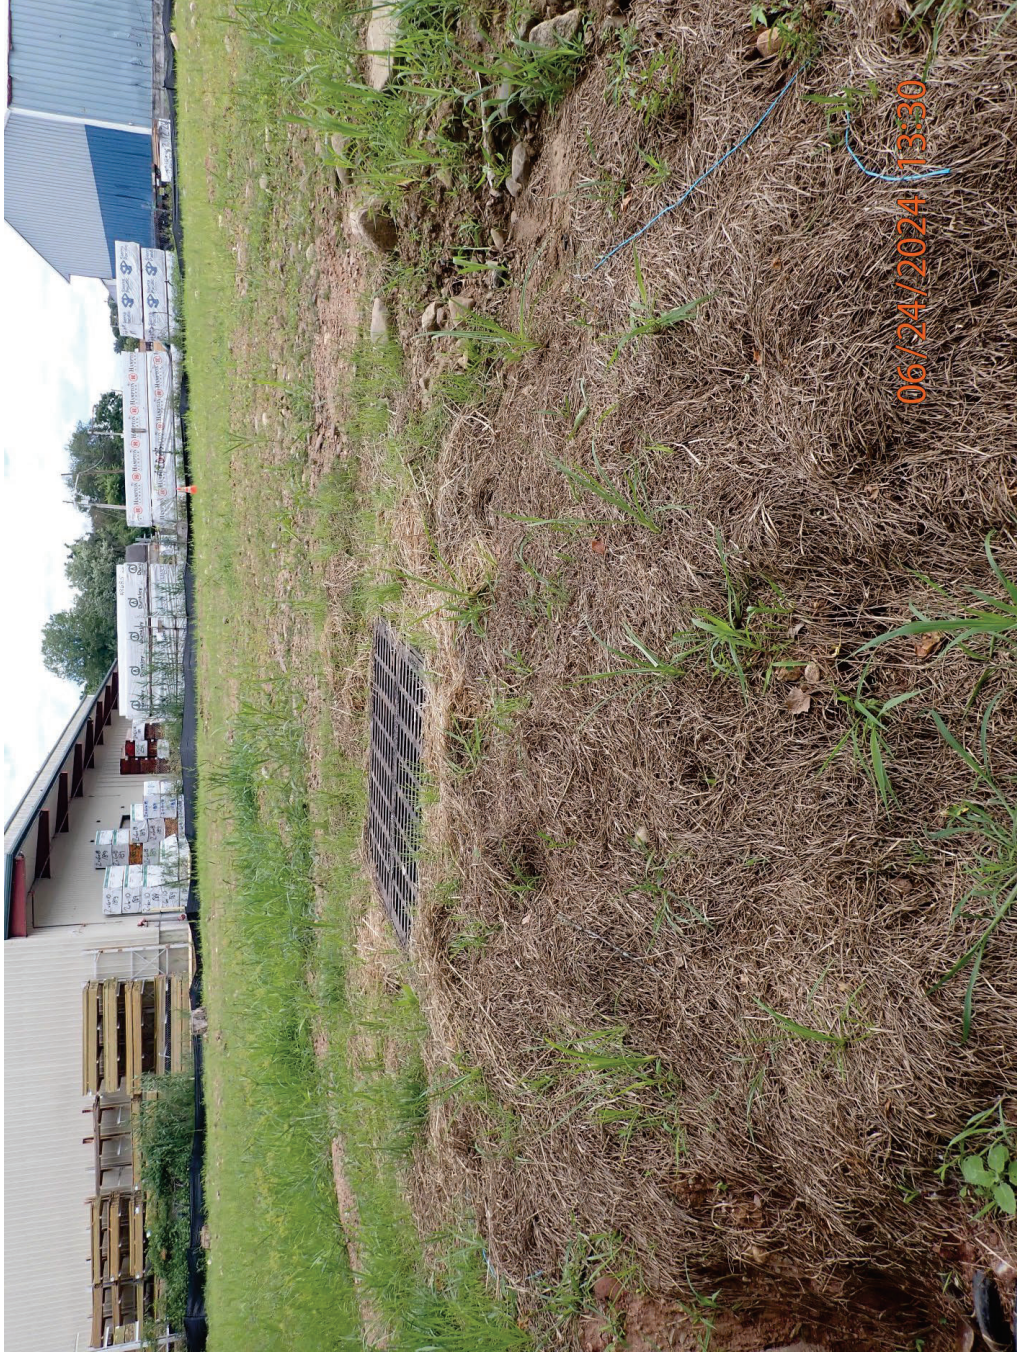
**Date:** 6/24/2024  
**Time:** 1:30 PM  
**Photographer:** S. Andreescu  
**Photo ID:** 5 – P6240564

**Description:**  
(5/8) Panorama of site

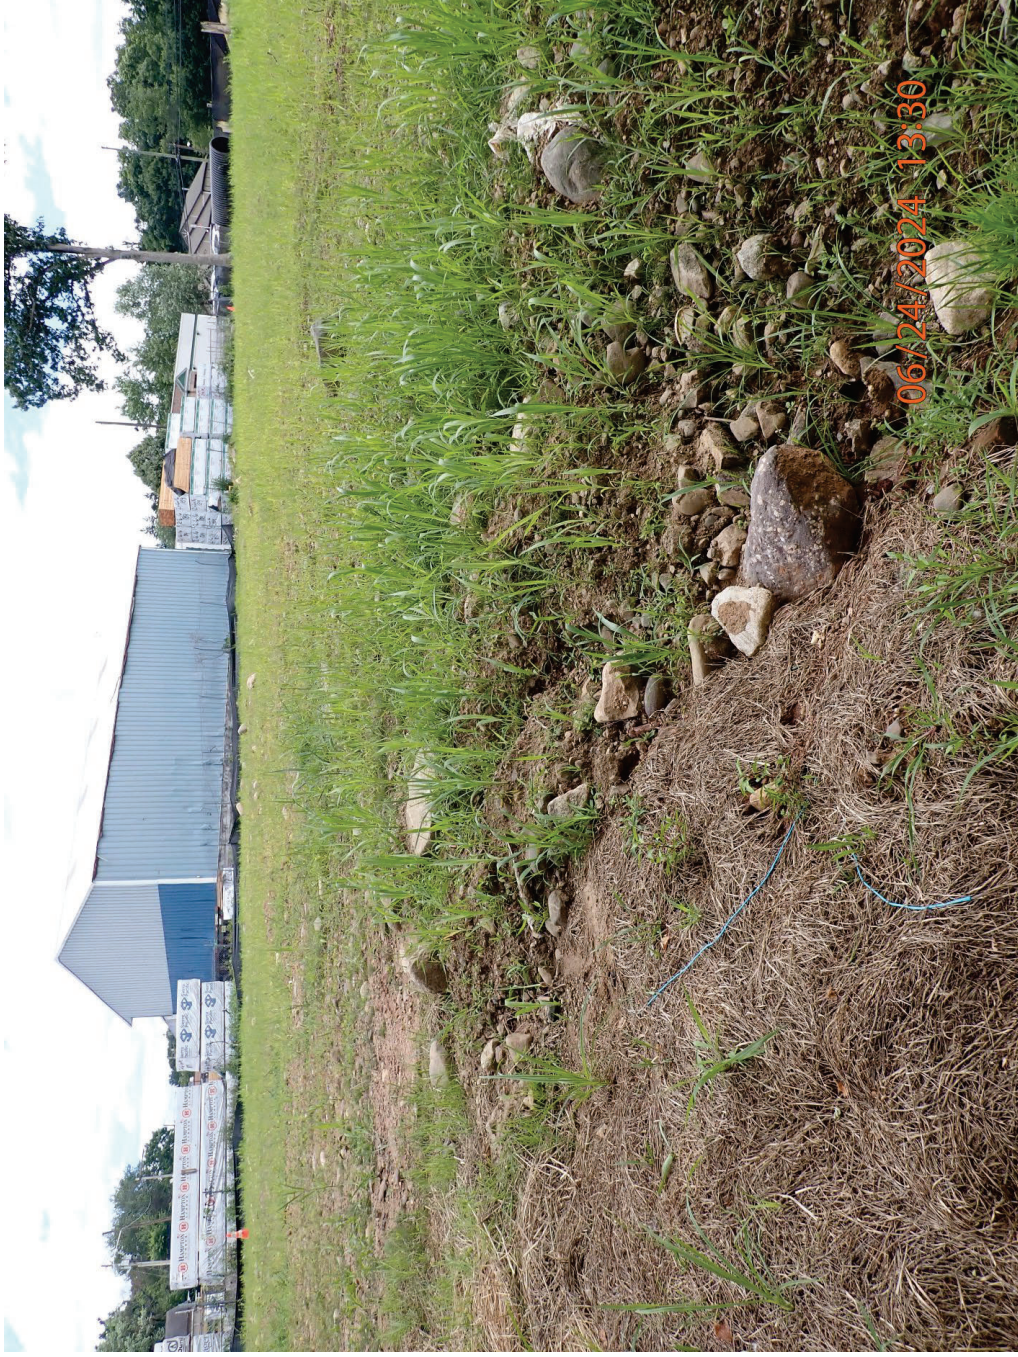
**Date:** 6/24/2024  
**Time:** 1:30 PM  
**Photographer:** S. Andreescu  
**Photo ID:** 6 – P6240565  
**Description:**  
(6/8) Panorama of site

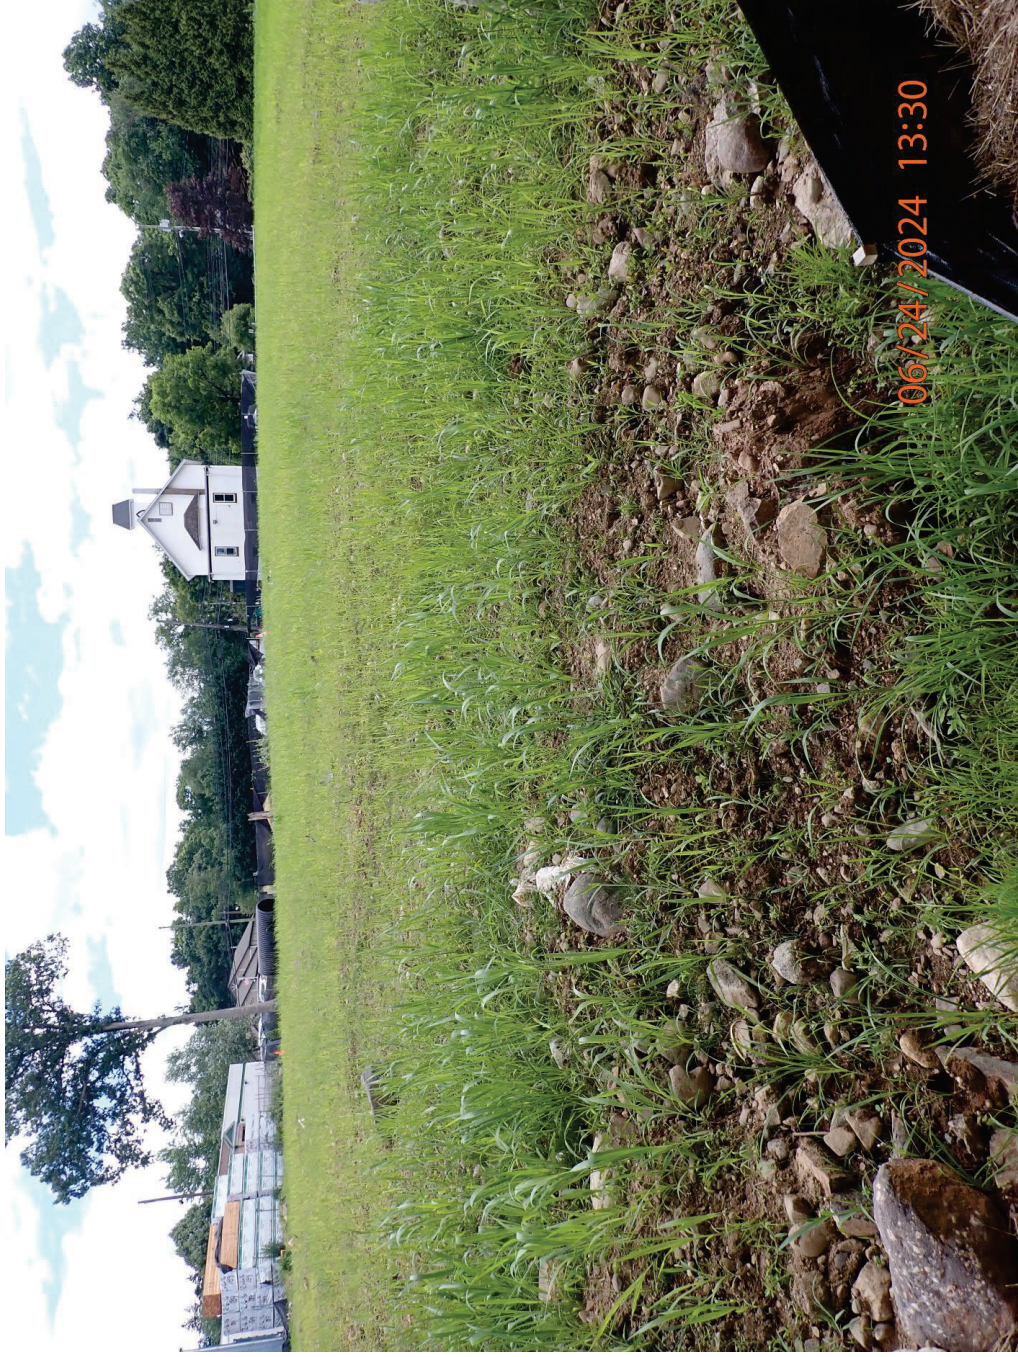
**Date:** 6/24/2024  
**Time:** 1:30 PM  
**Photographer:** S. Andreescu  
**Photo ID:** 7 – P6240566  
**Description:**  
(7/8) Panorama of site

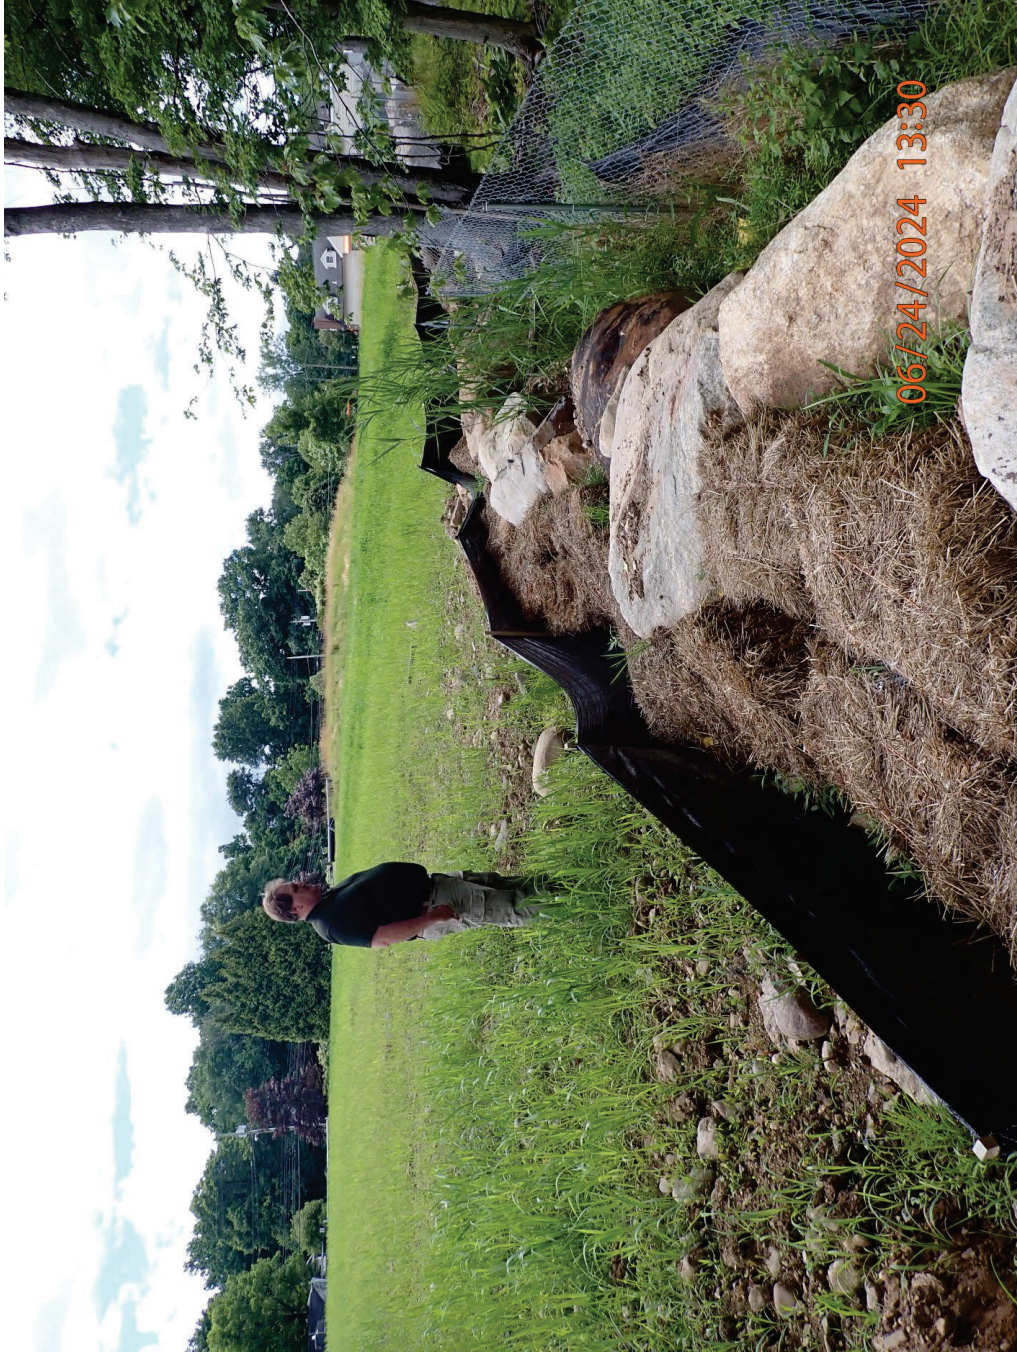
**Date:** 6/24/2024  
**Time:** 1:30 PM  
**Photographer:** S. Andreescu  
**Photo ID:** 8 – P6240567

**Description:**  
(8/8) Panorama of site

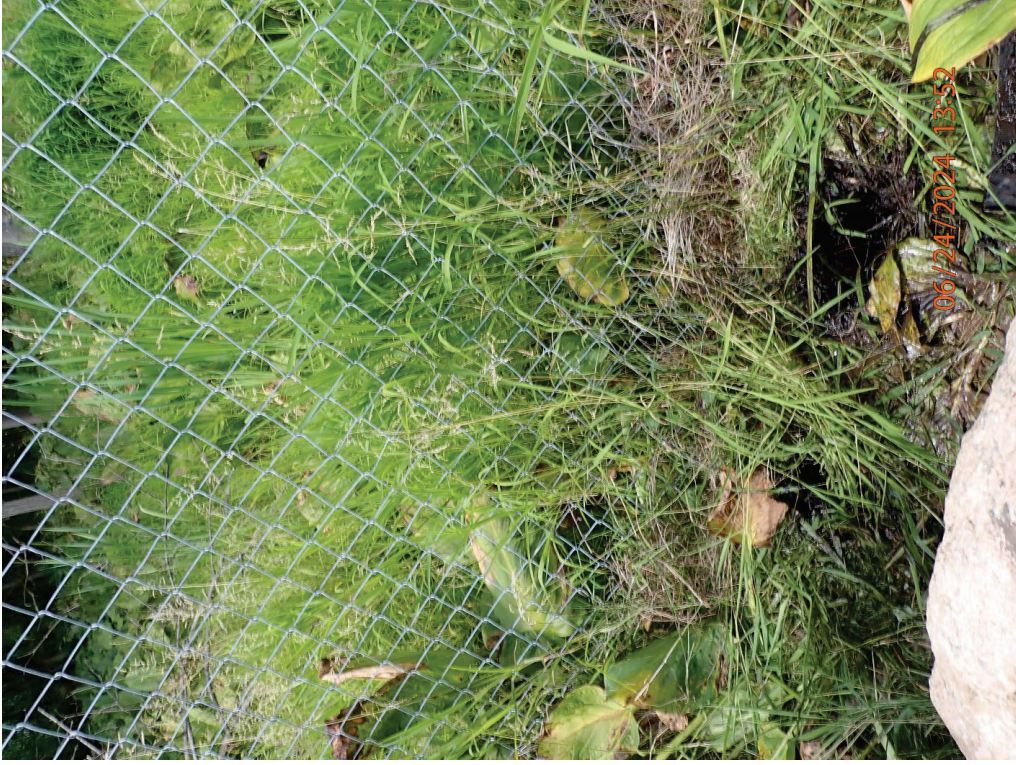
**Date:** 6/24/2024  
**Time:** 1:52 PM  
**Photographer:** S. Andreescu  
**Photo ID:** 14 – P6240573  
**Description:**  
Soil pit location

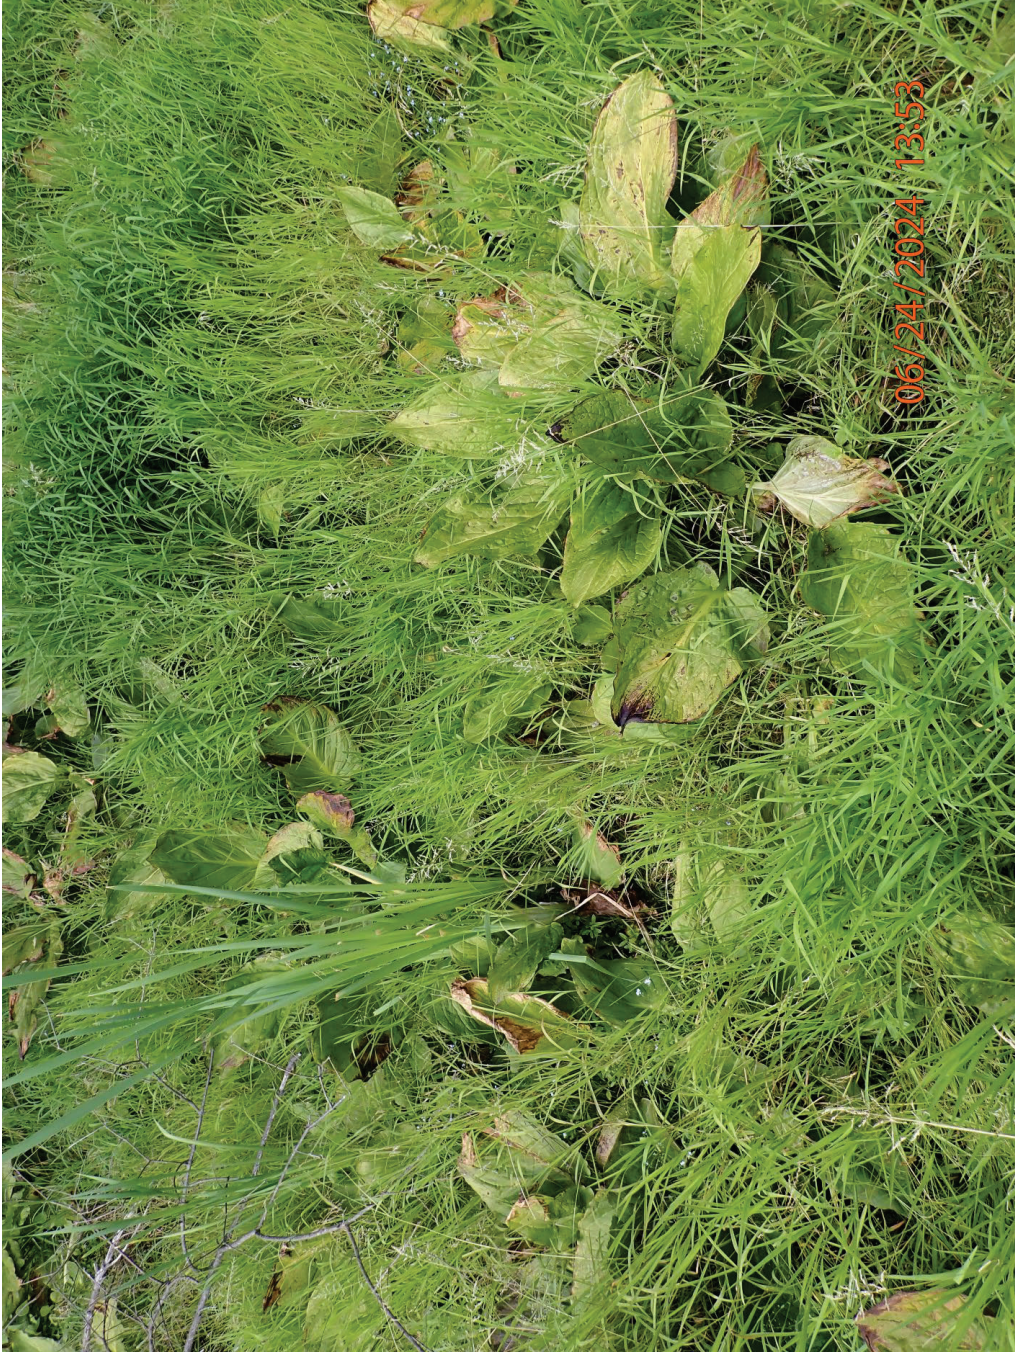
**Date:** 6/24/2024  
**Time:** 1:53 PM  
**Photographer:** S. Andreescu  
**Photo ID:** 15 – P6240574

**Description:**  
Soil pit location
