## INSPECTION REPORT

| Type of Inspection | Compliance Evaluation Inspection (CEI) | | |
| Company Name | Northern Star (POGO), LLC | | |

The facility was inspected to ensure compliance with standards for hazardous waste generators and universal waste management (40 C.F.R. Parts 262 through 273) and used oil management (40 C.F.R. Part 279). The inspection was conducted as part of a Core Program requirement for FY 2024.

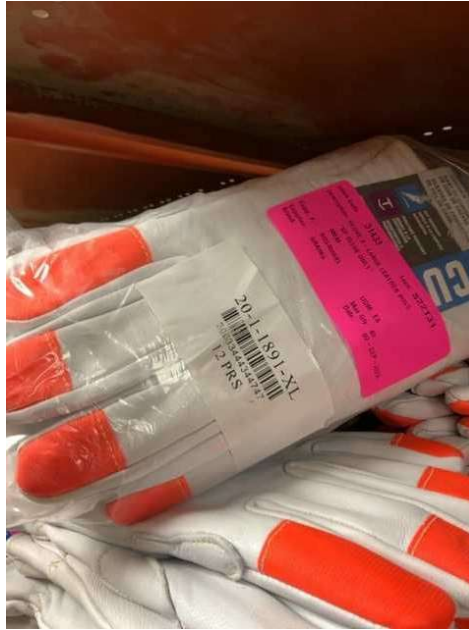
| Warehouse | | | 64.45365462, -144.90493454 |

| <b>Building:</b> Warehouse | <b>Area:</b> | <b>Sub-area:</b> |
|---|---|---|
| Failure to make a hazardous waste determination at the point of generation for waste leather gloves. | <b>Regulation:</b> | <b>Sections:</b> |

| Close-up view of leather gloves in stock for issue at the facility. | | | |

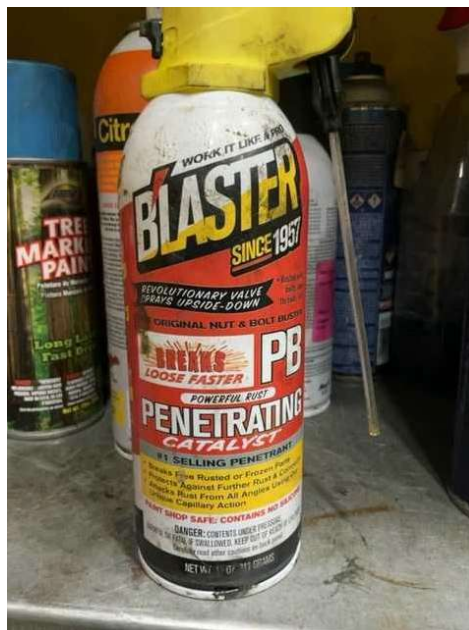
| Mobile Equipment Maintenance (MEM)/Yellow Flammable storage cabinet | | | 64.45365462, -144.90493454 |

| View of waste aerosol can in storage cabinet. | | | |

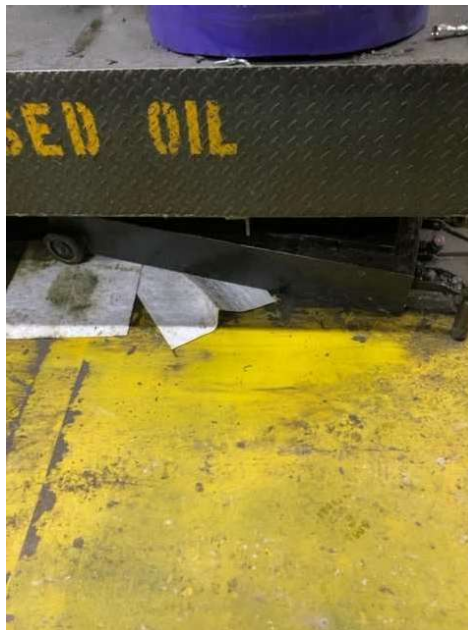
| Mobile Equipment Maintenance (MEM)/Yellow Flammable storage cabinet | | | 64.45365462, -144.90493454 |

| View of a used oil receiver that is not labeled with the words "Used Oil." | | | |

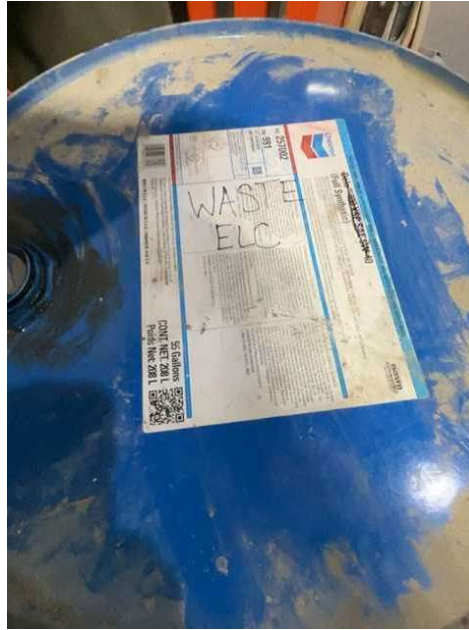
| #1875 Light Vehicle Shop | | | 64.45362822, -144.90491903 |

| View of container of used antifreeze. | | | |

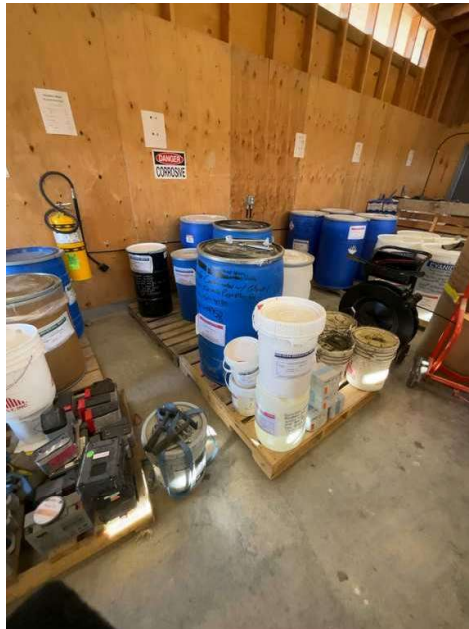
| Non-Flammable CAA | | | [Geographic Coordinates] |

| Another view of unlabeled universal waste batteries. | | | |

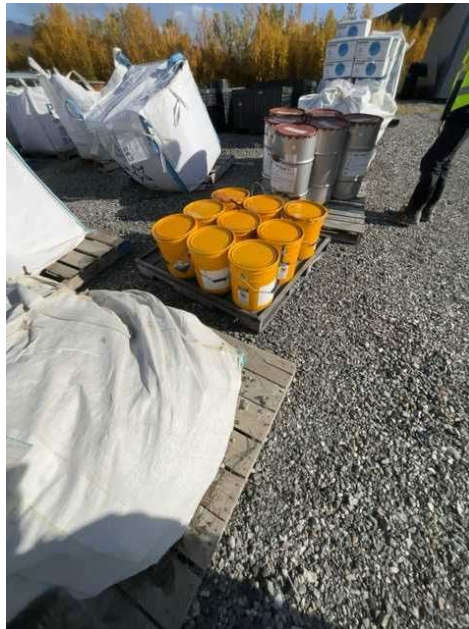
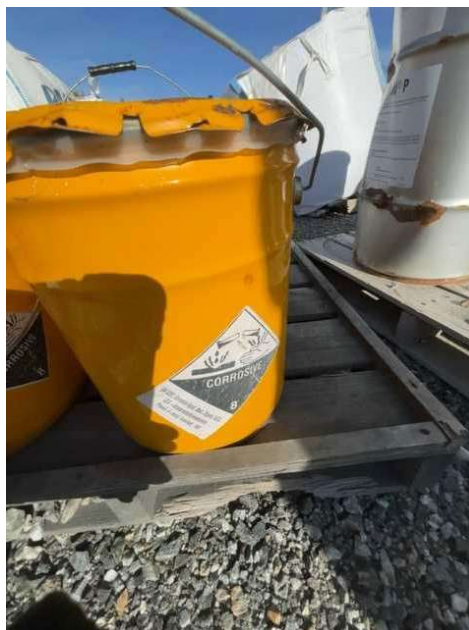
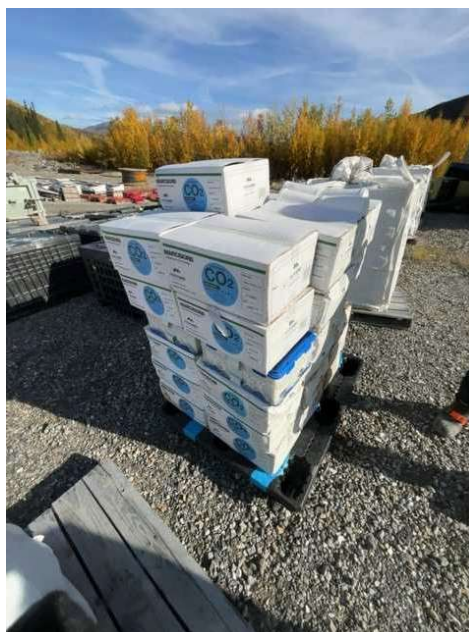
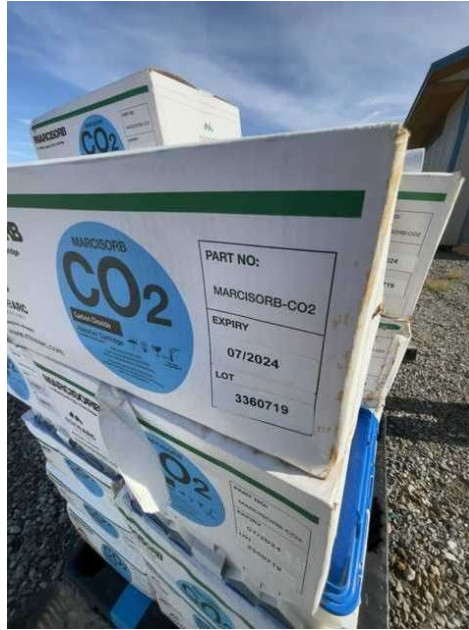
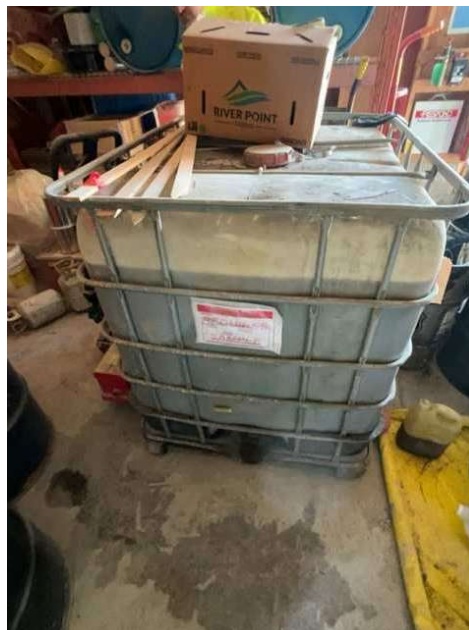
| Non-Flammable CAA/Area outside CAA | | | 64.45362822, -144.90491903 |

| Failure to make a hazardous waste determination at the point of generation. | <b>Regulation:</b> | <b>Sections:</b> |

| View of suspected wastes outside of the CAA. | | | |

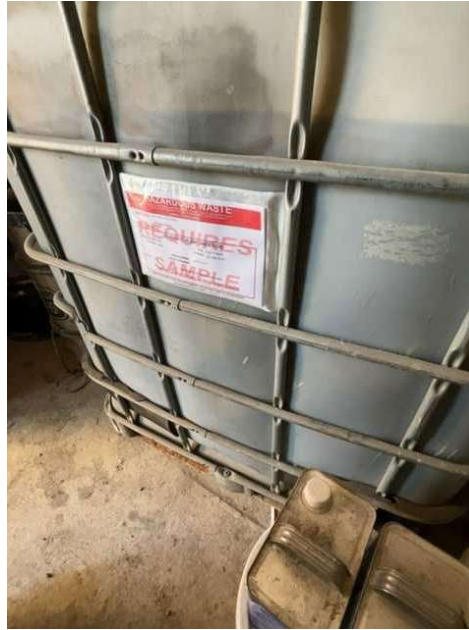
| Flammable CAA | | | 64.45362822, -144.90491903 |

2024. (At the time of the inspection, this IBC Tote was labeled with the words hazardous waste and marked with a hazard indicator.)

| Another view of the 375-gallon tote. | | | |

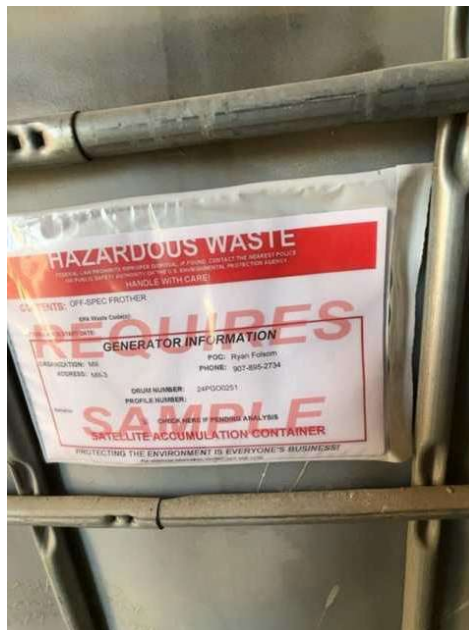
| Flammable CAA | | | 64.45362822, -144.90491903 |

| Another view of the labeling on the 375-gallon tote. | | | |

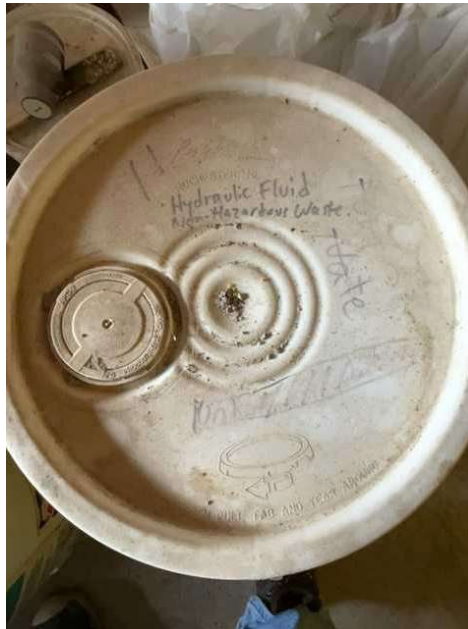
| Flammable CAA | | | 64.45362822, -144.90491903 |

| <p>A five-gallon container of waste hydraulic fluid not labeled with the words "Used Oil."</p> <p>Failure to make a hazardous waste determination at the point of generation for multiple containers in various sizes that appeared to be inherently waste-like. There was no indication as to how long the suspected wastes had been onsite.</p> | <b>Regulation:</b> | <b>Sections:</b> |

| A five-gallon, yellow container of waste hydraulic fluid not labeled with the words "Used Oil." | | | |

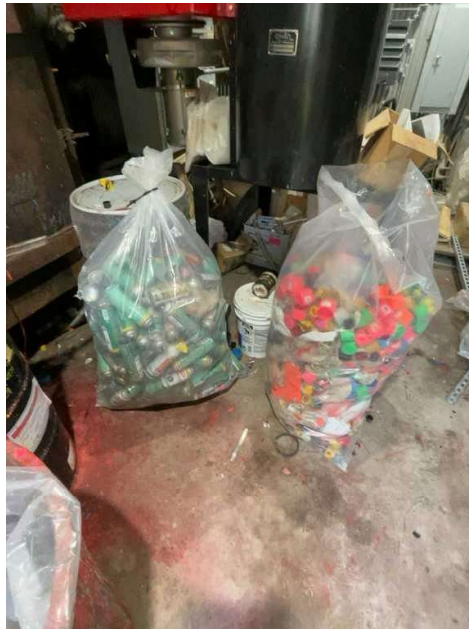
| Old Incinerator/ Aerosol Puncturing Area | | | 64.45362822, -144.90491903 |

There were also another 22 waste aerosol cans on top of a 55-gallon container that was labeled "Universal Waste - Aerosols." These 22 loose waste aerosol cans were also not labeled or clearly marked with any of the phrases previously mentioned.

| <p>At the time of the inspection there were four bags of waste aerosol cans and another 22 loose waste aerosols on top of a container that were not labeled or clearly marked with any of the following phrases: "Universal Waste – Aerosol," "Used Aerosol," or "Waste Aerosol."</p> <p>Failure to maintain and operate with regard to a SAA container being used to accumulate waste aerosol can residue. There was a significant amount of aerosol can residue that had been released in and around the area where the aerosol can were punctured.</p> | <b>Regulation:</b> | <b>Sections:</b> |

| View of 22 waste aerosol cans on top of a universal waste container, seen here not labeled. | | | |

All aerosol bags noted during the inspection have been punctured. Incoming Aerosols Connex is completely empty as of September 25, 2024 – see Attachment 5.

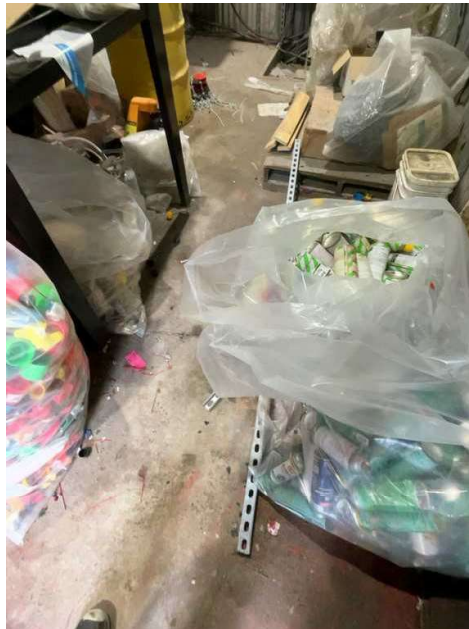
| Old Incinerator/ Aerosol Puncturing Area | | | 64.45362822, -144.90491903 |

| Another view of the same bag of waste aerosol cans seen in the previous photo. | | | |

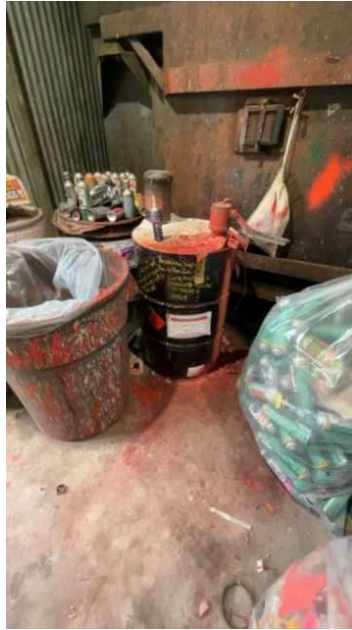
| Old Incinerator/ Aerosol Puncturing Area | | | 64.45362822, -144.90491903 |

| A view of two additional bags of unlabeled waste aerosol cans. | | | |

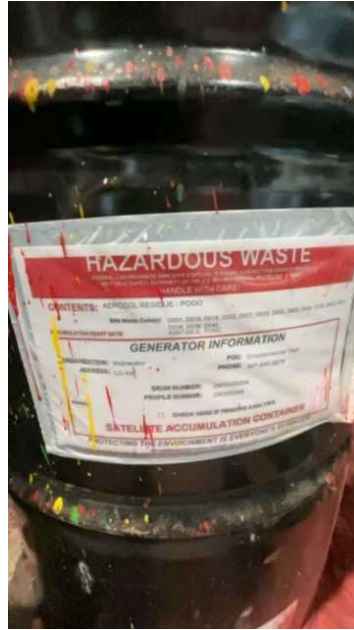
| Old Incinerator/ Aerosol Puncturing Area | | | 64.45362822, -144.90491903 |

| Close-up view of the SAA container with splattering and overspray of aerosol can contents all over the SAA. | | | |

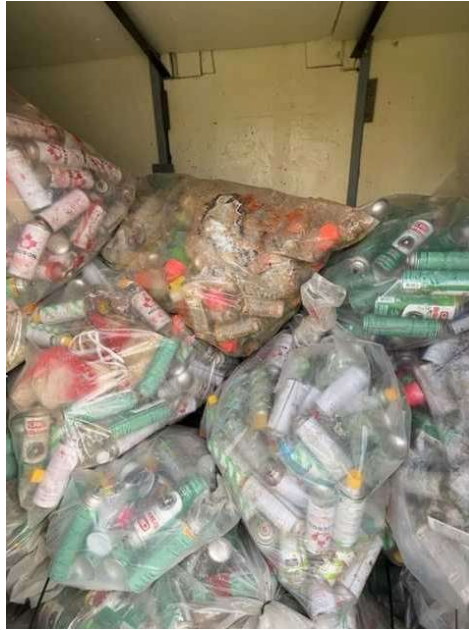
| Old Incinerator/ Aerosol Puncturing Area/Adjacent Connex | | | 64.45362822, -144.90491903 |

| Another view of 45 to 50 bags of waste aerosols not labeled or clearly marked with any of the following phrases: "Universal Waste – Aerosols," "Waste Aerosols," or "Used Aerosols." | | | |

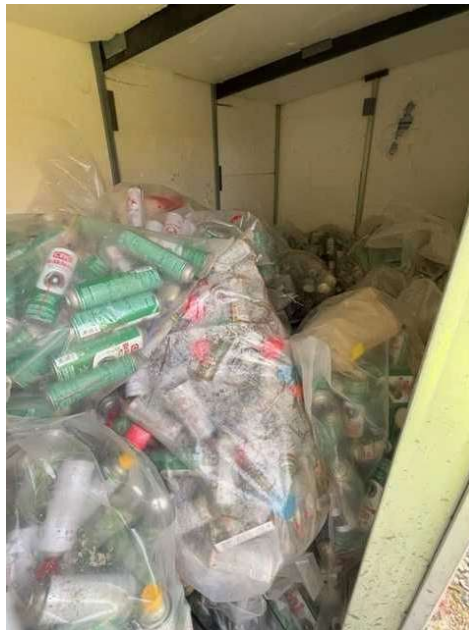
| Old Incinerator/ Aerosol Puncturing Area/Adjacent Connex | | | 64.45362822, -144.90491903 |

| Another view of 45 to 50 bags of waste aerosols not labeled or clearly marked with any of the following phrases: "Universal Waste – Aerosols," "Waste Aerosols," or "Used Aerosols." | | | |

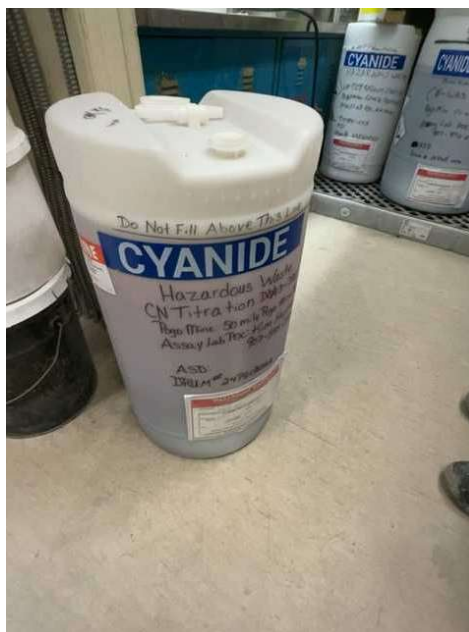
| Assay Lab/SAA | | | 64.45362822, -144.90491903 |

| View of the SAA. | | | |

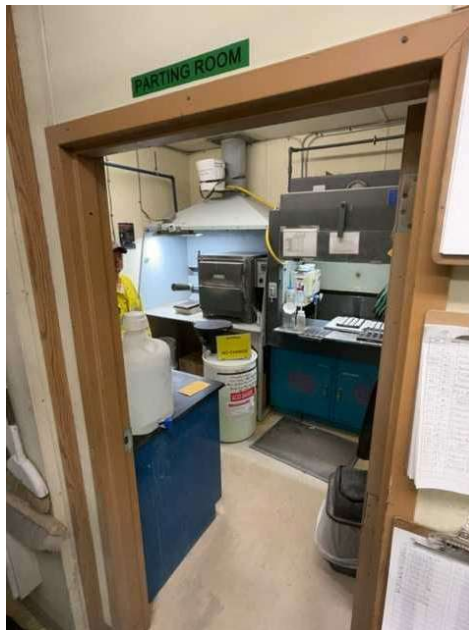
| Assay Lab/SAA | | | 64.45362822, -144.90491903 |

| View of the SAA. | | | |

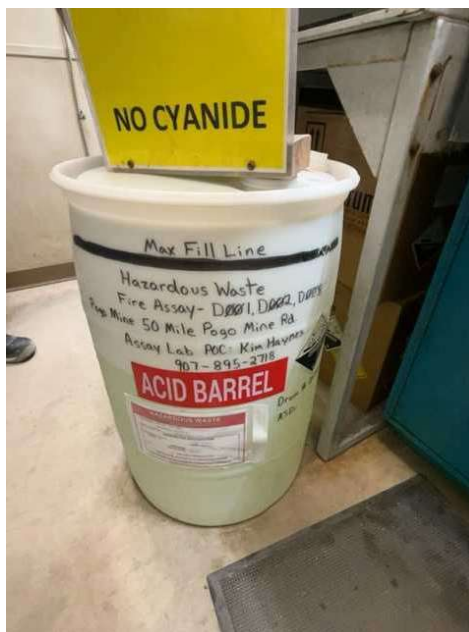
| Assay Lab/SAA | | | 64.45362822, -144.90491903 |

| View of SAA in parting room. | | | |

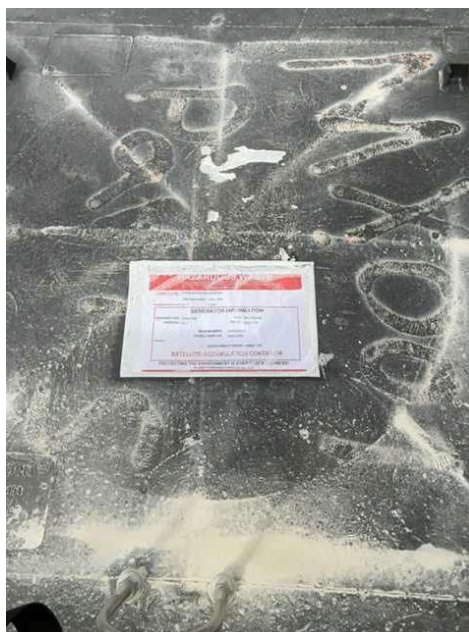
| Assay Lab/CAA | | | 64.45362822, -144.90491903 |

| View of waste tote containing hazardous Assay lab wastes. | | | |

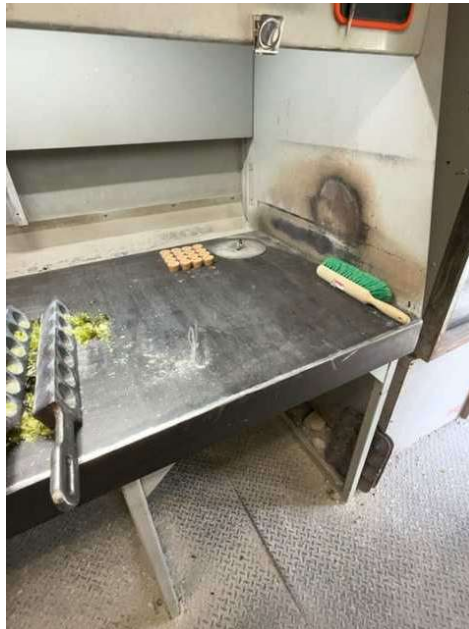
| Assay Lab/SAA | | | 64.45362822, -144.90491903 |

| View of the round lid for the table opening seen here on another table. | | | |

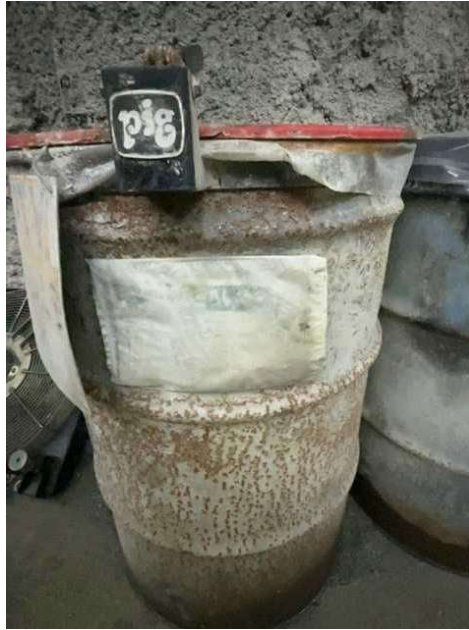
| Under Ground/#1352 Shop | | | 64.4544368, -144.90612976 |

| View of the aerosol collection container with a universal waste label that is obstructed with dirt and grime. | | | |

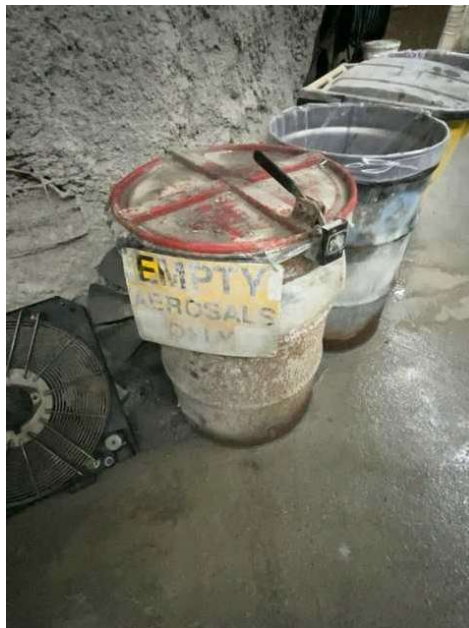
| Under Ground/#1352 Shop | | | 64.4544368, -144.90612976 |

| Another view of the aerosol collection container with a universal waste label that is obstructed with dirt and grime. | | | |

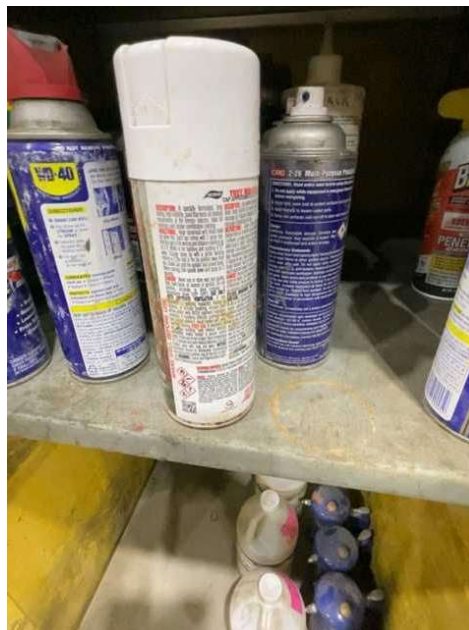
| Under Ground/#1352 Shop | | | 64.45362822, -144.90491903 |

| View of waste aerosol can, seen here in the front, center of the second shelf of the storage cabinet. | | | |

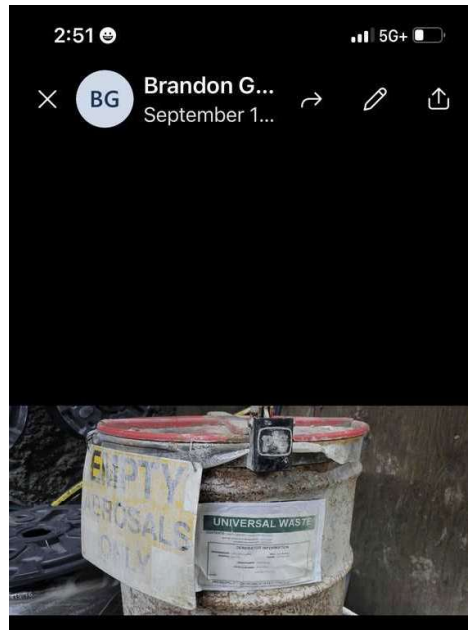
| Assay Lab/CAA | | | [Geographic Coordinates] |

| Photo of the container label sent in by the facility showing no changes. The label still indicates the container is an SAA container vs an accumulation container and there is no ASD. | | | |
