## Region 6 - Enforcement & Compliance Assurance Division

### INSPECTION REPORT

| Media: | RCRA Compliance Evaluation Inspection | |
| Company Name: | Qarbon Aerospace Foundation | |

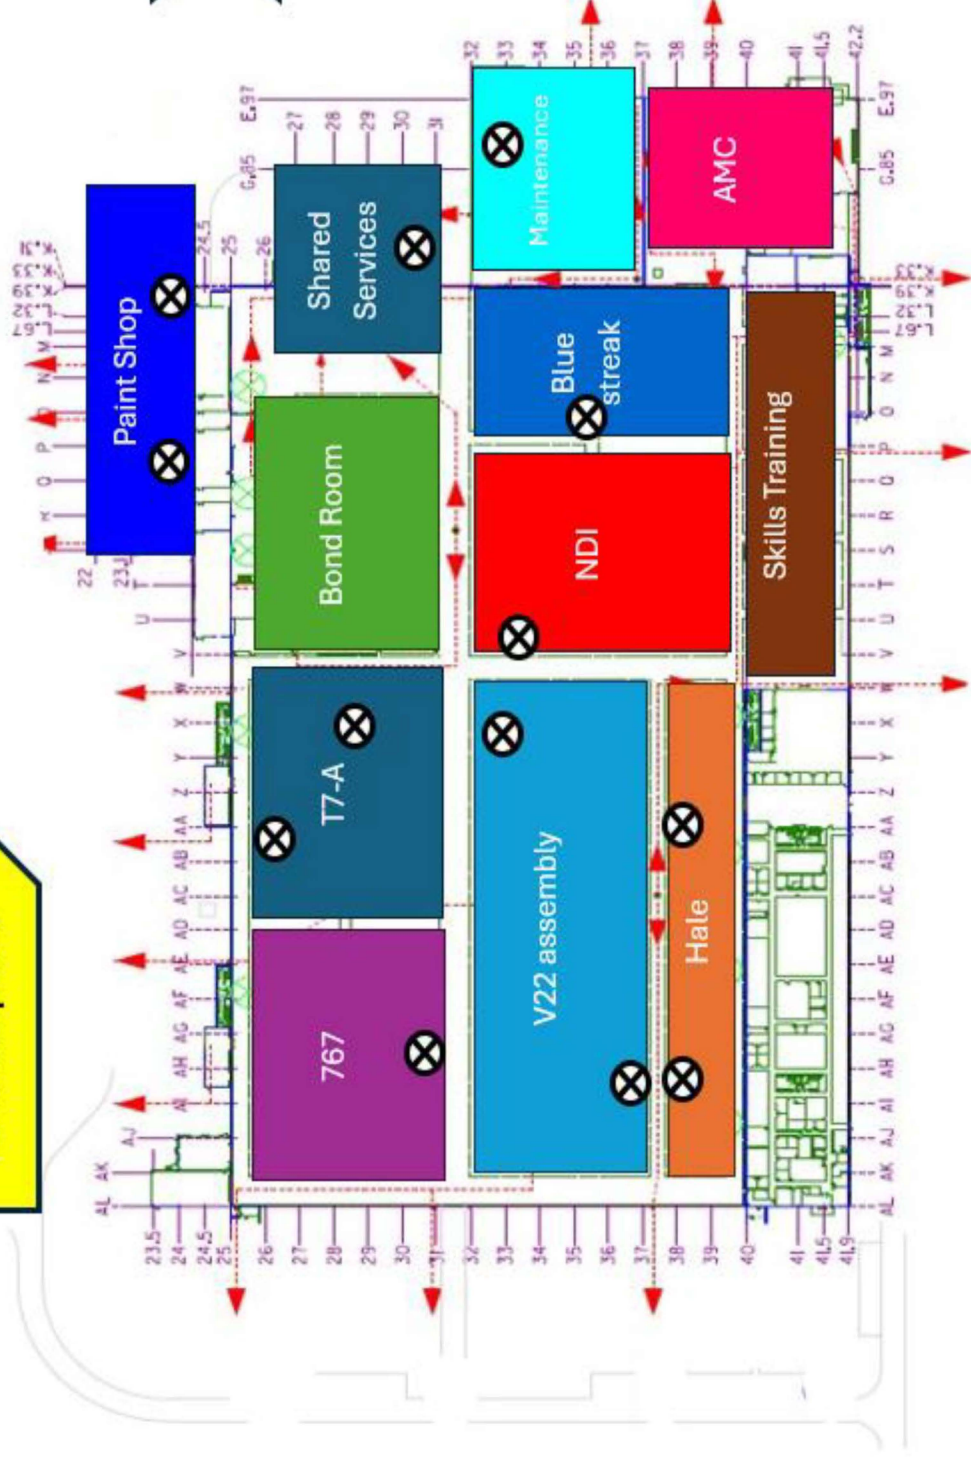
Paint Compactor

There are two Satellite Accumulation Areas allocated for the painting operations. During my inspection, I observed a paint compactor on the northwest side of the main building. The paint waste from the painting operations was consolidated and processed at the paint compactor. Additionally, I saw a rolloff box connected to the paint compactor that contained paint waste but was missing universal waste labeling (Appendix 1, Photo 4).

- The facility failed to conduct a weekly inspection of CAA during the fourth week of December 2024 (40 CFR § 262.16(b)(2)(iv)).
- The facility failed to label or clearly mark four boxes and two bundles of universal waste lamps with one of the following phrases: "Universal Waste – Lamp(s)", or "Waste Lamp(s)", or "Used Lamp(s)" (40 CFR § 273.34(e)).
- The facility failed to label or clearly mark the rolloff box connected to the paint compactor, which contained paint waste, with the words "Universal Waste – Paint and Paint-Related Wastes" (30 TAC 335.262(c)(2)(F)).
  - As a part of corrective action, Qarbon submitted a picture of the same rolloff box with a universal waste label identifying contents as Paint and Paint-Related Waste on October 9, 2025.
