**Report Title:** Clean Water Act, Section 404 Inspection Report for the Johnson Farms Site  
**Inspection Date(s):** 02/01/2023  
**Start Time:** 9:00am **End Time:** 11:40am

**Regulatory Program(s):** Inspections authorized pursuant to Clean Water Act, Sections 308 and 404 (33 U.S.C. §§ 1318 and 1344)  
**Site Name:** Johnson Farms

**Site Location:** South of Slalom Drive (Virginia Beach Parcel ID: 14949977880000)  
Virginia Beach, Virginia 23453  
**Latitude:** 36.77212448° N **Longitude:** -76.051011° W

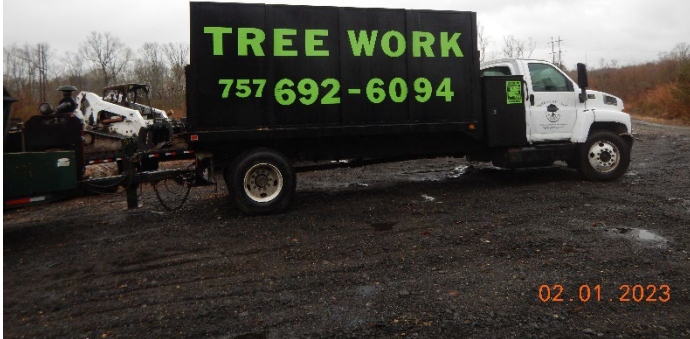
| | <p>Johnson Farms<br/>Date: February 1, 2023<br/>Photo ID: DSCN4331<br/>Photo taken by: Robert George</p> <p>Notes: View of a Tree Work chipper truck located at the site entrance, south of Slalom Dr.</p> |

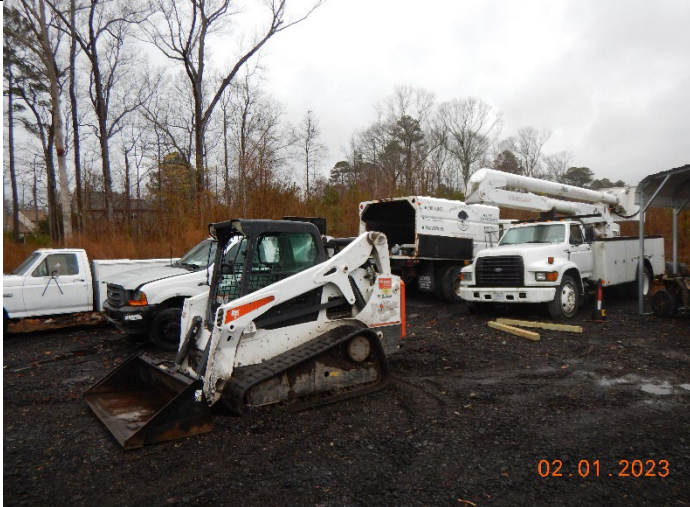
| | <p>Johnson Farms<br/>Date: February 1, 2023<br/>Photo ID: DSCN4332<br/>Photo taken by: Robert George</p> <p>Notes: View of machinery associated with the forestry business onsite, including: a compact track loader, boom truck, chipper truck, and two light-duty trucks.</p> |

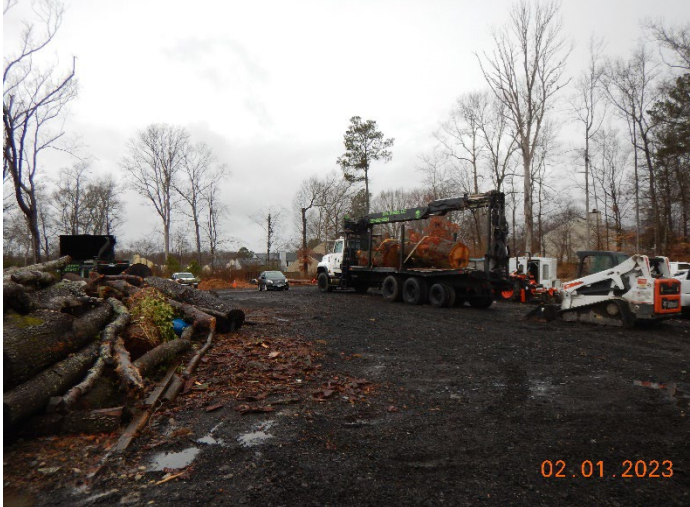
| | <p>Johnson Farms<br/>Date: February 1, 2023<br/>Photo ID: DSCN4333<br/>Photo taken by: Robert George</p> <p>Notes: Westward view of forestry machinery observed onsite.</p> |

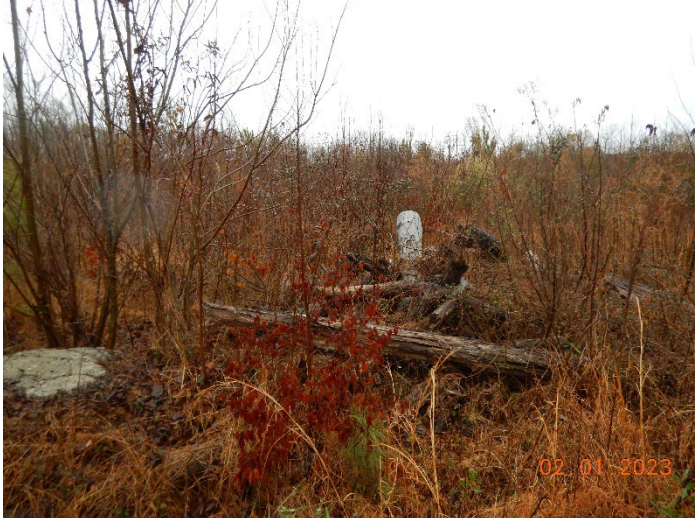
| <p>02.01.2023</p> | <p>Johnson Farms<br/>Date: February 1, 2023<br/>Photo ID: DSCN4334<br/>Photo taken by: Robert George</p> <p>Notes: Southeastward view of the site.</p> |

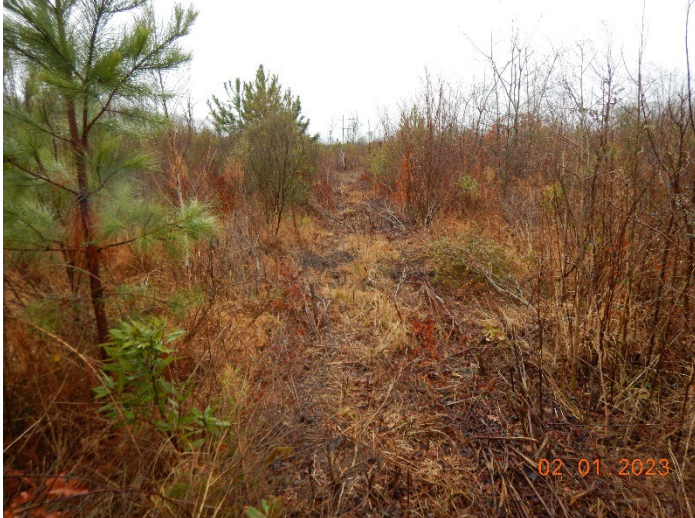
| <p>02.01.2023</p> | <p>Johnson Farms<br/>Date: February 1, 2023<br/>Photo ID: DSCN4335<br/>Photo taken by: Robert George</p> <p>Notes: View of a path that had been recently mowed through the early successional habitat onsite.</p> |

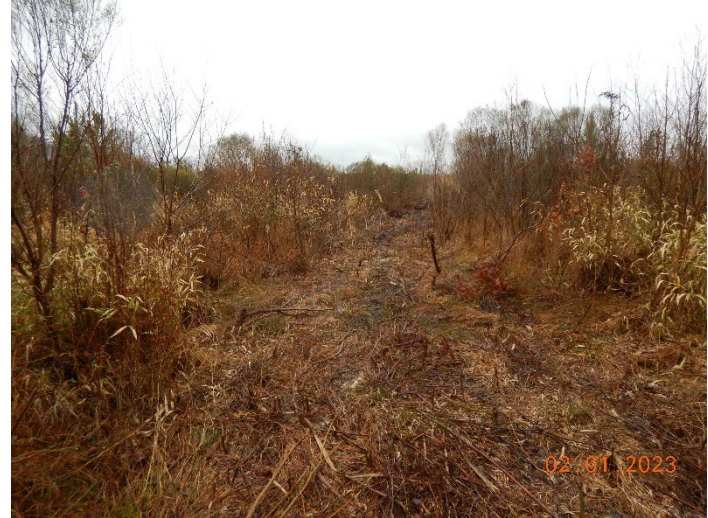
| | <p>Johnson Farms<br/>Date: February 1, 2023<br/>Photo ID: DSCN4337<br/>Photo taken by: Robert George</p> <p>Notes: View of a path that had been recently mowed through the early successional habitat onsite.</p> |

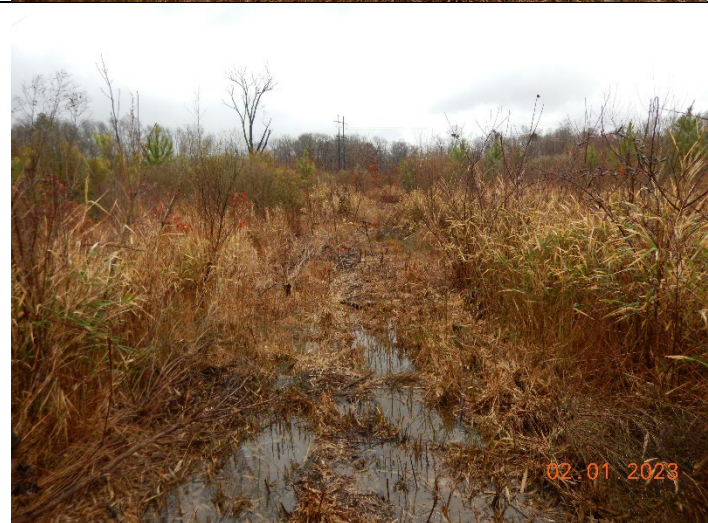
| | <p>Johnson Farms<br/>Date: February 1, 2023<br/>Photo ID: DSCN4338<br/>Photo taken by: Robert George</p> <p>Notes: View of a path that had been recently mowed through the early successional habitat onsite.</p> |

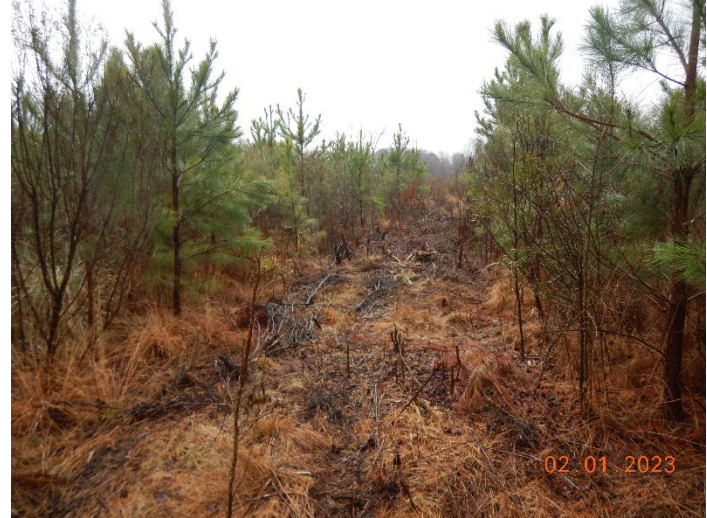
| | <p>Johnson Farms<br/>Date: February 1, 2023<br/>Photo ID: DSCN4340<br/>Photo taken by: Robert George</p> <p>Notes: View of a path that had been recently mowed through the early successional habitat onsite.</p> |

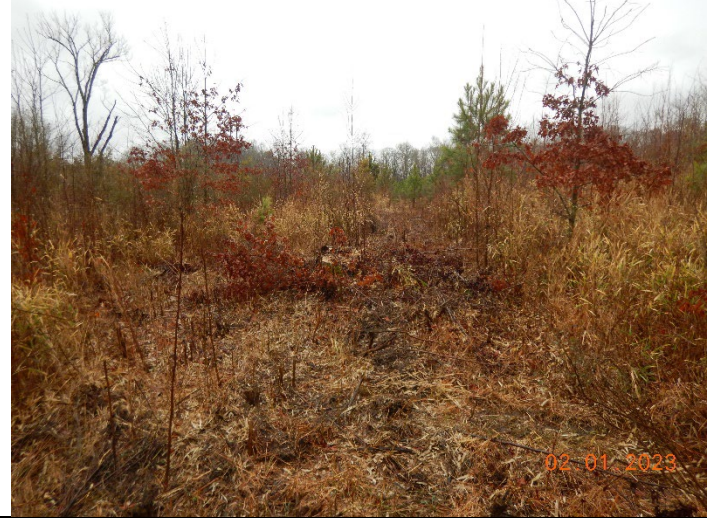
| | <p>Johnson Farms<br/>Date: February 1, 2023<br/>Photo ID: DSCN4341<br/>Photo taken by: Robert George</p> <p>Notes: View of a path that had been recently mowed through the early successional habitat onsite.</p> |

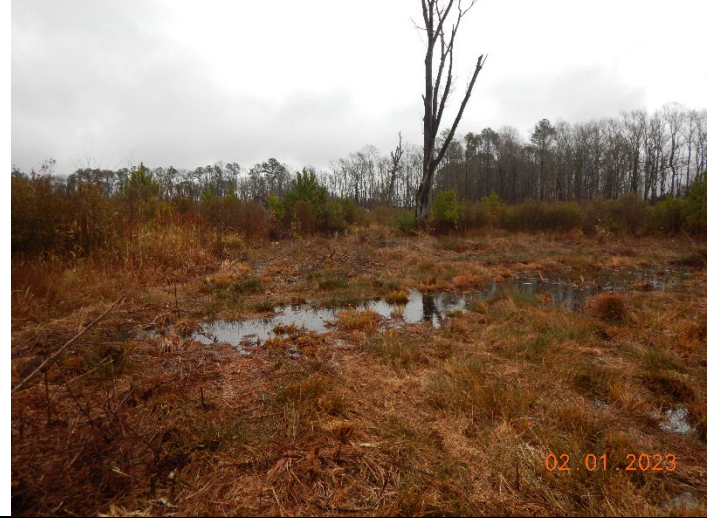
| | <p>Johnson Farms<br/>Date: February 1, 2023<br/>Photo ID: DSCN4342<br/>Photo taken by: Robert George</p> <p>Notes: View of a mowed area located on the eastern portion of the site.</p> |

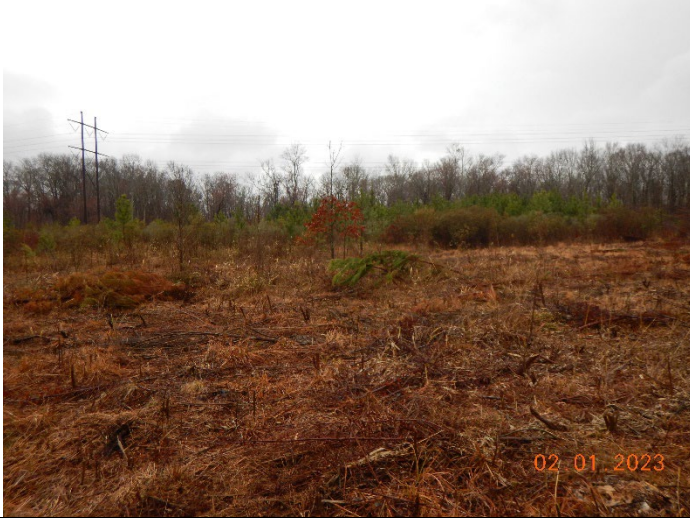
| | <p>Johnson Farms<br/>Date: February 1, 2023<br/>Photo ID: DSCN4343<br/>Photo taken by: Robert George</p> <p>Notes: Southward view of a mowed area located on the eastern portion of the site.</p> |

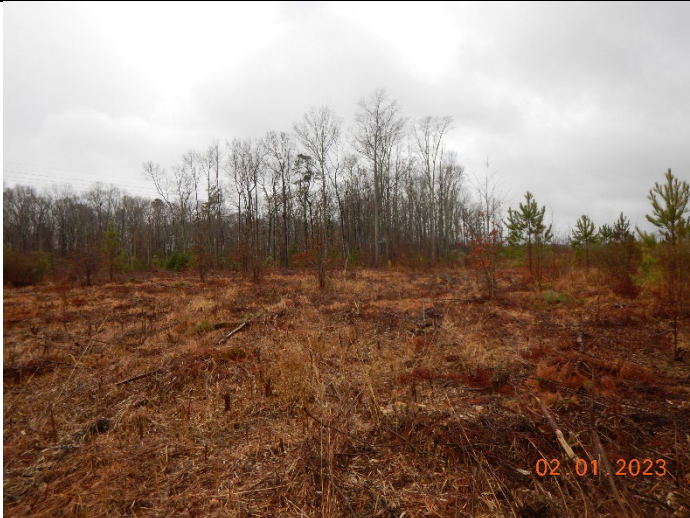
| | <p>Johnson Farms<br/>Date: February 1, 2023<br/>Photo ID: DSCN4344<br/>Photo taken by: Robert George</p> <p>Notes: View of a mowed area located on the eastern portion of the site.</p> |

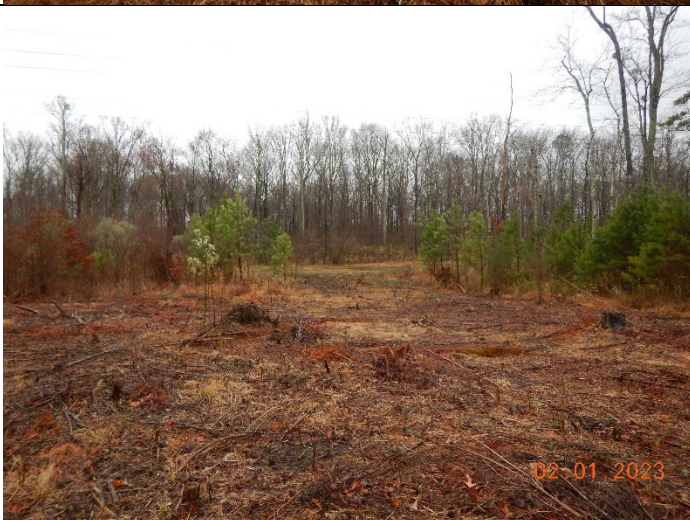
| | <p>Johnson Farms<br/>Date: February 1, 2023<br/>Photo ID: DSCN4345<br/>Photo taken by: Robert George</p> <p>Notes: View of a mowed area located on the eastern portion of the site.</p> |

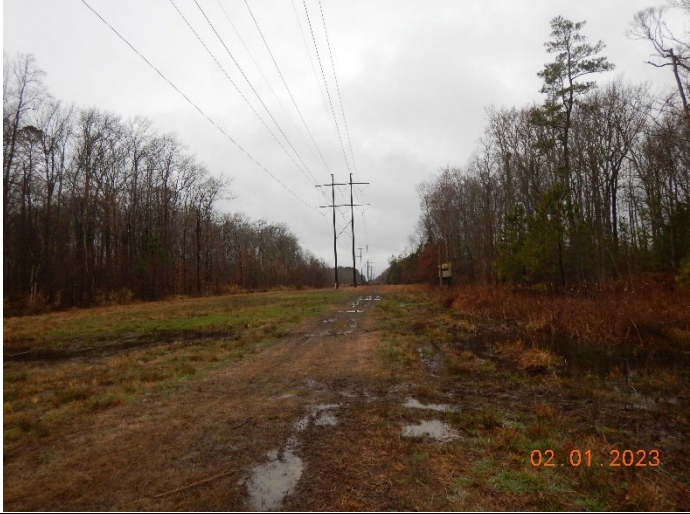
| A photograph showing a dirt road or path leading towards a transmission tower in the distance. The area is surrounded by trees and vegetation, with a cloudy sky above. A date stamp "02.01.2023" is visible in the bottom right corner of the photo. | <p>Johnson Farms<br/>Date: February 1, 2023<br/>Photo ID: DSCN4346<br/>Photo taken by: Robert George</p> <p>Notes: Westward view of the transmission-tower easement that bisected the site.</p> |

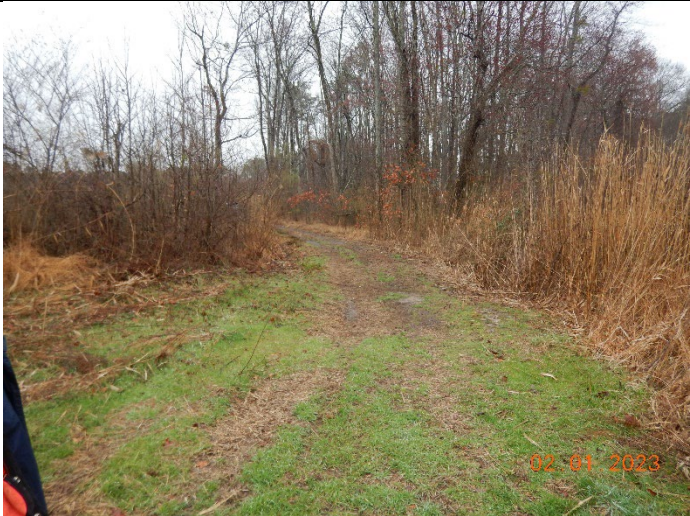
| A photograph of a narrow dirt trail winding through a wooded area. The ground is covered with grass and fallen leaves. A date stamp "02.01.2023" is visible in the bottom right corner of the photo. | <p>Johnson Farms<br/>Date: February 1, 2023<br/>Photo ID: DSCN4347<br/>Photo taken by: Robert George</p> <p>Notes: Northward view of a pre-existing trail that was observed on the eastern border of the site.</p> |

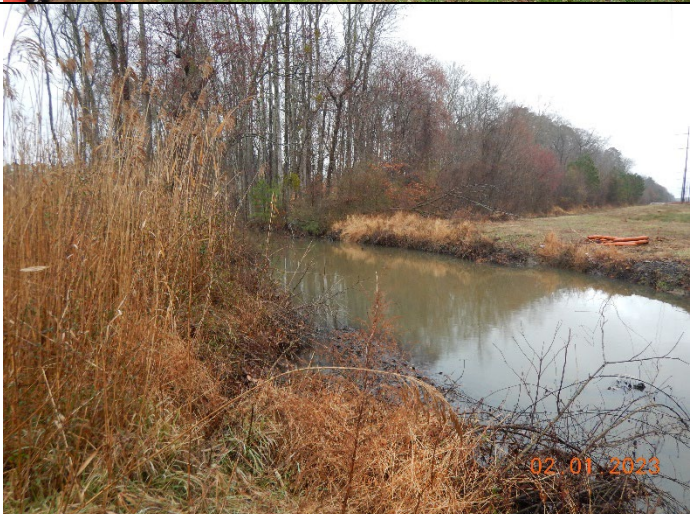
| A photograph of a small creek flowing through a wooded area. The water is calm, reflecting the surrounding trees. A date stamp "02.01.2023" is visible in the bottom right corner of the photo. | <p>Johnson Farms<br/>Date: February 1, 2023<br/>Photo ID: DSCN4348<br/>Photo taken by: Robert George</p> <p>Notes: View of West Neck Creek, which bordered the site to the east.</p> |

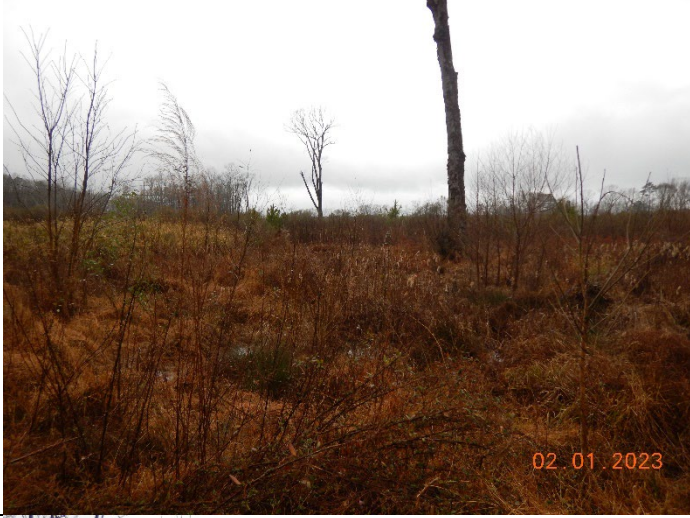
and no ditches were observed to be connected to the stream. The Site to the west appeared to have naturalized (DSCN4349 and DSCN4350).

| | <p>Johnson Farms<br/>Date: February 1, 2023<br/>Photo ID: DSCN4349<br/>Photo taken by: Robert George</p> <p>Notes: Westward view of the site.</p> |

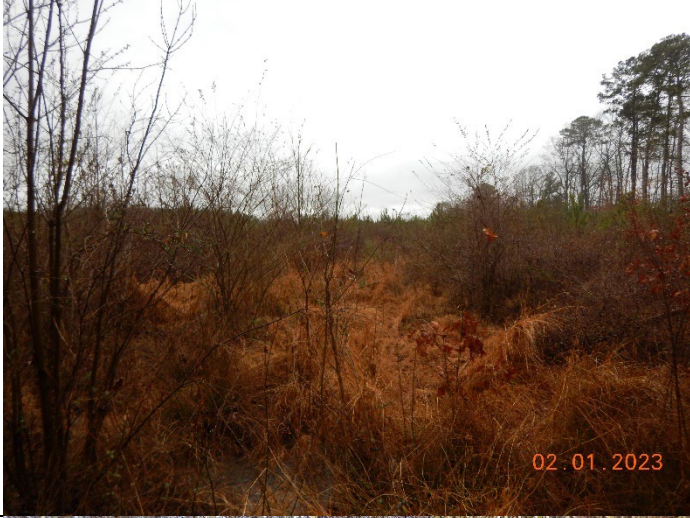
| | <p>Johnson Farms<br/>Date: February 1, 2023<br/>Photo ID: DSCN4350<br/>Photo taken by: Robert George</p> <p>Notes: Westward view of the site.</p> |

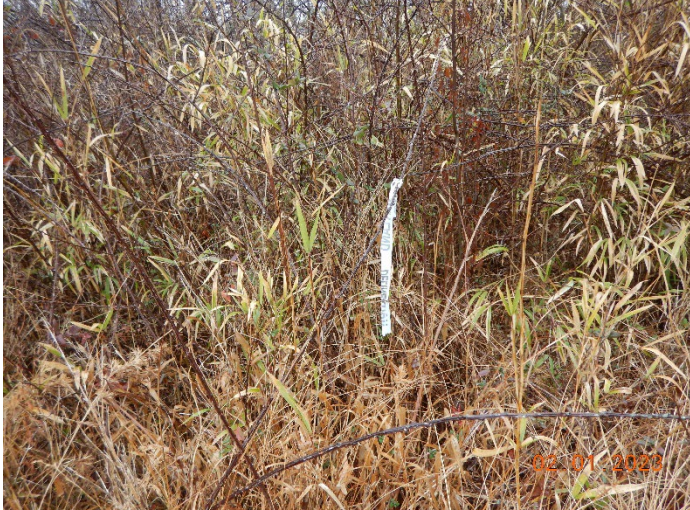
| | <p>Johnson Farms<br/>Date: February 1, 2023<br/>Photo ID: DSCN4351<br/>Photo taken by: Robert George</p> <p>Notes: Wetland delineation flag observed along the periphery of the site.</p> |

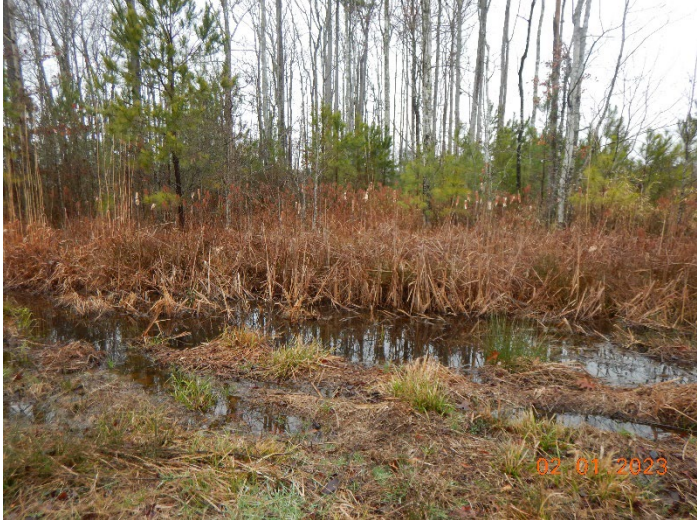
| <p>02.01.2023</p> | <p>Johnson Farms<br/>Date: February 1, 2023<br/>Photo ID: DSCN4352<br/>Photo taken by: Robert George</p> <p>Notes: Northward view of a palustrine emergent wetland, dominated by broadleaf cattail (<i>Typha latifolia</i>), located immediately to the north of the transmission-tower easement.</p> |

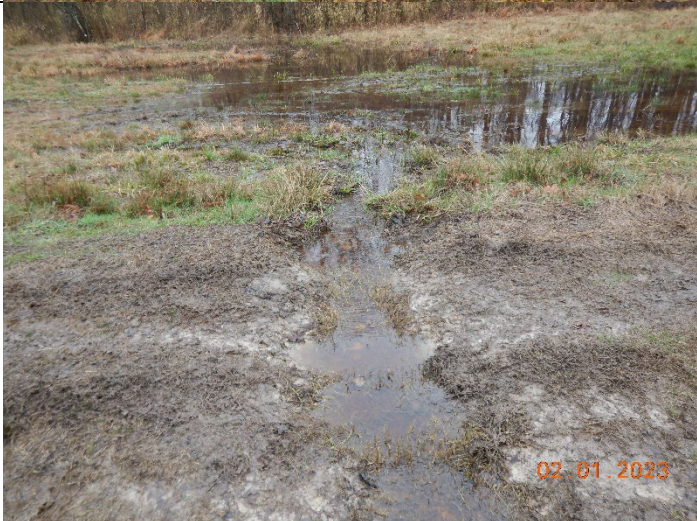
The inspection team then returned to the transmission-tower easement and walked west to the central portion of the Site (DSCN4351-DSCN4354). Surface water was observed draining from the northern portion of the Site to the southern portion of the Site across the transmission-tower easement (DSCN4353). Immediately to the south of the transmission-tower easement, the inspection team observed an area where woody debris and wood chips were discharged (DSCN4355-DSCN4357, DSCN4360, DSCN4361). Henceforth, this area will be referred to as Area of Concern (“AOC”) 1.

| <p>02.01.2023</p> | <p>Johnson Farms<br/>Date: February 1, 2023<br/>Photo ID: DSCN4353<br/>Photo taken by: Robert George</p> <p>Notes: Southward view of surface water draining from the northern portion of the site across the transmission-tower easement.</p> |

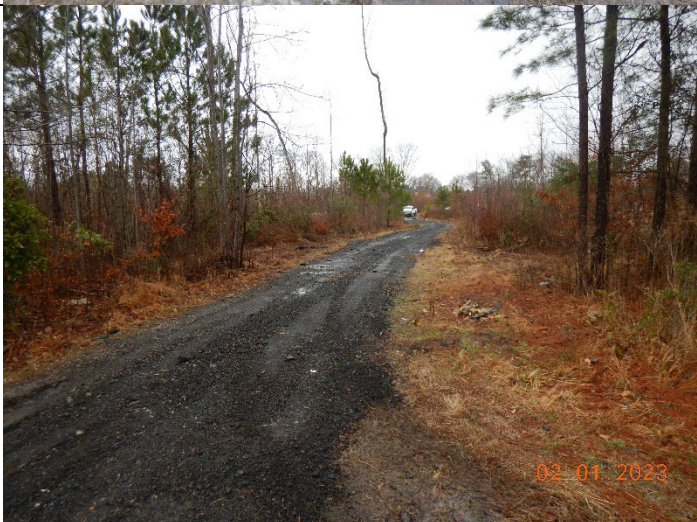
| <p>02.01.2023</p> | <p>Johnson Farms<br/>Date: February 1, 2023<br/>Photo ID: DSCN4354<br/>Photo taken by: Robert George</p> <p>Notes: Northward view of a pre-existing gravel road that bisected the western portion of the site.</p> |

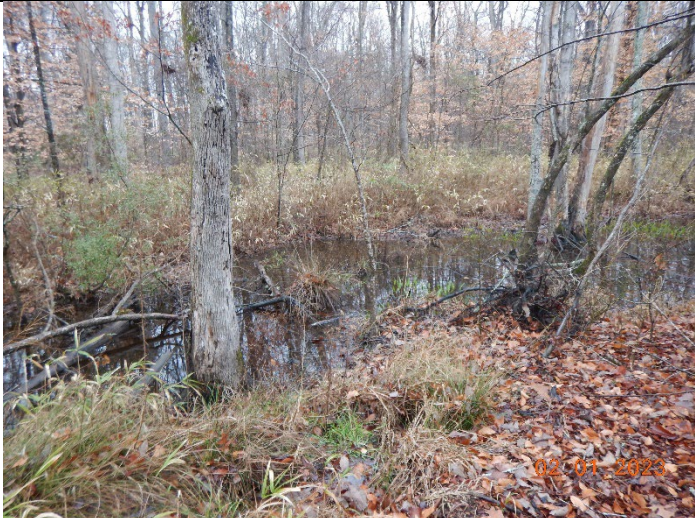
The inspection team walked southward on a path that bordered the western branch of West Neck Creek and documented the conditions (DSCN4362). A culvert was observed draining the Site and discharging water into the stream (DSCN4363 and DSCN4364). The inspection team then walked northward and encountered Mr. Deans at the transmission-tower easement at approximately 10:40 am. Mr. Deans stated that he purchased the property in the fall of 2022 and the Site was left in a state of disrepair by the former lessee, Mr. Mason. Mr. Deans stated that he cleaned up the Site and that the pile of wood chips at AOC-1 preceded his ownership, however, he stated that he recently added two loads and spread them out.

| | <p>Johnson Farms<br/>Date: February 1, 2023<br/>Photo ID: DSCN4362<br/>Photo taken by: Robert George</p> <p>Notes: Eastward view of the southern portion of the site.</p> |

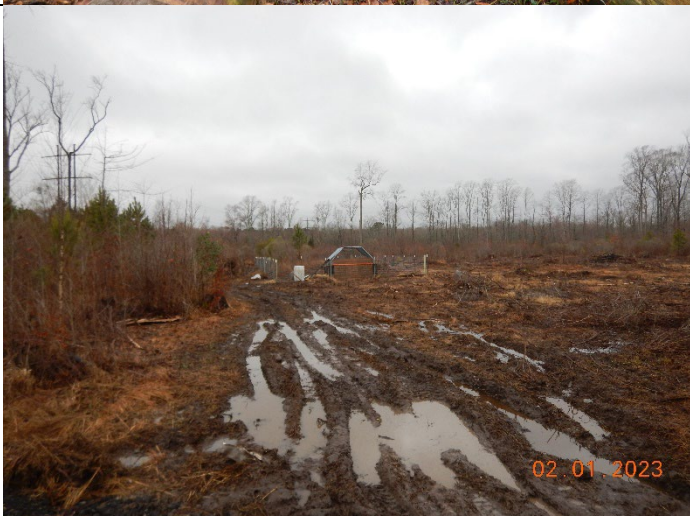
The EPA walked northward on a gravel road that was located on the central portion of the Site. A goat enclosure was observed to the west of the road (DSCN4369). To the east of the road, a dirt pile with concrete pieces was observed to be placed in wetlands along the road (DSCN4371-DSCN4374). Henceforth, this area will be referred to as AOC-2 (Attachment 2).

| | <p>Johnson Farms<br/>Date: February 1, 2023<br/>Photo ID: DSCN4369<br/>Photo taken by: Robert George</p> <p>Notes: Westward view of a goat enclosure located on the central portion of the site.</p> |

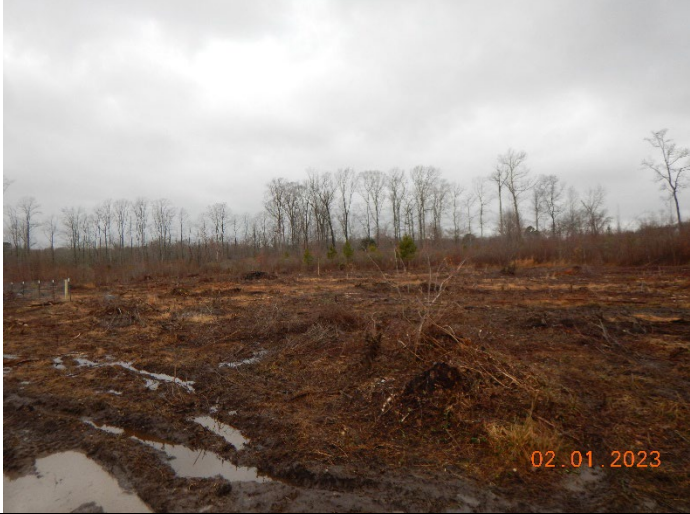
| | <p>Johnson Farms<br/>Date: February 1, 2023<br/>Photo ID: DSCN4370<br/>Photo taken by: Robert George</p> <p>Notes: Westward view of the central portion of the site.</p> |
