# NPDES Compliance Inspection Report

## Ridgefield Heights Ridgefield, Washington

NPDES Permit Tracking Number  
# WAR306634

Inspection Date: 12/20/2022

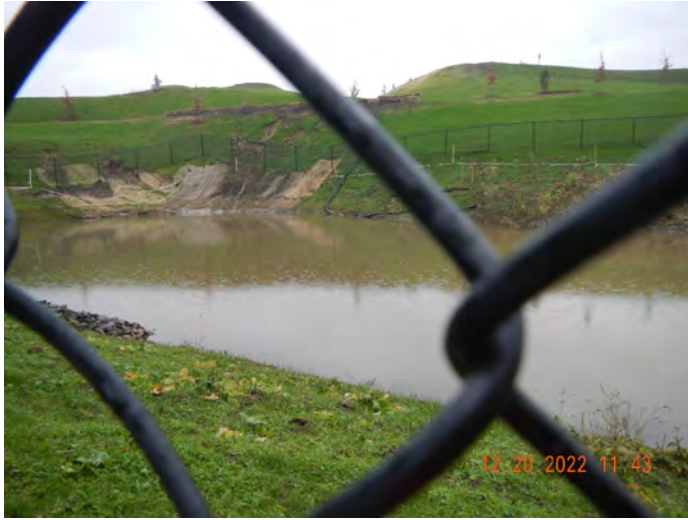
Photo #:09 (DSCN3105)  
Description: Facing north of Pond A.

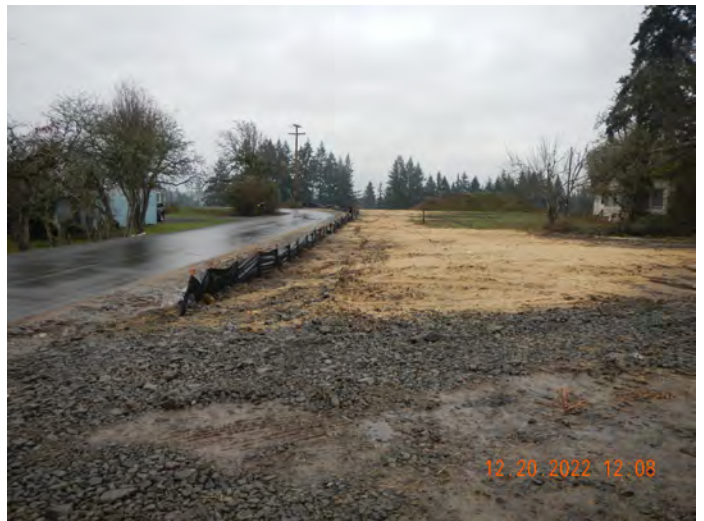
Photo #:16 (DSCN3112)  
Description: Facing north, photo of an entrance to Phase 3 along S. 25<sup>th</sup> Place.

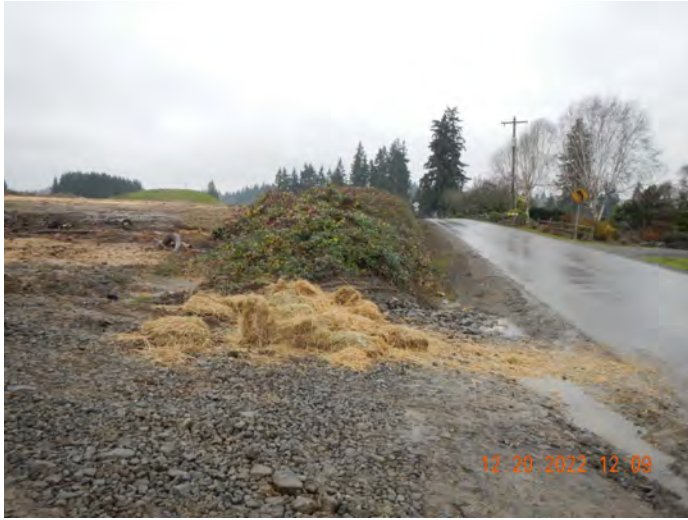
Photo #:17 (DSCN3113)  
Description: Facing south, photo of an entrance to Phase 3 along S. 25<sup>th</sup> place.

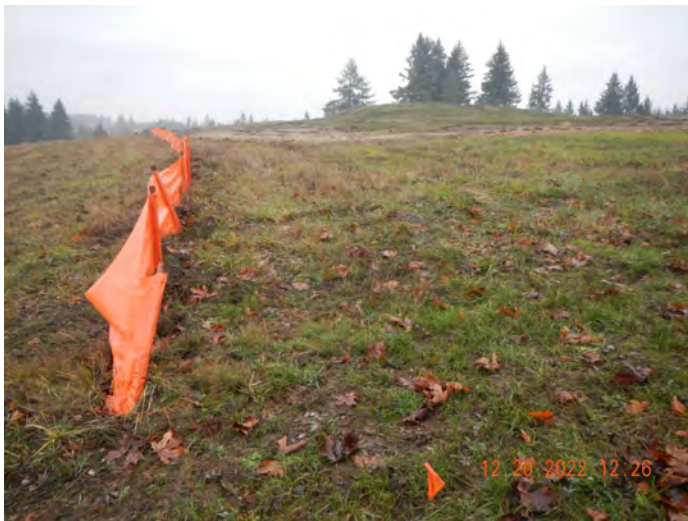
Photo #:19 (DSCN3115)  
Description: Facing north, perimeter silt fencing along the northwest perimeter.

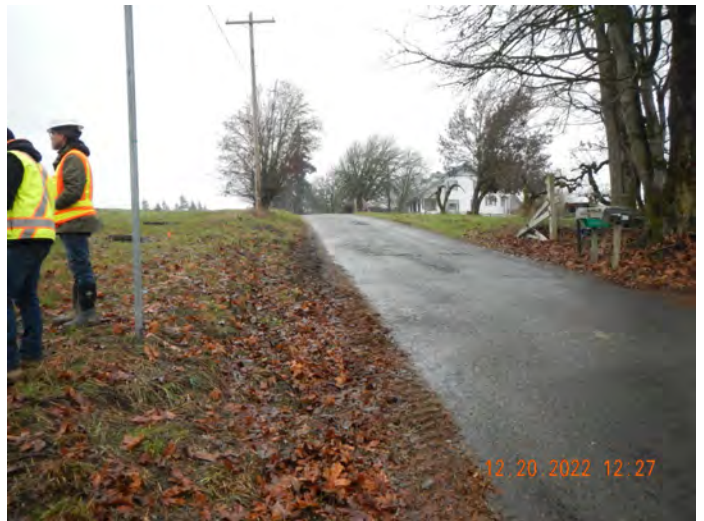
Photo #:20 (DSC3116)  
Description: Facing east photo of the uncleared areas/perimeter north of S. 25<sup>th</sup> Place.

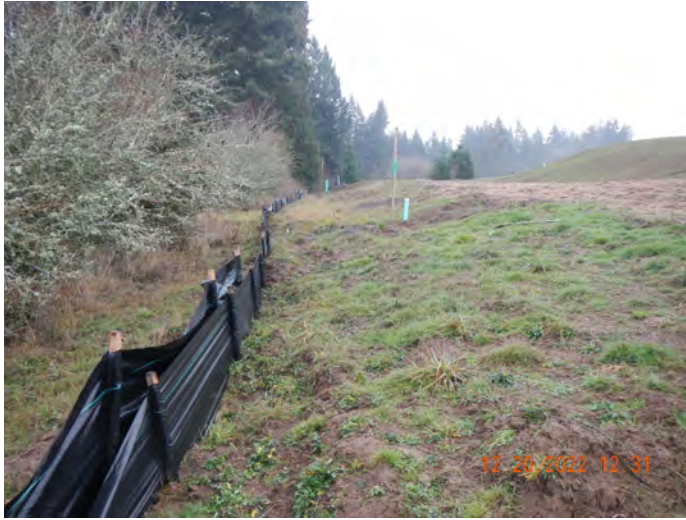
Photo #:21 (DSCN3117)  
Description: Facing east, photo of northern perimeter silt fencing

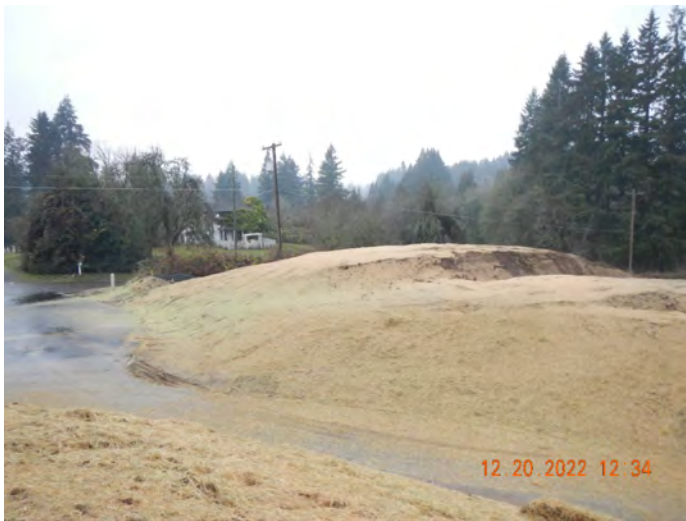
Photo #:23 (DSCN3119)  
Description: Facing west, photo of fire access road and stockpiles within Phase 5.

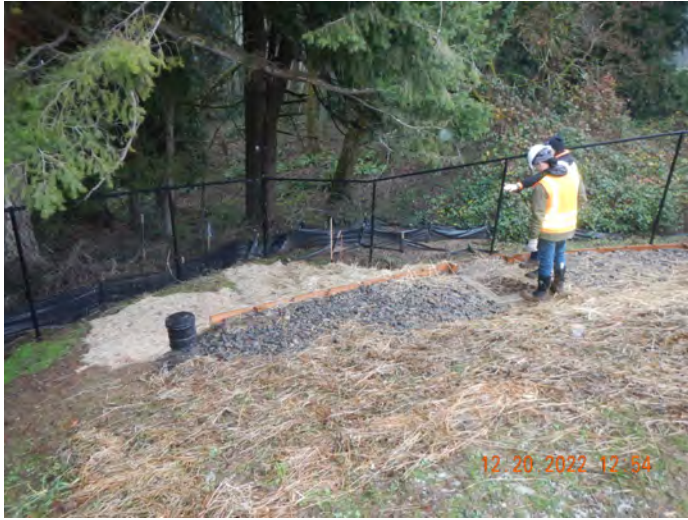
Photo #:25 (DSCN3121)  
Description: Facing north, photo of Pond B. outfall location.

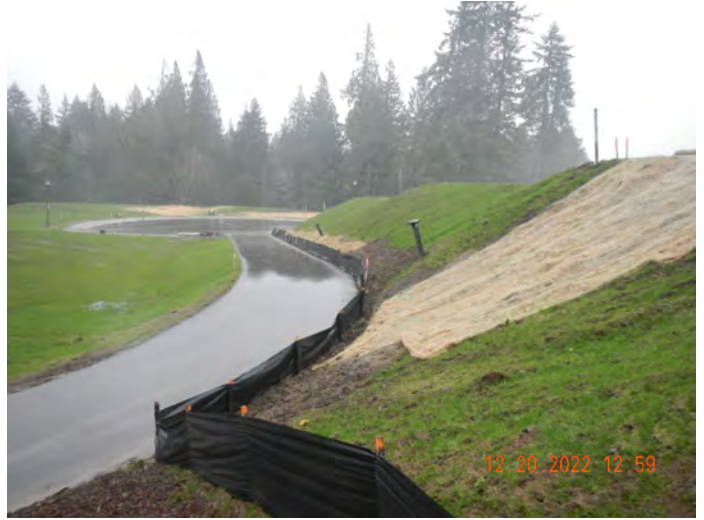
Photo #:26 (DSC3122)  
Description: Facing east, photo of area east of Pond B and west of Pond C.

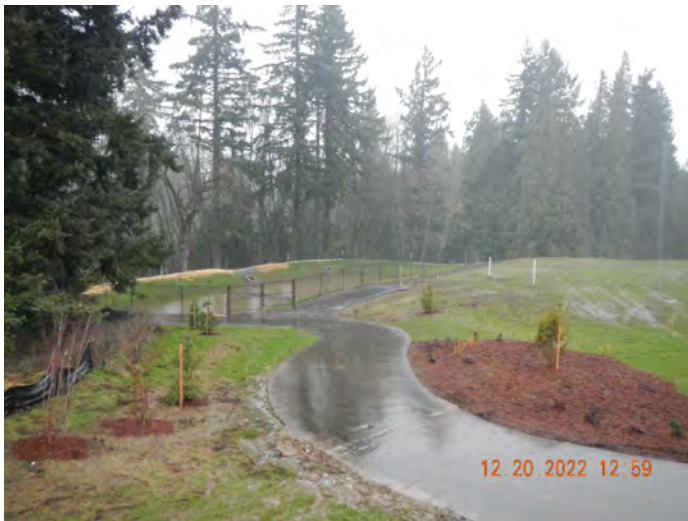
Photo #:27 (DSCN3123)  
Description: Facing northeast, photo of access road to Pond C.

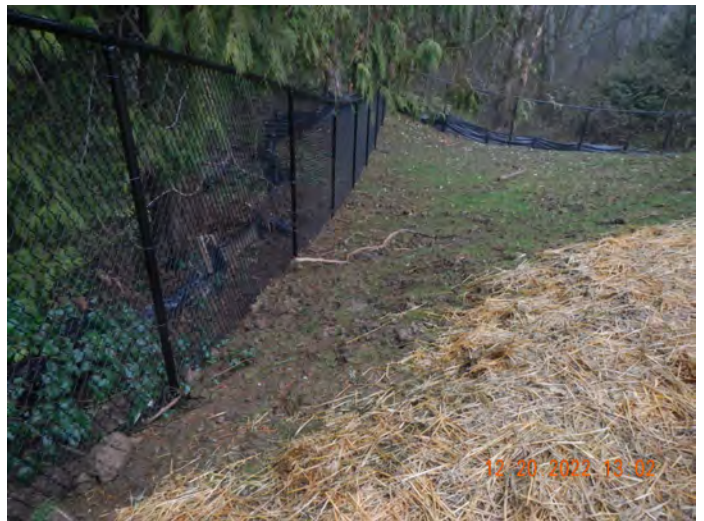
Photo #:28 (DSCN3124)  
Description: Facing north, photo of area northwest of Pond C.

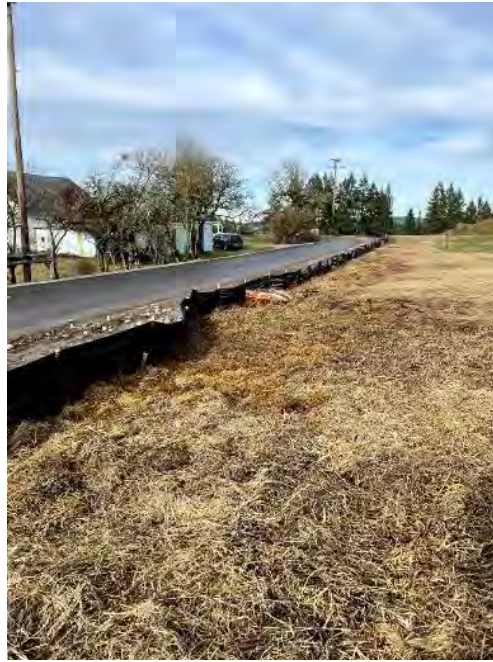
Photo 8c. West entrance to Phases 3-5 needs maintenance (Facing south).
