**Clean Air Act Inspection Report**

**Inspection Date:** October 8, 2024

**Facility Name:** R. M. Packer Company, Inc.

**Facility Location:** 188 Beach Road, Tisbury, MA 02568

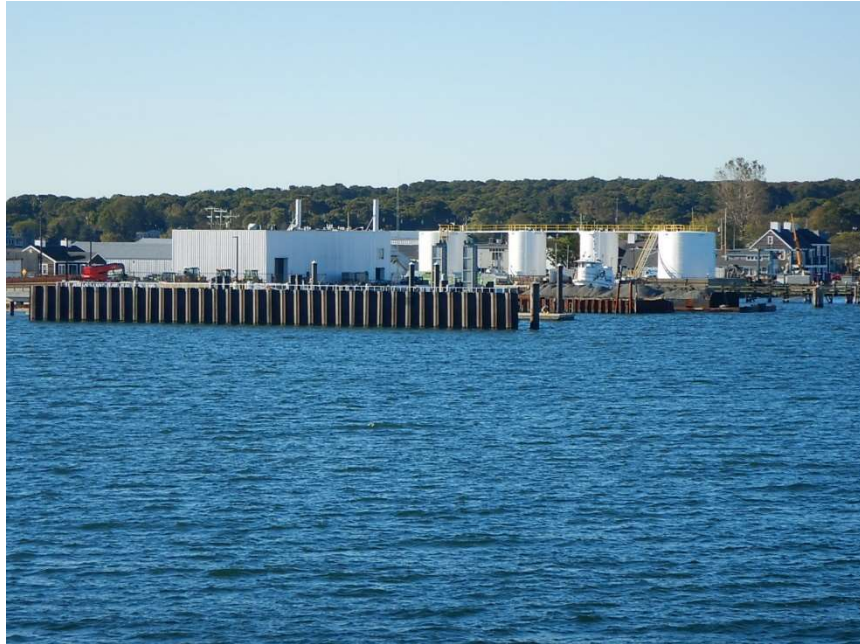
| Number | Image Identification | Description | Time (A.M.) |
|---|---|---|---|
| 1 | DSCN1742.JPG | R.M. Packer facility from the water | 8:48 |

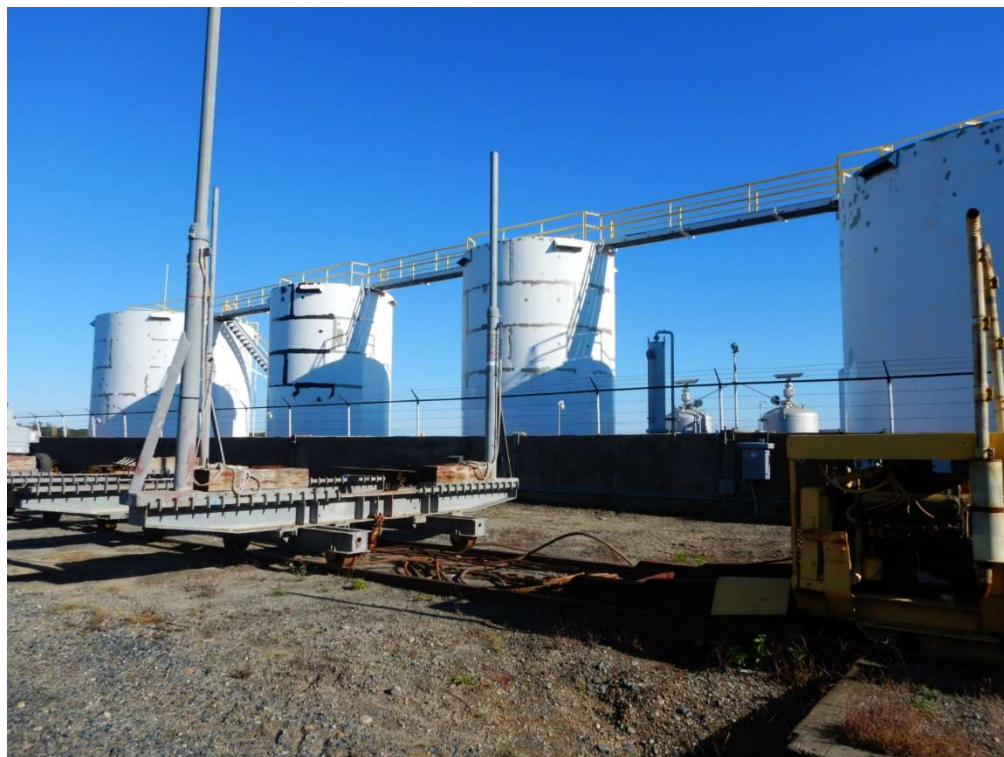
| Number | Image Identification | Description | Time (A.M.) |
|---|---|---|---|
| 2 | DSCN1743.JPG | Fuel storage tanks (left to right: 1, 2, 3, 4) | 9:19 |

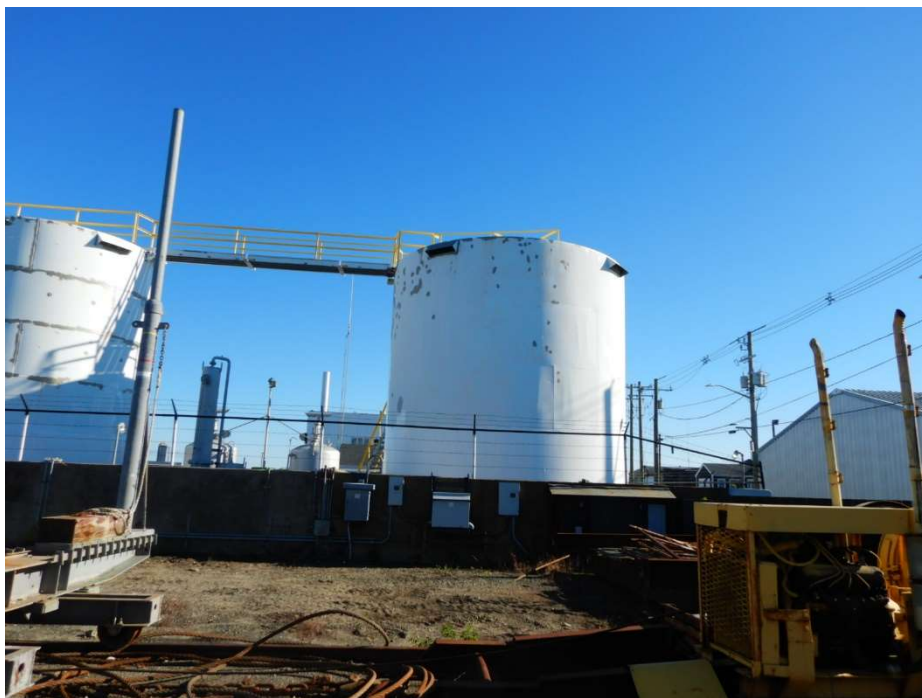
| Number | Image Identification | Description | Time (A.M.) |
|---|---|---|---|
| 3 | DSCN1744.JPG | Gasoline storage tank (Tank 4) | 9:19 |

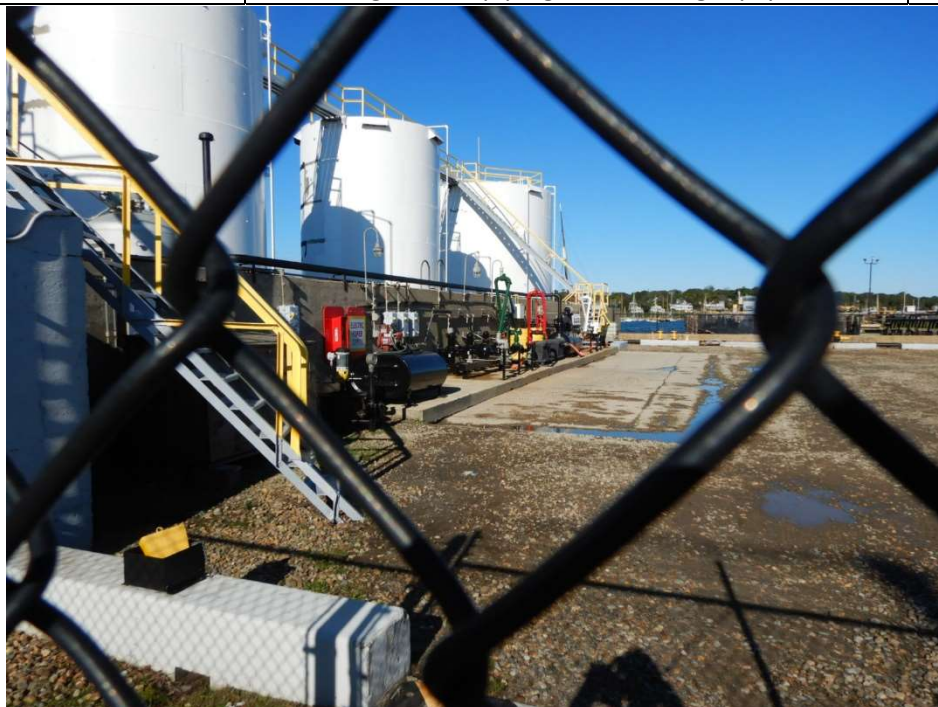
Mr. Bailey explained that the loading rack includes different colored loading pipes associated with specific types of fuels: green for diesel fuel, red for dyed heating oil, yellow for #2 oil, and white for gasoline. See photo DSCN1745.JPG. In the loading area, the inspectors observed thermal expansion valves and tanks for the diesel/fuel oils and

| Number | Image Identification | Description | Time (A.M.) |
|---|---|---|---|
| 4 | DSCN1745.JPG | Storage tanks, piping, and loading equipment | 9:24 |

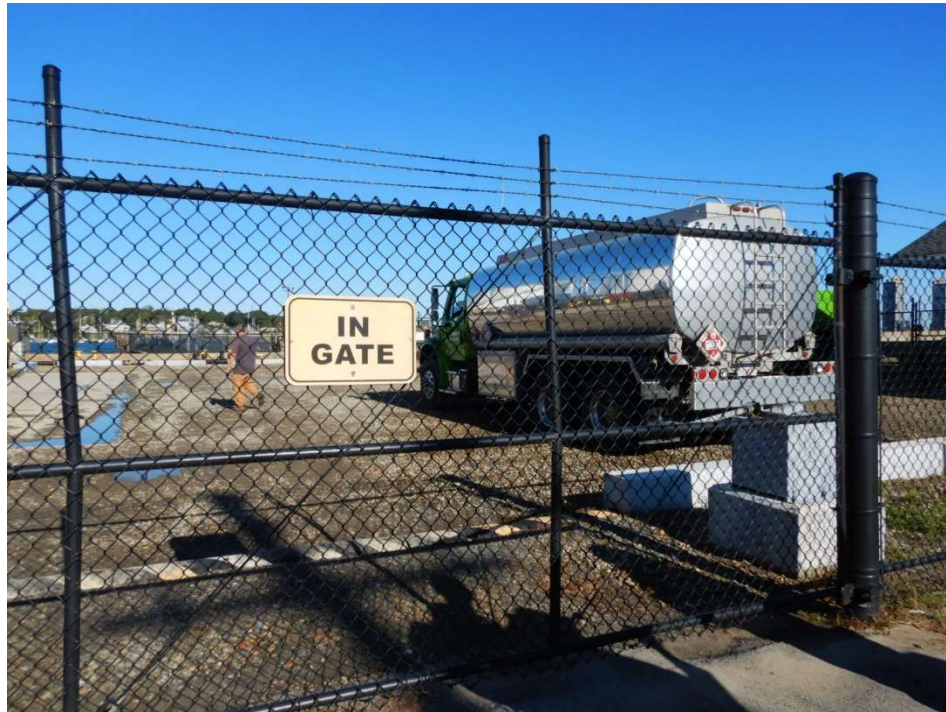
| Number | Image Identification | Description | Time (A.M.) |
|---|---|---|---|
| 5 | DSCN1746.JPG | Delivery truck | 9:24 |

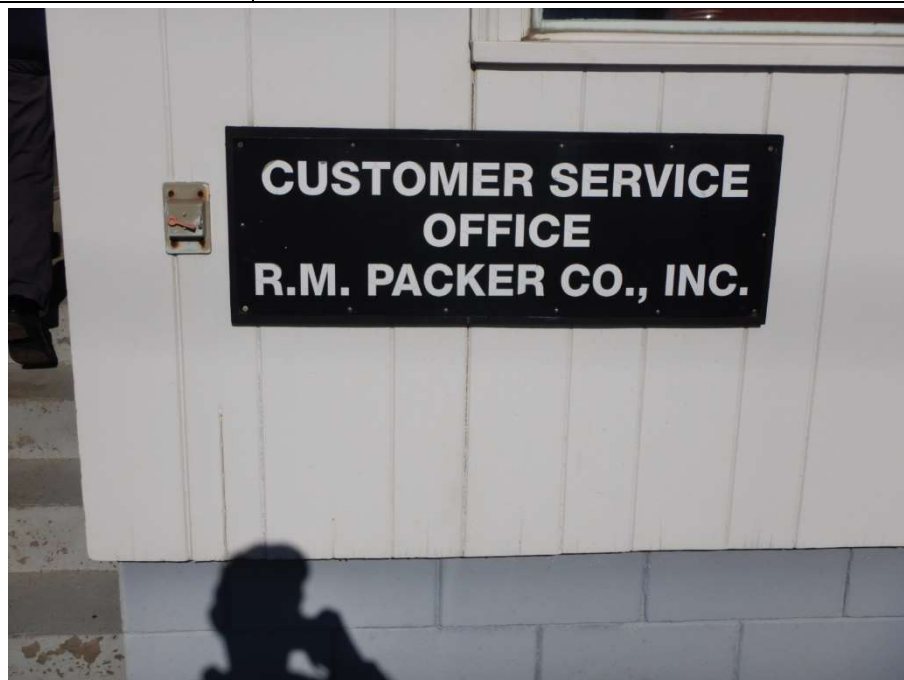
| Number | Image Identification | Description | Time (A.M.) |
|---|---|---|---|
| 6 | DSCN1747.JPG | Facility sign | 9:27 |

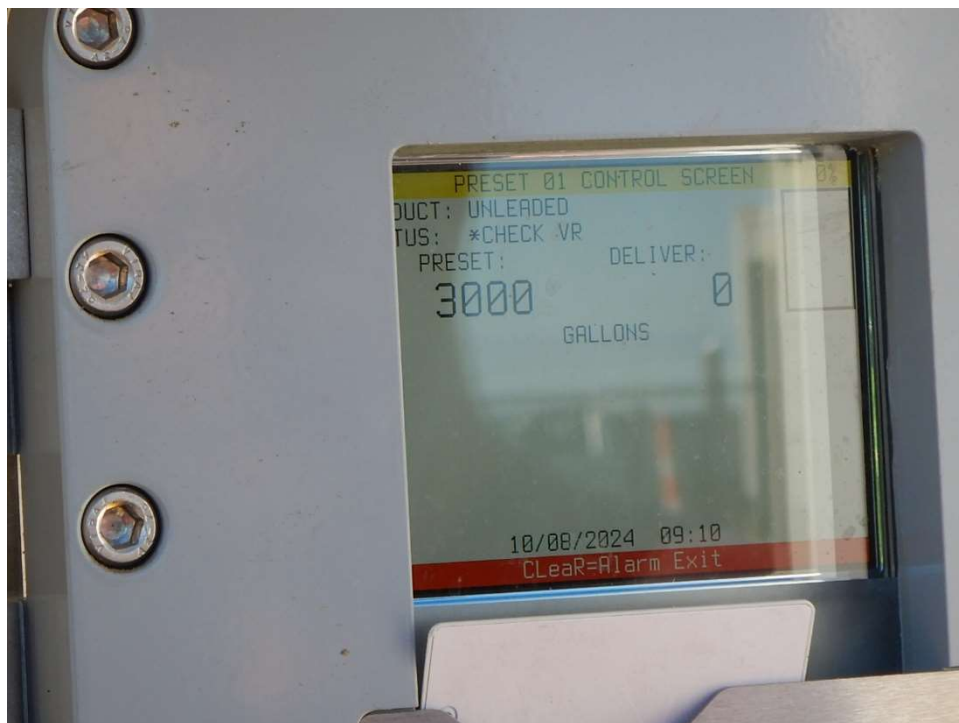
| Number | Image Identification | Description | Time (A.M.) |
|---|---|---|---|
| 9 | DSCN1750.JPG | Toptech EXI fuel loading control system screen | 9:48 |

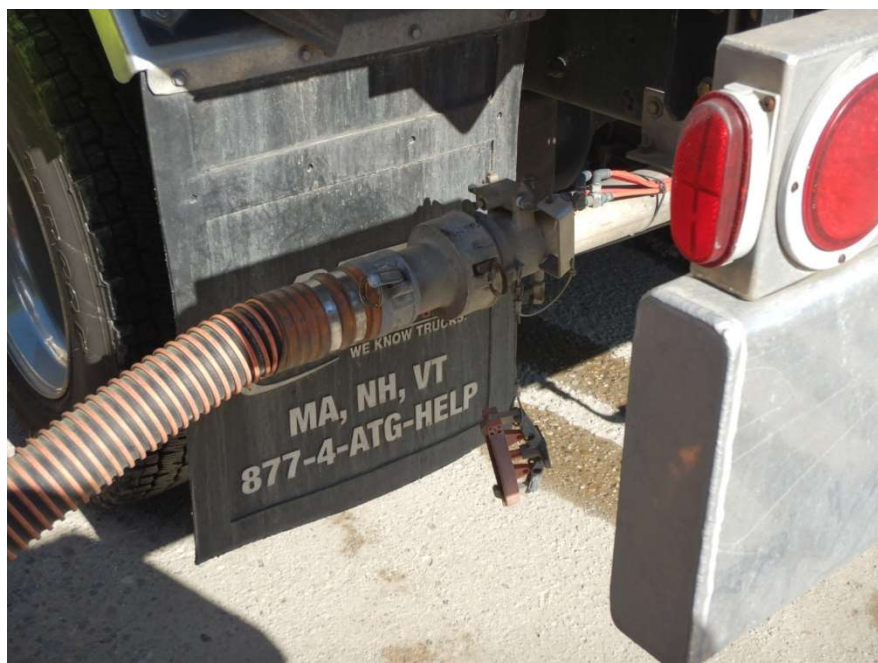
| Number | Image Identification | Description | Time (A.M.) |
|---|---|---|---|
| 12 | DSCN1753.JPG | Vapor return line on truck | 9:52 |

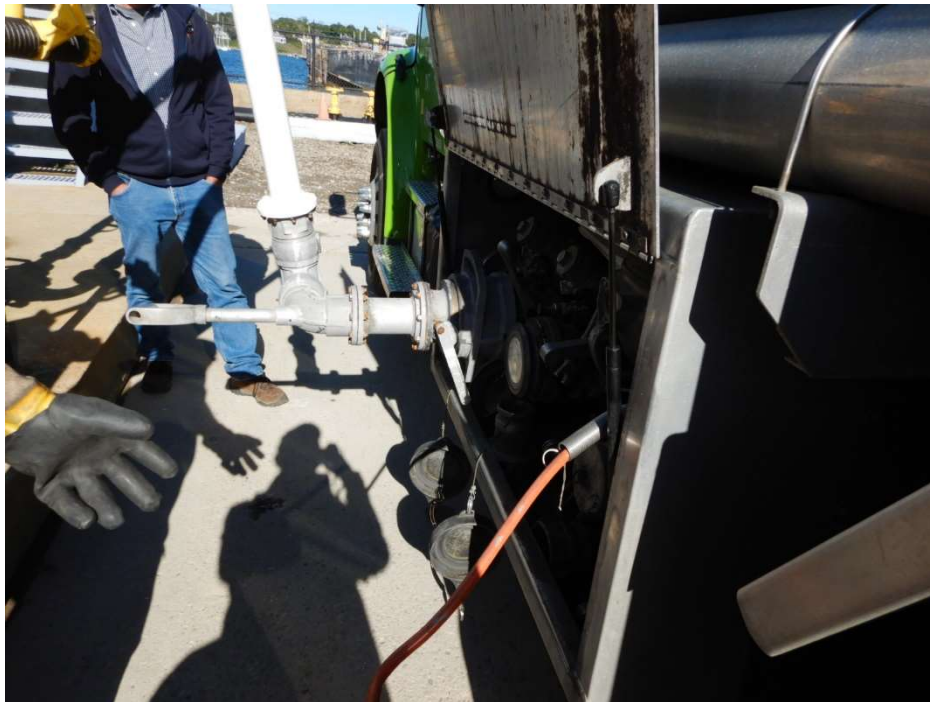
| Number | Image Identification | Description | Time (A.M.) |
|---|---|---|---|
| 15 | DSCN1756.JPG | Gasoline line connected to truck | 9:57 |

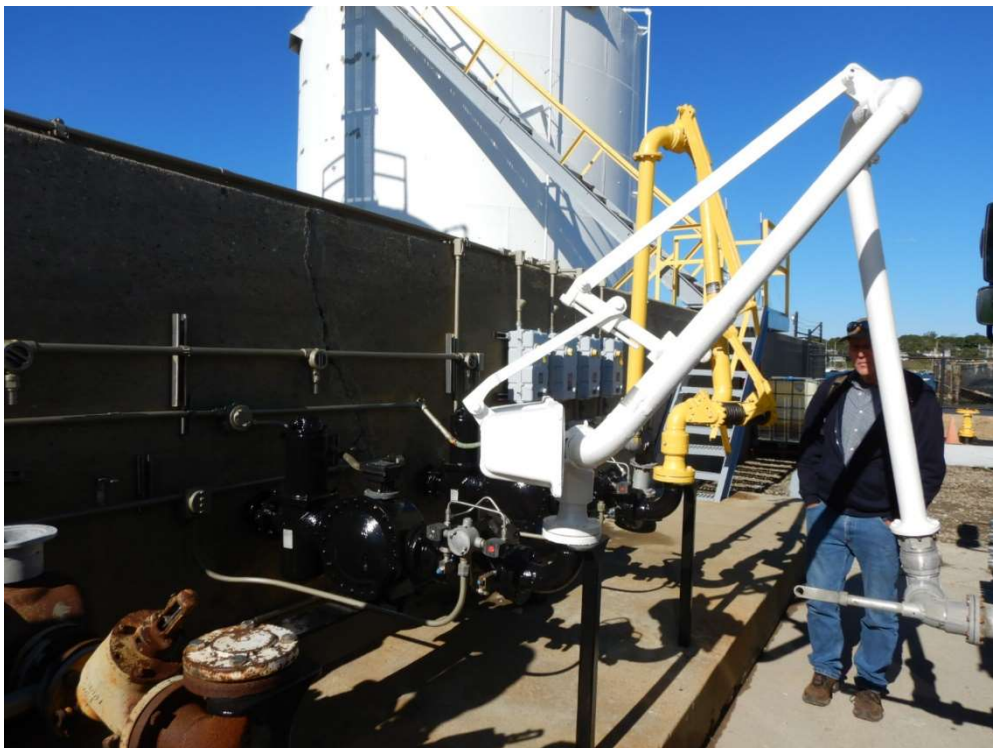
| Number | Image Identification | Description | Time (A.M.) |
|---|---|---|---|
| 16 | DSCN1757.JPG | Gasoline loading rack (white) | 9:57 |

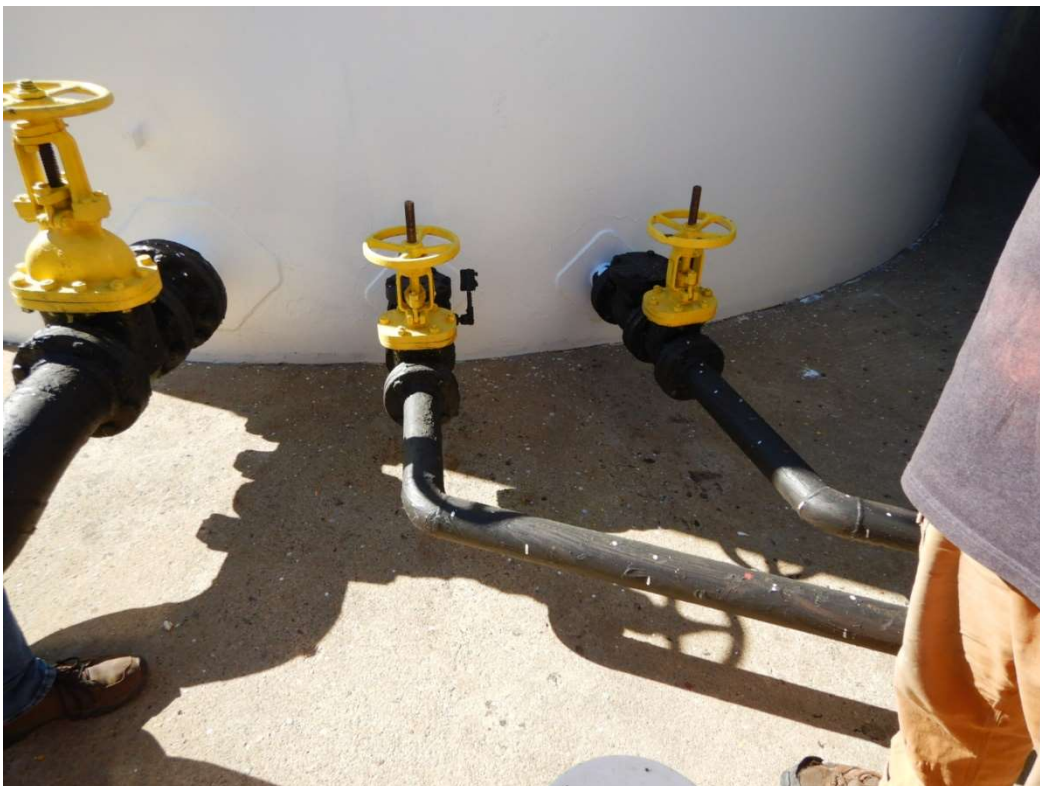
| Number | Image Identification | Description | Time (A.M.) |
|---|---|---|---|
| 18 | DSCN1759.JPG | Gasoline lines from Tank 4 | 10:06 |

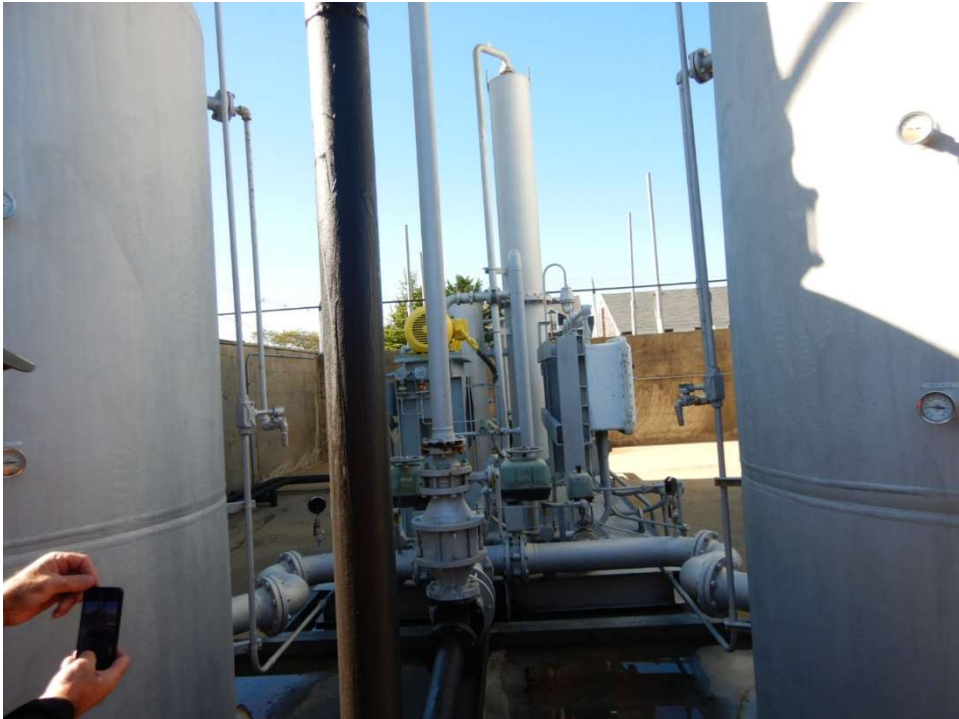
| Number | Image Identification | Description | Time (A.M.) |
|---|---|---|---|
| 22 | DSCN1763.JPG | Absorption tower (center) | 10:10 |

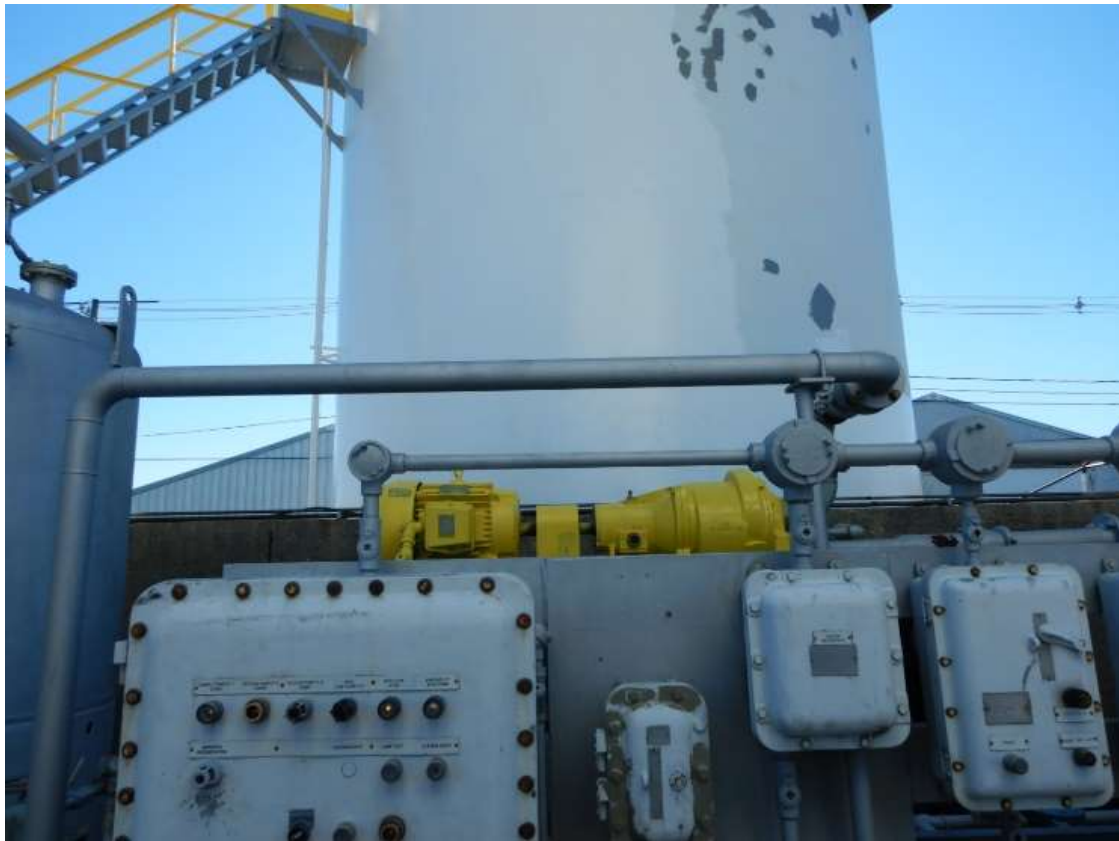
| Number | Image Identification | Description | Time (A.M.) |
|---|---|---|---|
| 23 | DSCN1764.JPG | Vacuum pump (yellow) | 10:12 |

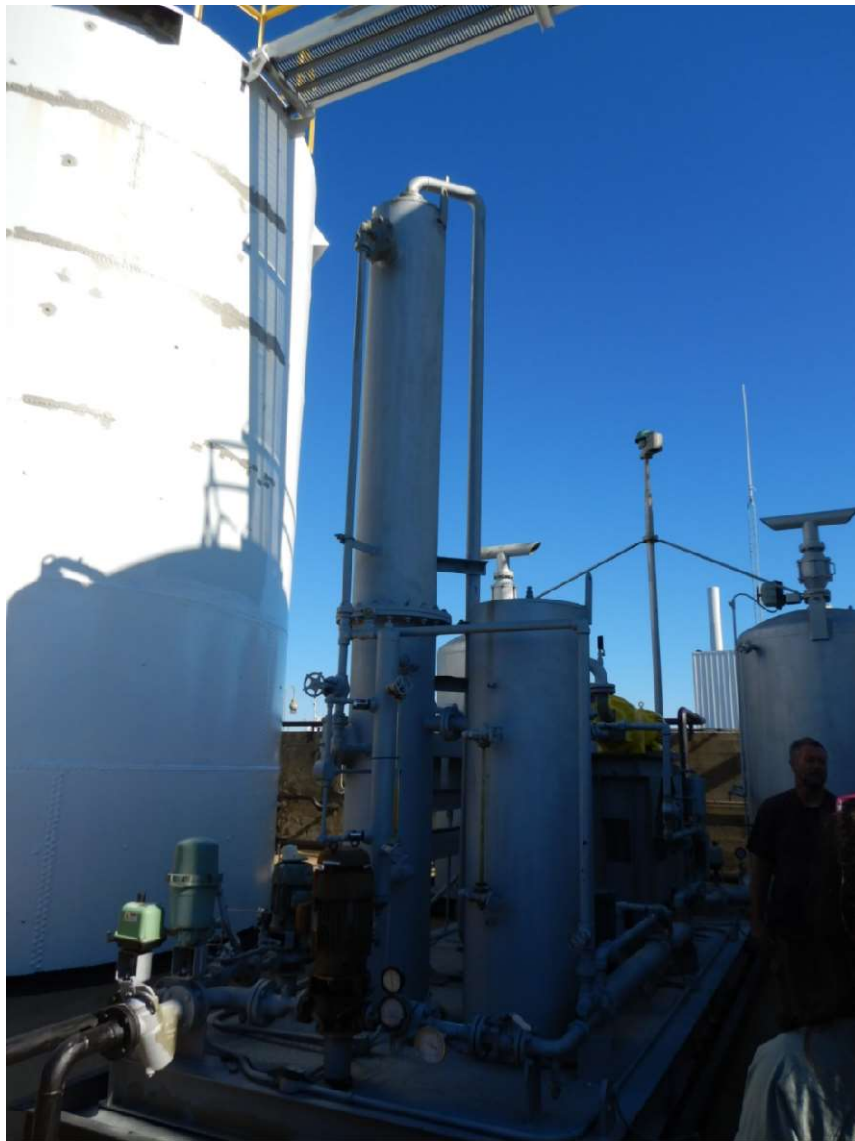
| Number | Image Identification | Description | Time (A.M.) |
|---|---|---|---|
| 24 | DSCN1765.JPG | Absorption tower | 10:13 |

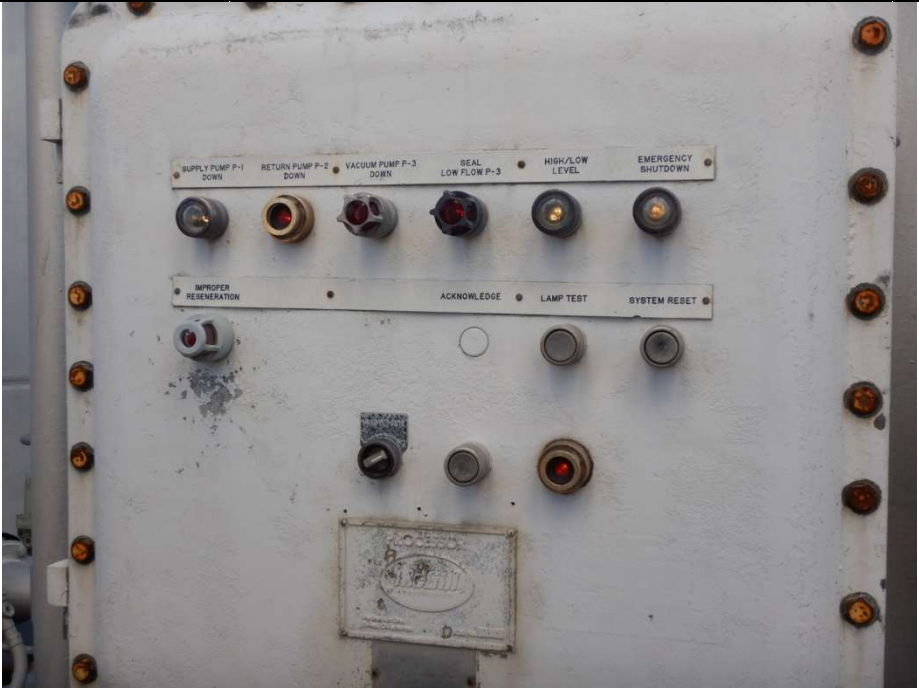
Inspector Rapp asked Mr. Bailey about the “electrical problems” indicated in the October 2023 semi-annual report from Packer. Mr. Bailey said that the VRU is an old system and there were several solenoids and valves that needed repair or replacement but the system is now working well. Inspector Rapp asked Mr. DeBlase about the VRU’s program logic controller (“PLC”) issues noted in the Spring 2024 semi-annual report, specifically if the PLC had needed to be replaced in order for the lockout system to work. Mr. DeBlase said that they resolved the issues and were able to continue using the original PLC.

| Number | Image Identification | Description | Time (A.M.) |
|---|---|---|---|
| 25 | DSCN1766.JPG | VRU control panel | 10:15 |

Mr. DeBlase noted that although the VRU is functioning well currently, Packer has applied for a permit at MassDEP to allow the replacement of the VRU with a vapor control unit ("VCU"). He said they are waiting for a response from MassDEP.

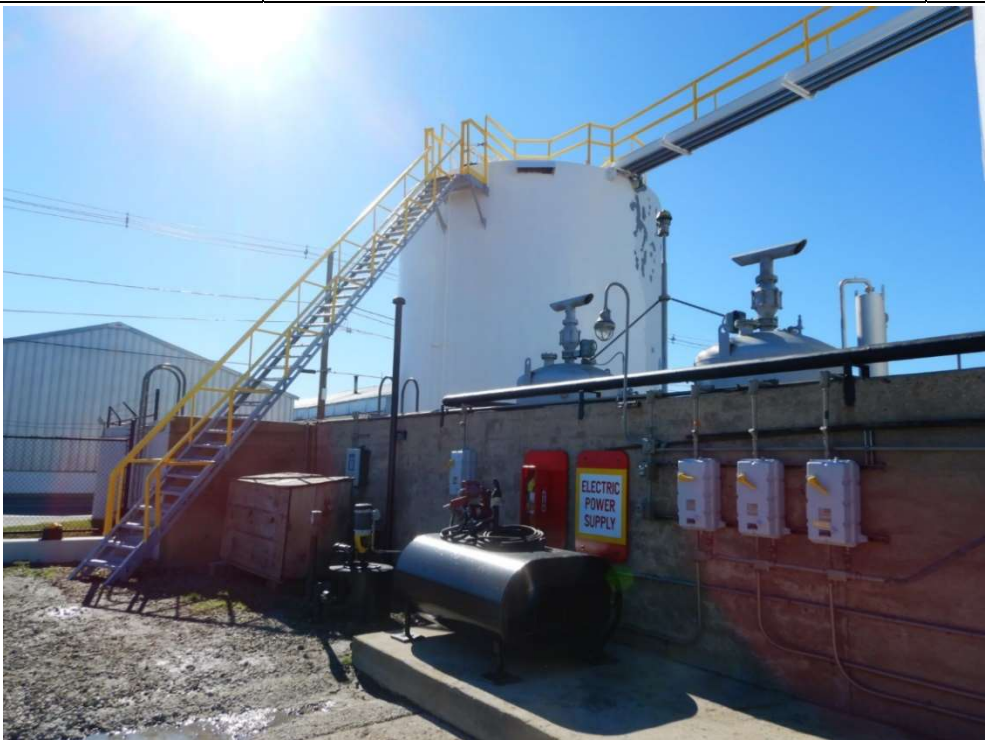
| Number | Image Identification | Description | Time (A.M.) |
|---|---|---|---|
| 26 | DSCN1767.JPG | Gasoline storage tank behind berm wall | 10:38 |

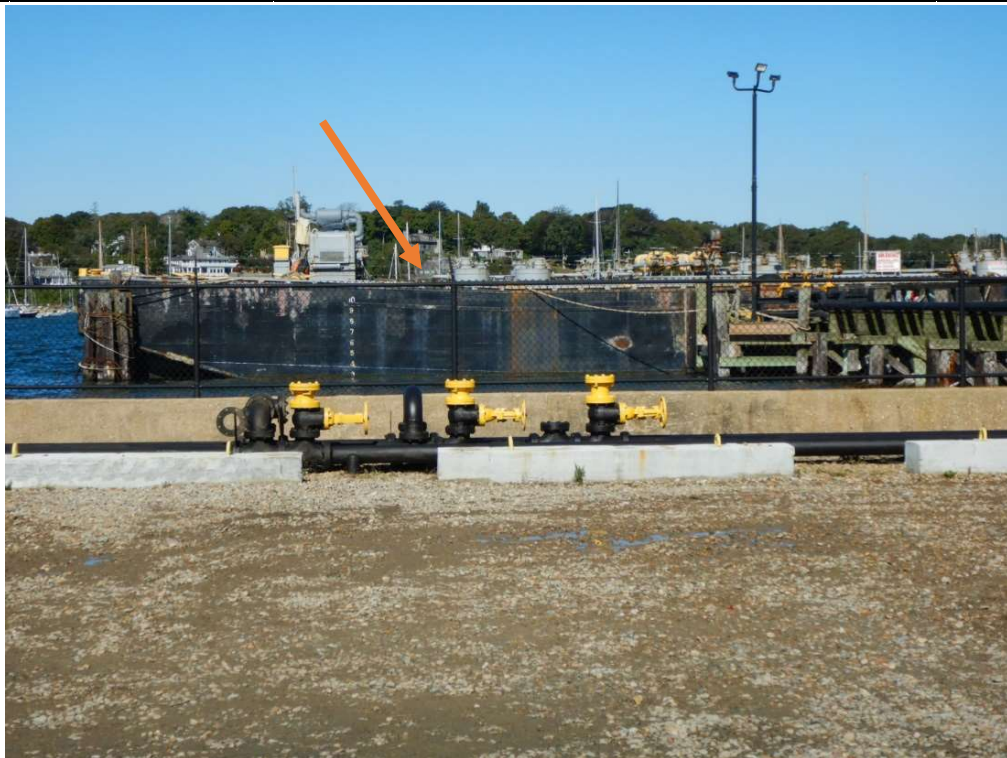
| Number | Image Identification | Description | Time (A.M.) |
|---|---|---|---|
| 27 | DSCN1768.JPG | Fuel barge parked at dock | 10:39 |

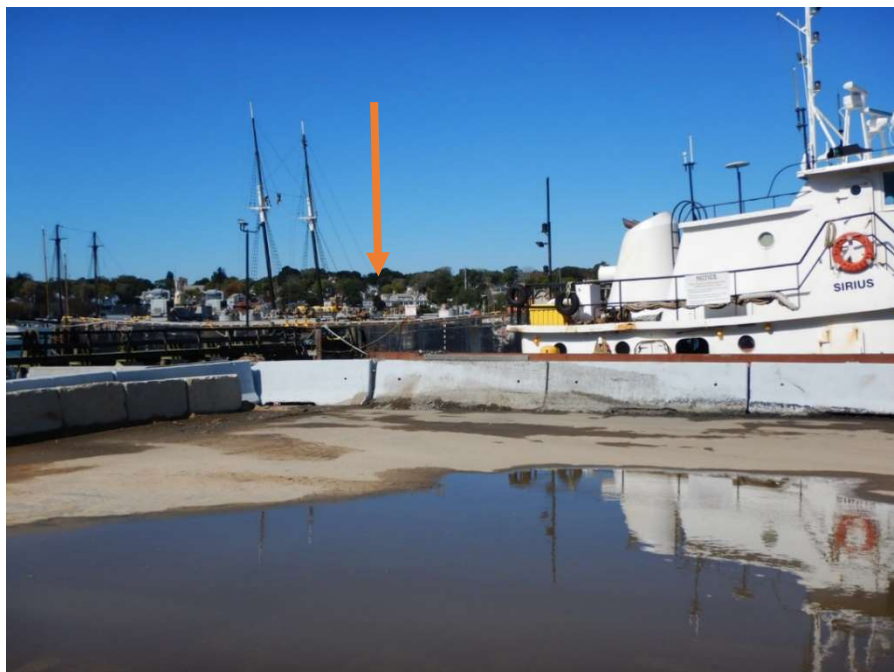
| Number | Image Identification | Description | Time (A.M.) |
|---|---|---|---|
| 28 | DSCN1769.JPG | Fuel barge parked at dock | 10:59 |
