**Region 2 Caribbean Environmental Protection Division  
Multimedia Permits and Compliance Branch**

**CAA Inspection Report**

**Inspection Date:** 12/4/2024

**Facility Name:** Steri-Tech Inc.

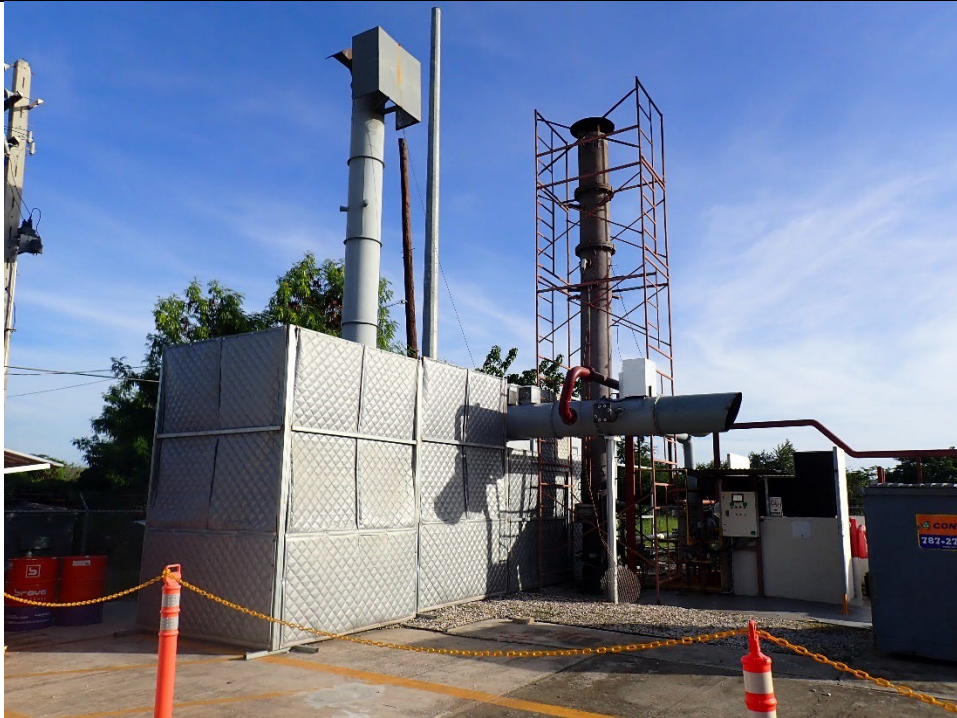
| Appendix A: Digital Image Log for Steri-Tech Inc., Salinas, PR | | | | |
|---|---|---|---|---|
| 1 | PC040001 | <div><p>Partial view of the facility Catalytic Recuperative Oxidizer (CRO) and Thermal Oxidizer (TO)</p></div> | 12-4-24 | 16:13 PM |

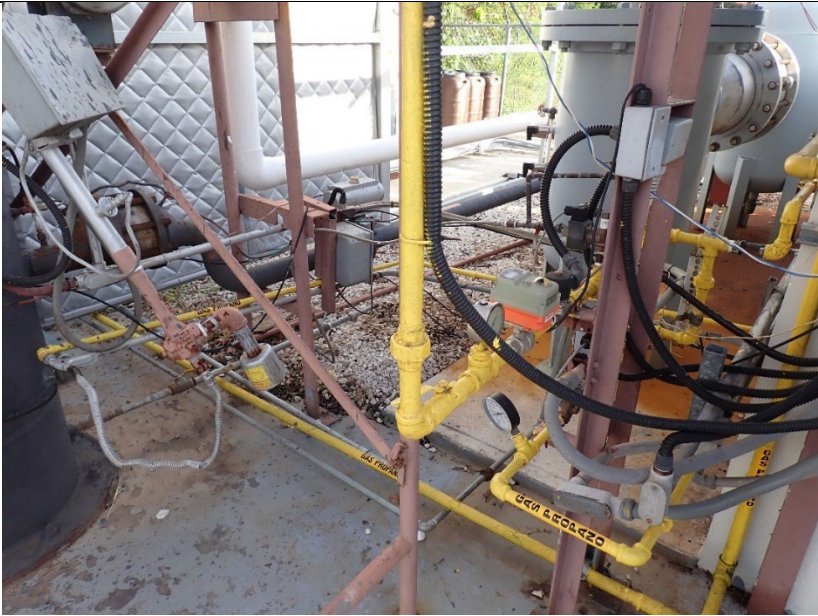
| 5 | PC040005 | <p data-bbox="573 683 1386 743">Partial view of the CRO and TO propane supply piping.</p> | 12-4-24 | 16:21 PM |

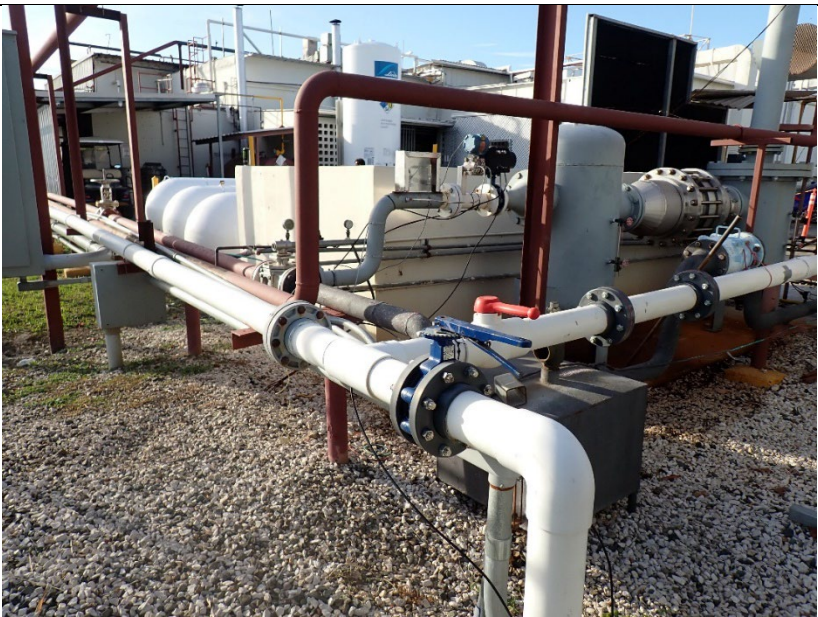
| 6 | PC040006 | <p data-bbox="573 1356 1386 1421">Partial view of the facility aeration rooms and sterilization chambers process gas piping.</p> | 12-4-24 | 16:23 PM |

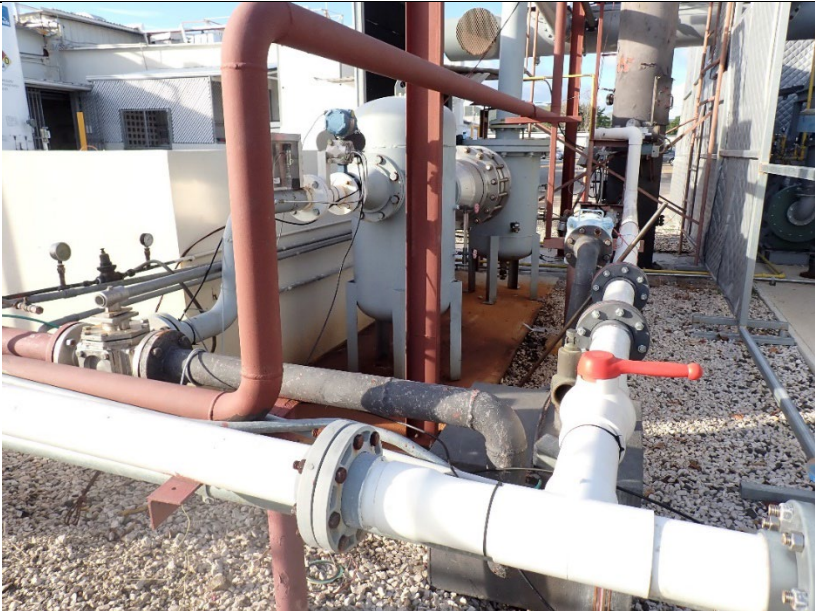
| 7 | PC040007 | <p data-bbox="573 683 1499 711">Partial view of the facility aeration rooms and sterilization chambers process gas piping.</p> | 12-4-24 | 16:23 PM |

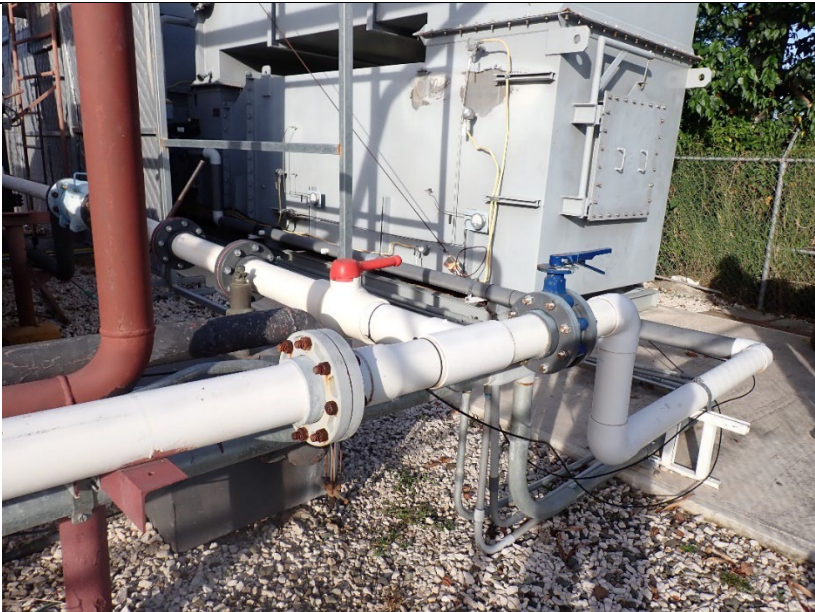
| 8 | PC040008 | <p data-bbox="573 1356 1499 1383">Partial view of the facility aeration rooms and sterilization chambers process gas piping.</p> | 12-4-24 | 16:23 PM |

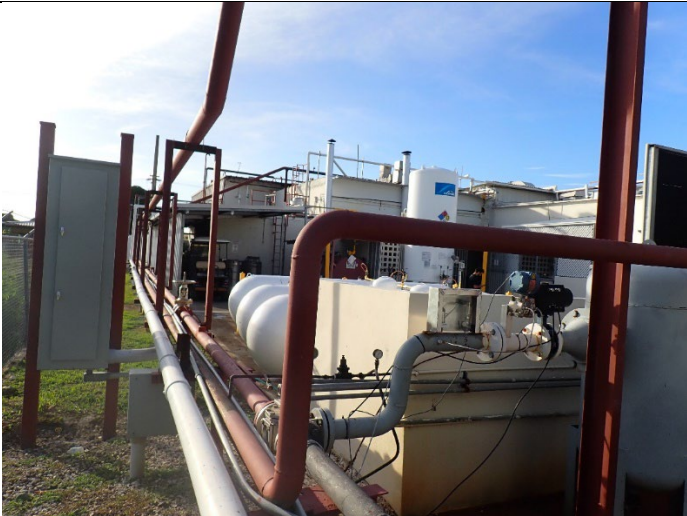
| 9 | PC040009 | <p>Partial view of the facility aeration rooms and sterilization chambers process gas piping.</p> | 12-4-24 | 16:23 PM |

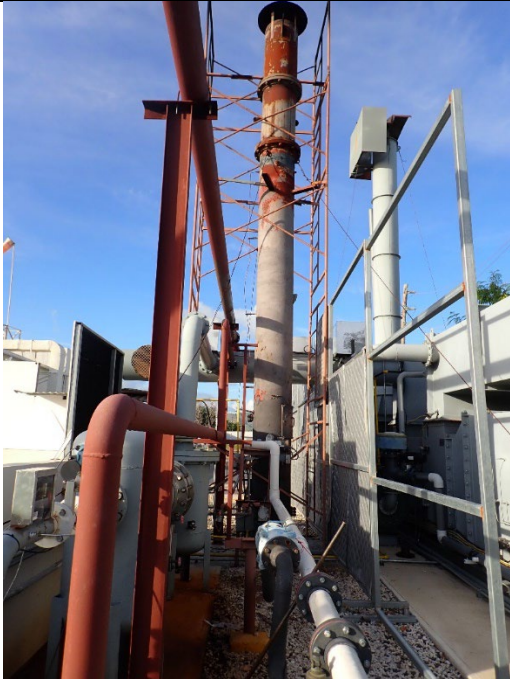
| 10 | PC040010 | <p>Partial view of the facility aeration rooms and sterilization chambers process gas piping and its CRO and TO emission stacks.</p> | 12-4-24 | 16:23 PM |

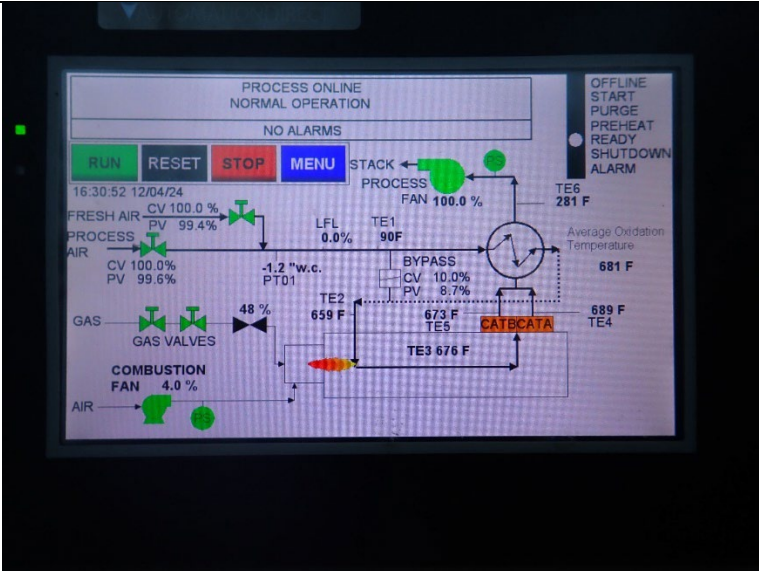
| 11 | PC040011 | <p>View of the CRO outdoor control panel screen.</p> | 12-4-24 | 16:25 PM |

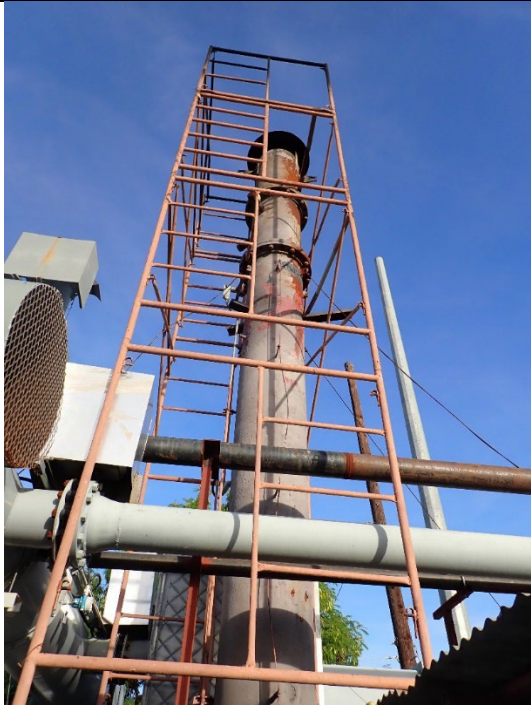
| 14 | PC040014 | <p>Partial view of the TO emission stack.</p> | 12-4-24 | 16:31 PM |
