## Region 6 - Enforcement & Compliance Assurance Division

### INSPECTION REPORT

| Regulatory Program(s) | Safe Drinking Water Act (SDWA) – Lead and Copper Rule (LCR) | |
| System Name: | <b>Sandia Resort and Casino Public Water System</b> | |

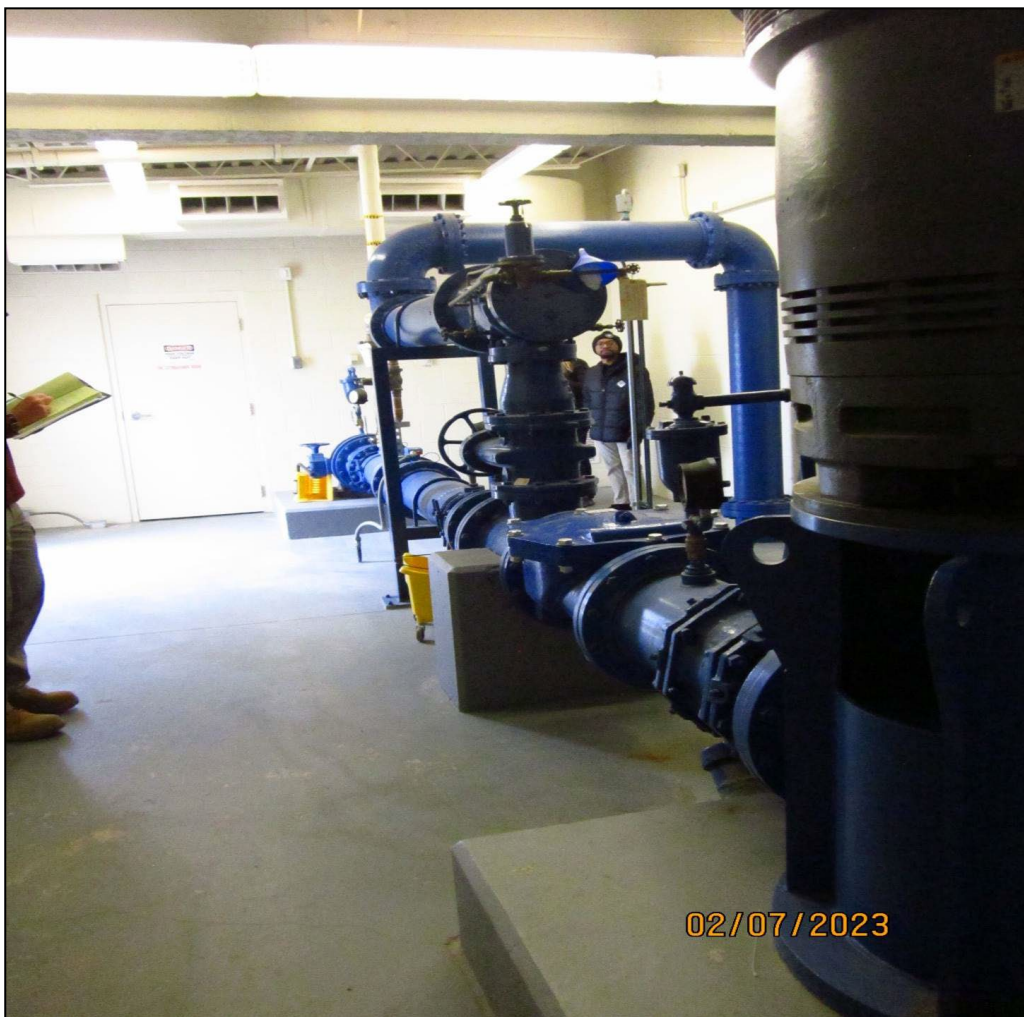
Photo No. 12

**Photograph 12. Well No. 2 (W0002)** View of the W0002 line, including the pump, air relief valves, check valve and pump-to-waste line that had an isolation valve.

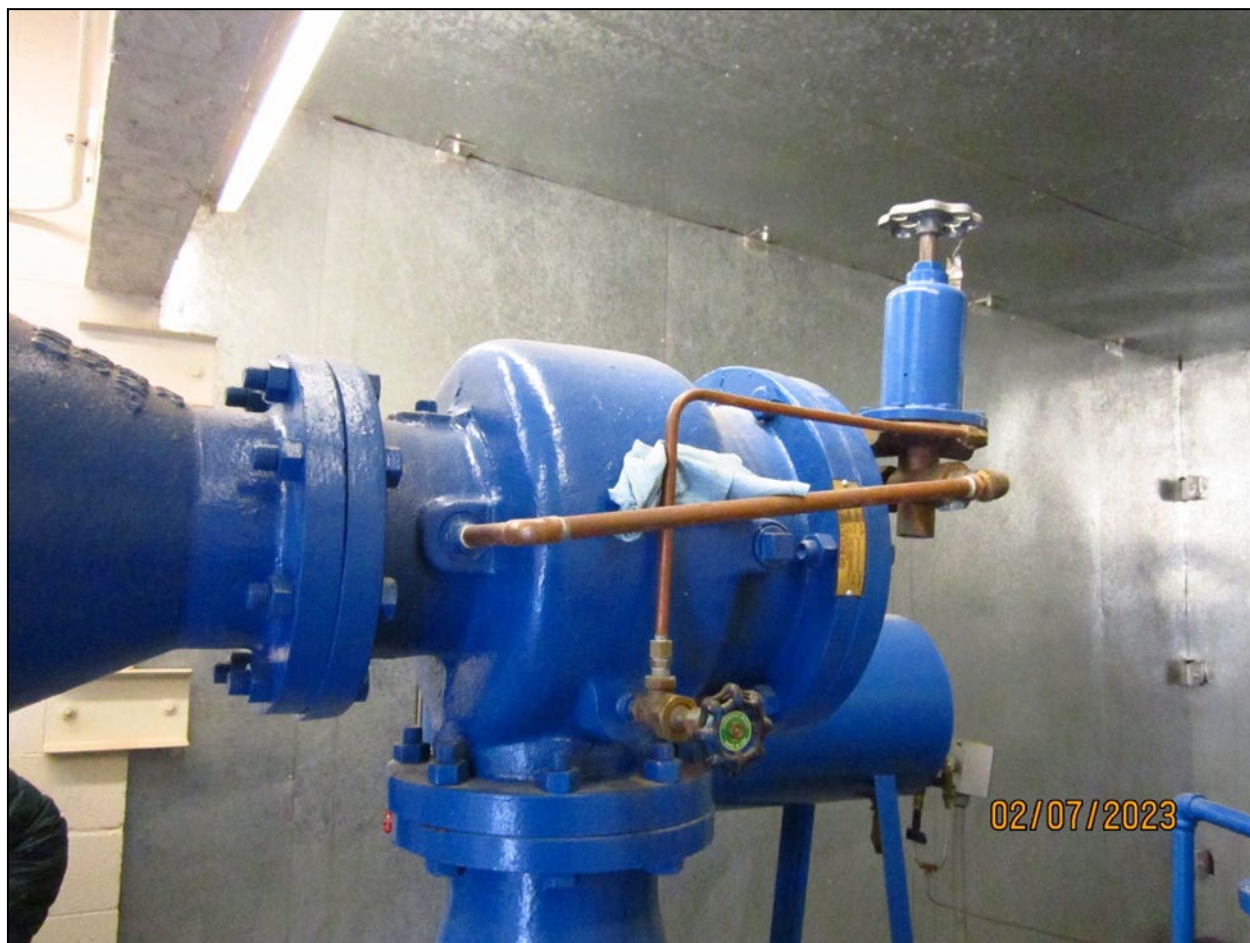
Photo No. 13

**Photograph 13. W0002 PRV** View of the PRV on the pump-to-waste line extending from the W0002 pump raw water line.

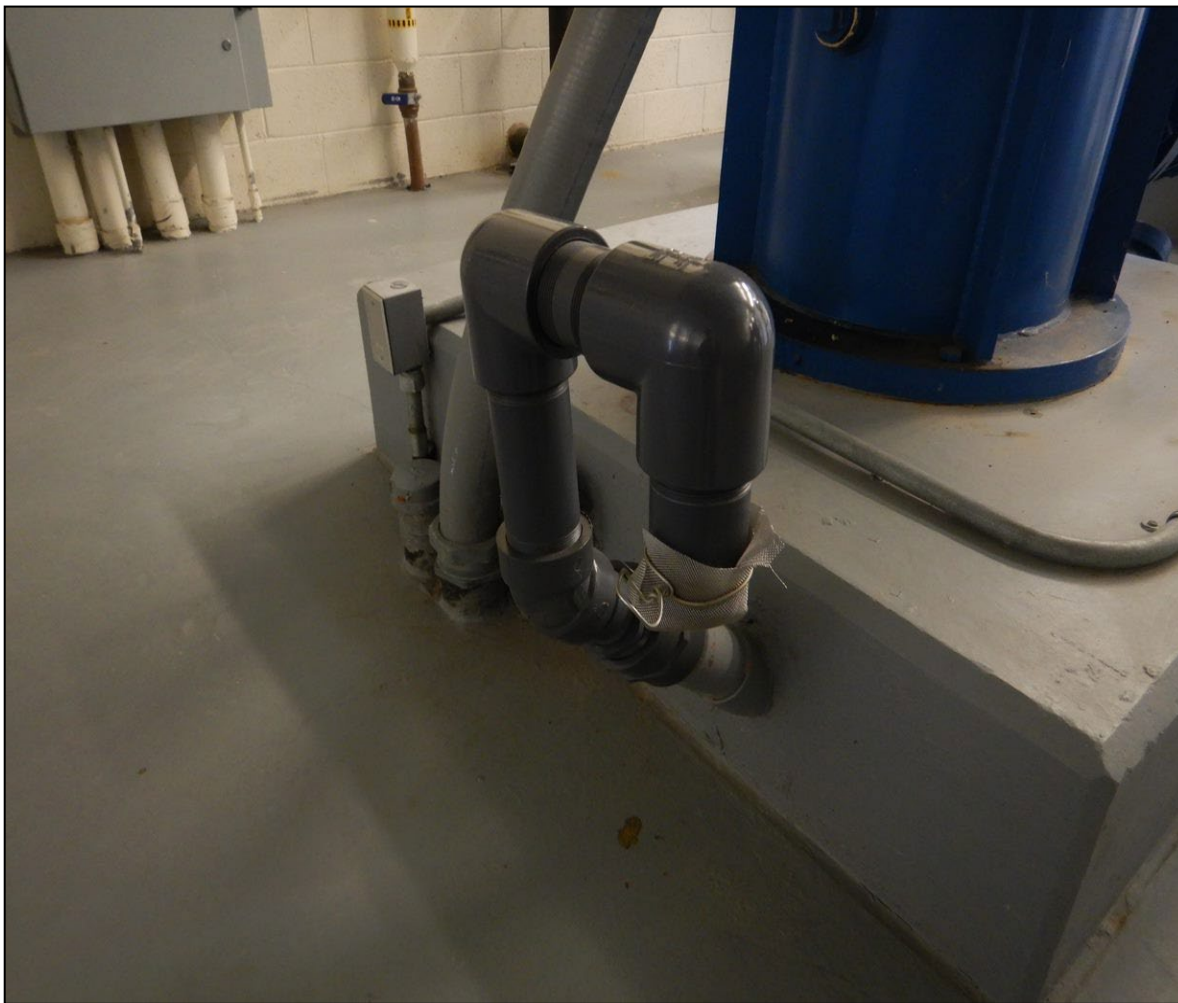
Photo No. 14

**Photograph 14. W0002 Air Relief Valve** View of a screened air relief valve at Wellhead Casing No. 2.

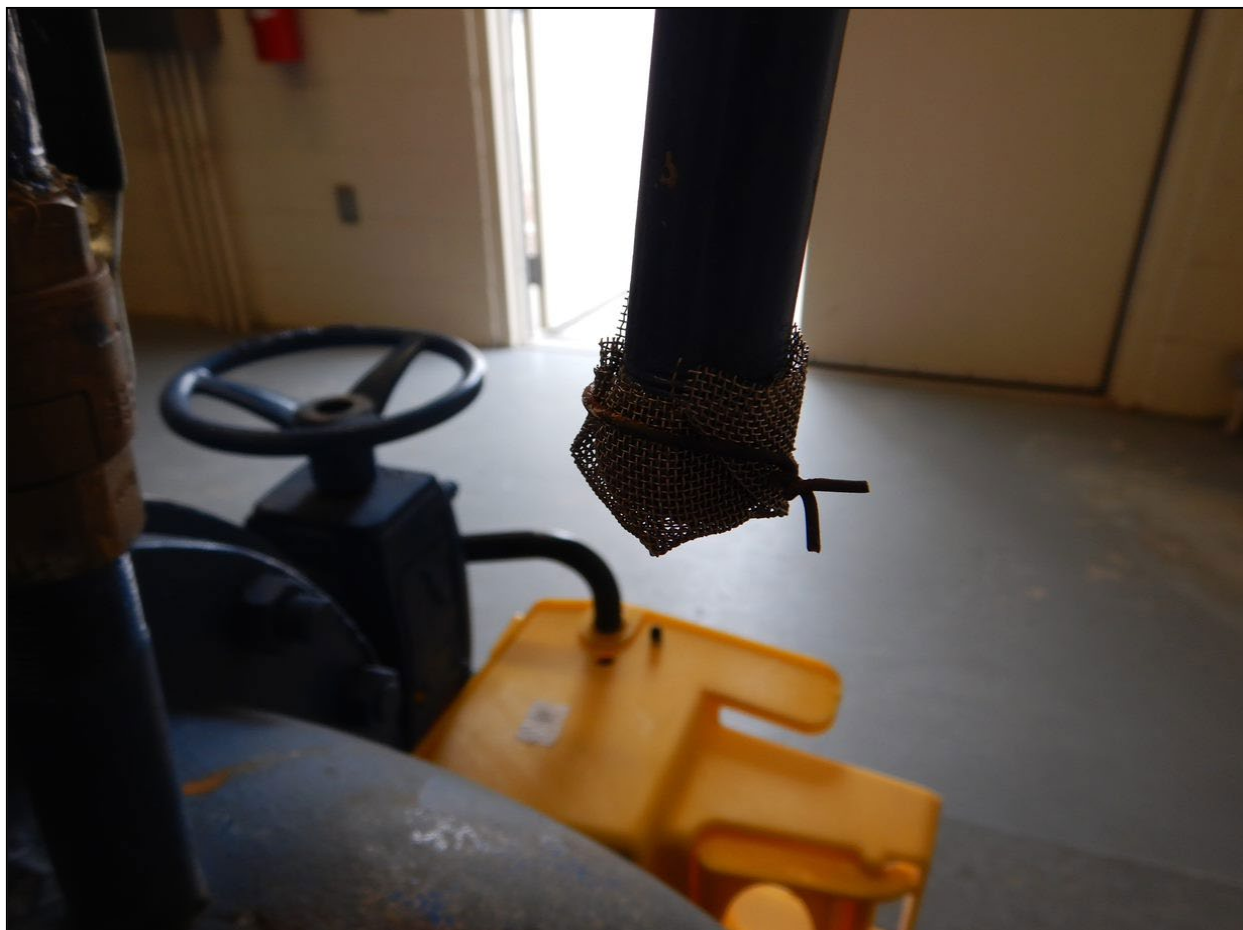
Photo No. 15

**Photograph 15. W0002 Air Relief Valve** View of a screened air relief valve on the W0002 pump raw water line.

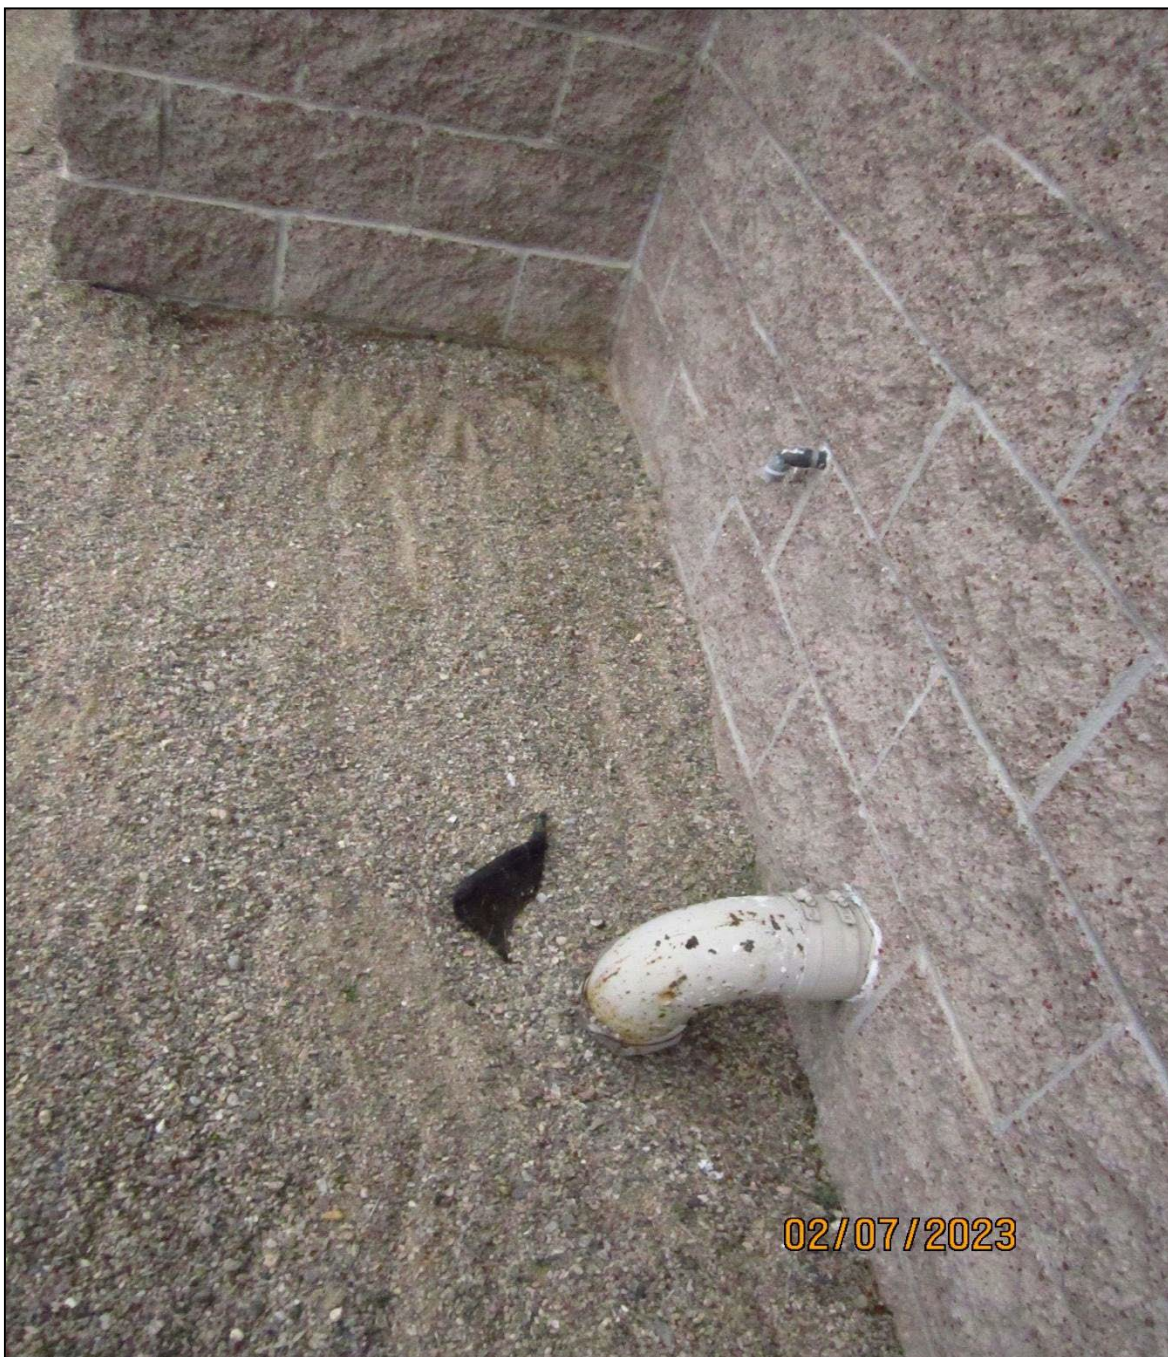
Photo No. 16

**Photograph 16. Check Valve Release Pipe (W0002 Building)** View of the check valve release pipe leading to the outside of the W0002 building. The opening of the pipe was screened.

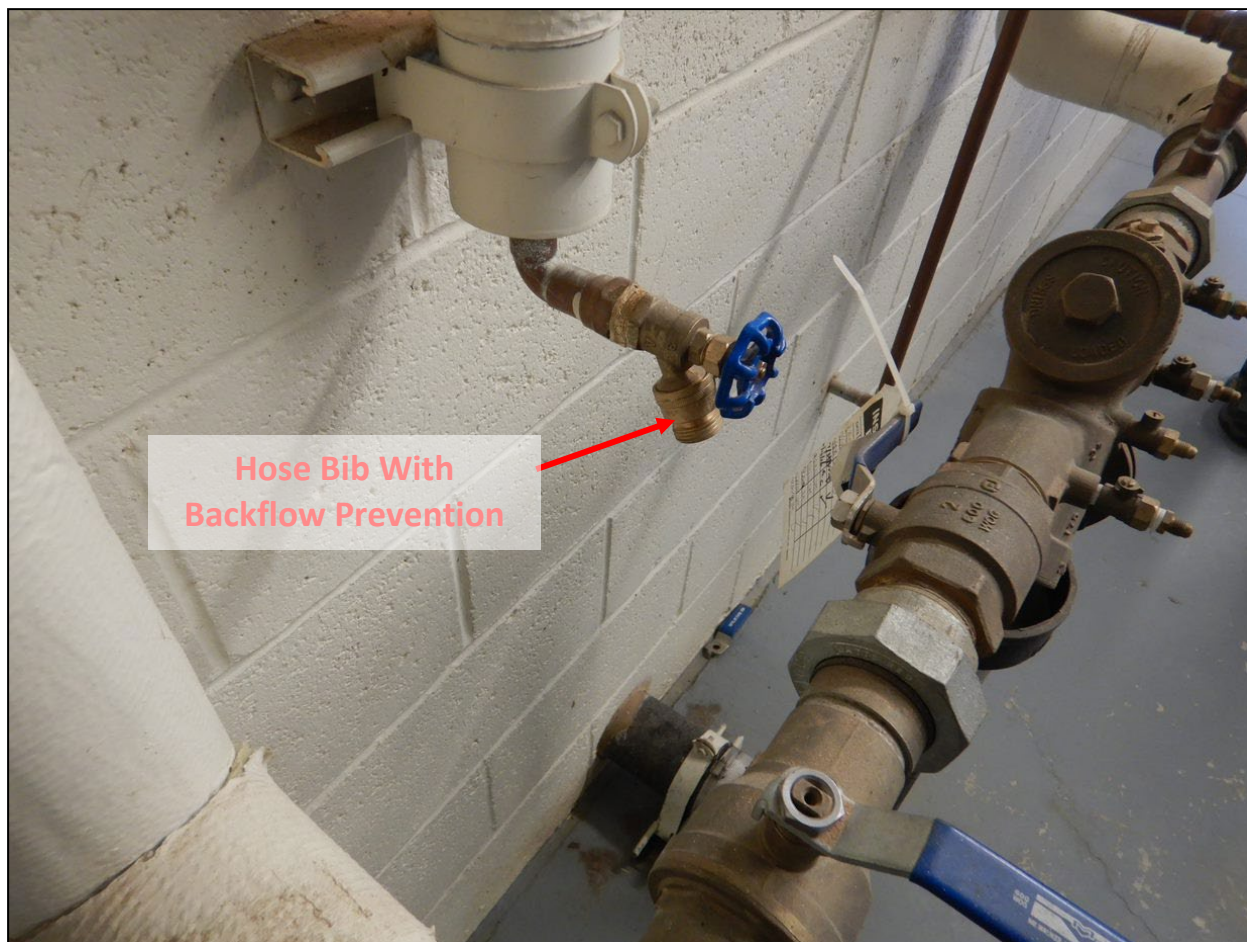
Photo No. 17

**Photograph 17. Hose Bib, W0002 Building** Hose bib with vacuum backflow protection and the backflow assembly for the non-potable water line servicing the well house.

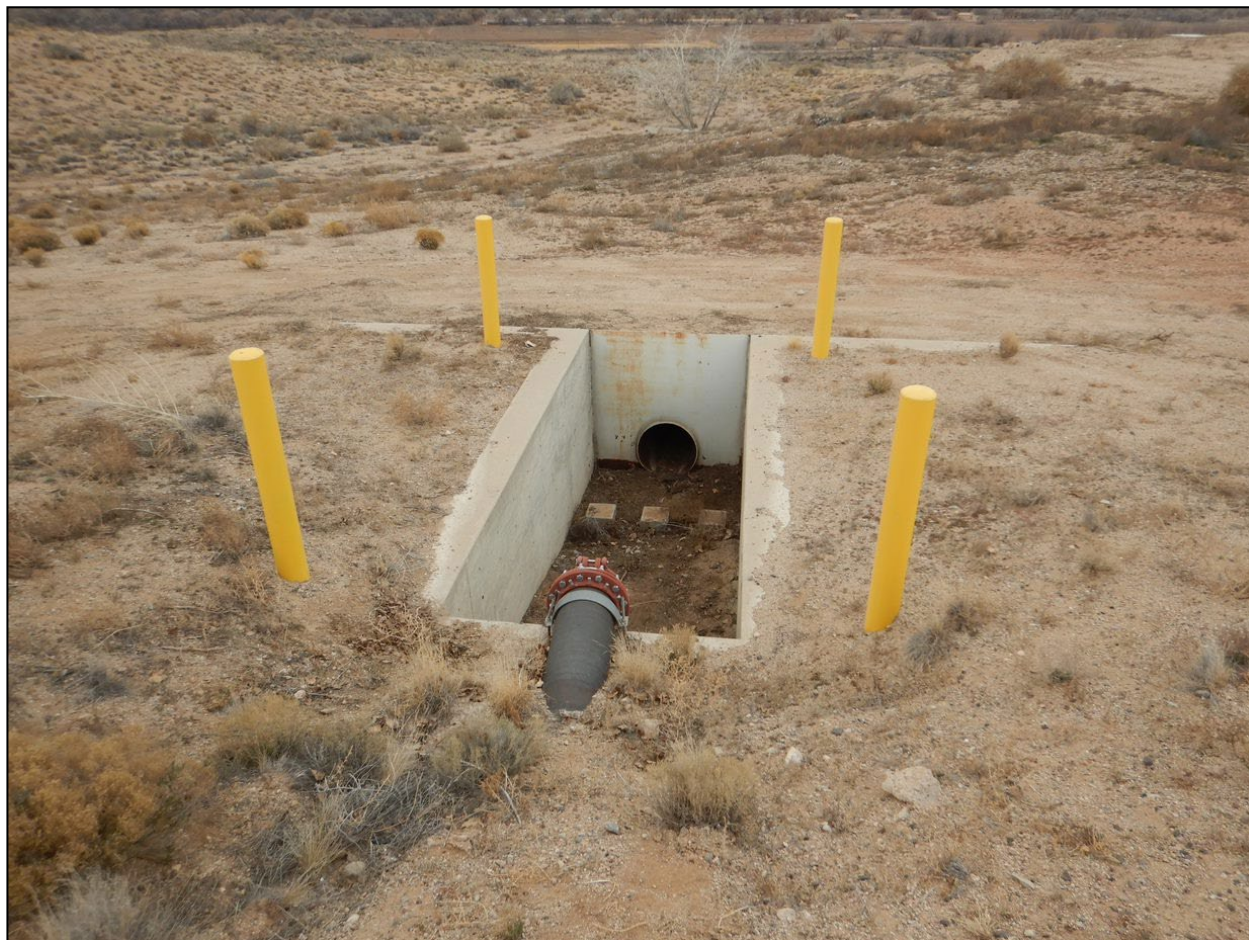
Photo No. 18

**Photograph 18. W0002 Pump-to-Waste Discharge Pipe** View of the pump-to-waste discharge pipe northwest of the W0002 building. The pipe discharged into a concrete walled basin which was dry.

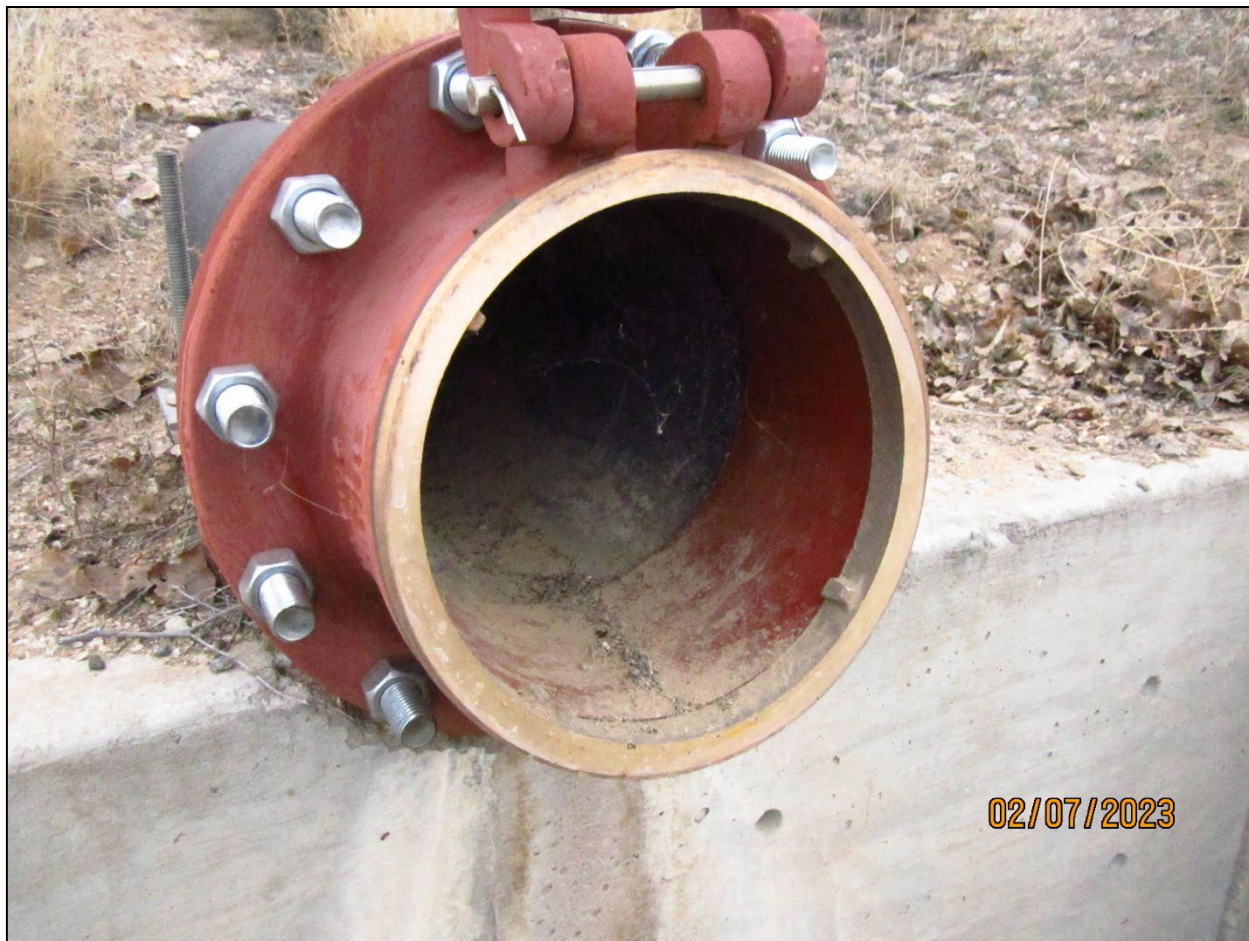
Photo No. 19

**Photograph 19. W0002 Pump-to-Waste Discharge Pipe Opening** View of the open W0002 pump-to-waste discharge pipe. The pipe did not contain water, moisture, or debris in the invert.

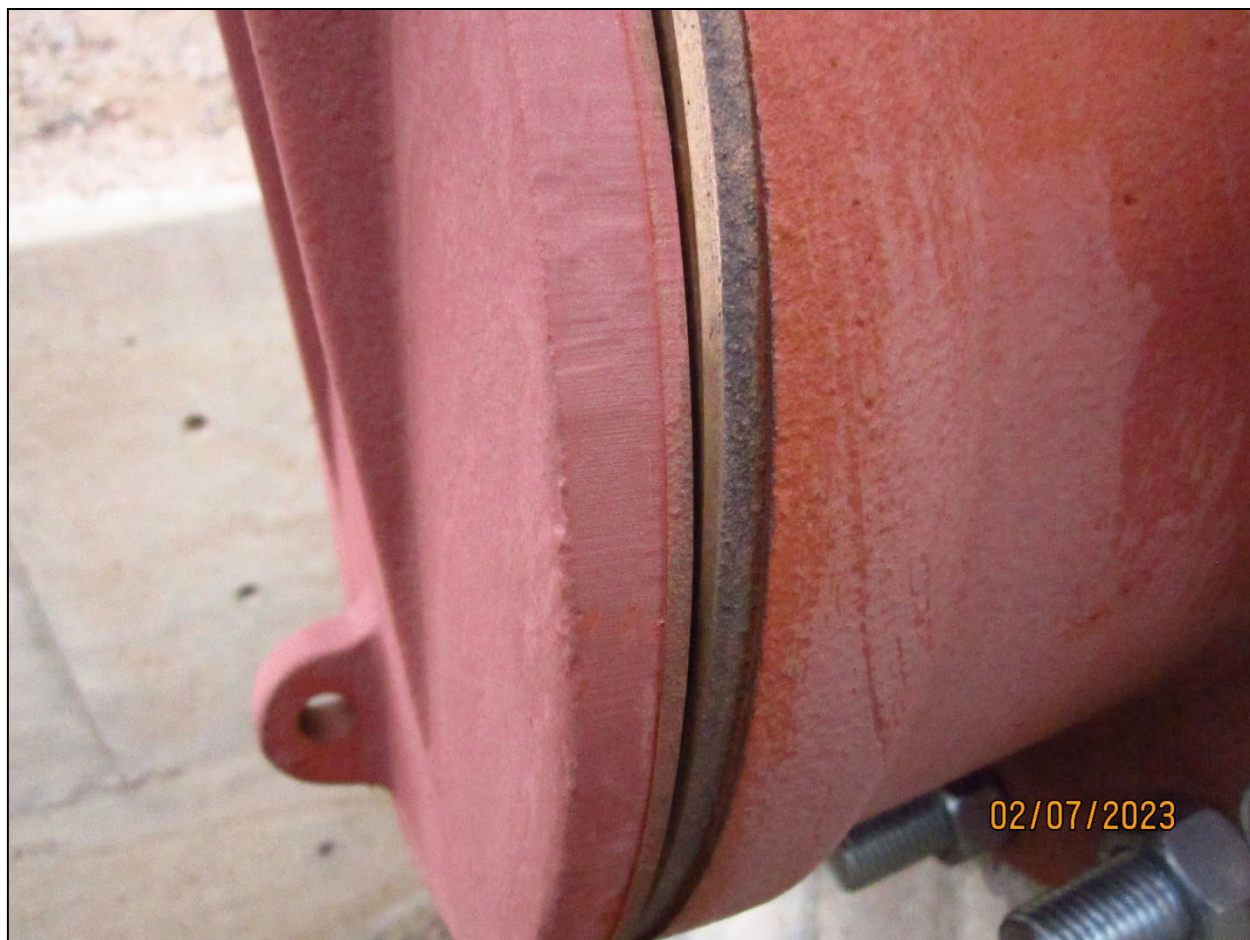
Photo No. 20

**Photograph 20. W0002 Pump-to-Waste Discharge Pipe Opening (Flapper)** Close up view of the W0002 discharge flapper that had a tight seal with no space for insect or debris entry.

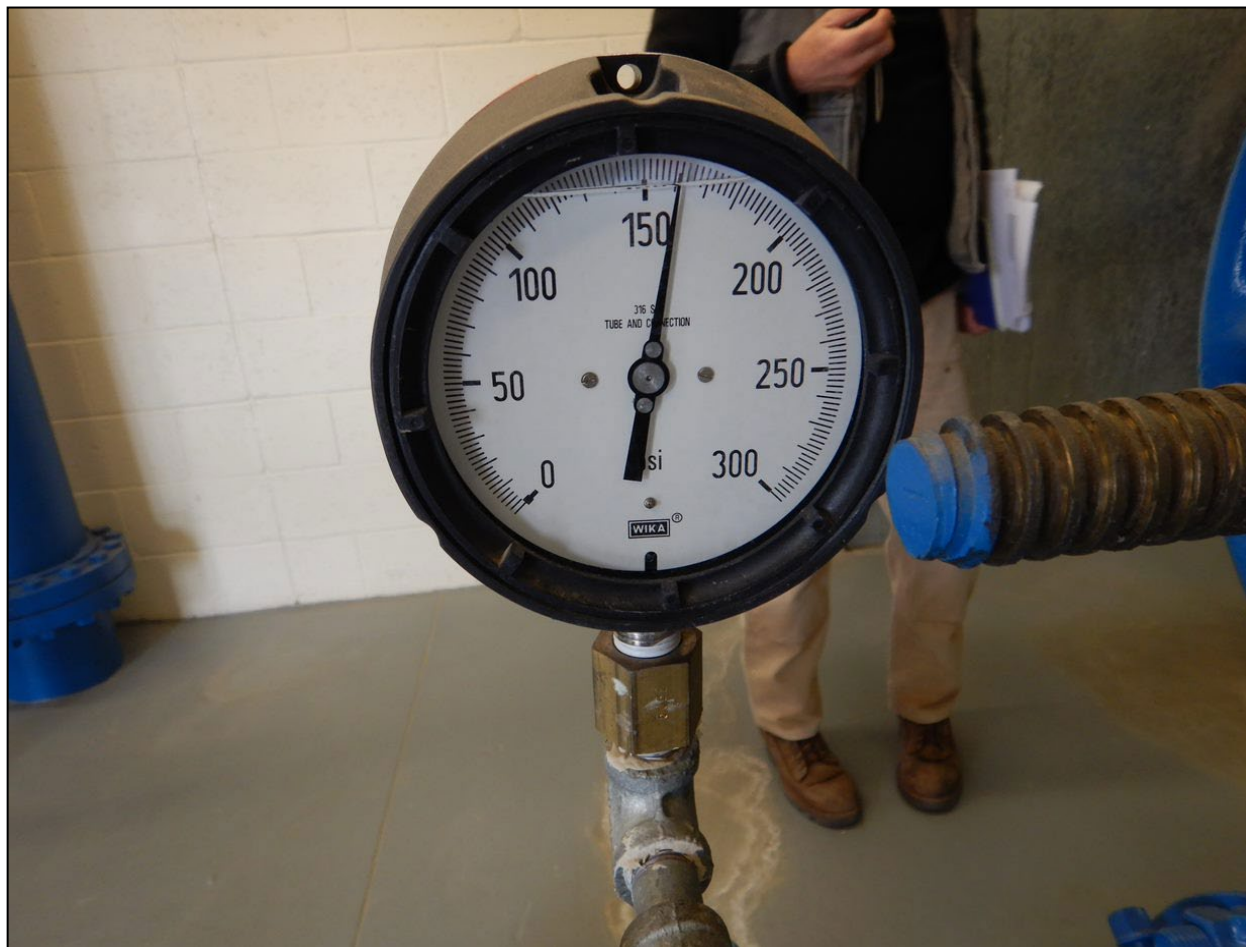
Photo No. 21

**Photograph 21. W0002 Pump Line Pressure Gauge** View of one of the pressure gauges on the W0002 pump raw water line, downstream of the check valve. The W0002 pump was not operating during the inspection. The gauge read approximately 162 psi.

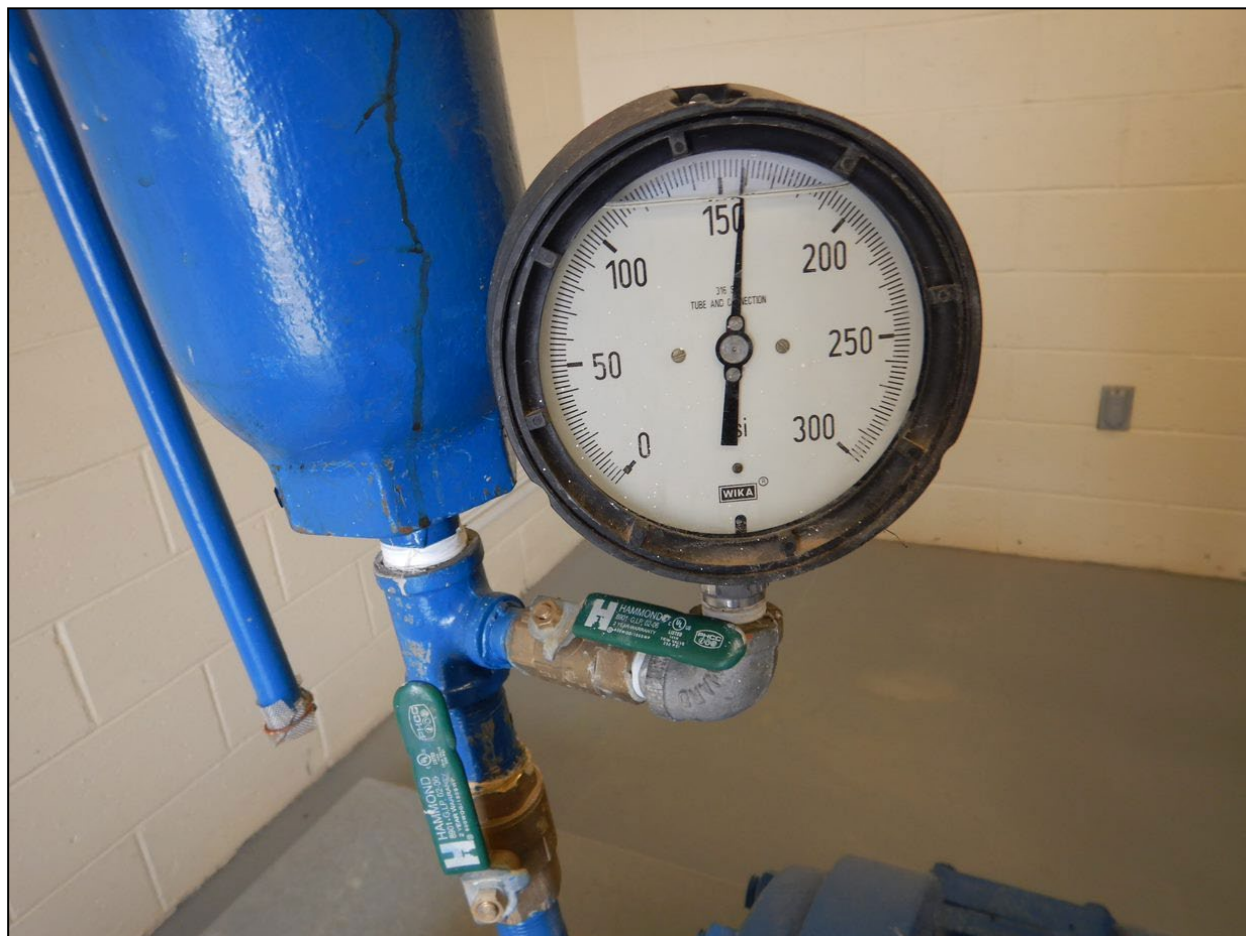
Photo No. 22

**Photograph 22. W0002 Pump Line Pressure Gauge** View of an additional pressure gauge on the W0002 pump line, immediately prior to the raw water being transferred to the W0001 building. The W0002 pump was not operating during the inspection. This gauge also read approximately 158 psi.

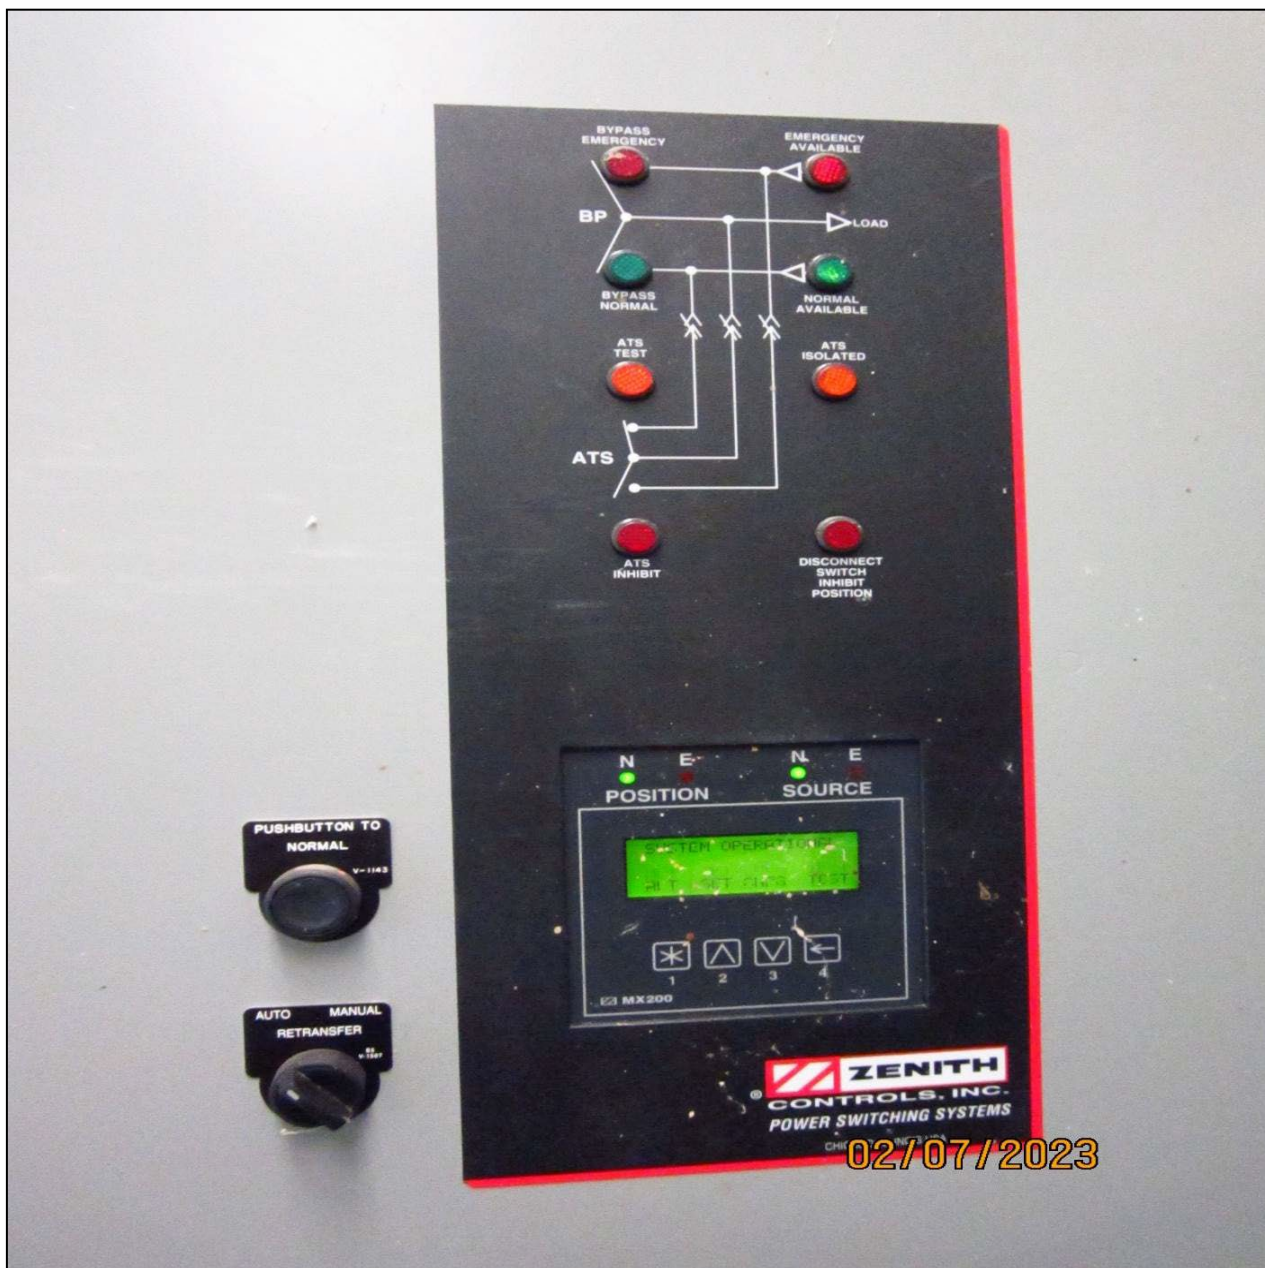
Photo No. 24

**Photograph 24. Switch Gear Control Cabinet, W0002 Building** View of a switch gear control cabinet that was present in the W0002 building.

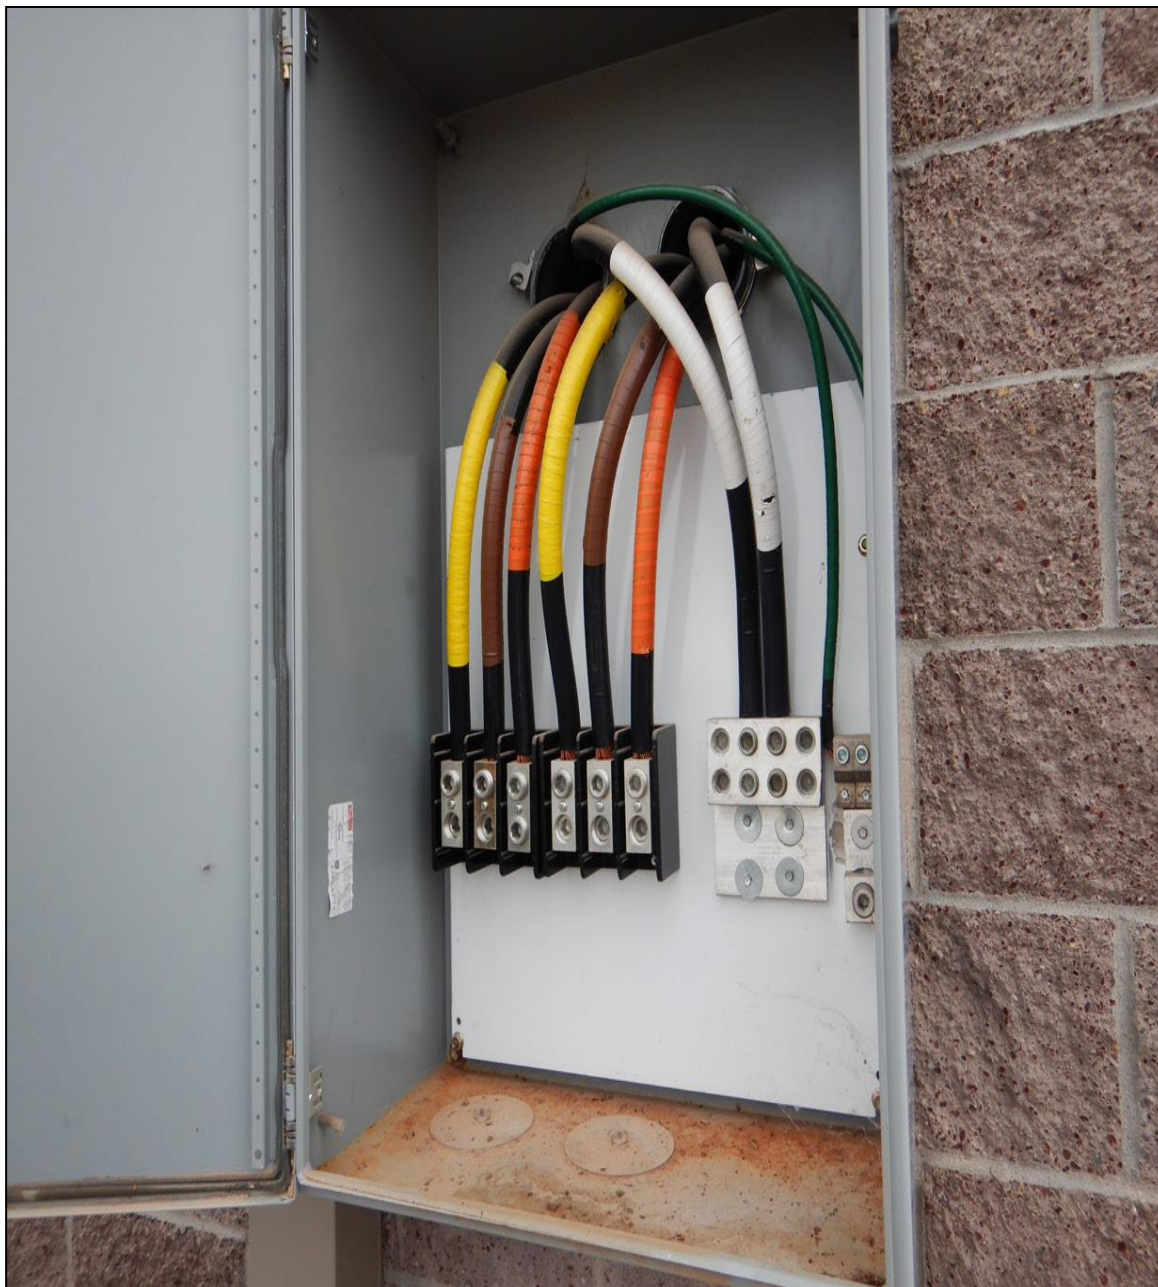
Photo No. 25

**Photograph 25. Switch Gear MCC Box, W0002 Building** View of the inside of the switch gear connection cabinet where a trailer generator could be wired up to provide power in the event of a power loss/failure.

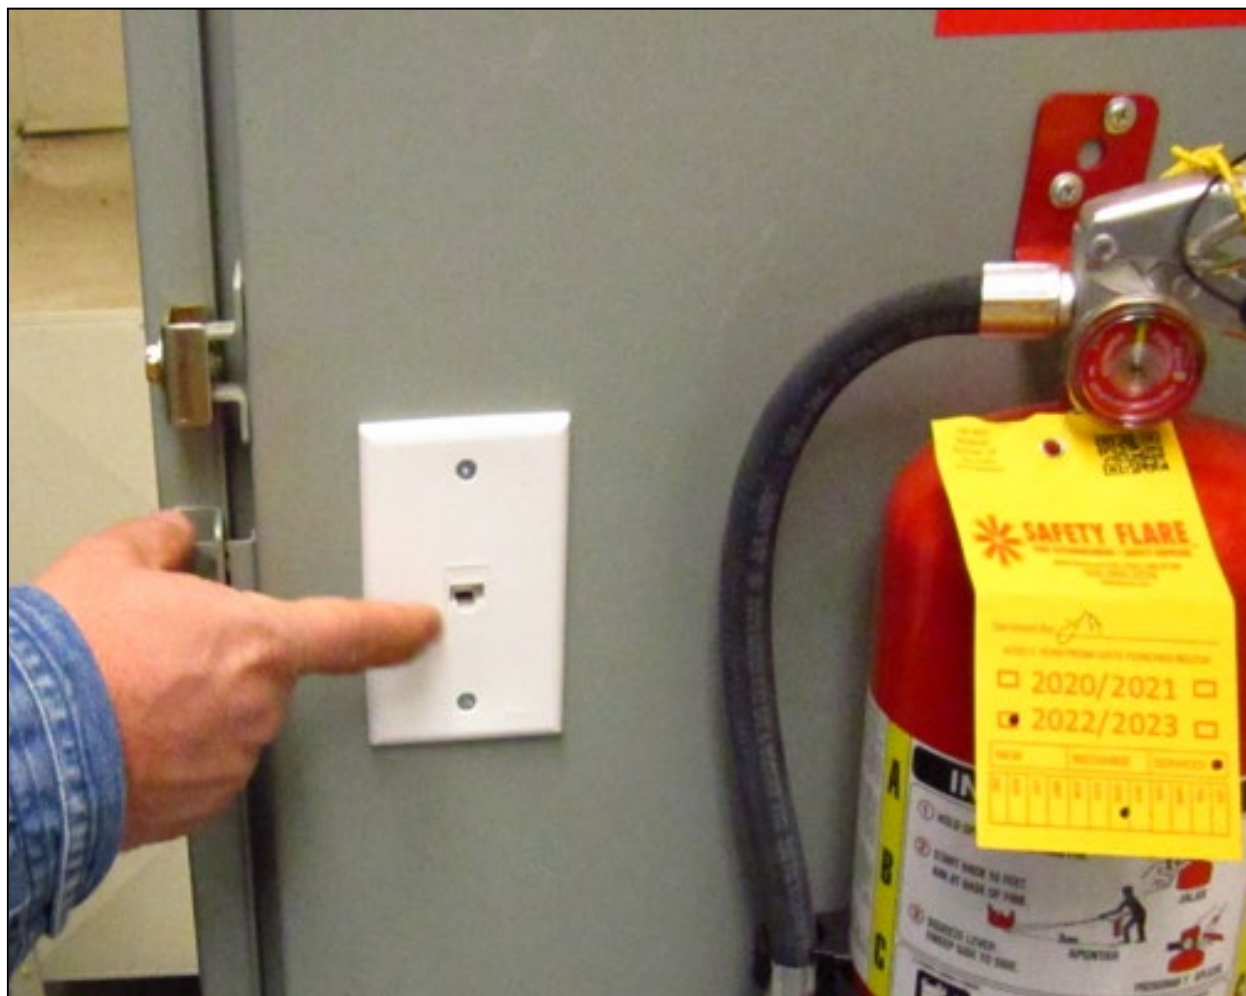
Photo No. 26

**Photograph 26. Communications Jack, W0002 Building** View of a newly installed communications jack so that a laptop computer could be used to observe and control W0002 operations.

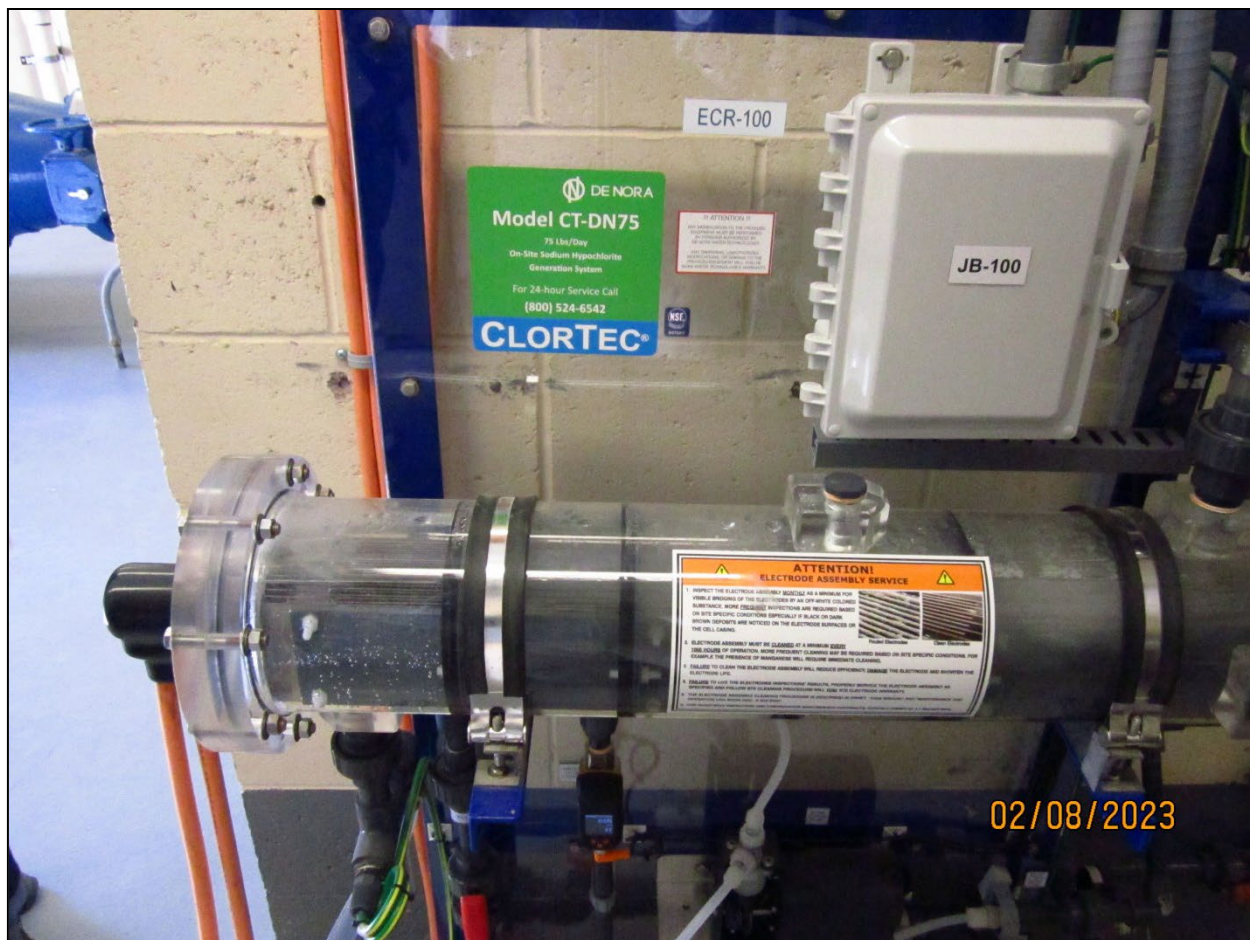
Photo No. 27

**Photograph 27. ClorTec Unit, W0001 Building** View of the ClorTec unit, located in the W0001 building. The unit converts brine to a hypochlorite solution used for disinfection of raw and produced water.

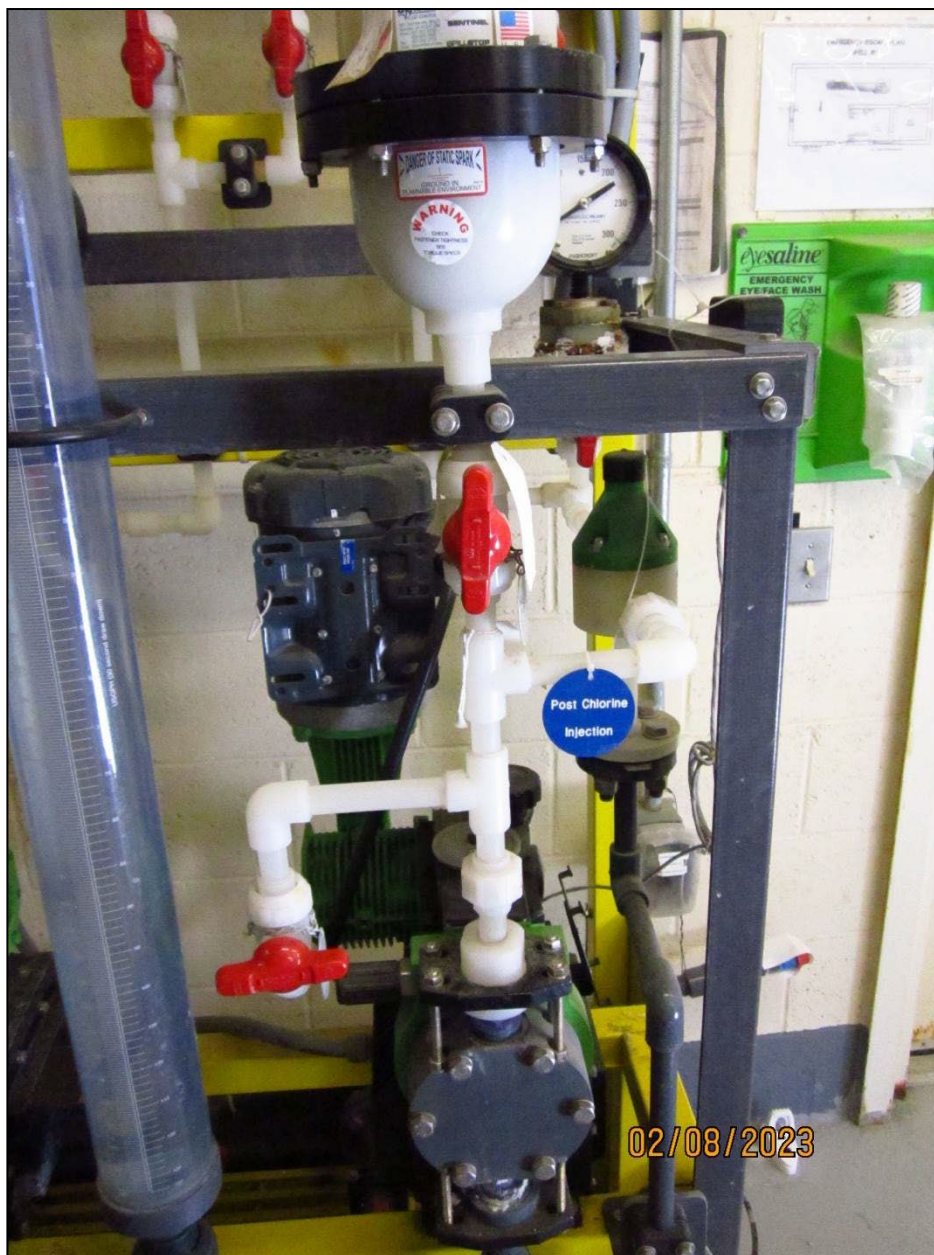
Photo No. 28

**Photograph 28. Chlorine Pump, W0001 Building** View of one of the two chlorine pumps associated with the ClorTec unit, located in the W0001 building. Two pumps were present, one for pre-chlorination and one for post-chlorination.

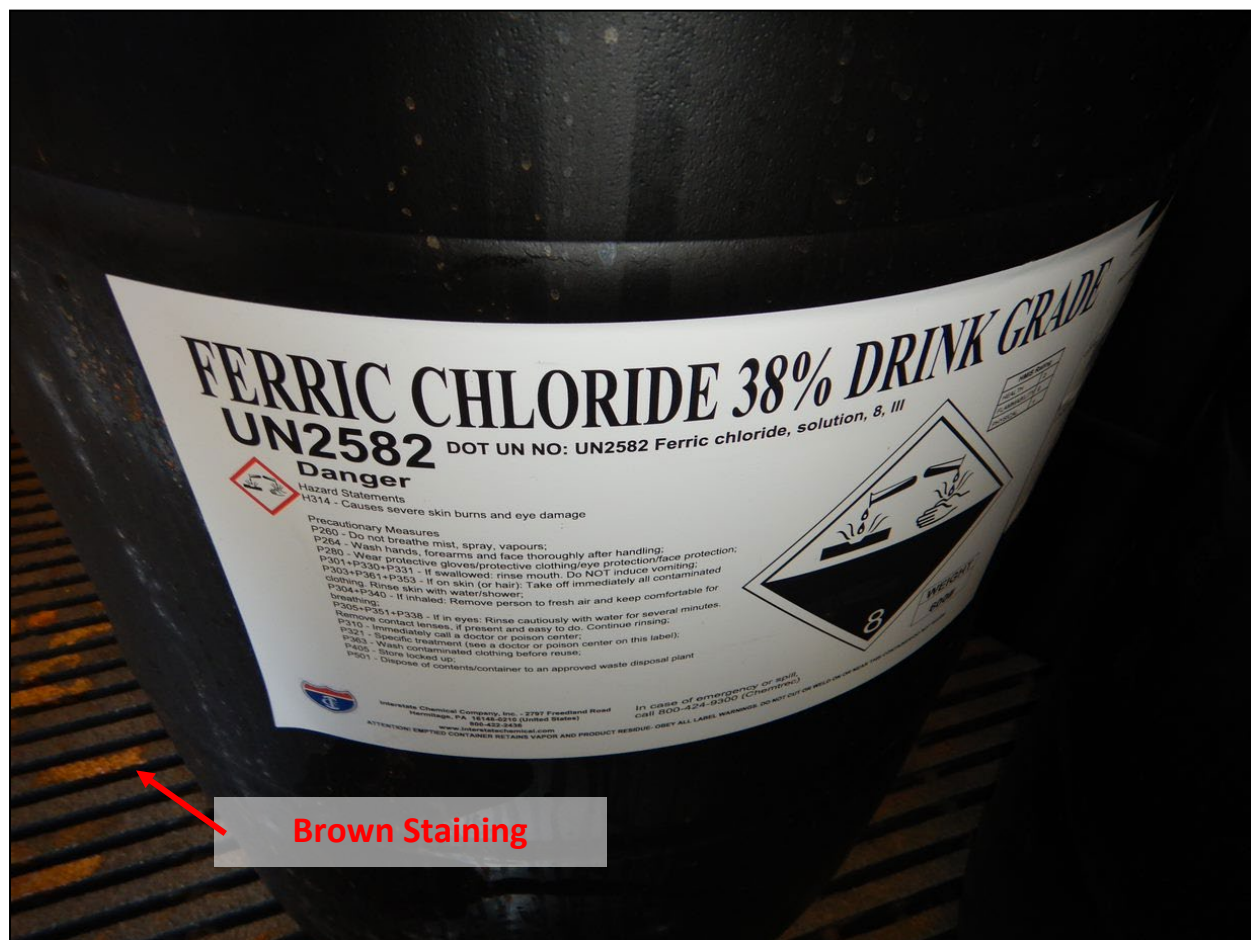
Photo No. 29

**Photograph 29. Ferric Chloride Barrel, Ferric Chloride Storage/Pump Room** View of one of the empty 38% ferric chloride barrels in the ferric chloride room. The barrel was sitting on secondary containment. There was some brown staining on the containment around the barrels.
