## Region 6 - Enforcement & Compliance Assurance Division

### INSPECTION REPORT

| Regulatory Program(s) | Safe Drinking Water Act (SDWA) – Lead and Copper Rule (LCR) | |
| System Name: | <b>Sandia Resort and Casino Public Water System</b> | |

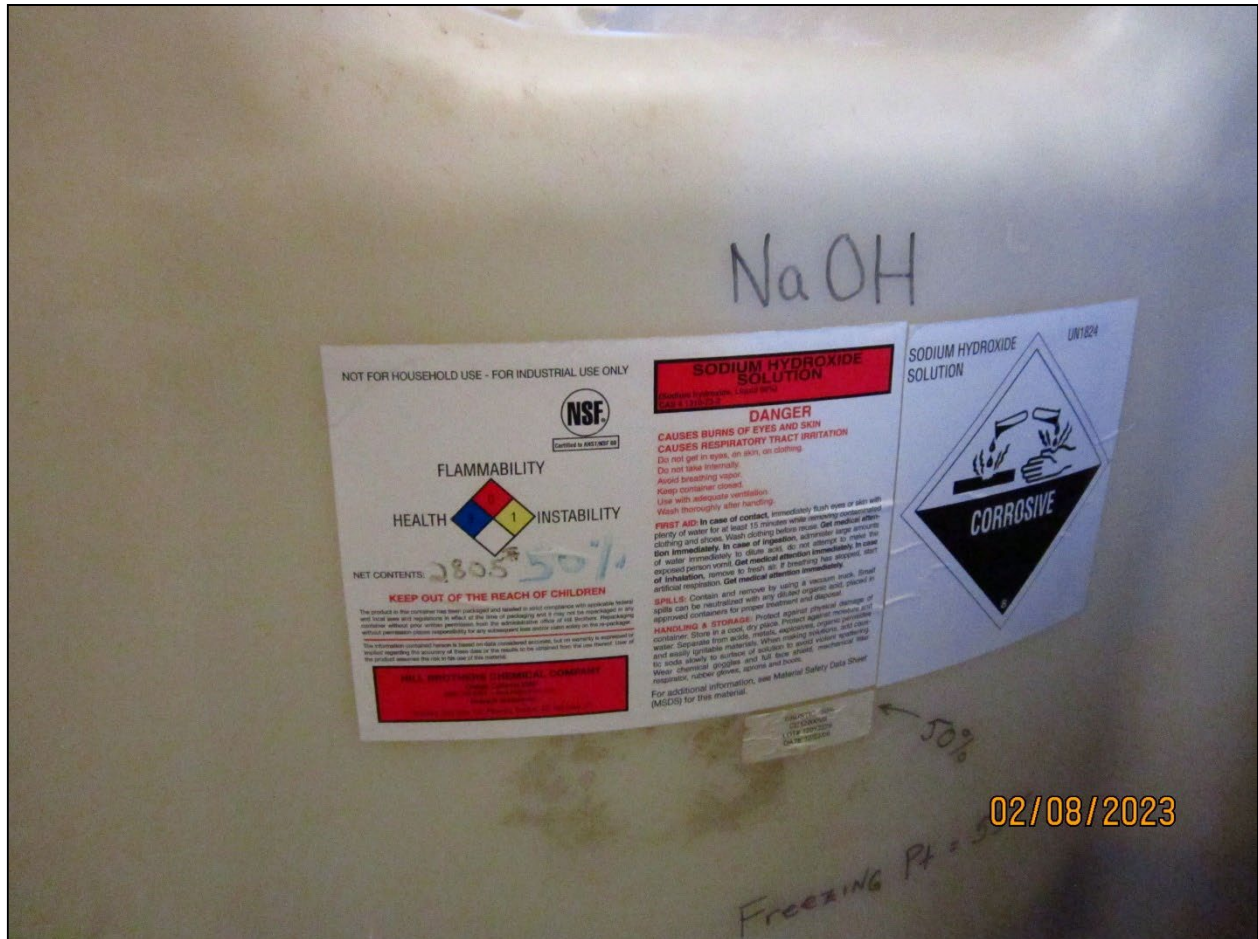
Photo No. 32

- Observation 8.** There did not appear to be heat in in the sodium hydroxide (caustic soda) storage/pump room to prevent caustic soda from freezing. The tote carrying the caustic soda was labeled to have a freezing point of 53° F. A wall thermometer in the room indicated that the temperature was 64° F at the time of the inspection (refer to Appendix 1, Photographs 32 and 33).

**Photograph 32. Sodium Hydroxide Tote, Sodium Hydroxide Storage/Pump Room** View of the sodium hydroxide (caustic soda) storage tote in the sodium hydroxide room. The tote was labeled with a marker stating a freezing point of 53° F.

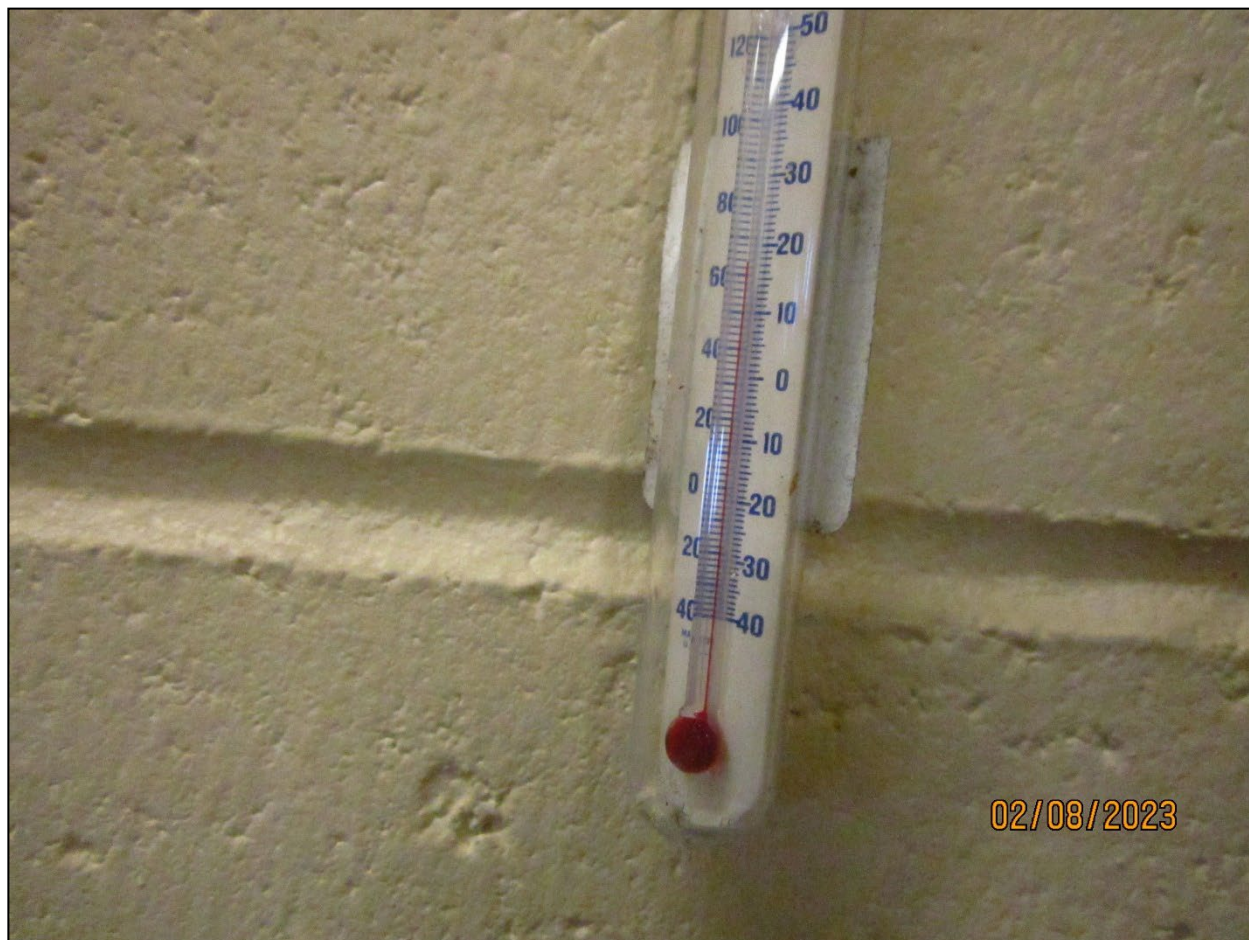
Photo No. 33

**Photograph 33. Thermometer, Sodium Hydroxide Storage/Pump Room** View of a thermometer on the wall of the sodium hydroxide room. The thermometer read 64° F.

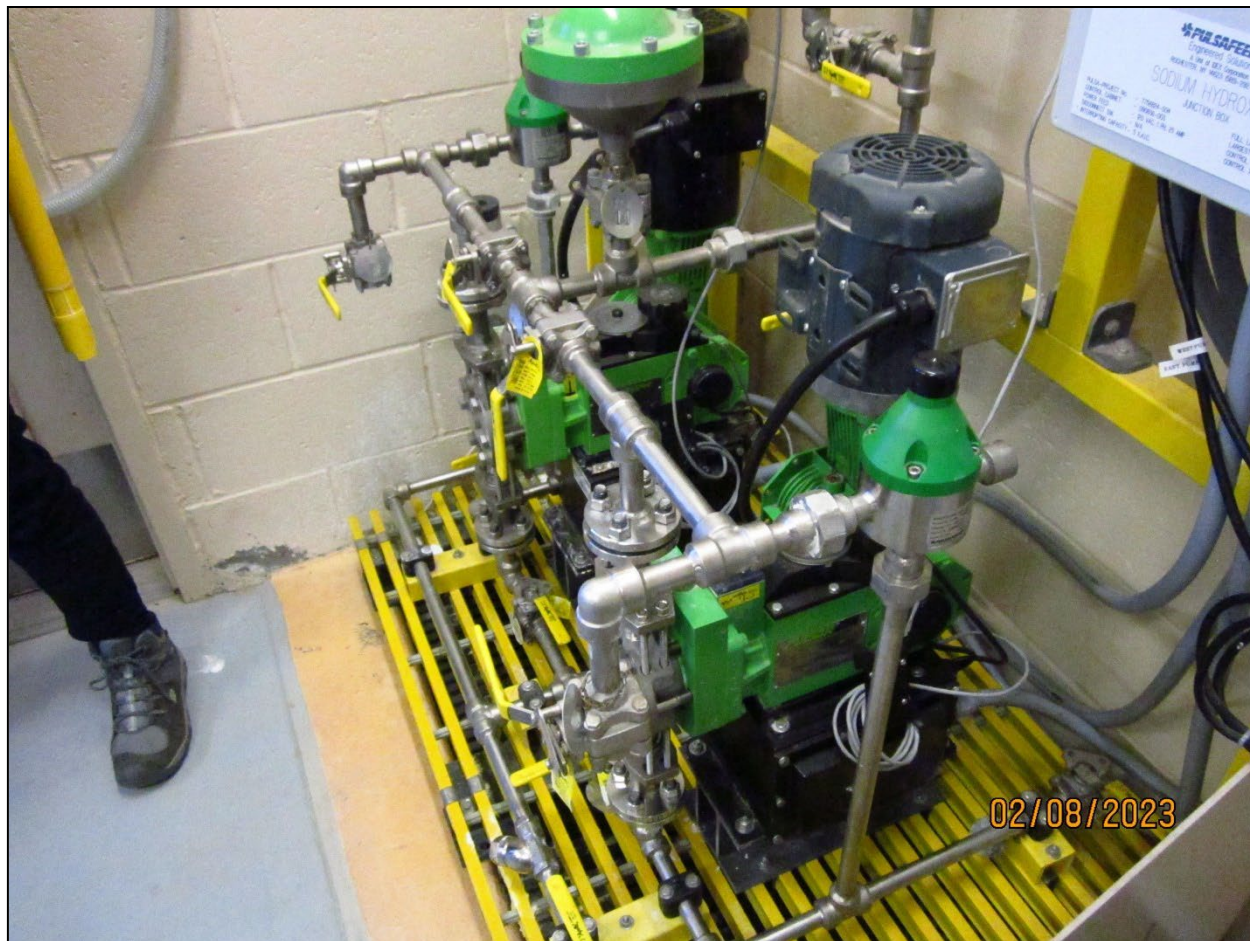
Photo No. 34

**Photograph 34. Sodium Hydroxide Pumps, Sodium Hydroxide Storage/Pump Room** View of the sodium hydroxide pumps in the room. The pumps were positioned on a pump skid over secondary containment. There did not appear to be signs of spills/leaks.

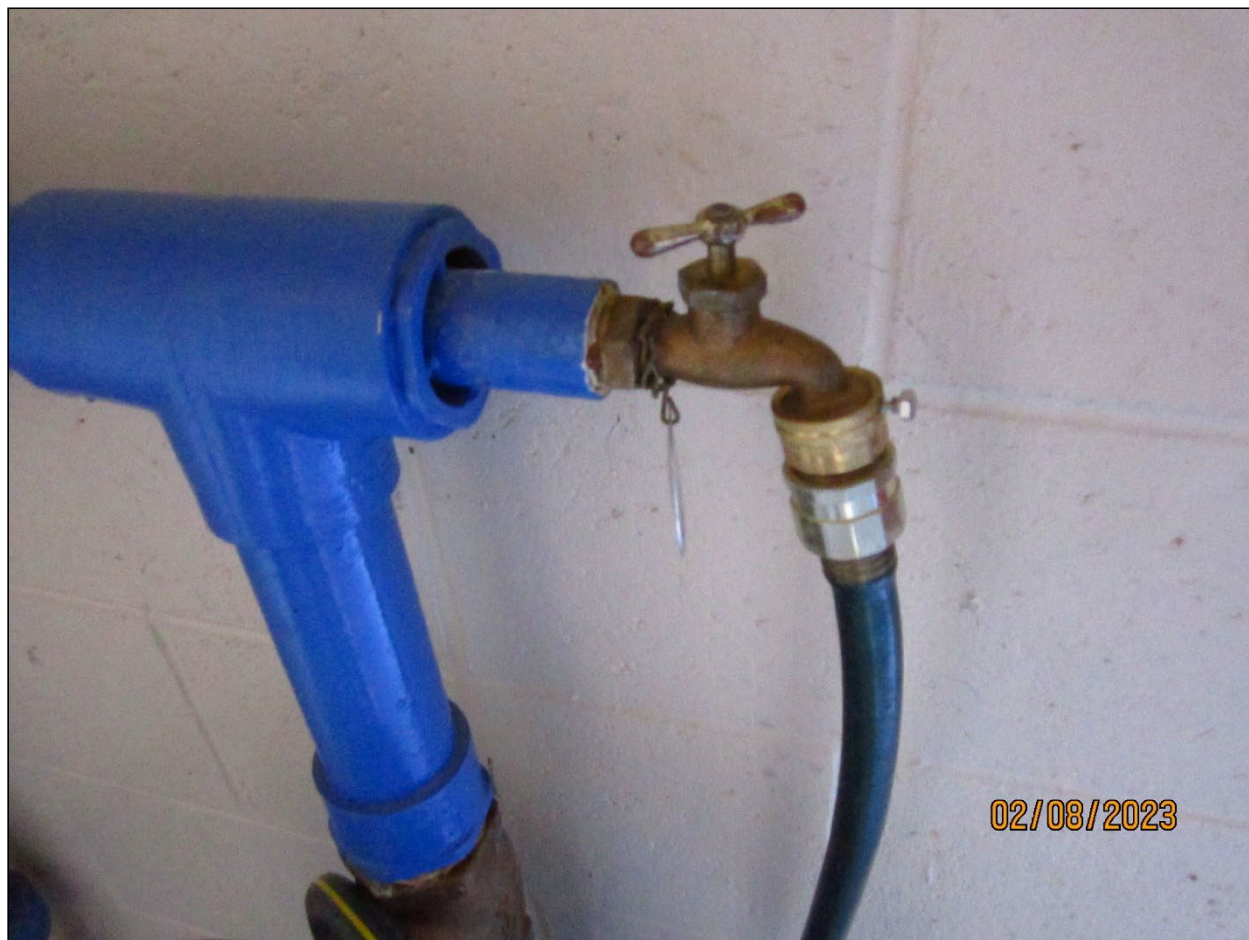
Photo No. 35

**Photograph 35. Hose Bib, Sodium Hydroxide Storage/Pump Room** View of a hose bib inside of the sodium hydroxide storage room. The bib contained backflow prevention.

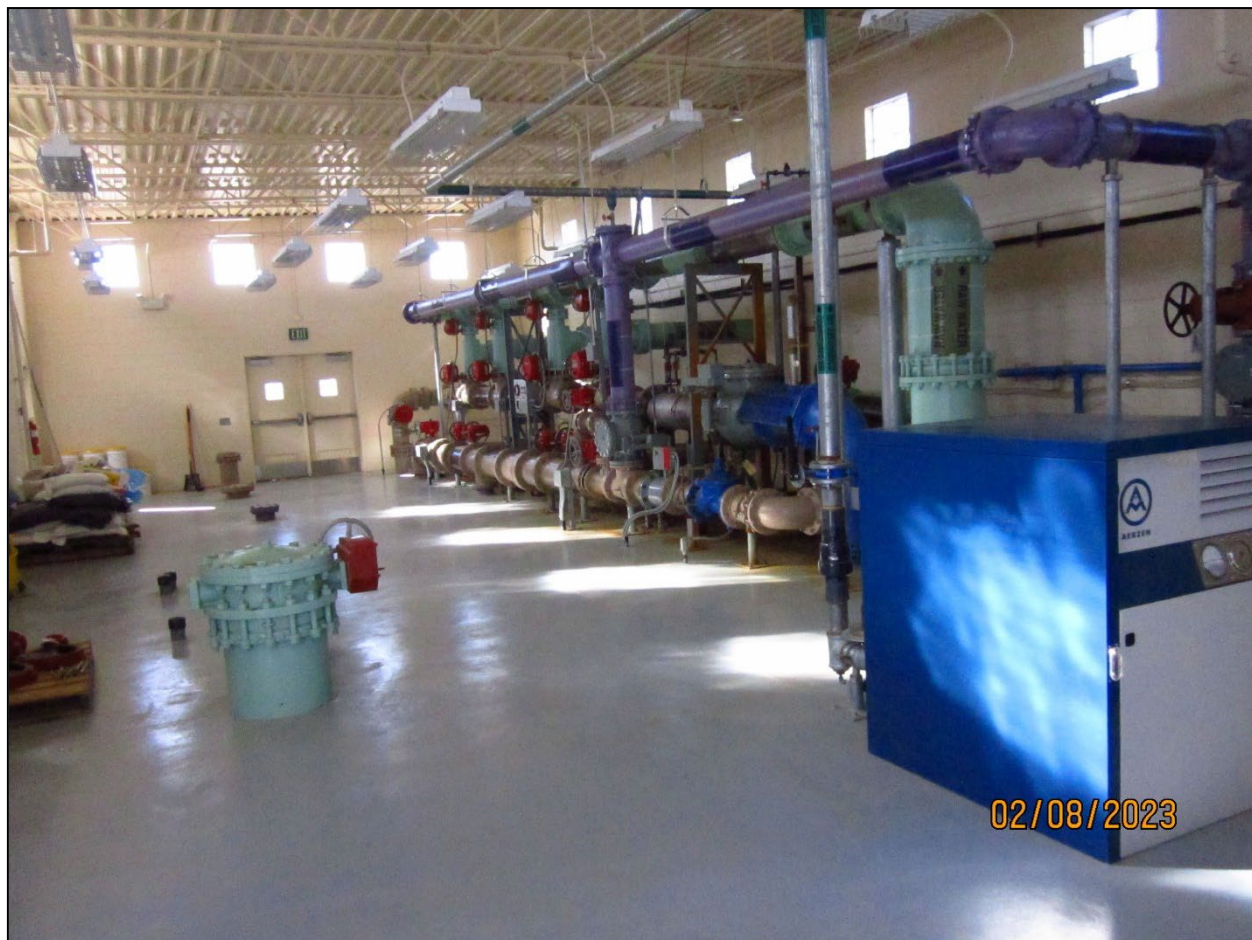
Photo No. 37

**Photograph 37. Treatment Room** View of the treatment room for the Sandia Resort and Casino PWS. The filter units were located on the exterior of the building.

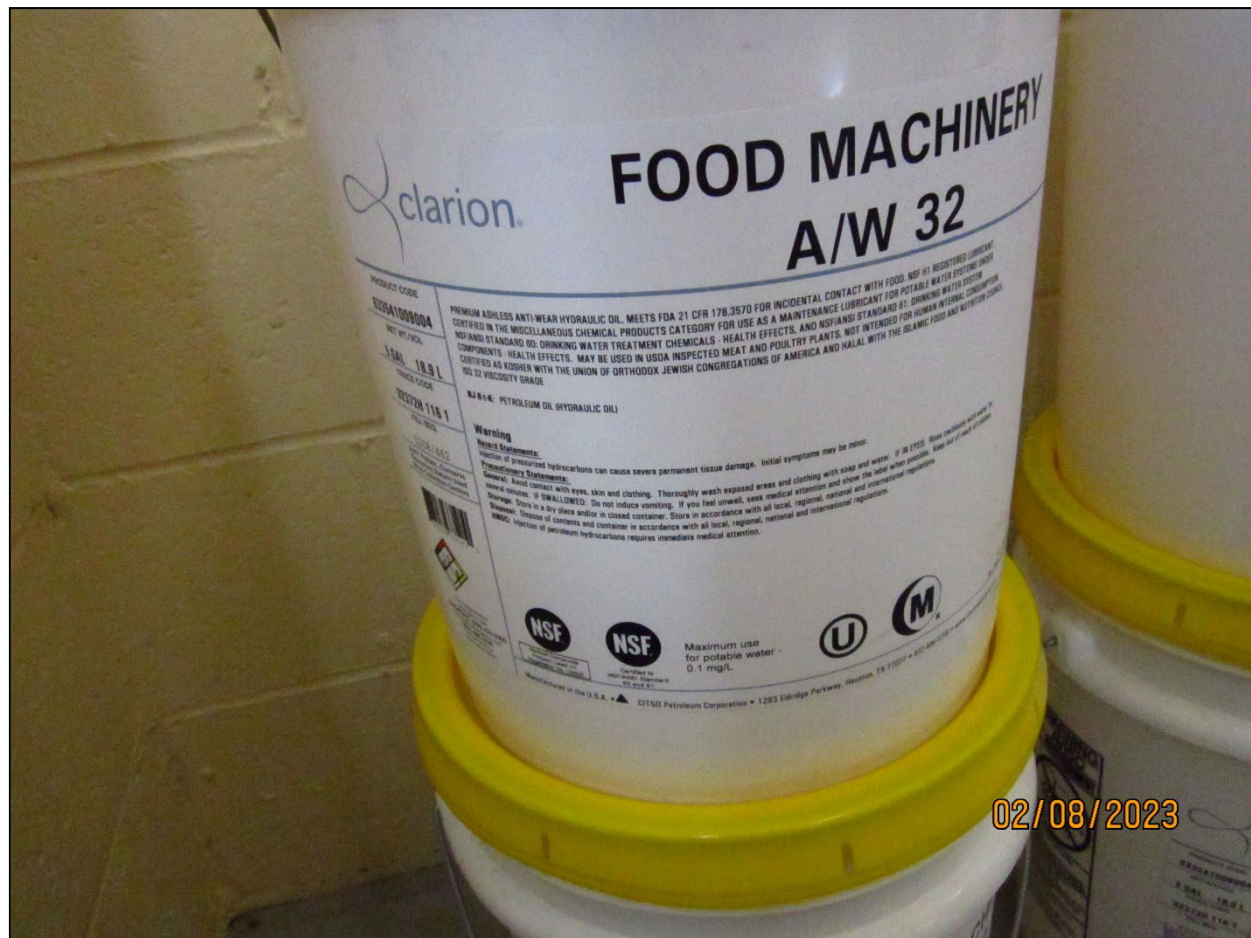
Photo No. 38

**Photograph 38. Food Grade Lubricant, Treatment Room** View of the Clarion food grade machinery lubricant that was being stored in the treatment room.

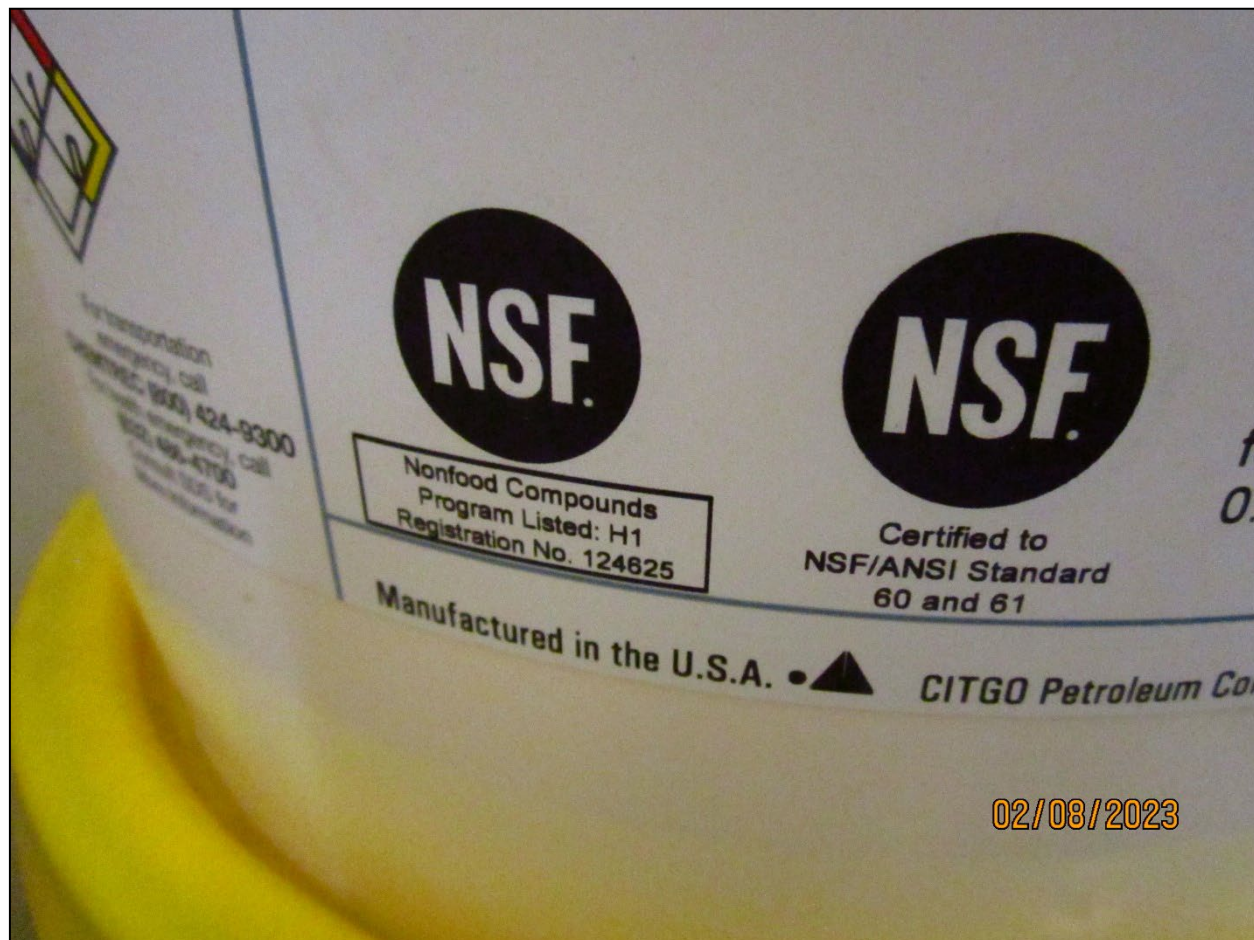
Photo No. 39

**Photograph 39. Food Grade Lubricant, Treatment Room** Close up view of the Clarion food grade machinery lubricant label that was being stored in the treatment room. The lubricant was NSF/ANSI 60 and 61 standard certified.

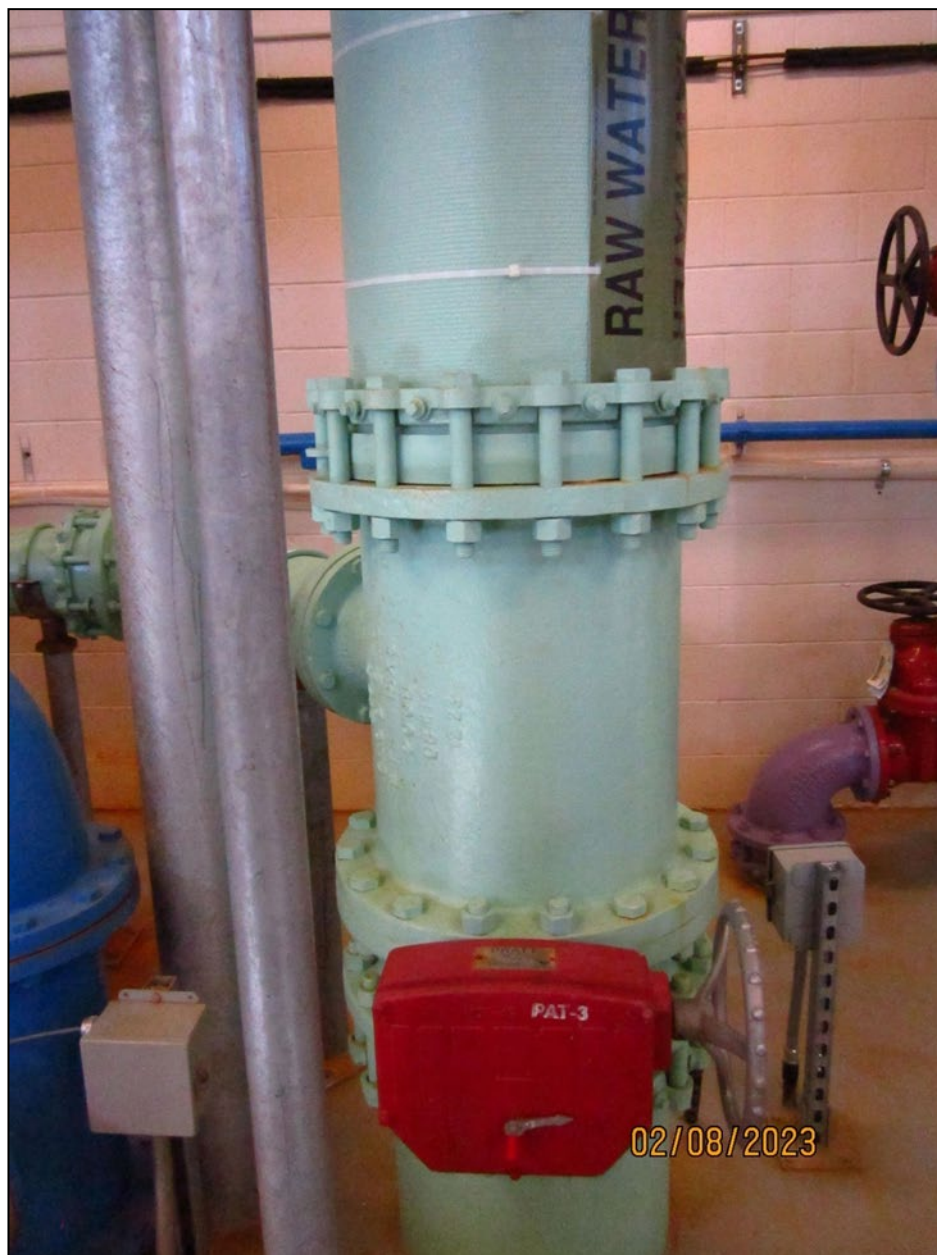
Photo No. 42

During normal operation, raw water enters the treatment building through a raw water influent line (refer to [Appendix 1, Photograph 42](#)). A control valve was present on the raw water influent line, and it was in the “closed” position during the inspection (refer to [Appendix 1, Photograph 43](#)). The raw water filter line is initially injected with ferric chloride for arsenic precipitation (refer to [Appendix 1, Photograph 44](#)). There was brown staining on the infrastructure surrounding the ferric chloride injection point, as well as on valves, piping, nuts/bolts, and the floor (refer to [Appendix 1, Photographs 45 and 46](#)). The staining was indicative of a ferric chloride release. Following ferric chloride injection, the water flows through two Tonka filters. The filter media includes anthracite, sand, and gravel. There was one filter for each well, and each filter contained two cells. Each filter contains two air relief ports which extend out of the top of the filter units, one for each cell. Three of the air relief ports contained piping which extended out and downturned, with a screen placed over the end. However, one of the air relief ports for Filter No. 2 had been recently replaced and did not contain a downturned pipe or a screen over its opening (refer to [Appendix 1, Photograph 47](#)).

**Photograph 42. Raw Water Influent Line, Treatment Room** View of the raw well water influent line in the treatment room. Water enters through this line before the bypass line, filtration units, and chemical addition treatment.

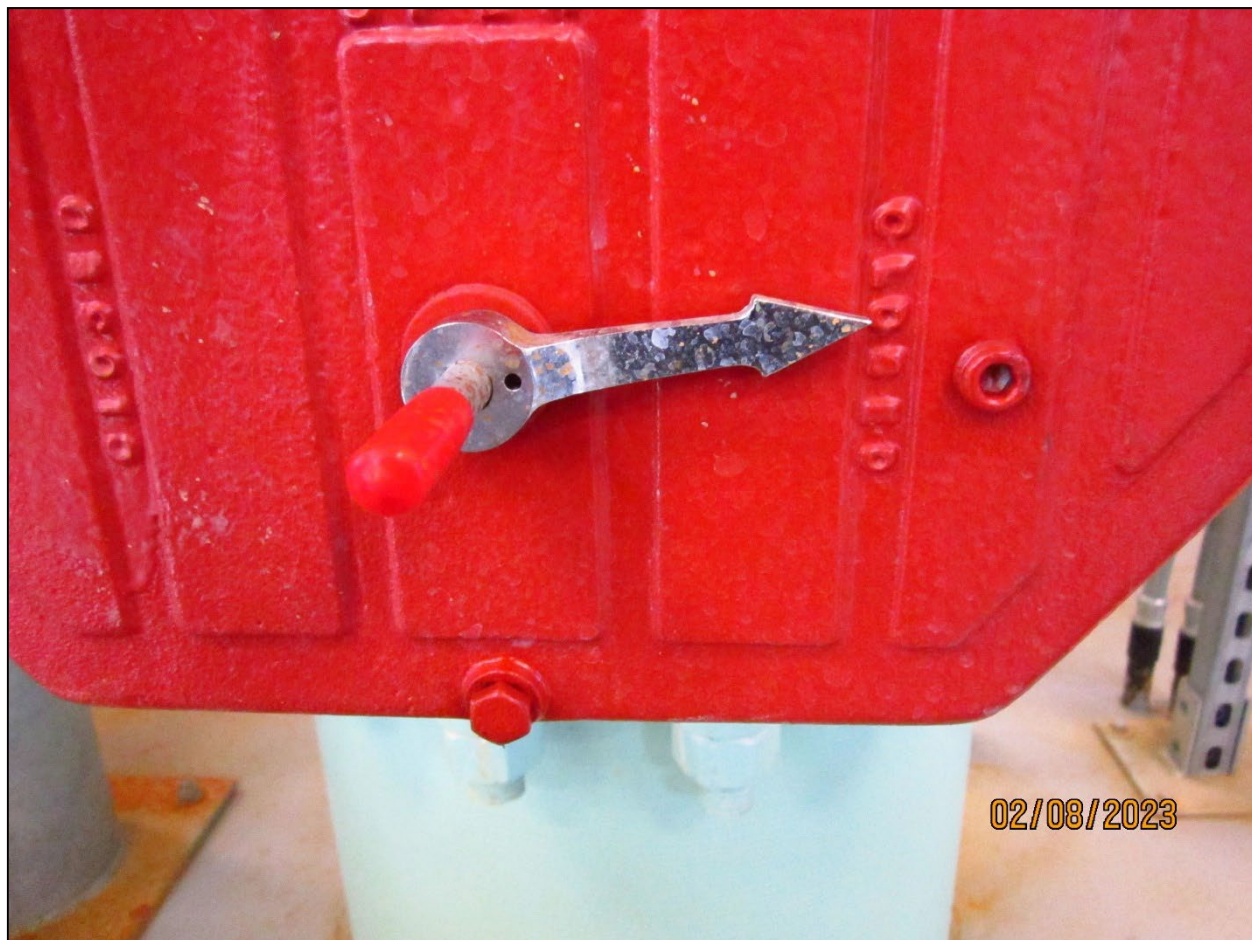
Photo No. 43

**Photograph 43. Control Valve, Raw Water Influent Line** Close up view of the control valve on the raw well water influent line into the treatment system. The valve was in the “closed” position.

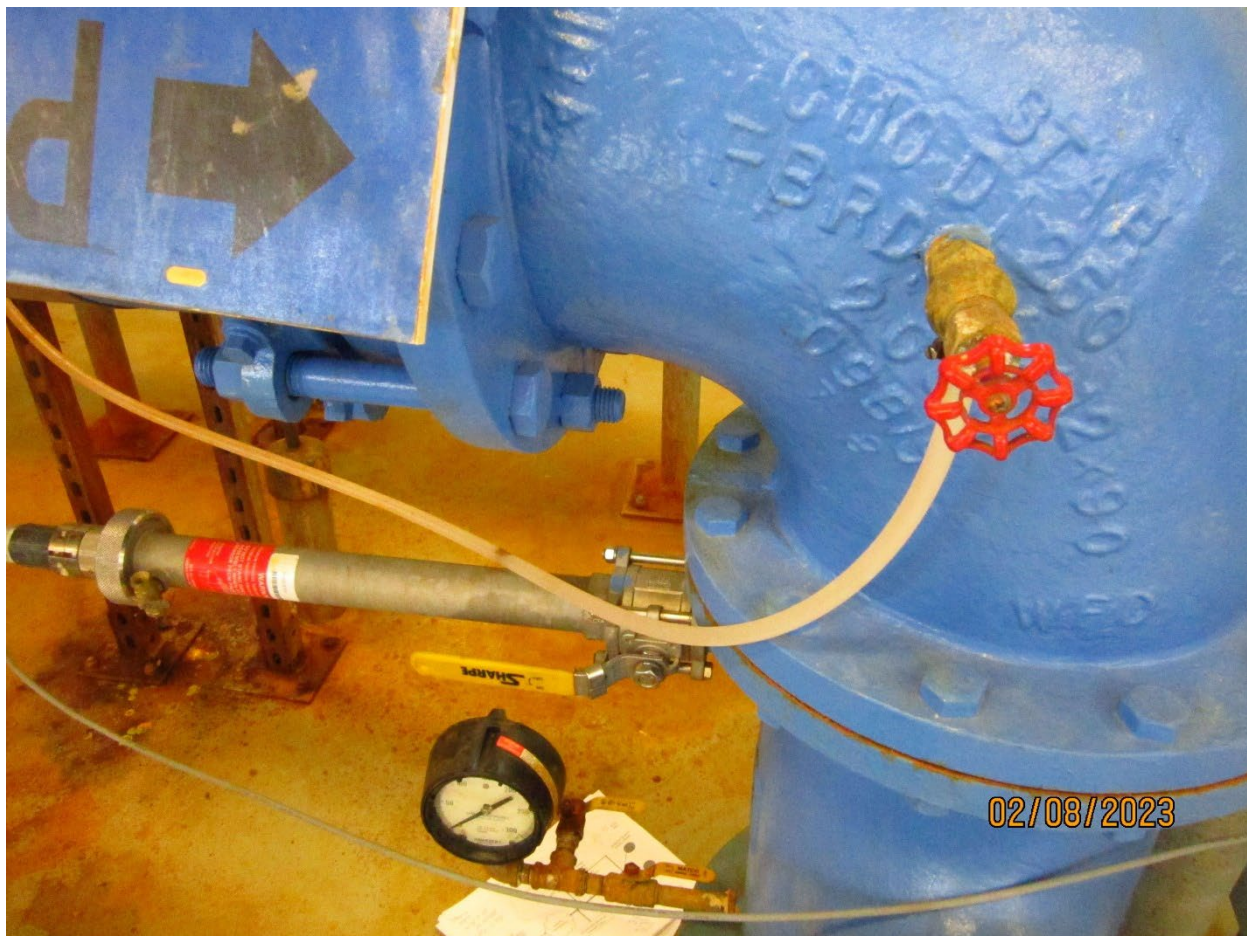
Photo No. 51

**Photograph 51. Sample Tap, Treatment Room** View of a finished water sample tap at the end of the treatment system. This sample point represents the water treated by Filter Nos. 1 and 2, as well as the water contributed by the raw water bypass line.

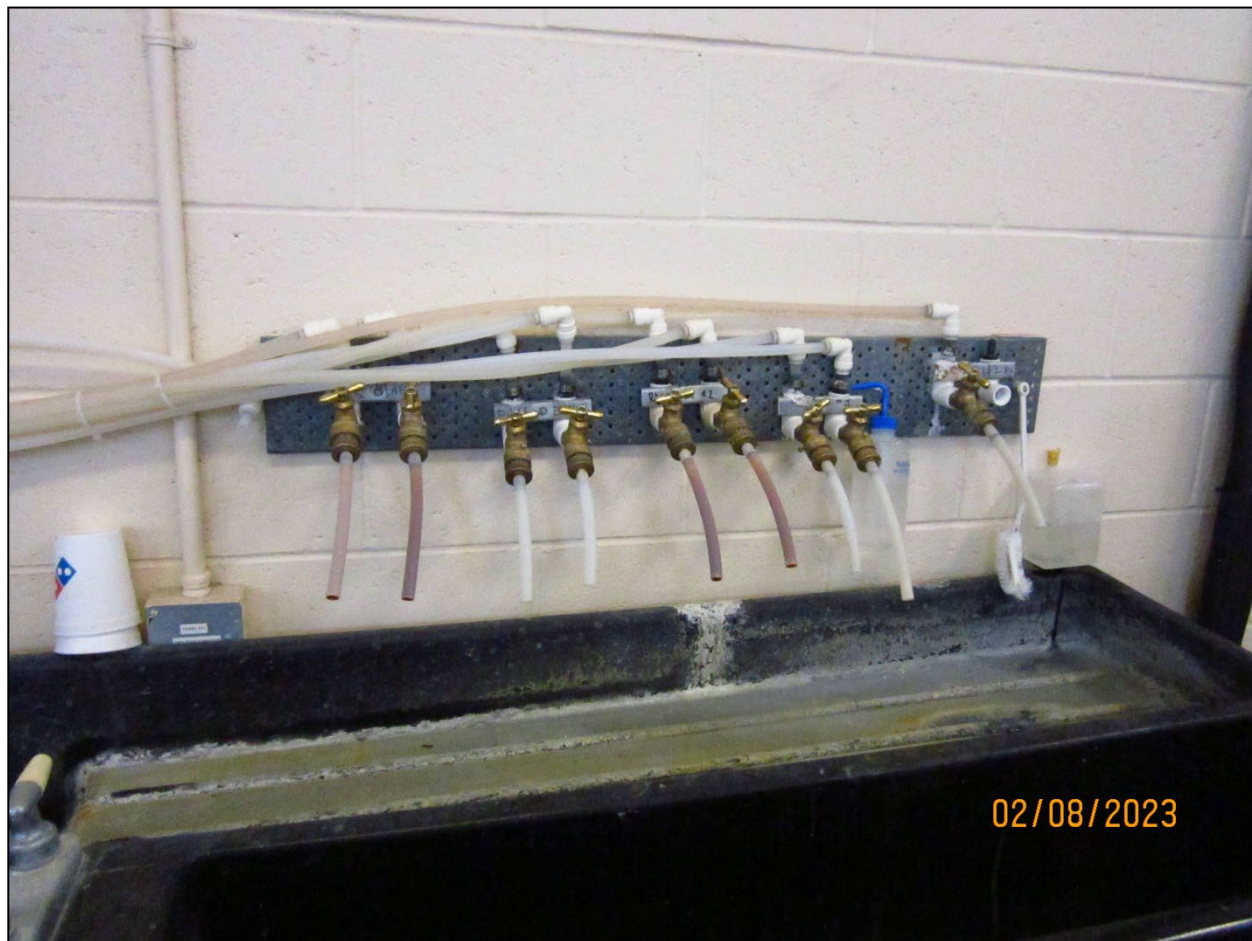
Photo No. 52

A sampling sink was present next to the treatment infrastructure, and there were several sample lines taken from various points in the treatment process (refer to [Appendix 1, Photograph 52](#)). These points include raw influent, water post filtration from Filter Nos. 1 and 2, and final treated effluent. The interior of the tubing from the samples for Filter Nos. 1 and 2 was stained red-brown due to the addition of ferric chloride (refer to [Appendix 1, Photograph 53](#)).

**Photograph 52. Sampling Sink, Treatment Room** View of the sampling sink in the treatment room. There were several sample lines taken from various points in the treatment process. These points include raw influent, water post filtration from Filter Nos. 1 and 2, and Entry Point 1, the entry point into the distribution system.

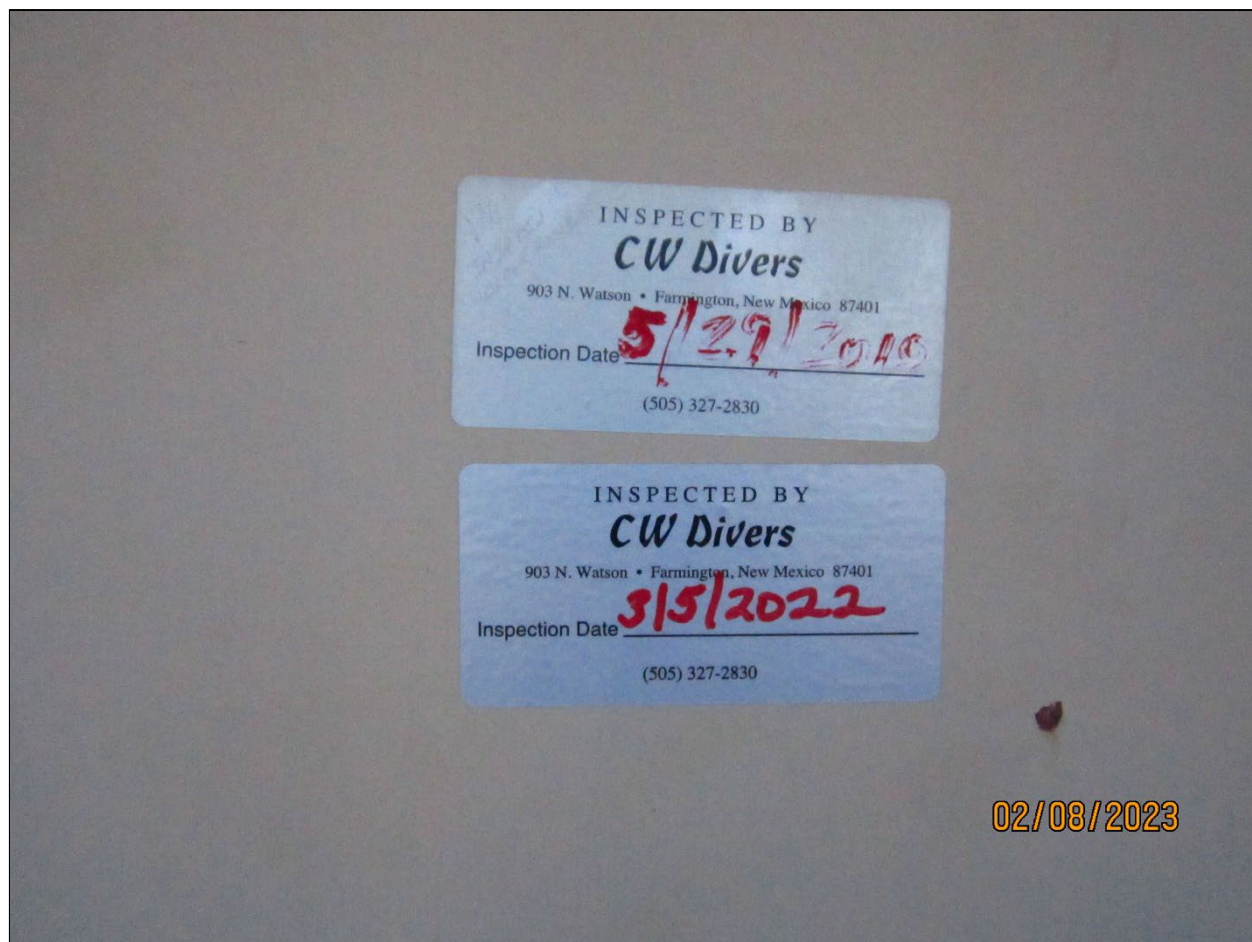
Photo No. 54

The ST001 tank is a 3 MG tank, and operators said that their target level in the tank was 18-20 feet. Operators indicated that they had approximately 7-14 days' worth of water storage if there was an issue with the wells. The tank was last inspected (by divers) on March 5, 2022 (refer to [Appendix 1, Photograph 54](#)). On the second day of the inspection, the tank level was at approximately 18.5 feet (refer to [Appendix 1, Photograph 55](#)). During normal operation, the lead well pump is programmed through SCADA to start pumping if the tank level gets below 18 feet, and the lag pump is programmed to turn on at 17 feet. However, due to the failed effluent valve in the treatment system, the operators changed the set points for the lead and lag well pumps in SCADA to 16 and 15 feet, respectively, until the valve was repaired. This was to ensure that the wells pumps would not turn on while the repair was taking place.

**Photograph 54. Sandia Casino Tank (ST001)** View of the diver inspection sticker on the outside of the ST001 tank. The last inspection took place on March 5, 2022.

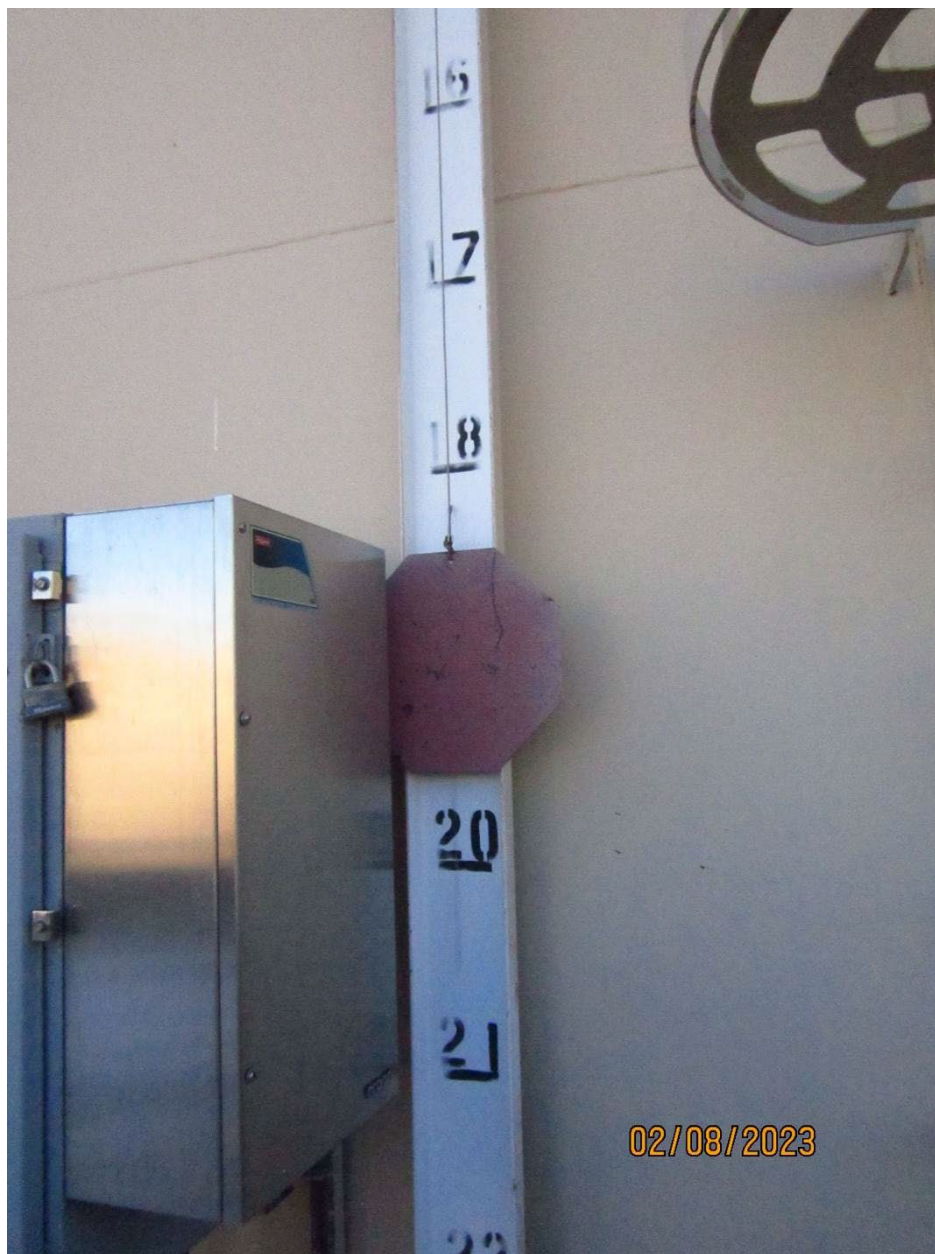
Photo No. 55

**Photograph 55. Sandia Casino Tank (ST001)** View of the tank level indicator at the ST001 tank. The tank level was at 18.5 feet on February 8, 2023. During normal operation, the lead well pump is programmed through SCADA to start pumping if the tank level gets below 18 feet, and the lag pump is programmed to turn on at 17 feet. However, due to the failed effluent valve in the treatment system, the operators changed the set points for the lead and lag well pumps to 16 and 15 feet, respectively until the valve was repaired.

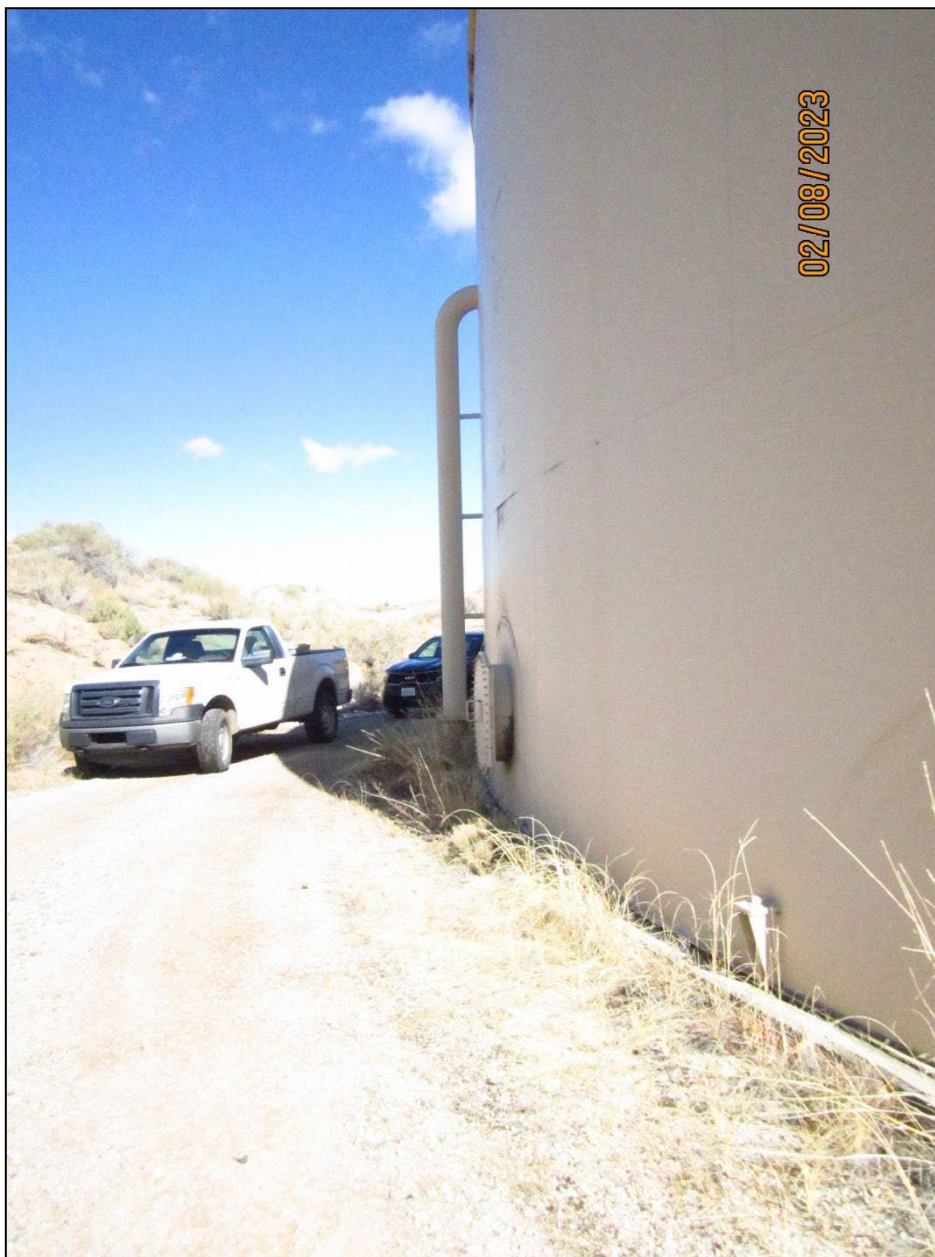
Photo No. 57

**Photograph 57. Sandia Casino Tank (ST001)** View of the overflow line extending from the top of the tank. The overflow line goes below grade and discharges into a circular concrete basin.

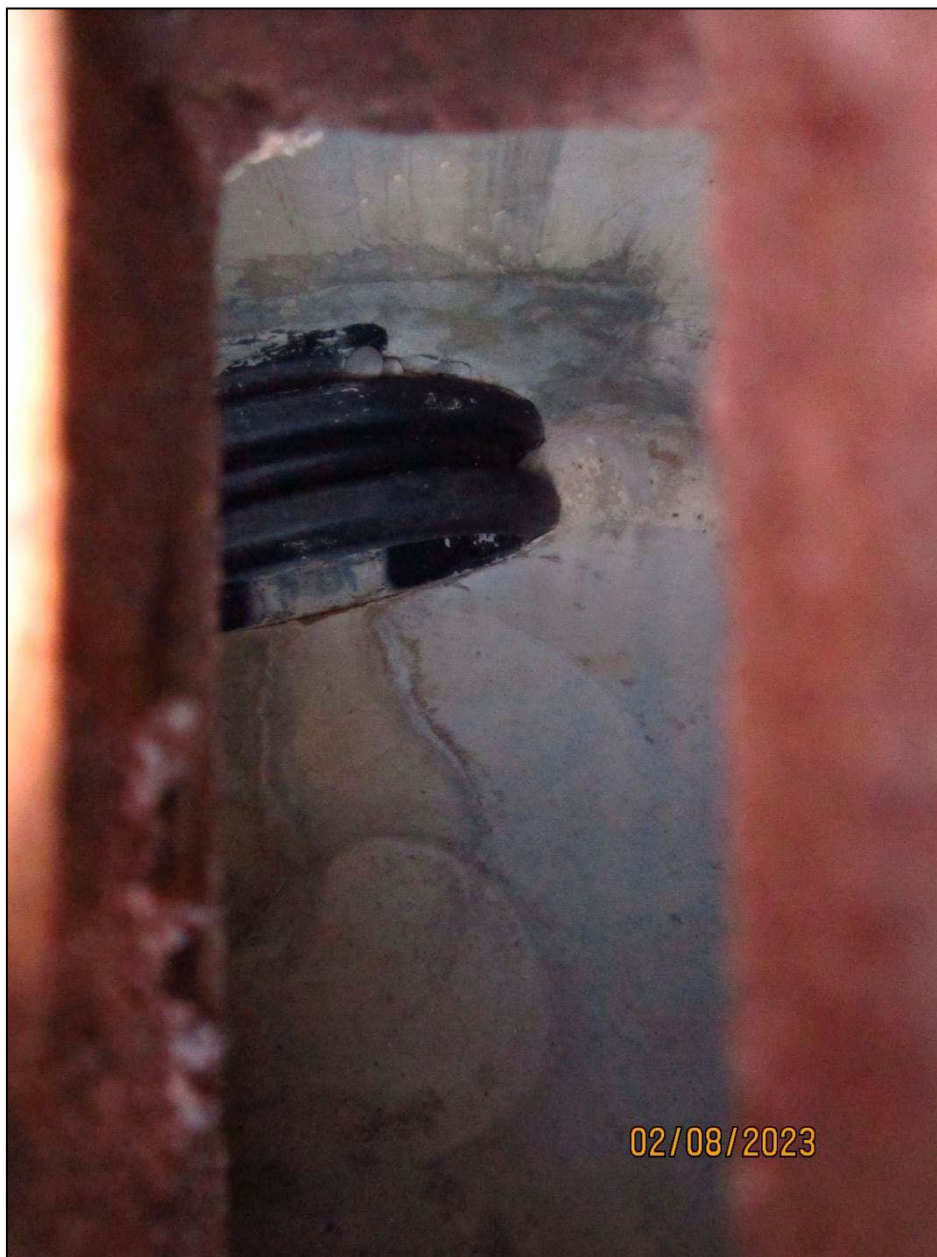
Photo No. 59

**Photograph 59. Underground ST001 Overflow Pipe Discharge** View of the larger diameter discharge pipe in the concrete basin that flows toward the outfall, approximately 500 feet from the ST001 tank.

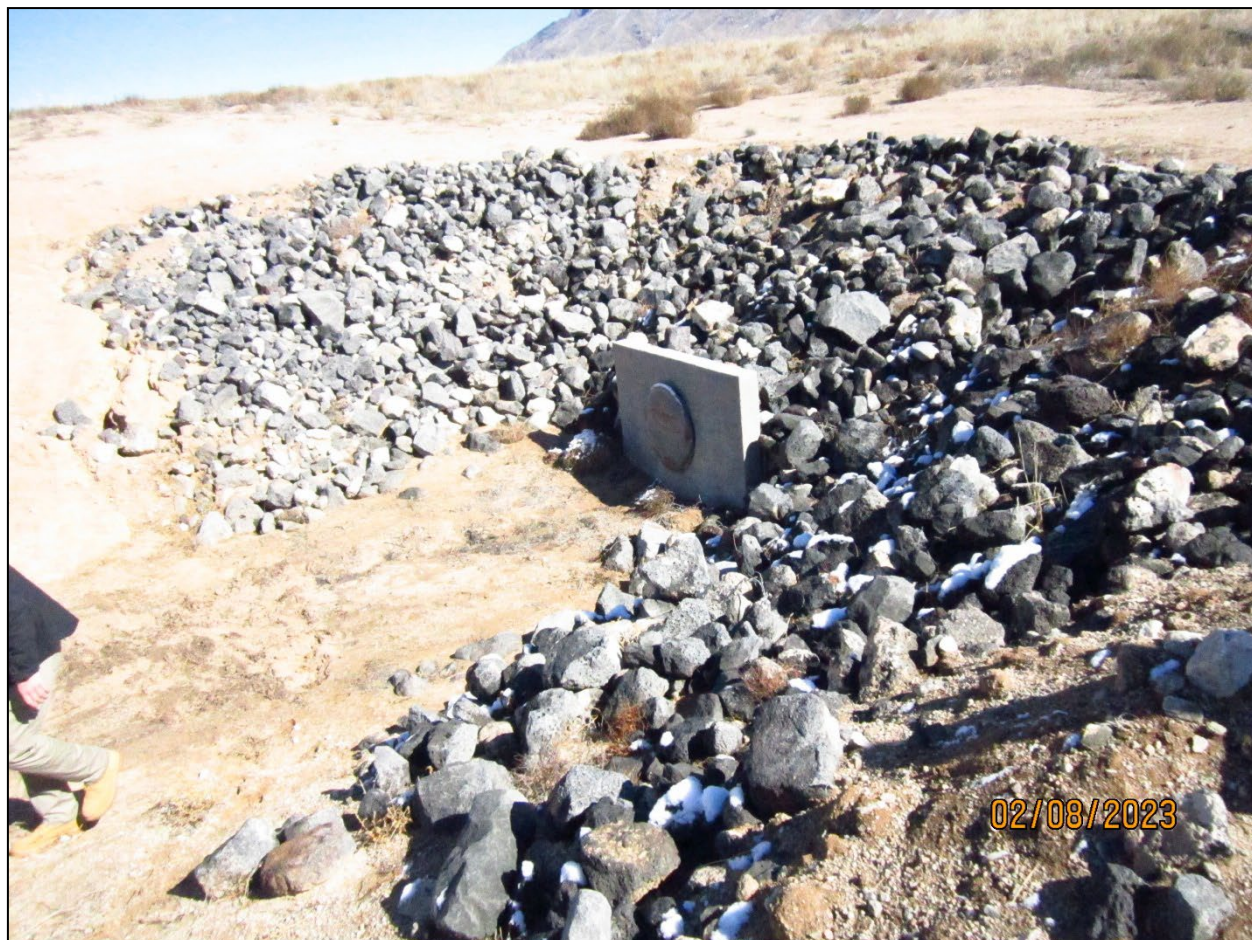
Photo No. 60

- There was some algal growth/staining around the ST001 tank (refer to [Appendix 1, Photograph 56](#)). It appeared that water drained in certain areas on top of the tank and consistently ran off in the same places.
- The overflow pipe extending from the top of the ST001 tank discharged into a drainage manhole below grade (refer to [Appendix 1, Photograph 57](#)). The opening in the manhole that the line discharges through was uncovered and did not contain an air gap (refer to [Appendix 1, Photograph 58](#)). A second, larger diameter pipe was also present in the manhole (refer to [Appendix 1, Photograph 59](#)). This pipe is where the flow goes after discharging from the tank before ultimately discharging through a nearby outfall. The opening of the outfall was screened (refer to [Appendix 1, Photographs 60 and 61](#)).

**Photograph 60. ST001 Tank Overflow Outfall** View of the overflow outfall for the ST001 tank, located approximately 500 feet west of the tank. The opening to the outfall pipe was screened.

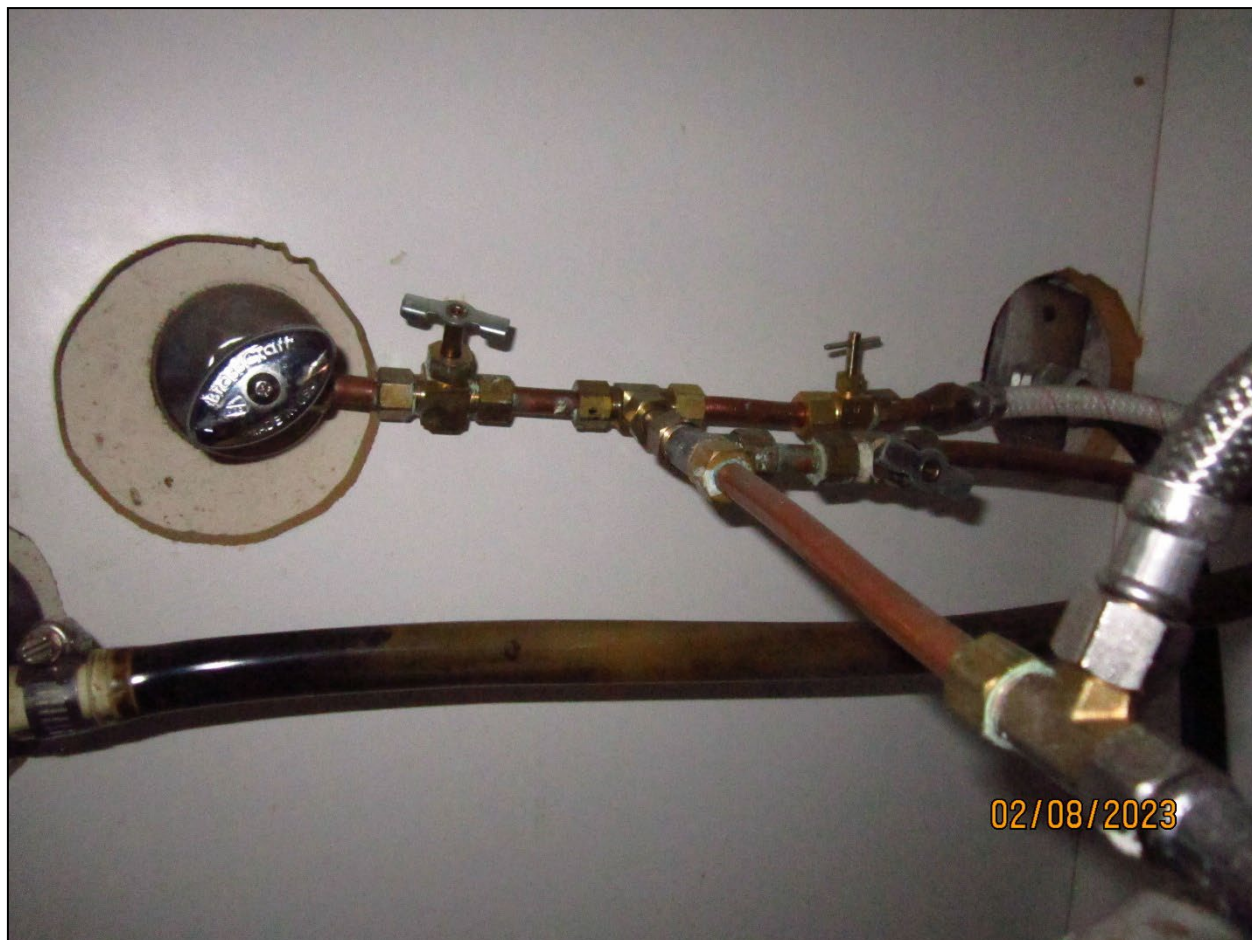
Photo No. 62

The "Poker Pit" LCR sampling point (identified as station LCR010) at the casino was observed as a component of the inspection. The location was at a sink where casino employees used water to make drinks. The plumbing under the sink consisted of copper lines (refer to [Appendix 1, Photograph 62](#)). All of the visual piping joints were compressed joints, and no solder was observed. Lead monitoring and analytical data was reported to be posted on the wall near the sink (refer to [Appendix 1, Photograph 63](#)) after monitoring events.

**Photograph 62. "Poker Pit" LCR Sample Point, Casino** View of the copper lines at the Poker Pit LCR010 sampling point at the Casino. All of the visual piping joints were copper compression joints, and no solder was observed.
