## Region 6 - Enforcement & Compliance Assurance Division

### INSPECTION REPORT

| Regulatory Program(s) | Safe Drinking Water Act (SDWA) – Lead and Copper Rule (LCR) | |
| System Name: | <b>Sandia Resort and Casino Public Water System</b> | |

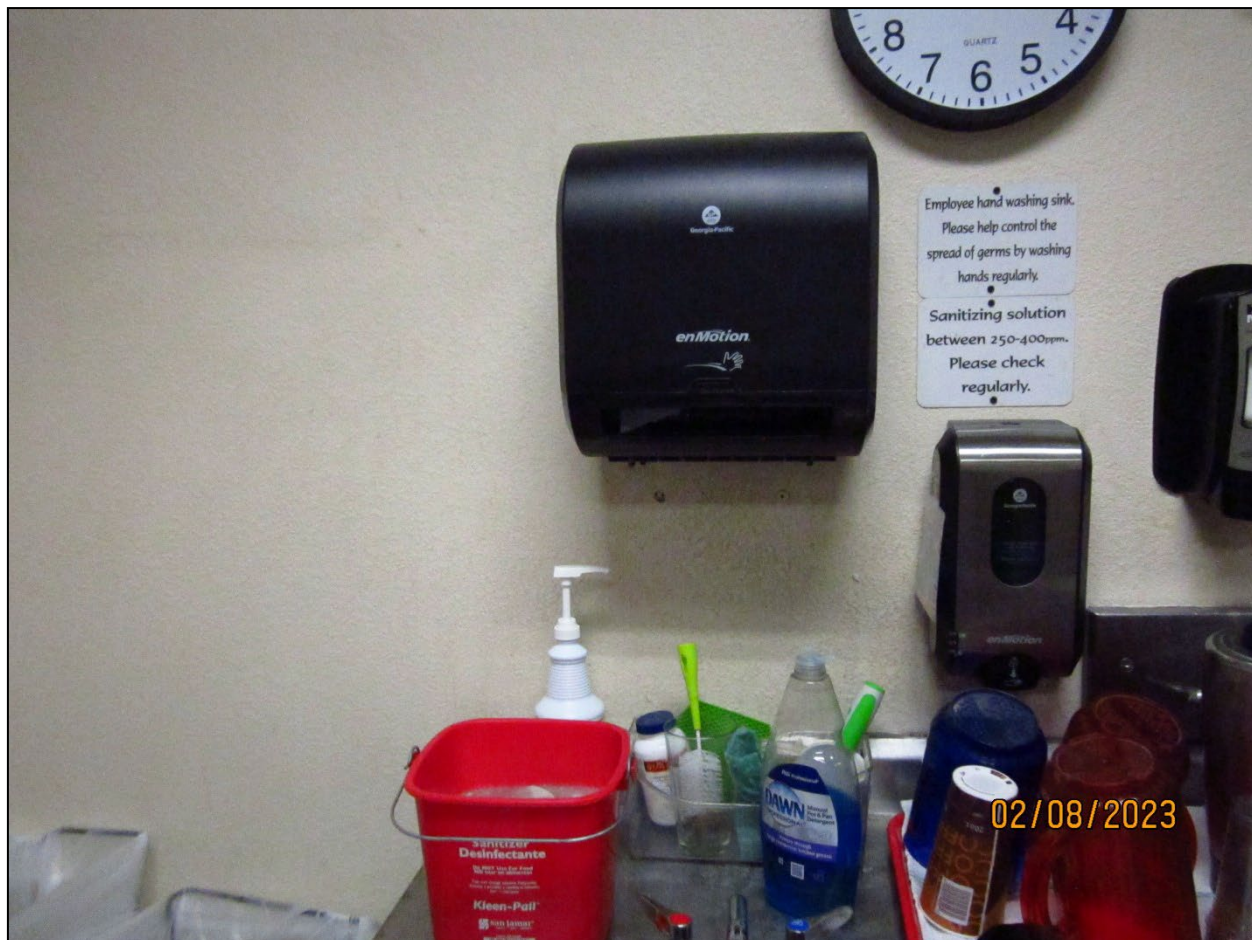
Photo No. 63

The "Poker Pit" LCR sampling point (identified as station LCR010) at the casino was observed as a component of the inspection. The location was at a sink where casino employees used water to make drinks. The plumbing under the sink consisted of copper lines (refer to [Appendix 1, Photograph 62](#)). All of the visual piping joints were compressed joints, and no solder was observed. Lead monitoring and analytical data was reported to be posted on the wall near the sink (refer to [Appendix 1, Photograph 63](#)) after monitoring events.

**Photograph 63. "Poker Pit" LCR Sample Point, Casino** View of the Poker Pit sink area where the LCR010 sample is taken. Lead monitoring and analytical data was posted on the wall immediately to the left of the paper towel dispenser.

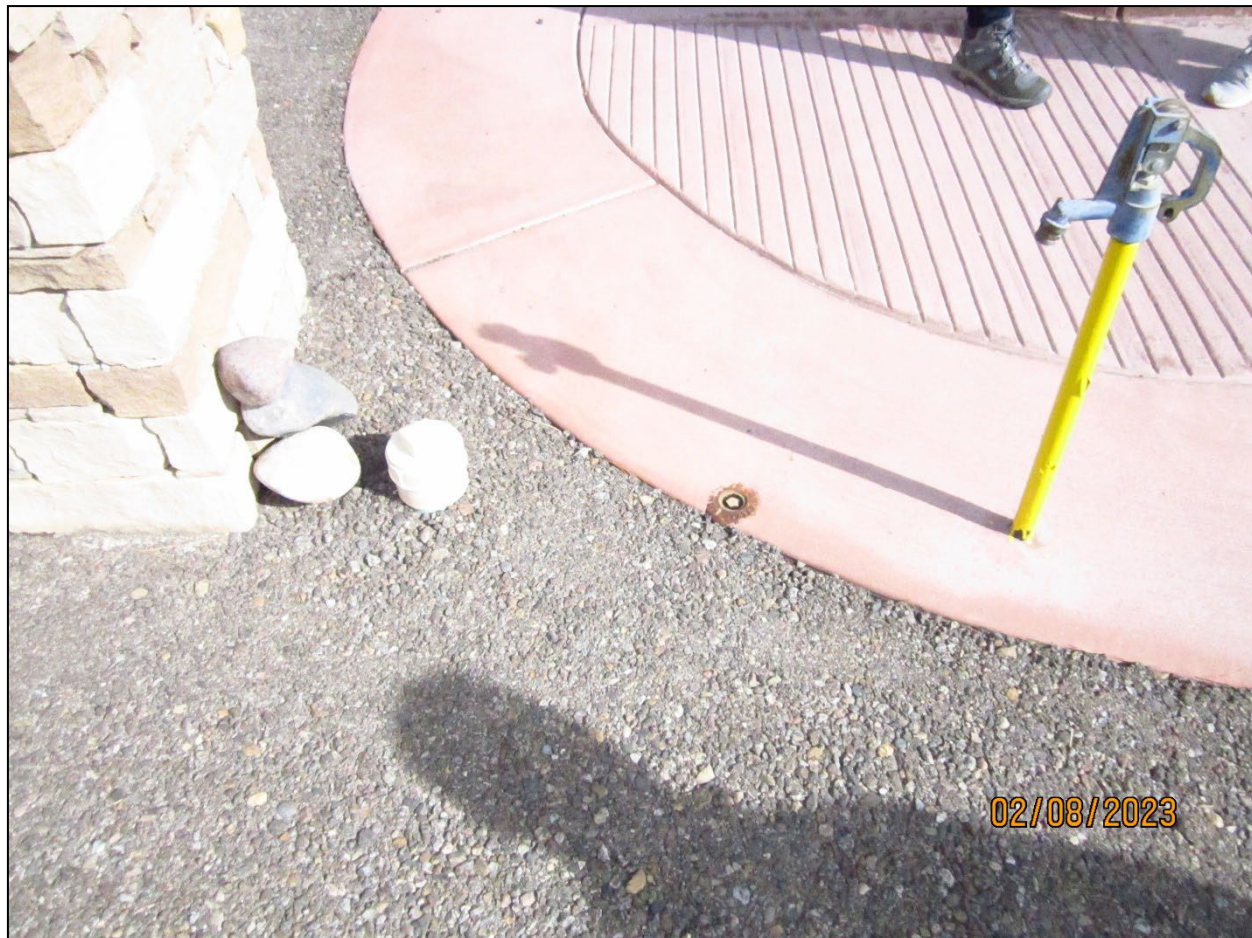
Photo No. 64

The EPA Inspection Team observed the four RV parking spots in the casino parking lot that were each serviced with potable water and a sewer connection. The water connections did not contain backflow prevention. The sanitary sewer cleanout locations at each parking spot were within three feet of the potable water connections (refer to [Appendix 1, Photograph 64](#)).

**Observation 16.** The potable water connections at the four RV parking spots outside of the casino did not contain backflow prevention (refer to [Appendix 1, Photograph 64](#)). Also, the water connections were located approximately three feet away from sanitary sewer cleanout locations.

**Photograph 64. RV Potable Water and Sanitary Sewer Clean-Out Hookups, Casino Area** View of one of the four RV parking spot potable water and sewer hookups outside of the casino. The RV parking spots were each serviced with a potable water and sewer connection. The potable water connections did not contain backflow prevention. The sanitary sewer clean-out locations at each parking spot were within three feet of the potable water connections.
