**Region 6 Compliance Assurance and Enforcement Division  
INSPECTION REPORT**

| Inspection Date(s): | June 28, 2018 | | |
| Media: | Drinking Water | | |
| Company Name: | Weston Water Supply Corporation (WSC) | | |

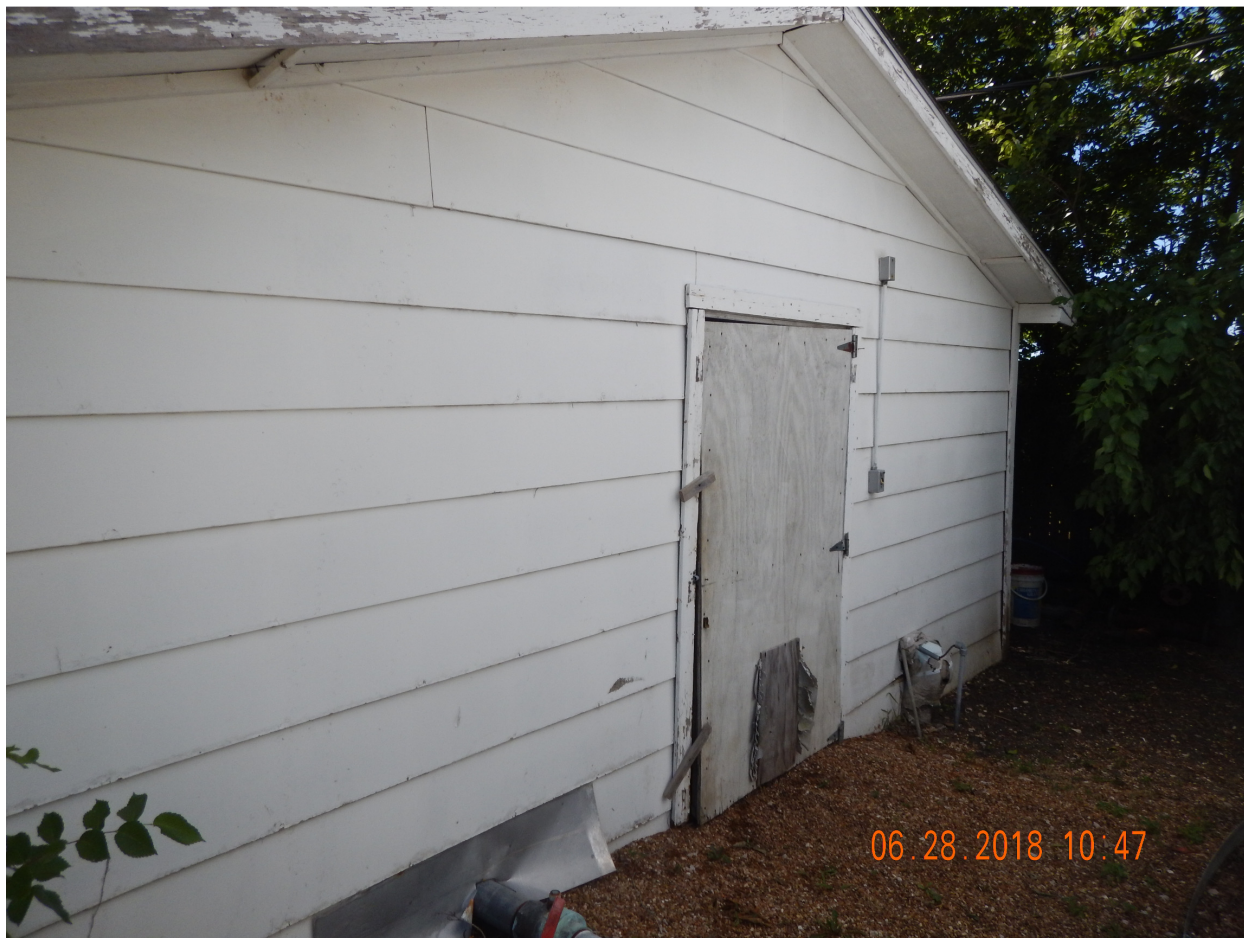
Photo File Name: DSCN0316

Description: Abandoned well house inside view with existing SCADA as shown. Need to remove SCADA equipment currently in existing building (to be demolished) and move to new SCADA building. Recommend using design plans and specifications by licensed engineer.
