REPORT OF COMPLIANCE EVALUATION INSPECTION  
(INDUSTRIAL STORMWATER)

**Alter Trading Corporation/Alter Metal Recycling-Columbus**

Authorization Number: **ISW-202201042**

**July 30 and August 2, 2024**

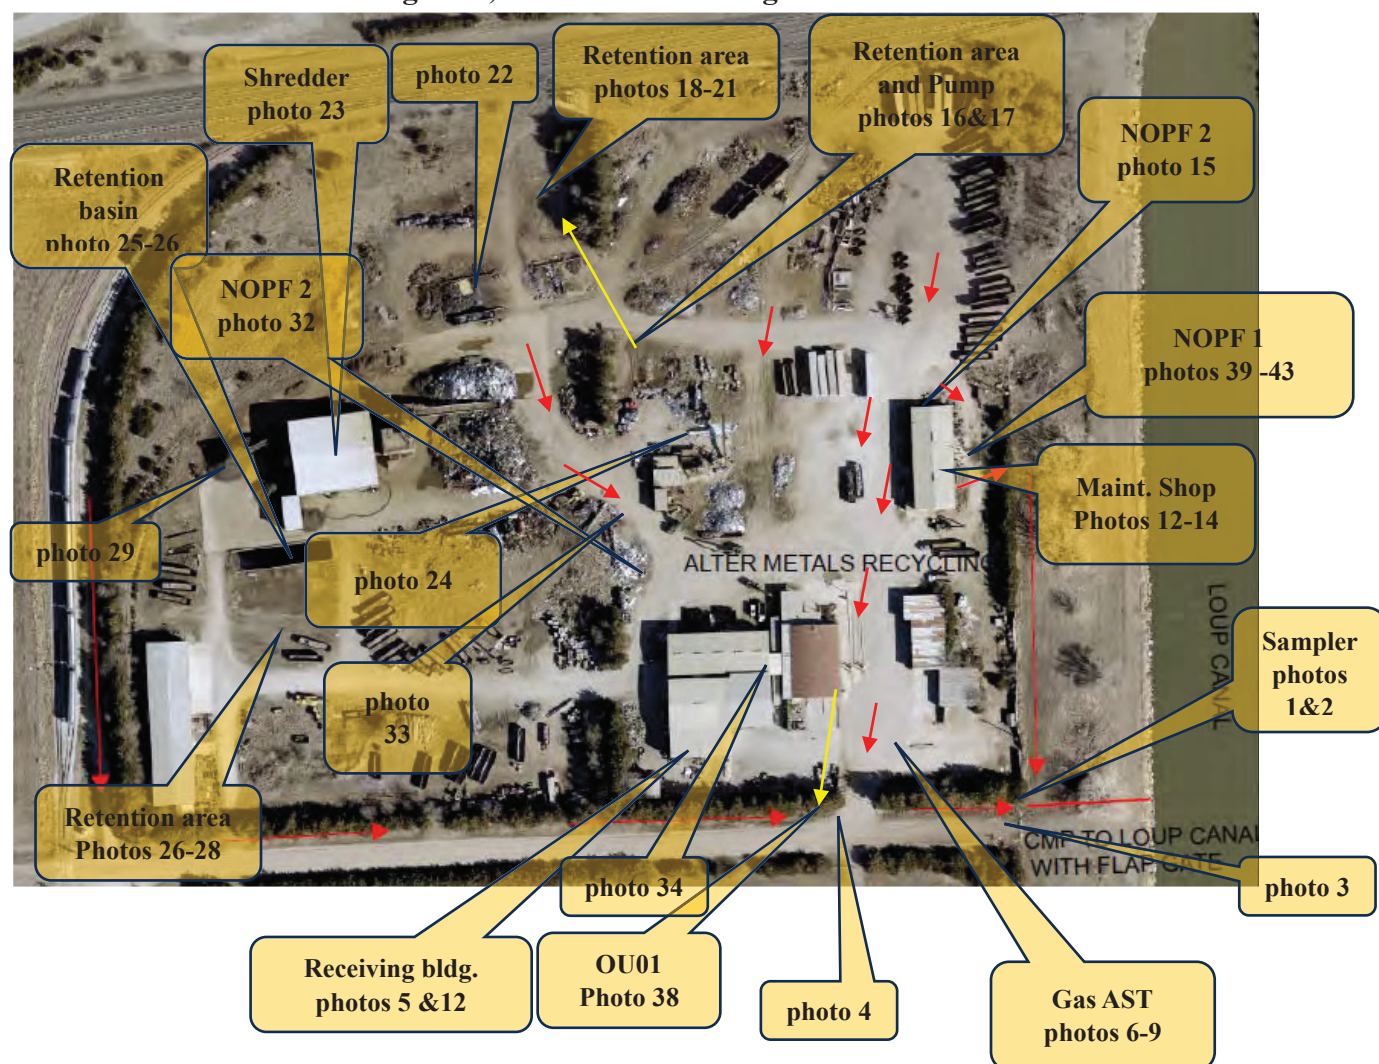
**Figure 1, Alter Metal drainage Patters**

The site is located 150 feet east of the Loup Canal. Stormwater runoff from the site would generally flows south toward the ditch. Water in the ditch would flow east to the Loup Canal.
