## REGION 10 Enforcement Division

### INSPECTION REPORT

| <b>Company Name:</b> | State of Alaska Department of Transportation and Public Facilities (Alaska DOT & PF) | | |
| <b>Facility or Site Name:</b> | ALASKA DOT & PF SOLDOTNA | | |

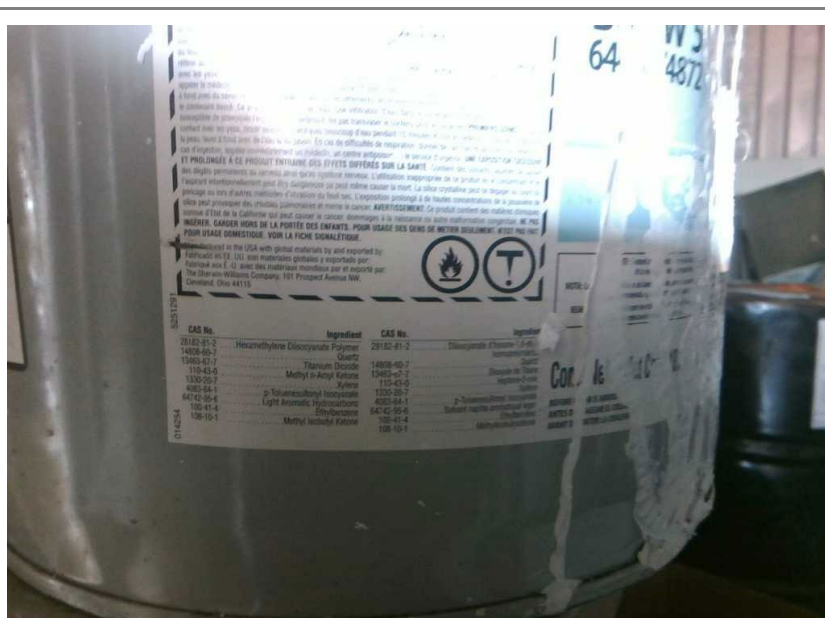
| Observation_Image-<br>202104271119481948246649.jpg |

| Another view of the labeling on the five-gallon container. |

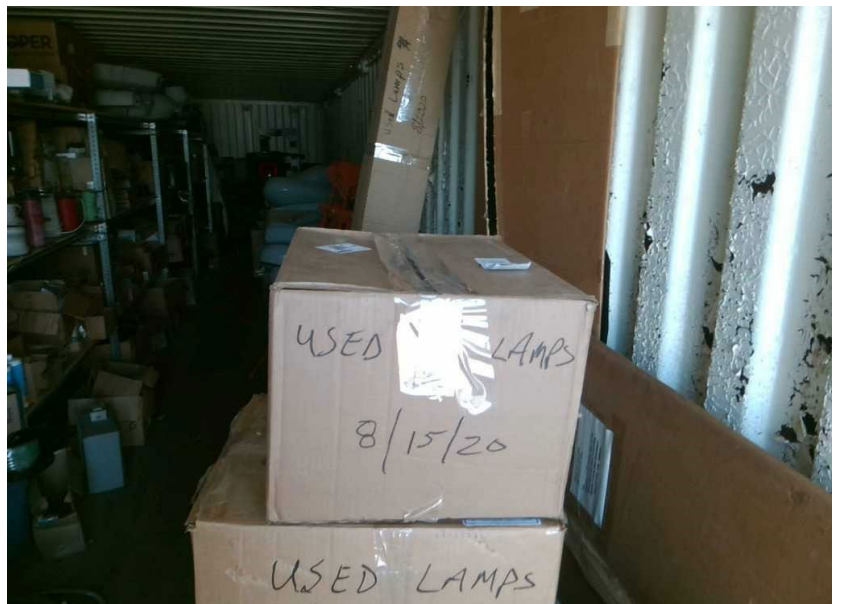
View of the waste high-pressure sodium bulbs that were observed in the Cold Shed/Facilities Connex after the waste bulbs were re-packaged in a closed container, labeled "Used Lamps" and dated 8/15/2020 during the inspection.

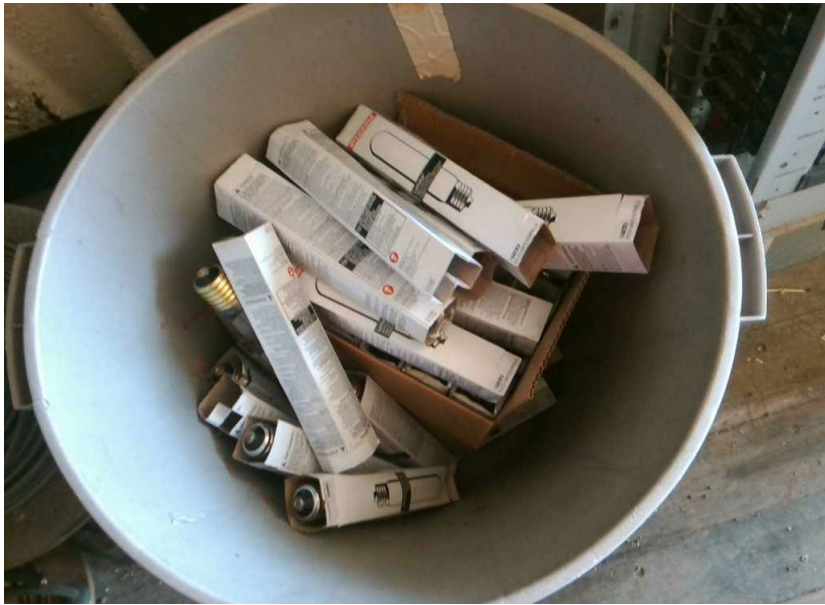
| Observation_Image-202104271233453345737029.jpg | |

| View of a trash receptacle that was being used to accumulate waste high-pressure sodium bulbs. The container seen in the photo is not closed but is labeled and dated. | |

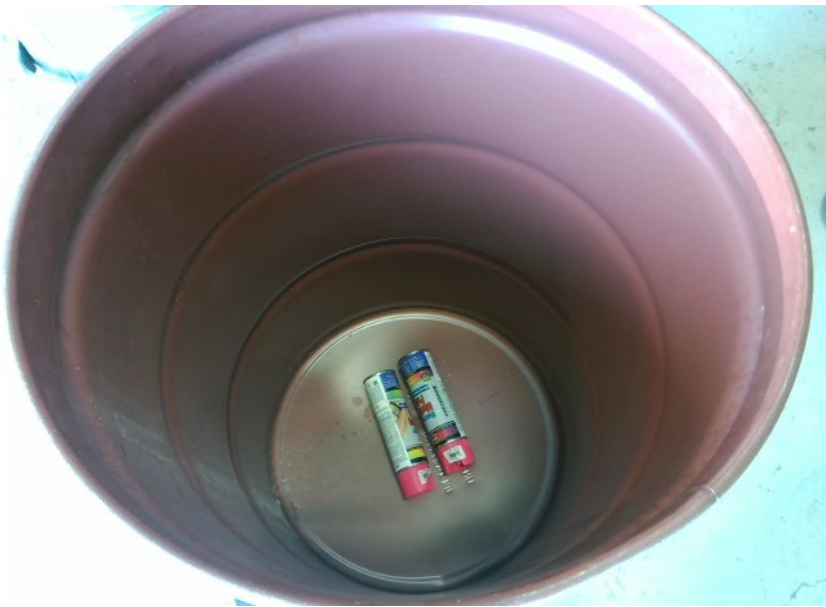
| Observation_Image-202104271451495149229289.jpg | |

I observed two aerosol cans of survey marking paint that felt empty and appeared to be waste-like. Mr. Smith looked at the aerosol cans and verified that they were waste aerosol cans.

| <p>Mr. Smith put the waste aerosol cans into a 55-gallon container and labeled the container with the words "Hazardous Waste" during the inspection.</p> | |

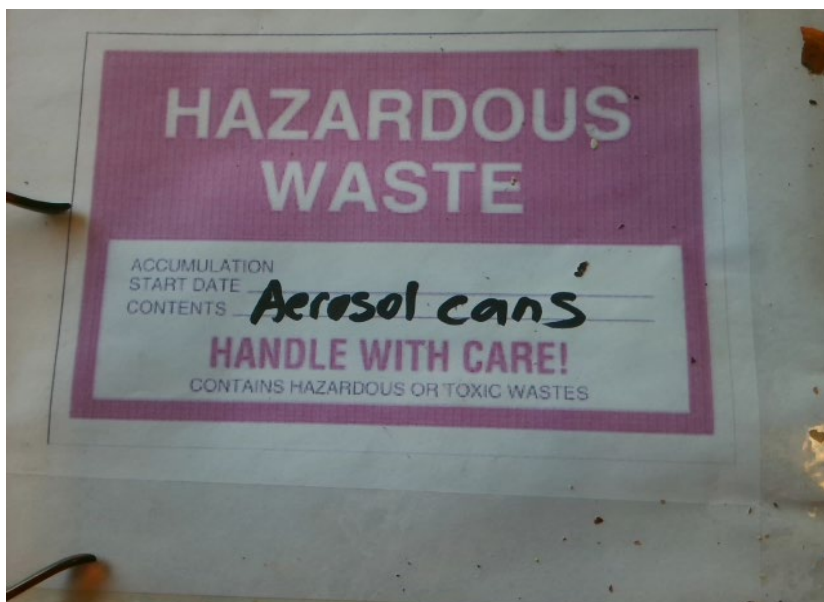
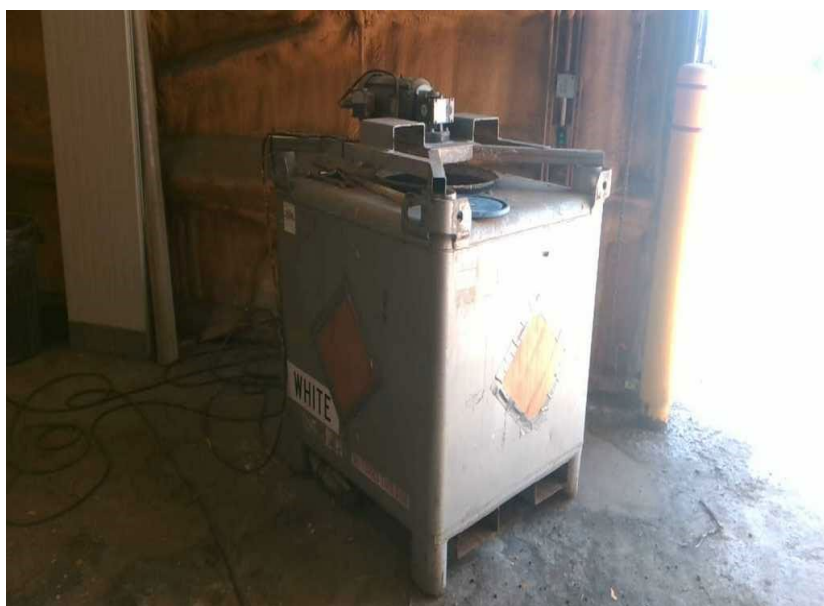
While inspecting the Sand Shed, I saw a 250-gallon stainless steel tote with what looked like dried white traffic paint in the bottom. According to Jeffrey Mahan, M&O Equipment Operator, the tote is used to stage the paint mixer. According to Mr. Mahan, the paint mixer is placed inside of the totes of traffic paint to mix the paint. The mixer is then removed and placed inside an empty tote. Mr. Mahan explained that the dried paint that I observed in the bottom of the tote had dripped off the mixer and accumulated in the bottom of the tote between 2016 and 2018. At the time of the inspection, there was approx. 3 to 3.5 inches of the dried white and yellow traffic paint in the bottom of the tote. Safety Data Sheets for Alaska Low VOC White Solvent Paint and Alaska Low VOC LF Yellow Solvent Paint were provided by the facility. According to the information contained in the SDS's, the Alaska Low VOC White Solvent Paint is hazardous for ignitability (D001) with a flashpoint of -4°F. The Alaska Low VOC LF Yellow Solvent Paint is hazardous for ignitability (D001) with a flashpoint of -4°F and toxicity for benzene (D018). The Alaska Low VOC LF Yellow Solvent Paint contains benzene at less than 0.1% by weight or roughly less than 1,000 parts per million (ppm). The maximum regulatory concentration for benzene is 0.5 ppm.

| View of the tote that holds the paint mixer. |

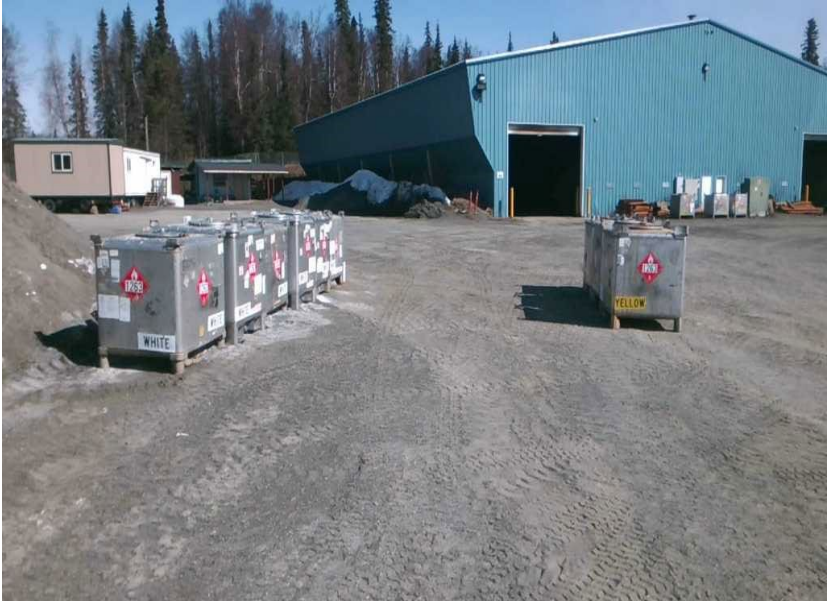
| Observation_Image-20210427120248248482719.jpg | |

As I left the Sand Shed, I saw additional stainless-steel totes containing both white and yellow traffic paint. According to Mr. Mahan, the traffic painting equipment is cleaned out with toluene. The waste paint and toluene mixture is placed back into a stainless-steel tote and sent back to the manufacturer where it is recycled back into the paint manufacturing process.
