**Region 6 - Enforcement & Compliance Assurance Division**  
**INSPECTION REPORT**

| Inspection Date(s): | 03/06-09/2023 | |
| Media Program: | RCRA Compliance Evaluation Inspection | |
| Facility Name: | <b>TotalEnergies Carville Polystyrene Plant</b> | |

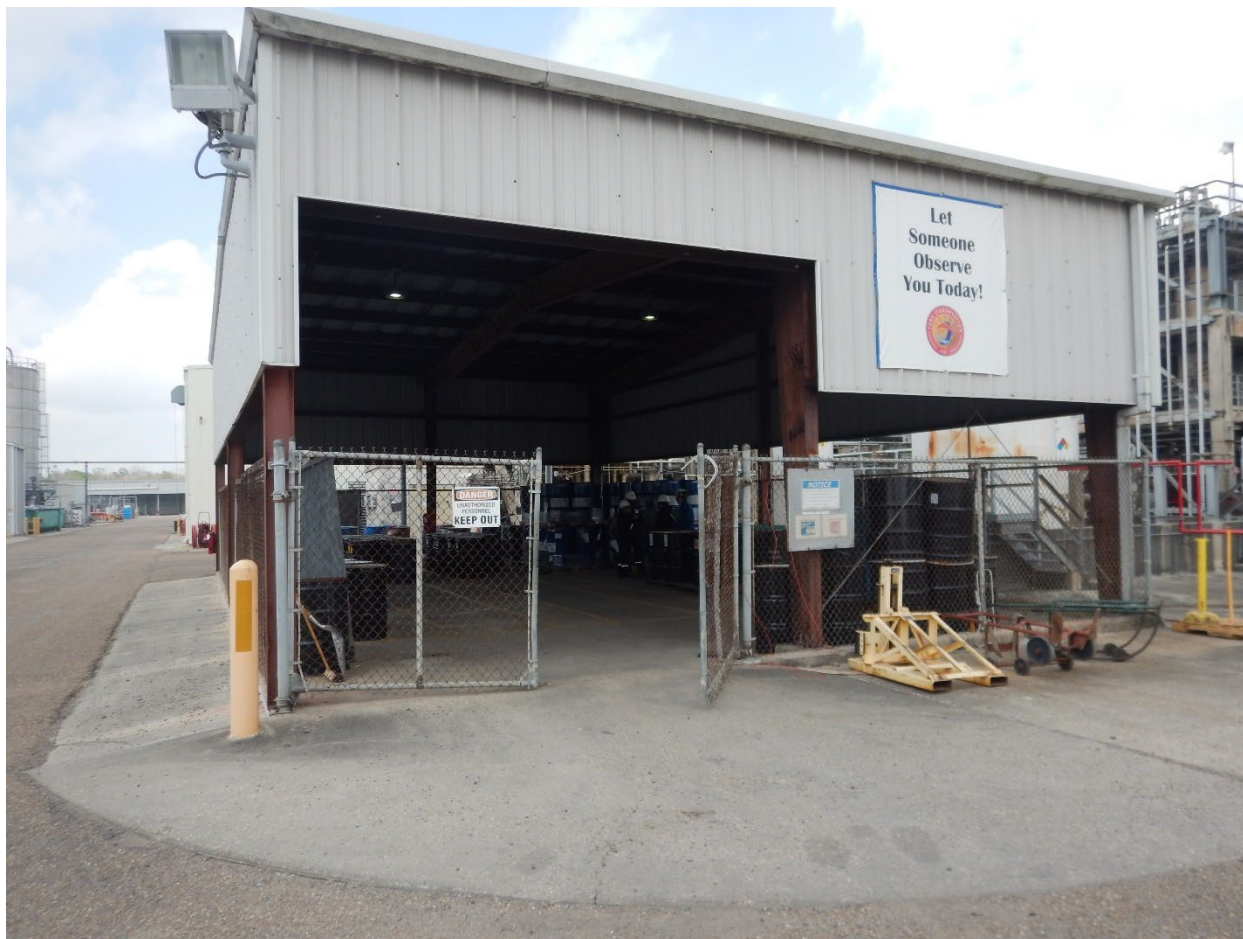
| Photo #: | DSCN0932.JPG |

| Description: External view of the designated hazardous waste container central accumulation area | |

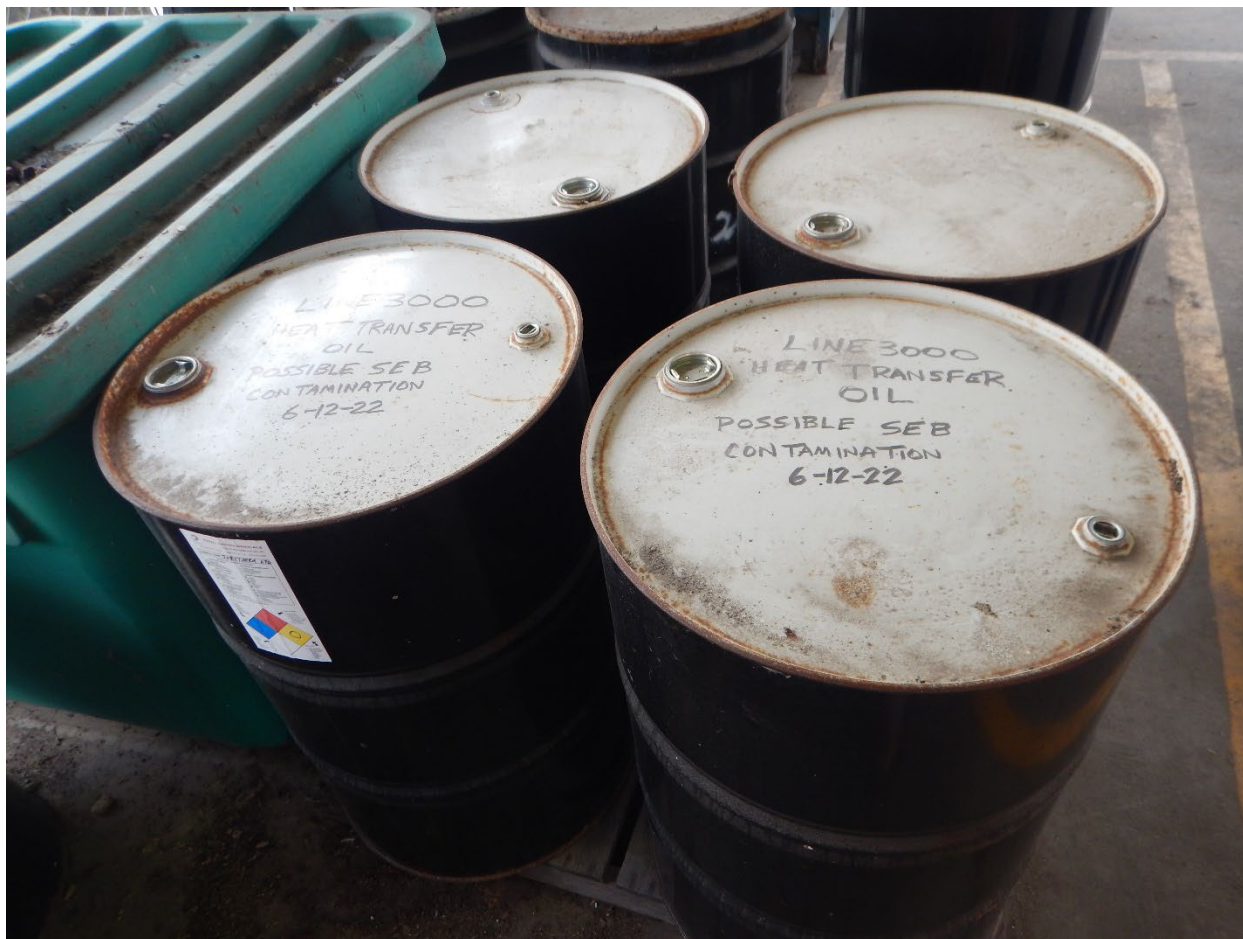
| Photo #: | DSCN0942.JPG |

| Description: Unlabeled drums located in the hazardous waste container central accumulation area | |

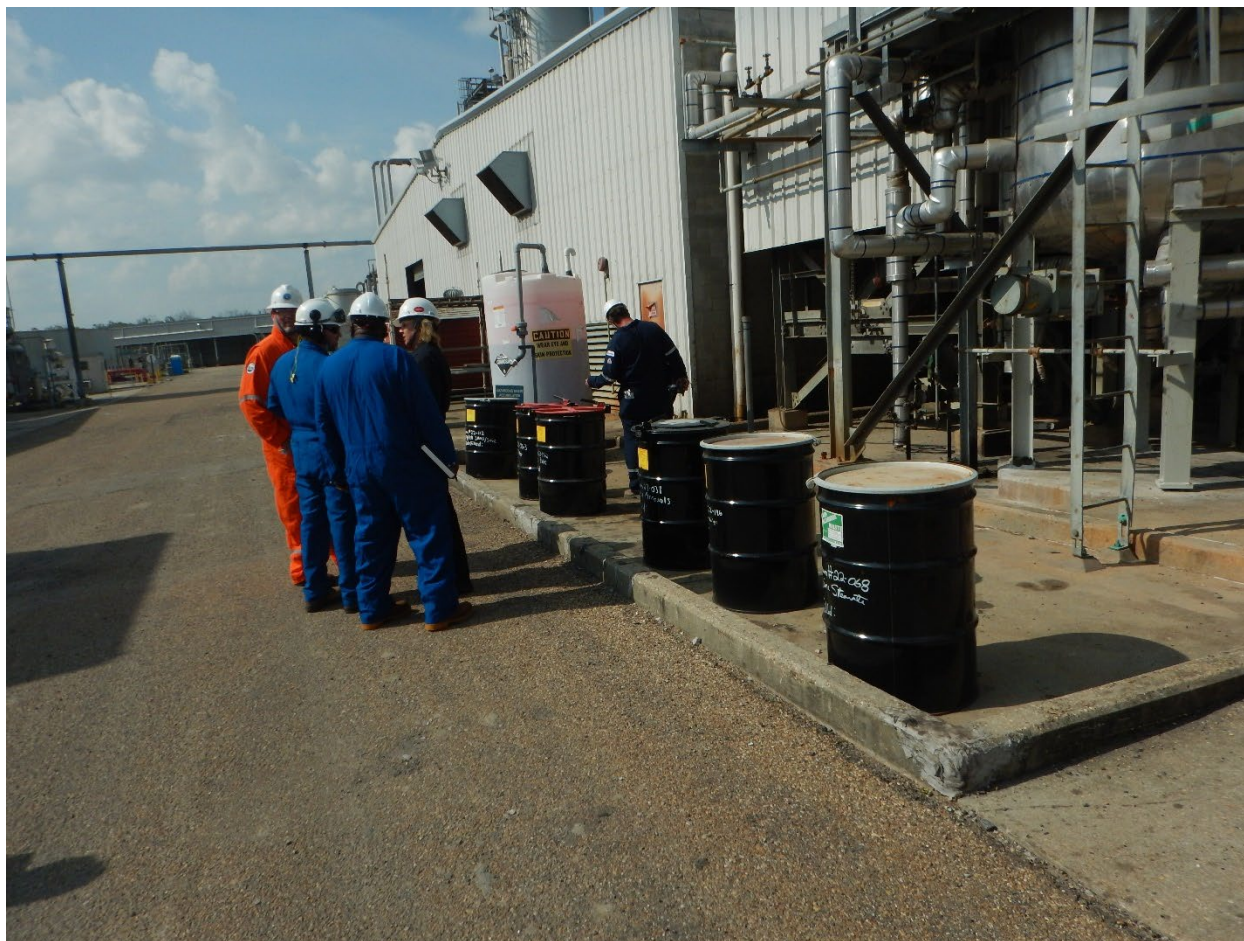
| Photo #: | DSCN0952.JPG |

| Description: Claimed satellite accumulation area for Lines 4 and 5 with 6 x 55 gallon containers. 5 labeled as hazardous | |

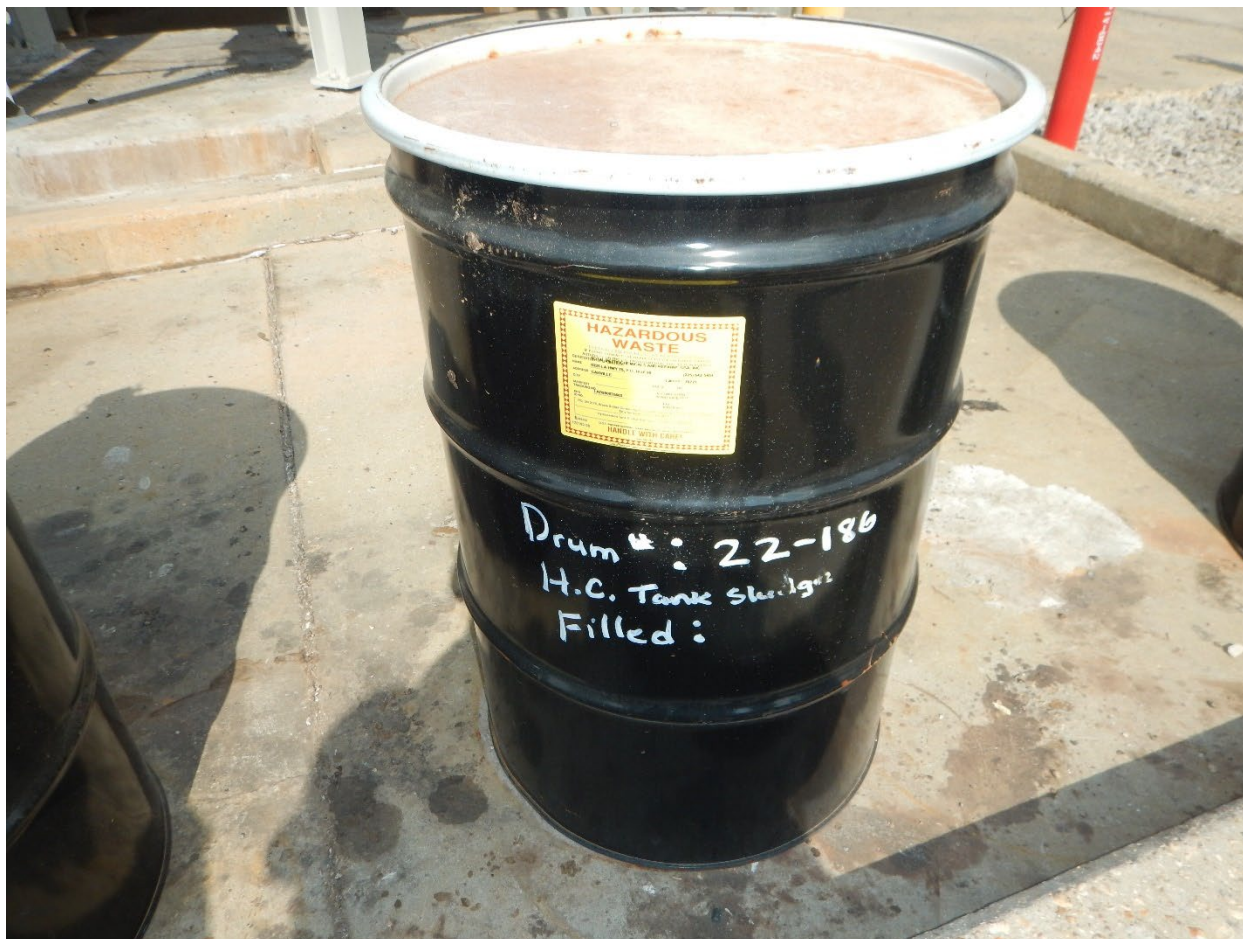
| Photo #: | DSCN0954.JPG |

| Description: Hazardous waste labeled container located in claimed satellite accumulation area for Lines 4 and 5. Hydrocarbon Tank Sludge | |

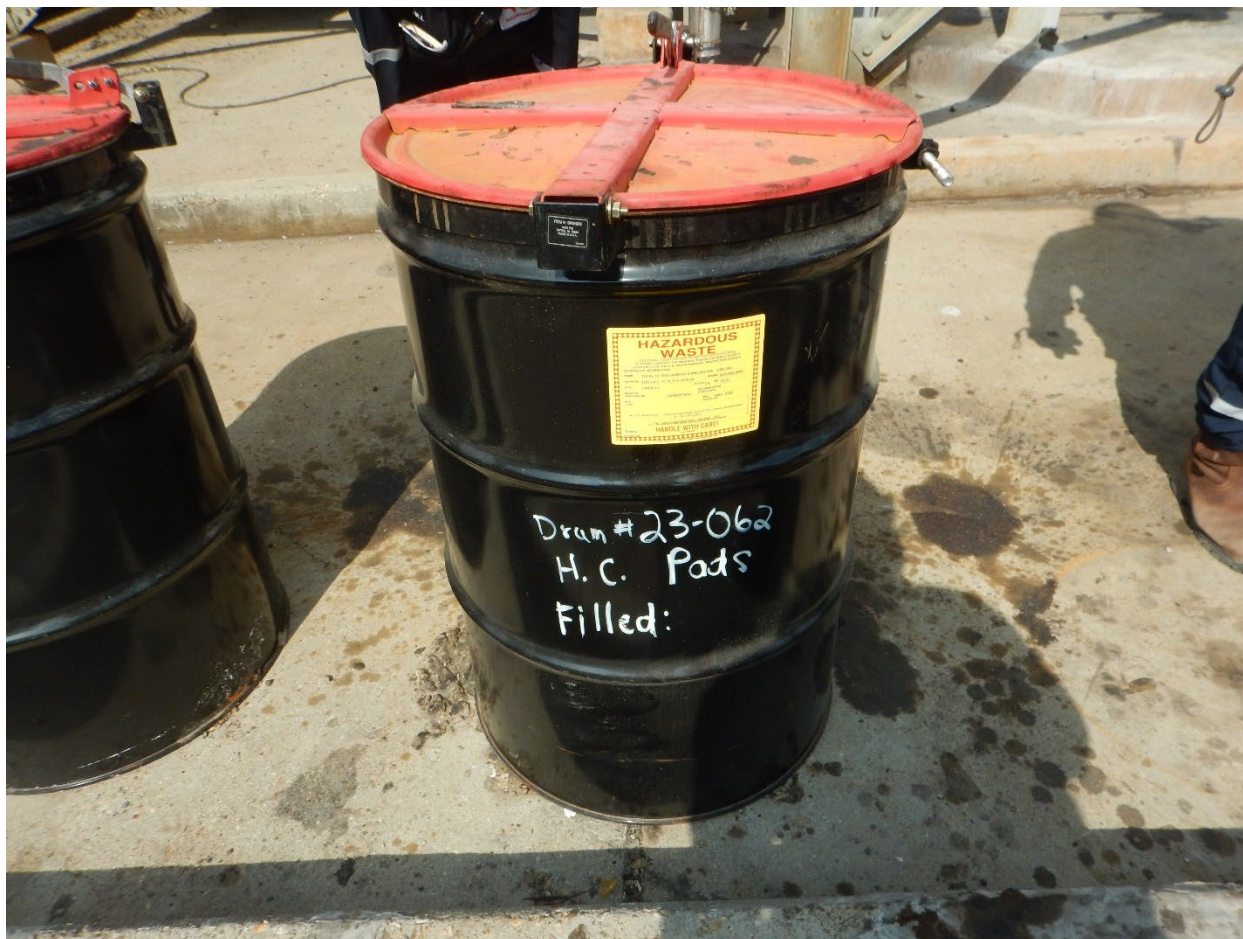
| Photo #: | DSCN0956.JPG |

| Description: Hazardous waste labeled container located in claimed satellite accumulation area for Lines 4 and 5. Hydrocarbon Contaminated Absorbent Pads | |

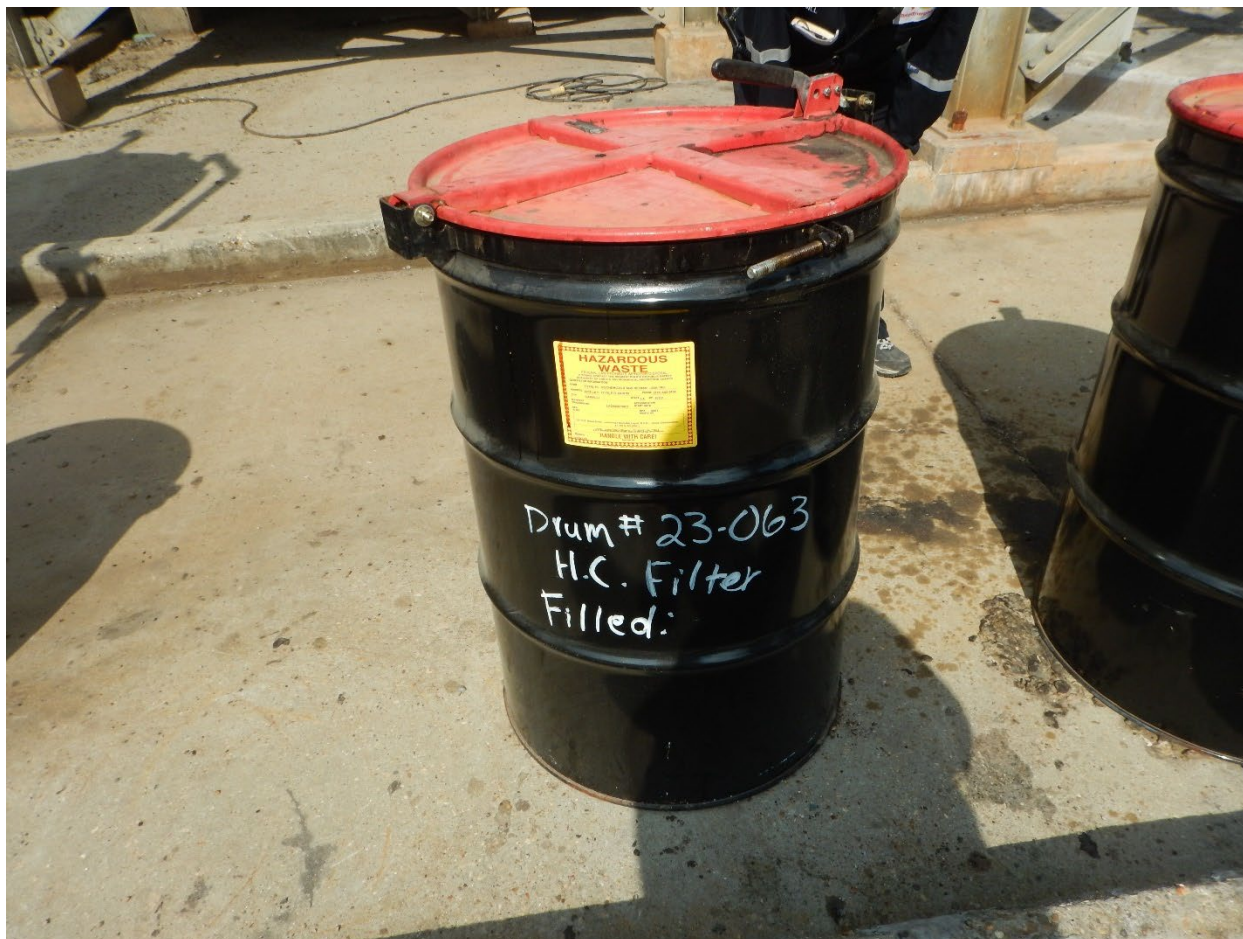
| Photo #: | DSCN0957.JPG |

| Description: Hazardous waste labeled container located in claimed satellite accumulation area for Lines 4 and 5. Hydrocarbon Contaminated Filters | |

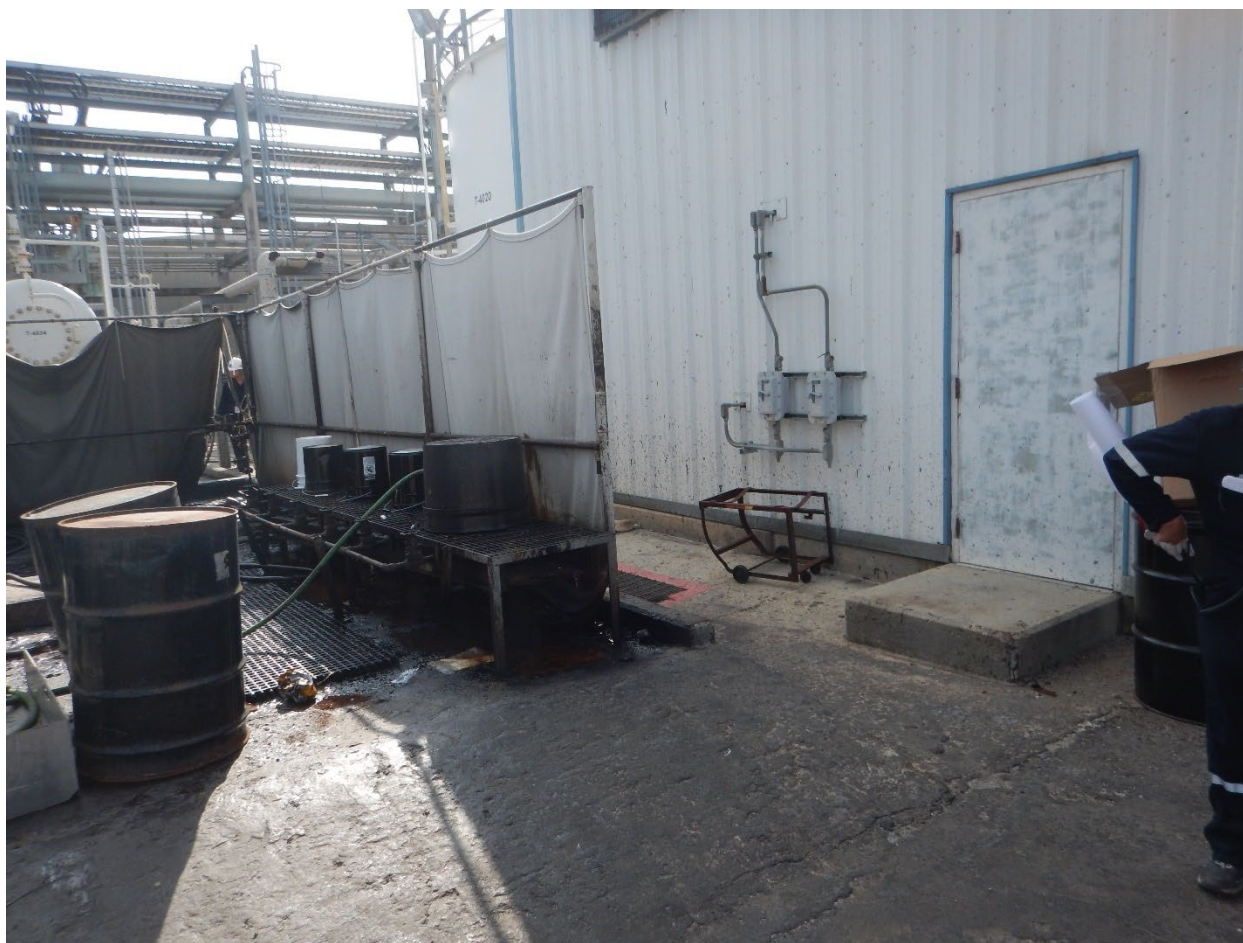
| Photo #: | DSCN0962.JPG |

On March 6, 2023, we observed hazardous waste (D001) being accumulated on the ground (Appendix 1, Photo No. 30). The unit is used for cleaning containers and process equipment and was extensively stained at the time of inspection. The unit is surrounded by an unsecured tarp on 3 sides which allow material to be released from the unit during power washing. The tarp is in poor condition and the waste is visible on nearby walls and process equipment from drag-out and overspray (Appendix 1, Photo No. 31-33). Hazardous waste is generated and not contained pursuant to 40 CFR 262.17(a)(1)(ii) and since the hazardous waste was not promptly cleaned up, we determined the material to be abandoned as defined in 40 CFR 261.2(a)(2)(i)(A).

| Description: Steam out area located north of Line 4. Note: waste material staining present on wall of nearby building. | |

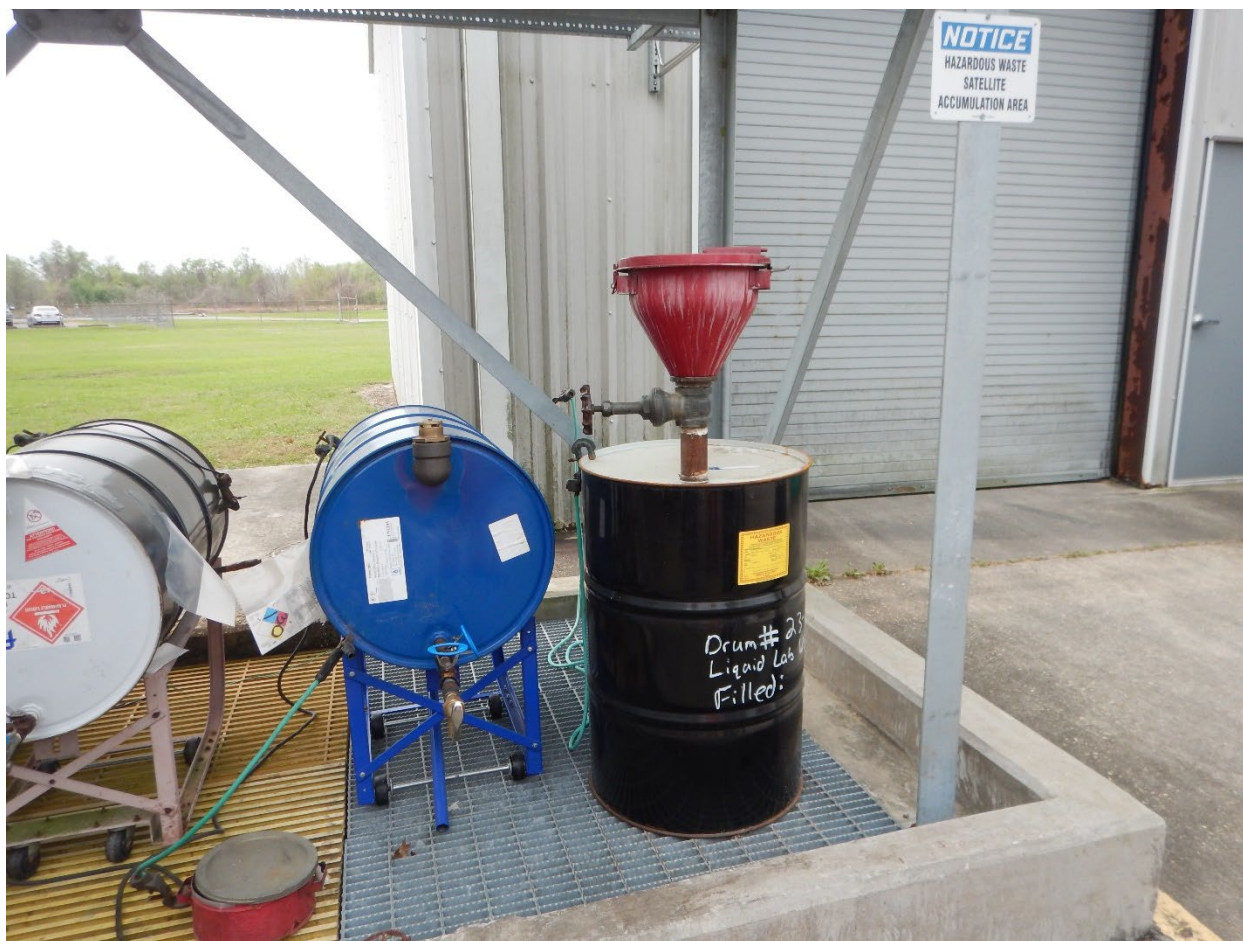
| Photo #: | DSCN0977.JPG |

| Description: Hazardous waste labeled container located behind the laboratory in satellite accumulation area. Liquid lab waste | |

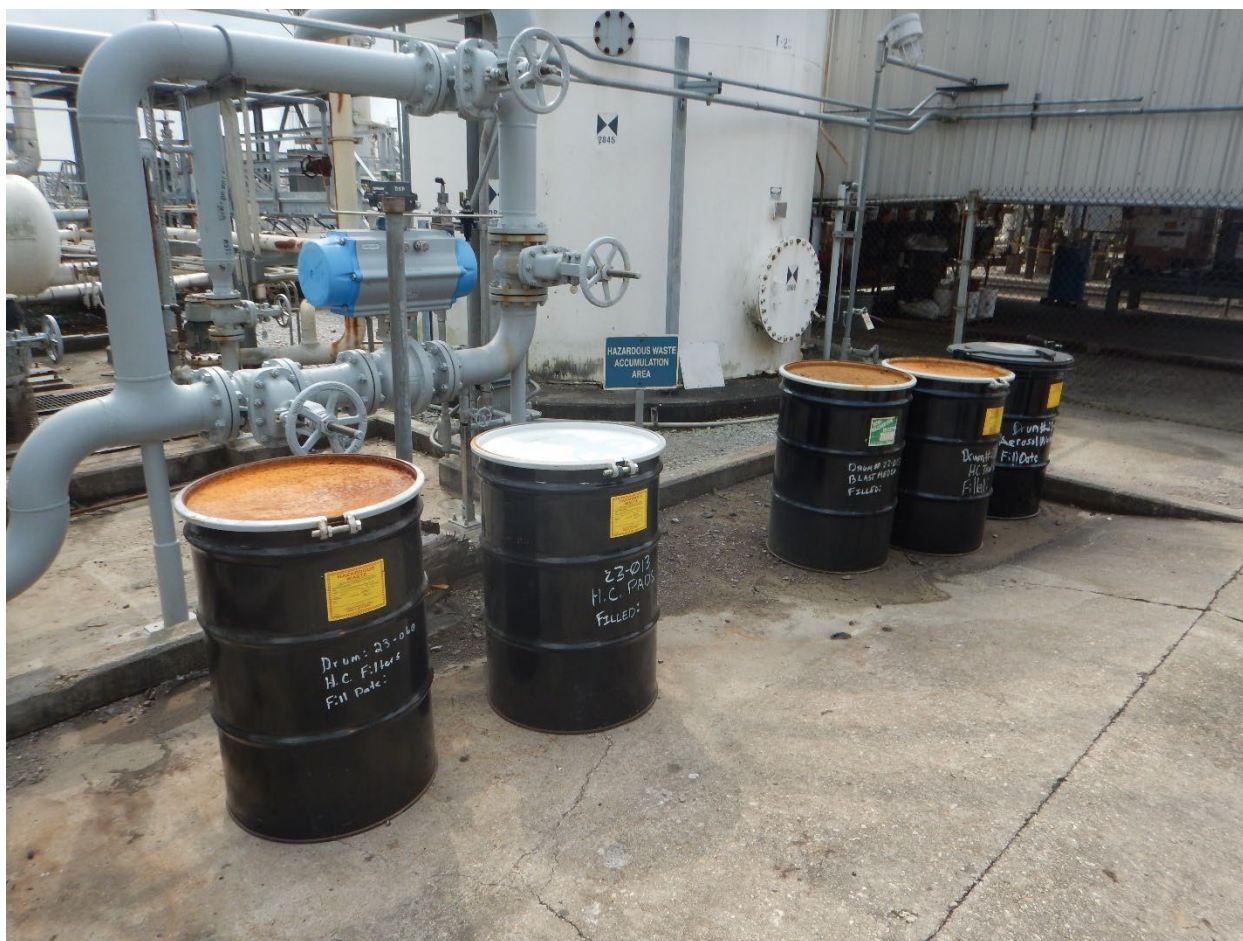
| Photo #: | DSCN0986.JPG |

| Description: Claimed satellite accumulation area for Line 3 with 5 x 55 gallon containers. 4 labeled as hazardous waste | |

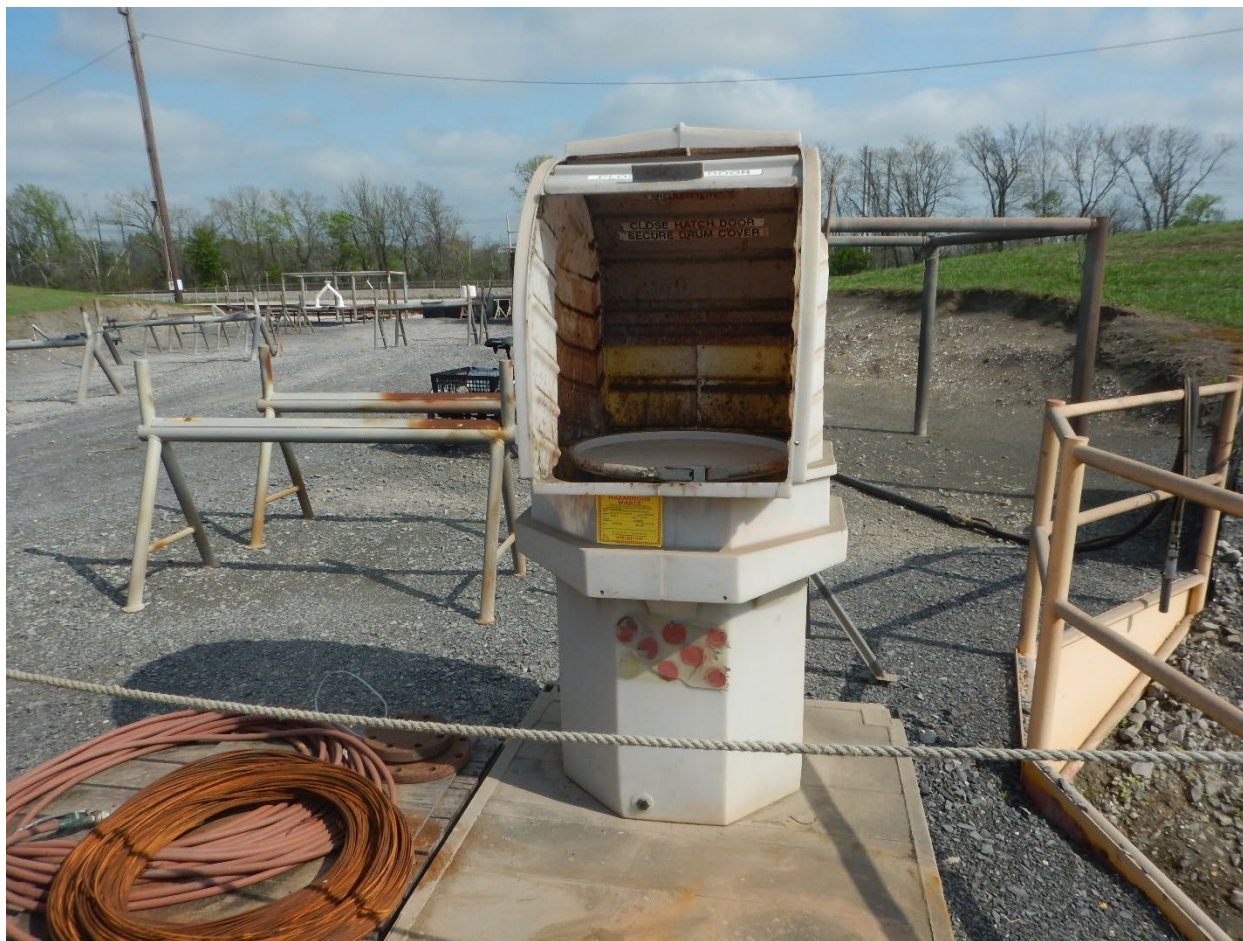
| Photo #: | DSCN0992.JPG |

| Description: Satellite Accumulation area for painting area. 1 x 55 gallon container labeled as Hazardous Waste. Spent Thinner | |

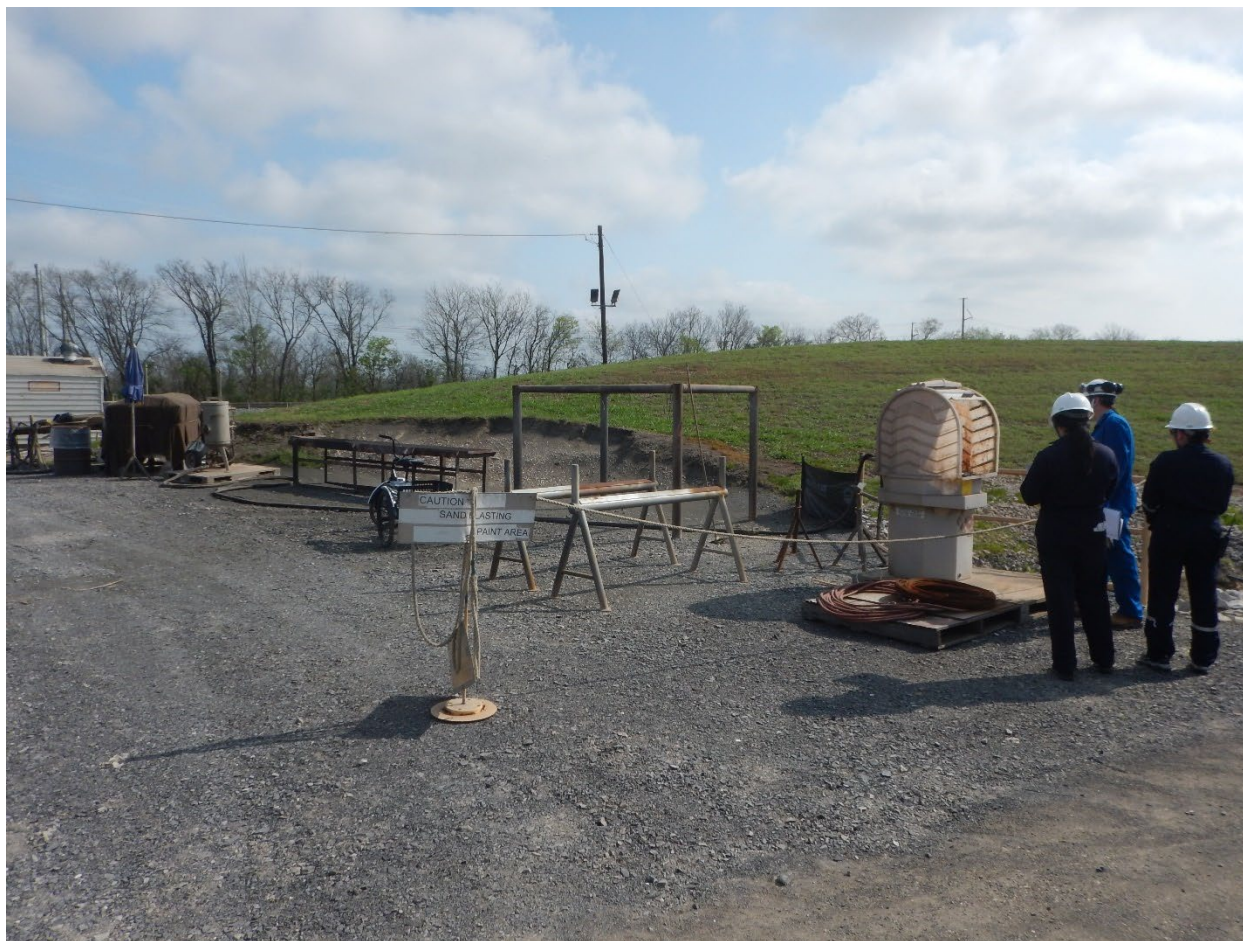
| Photo #: | DSCN0993.JPG |

| Description: Satellite Accumulation area for painting area. 1 x 55 gallon container labeled as Hazardous Waste. Spent Thinner. | |

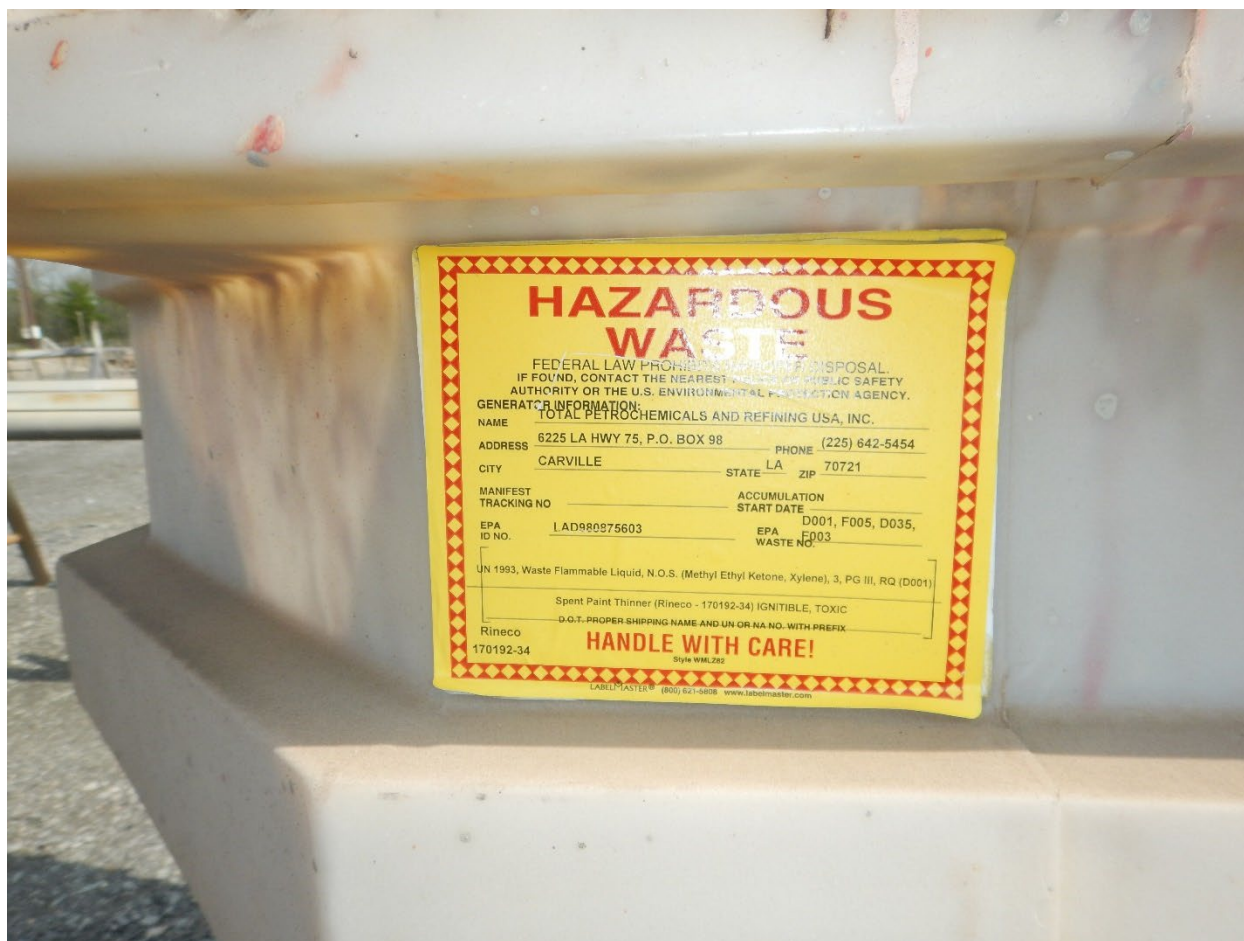
| Photo #: | DSCN0994.JPG |

| Description: Hazardous Waste label on container located in the satellite accumulation area for the painting area. Spent Thinner. | |
