# NPDES Compliance Inspection Report

## Parker Hannifin – Enumclaw

**NPDES Permit Tracking Number  
# WAR004622**

**Inspection Date: 01/18/2023**

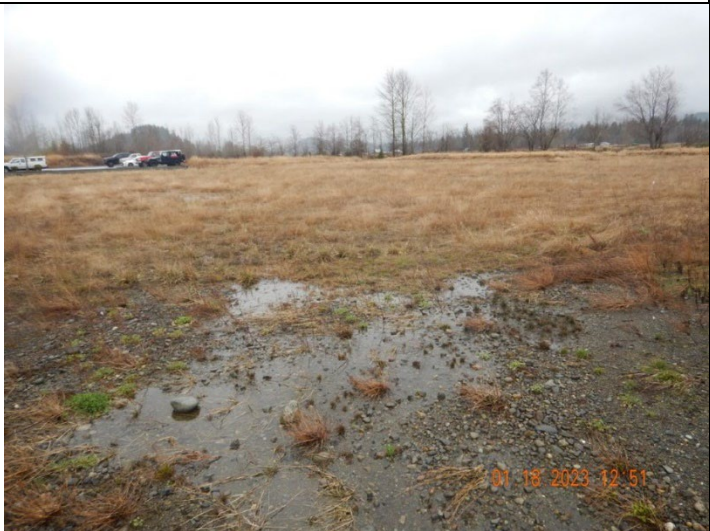
We walked across the southern perimeter to a catch basin at the southwest corner of land leased by the Facility, also by Battersby Avenue (**Photo 22**). Mr. Myron said he thought this might belong to the City of Enumclaw's municipal separate storm sewer system. Inside the catch basin appeared to be a receiving pipe from the east, and an outfall pipe to the north (**Photo 23**). North of the catch basin, we saw the apparent discharge point from the catch basin (**Photo 24**). We observed water to the north of this point, possibly infiltrating as we did not see an apparent flow (**Photo 25**).

Photo: #25 (DSCN0482.JPG)  
 Description: Facing north from vantage in Photo 24, photo shows the lands east of the Facility, which they lease.

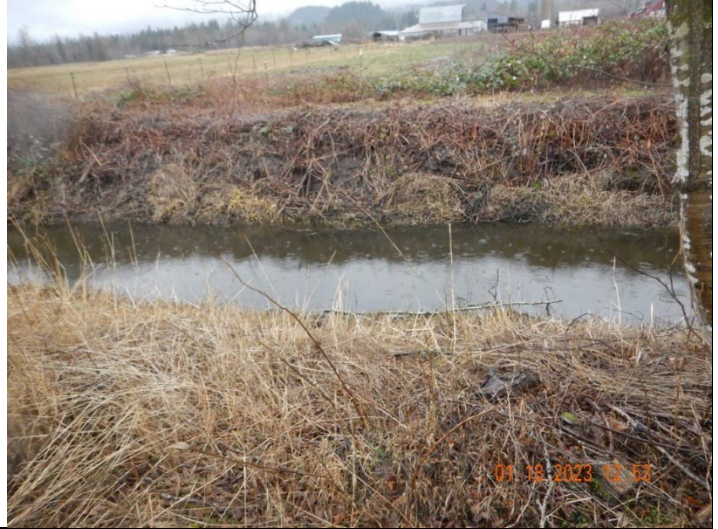
We continued north along the eastern edge of the leased land. We saw a berm separating the land from the Drainage District 5 lateral (lateral, **Photo 28, 35**). We also saw a cut in the berm with a rock check dam (**Photo 26**).

Photo: #28 (DSCN0485.JPG)  
 Description: Facing east, photo shows lateral of Drainage District 5 flowing north from Battersby Avenue.

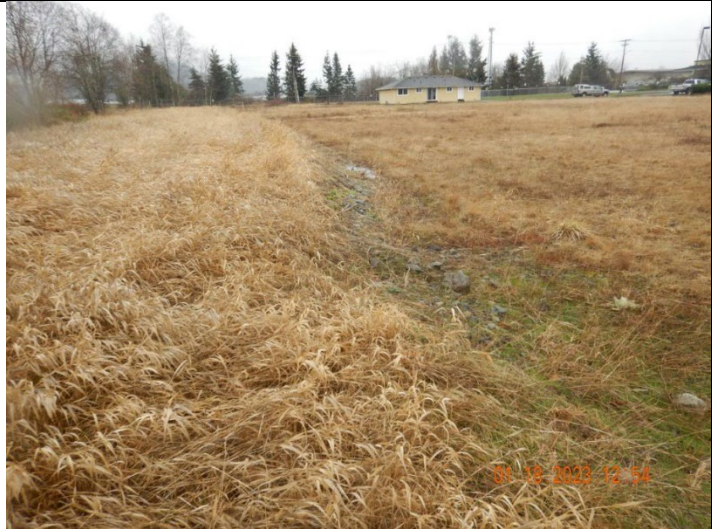
As we continued north, we saw the surface water flow rather than stand (**Photo 27**). Along the property edge we saw the beginning of a swale collecting the flowing water (**Photo 29, 30**). Mr. Myron stated this was one of three swales on the leased land directing stormwater to their retention pond.

Photo: #29 (DSCN0486.JPG)  
 Description: Facing south, image of channel carrying surface water north across lands leased by the Facility.

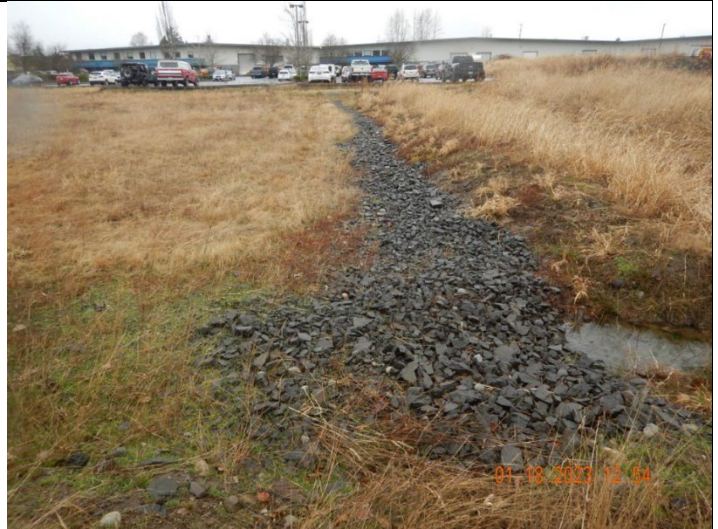
Photo: #30 (DSCN0487.JPG)  
 Description: Facing west towards Facility. Image of channel, and apparent rock dam, carrying surface water generally east and north across lands leased by the Facility.

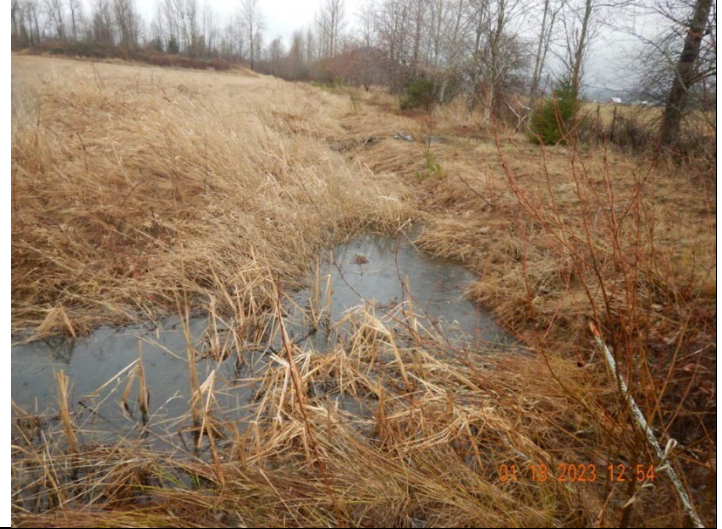
Photo: #32 (DSCN0489.JPG)

Farther north we saw some debris in the swale (**Photo 31, 33**). We noted the flow in the swale increased as we went north (**Photo 32**), in part due to the swale collecting additional flow across the land (**Photo 34**). Mr. Myron showed me a map that showed the direction of water flowing across the site. He stated the map is part of the Facility's Stormwater Pollution Prevention Plan (SWPPP).

Description: Photo of surface water in channel flowing generally east and north across lands leased by the Facility. Vantage of photo is north from Photos 29-31.

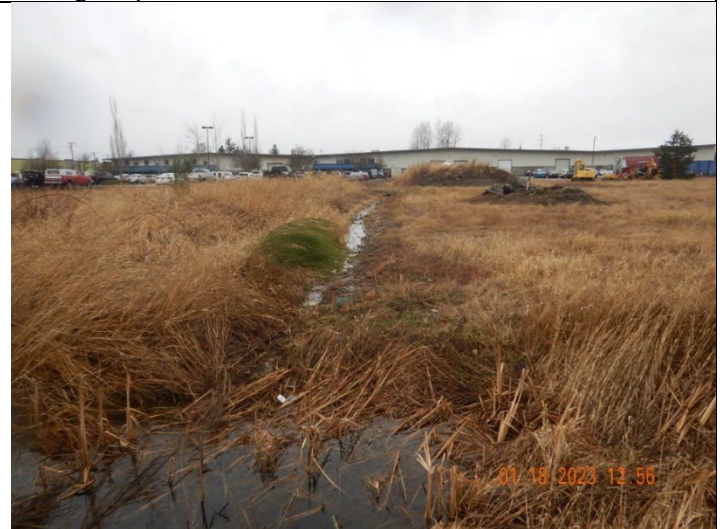
Photo: #34 (DSCN0491.JPG)

Description: Photo of surface water in channel flowing east from the facility to larger channel flowing northwards on lands leased by the Facility.

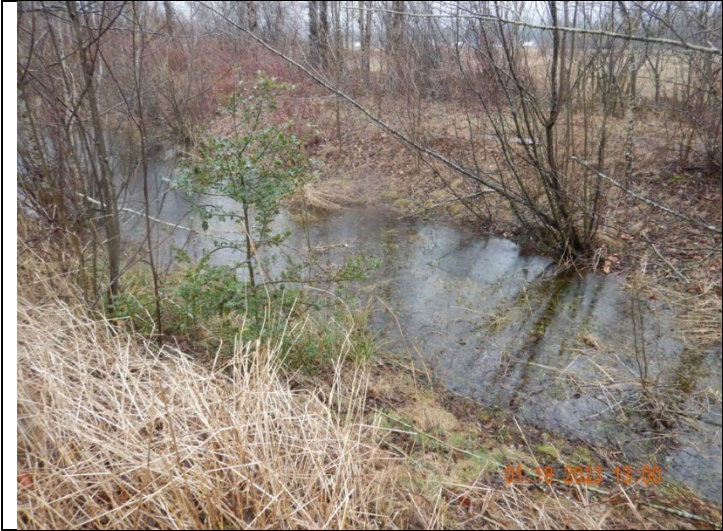
Photo: #35 (DSCN0492.JPG)

Description: Facing northeast, standing on the berm separating the leased lands, image shows Drainage District 5 lateral flowing north.

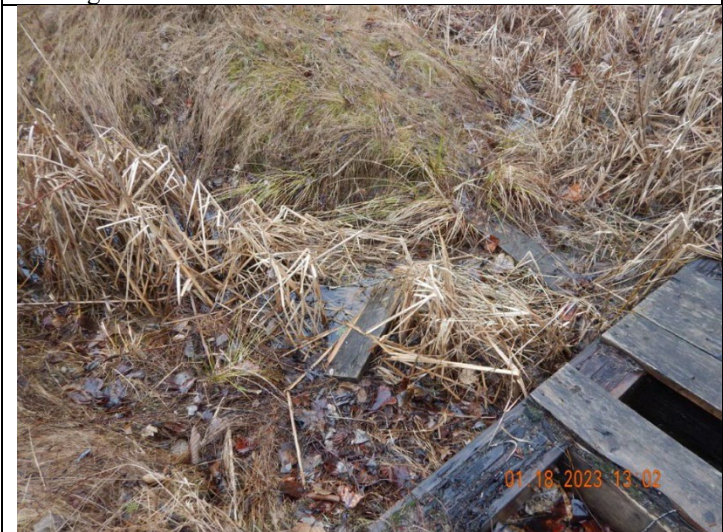
Photo: #37 (DSCN0494.JPG)

We crossed an older wooden bridge, with another swale flowing into the pond under the bridge (**Photo 37, 38**). We observed the stormwater pond and saw a corrugated metal pipe in the northeast corner of the pond (**Photo 39, 40**). Next to the pond we saw a Type 2 catch basin that Mr. Myron said would be their sample point in the event of a discharge. He and Mr. Clark reiterated they do not believe the stormwater has discharged from the Facility's retention pond. Mr. Myron pulled the lid from the catch basin, and he and Mr. Clark showed the corrugated pipe connecting inside the catch basin, and feeding water into a stand pipe (**Photo 41**). Mr. Clark said the water would need to rise several feet inside the catch basin before it would flow fully up the stand pipe, and discharge into the near-by lateral.

Description: Water flowing north from lands leased by the Facility towards stormwater pond. Constructed wood in foreground is part of bridge crossing the swale as it flows into the pond.

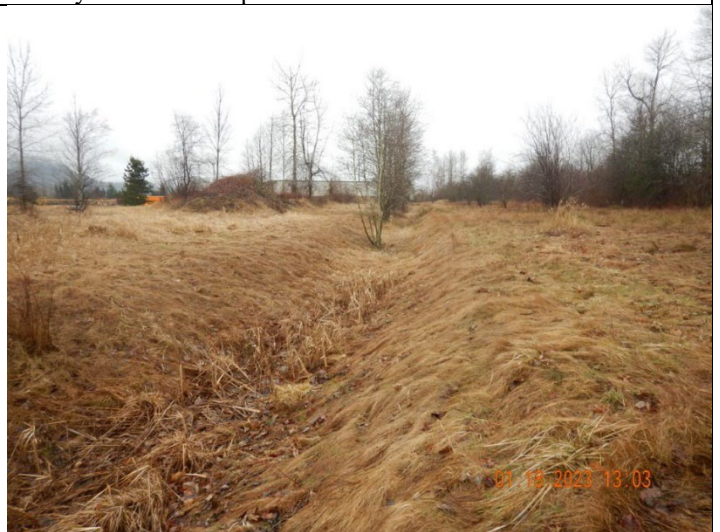
Photo: #38 (DSCN0495.JPG)

Description: Facing south, with Facility in background, image shows another swale capable of conveying water into stormwater pond.

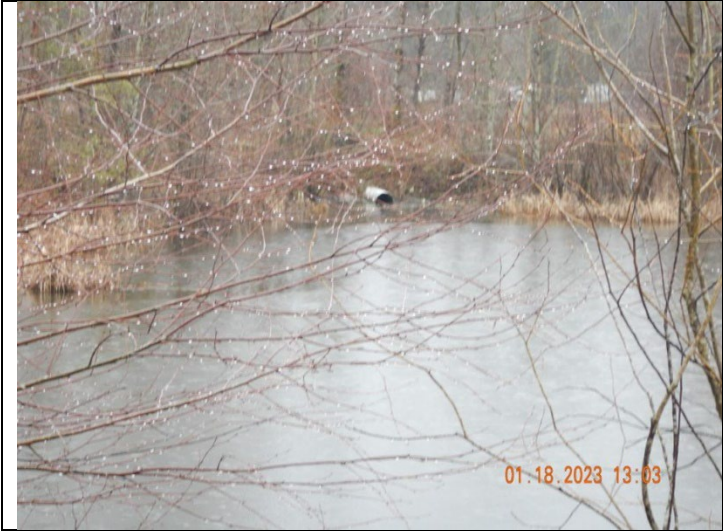
Photo: #39 (DSCN0496.JPG)  
Description: Facing northeast, image of Facility's on-site stormwater retention pond with an outfall pipe in background.

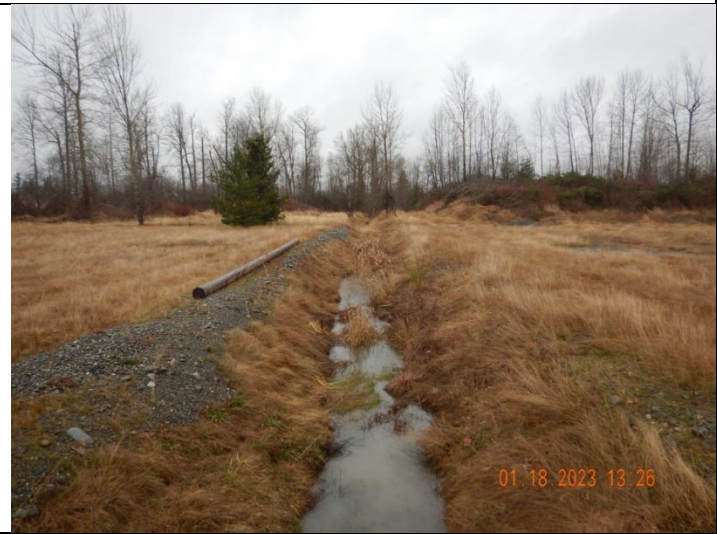
Photo: #45 (DSCN0502.JPG)

I went over to the berm next to the lateral and I saw a white pipe actively discharging water into the lateral (**Photo 42, 43**). Mr. Myron and Mr. Clark said they did not know the source of the discharge. I pointed out the pipe was directly opposite their on-site retention pond, and there did not appear to be any other dischargers in the area. I asked if they knew of any other source discharging either into their pond, or across the Facility's leased land. They said they did not. Mr. Myron did show me another pipe, apparently made of concrete, that he said they thought served as the discharge point for water from the pond into the lateral (**Photo 44**). The pipe appeared in poor repair, and cracked further while Mr. Myron examined it. We left the pond heading back to the Facility, and I saw the third swale conveying stormwater to the Facility's pond (**Photo 45**).

Description: Facing north, back towards Facility stormwater pond. Images shows another swale of water flowing across lands leased by the Facility.
