**U.S. ENVIRONMENTAL PROTECTION AGENCY  
REGION III WATER BRANCH, ENFORCEMENT  
AND COMPLIANCE ASSURANCE DIVISION  
CLEAN WATER ACT  
COMPLIANCE INSPECTION REPORT**

**Name of Facility:** Antrim Township

| <b>Type of Inspection:</b> | MS4 Compliance Inspection |
| <b>NPDES Permit No:</b> | PAI133536 |

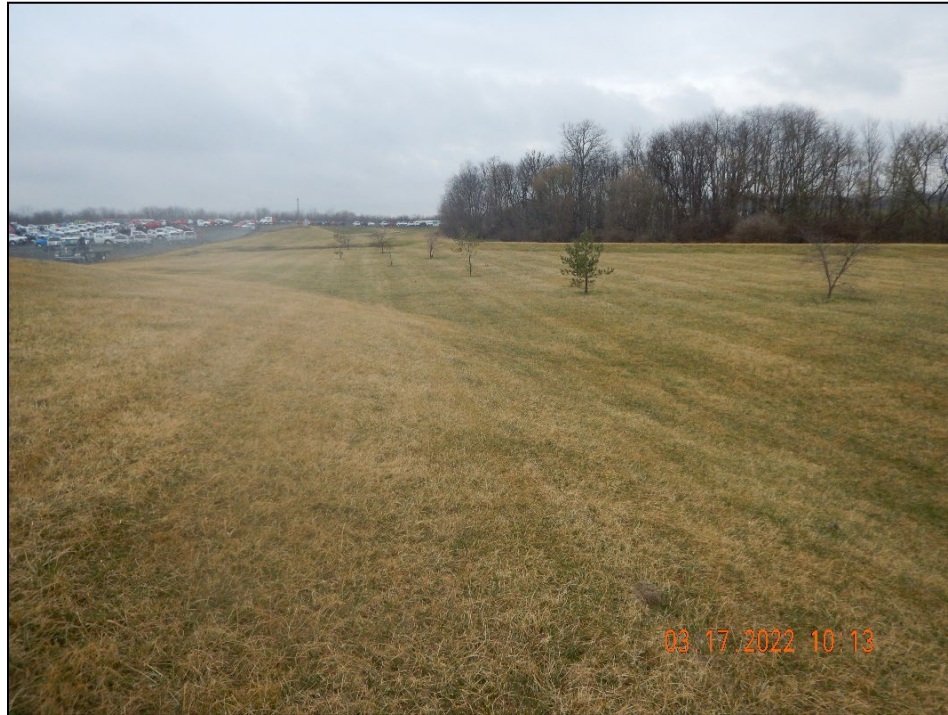
- 1) The first stormwater basin appeared well maintained and lacked debris or trash (refer to Photograph 19).
- 2) The EPA Inspection Team did not observe any stormwater discharge at the outfall into an unnamed tributary to Conococheague Creek during the inspection (refer to Photographs 20 through 22). Township representatives stated that the unnamed tributary experiences intermittent flow during wet weather.
- 3) The second and third stormwater basins’ overflow spillways appeared to require maintenance, specifically the removal of vegetation (refer to Photograph 23 through 29).
- 4) The Township representatives stated that the outfall discharges sheet flow from the field south of the outfall into the unnamed tributary to Conococheague Creek. The location is a point source discharge into a surface water, and therefore would potentially be considered to be an outfall.

**Photograph 19. Vehicle Facility Yard:** (DSCN3669.JPG) View, facing west, of the first post-construction stormwater basin. The basin is owned and maintained by the owners of the private vehicle facility south of the basin.

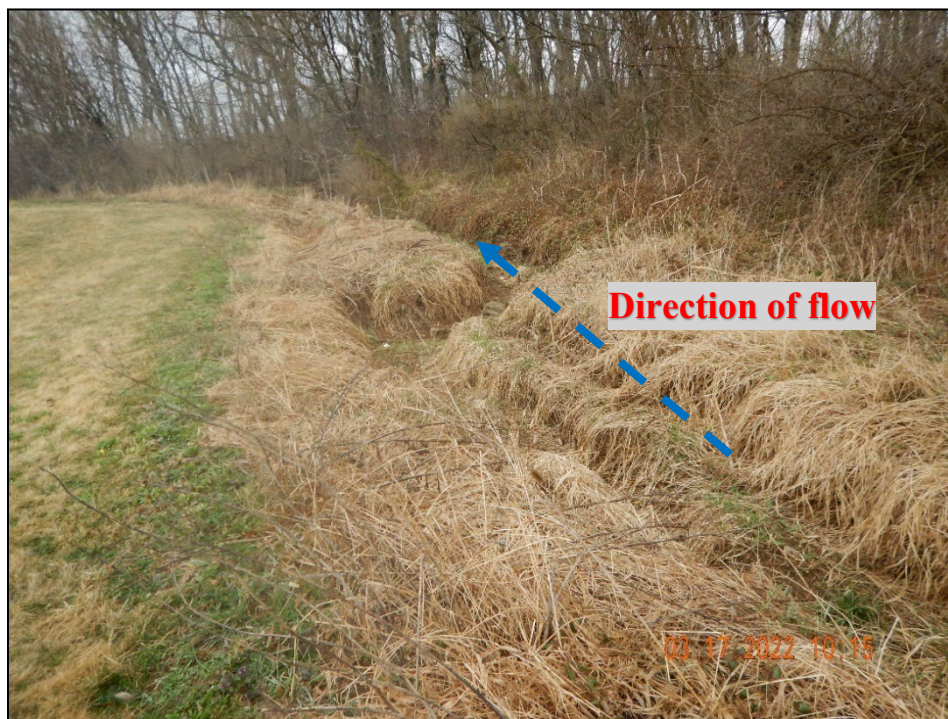
**Photograph 20. Vehicle Facility Yard:** (DSCN3670.JPG) View, facing west, downstream of the outfall near the vehicle facility.

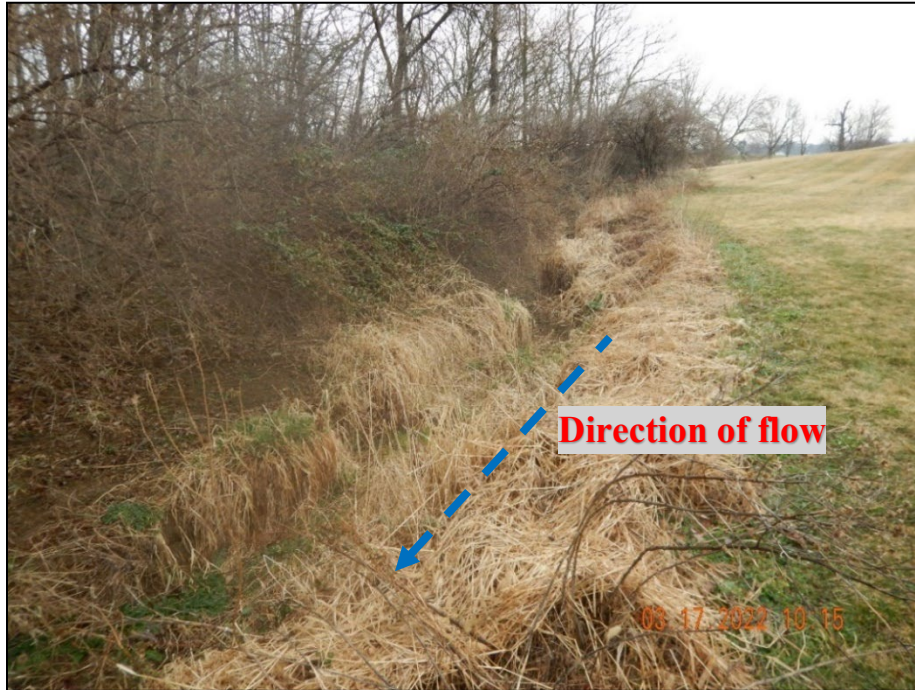
**Photograph 21. Vehicle Facility Yard:** (DSCN3671.JPG) View, facing east, upstream of the outfall near the vehicle facility. Stormwater flows north to south in the unnamed tributary to Conococheague Creek.

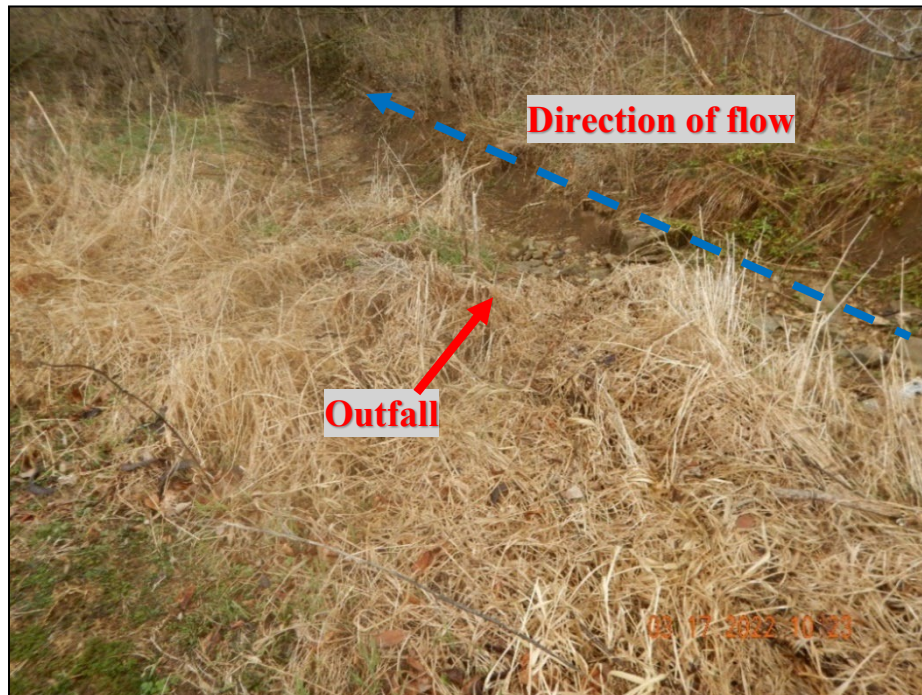
**Photograph 22. Vehicle Facility Yard:** (DSCN3673.JPG) View, facing north, of the approximate location for the outfall by the vehicle facility. Stormwater discharges to the unnamed tributary to Conococheague Creek.

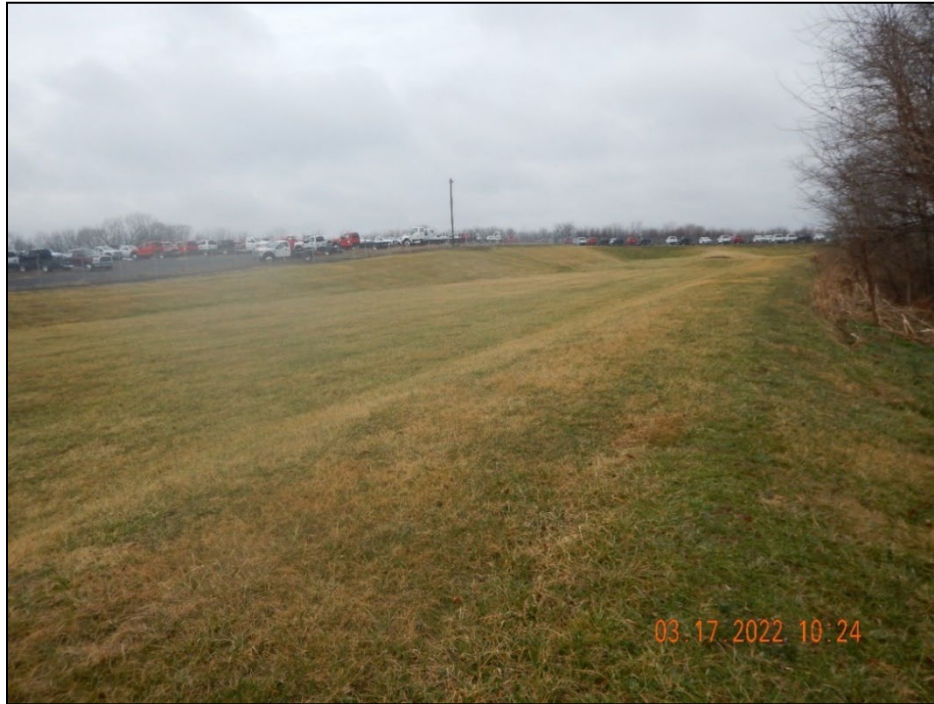
**Photograph 23. Vehicle Facility Yard:** (DSCN3675.JPG) View, facing west, of the second stormwater basin.

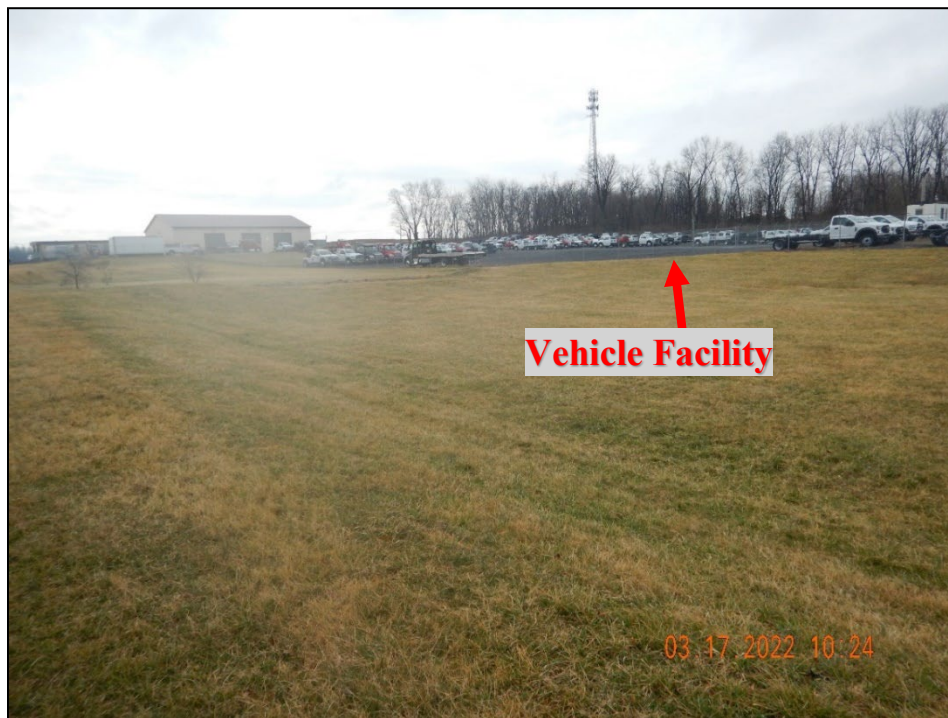
**Photograph 24. Vehicle Facility Yard:** (DSCN3675.JPG) View, facing southeast, of the second stormwater basin. The vehicle facility that owns the stormwater basins is located adjacent to the stormwater basins.

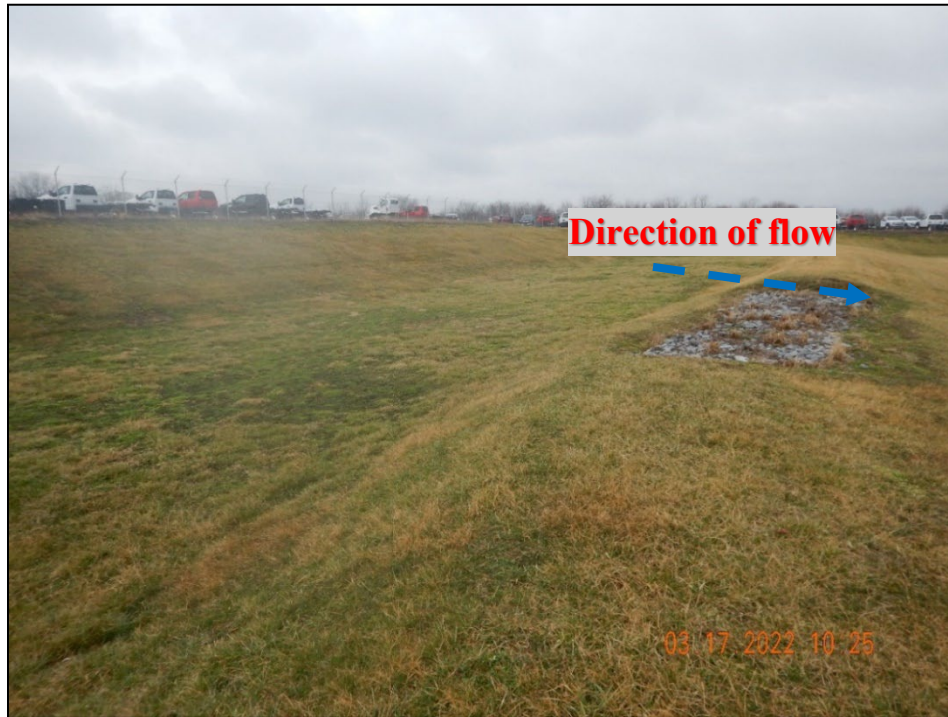
**Photograph 25. Vehicle Facility Yard:** (DSCN3677.JPG) View, facing northwest, of the second stormwater basin.

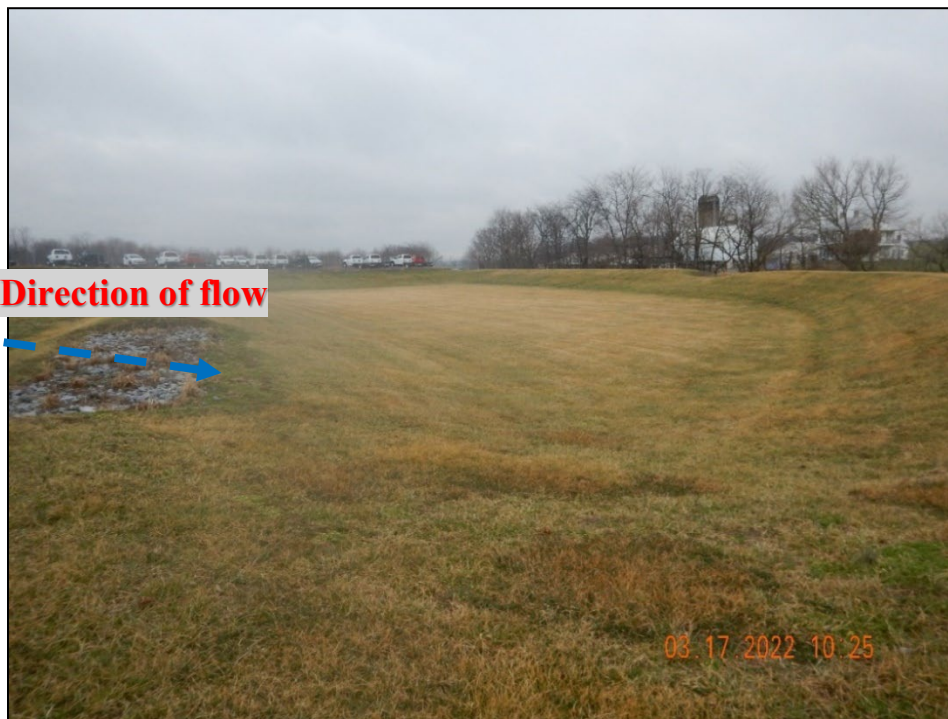
**Photograph 26. Vehicle Facility Yard:** (DSCN3678.JPG) View, facing northwest, of the third stormwater basin. The third stormwater basin would receive stormwater overflow from the second stormwater basin in the event of extreme rainfall.

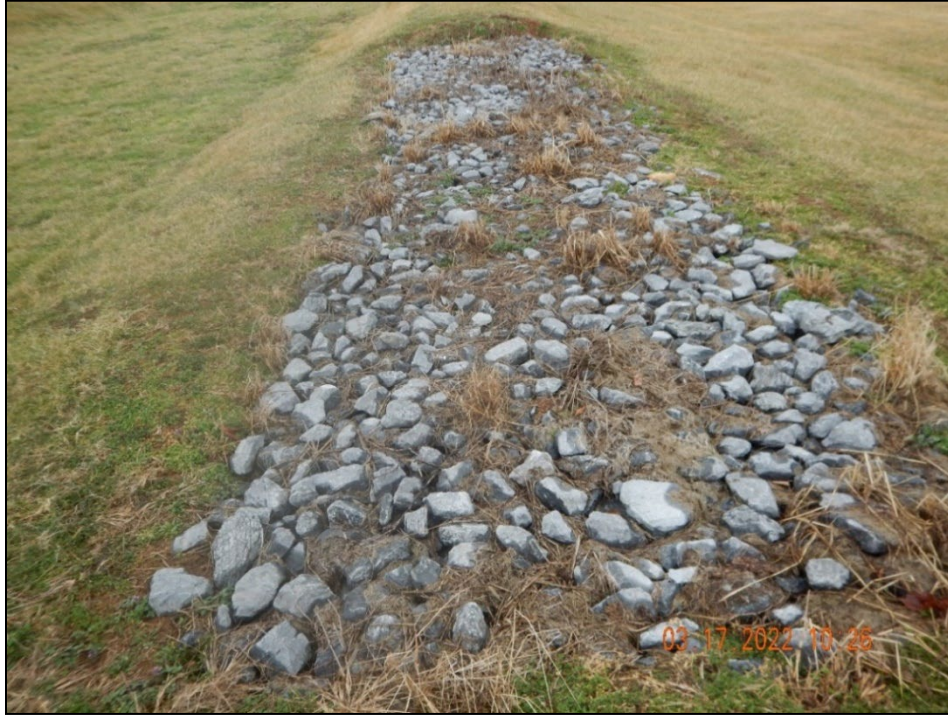
**Photograph 27. Vehicle Facility Yard: (DSCN3680.JPG)** View of the overflow spillway from stormwater basin 2 into stormwater basin 3.

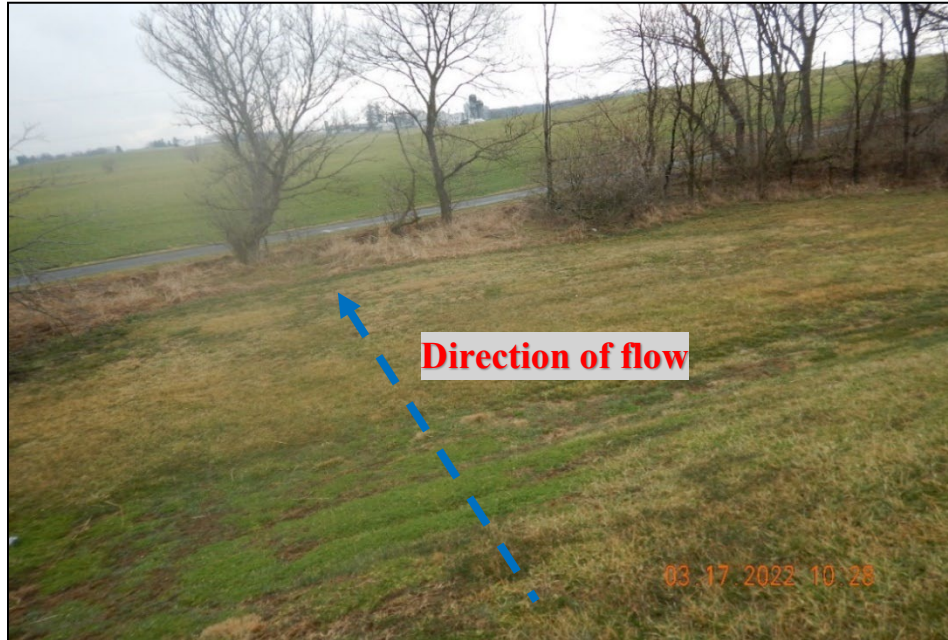
**Photograph 29. Vehicle Facility Yard:** (DSCN3683.JPG) View, facing north, of the area receiving stormwater discharge to an unnamed tributary to Conococheague Creek from stormwater basin 3. No flow was observed at the time of the inspection. If stormwater overflow were to occur, flow would be discharged to the unnamed tributary to the Conococheague Creek.

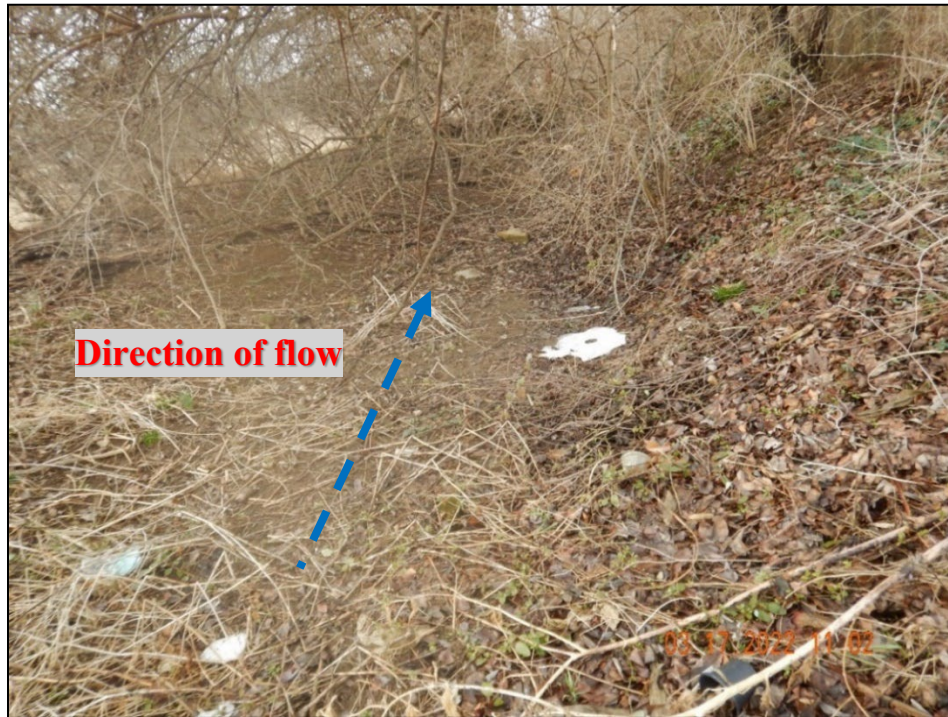
- 1) Stormwater flow was not observed at the outfalls at the time of the inspection (refer to Photographs 32 through 35). Runoff from neighboring private properties' yards contribute to Paddy Run upgradient of the outfalls. Paddy Run's channel is maintained by the owners of the adjacent private properties. Vegetation was growing inside the channel. The Township representatives stated that the Township did not have a formal agreement with the owners to maintain the channels.
- 2) Outfall #0245 appeared to be in good condition and was free of sediment and debris. Sediment and debris were observed at Outfall #0240 (refer to Photograph 33). Township representatives stated that the road crew is responsible for cleaning out the culvert that connects Outfalls #0245 and #0240. Township representatives did not specify the frequency in which the culvert is serviced.

**Photograph 35. Outfalls #0240 & #0245 Jason Drive:** (DSCN3704.JPG) View, facing south, downgradient of Outfall #0240 of Paddy Run.

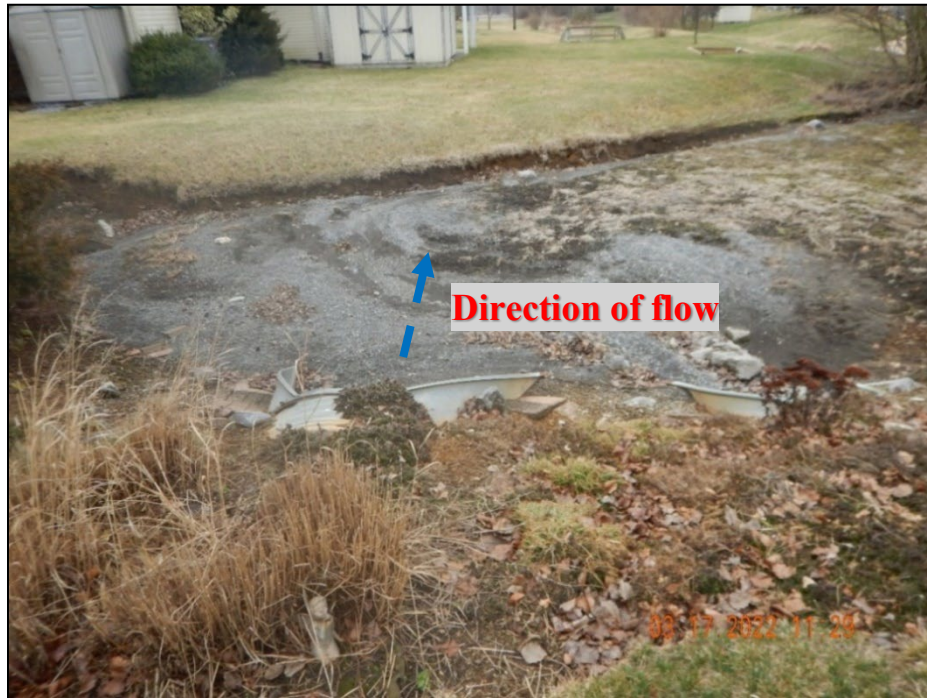
- 1) The storm drain Outfall #0250 appeared to be in good condition and did not have debris or trash (refer to Photograph 38).
- 2) The inlets in the stormwater basin that receives discharge from Outfall #0250 were free of sediment, debris, and trash (refer to Photograph 39 and 40).
- 3) All stormwater basins did not appear to connect to waters of the U.S. and therefore this “outfall” location would potentially not qualify as an outfall.

**Photograph 39. Outfall #0250 Nicole Drive: (DSCN3714.JPG)** View, facing south, of the stormwater basin to which Outfall #0250 discharges (owned and operated by PennDOT).

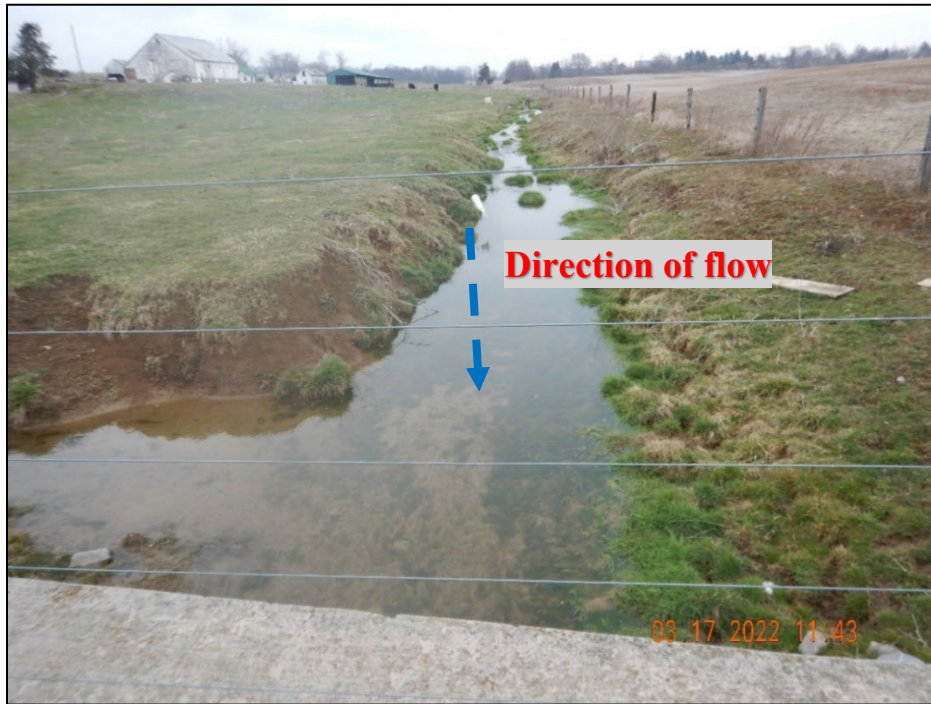
- 1) Outfall #0130 appeared to be free of sediment and debris (refer to Photographs 41 and 42). The outfall discharges into an unnamed tributary to Conococheague Creek.

**Photograph 41. Outfall #0130 East Weaver Road:** (DSCN3720.JPG) View, facing north, upstream of Outfall #0130 to the unnamed tributary to Conococheague Creek.

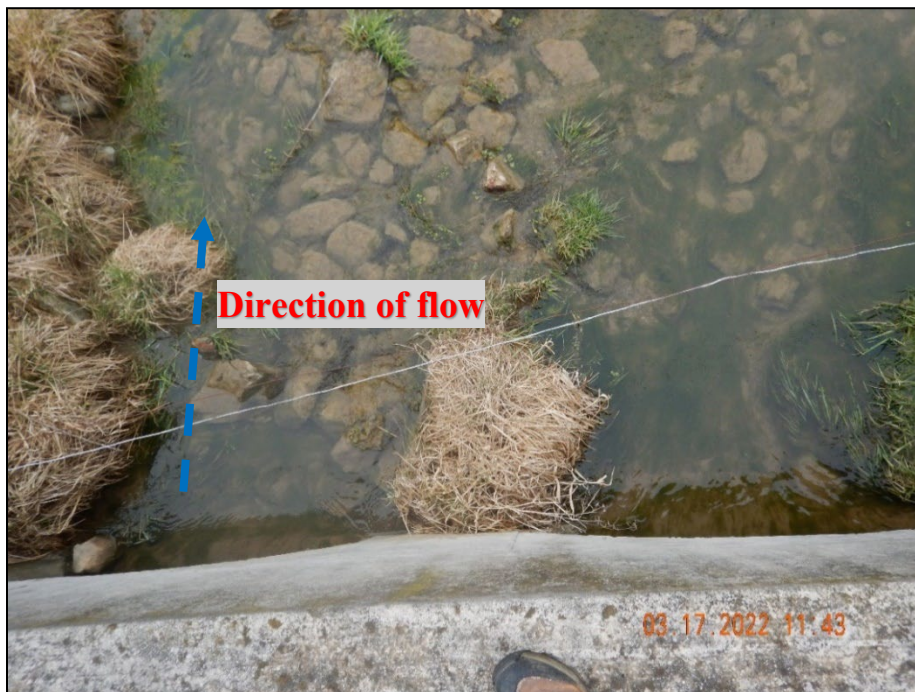
**Photograph 42. Outfall #0130 East Weaver Road:** (DSCN3723.JPG) View, facing south, downstream of Outfall #0130. The outfall discharges runoff to the unnamed tributary to Conococheague Creek.
