INSPECTION REPORT

<b>Inspection Date(s):</b>	05/10/2022	Announced: No
<b>Time:</b>	Entry: 08:25 AM (ET)	Exit: 11:14 AM (ET)
<b>Media:</b>	Water	
<b>Statute(s)/Program(s):</b>	Clean Water Act, NPDES, WWTP	
<b>Type of inspection:</b>	CEI - Compliance Evaluation Inspection	
<b>Access:</b>	Granted	
<b>Permittee Name:</b> Village of Mt. Orab		
<b>Facility or Site Name:</b> Mt. Orab WWTP		
<b>Facility/Site Physical Address:</b> 12943 US Route 68		
<b>(City, state, zip code)</b> Mt. Orab, OH 45154		
<b>County/Parish:</b> Brown County		
<b>Facility GPS Coordinates:</b> 38.993133, -83.921373		
<b>Mailing address:</b>		
<b>(If different)</b>		
<b>(City, state, zip code)</b>		
<b>Facility/Site Identifier:</b> Mt. Orab WWTP		
<b>Permit Number:</b> OH0026646		
<b>SIC or NAICS:</b> 4952

## SECTION I – INTRODUCTION

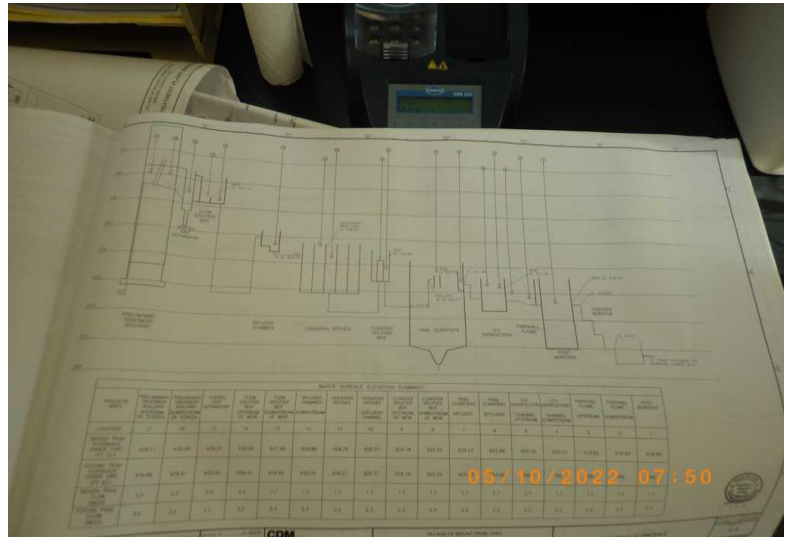
WWTP schematic  
 RIMG2658.JPG  
 05/10/2022 08:50 AM (ET)  
 Andi Hodaj  
 [Unit/Area]  
 No CBI  
 No PII  
 Schematic of the wastewater treatment plant.

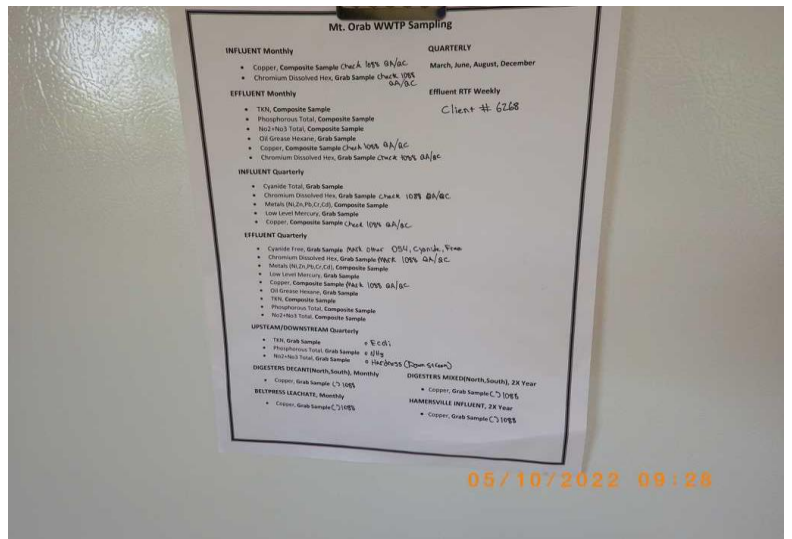
List of pollutants that MASI analyzes  
 RIMG2680.JPG  
 05/10/2022 10:28 AM (ET)  
 Andi Hodaj  
 [Unit/Area]  
 No CBI  
 No PII

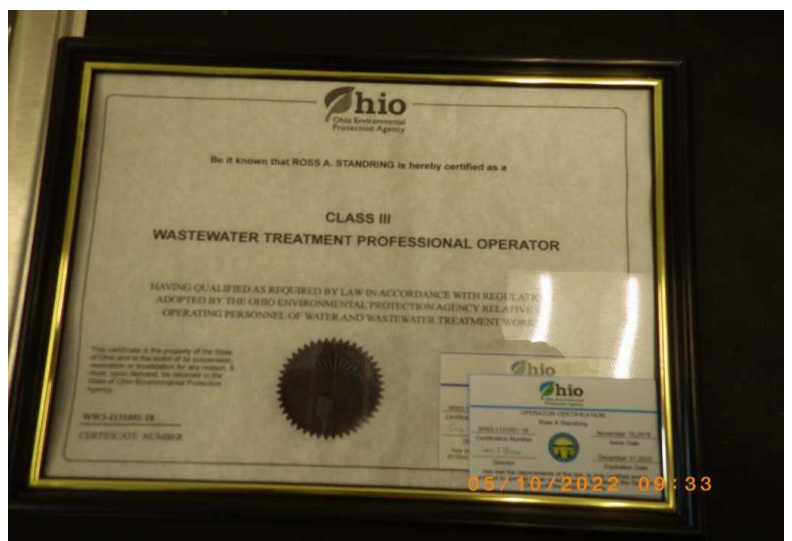
Certificate of operator  
 RIMG2681.JPG  
 05/10/2022 10:33 AM (ET)  
 Andi Hodaj  
 [Unit/Area]  
 No CBI  
 No PII  
 Class III operator certificate for Mr. Standing.

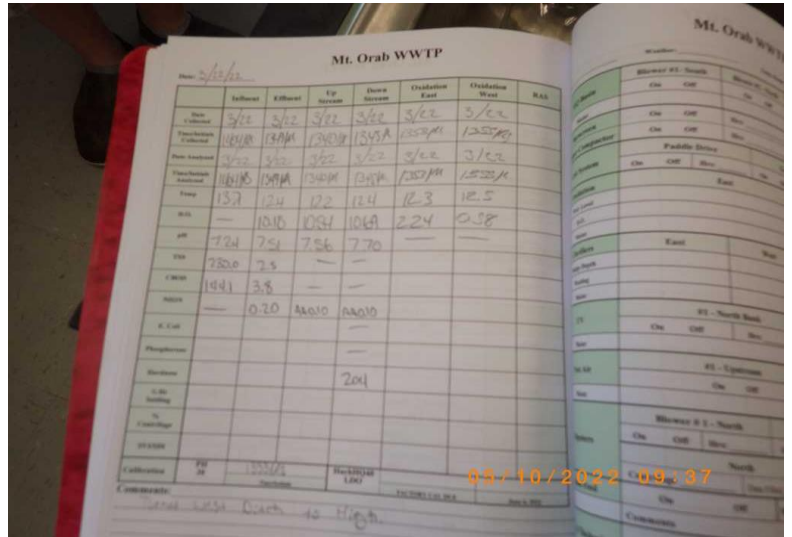
Log of measurements  
 RIMG2682.JPG  
 05/10/2022 10:37 AM (ET)  
 Andi Hodaj  
 [Unit/Area]  
 No CBI  
 No PII  
 Logbook of pollutant measurements for pollutants that are measured in the in-house lab.

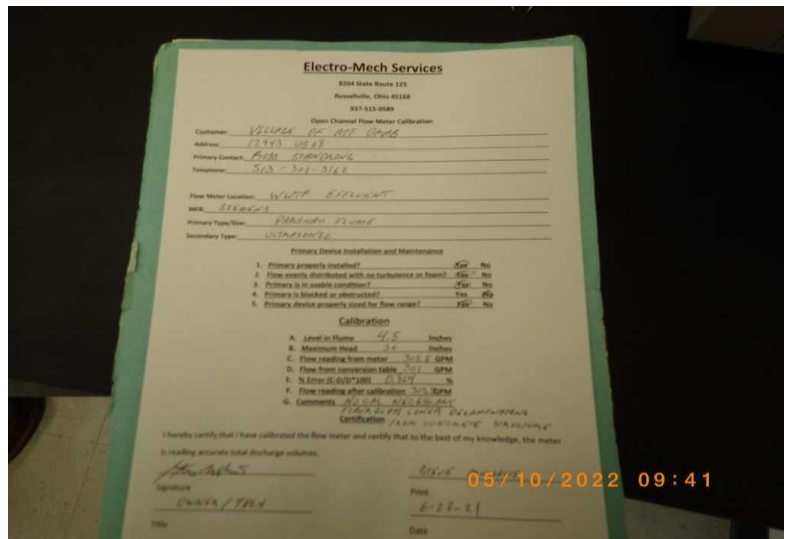
Flow meter calibration  
 RIMG2683.JPG  
 05/10/2022 10:41 AM (ET)  
 Andi Hodaj  
 [Unit/Area]  
 No CBI  
 No PII  
 Record of flow meter calibrations.

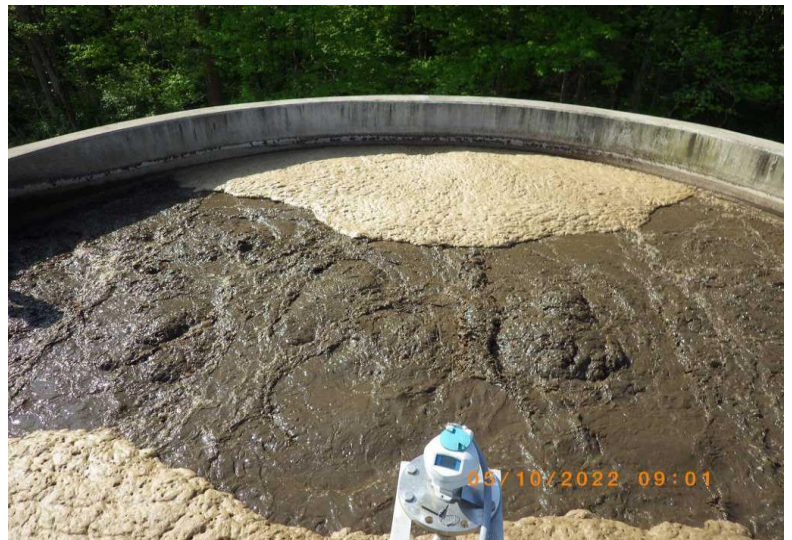
Digester  
 RIMG2678.JPG  
 05/10/2022 10:01 AM (ET)  
 Andi Hodaj  
 Digesters  
 No CBI  
 No PII  
 The south aerobic digester. Camera looking south.

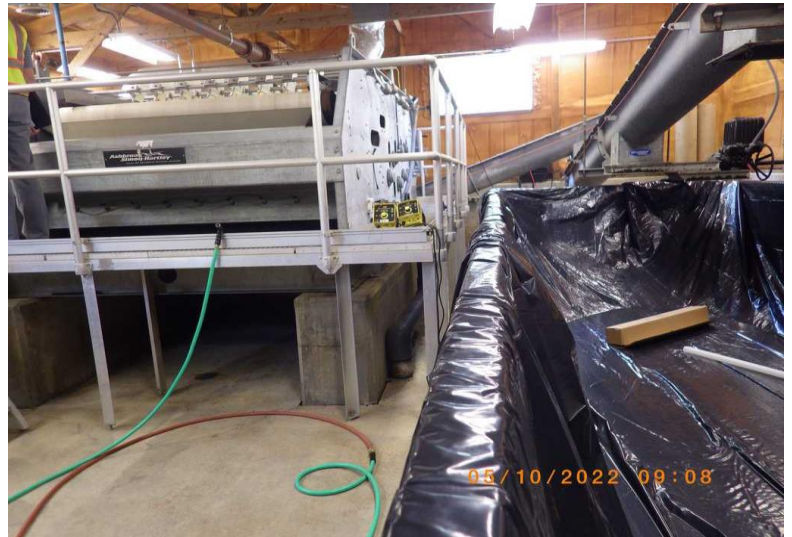
Belt press
RIMG2679.JPG
05/10/2022 10:08 AM (ET)
Andi Hodaj
Digesters
No CBI
No PII
Belt press and dumpster. Camera looking southwest.

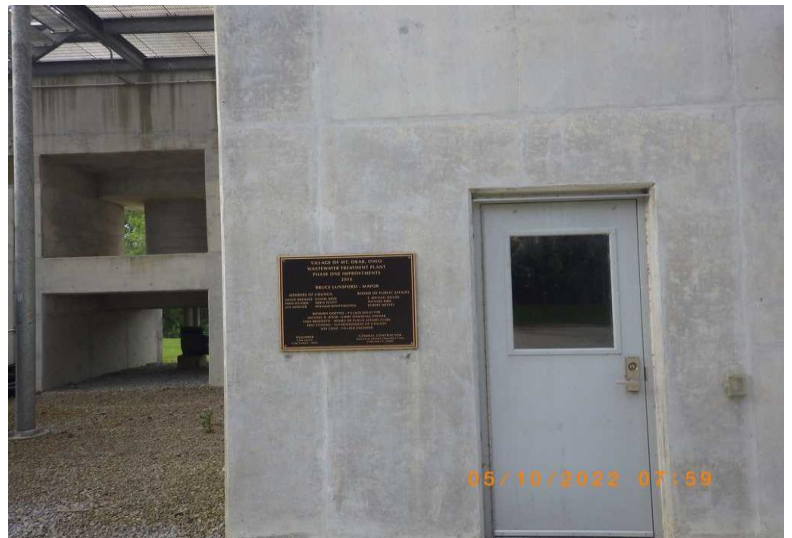
Pretreatment building
RIMG2659.JPG
05/10/2022 08:59 AM (ET)
Andi Hodaj
Pretreatment
No CBI
No PII
Pretreatment building was built in 2016.

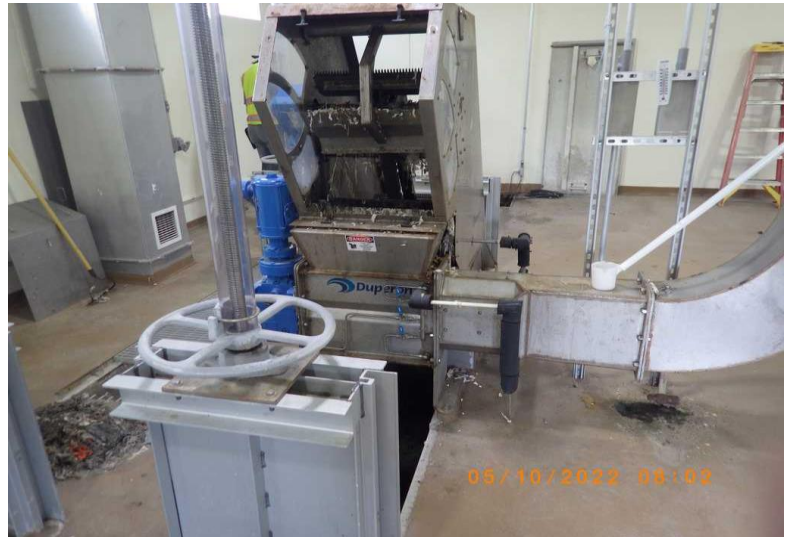
Influent channel  
 RIMG2660.JPG  
 05/10/2022 09:02 AM (ET)  
 Andi Hodaj  
 Pretreatment  
 No CBI  
 No PII  
 Influent channel and bar screen inside the pretreatment building.

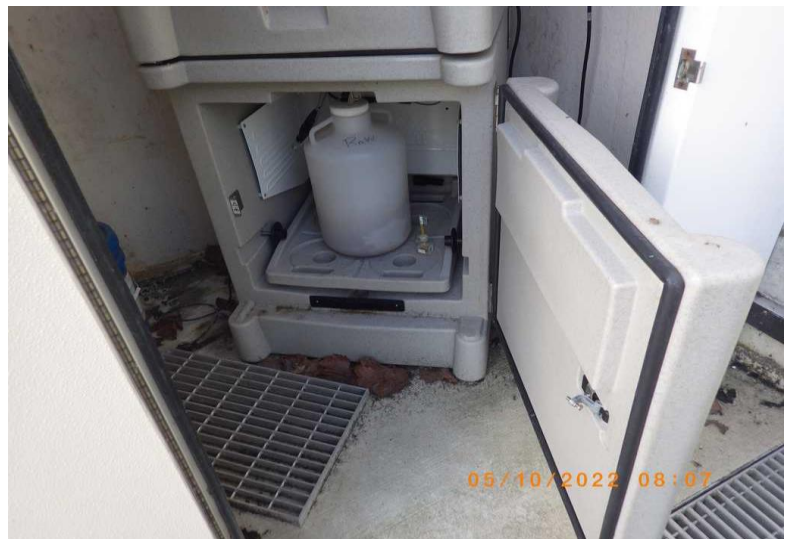
Influent autosampler  
 RIMG2661.JPG  
 05/10/2022 09:07 AM (ET)  
 Andi Hodaj  
 Pretreatment  
 No CBI  
 No PII  
 Influent autosampler and the thermometer inside it in the pretreatment building.

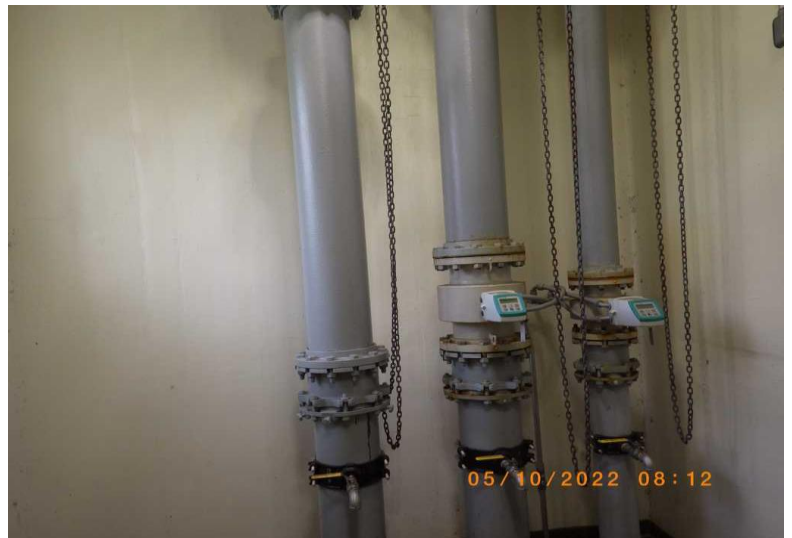
Inflow pipes  
 RIMG2662.JPG  
 05/10/2022 09:12 AM (ET)  
 Andi Hodaj  
 Pretreatment  
 No CBI  
 No PII  
 Inflow pipes, from left to right: for future expansion, from Mt. Orab and from Hamersville.

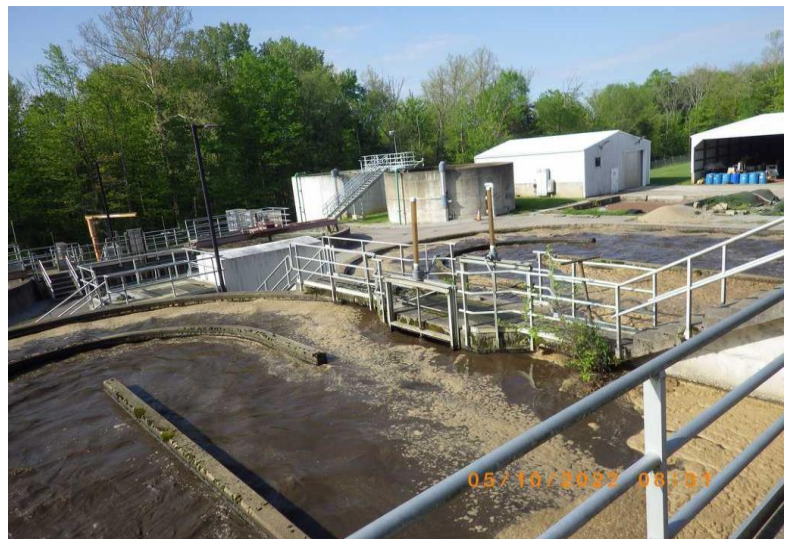
Oxidation ditches
RIMG2664.JPG
05/10/2022 09:31 AM (ET)
Andi Hodaj
Secondary treatment
No CBI
No PII
Oxidation ditches. Camera looking southwest.

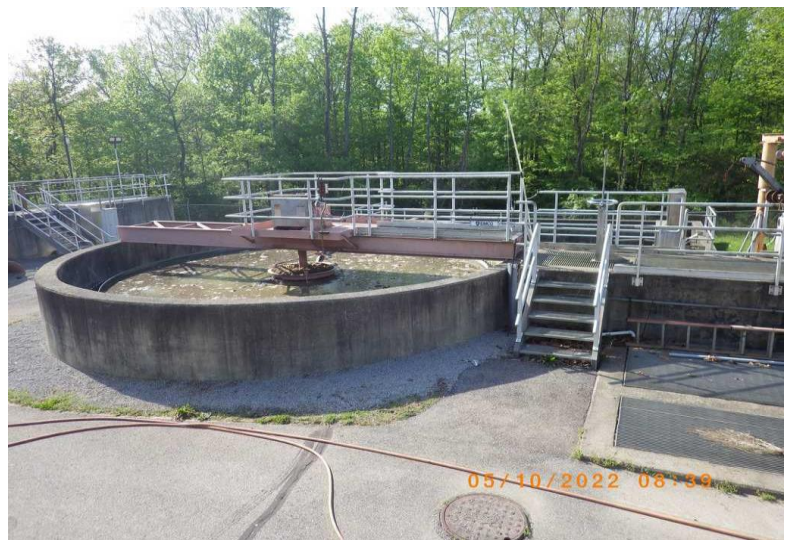
Clarifier
RIMG2667.JPG
05/10/2022 09:39 AM (ET)
Andi Hodaj
Secondary treatment
No CBI
No PII
One of the three clarifiers. Camera looking Southeast.

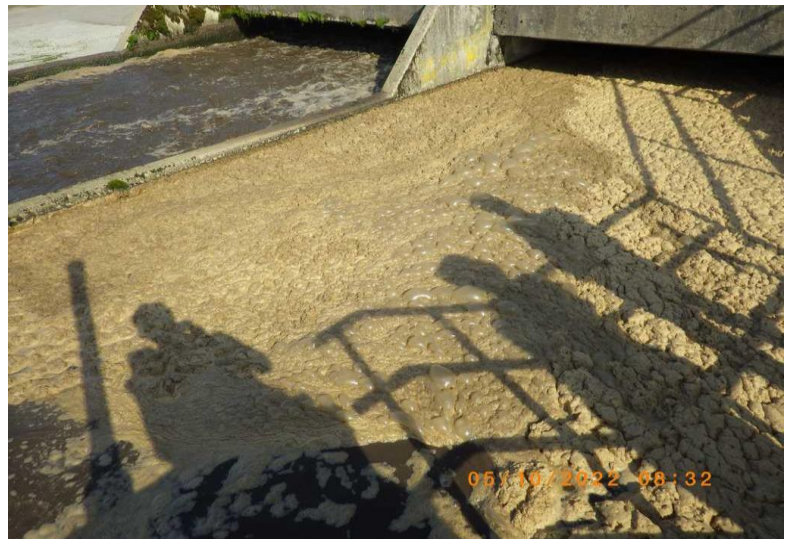
Oxidation ditch
RIMG2665.JPG
05/10/2022 09:32 AM (ET)
Andi Hodaj
Secondary treatment
No CBI
No PII
The west oxidation ditch. Camera looking northwest.

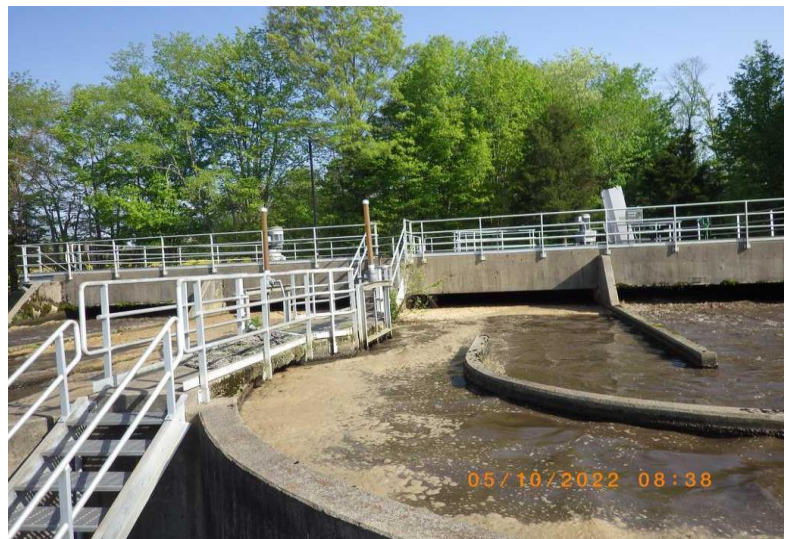
Oxidation ditches
RIMG2666.JPG
05/10/2022 09:38 AM (ET)
Andi Hodaj
Secondary treatment
No CBI
No PII
Oxidation ditches. Camera looking north.

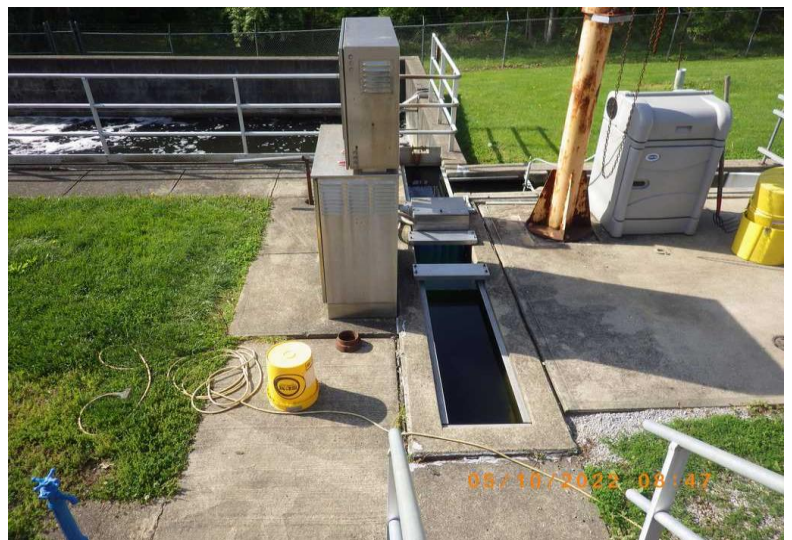
UV disinfection
RIMG2671.JPG
05/10/2022 09:47 AM (ET)
Andi Hodaj
Secondary treatment
No CBI
No PII
UV disinfection channel. Camera looking south.

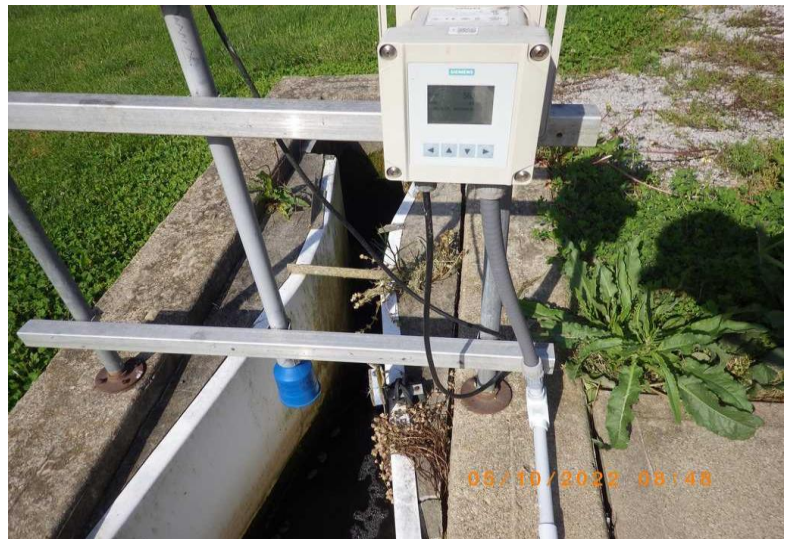
Flow meter
RIMG2672.JPG
05/10/2022 09:48 AM (ET)
Andi Hodaj
Secondary treatment
No CBI
No PII
Effluent flow meter. Camera looking south.

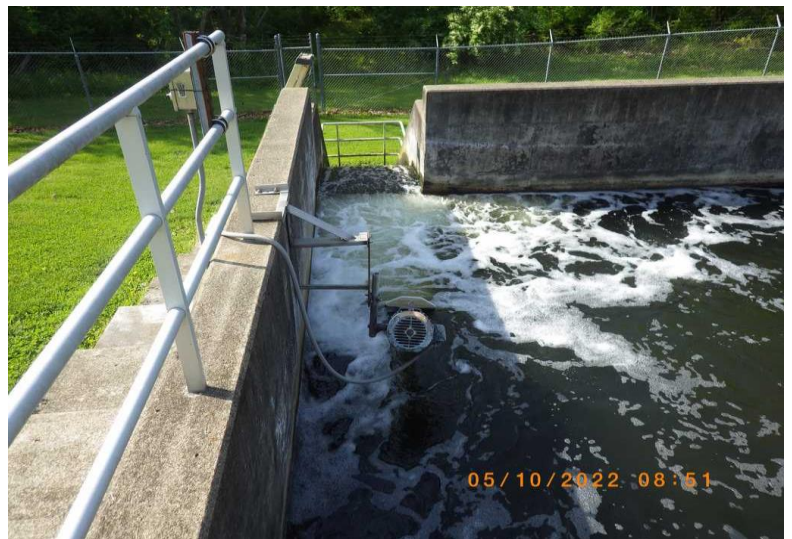
Post aeration tank
RIMG2673.JPG
05/10/2022 09:51 AM (ET)
Andi Hodaj
Secondary treatment
No CBI
No PII
Post aeration tank and the top of the cascade aerator. Camera looking southwest.

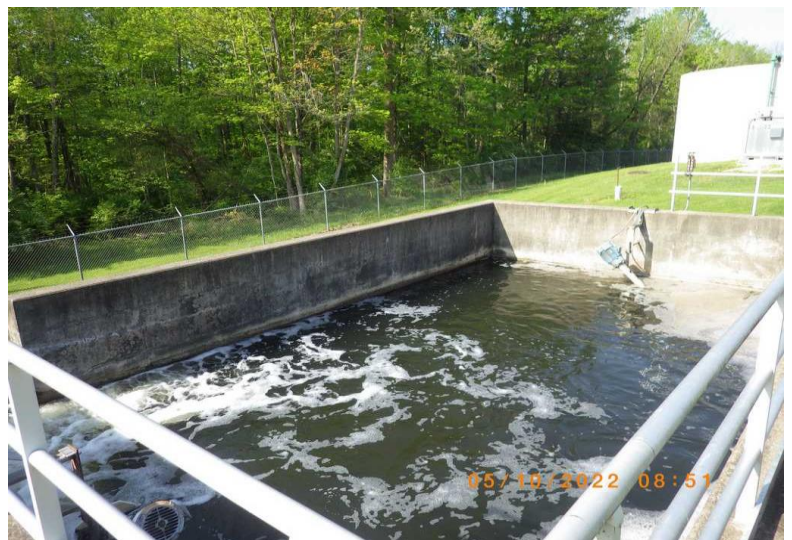
Post aeration tank
RIMG2674.JPG
05/10/2022 09:51 AM (ET)
Andi Hodaj
Secondary treatment
No CBI
No PII
Post aeration tank. Camera looking southwest.

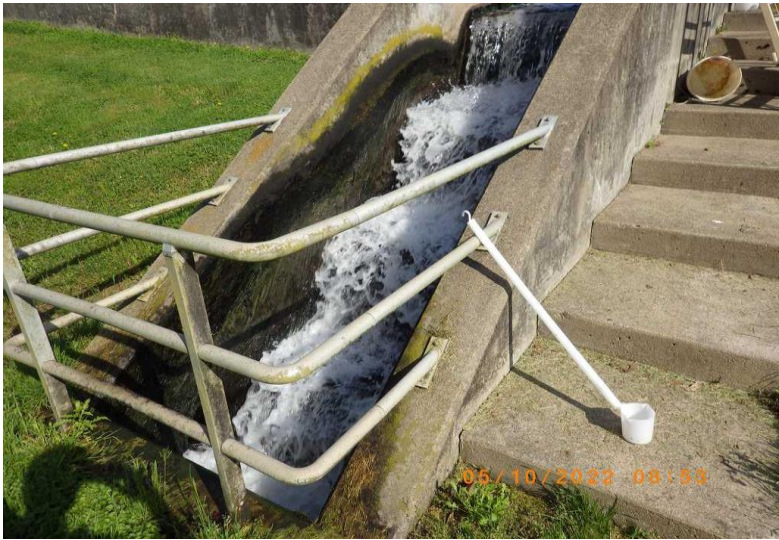
Cascade aerator

RIMG2675.JPG	
05/10/2022 09:53 AM (ET)	
Andi Hodaj	
Secondary treatment	
No CBI	
No PII	
Cascade aerator. Camera looking northwest.	
New clarifier	 
RIMG2677.JPG	
05/10/2022 10:00 AM (ET)	
Andi Hodaj	
Secondary treatment	
No CBI	
No PII	
The clarifier built in 2008. Camera looking east.
