**CWA COMPLIANCE EVALUATION INSPECTION REPORT  
U.S. ENVIRONMENTAL PROTECTION AGENCY, REGION 5**

Quality Dairy, LLC  
N 5232 BK Line Road  
Luxemburg, Wisconsin 54217  
Kewaunee County  
44.513856937943395, -87.764180364316

**NPDES Permit Number:** WI-0059579

**Date of Inspection:** 06/05/2024

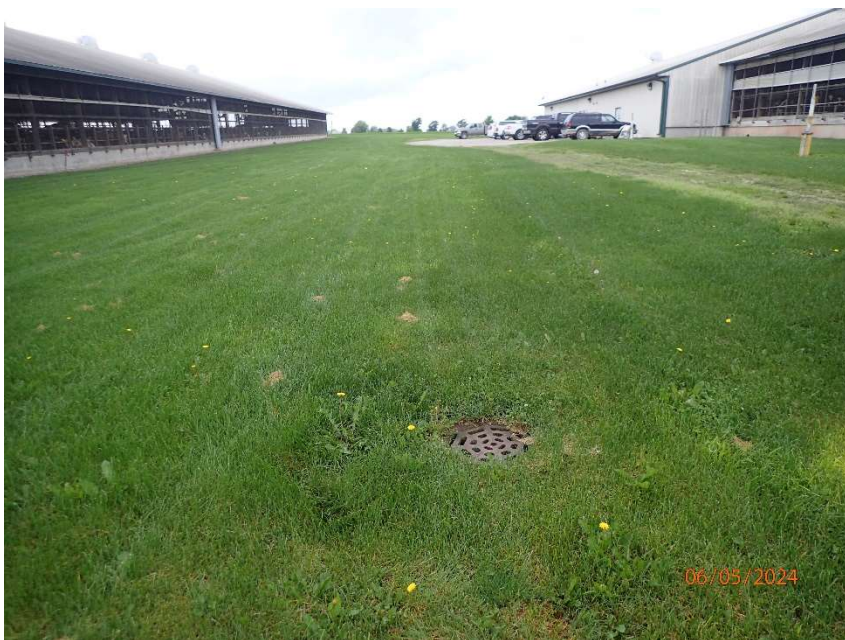
1: P6050658

The walkthrough began on the south side of the Milking Parlor. The Inspectors walked east in the grassed area north of Barn three and observed a storm water drain inlet near the east end of the grassed area (photo 1). The Inspectors then walked west along the north side of Barn 3 and across west end (photos 2 and 3). The Inspectors observed a bunker on the west end of Barn 3 with a pipe through the concrete at ground level. There were some organic solids around the west side of the bunker. No surface water flow paths were observed from the area.

Description: Storm water drain located between Barn 3 and the parlor walkway.

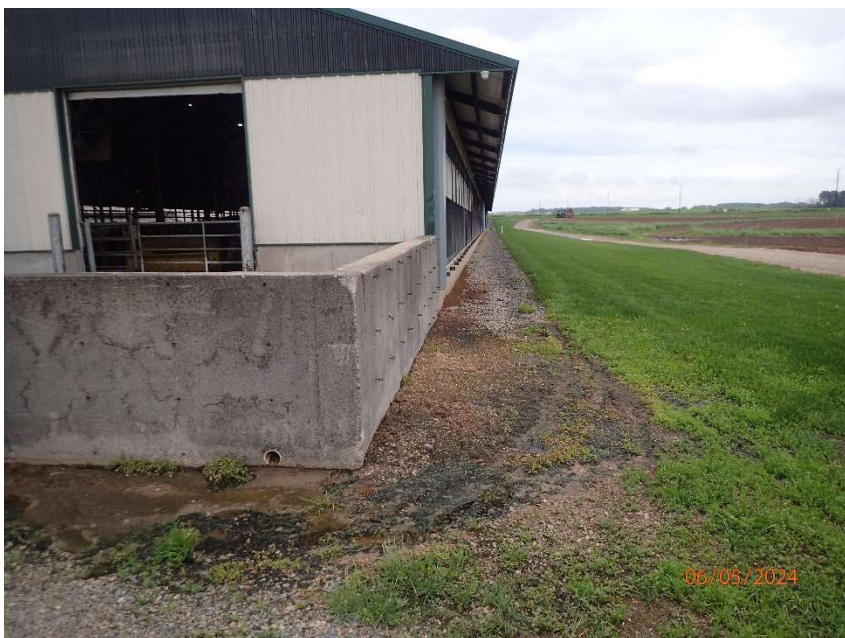
2: P6050659

Description: Looking east along the south side of Barn 3. Note the drain at the bottom of the temporary bunker.

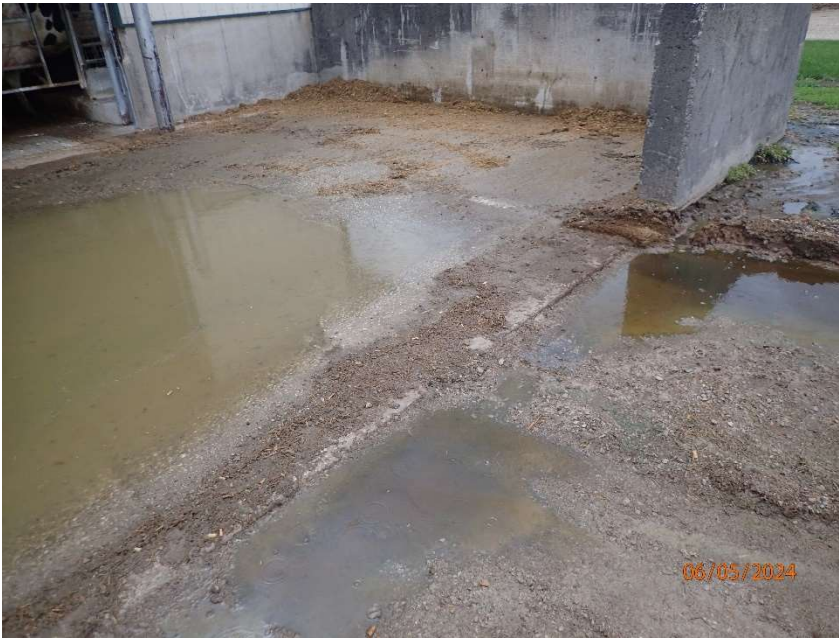
3: P6050660

Description: Looking southeast into the temporary bunker located at the southwest corner of Barn 3.

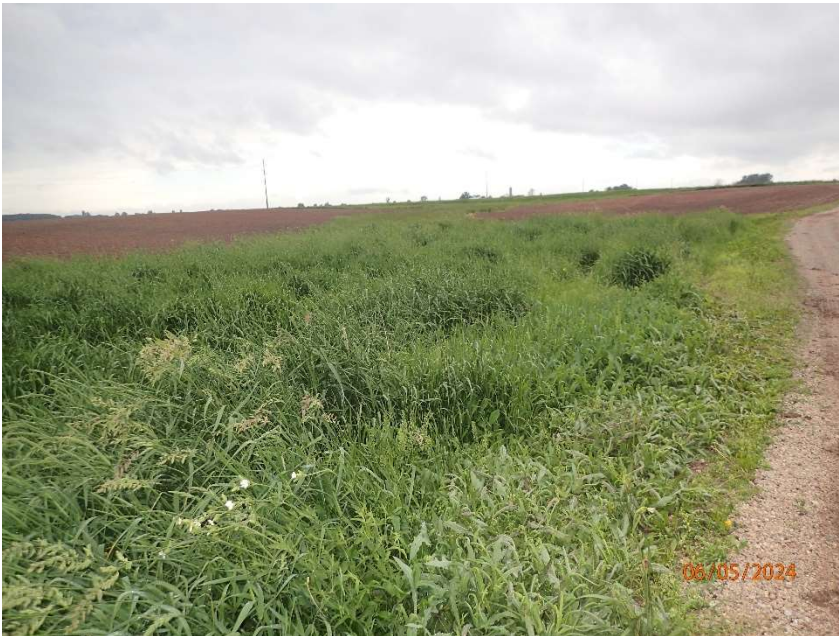
4: P6050661

The Inspectors walked east along the south side of Barn 3 and observed the two grassed waterways flowing into the culvert under the Facility from the South (photos 4-6).

Description: Looking southwest along grassed waterway that flows into culvert under the Facility.

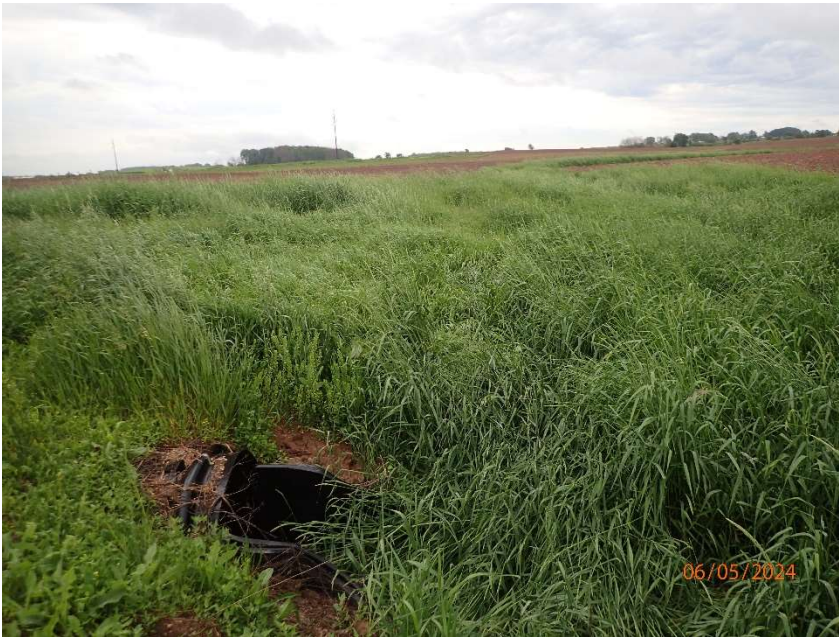
5: P6050662

Description: Looking southeast along additional grassed waterway which flows into culvert under the Facility.

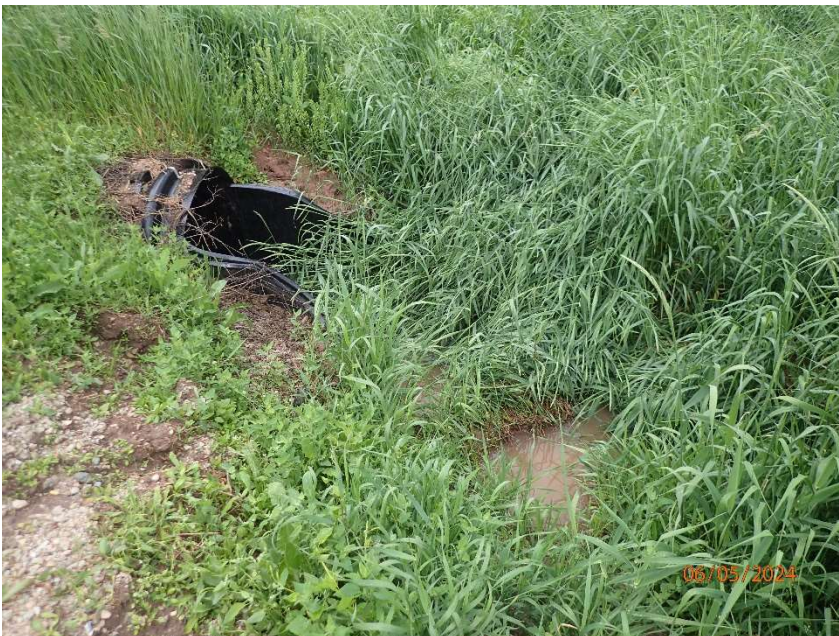
6: P6050663

Description: Looking down at the confluence of the two grassed waterways as they enter the culvert under the Facility.

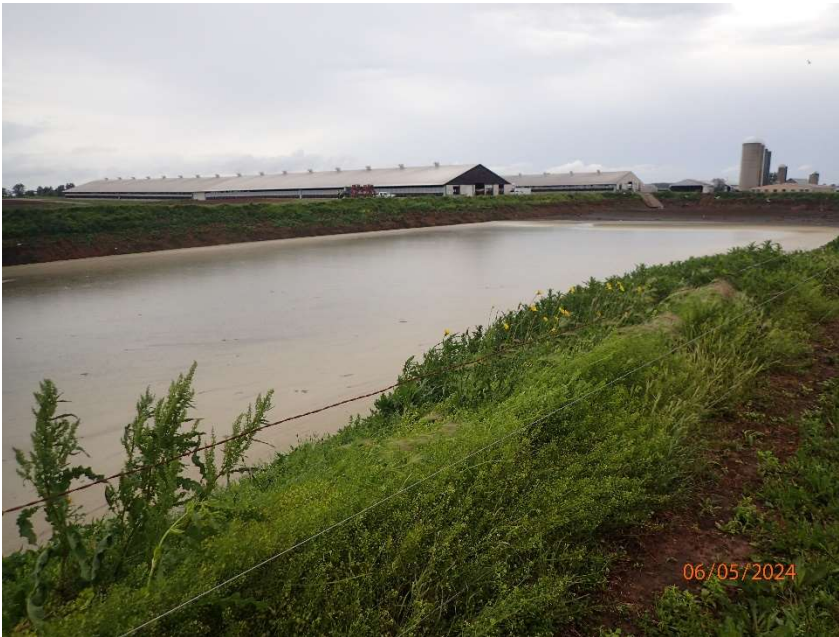
9: P6050666

Description: Looking northwest from the southeast corner of Manure Storage 2.

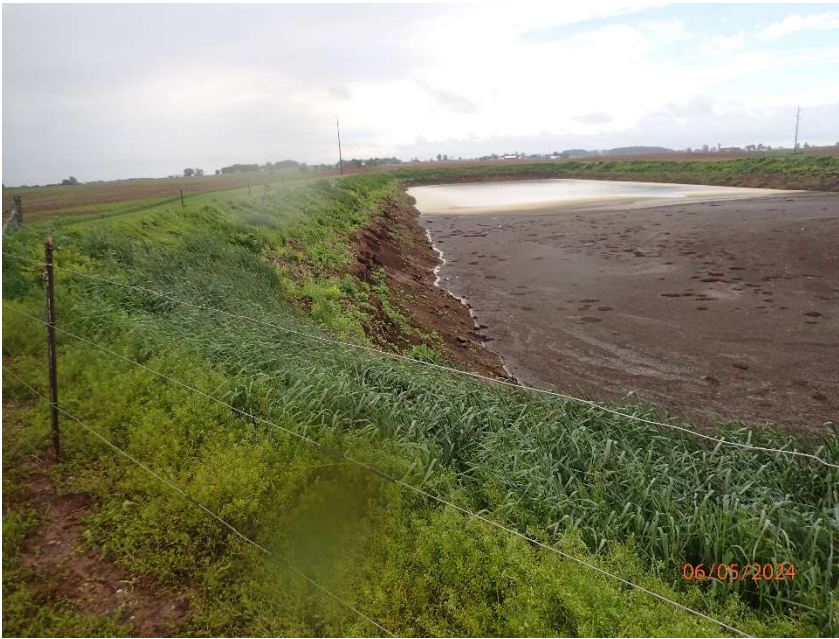
11: P6050668

Description: Looking South along the east side of Manure Storage 2.

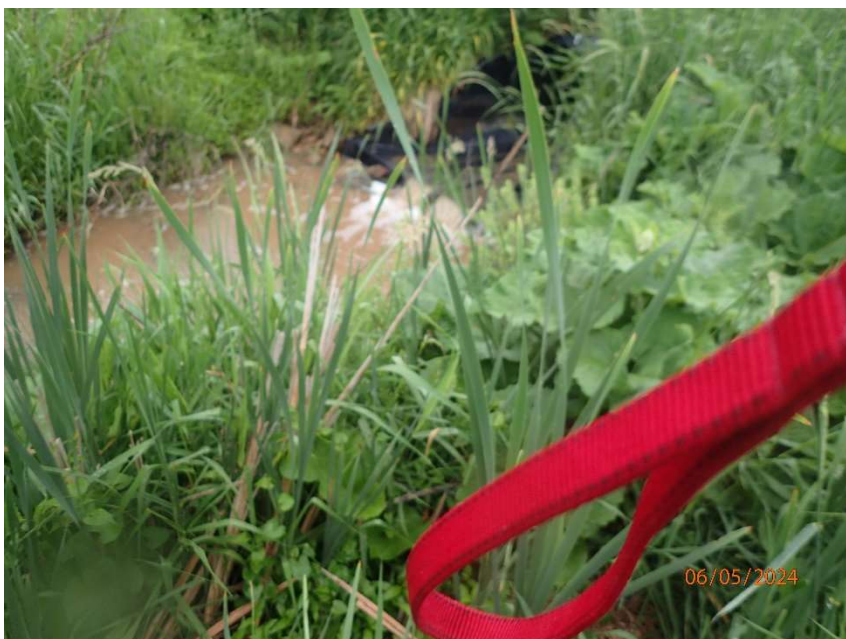
14: P6050671

The Inspectors then walked northeast to the outlet of the culvert observed previously on the south side of the Facility (photos 14-16).

Description: Outlet of culvert under the Facility from the south side.

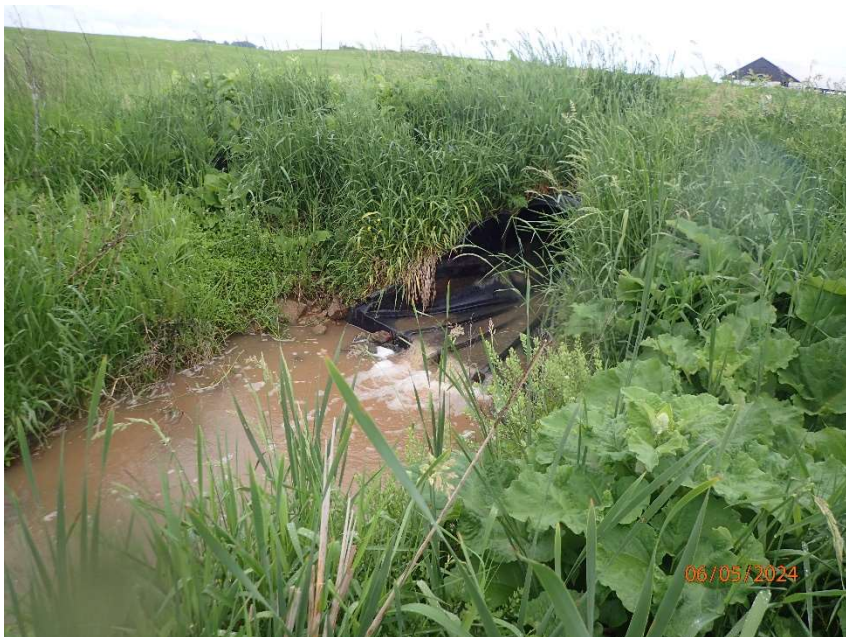
15: P6050672

Description: Outlet of culvert under the Facility from the south side.

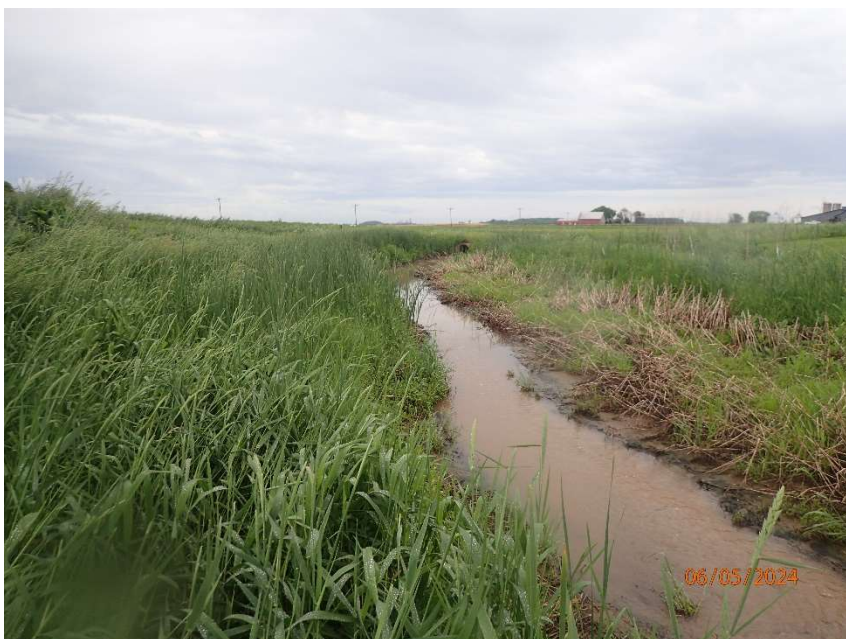
16: P6050673

Description: Downstream along waterway flowing out of culvert under the Facility.

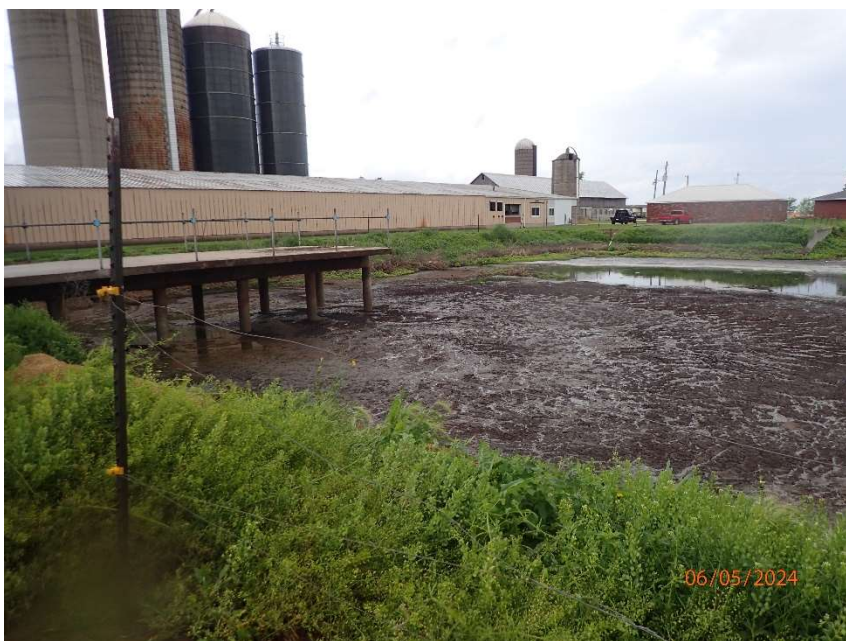
17: P6050674

The Inspectors then walked north and observed Manure Storage 1 (photos 17 - 19). The Inspectors did not observe a depth marker present in Manure Storage 1. The Inspectors

Description: Looking northwest from the south side of Manure Storage 1. The pier in Manure Storage 1 is left over from a previous manure handling system.

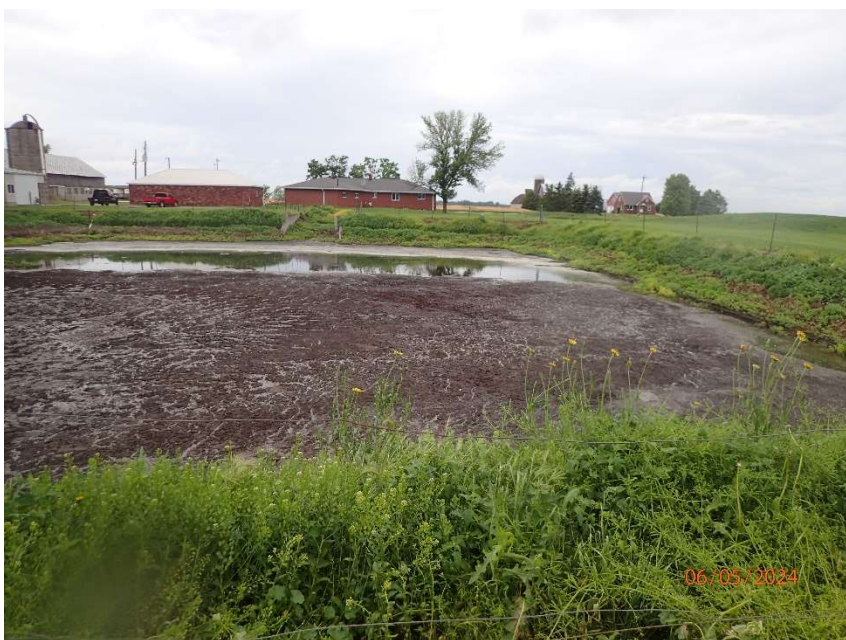
18: P6050675

Description: Looking north at Manure Storage 1.

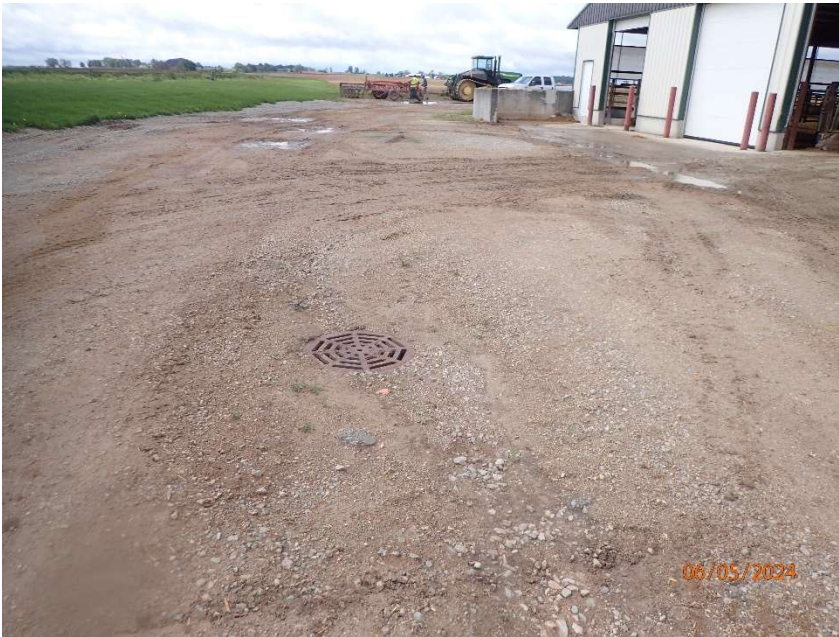
21: P6050678

The Inspectors then walked back southwest to the east end of Barn 3. The Inspectors observed a stormwater drain surface inlet in the gravel area (Photo 21). The Inspectors then walked west in the grassed area between Barn 3 and Barn 2. The Inspectors observed a stormwater drain surface inlet near the west end of the grassed area (photo 22). The Inspectors then walked east and observed the mortality staging area located at the southeast corner of Barn 2 (photos 23 and 24). The Inspectors observed and noted to the Operator that, while no runoff was observed, it appeared that there was the possibility for runoff from the mortality staging area to flow to the grassed area between Barn 2 and Barn 3 and then to the stormwater drain. The Operator stated that he would look into using a covered shed at the northeast corner of Barn 2 as a mortality staging area (photo 25).

Description: Stormwater drain inlet located at the east end of Barn 3.

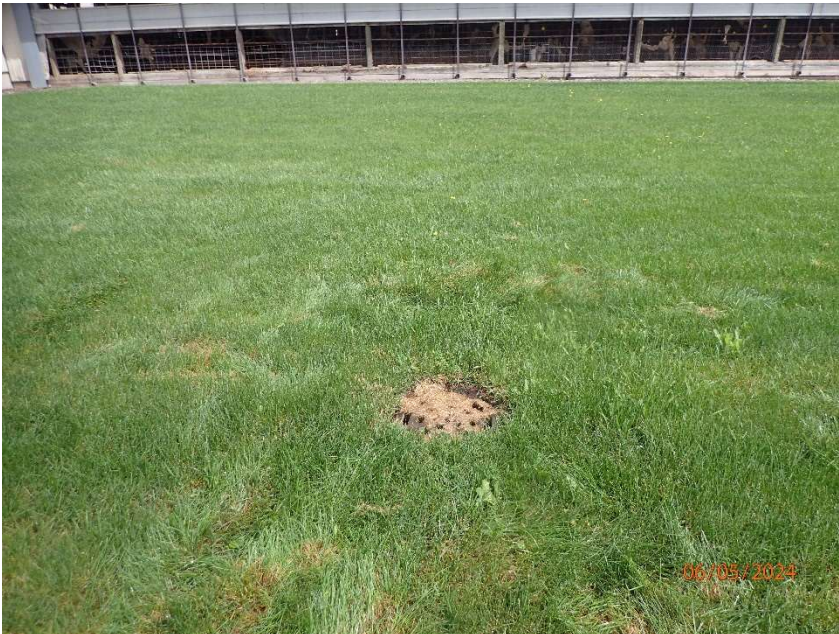
22: P6050679

Description: Stormwater drain inlet located centrally between Barn 2 and Barn 3 west of the walkway.

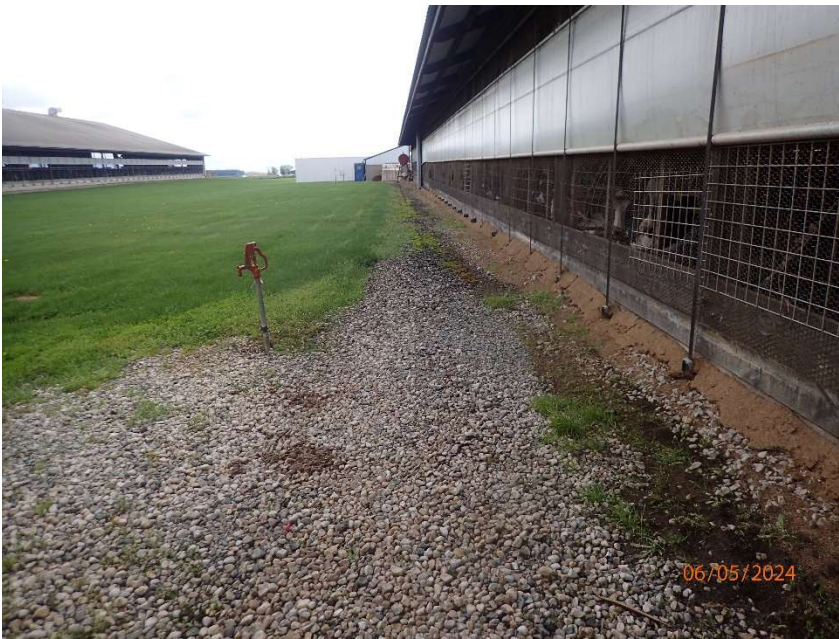
26: P6050683

The Inspectors then walked west to the west end of the grassed area between Barn 2 and Barn 1. The Inspectors observed a stormwater drain surface inlet (photos 26 and 27). The Inspectors then walked east to the east end of Barn 1 and observed series of stormwater drain surface inlets located between the Dry Cow Barn and the Commodity Building (photos 28-31).

Description: Looking east along the north side of Barn 2.

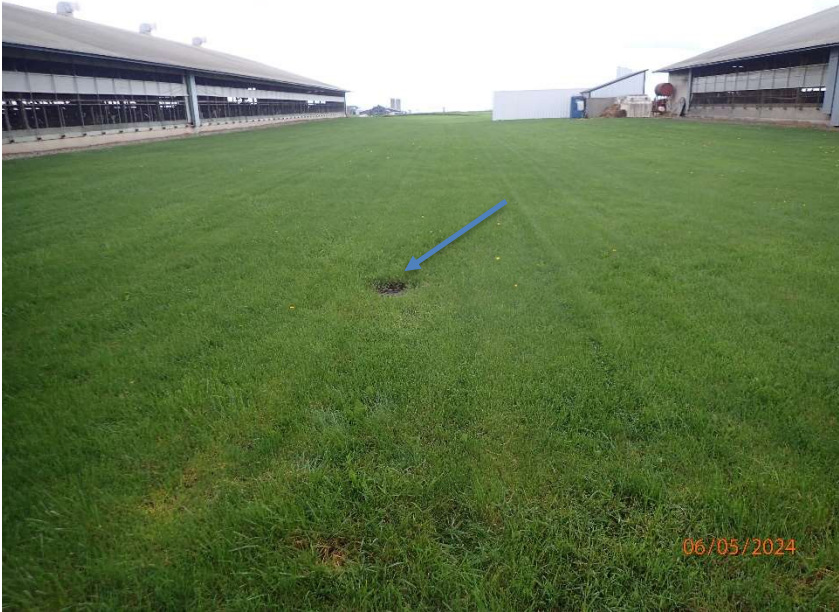
27: P6050684

Description: Looking east across grassed area between Barn 2 (right) and Barn 1 (left). Note stormwater surface drain inlet (blue arrow).

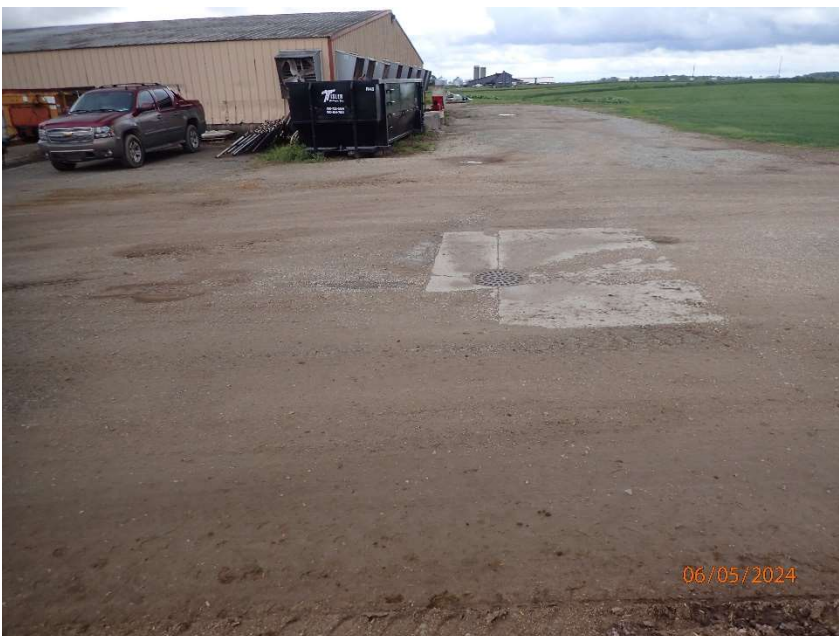
28: P6050685

Description: Stormwater surface drain inlet located in access road northeast of Barn 1.

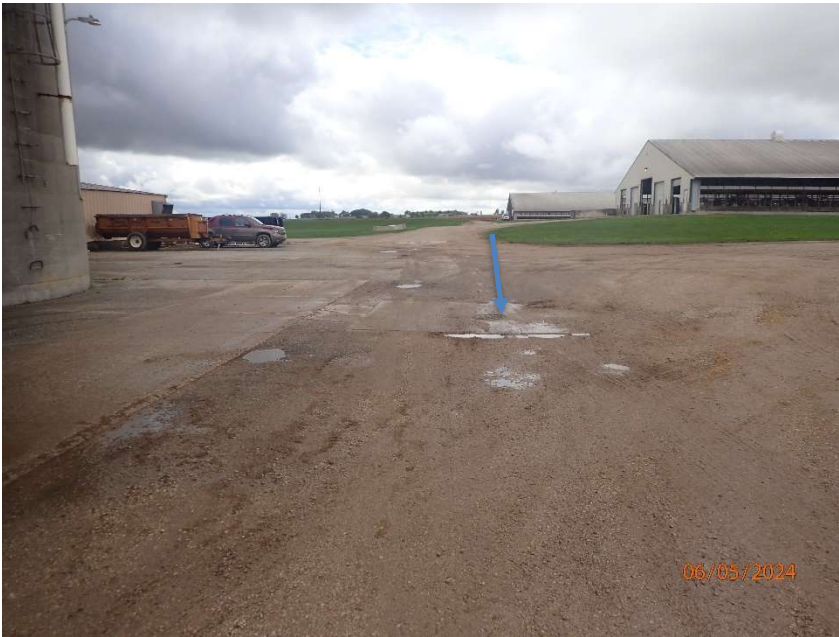
29: P6050686

Description: Stormwater surface drain inlet (blue arrow) west of dry cown barn and east of Commodity Barn.

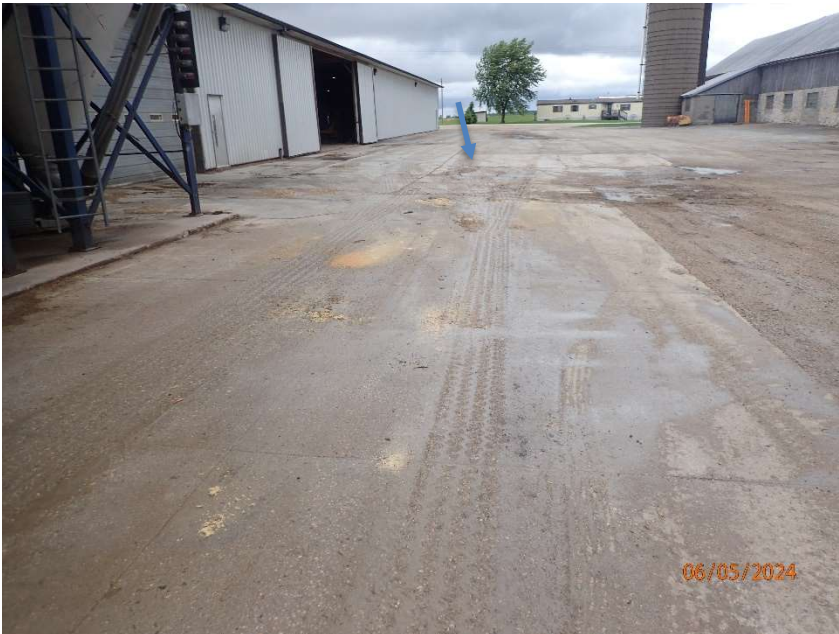
30: P6050687

Description: Looking north toward stormwater suface drain inlet (blue arrow) north of drain seen in photo 29.

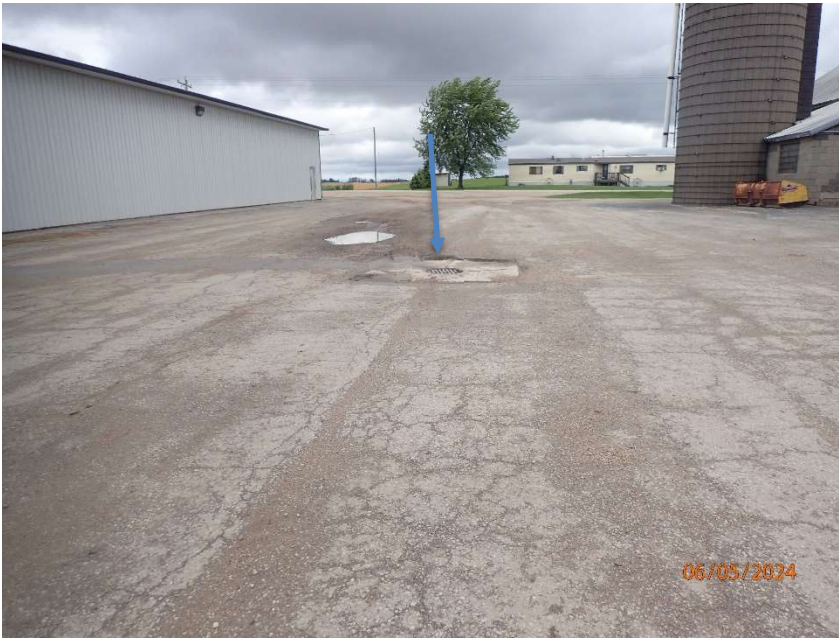
31: P6050688

Description: Additional stormwater surface drain inlet (blue arrow) east of the east end of the Commodity Barn.

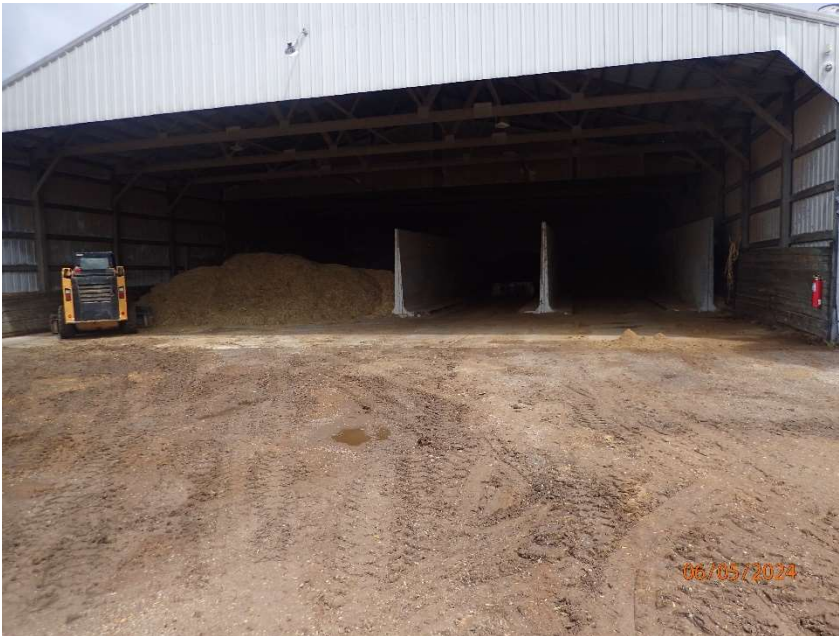
32: P6050689

Description: Looking north into the south end of the Commodity Barn where they store bedding.

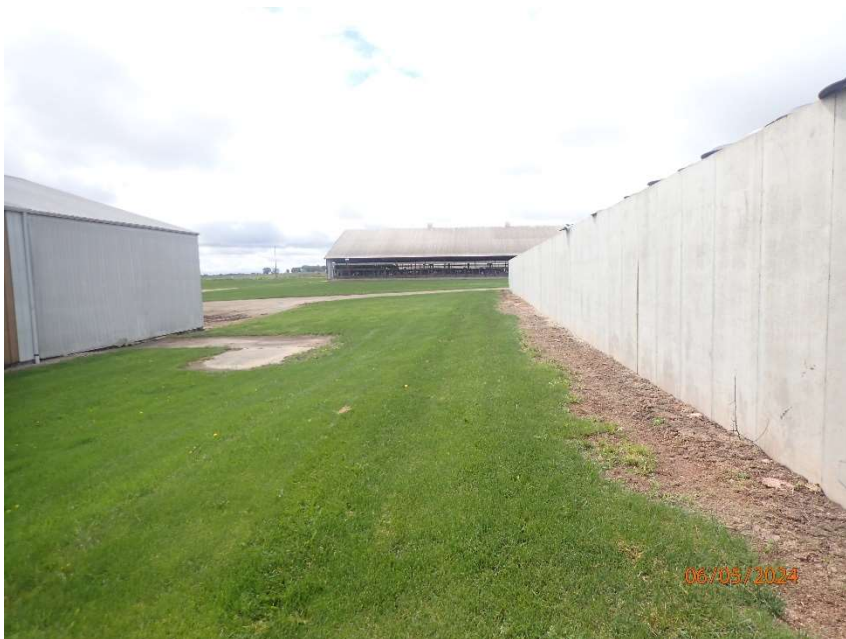
33: P6050690

Description: Looking south between bunker (right) and west side of the Commodity Barn (left).

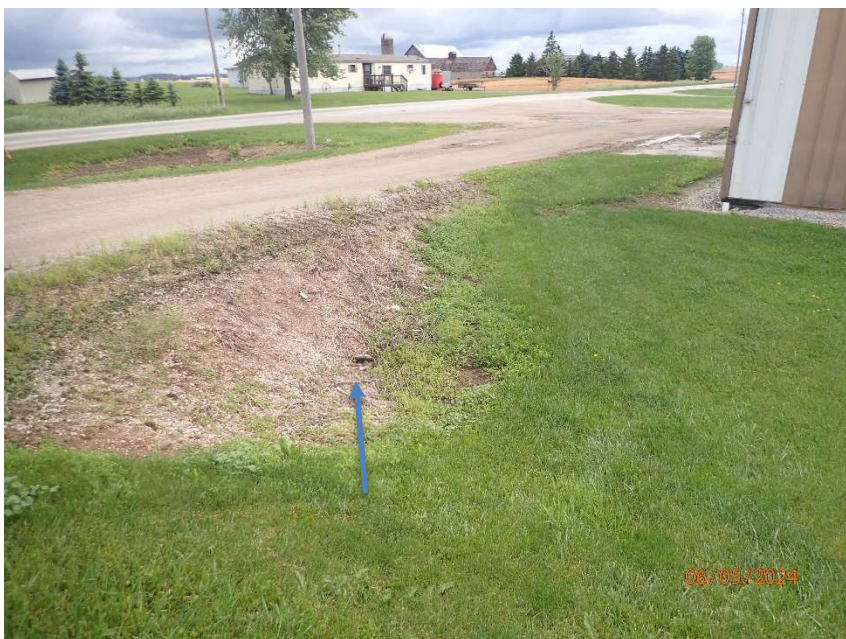
34: P6050691

The Inspectors walked south to the southern end of the Commodity Building and then north between the east side of the feed pad and the west side of the Commodity Building (photos 32 and 33). The Inspectors continued walking north and observed a pipe under the access road that could convey stormwater from the north end of the grassed area between the Commodity Building and the feed pad to the roadside ditch south of Luxemburg Road (photos 34 and 35).

Description: Inlet for stormwater culvert (blue arrow) under access road.

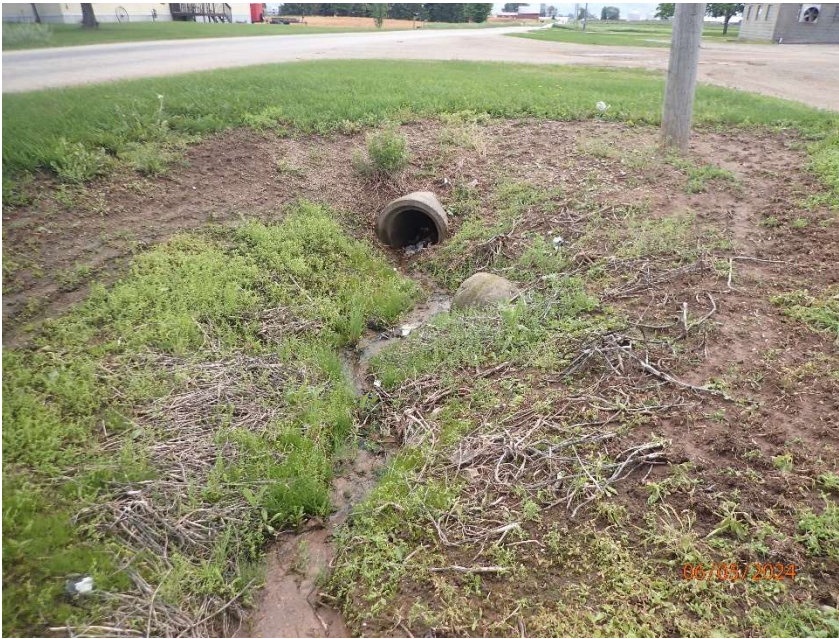
35: P6050692

Description: Outlet of stormwater culvert under access road to roadside ditch on the south side of Luxemburg Road.

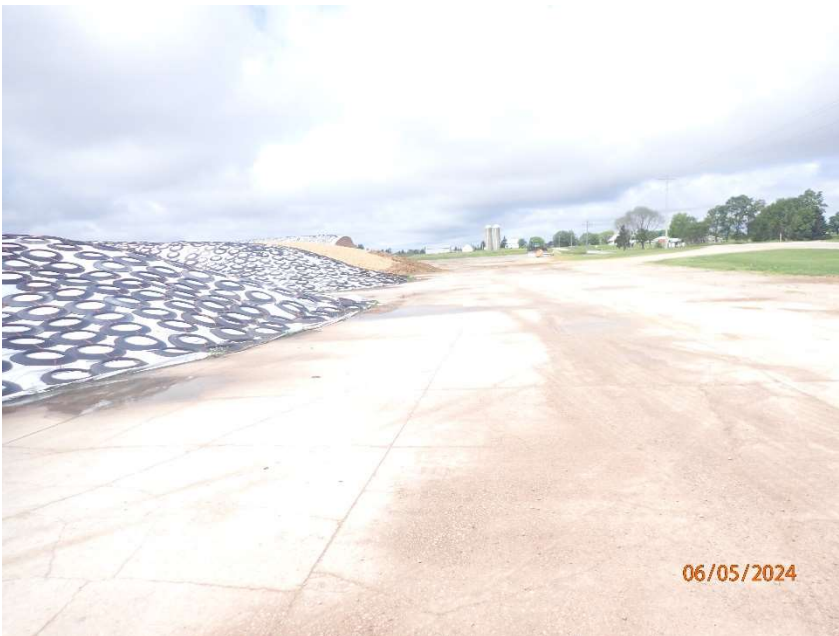
36: P6050693

Description: Looking west along the north side of the feed pad.

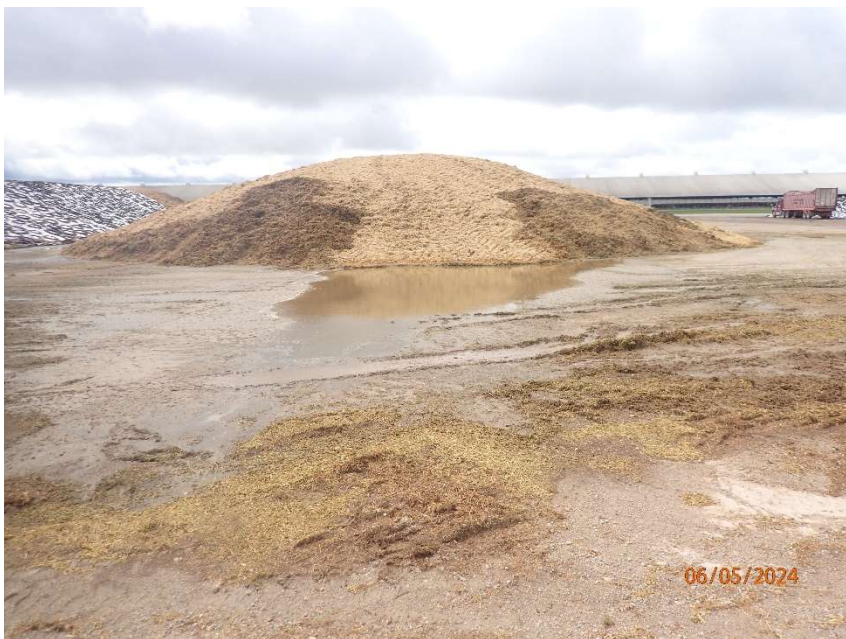
37: P6050694

Description: Looking south at a mound of feed not yet covered.

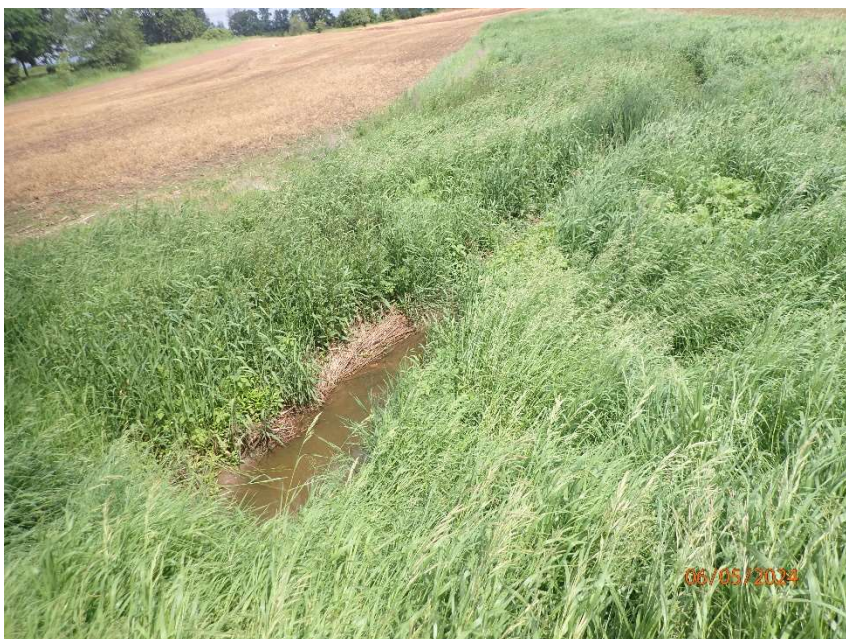
38: P6050695

The Inspectors then walked west across the north end of the feed pad and observed a pipe outletting on the north side of Luxemburg Road north of the northwest corner of the feed pad (photo 38). The Inspectors then walked south along the west side of the feed pad and observed two stormwater drain surface inlets in the grass between the feed pad and BK Line Road (photos 39 and 41). The Inspectors also observed an area where it appeared wind had blown feed over the berm of the feed pad (photo 40).

Description: Looking north downstream along the waterway on the north side of Luxemburg Road

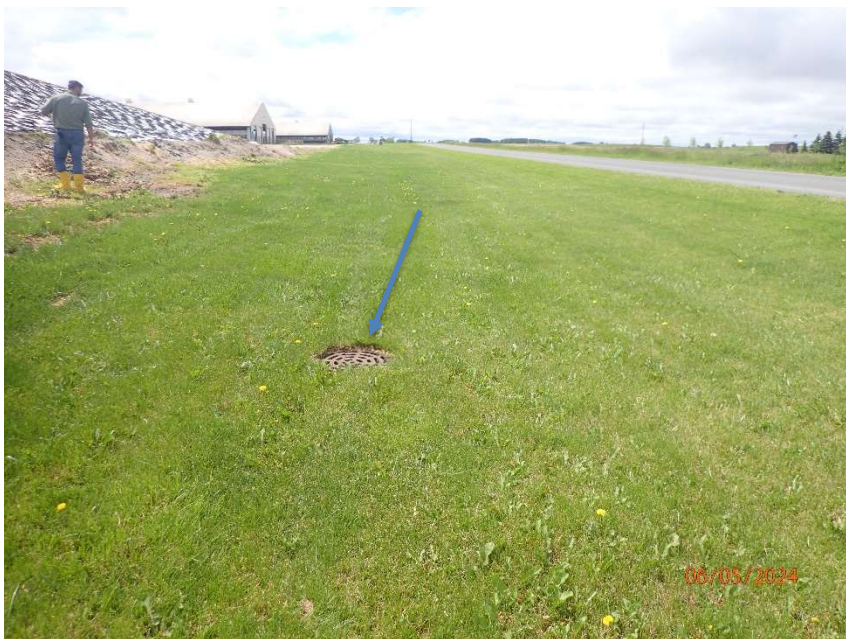
39: P6050696

Description: Looking south along the west side of the feed pad east of County Line Road. Note stormwater surface drain inlet (blue arrow).

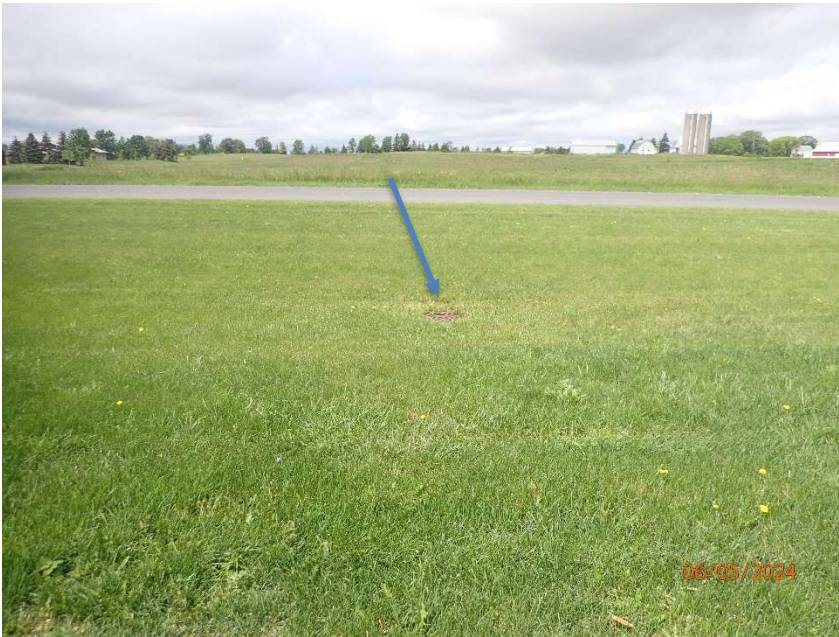
41: P6050698

Description: Stormwater drain surface inlet (blue arrow) in grass area west of the southwest corner of the feed pad.

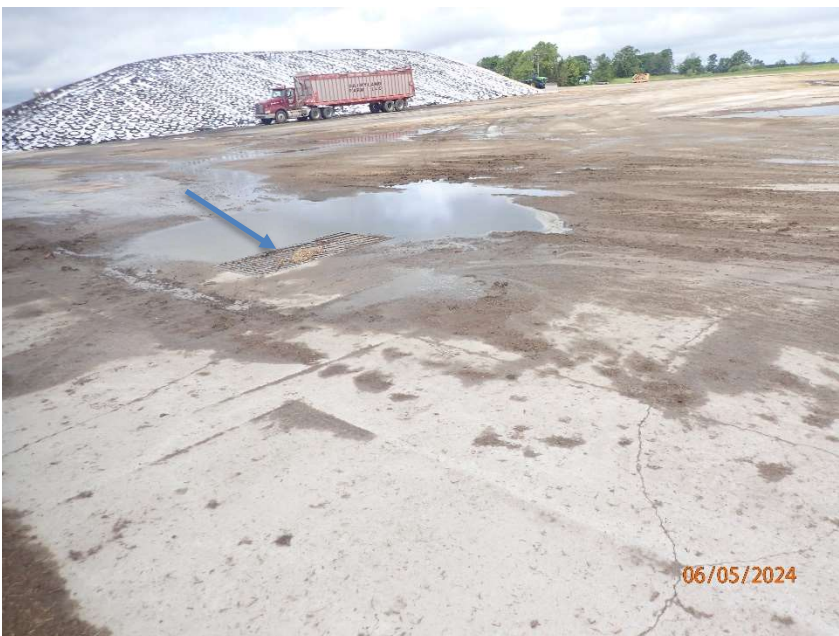
42: P6050699

The Inspectors then walked south to the southwest corner of the feed pad and then east. The Inspectors observed the runoff collection drain that collects the runoff from the feed pad (photo 42).

Description: Feed pad leachate collection inlet (blue arrow) on the south side of the feed pad.

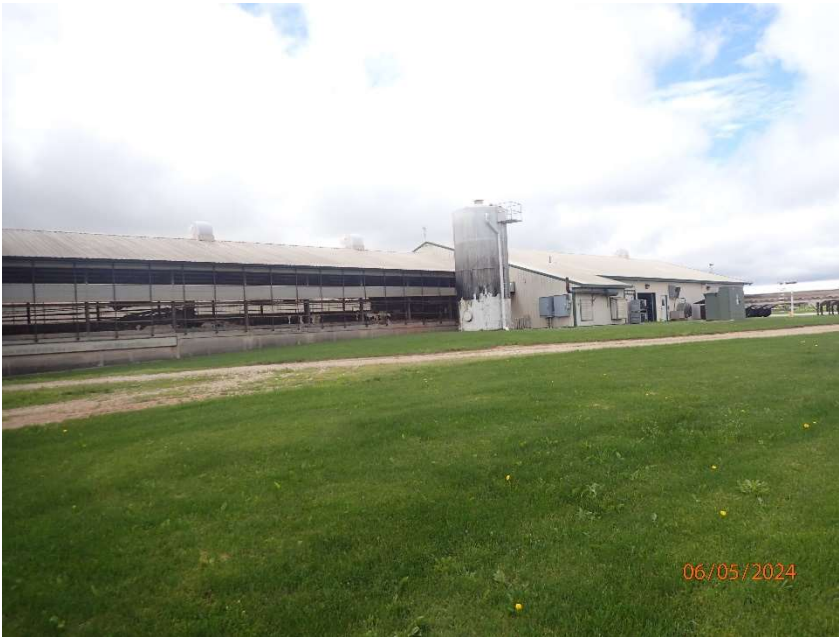
43: P6050700

Description: Looking southwest at the plate cooler water tank.

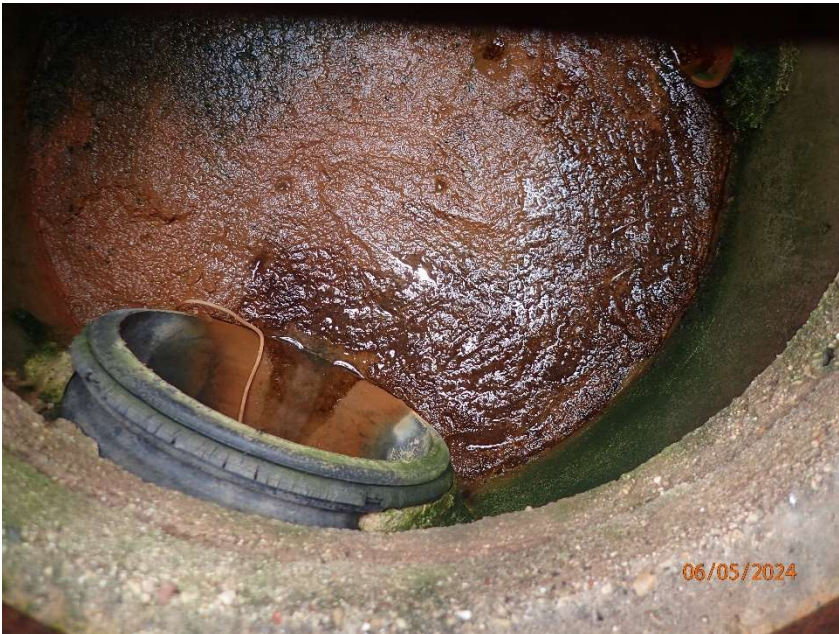
44: P6050701

Description: Looking down into interior of the stormwater drain at the east end of the grassed area between Barn 1 and the milking Parlor.

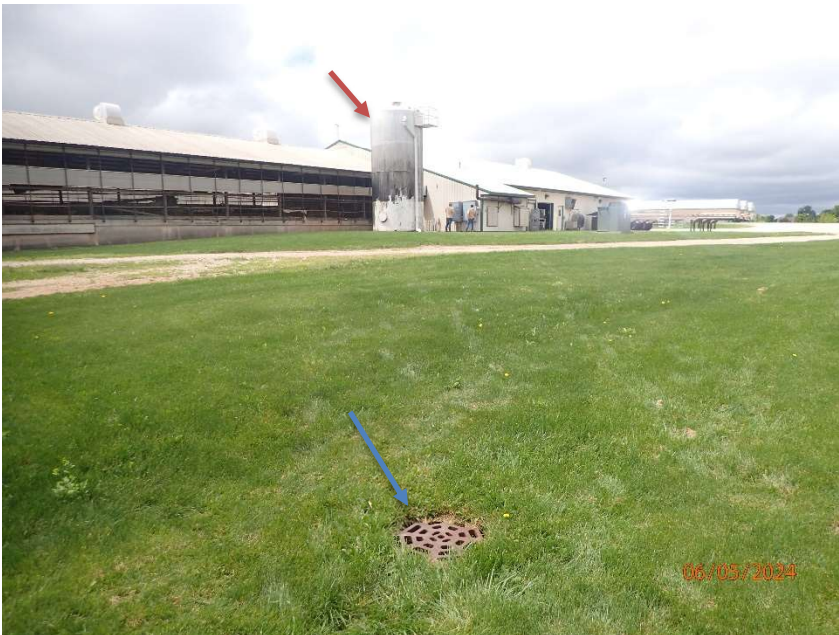
46: P6050703

The Inspectors then walked west around the west end of Barn 1 and then east to the east end of the grassed area between Barn 1 and the Milking Parlor. The Inspectors observed a stormwater drain surface inlet (photo 46). Inside the stormwater drain, the Inspectors observed a white pipe with trace wire entering the drain from the southwest (photo 45). The Inspectors walked southwest to the plate cooler tank and behind the tank they

Description: Looking southwest toward the plate cooler water tank (red arrow). Stormwater drain surface inlet in foreground (blue arrow).

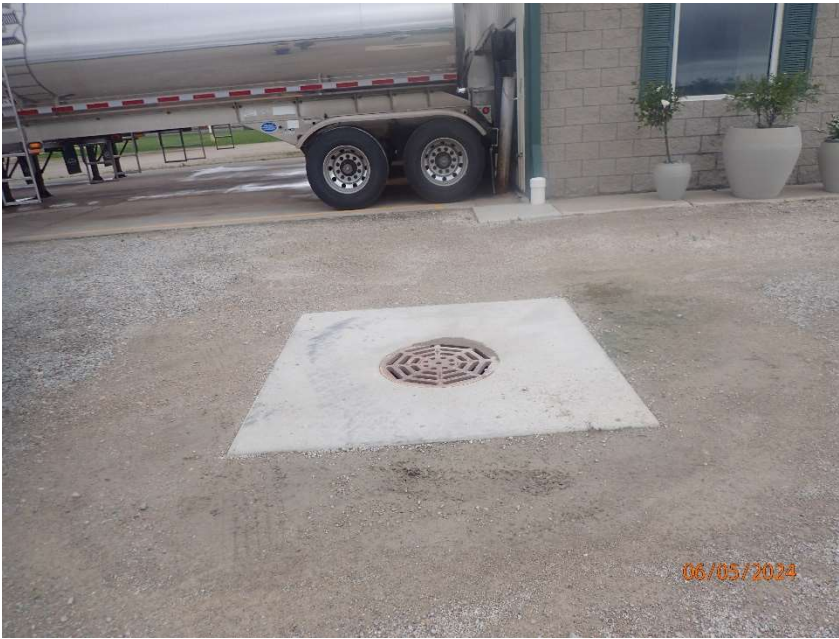
49: P6050706

The Inspectors then walked west and observed a surface drain near the milk tanker parking area (photo 48). The Operator stated that this drain was not connected to the rest of the storm water drains. This drain is collected and sent to storage. He stated that WDNR had required that this drain collect any milk tank wash water. The inspectors then walked south and observed a stormwater drain surface inlet near the northwest corner of the Milking Parlor (photo 49).

Description: Looking east at storwater surface drain inlet west of the northwest corner of the Milking Parlor.
