**Region 6 - Enforcement & Compliance Assurance Division**  
**INSPECTION REPORT**

| Inspection Date(s): | 06/08/2023 | |
| Regulatory Program(s) | AWIA/SDWA | |
| Facility Name: | <b>Cross County Rural Water System</b> | |

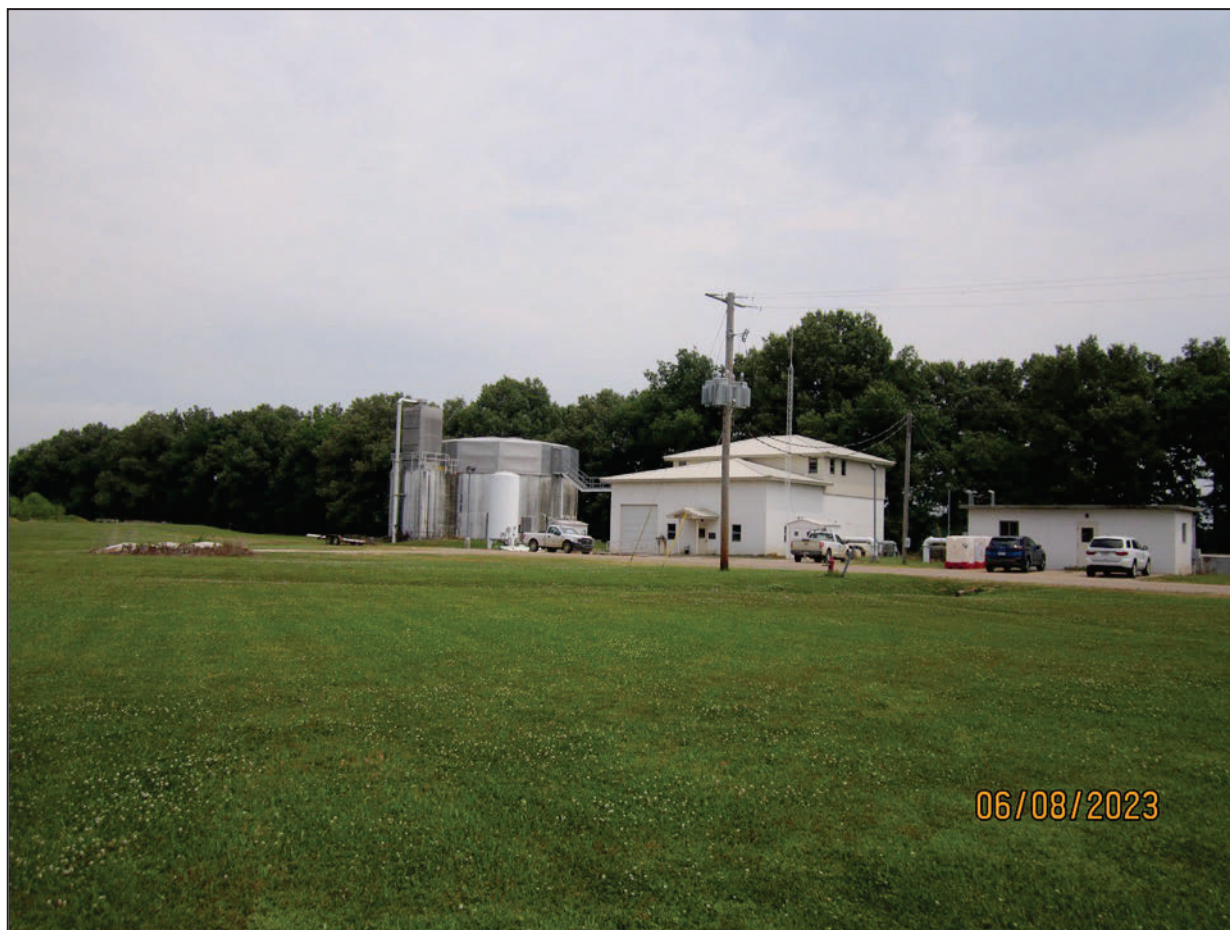
Photo No. 6

The tour then followed the raw water to the treatment process (refer to [Appendix 2, Photograph 6](#)). The raw water was run through one of two aerators. Both aerator units were operating (refer to [Appendix 2, Photograph 7](#)). The aerated raw water is then chlorinated as it flows to the clarifier. The raw water is also dosed with coagulant and caustic soda at the clarifier. The clarifier was not operating properly; there were heavy solids built up on the bottom of the unit and channeling was observed within the solids. The clarifier's rake arm was not operational and could not be located on the bottom of the clarifier. It was unclear if the rake arm was buried in the solids or if any of the solids were being drained to the sedimentation ponds (refer to [Appendix 2, Photograph 8](#)). In addition, there were heavy solids, bio-growth, and debris throughout the unit, including the troughs delivering produced water to the filters (refer to [Appendix 2, Photographs 9, 10, and 11](#)). The center of clarifier operational deck had maintenance materials and debris, including a grease gun on the deck (refer to [Appendix 2, Photograph 12](#)).

**Photograph 6. Water Treatment Plant** View of the aeration and clarifier structures, the chemical and filter building and the valve building supporting the clearwell's operations.

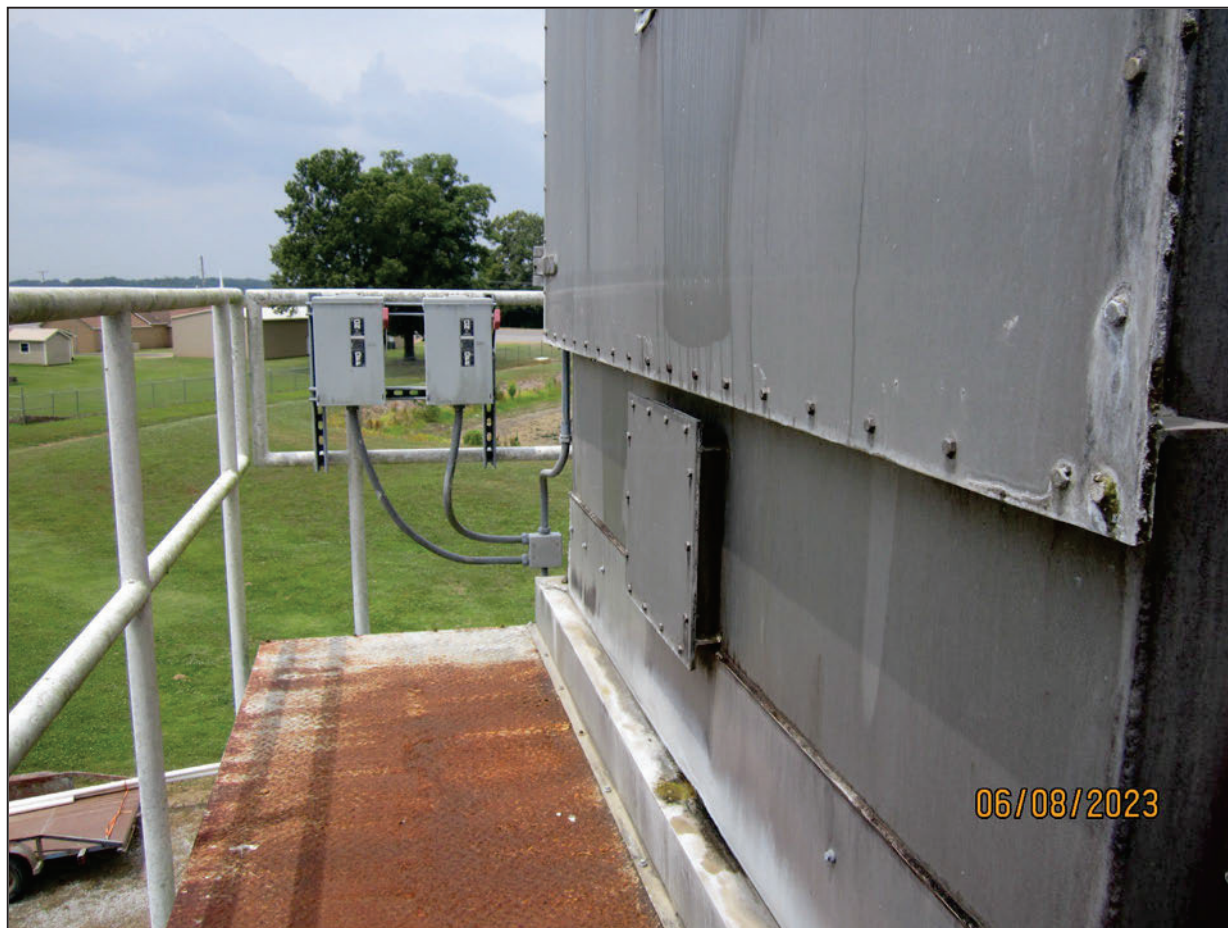
Photo No. 7

**Photograph 7. Water Treatment Plant, Aerators** View of one of the aerators and the control panel for both units. Both units were operating.
