Compliance Evaluation Inspection Report
Federal Reserve Bank of New York
100 Orchard Street, East Rutherford, NJ
07/23/2024

COMPLIANCE EVALUATION INSPECTION

Facility Name: Federal Reserve Bank of New York
Facility Address: 100 Orchard Street, East Rutherford, NJ 07073
Latitude & Longitude: 40.82888548908127, -74.09549109746908

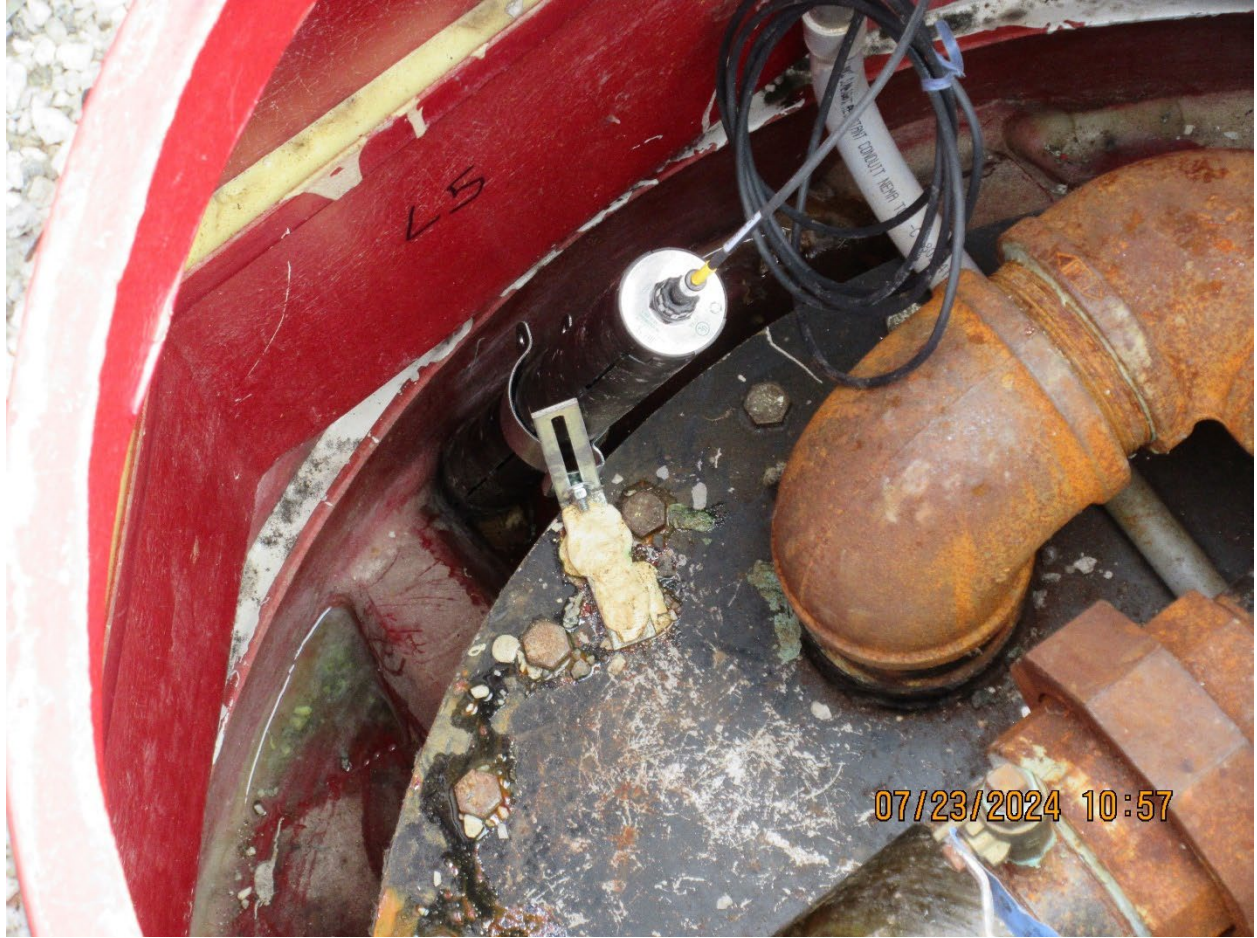
Photo #7

Tank 1, located furthest to the North, had a piping sump clear of any debris or water even after the day's heavy rainfall (Photo #6). The liquid sensor for the sump was located within a reasonable distance from the bottom to be able to detect leaks early (Photo #7). The pipes in these piping sumps are used for the tanks' connections to one another, as they were observed to be manifolded. The "Manway" sump, located directly next to it, was also dry and free from debris with its liquid sensor in an adequate position (Photo #8). The secondary fill port for tank 1 was next, and a flapper valve could be visually seen through the port with no significant debris or liquid present in the spill bucket (Photos #9 and 10). Next to this was a sensor sump with no observed concerns (Photo #11). Upon opening the turbine sump (Photo #12) there was a pungent smell of diesel vapors that was not present in the prior sumps, or the sumps looked at after. Mr. Anton explained these turbine sumps contained a diesel fuel filtration system. Besides the diesel vapor smell, the sump was observed in adequate condition, with no debris or water inside and the water sensor being properly positioned.

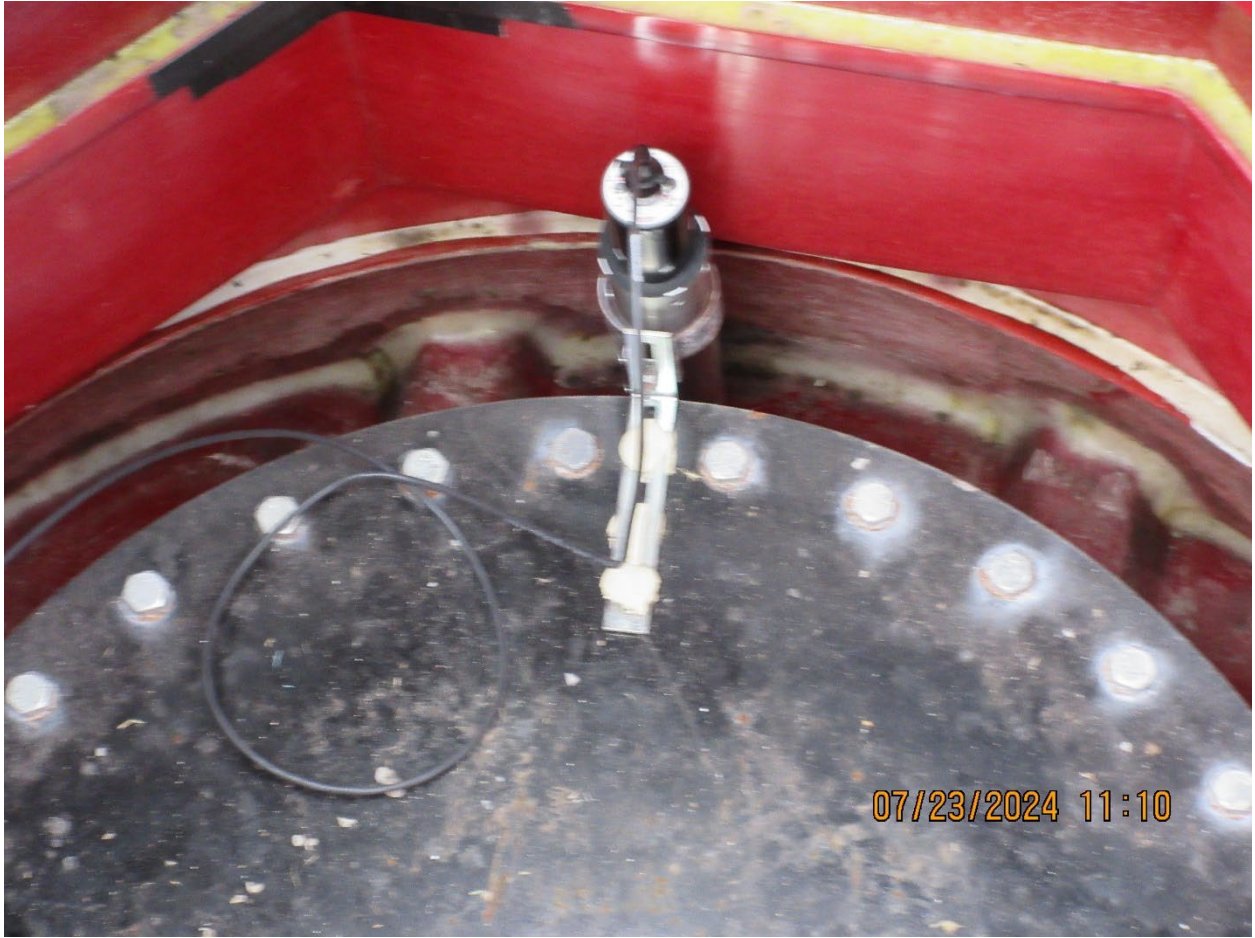
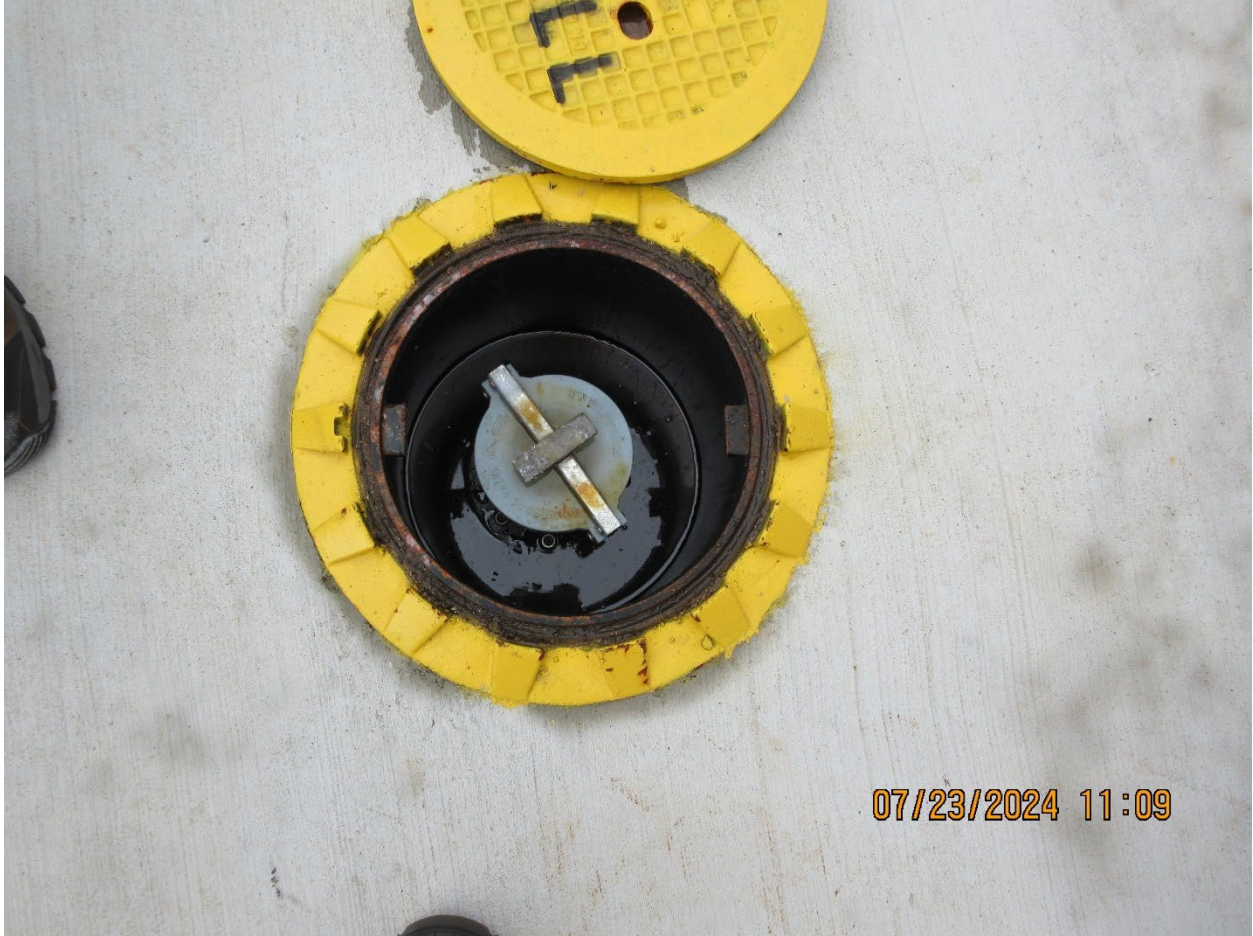
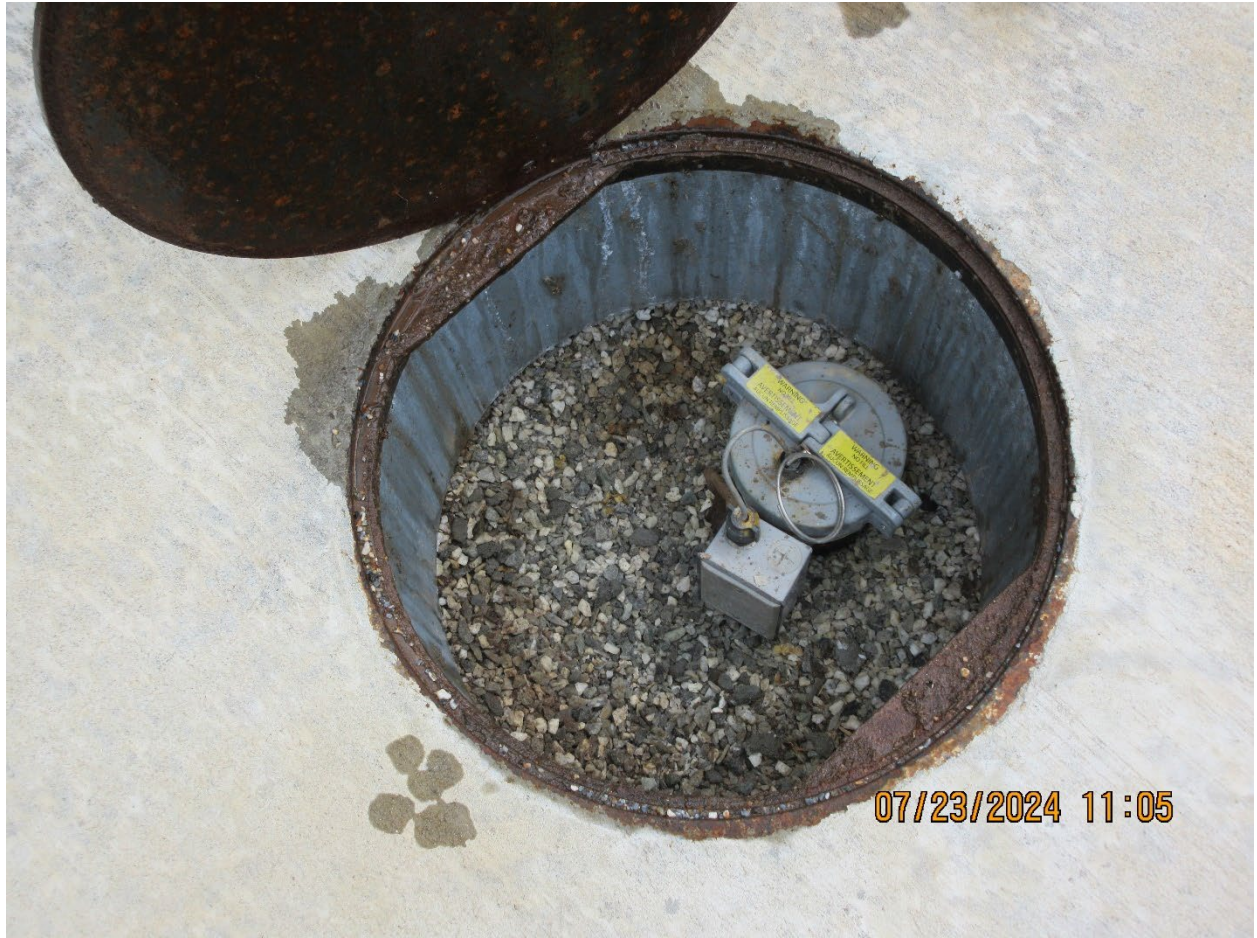
Tank 2, located around four feet to the right of tank 1, was observed to be in adequate order. The tank 2 piping sump was clear of any debris or water, and its liquid sensor was properly positioned (Photo #13 and 14). The "Manway" sump was also dry, free from debris, and had its liquid sensor in its proper position (Photo #15). The secondary fill port had the presence of some liquid in the spill bucket (Photo #16), but there was a rainfall event earlier in the day. The sensor sump next to the fill port had no observed concerns (Photo #17). The turbine sump for tank 2 was observed to be in adequate condition and lacked the strong smell of diesel tank 1's turbine sump had upon opening (Photo #18).

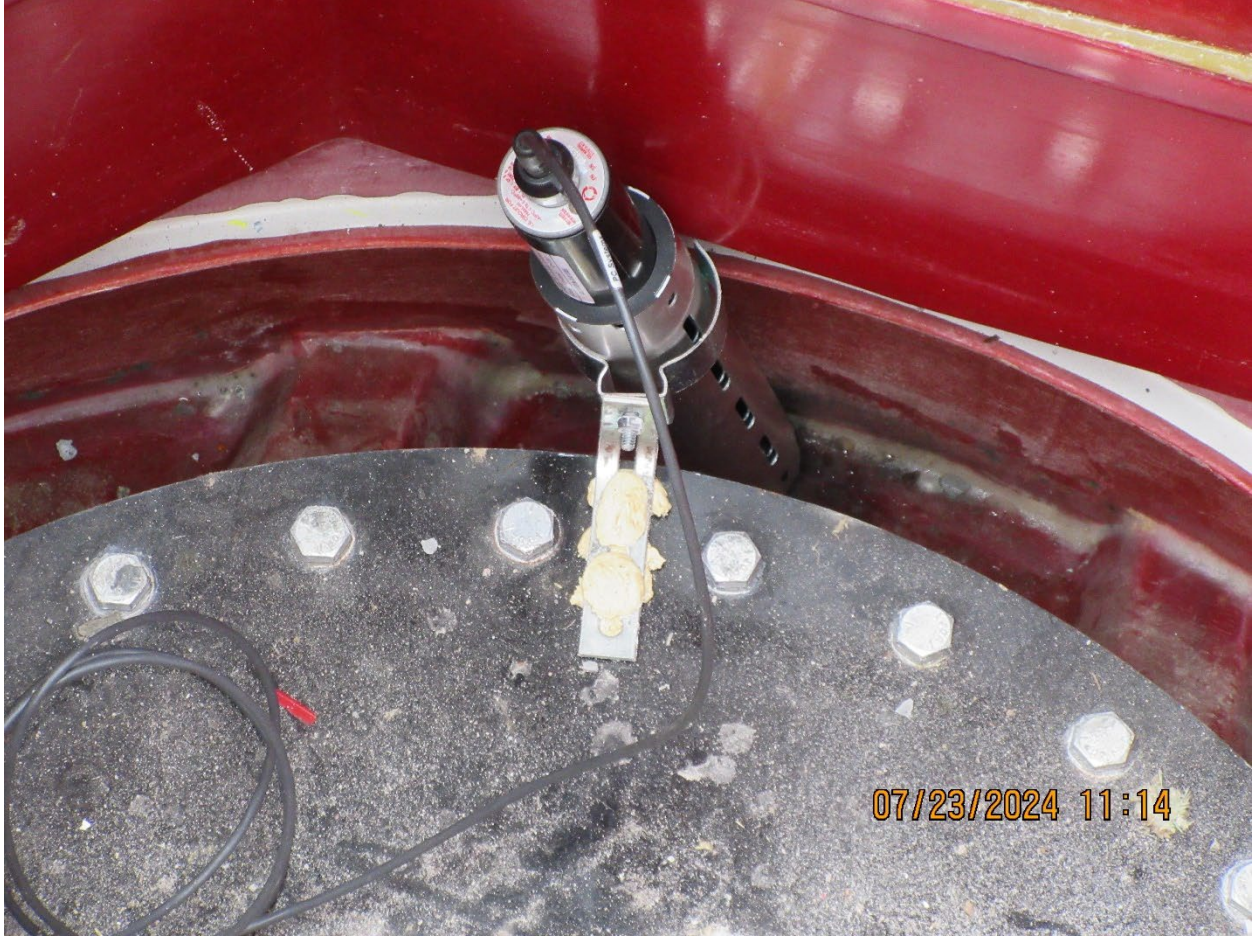
Photo #21

Tank 3 was located another three feet to the right of tank 2 and was not observed to have any concerns. Tank 3's piping sump was water and debris free while its liquid sensor was in the proper orientation and positioning (Photo #19 and 20). The manway sump was dry and free of debris as well, with its liquid sensor in an adequate position (Photo #21). Like tank 2, the secondary fill port for tank 3 had the presence of some liquid in its spill bucket. However, unlike tank 2, this liquid was observed to have a visible oily film on the surface (Photos #22 and 23).

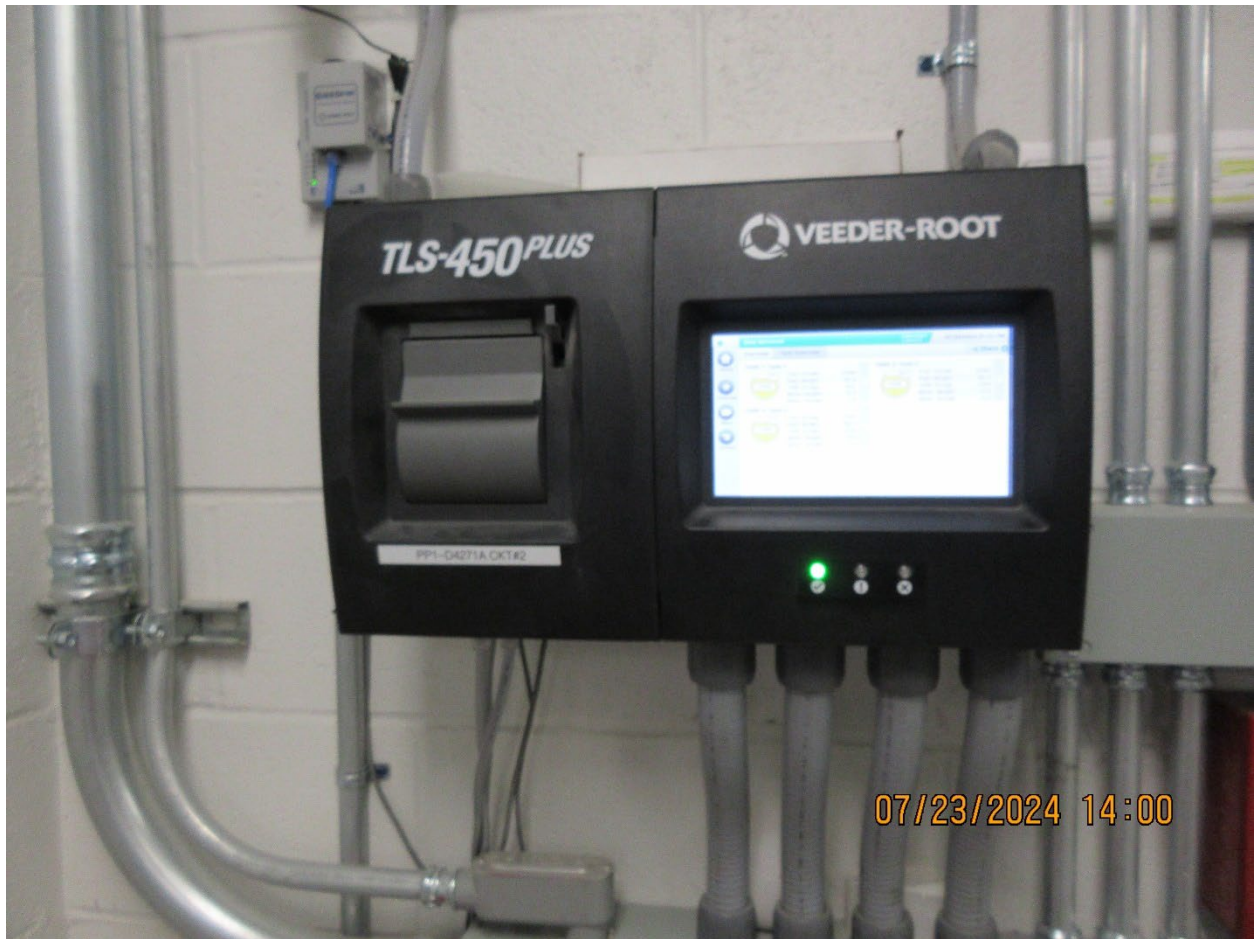
Photo #28

Underground pipes from the three USTs are directed to this room, where they transition into exposed above ground pipes and converge with the pumps and there is a concrete basin to collect any leaks (Photo #26 and 27). Records indicate that electronic leak monitoring is planned for this room, but not installed as of February 2024. The ATG was observed to be a Veeder-Root TLS-450 Plus and was located perpendicular to the pumps on the wall (Photo #28). The ATG showed no error message and indicated that all systems were normal (Photo #29). Unclear whether interstitial monitoring was in use for piping.
