# **Factors Influencing the Effective Life of Chainsaw Protective Legwear**

Mark J.M. Sullman,  
Liro Limited, P.O. Box 2244, Rotorua, New Zealand.  
email [REDACTED]@massey.ac.nz

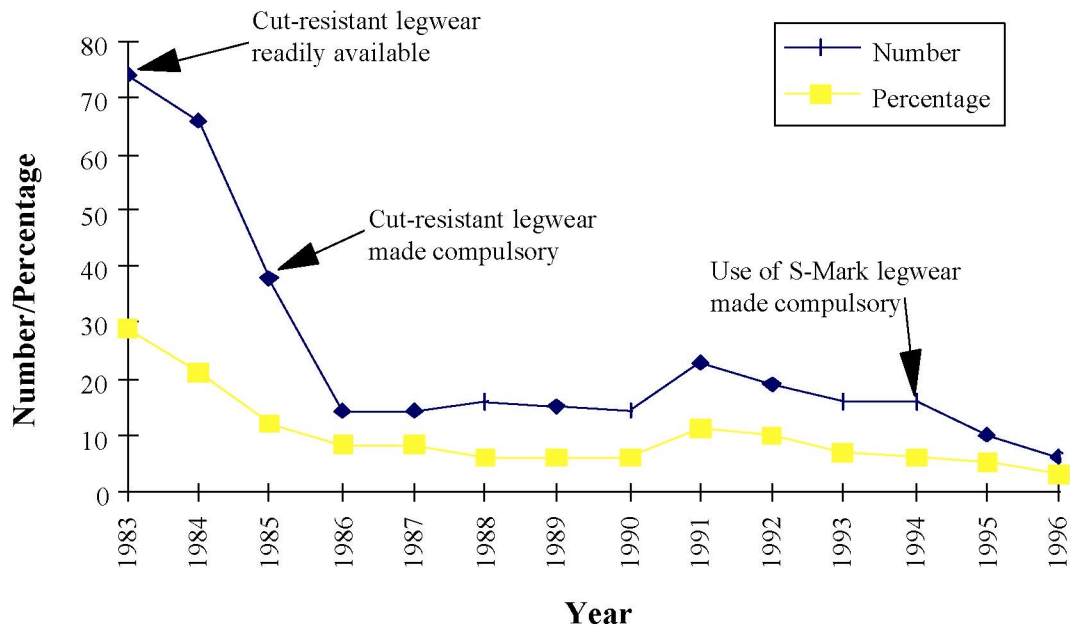
Figure 1 - Chainsaw cuts to the leg - 1983 to 1996

Figure 1 illustrates the proportion and number of all lost time injuries that were chainsaw cuts to the leg (a lost time injury is defined as an injury which causes a worker to miss the next scheduled full day's work). This shows an initial dramatic decline from 1983, where chainsaw cuts to the leg accounted for 29% of all reported lost time injuries, to 1986 where this figure was only 8%. This decline was attributed to the introduction and compulsory use of protective legwear [3].

Figure 1 also shows that from 1986 until 1994, chainsaw lacerations to the leg fluctuated between 6-11% of all reported lost time injuries. However, in 1994 the use of protective legwear with the S-mark was made compulsory in the New Zealand logging industry. S-Mark certification provides evidence that the legwear is certified to be of the level required by the New Zealand Standard [6]. The compulsory use of S-Marked legwear resulted in a further small decrease in the number and percentage of chainsaw lacerations to the leg. Figure 1 shows that the introduction of cut-resistant legwear and the S-Mark did not totally eliminate chainsaw cuts to the leg.
