**CAA Inspection Report**

**Inspection Date:** April 30, 2024

**Facility Name:** Municipality of Arecibo Landfill

**Facility Address:** PR-682 Interior, Bo. Factor, Garrochales Sector, Arecibo, Puerto Rico

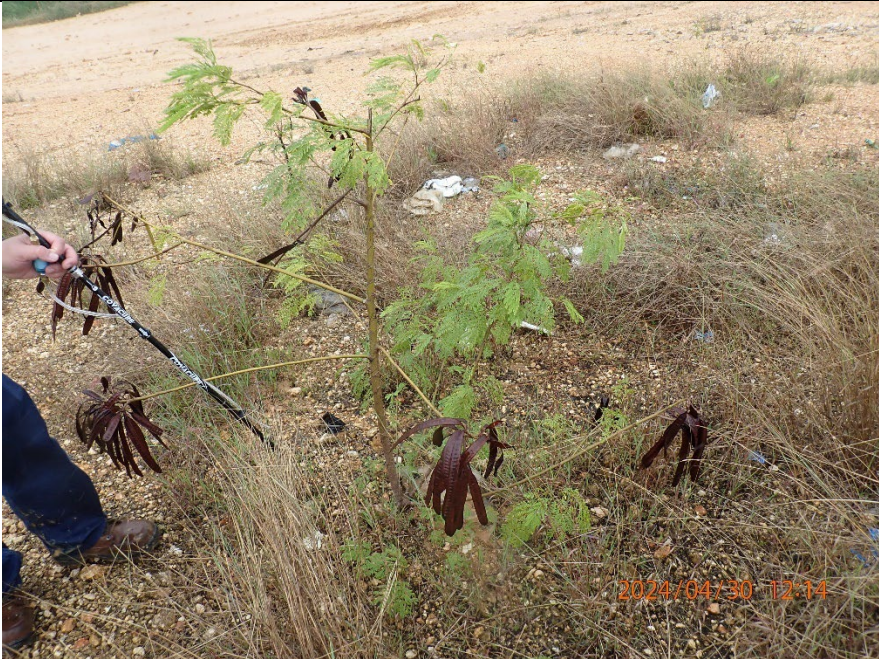
| 12 | P4300057.JPG | <p>Woody shrub</p> | 4/30/2024 | 1214 |

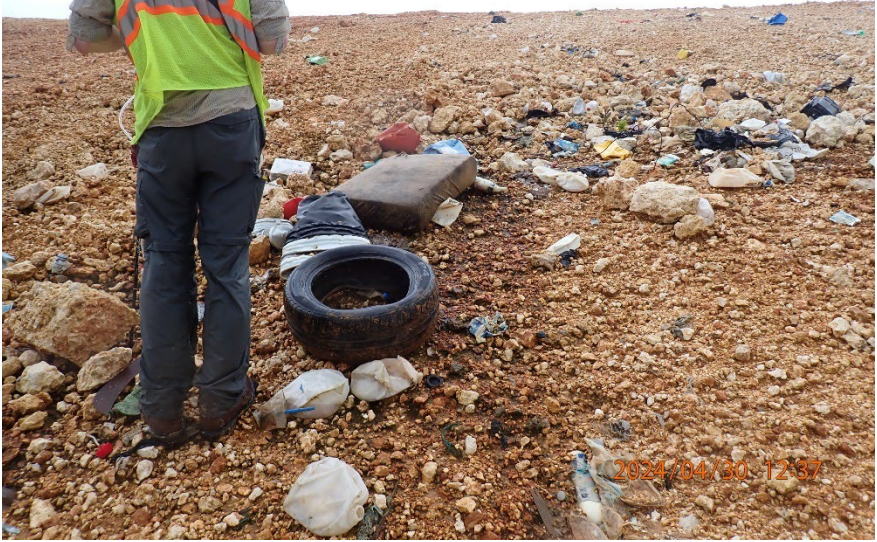
| 19 | P4300064.JPG | <p>Exposed waste</p> | 4/30/2024 | 1237 |

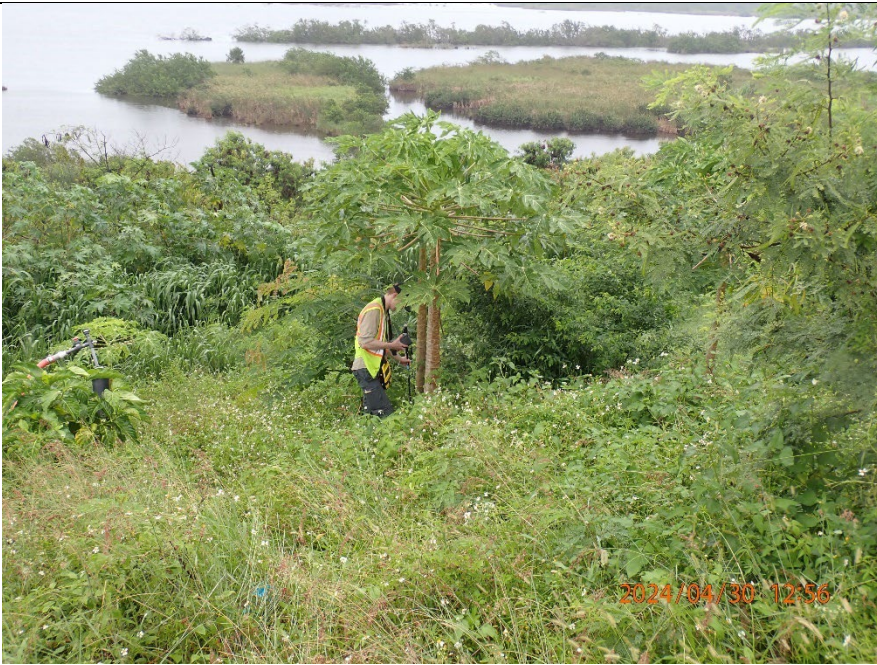
| 25 | P4300070.JPG | <p>2024/04/30 12:56</p> <p>EPA inspector next to a fully grown papaya tree</p> | 4/30/2024 | 1256 |

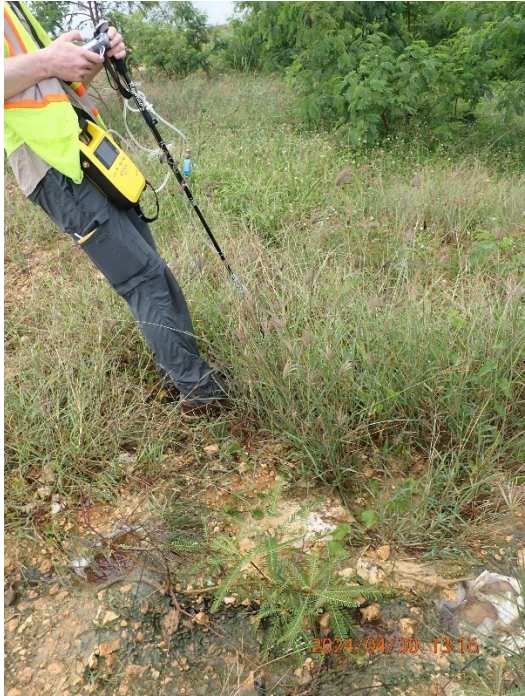
| 34 | P4300079.JPG | <p>Erosion exposed waste and vegetation</p> | 4/30/2024 | 1316 |

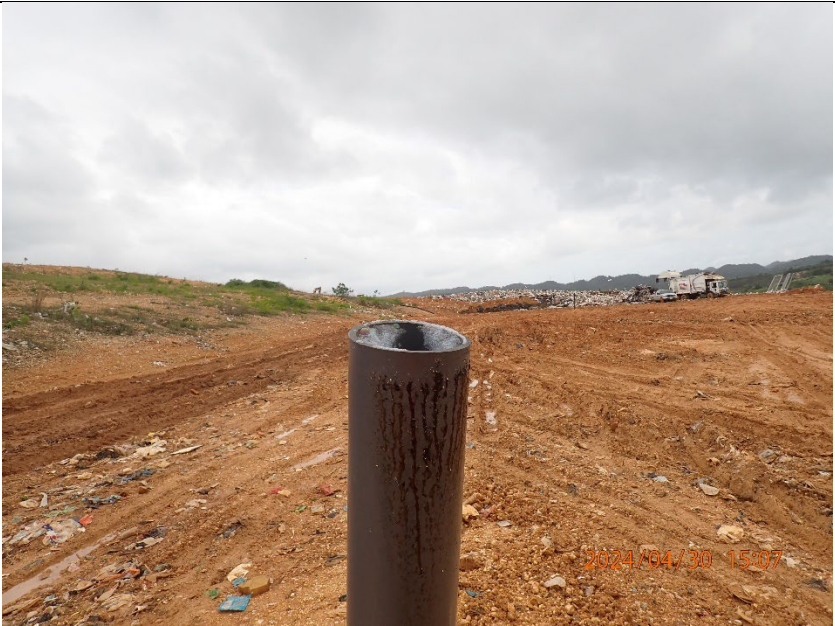
1. Significant number of uncapped GCCS wellheads found. The inspectors noted that it appeared to be a consistent practice for fully offline wells to be directly venting to atmosphere.

| 72 | P4300117.JPG | <p>Venting uncapped and disconnected landfill gas monitoring well (exceedance at base and top), showing condensation and bubbles at edge of opening</p> | 4/30/2024 | 1507 |

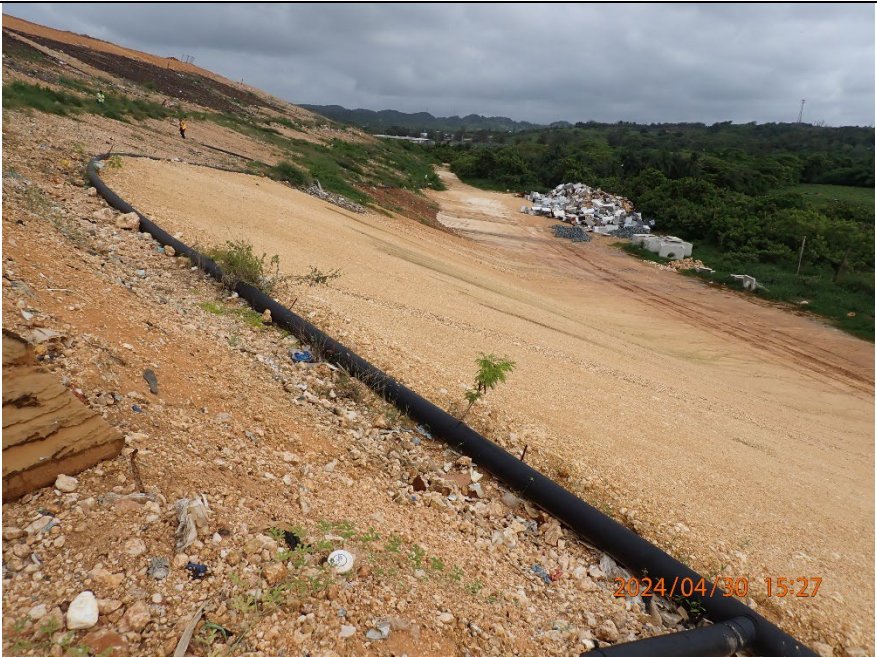
| 78 | P4300123.JPG | <p>South facing portion of the landfill and white good pile in background (upper right side)</p> | 4/30/2024 | 1527 |
