US Environmental Protection Agency – Region 2
 Caribbean Environmental Protection Division
 Response and Remediation Branch

Resource Conservation and Recovery Act (RCRA)

Facility Name:	DCN Administrative & Recycling Corp.		
EPA ID Number:	PRN008026791		
Date of Inspection:	August 18, 2022		
Generator Status in Record:	Non-Notifier		
Generator Status at the time of inspection:	SQG		
RCRA Permitted:	No		
Basis for Inspection:	Complaint		
Corrective Action:	No		
Project ID	CEPD-RCRA-22-0425		
Facility Physical Location: (Municipality, PR, zip code)	Bo. Martin Gonzalez, Sector La Palmita, PR Road - 887, km 0.9 Carolina, Puerto Rico 00985		
Geographical Coordinates:	18° 22' 58" N and 65° 58' 17" W		
Facility Owner:	Mr. Carlos Sanchez, President	(787) 257-5003	
	acordero@dncorporation.com		
	Mailing address: P.O. Box 744 Gurabo. Puerto Rico 00778		
Facility Operator:	Ms. Andrea Cordero, CEO	(787) 318-0598	
	acordero@dncorporation.com		
	Mailing address: P.O. Box 744 Gurabo. Puerto Rico 00778		
NAICS:	423930		
SIC:	5093		
Area:	6,735.6056 m ² (1.66 acres }		
Number Employees:	Approximately 11 (F/T)

Compliance Evaluation Inspection Report
DCN Administrative & Recycling, Corp.
EPA ID: PR

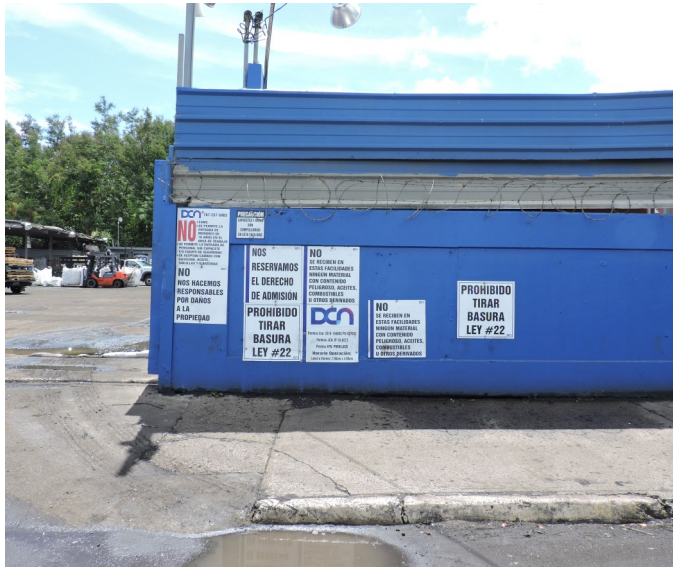
Picture 1 - DCN RECYCLING, CORP. — It is a 6,736 m2 scrap metal recycling facility located in Sector La Palmita, PR Road - 887, km 0.9 Carolina, Puerto Rico.

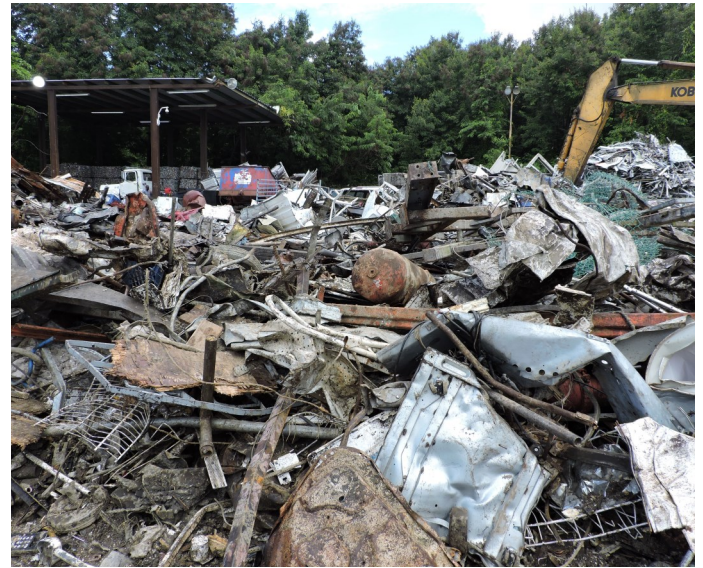
Picture 2—DCN RECYCLING, CORP. - The Facility operates as a scrap metal recycler processor and exporter of ferrous and nonferrous metals to China, Korea, Panamá and United States.

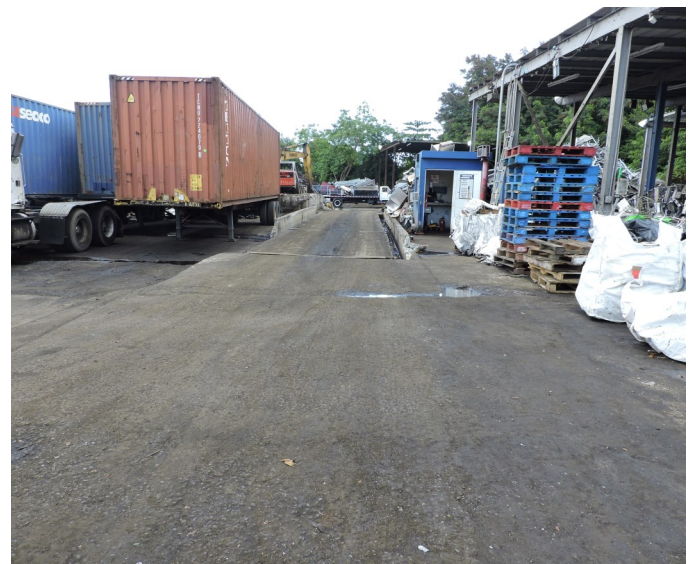
At the north side of the Facility there is a residential community known as Martin Gonzalez Ward, Sector La Palmita. As recorded at the Facility, any fluids generated from rainwater or auto crushing operations flow into the ground and downgradient towards the community and into an unnamed creek which is located north of the property edge (see **Picture 5**) which then flows into the Blasino Channel. Runoff would be expected to contain transmission fluids, gasoline, diesel, motor oil, antifreeze/coolant, windshield washer fluid, refrigerants, brake fluid, lead, and mercury. As evidenced during the Inspection, all mixed fluids generated from crushing and compacting operations are trapped into a metal tray-typed and collected with absorbent materials. Once the tray is full, it leaks onto bare soils and flow downgradient and off the property (see **Pictures 6 and 7**).

Picture 7—DCN RECYCLING, CORP. - As evidenced during EPA Inspection, once the tray is full, it leaks onto bare soils and flow downgradient and off the property.

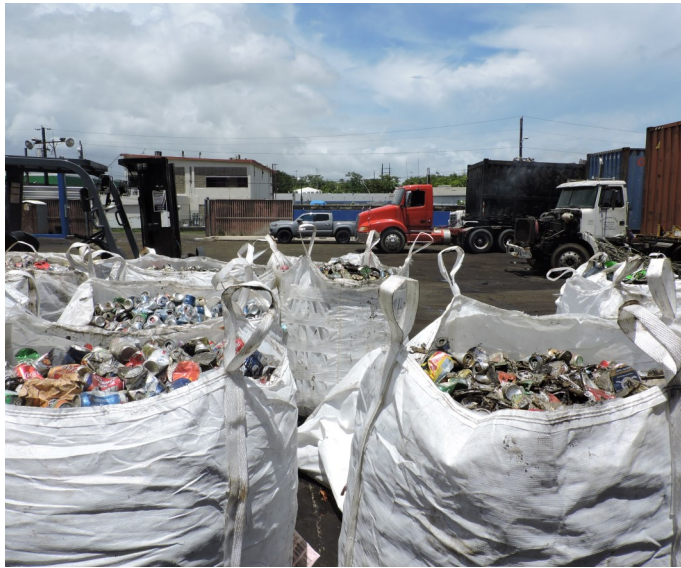
Picture 9- DCN RECYCLING, CORP. — The weighing scale station area is located at the center of the property. A loading concrete pad area is located north of the entrance where all scrap metals are collected and segregated according to material properties.

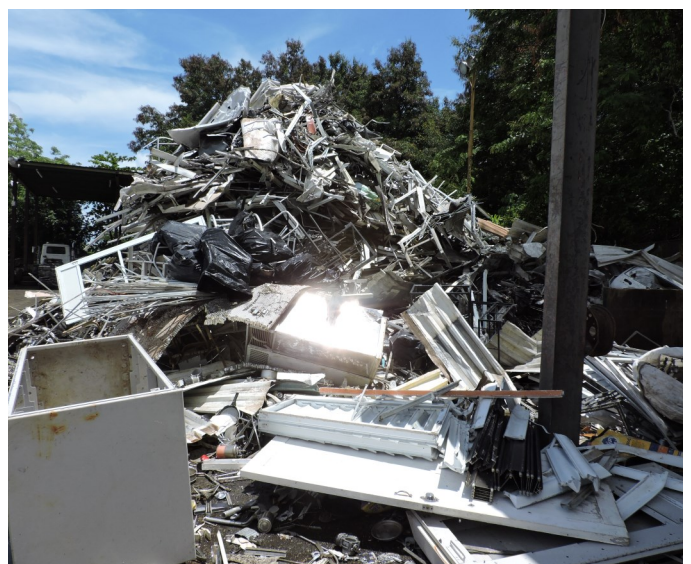
The EPA Inspector proceeded to inspect the Compacting Aluminum Accumulation Area in which all aluminum scrap metals are collected and processed in this area. The area consisted of steel shed with concrete pad in which a weighting scale is also used before and after segregating all aluminum metals before being transfer into 1-cy textile bags (see **Picture 12**) As observed by the EPA Inspector aluminum scrap metals are first segregated by metal properties (i.e., aluminum cans), crushed with compacting machines to reduce metals size, and then immediately transferred to 1-cy white cloth bags (see **Picture 13**). Observations recorded at the Compacting Aluminum Accumulation Area included:

Picture 12 - DCN RECYCLING, CORP. - The Aluminum Accumulation Area consisted of steel shed with concrete pad in which a weighing scale is also used before and after segregating all aluminum metals before being transfer into 1-cy textile bags.

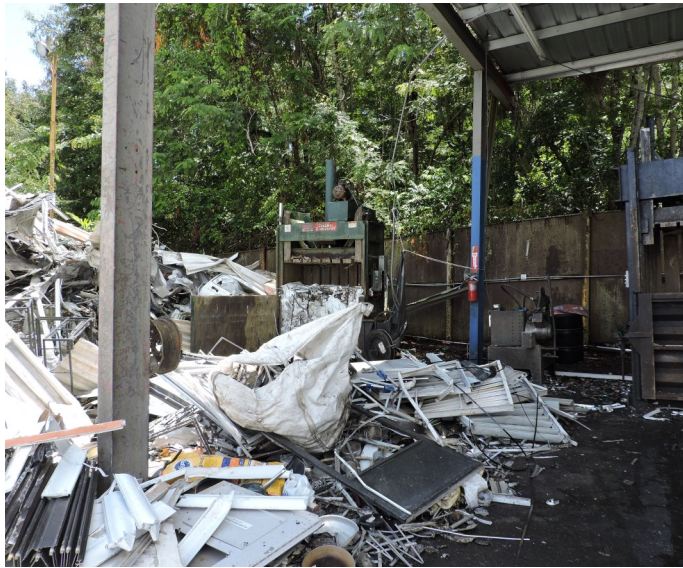
Picture 13- DCN RECYCLING, CORP. - EPA Inspector observed aluminum scrap metals are first segregated by metal properties (i.e., aluminum cans), crushed with compacting machines to reduce metals size, and then immediately transferred to 1-cy white cloth bags.

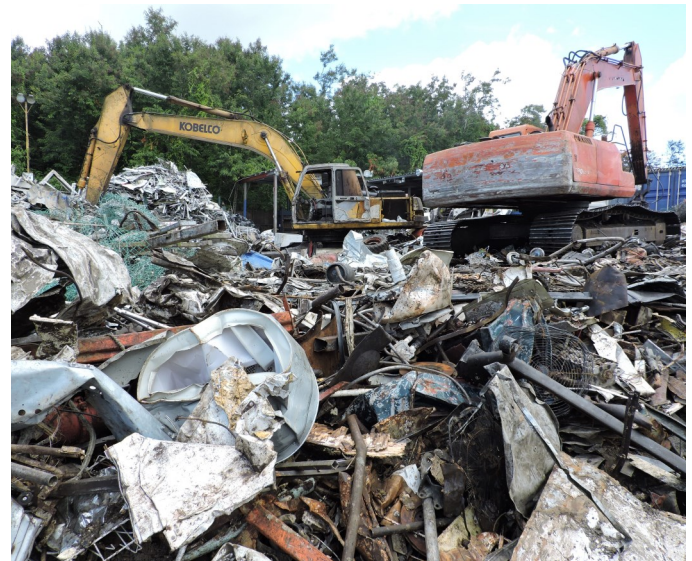
Picture 24 - DCN RECYCLING, CORP. - As observed by the EPA Inspector at the Ferrous Metal Collection Area, scrap metals are first segregated by metal properties, crushed with the excavator to reduce metals size, and then immediately sent to the cargo trucks.

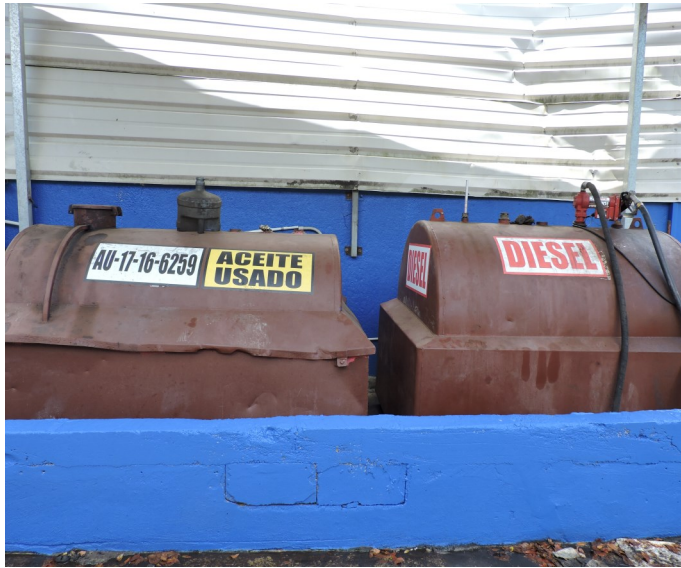
The EPA Inspector proceeded inspect the Fuel and Used Oil Storage Area. This area consisted of a metal shed with a ceiling and a secondary containment system and housed two (2) 500-gallon above ground-double wall tanks to store used oils and diesel clearly labeled (see **Picture 29**). The 500-gallon used oil tank was labeled with the Spanish words, “Aceite Usado,” (which is the translation for “Used Oil”). All leaking fluids from the crushing machine operations are stored in this tank. There was an EPA’s concern during the Inspection that runoffs from the Facility were accumulated at this location during rain events and were discharged directly toward a nonfunctional sump and then into the sidewalk curb nearby water creek located northwest of the property edge (see **Picture 30**). As observed during the Inspection, the Facility provided with absorbent materials around the used oil storage area to reduce the sediments and other debris that might be carried out by the stormwater. However, the EPA Inspector informed Ms. Cordero that absorbent materials would not control or prevent releases of used oil or stormwater run-off contaminated with transmission fluids, gasoline, diesel, motor oil, antifreeze/coolant, windshield washer fluid, refrigerants, brake fluid, lead, and mercury.

Picture 29 - DCN RECYCLING, CORP. - As observed, the Fuel and Used Oil Storage Area consisted of a metal shed with a ceiling and a secondary containment system and housed two (2) 500-gallon above ground-doble wall tanks to store used oils and diesel clearly labeled.

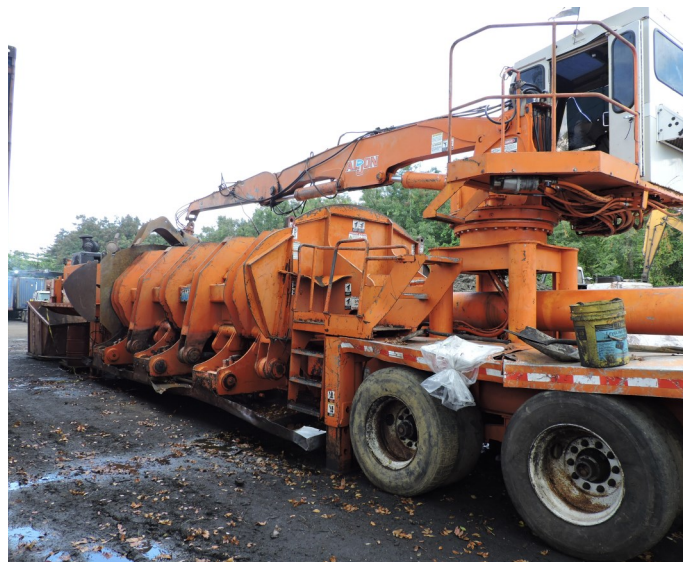
The EPA Inspector proceeded to inspect the Compacting Cars Area where crushing and bailing of junked cars is performed. The area consisted of an outdoor bare soil in which an ALJON 580 CL machine (i.e., crusher, bailer) is sited (see **Picture 32**). The machine has the capacity to manage over twenty (20) vehicles per day. Once the vehicles are placed in the area, the machine is turned on and all the cars along with other scrap metals are shredded and bailing into small metal blocks for further processing or final reclaiming. As observed during the Inspection, large amounts of scrap metal piles, and burned junked vehicles were accumulated in this area. According to Ms. Cardona, the crushing machine has been broken since July 2022, and will be repaired very soon. She added that the Facility used to crush around twenty (20) cars per day and to continue processing all accumulated scrap metals once the machine is fixed and operational.

Picture 32 - DCN RECYCLING, CORP. - The EPA Inspector proceeded to inspect the Compacting Cars Area where crushing and bailing of junked cars is performed. using an ALJON 580 CL machine (i.e., crusher, bailer) at the site.
